# Remediation Verification Report for a New Music Block, Martin Harris Centre for Music and Drama, University of Manchester

## Prepared for J Greenwood (Builders) Ltd

**10/2084.1/001 Rev. 0**

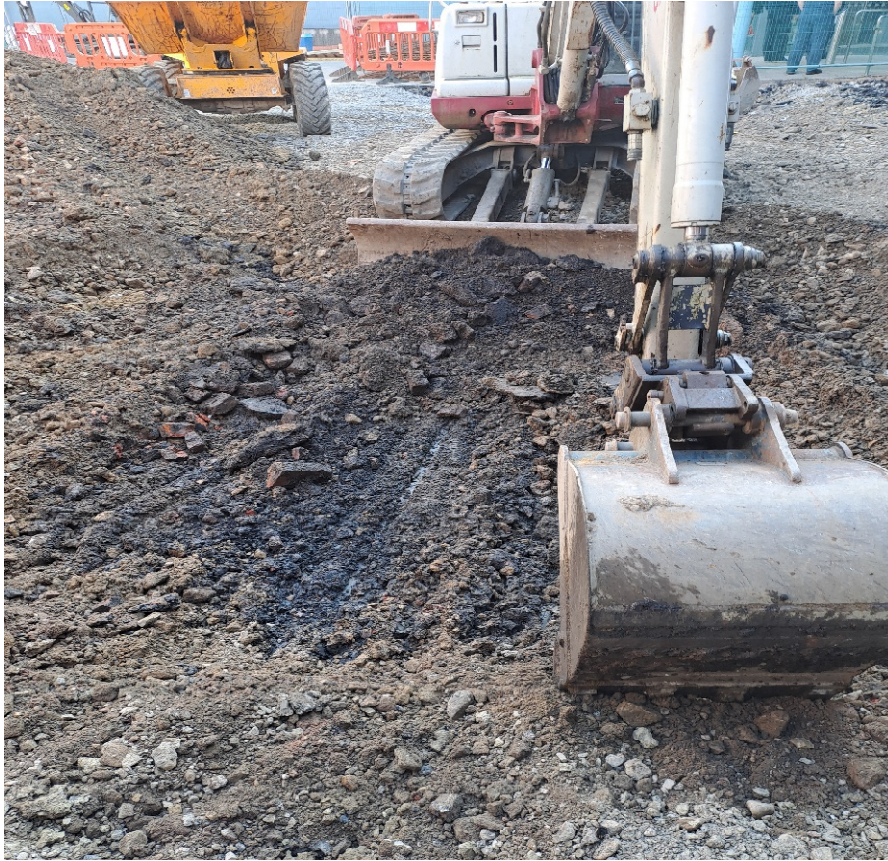
**Photograph A** – Image taken in the south western corner of the site facing east. Image showing black hydrocarbon staining within the Made Ground soils on site, subject to excavation.

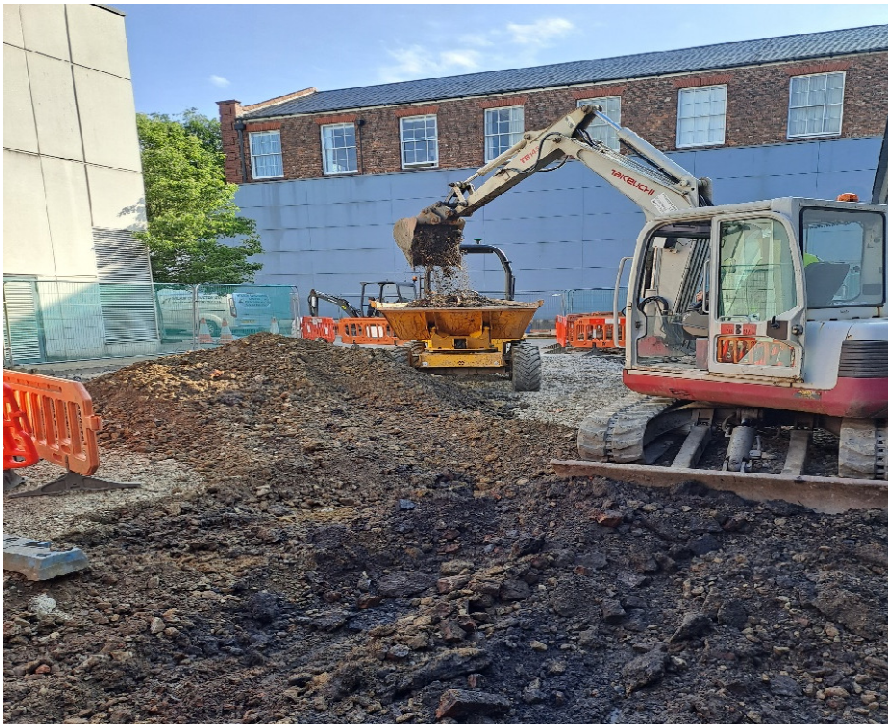
**Photograph B** – Image taken in the south western corner of the site facing east. Image showing the black hydrocarbon-impacted soils being excavated directly into a dumper headed for a offsite stockpile.

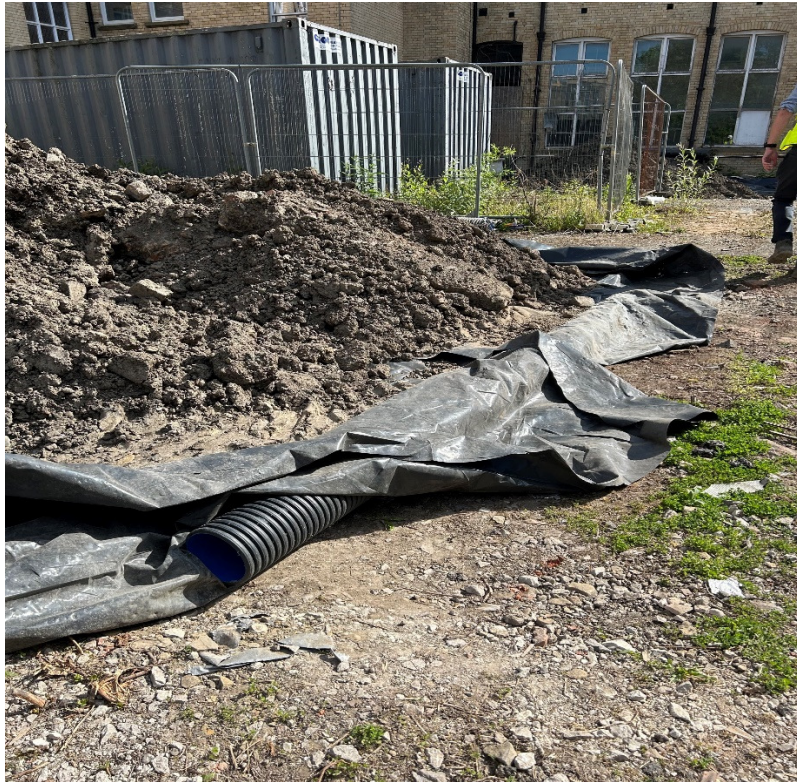
**Photograph C** – Image taken offsite. Image showing banded stockpile of contaminated soils ready for removal to landfill.

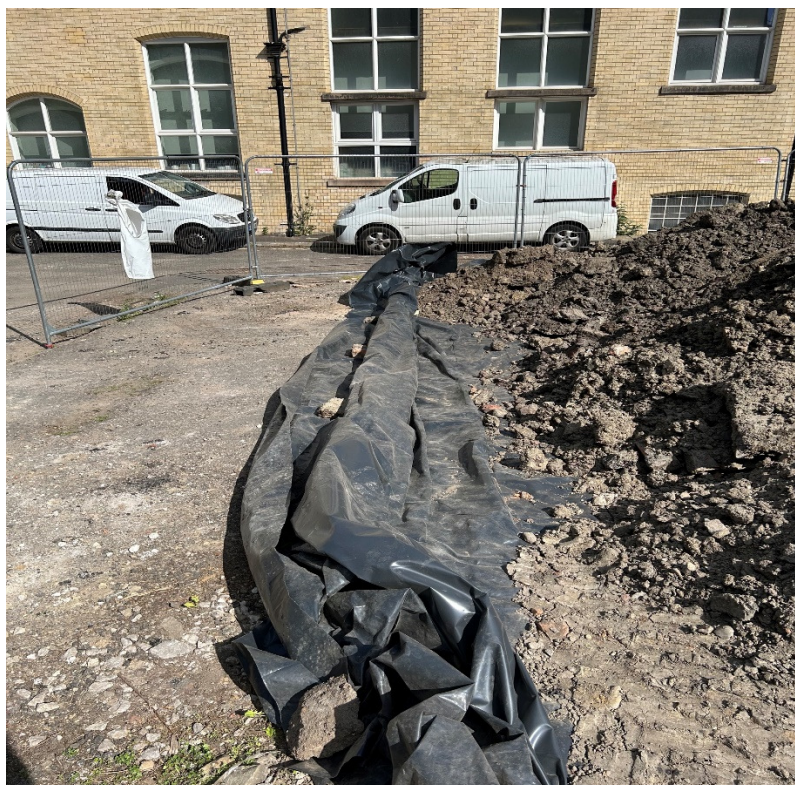
**Photograph D** – Image taken offsite. Image showing banded stockpile of contaminated soils ready for removal to landfill.

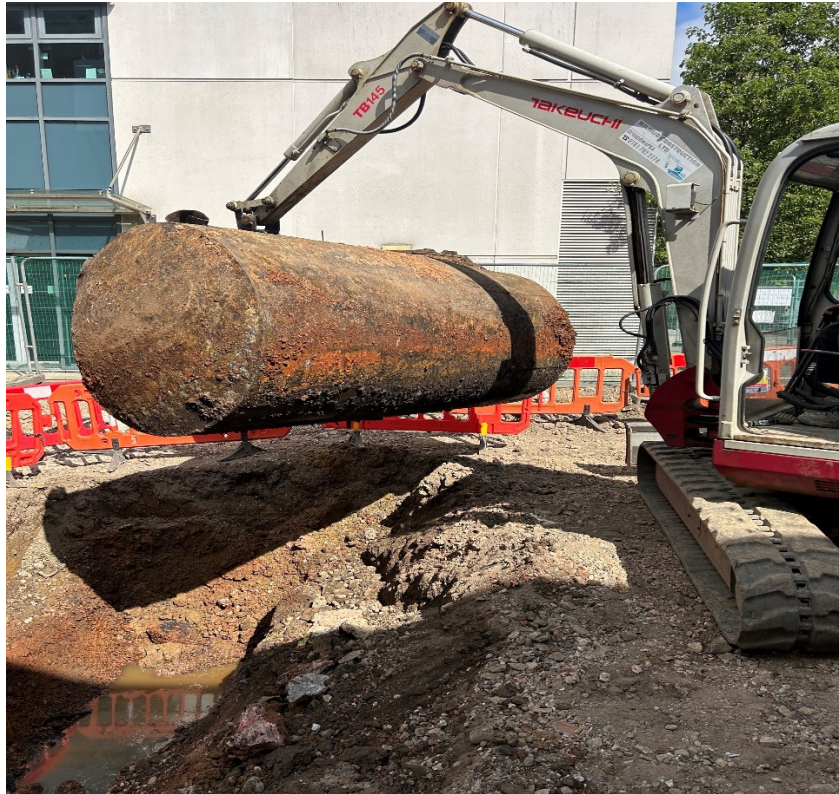
**Photograph E** – Image taken south of site facing north. Image showing the removal of the steel tank on site.

During the excavation works, a previously undiscovered below ground tank was encountered in the central part of the site, as shown in the Verification Plan. The tank was subsequently emptied by a licensed contractor (Mantank) before being removed. Details of the tank's excavation are presented in Section 6.1 below.

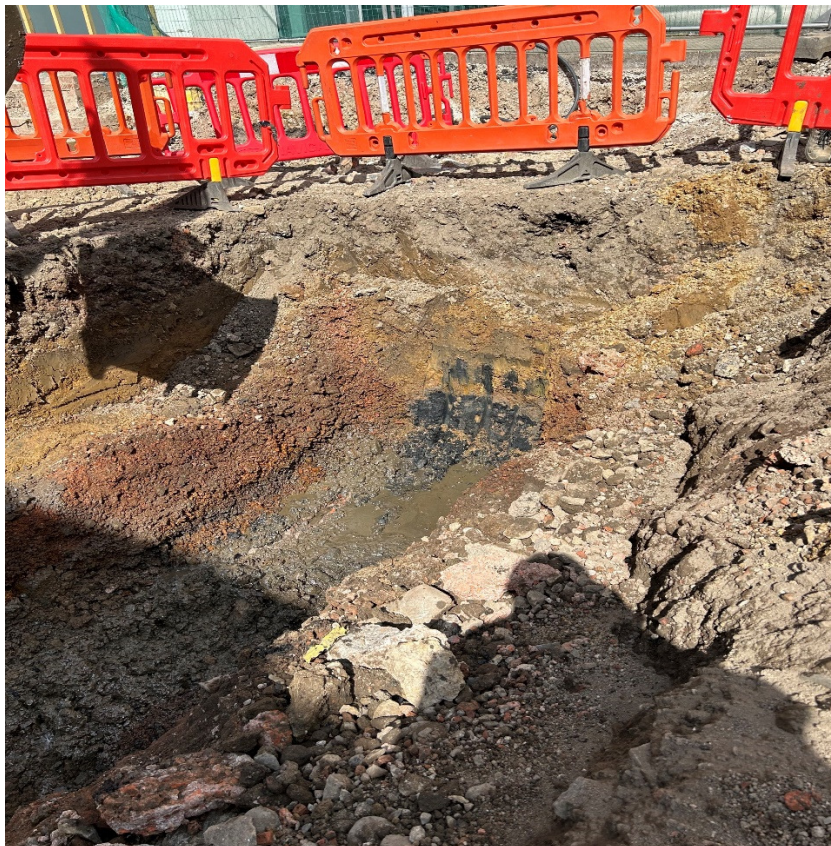
**Photograph F** – Image taken south of site facing north west. Image showing the resulting hydrocarbon impacted soils after the removal of the tank.

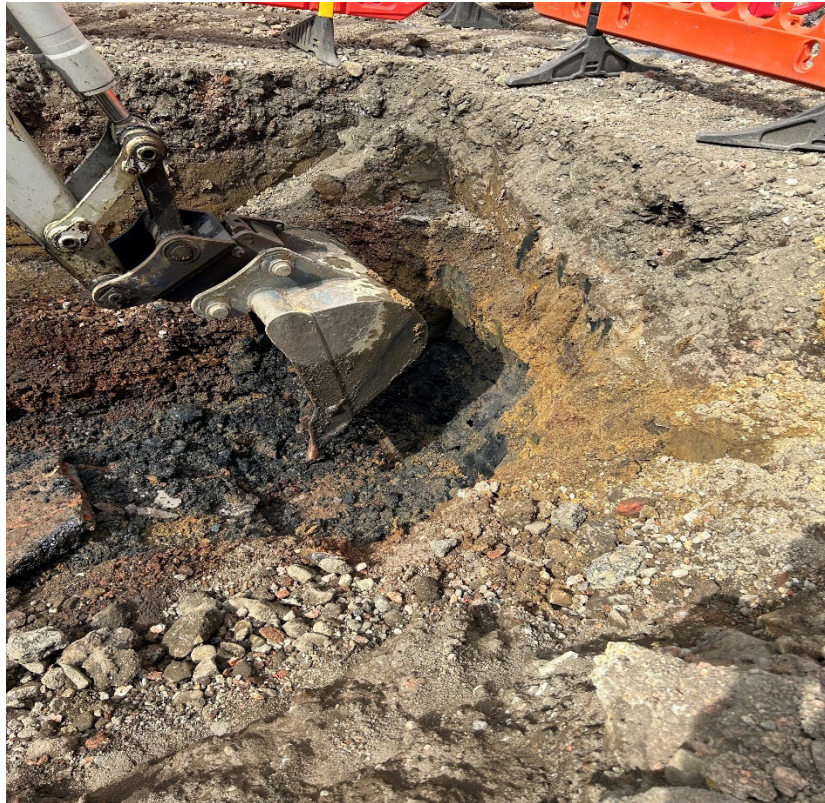
**Photograph G** – Image taken north east of site facing west. Image showing the resulting hydrocarbon impacted soils being excavated out after tank removal.

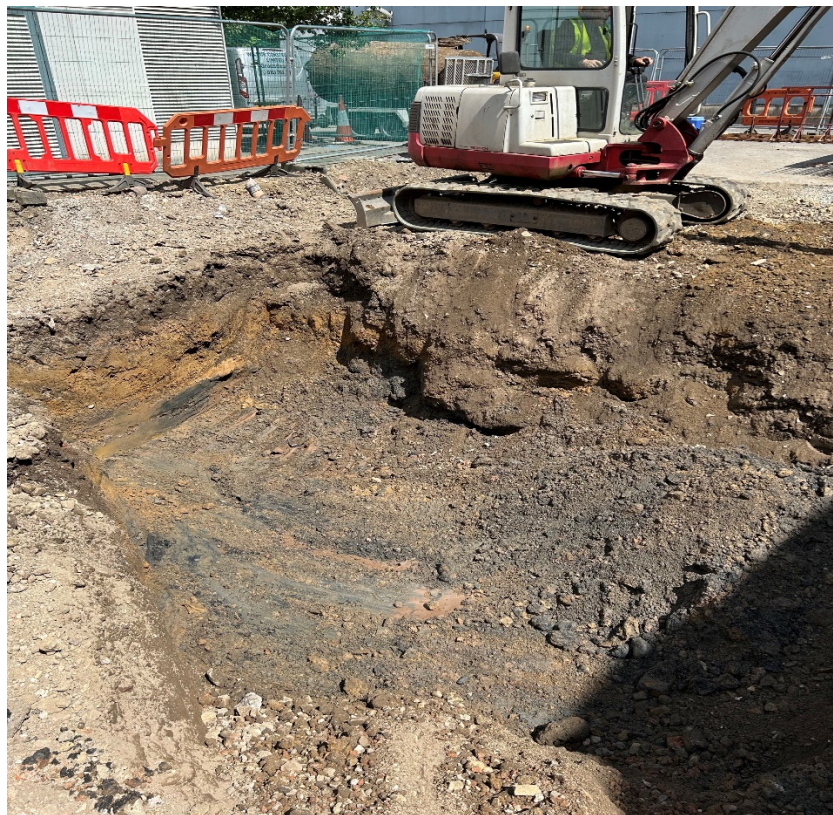
**Photograph H** – Image taken west of site facing north east. Image showing the clean uncontaminated ground in the location of the former tank after the excavating works.

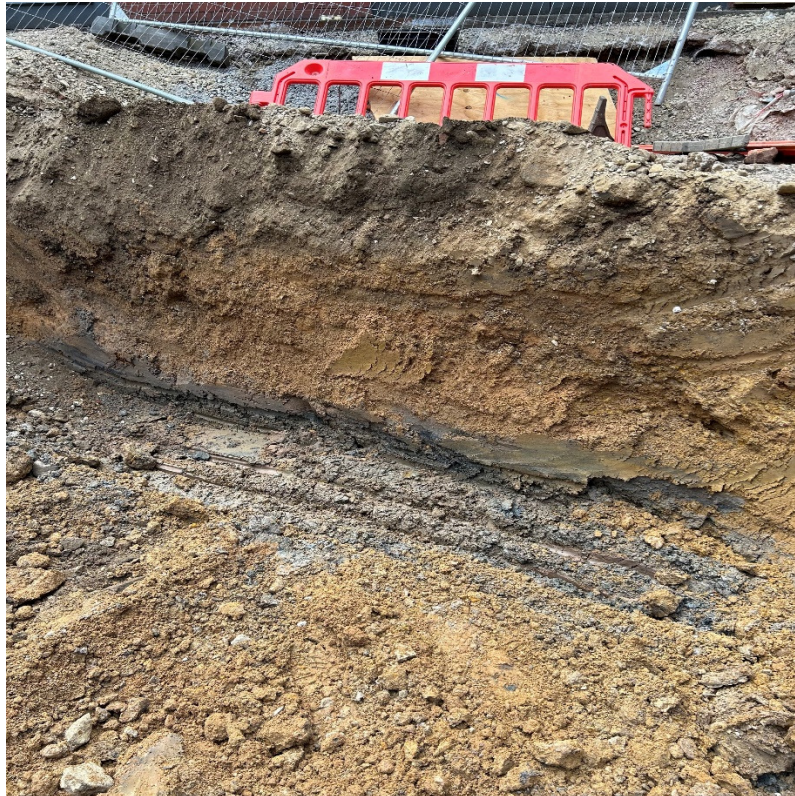
**Photograph I** – Image taken centre of site facing west. Image showing the clean uncontaminated ground in the location of the former tank after the excavating works.

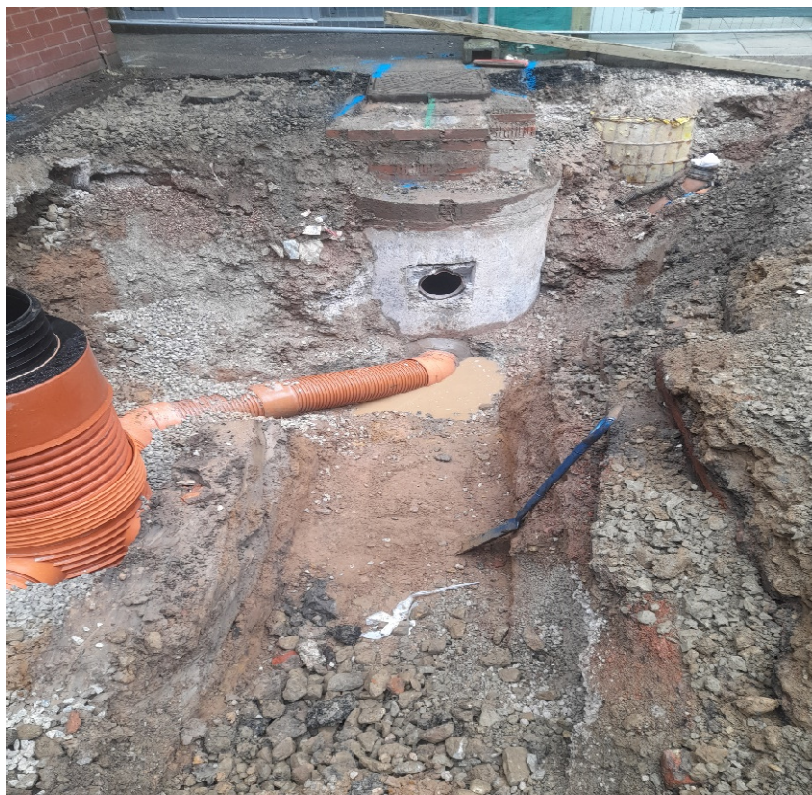
**Photograph J (taken via Dave Shacklady J Greenwood (Builders) Limited)** – Image taken west of site facing north. Image showing the natural ground and drainage in the location of WS1 following the clients removal of soils in the area.
