# Phase 2 Site Investigation Report Paradise Wharf, Ducie Street, Manchester

## Prepared for Victor (M1) Limited

**10/1836/002 Rev. 01**

| <b>Document</b> | Phase II Geo-Environmental Appraisal | |

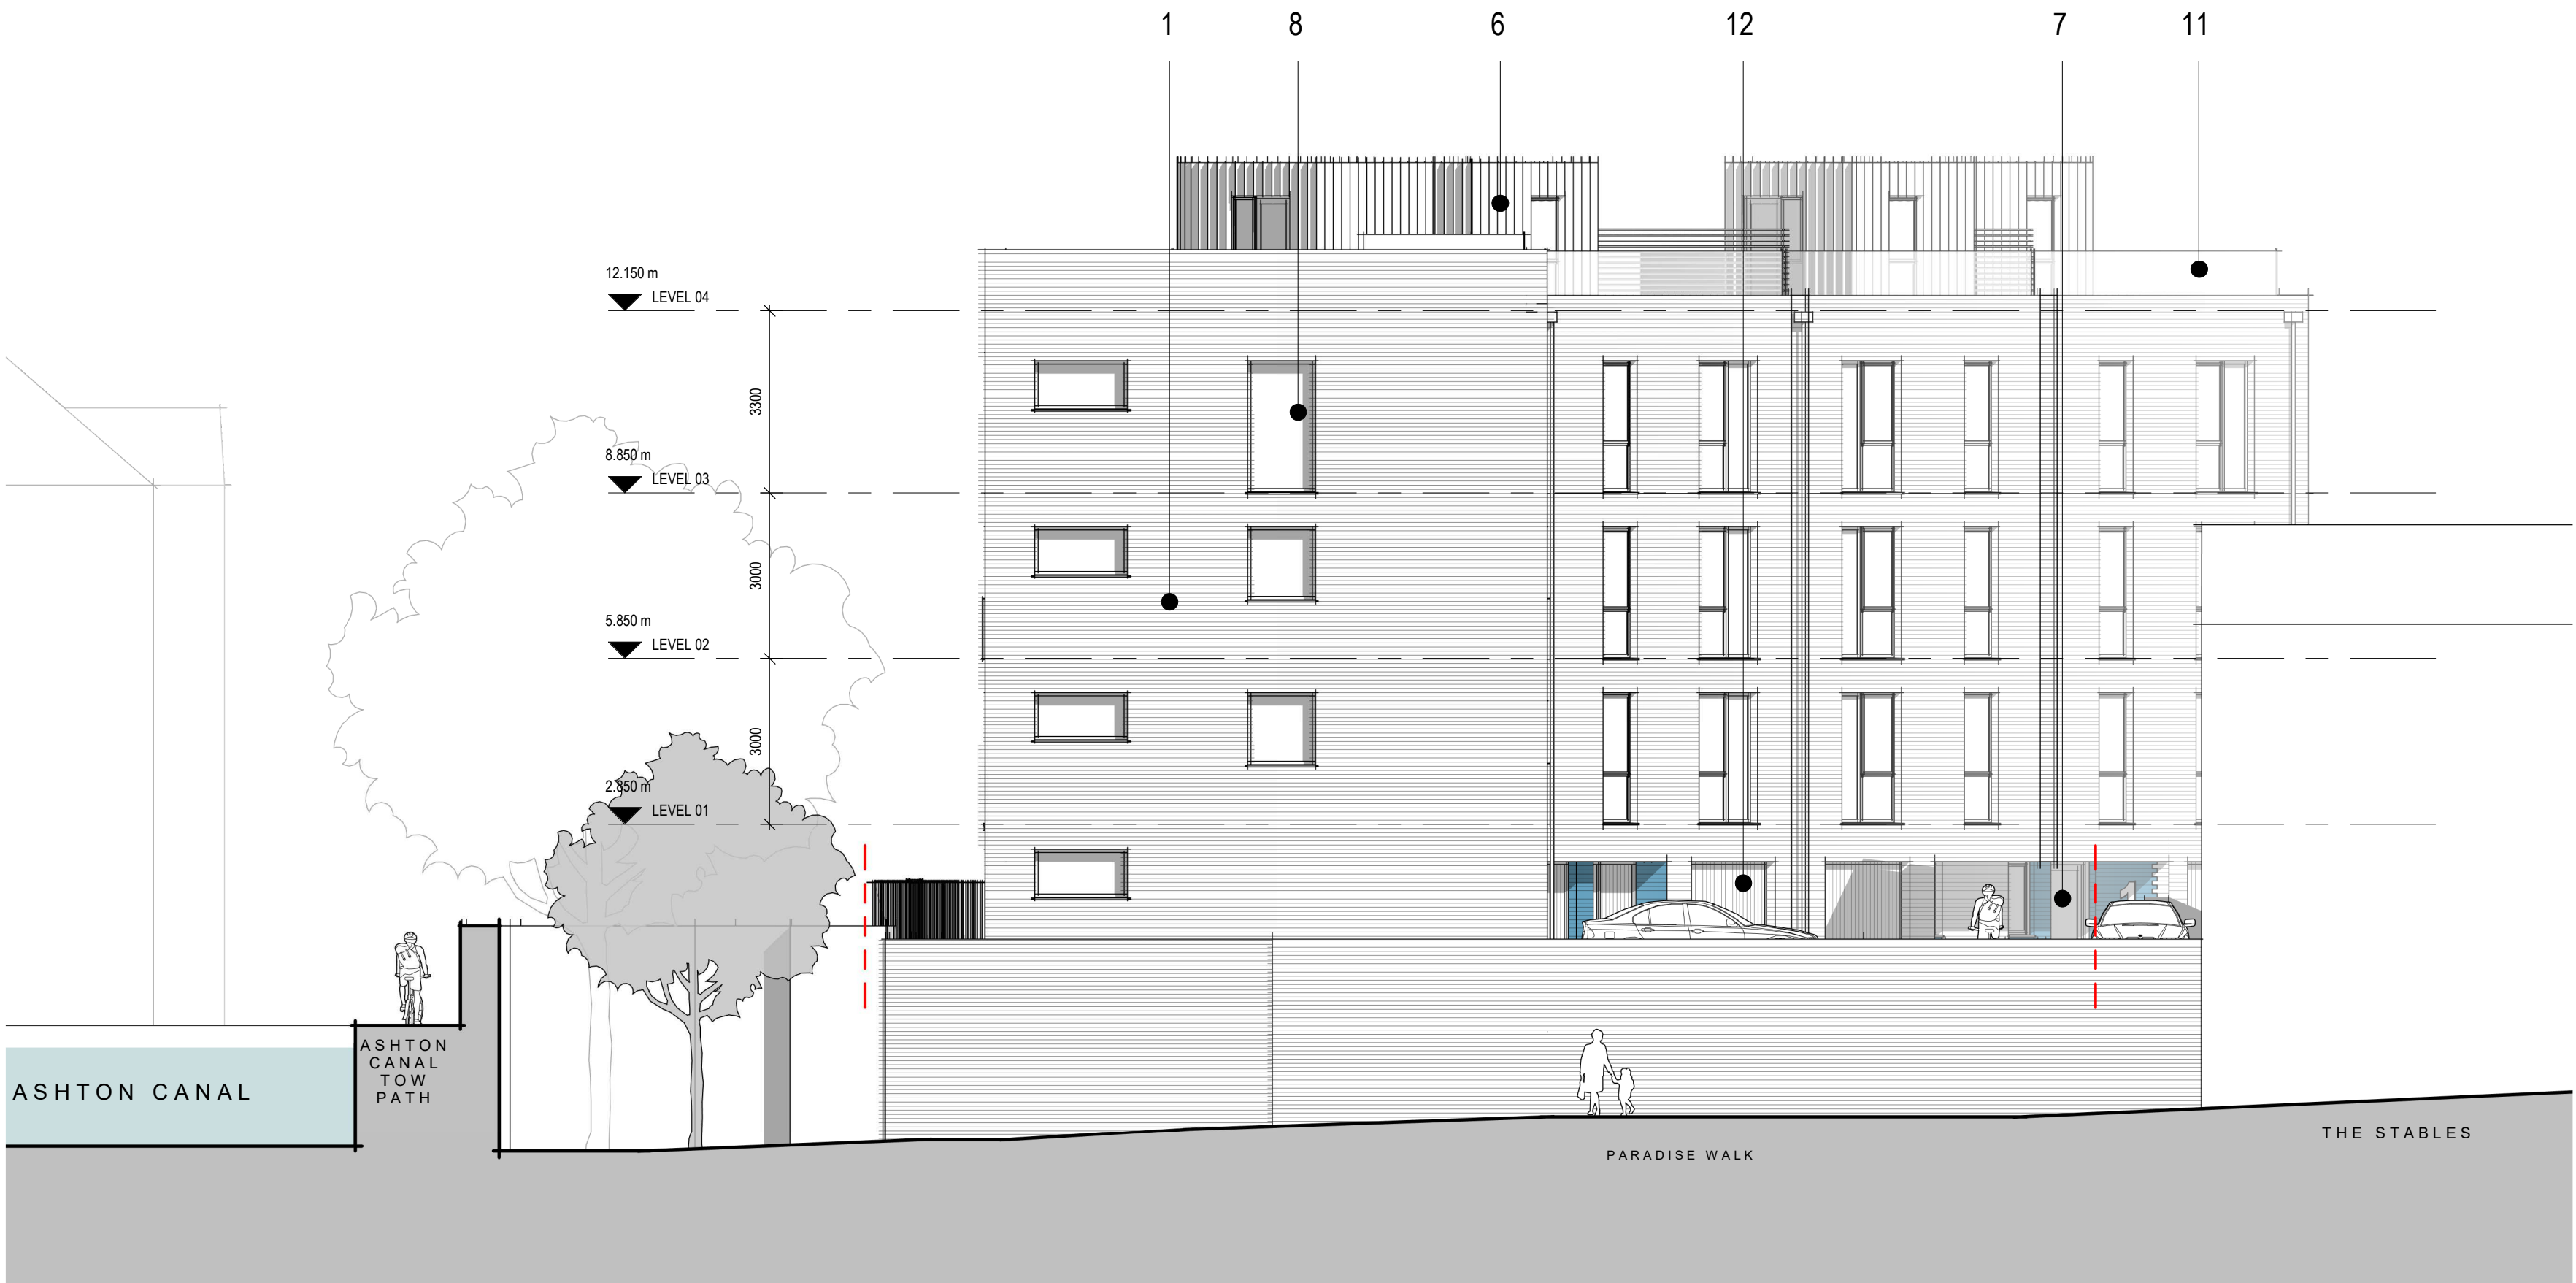
Elevation 1  
1 : 100

1. Red brickwork – colour and mortar to match the adjacent stables building
2. Black brickwork – specification TBC
3. Glazed brickwork to entrances – colour and specification TBC
4. Recessed brickwork panels – colour and specification to match adjacent brickwork
5. Recessed brickwork arch
6. Glazed ceramic cladding to top floor pop-ups
7. Entrance doors – specification TBC
8. PPC Aluminium framed, double glazed windows – colour : TBC
9. PPC Aluminium framed, double glazed terrace doors – colour : TBC
10. Powder coated, flat bar steel balustrade
11. Frameless, glazed balustrade
12. Timber garage door – colour and specification TBC
13. 25mm Projecting brickwork - colour and specification to match adjacent brickwork

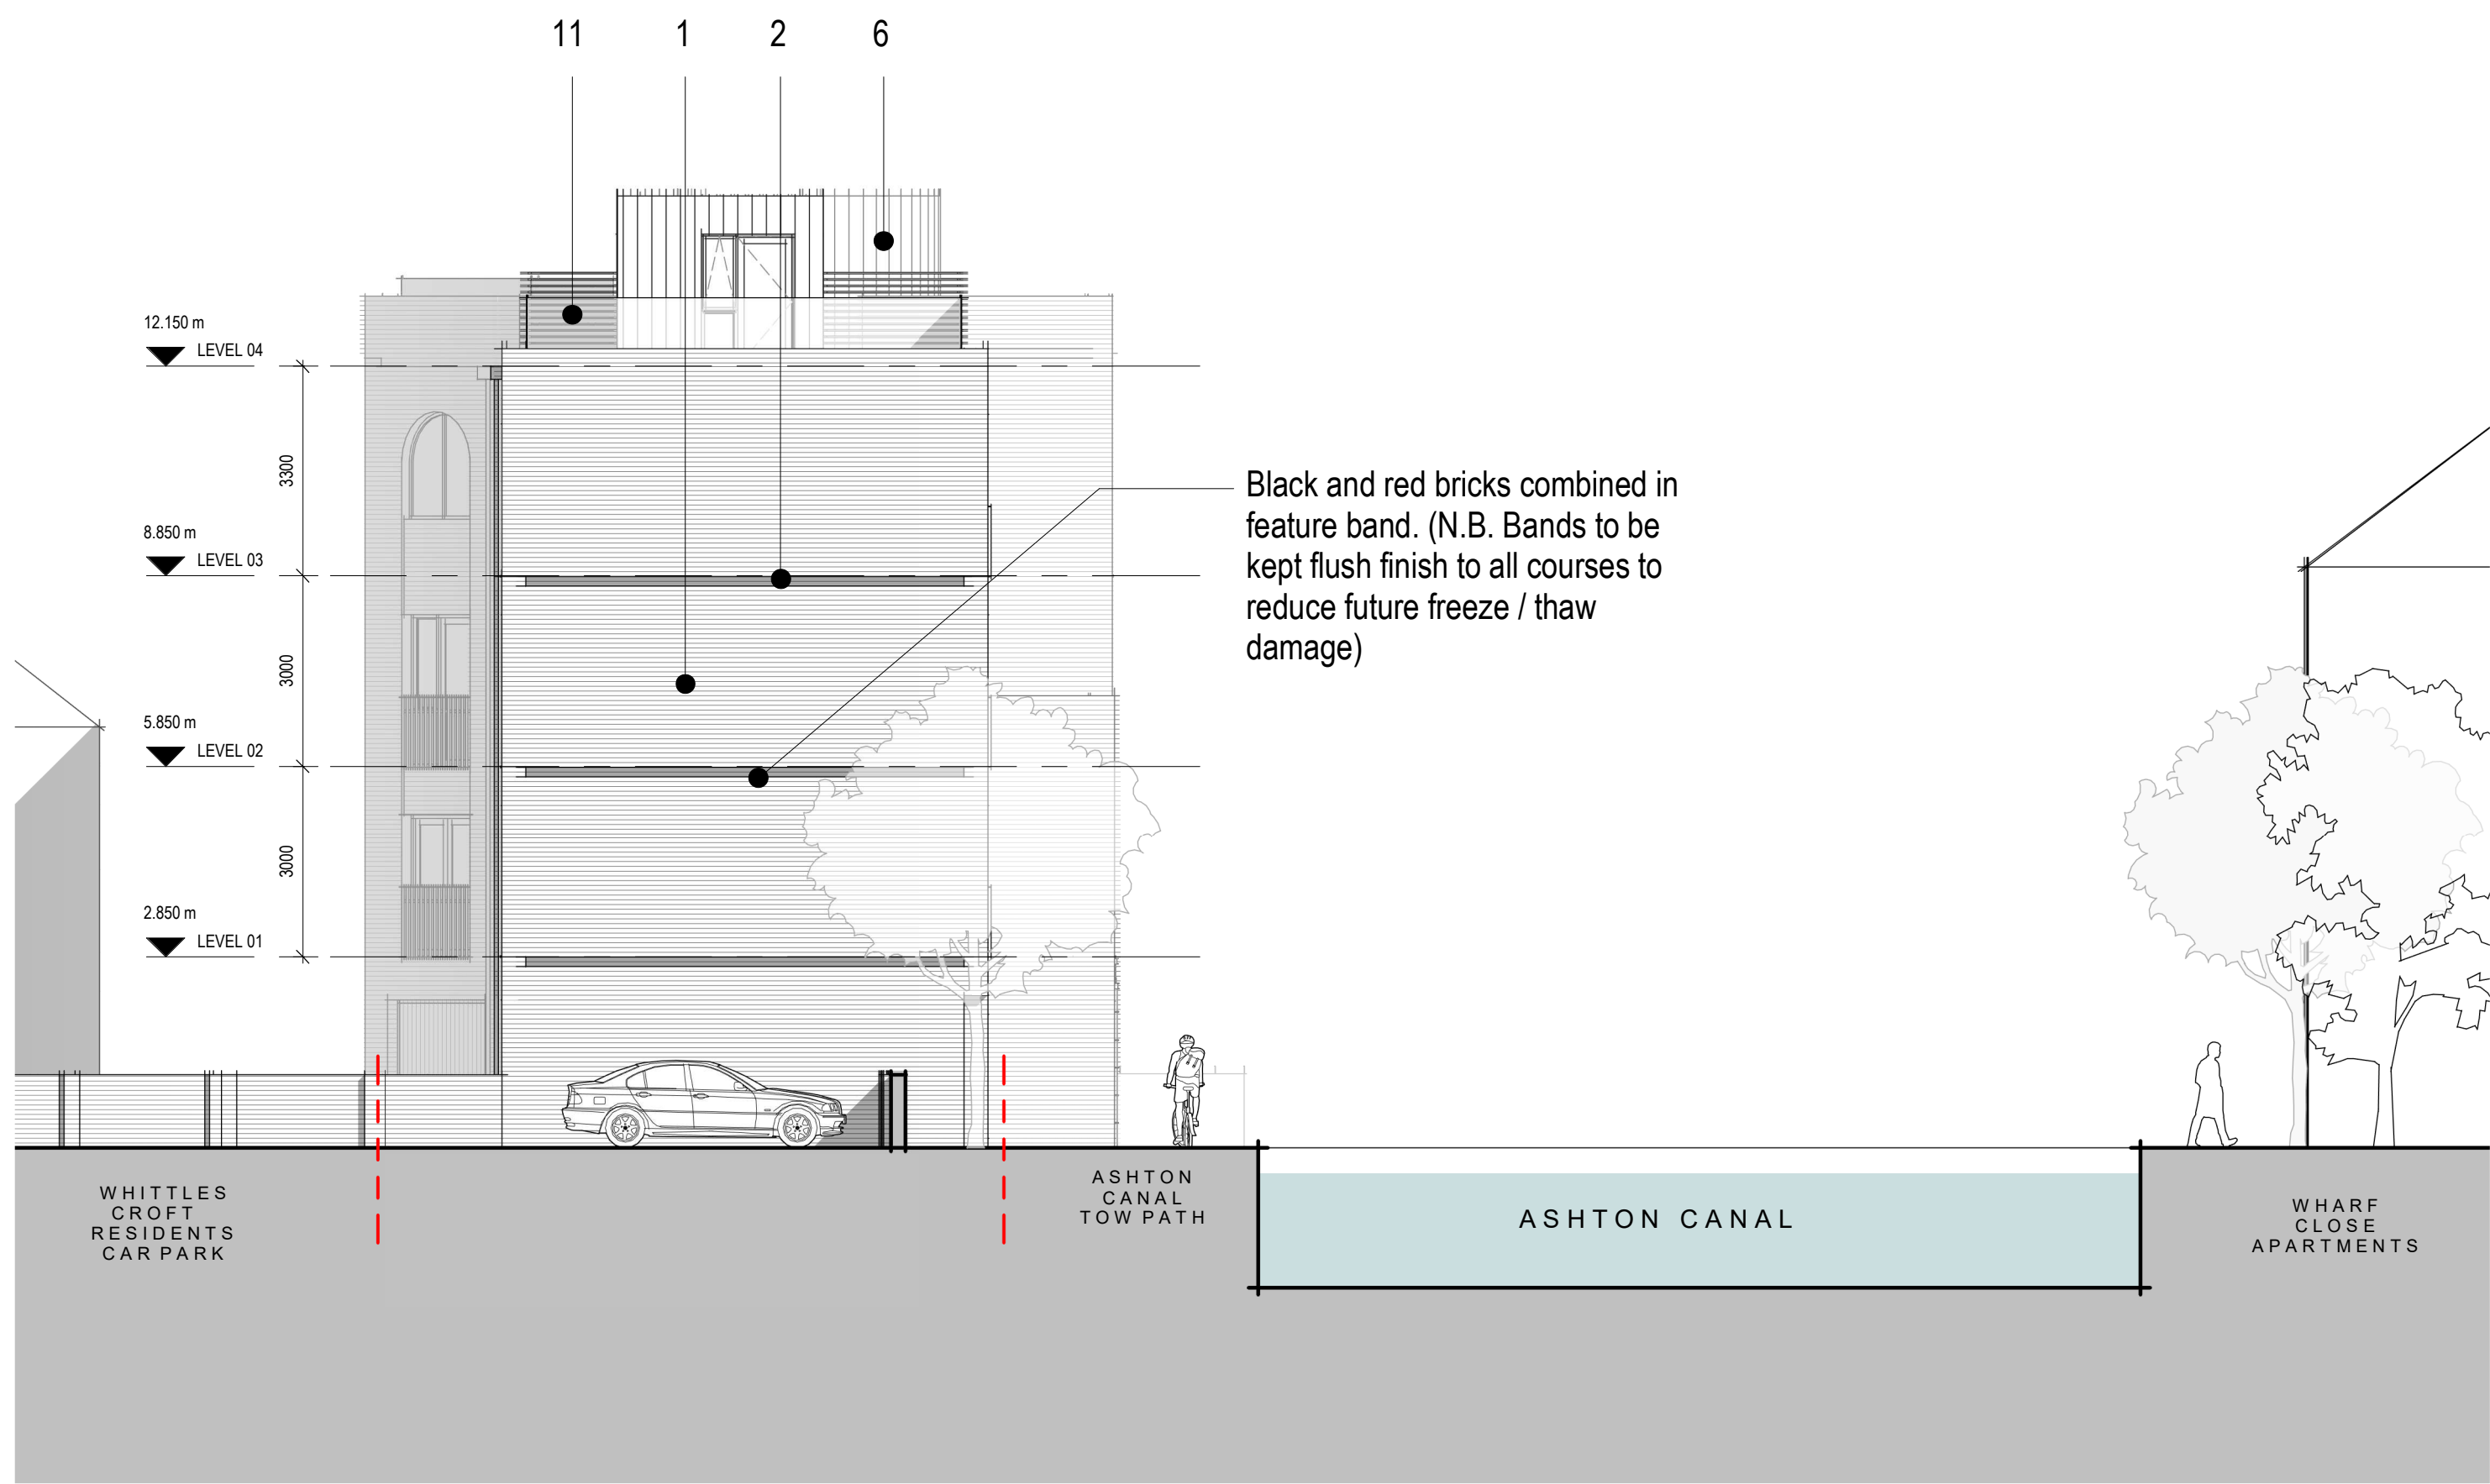
Elevation 3  
1:100

1. Red brickwork – colour and mortar to match the adjacent stables building
2. Black brickwork – specification TBC
3. Glazed brickwork to entrances – colour and specification TBC
4. Recessed brickwork panels – colour and specification to match adjacent brickwork
5. Recessed brickwork arch
6. Glazed ceramic cladding to top floor pop-ups
7. Entrance doors – specification TBC
8. PPC Aluminium framed, double glazed windows – colour : TBC
9. PPC Aluminium framed, double glazed terrace doors – colour : TBC
10. Powder coated, flat bar steel balustrade
11. Frameless, glazed balustrade
12. Timber garage door – colour and specification TBC
13. 25mm Projecting brickwork - colour and specification to match adjacent brickwork

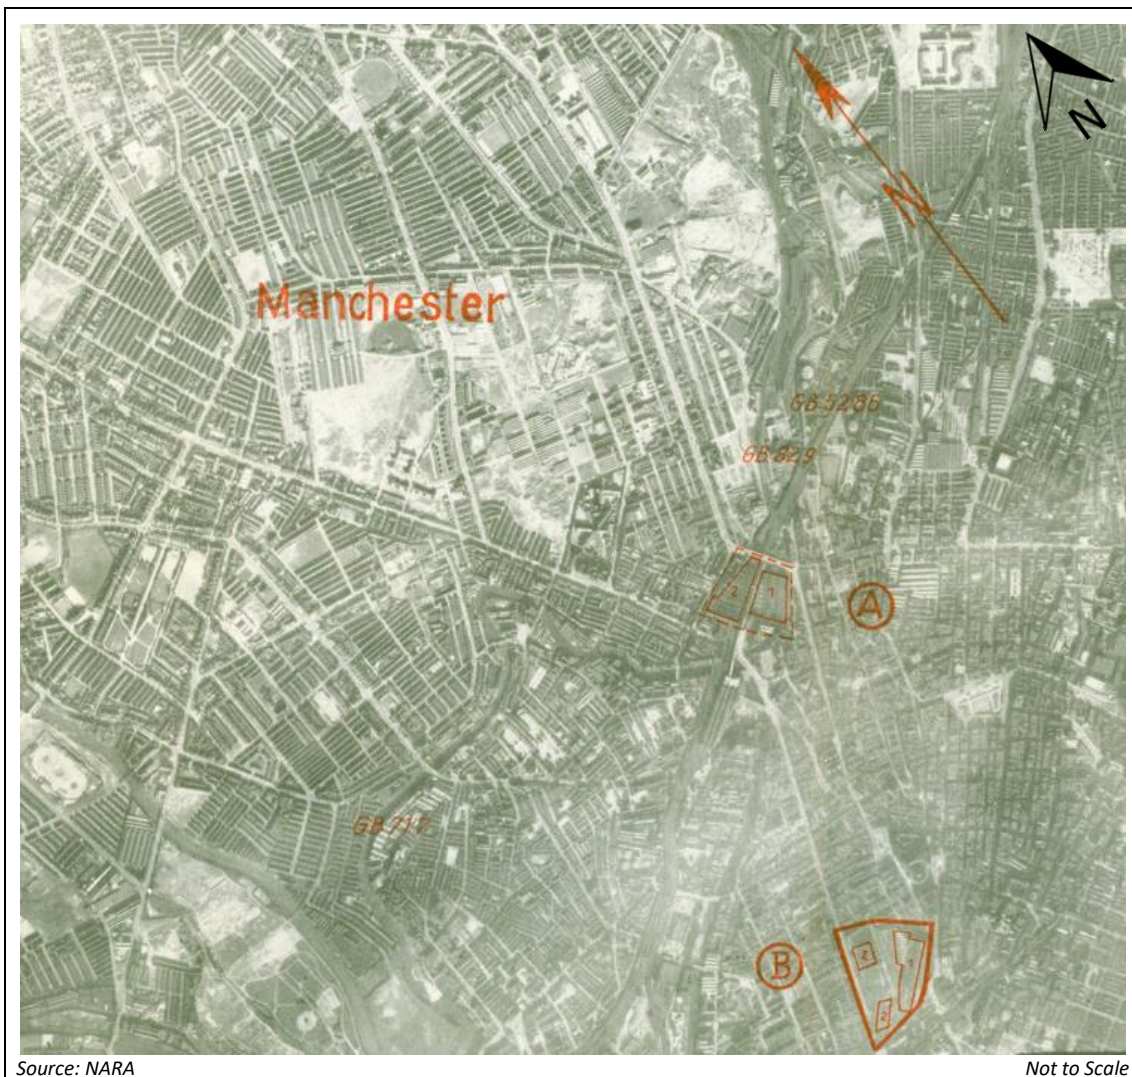
**Plate 2 Luftwaffe target photograph of central Manchester, 4<sup>th</sup> October 1939**

Plate 2 is a Luftwaffe target photograph of central Manchester, dated the 4<sup>th</sup> October 1939.

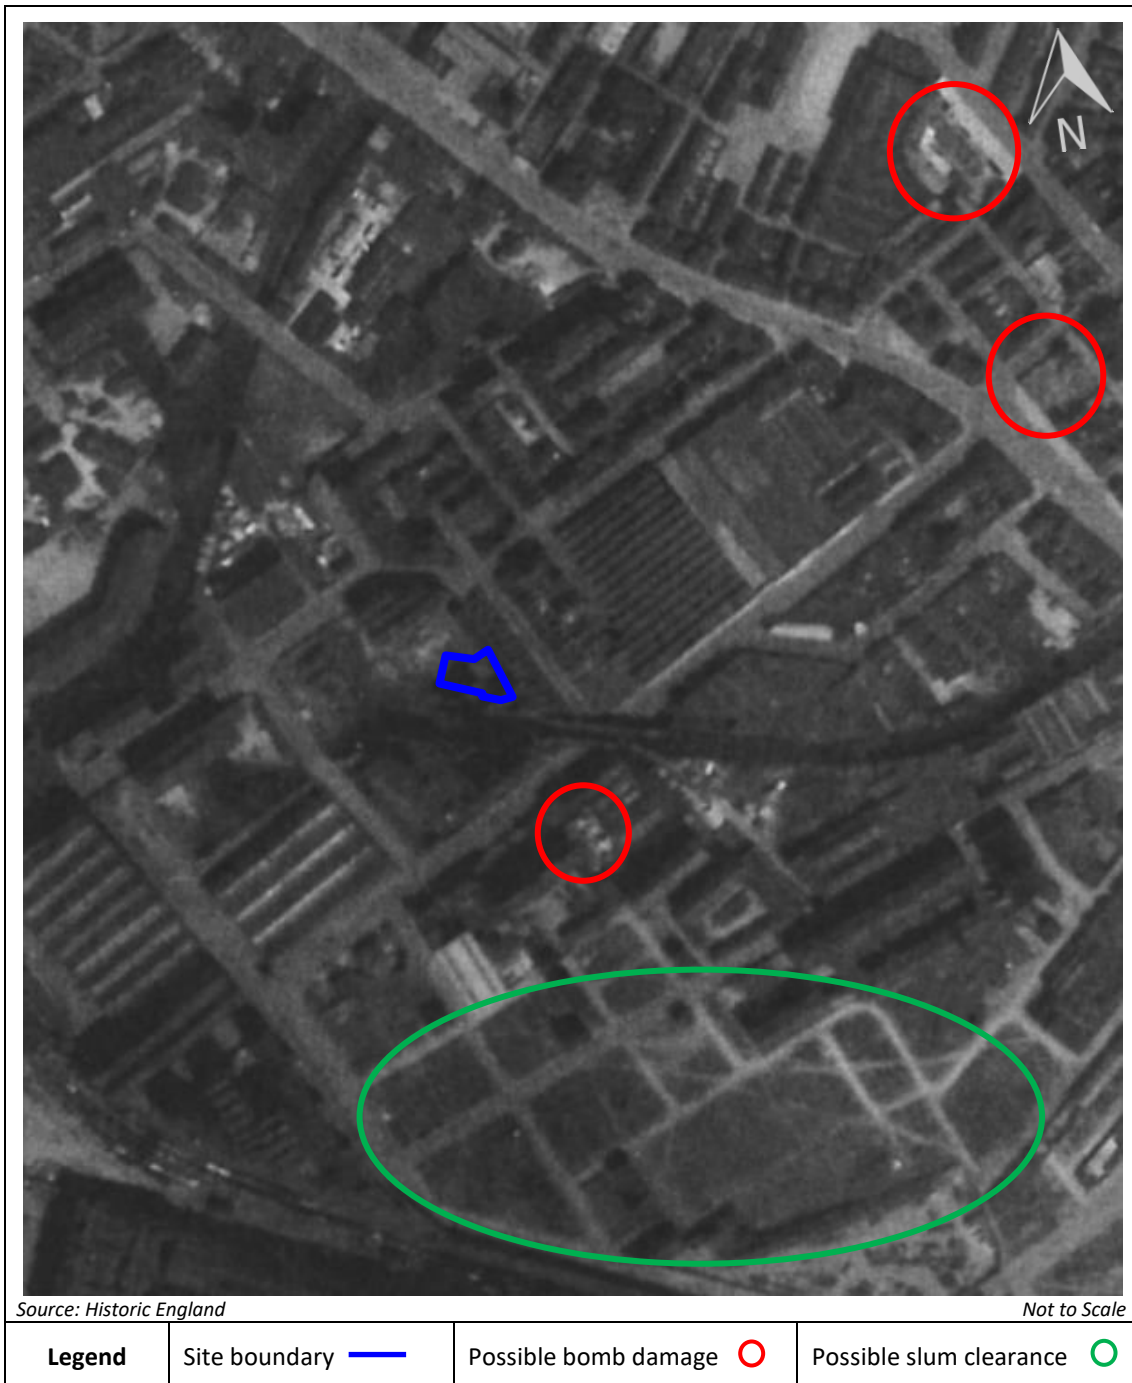
**Plate 3 Aerial photograph, 16<sup>th</sup> May 1948**

Plate 3 is an aerial photograph dated the 16<sup>th</sup> May 1948. No bomb damage has been identified on the Site.

Some areas of demolished and ruined buildings have been identified in the vicinity of the Site. Some of these relate to damage sustained during WWII air raids and others are likely to be the result of pre-WWII slum clearance.

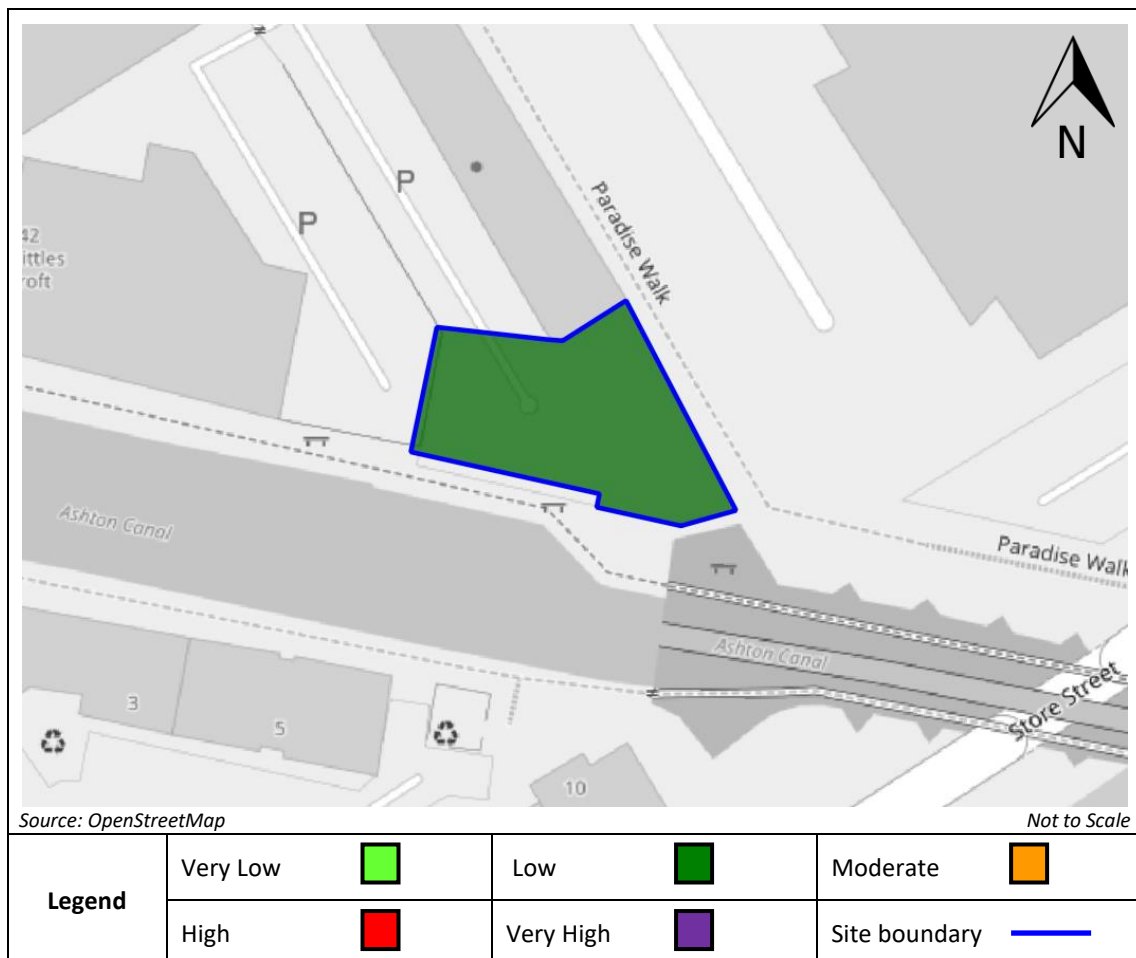
**Figure 4 UXO hazard zone plan of the Site**

No records have been found indicating that the Site was bombed and no bomb damage has been identified on the Site on historical aerial photography.

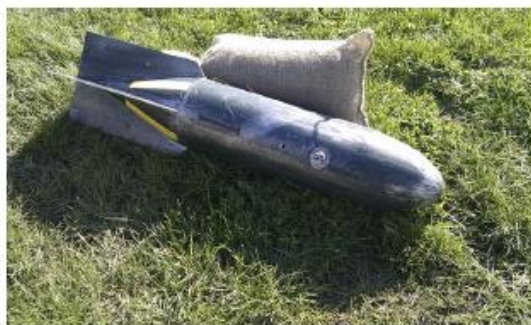
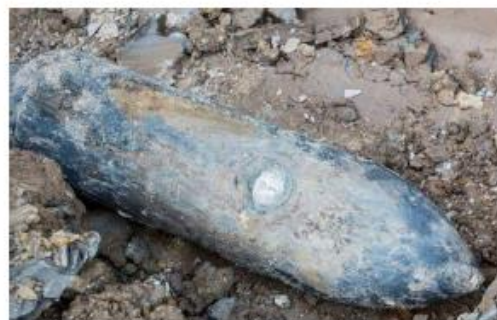
**Description** Thick nose welded to a steel body. Nose may be attached to Kopfring (a triangular section steel ring) or spike. Suspension bolt in eye/body and sheet metal tail attached to body with rivets/screws. Originally painted green-grey with a yellow stripe on the tail. Cast TNT, Amatol or Trialen filling.

**Function** Designed to maximise shock waves through air, water and earth and for general demolition. Used against easily damageable targets, including roads, aircraft hangars, rolling stock and small buildings. Spike bombs/ 'Stabo' (SC 50 with spikes attached to nose) were used against rail lines and country roads, with Kopfring used against naval targets.

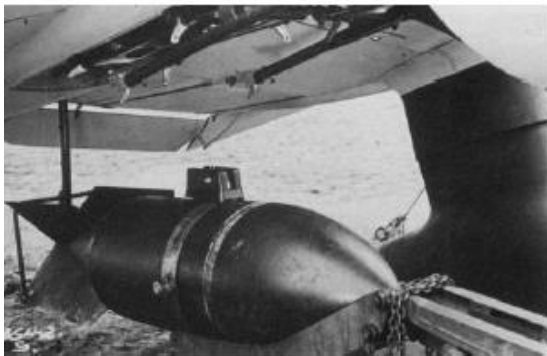
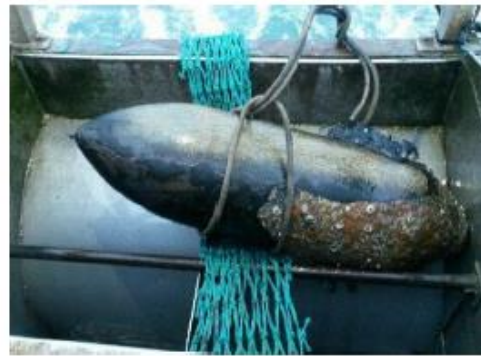
**Category** Bomb  
**Type** Sprengbombe-Cylindrisch (SC) 250kg

**Description** Thick nose welded to steel body. Nose may be attached to Kopfring (triangular section steel ring) or spike. Sheet metal tail attached to body with rivets/ screws. Suspension eye bolt in the nose/body. Originally painted green-grey with a yellow stripe on the tail. TNT; amatol; TNT and aluminium powder, naphthalene, ammonium nitrate and wax/ wood meal filling.

**Function** Designed to maximise shock waves through air, water and earth and general demolition. Used against railway installations, large buildings, ammunition depots and below-ground installations (to 8m). Spike bombs/ 'Stabo' (SC 50 with spikes attached to nose) used against rail lines and country roads.

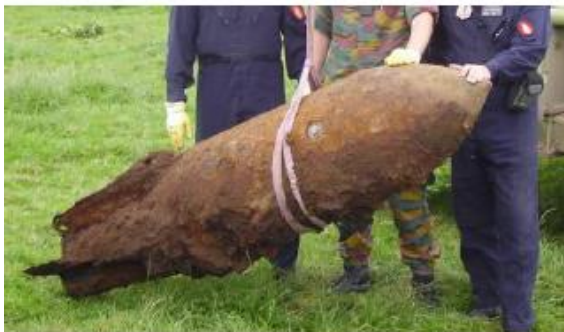
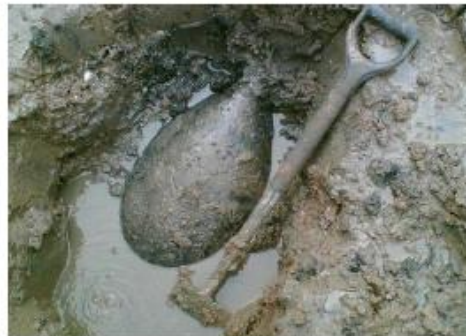
**Description** Thick nose welded to steel body. Nose may be attached to Kopfring (triangular section steel ring). Tail either steel sheet or drum-shaped. Suspension band. Originally painted green-grey/ buff (some later versions sky blue) with yellow stripe on tail. Filled with amatol, TNT or trialen.

**Function** Designed to maximise shock waves through air, water and earth and for general demolition. Used against railway property, large buildings, shipping and below-ground installations.

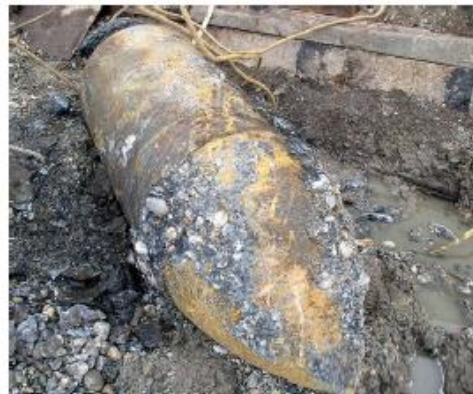
**Description** Thick nose welded to steel body. Nose attached to Kopfring (triangular section steel ring). Drum-shaped tail made of magnesium alloy. Suspension band. Originally painted sky-blue. Filled with amatol, TNT/aluminium/wood meal or trialen.

**Function** Designed to maximise shock waves through air, water and earth and for general demolition.

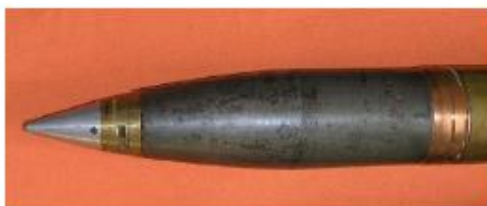
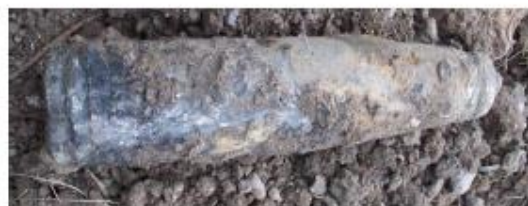
**Category** Projectile  
**Type** 3.7" Anti-Aircraft Shell

**Description** Brass cartridge case. Square-based shell with tapered nose, filled with Amatol, TNT or RDX/TNT. MK6 had forward centring bands and a wider driving band.

**Function** Used as a defence against enemy aircraft, fired from fixed batteries and mobile mountings. Could fire approximately 20 rounds per minute with a maximum ceiling of 41,000ft and horizontal range of 20,600 yards.

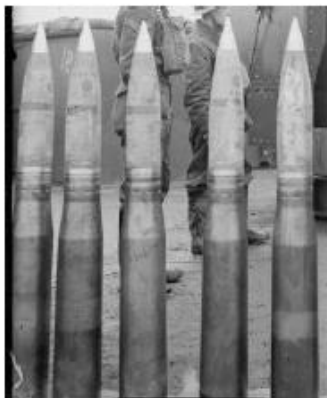
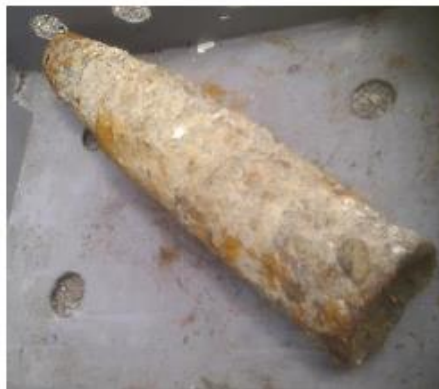
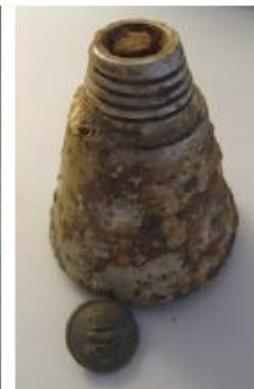
**Category** Projectile  
**Type** 4.5" Shell (Mark II – Anti-Aircraft)

**Description** Square-based, tapered-nosed shell filled with TNT or Amatol. Steel casing, rotating band of either copper or gilding metal located 3.5" in front of the base end with single groove.

**Function** Used as field artillery and adapted for use in anti-aircraft defence from fixed batteries. Rate of fire of 8 rounds per minute, maximum ceiling of 44,000ft and horizontal range of 22,800 yards.

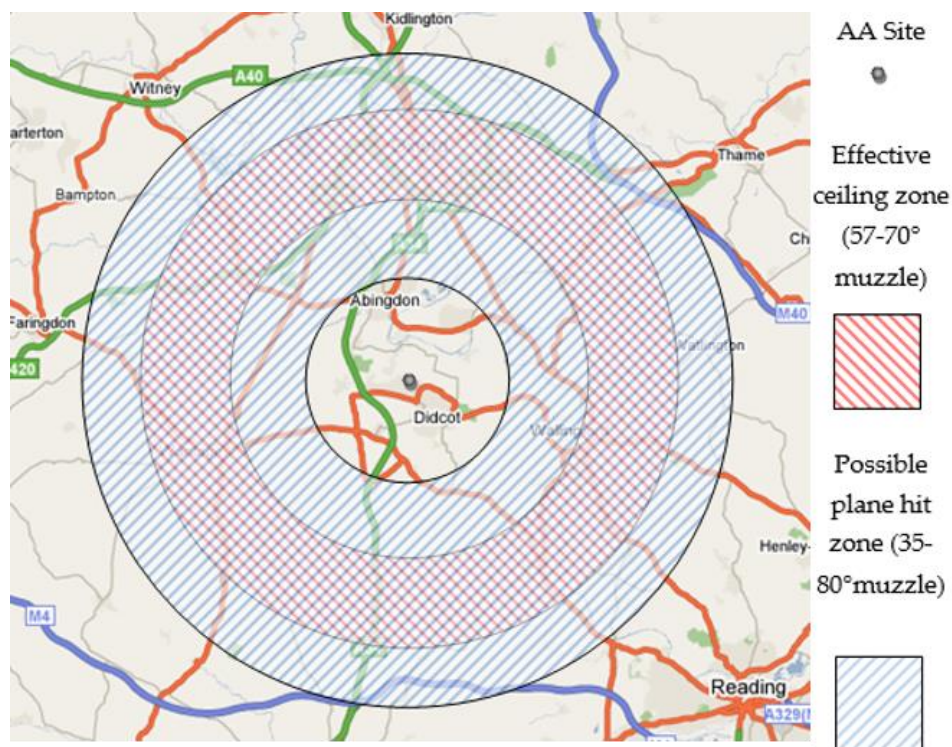
Unexploded AA (UXAA) shells were a common occurrence during WWII. As the figure below demonstrates, shells were unlikely to fall in the immediate vicinity of a gun battery but in the surrounding area. This would be dependent upon the angle of fire and the flight height of the attacking aircraft.

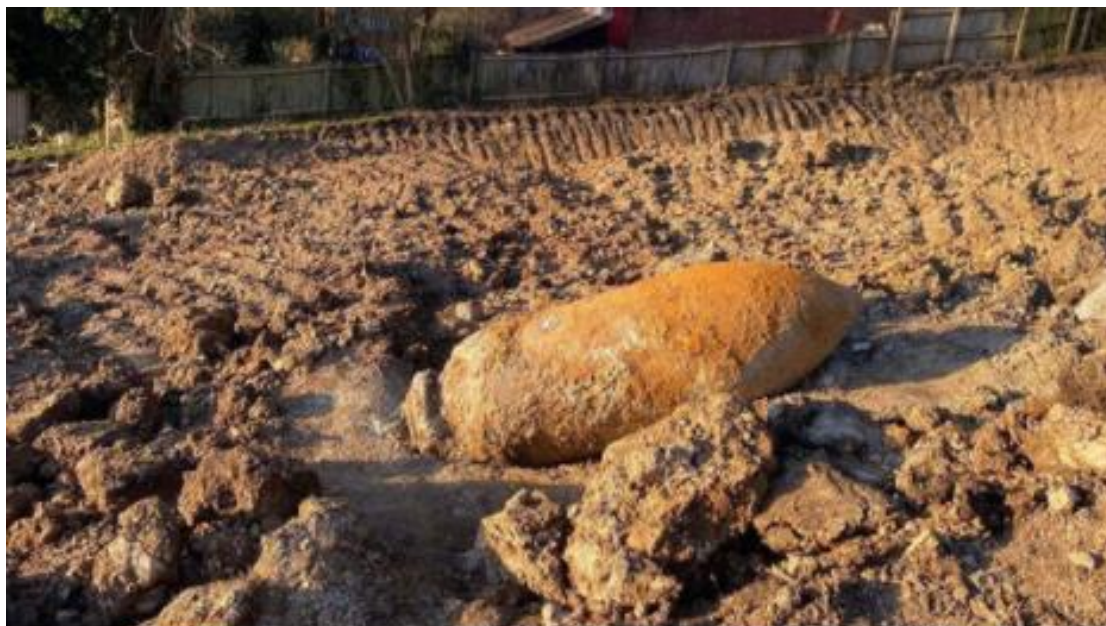
On the 26<sup>th</sup> February 2021, a 1,000kg German "Hermann" UXB was discovered by builders at Exeter University campus (see plate below). It was investigated and detonated in-situ following the evacuation of nearby properties and University halls of residence.

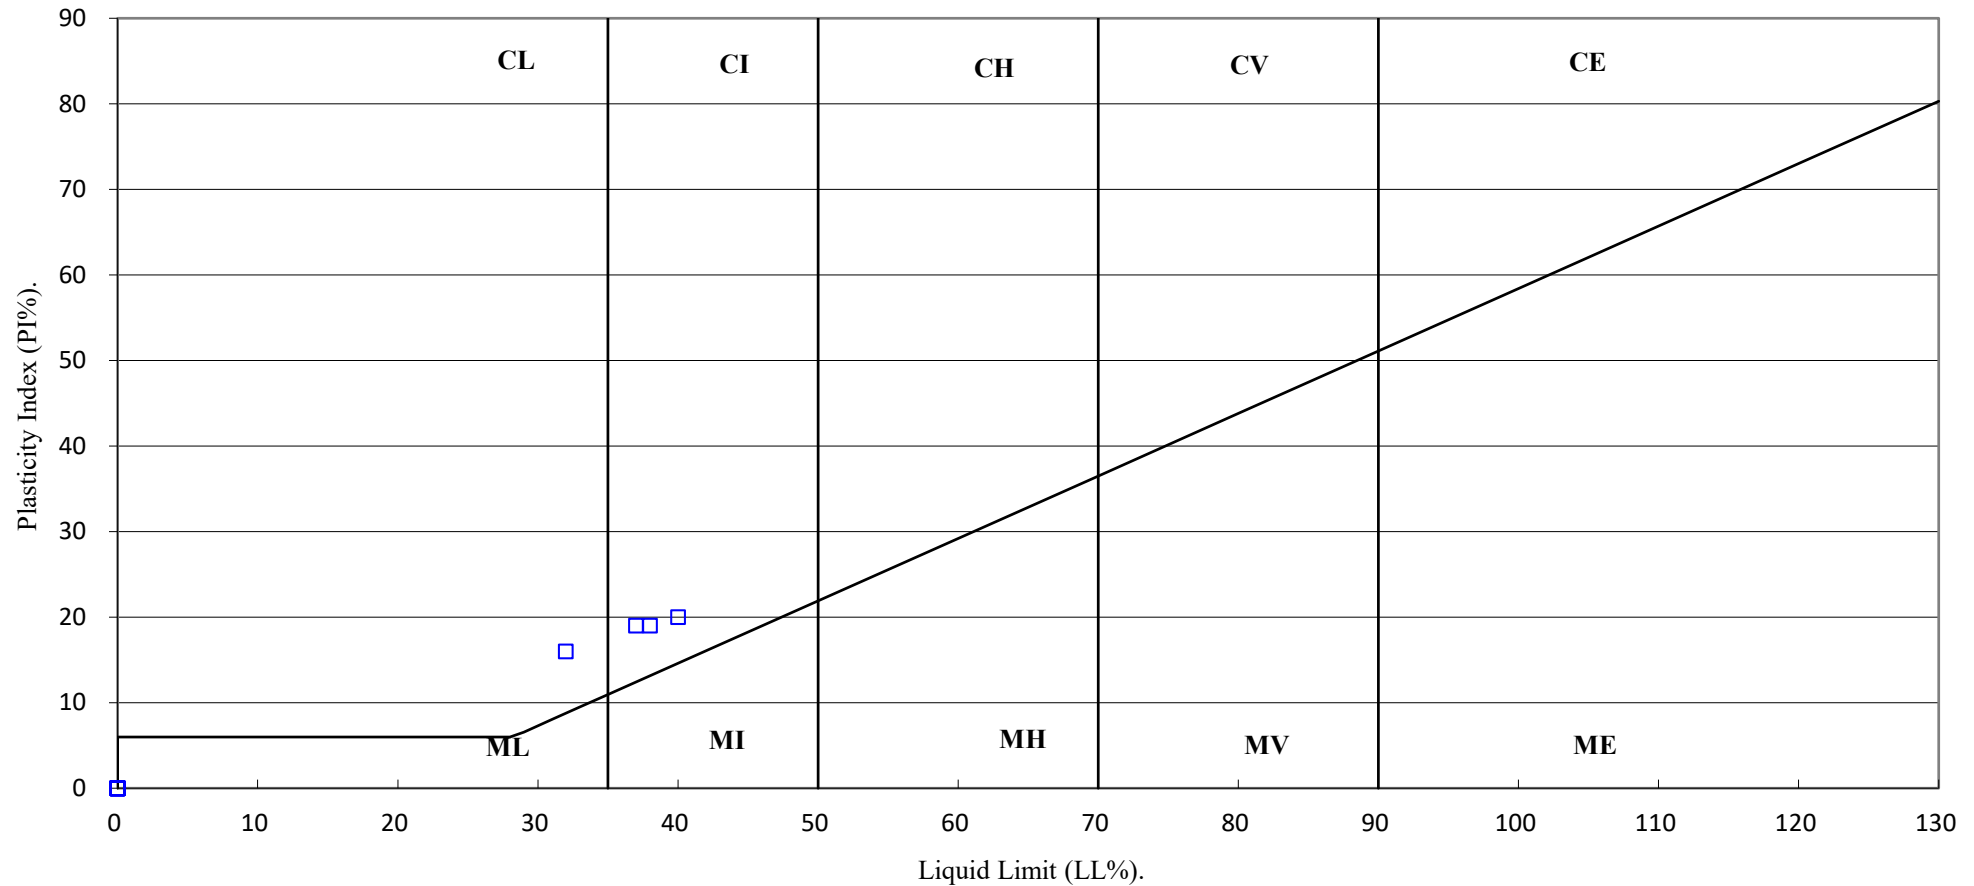
# PLASTICITY CHART FOR CASAGRANDE CLASSIFICATION.

Plastic Limit (PL) and Plasticity Index (PI). The results for LL ranged from 32% to 40%. The results for PL ranged from 16% to 20%. The results for PI ranged from 16% to 20%. This is indicative of a low to intermediate plasticity clay. Modified plasticity index values indicate that the samples have a low volume change potential. The natural moisture content of the samples ranged from 17% to 23%.

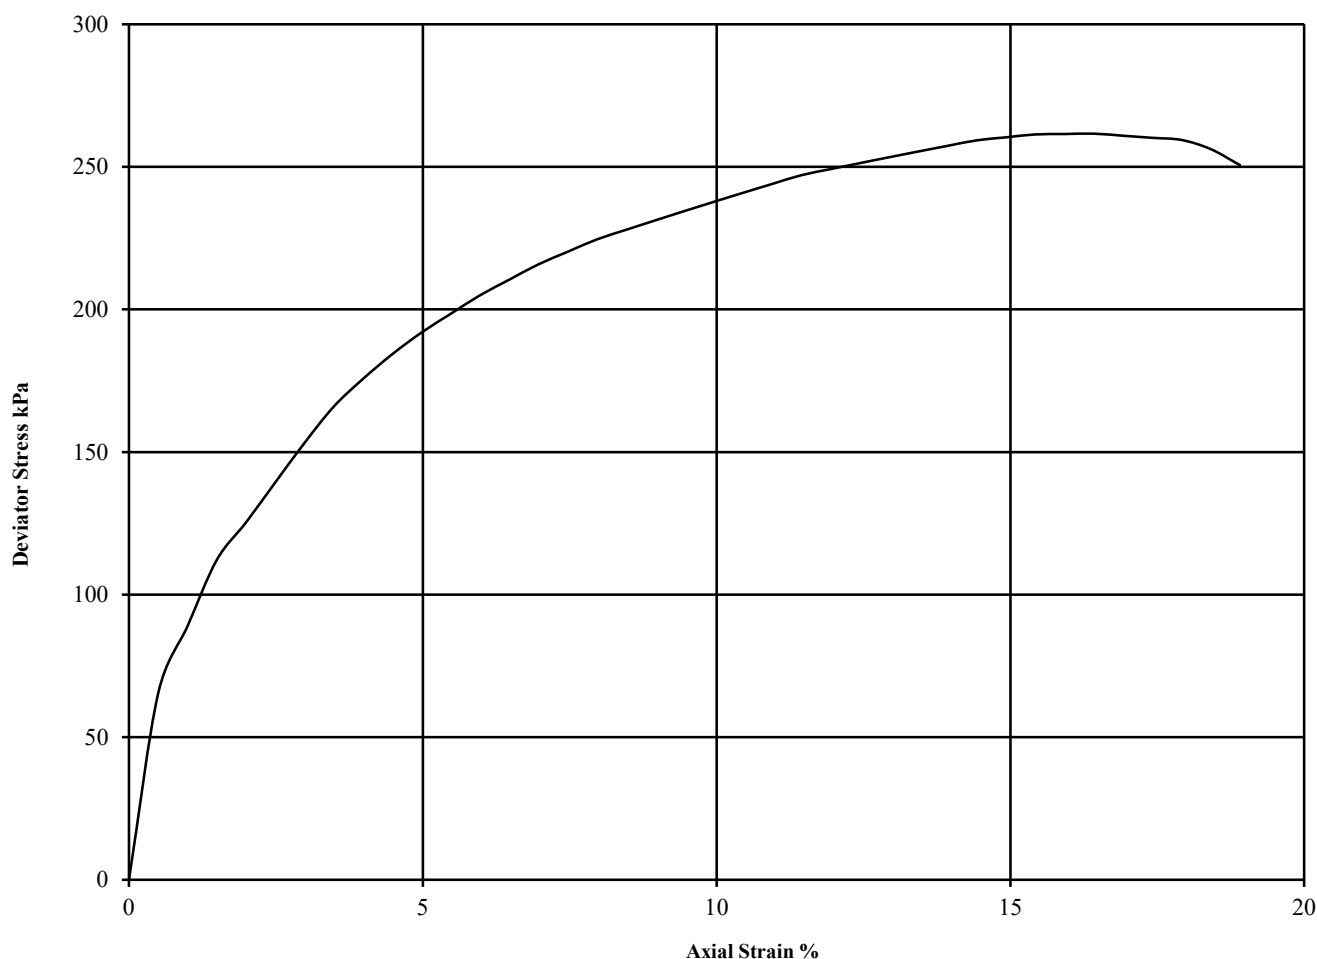
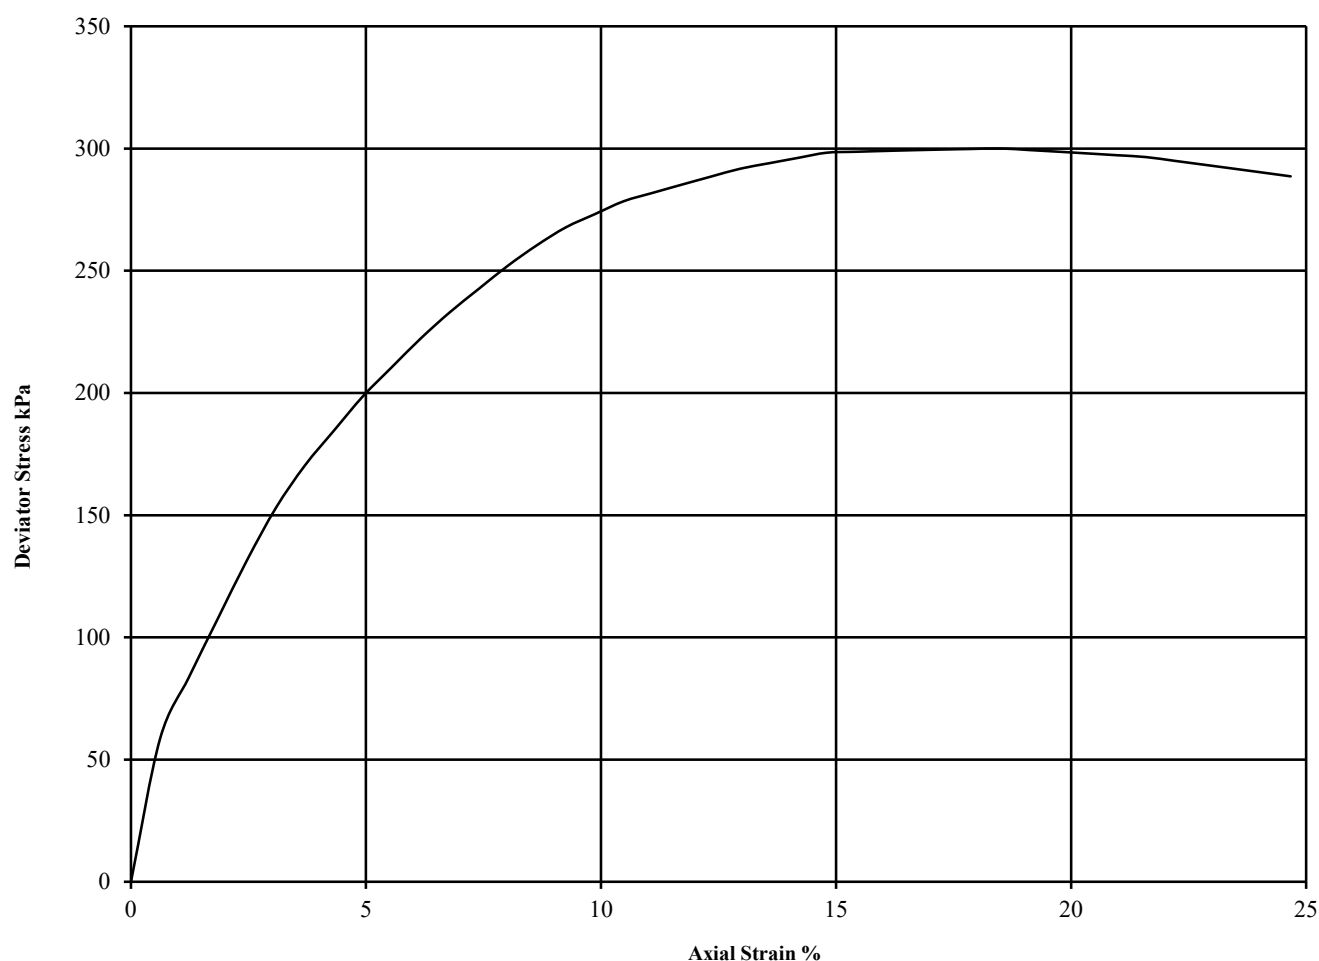
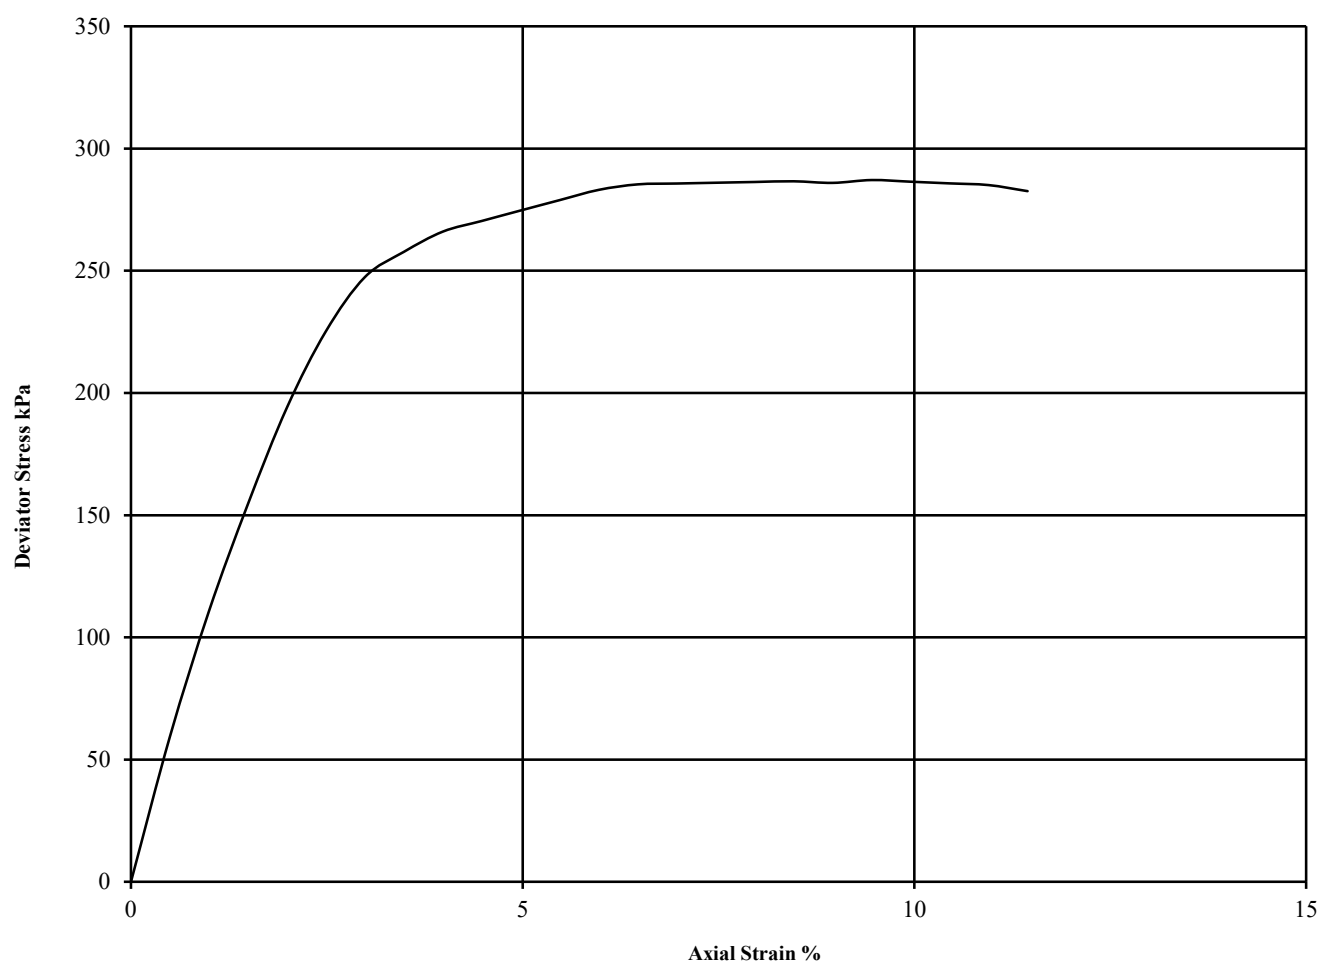
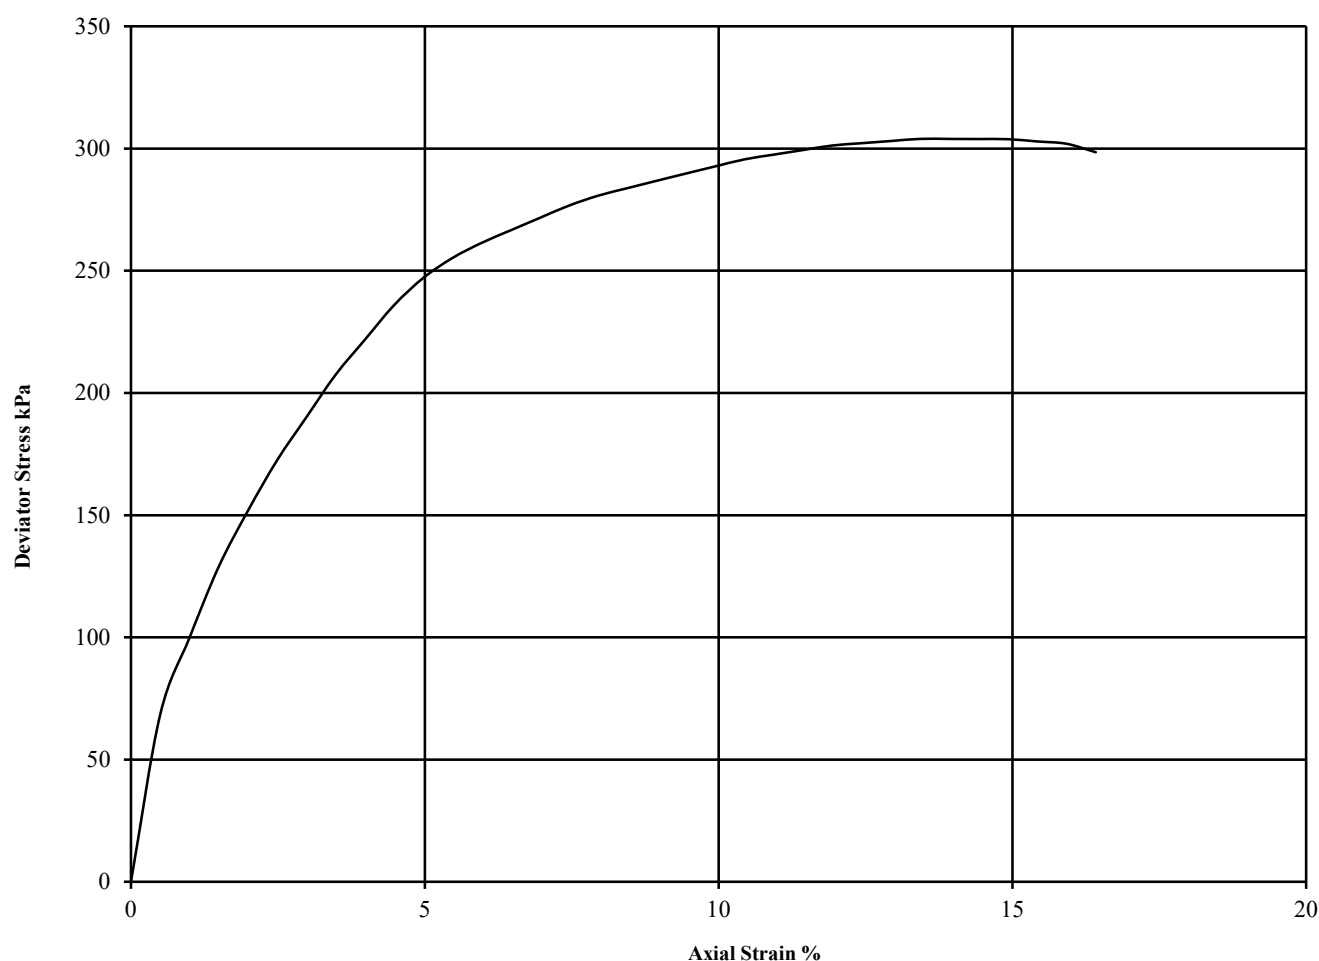
Four quick undrained triaxial compression tests undertaken on samples collected from the Devensian Till at depths of 5.50m, 7.00m, 10.00m and 11.50m bgl, gave results of 131kPa, 144kPa, 150kPa and 152kPa respectively. These are indicative of high strength clays. The natural moisture content of these samples ranged from 11 to 17%. The bulk densities ranged from  $2.09\text{Mg/m}^3$  to  $2.16\text{Mg/m}^3$ . The dry densities ranged from  $1.81\text{Mg/m}^3$  to  $1.95\text{Mg/m}^3$ .
