## **Historic Building Investigation**

Hammerstone Road  
Depot, Gorton,  
Manchester

SA/2023/40

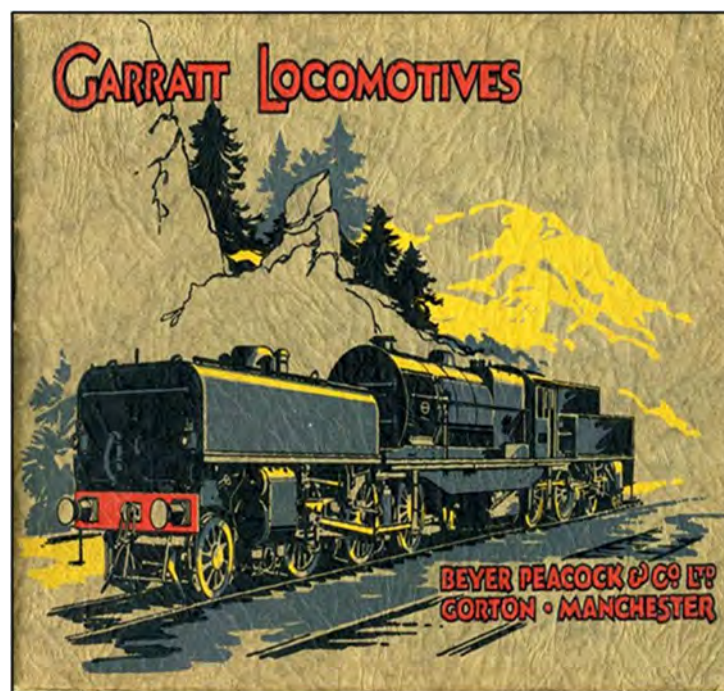
*Plate 6: Brochure for the Beyer-Garratt Locomotives*

By 1864 Beyer, Peacock & Co. were developing locomotives for the London Underground in its early days, they had developed a condensing tank engine specifically for use on tube trains. However, the companies most important addition to the world of locomotive engineering was the Beyer-Garratt Locomotive. This was designed by William Garratt after he came to work at Beyer, Peacock & Co. in 1907 (Plate 6). This new locomotive had an engine system that burned fuel much more economically which allowed the vehicle to be much more powerful and lighter than most on the market. The engine also allowed the train better traction meaning it could turn sharp corners with ease and traverse vertical terrain with heavy loads. All this made the Beyer-Garratt a first-choice train for exporting overseas to the Empire, the train did particularly well in Africa. Over its lifetime the company produced 1,636 Beyer-Garratt locomotives, 1,116 of which were built at the works in Gorton and exported around the world to 86 railways.

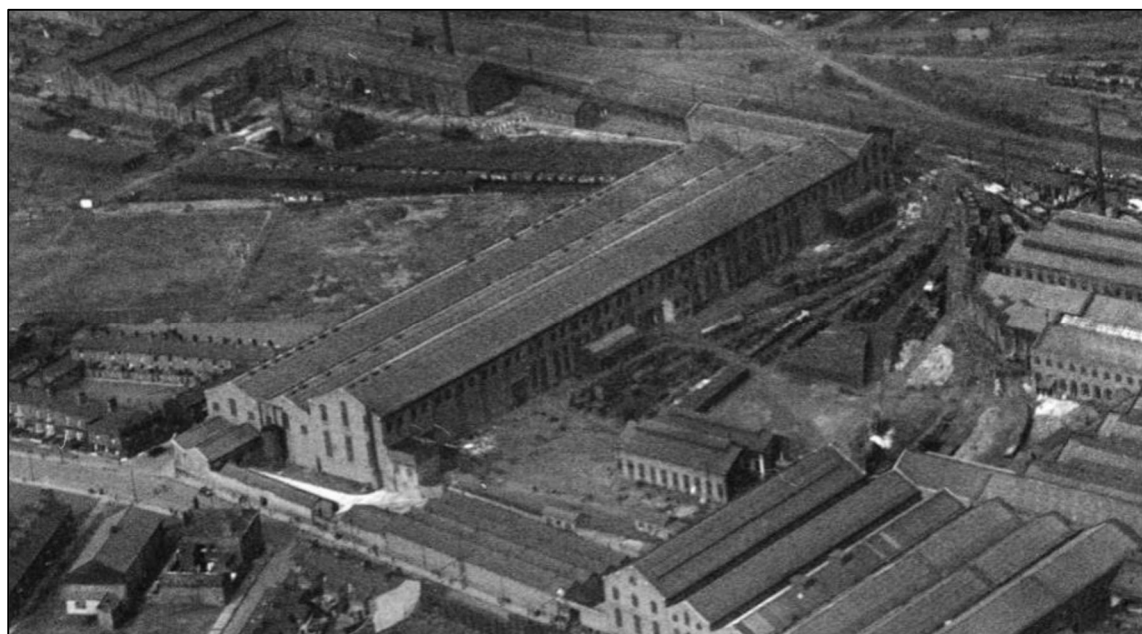
An aerial photograph of the site taken in 1927 shows the new boiler shop was situated to the western end of the site. The building was a three-bay gabled building with an attached riveting bay to the north. The ancillary buildings to the south included an attached substation with workshops to the south-east (Plate 9). In 1929 the Institute of Mechanical Engineers had again visited the foundry and produced a further detailed report:

*“Boiler and Tender Departments. – An outstanding feature of the firm’s policy of modernization is to be seen in the new boiler department, which came into operation in 1925. This department, which measures 600 feet long by 175 feet wide, consists of three longitudinal bays and a riveting bay. The main or boiler building and mounting bay is fitted with two crane gantries of 62 feet and 59 feet span respectively, one above the other. The upper accommodates travelling cranes of 50 tons capacity, and the lower one carries cranes of 10 and 5 tons capacity. The middle bay has a single gantry of 50 feet span for cranes of 20 and 10 tons capacity. The third bay has also a single gantry, but of 45 feet span and carrying cranes of 10 and 5 tons capacity. These three gantries lead to a high traverse end bay equipped with cranes, having remote control, of sufficient range of lift for dealing with the longest boiler shells. In the traverse bay are situated the deep-leg riveting machines. Adjacent to this bay, but outside the shop and alongside the railway, is a large, covered stores for unloading and storing of plates. The whole of the machinery and plant has been planned and laid out in order that the materials when received progress in proper sequence, involving a minimum of transport and handling, until they develop into a complete boiler, tender or tank ready for testing. The hydraulic and steam tests of boilers are carried out in a special section of the shop before being passed to the erecting department”.*

Plate 9: Aerial view of the new boiler shop taken in 1927

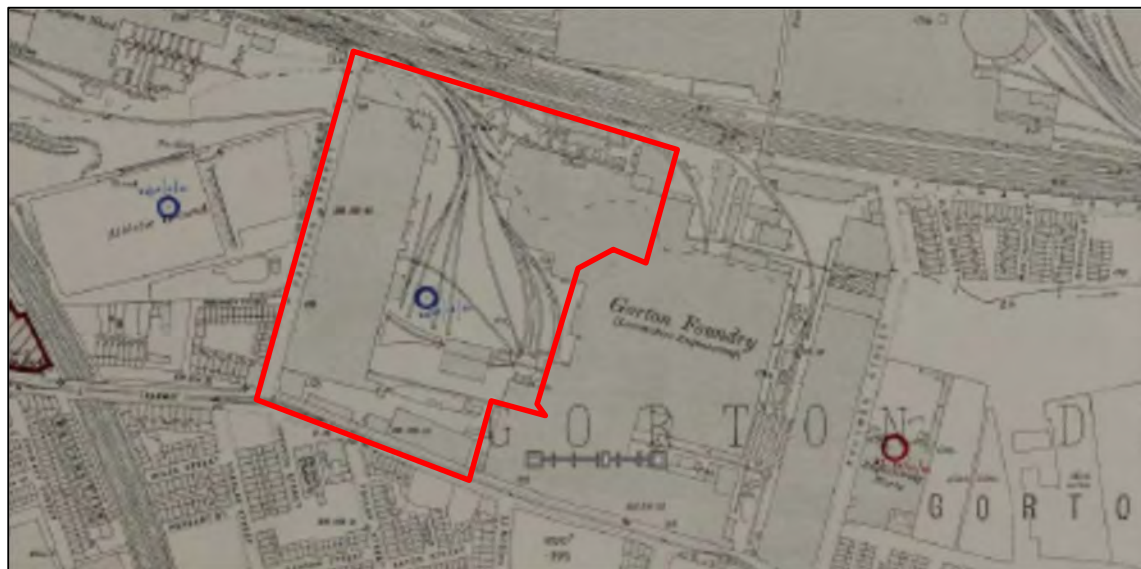
*Plate 10: Bomb Damage map of Manchester 1940-1941, showing the Site boundary with a blue circle identifying high explosives*

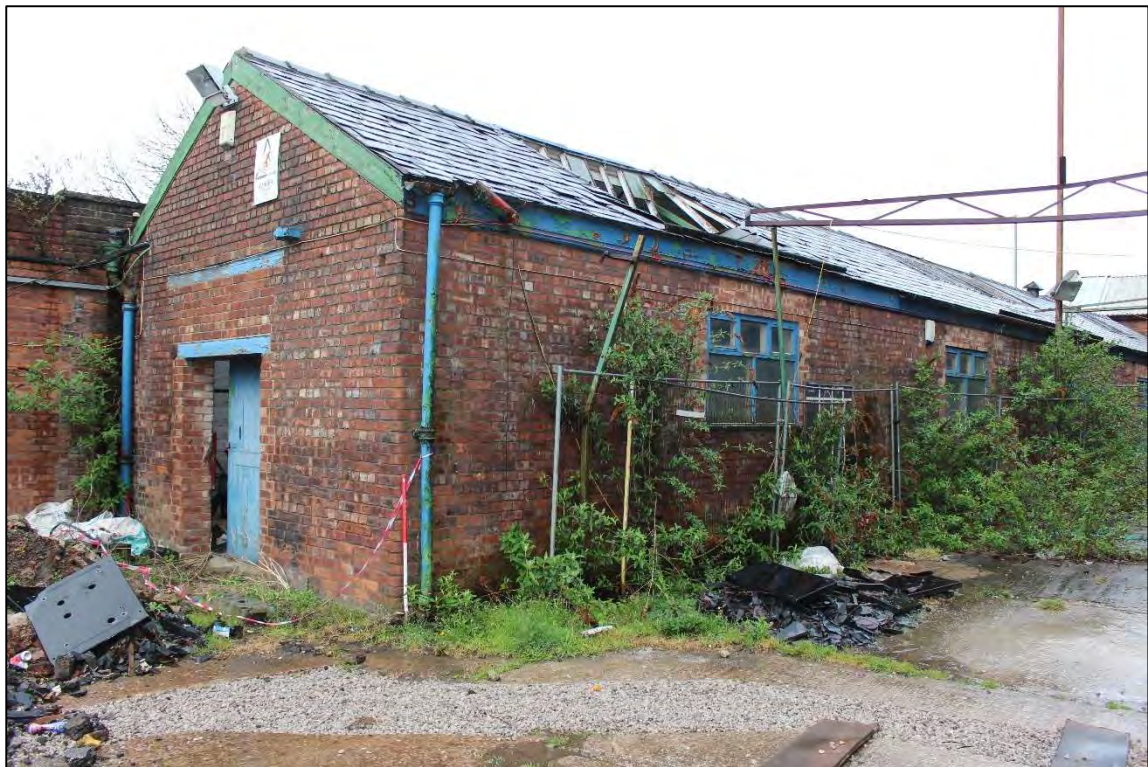
The southern ancillary building was a single-storey brick built shed with a pitched slate roof and timber barge boards (Plate 11). Internally the building could not be entered due to the collapsed roof, however the eastern section could be visually recorded via the eastern doorway at the centre of the eastern elevation.

*Plate 11: General view Shed 1 looking south-west*

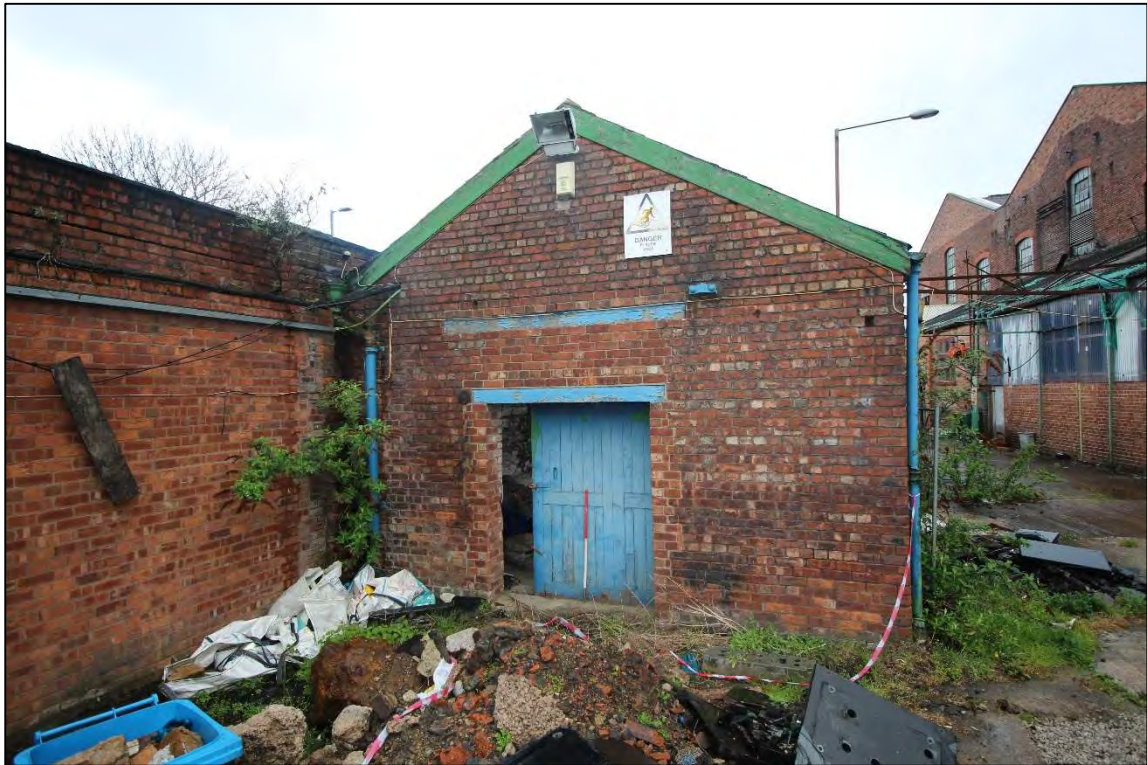
**External Description:** the eastern elevation formed the gable wall of the shed and was constructed in a three-course English Garden Wall bond (Plate 12). The southern end of the elevation had retained the original cast-iron rainwater goods.

*Plate 12: General view of the eastern elevation Shed 1*

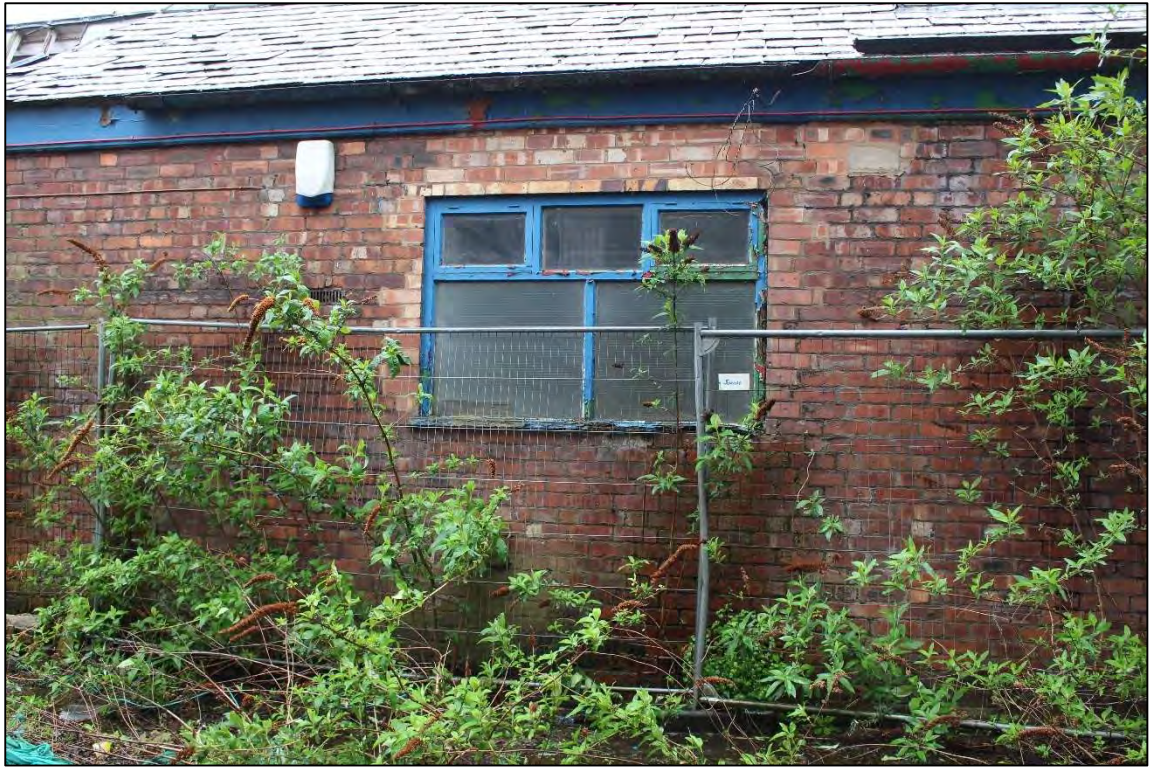
The northern elevation consisted of two window apertures to the eastern end and two doorways to the western end (Fig 2). The window openings contained an obscured steel lintel with the reveals having been repaired with later 20<sup>th</sup>-century brick that was bonded with cement mortar. Housed within the openings was a three-over-two five-light timber framed window with obscured glass to the lower two lights and clear glass above. The two upper lights opened outwards with an awning opening (Plate 13).

*Plate 13: The central window within the norther elevation of Shed 1*

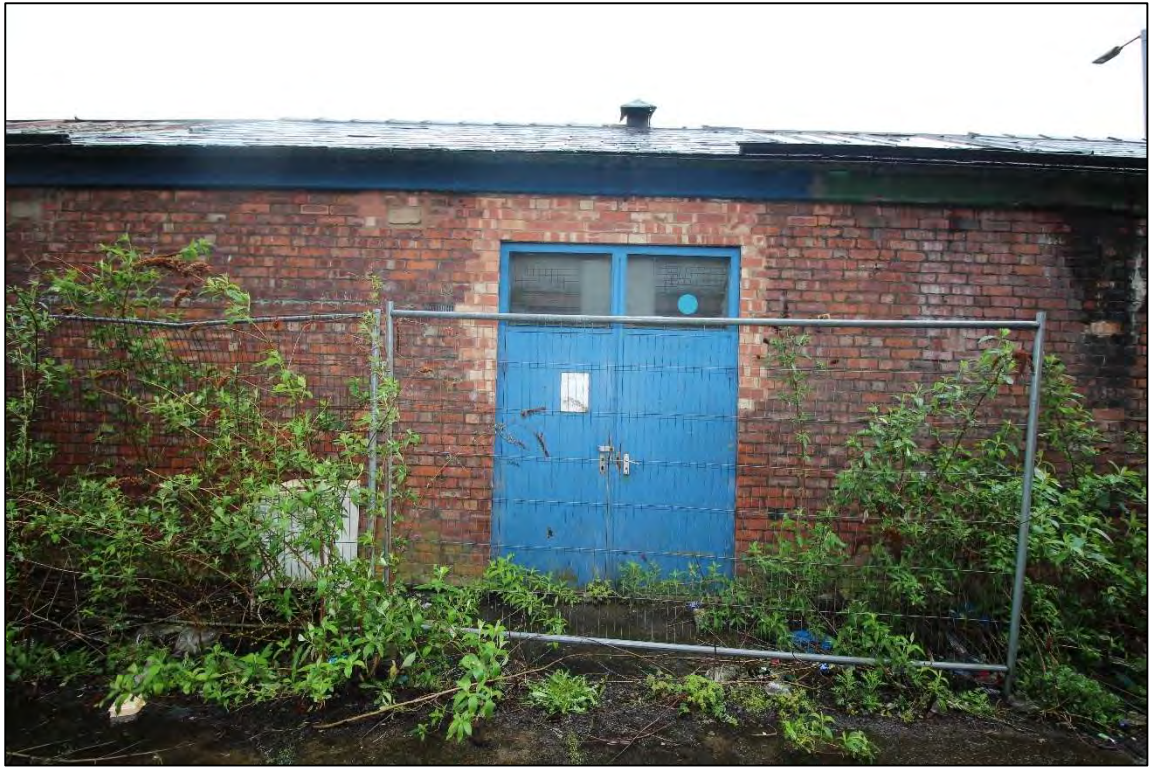
The western doorway was a later insertion and comprised an obscured steel lintel and a concrete threshold. The upper half of the brick door jambs had been replaced with modern brick and bonded with cement mortar (Plate 14). The 6' (1.83m) wide opening contained two flush timber doors with two fixed transom lights above (Plate 14). The door furniture consisted of modern aluminium door handles and hinges. The eastern doorway measured 3'7" (1.09m) wide and consisted of a flush timber door with a 6" timber lintel and a concrete threshold.

*Plate 14: The western doorway within the norther elevation of Shed 1*

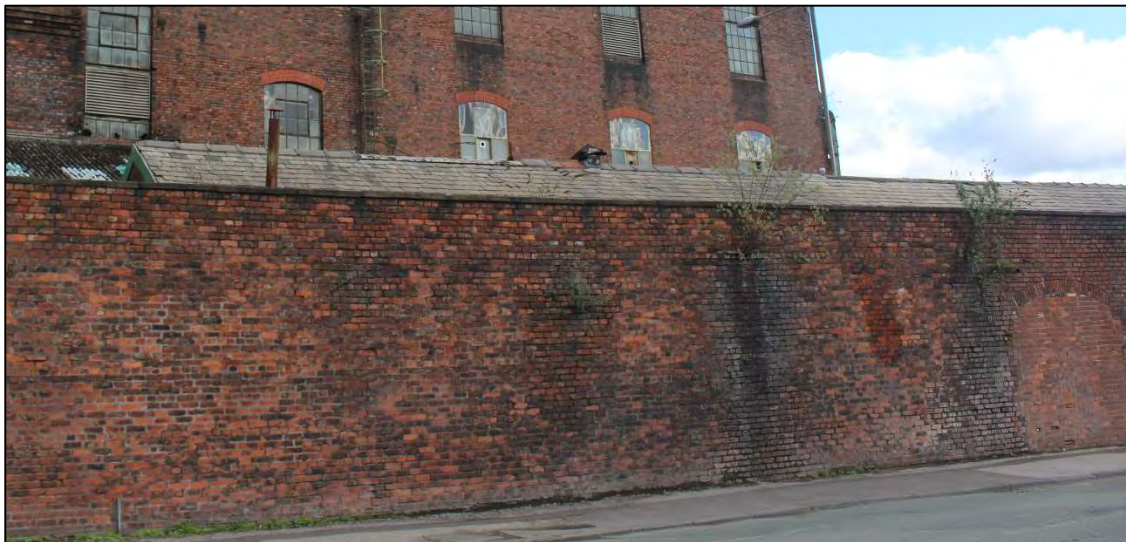
The southern elevation formed part of the sites boundary wall fronting Gorton Lane and was constructed in a four-course English Garden Wall bond (Plate 15). The only feature was a infilled cart doorway comprising a segmental arched head with a concrete threshold. The opening was infilled with modern brick laid in a stretcher bond and keyed into the original brick jambs (Plate 16).

*Plate 15: General view of the southern elevation Shed 1*

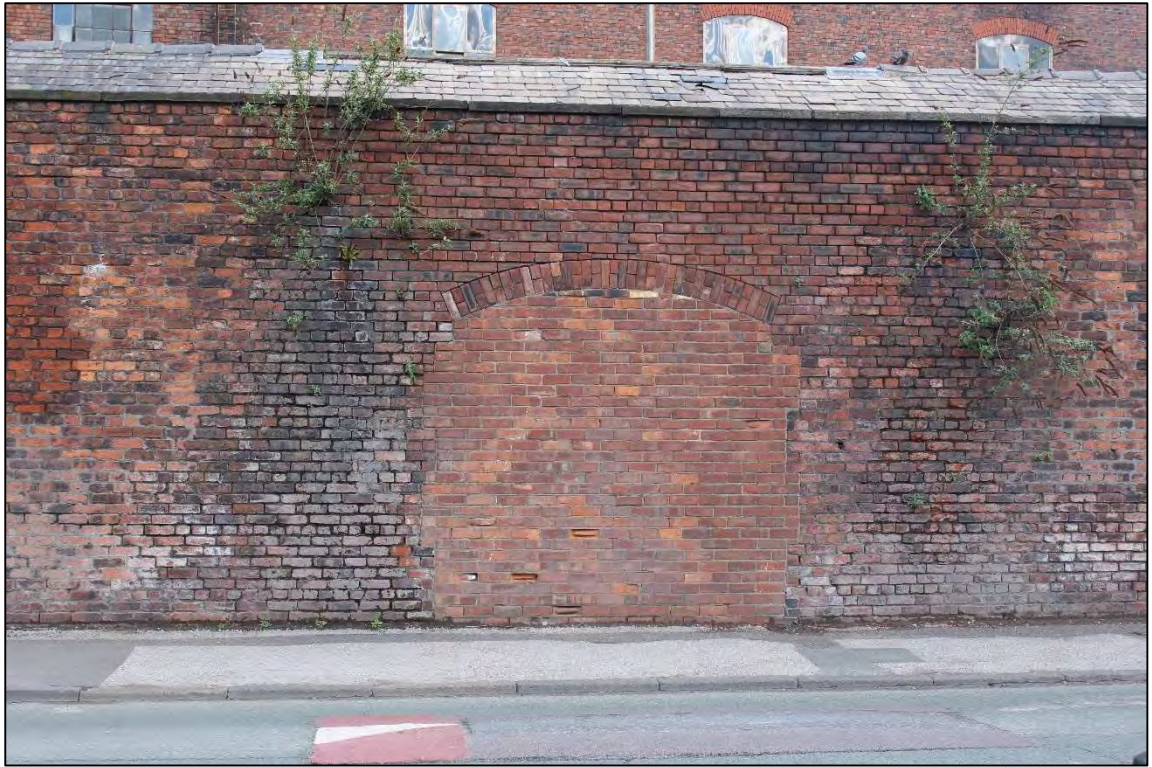
*Plate 16: Detail of the infilled doorway within the southern elevation*

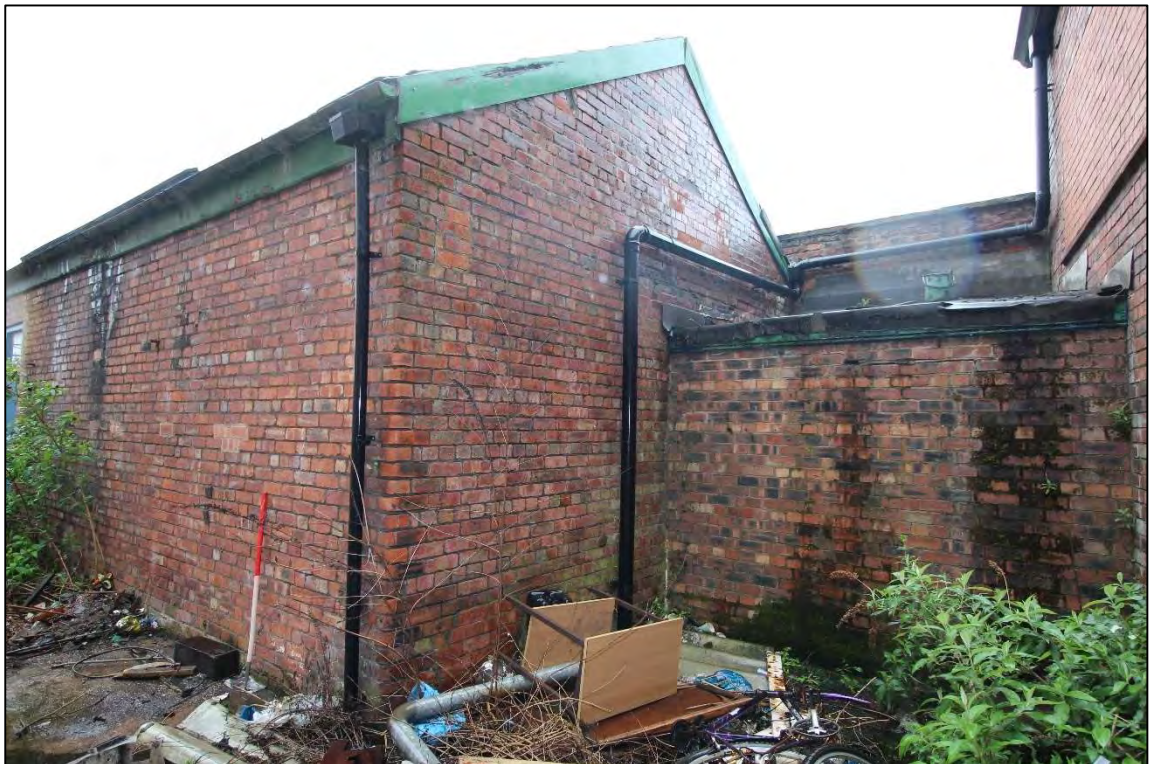
The western elevation formed the gable wall of the shed and was constructed in a three-course English Garden Wall bond. The elevation contained no historical features, although the original timber barge boards had been retained (Plate 17).

*Plate 17: General view of the western elevation Shed 1*

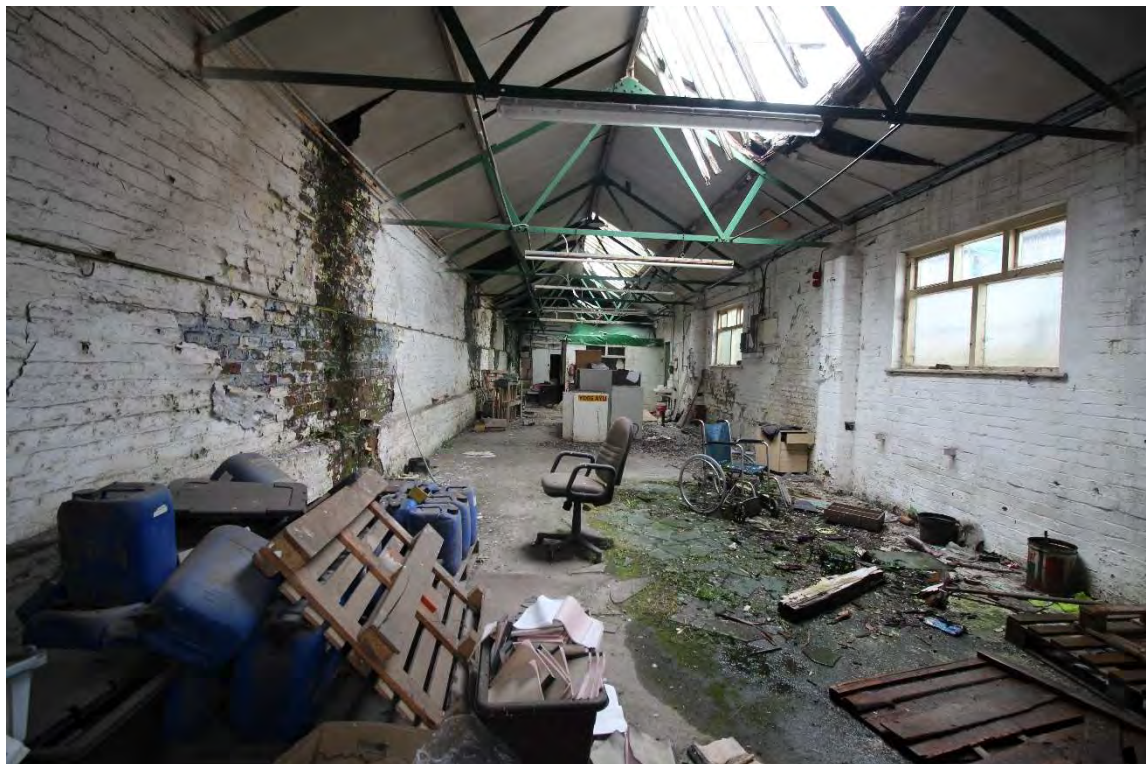
The northern wall contained two window apertures comprised a timber lintel with a flat timber internal sill. Between the windows was a bullnose brick buttress with a second buttress situated to the western end of the room (Plate 18). The southern wall stepped out a full bricks width at approximately 2'3" (0.68m) up from the concrete floor (Plate 18).

*Plate 18: General internal view of Shed 1, looking west*

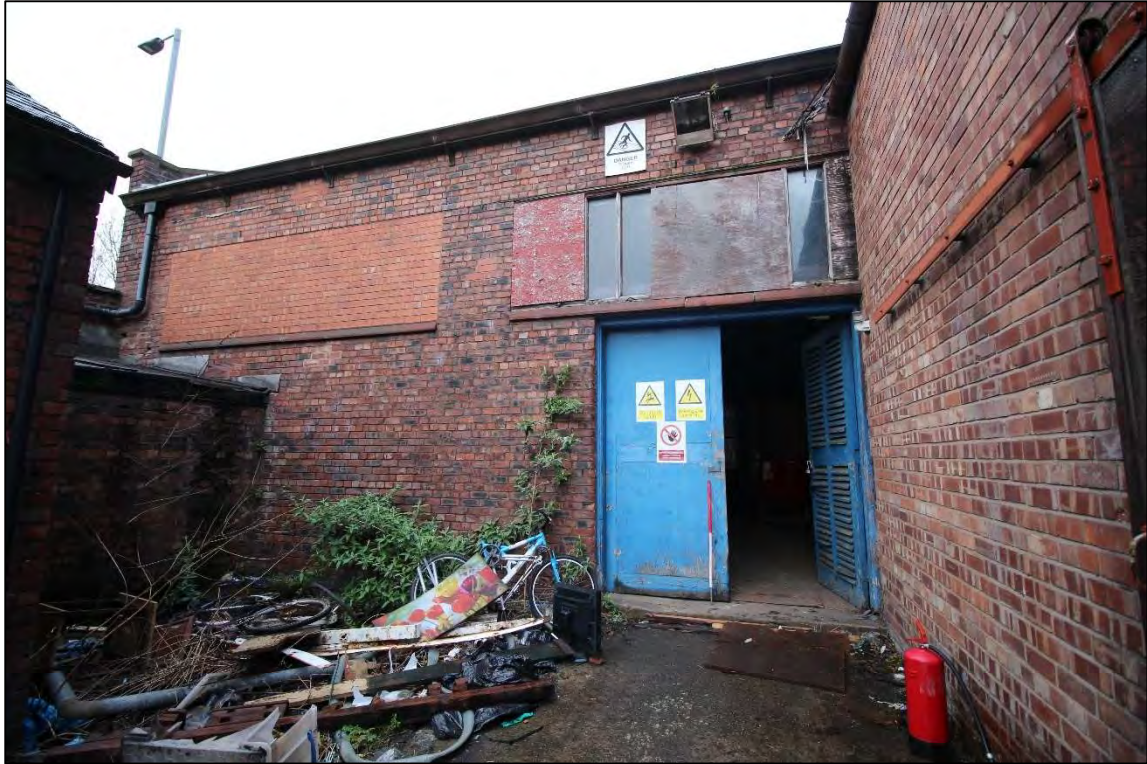
**External Description:** the eastern elevation comprised a single doorway to the northern end with two window apertures above lintel height of the doorway (Plate 19; Fig 3). The doorway measure 8'2½" (2.5m) and consisted of bullnose brick jambs, an obscured timber lintel and a concrete threshold. A two panelled door and a timber louvered door were housed within the opening (Plate 19).

*Plate 19: The eastern elevation Shed 2*

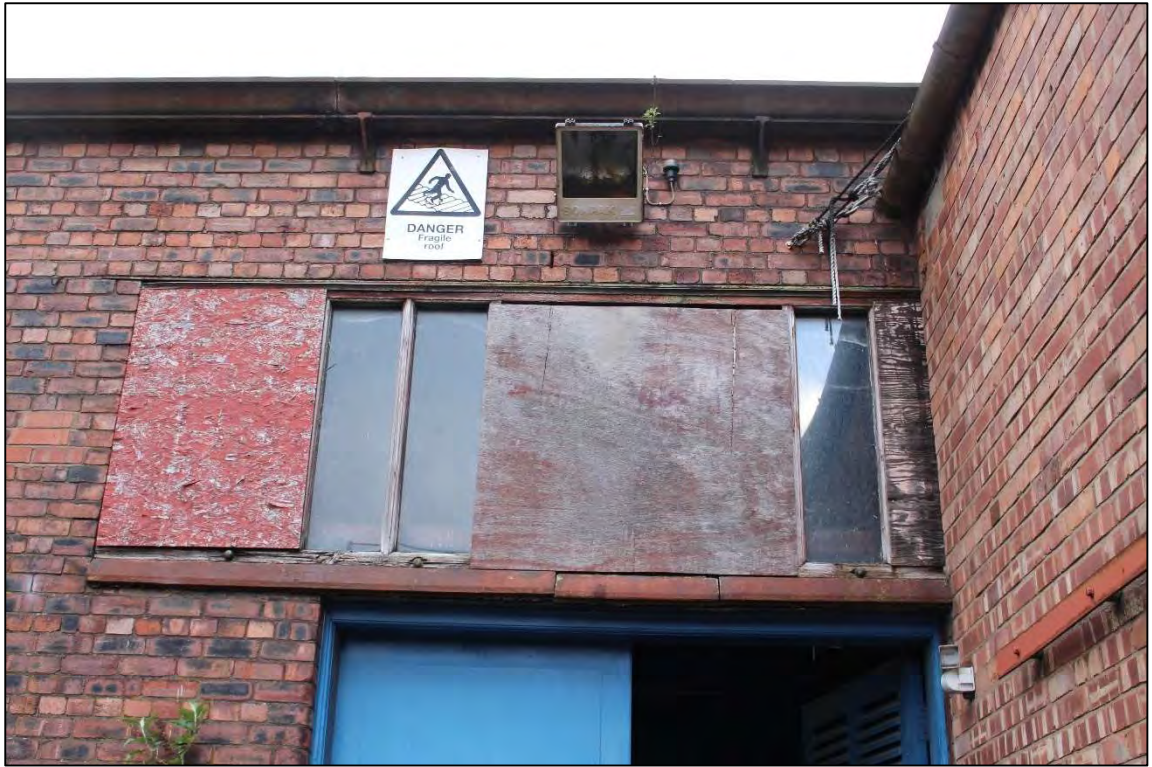
Directly above the doorway was an 11'6½" (3.51m) wide window with a flat steel bar lintel and a projecting chamfered terracotta sill that obscured the lintel to the doorway below. The opening housed a horizontal 11-light timber framed window with timber mullions and clear glass glazing (Plate 20). A second window aperture had been situated to the south and comprised chamfered terracotta sill, and a flat steel bar lintel. The 14'10" (4.52m) wide opening was infilled with modern bricks laid in a stretcher bond arrangement (Plate 21).

*Plate 20: Detail of the window above the doorway within the eastern elevation*

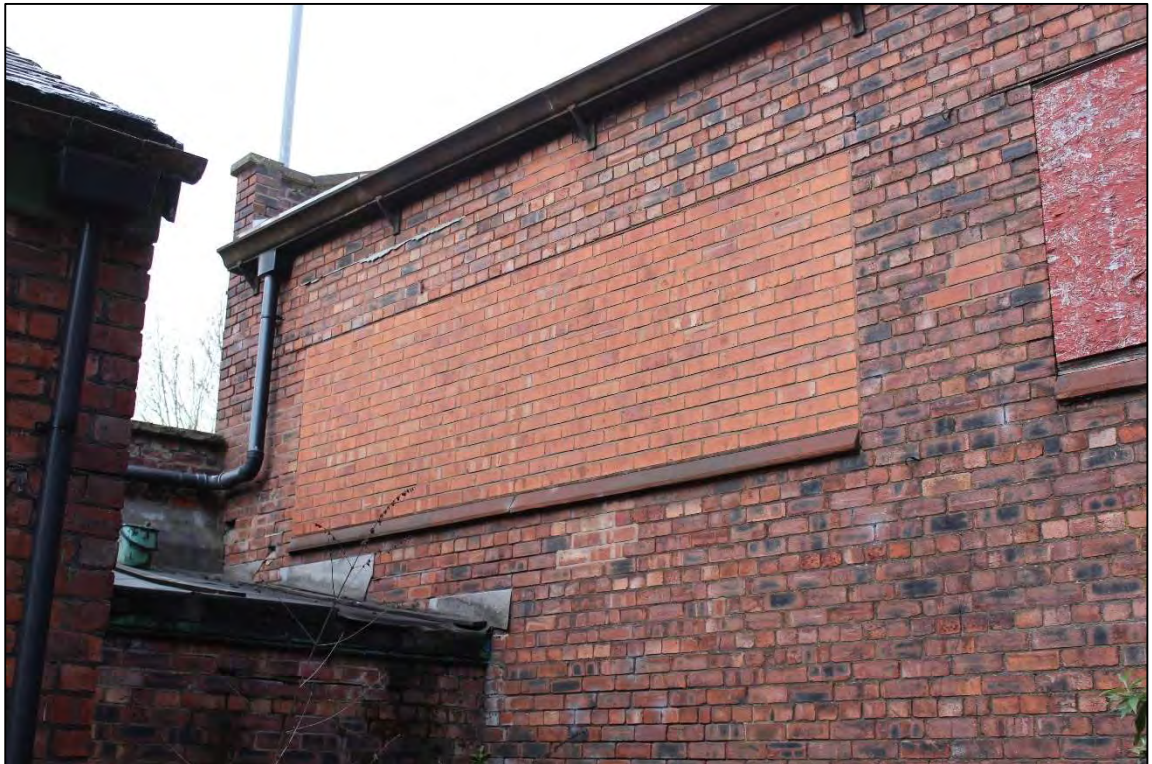
*Plate 21: The infilled window to the southern end of the eastern elevation*

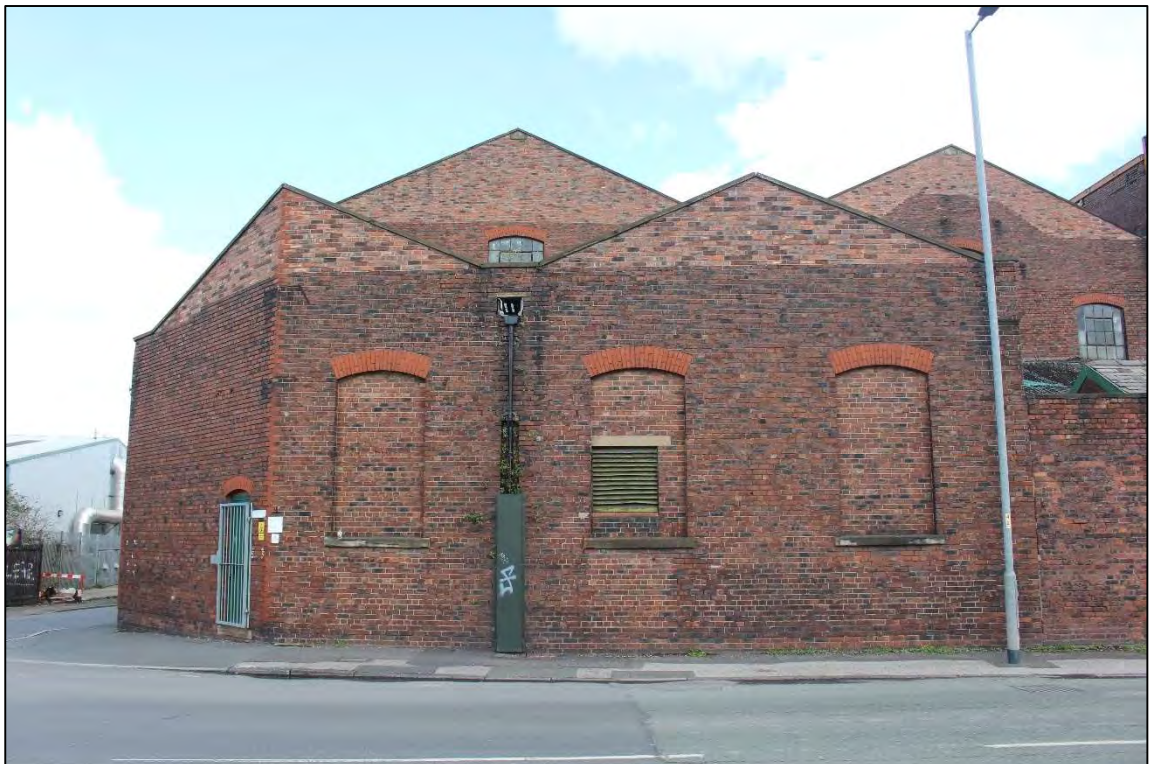
The southern elevation was constructed with two gables fronting Gorton Lane with the western gable having a dogleg at the corner (Fig 3). The elevation was constructed in a three-course English Garden Wall bond with oversailing stone copings to the roof (Plate 22). Three 4'11" (1.5m) wide windows comprising gauged segmental arched heads with protruding chamfered stone sills. The openings were brick infilled with a timber louvered vent with a concrete lintel was inserted into the central aperture (Plate 22). The south-west facing dogleg contained a single pedestrian doorway to the south-eastern end. This consisted of a segmental arched lintel with a concrete step affording access into the building from Gorton Lane. The opening housed a replaced steel panelled door with a modern galvanised security gate fixed to the outer face (Plate 23).

*Plate 22: General view of the southern elevation Shed 2*

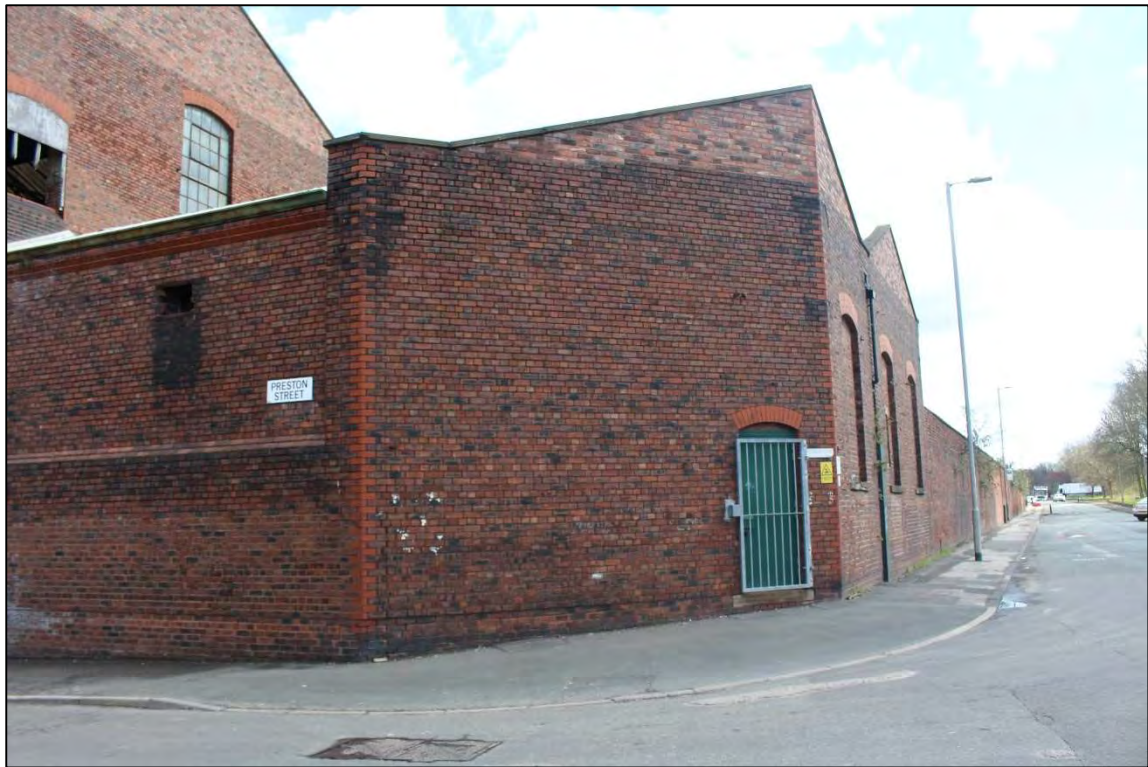
*Plate 23: General view of the south-western elevation Shed 2*

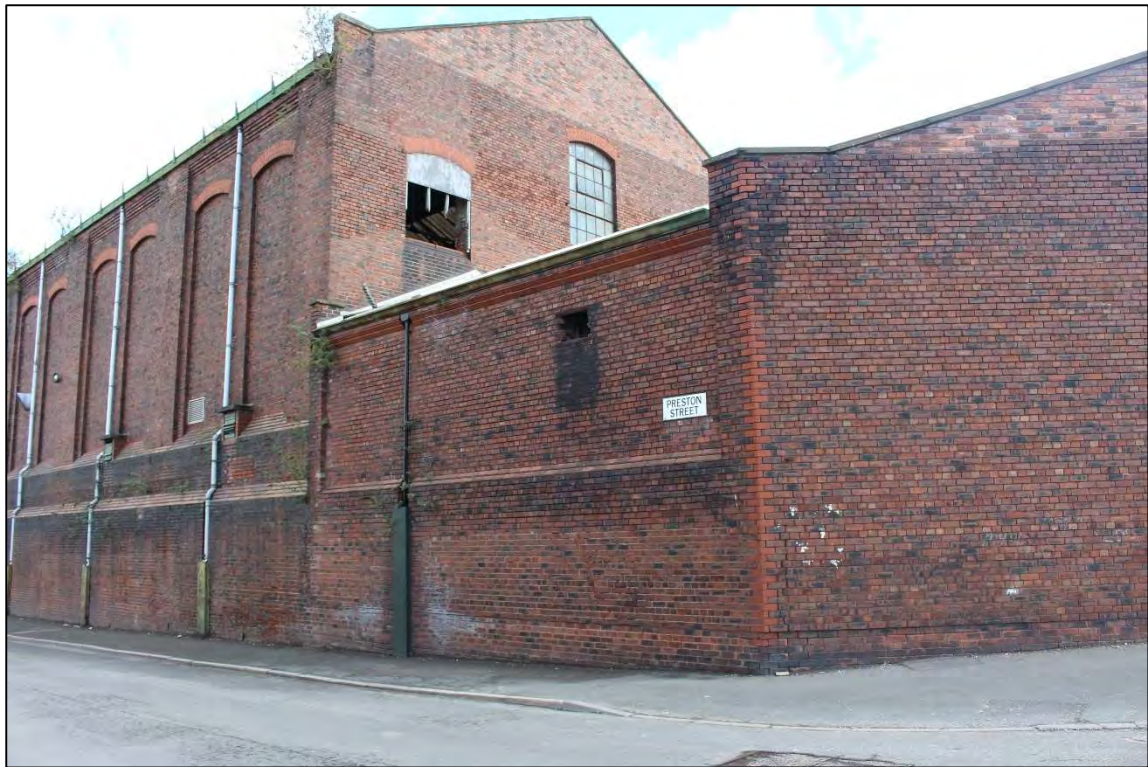
The western elevation was built in a three-course English Garden Wall bond with a horizontal recessed panel to the upper section of the wall (Plate 24; Fig 3). An inserted wall box with steel banding measured 2'1 $\frac{3}{4}$ " (0.65m) by 2'1 (0.63m) and was situated to the south-eastern end of the recess (Plate 24). The replaced gutter to the roof was obscured by moulded ogee cyma recta string course (Plate 24).

*Plate 24: General view of the western elevation Shed 2*

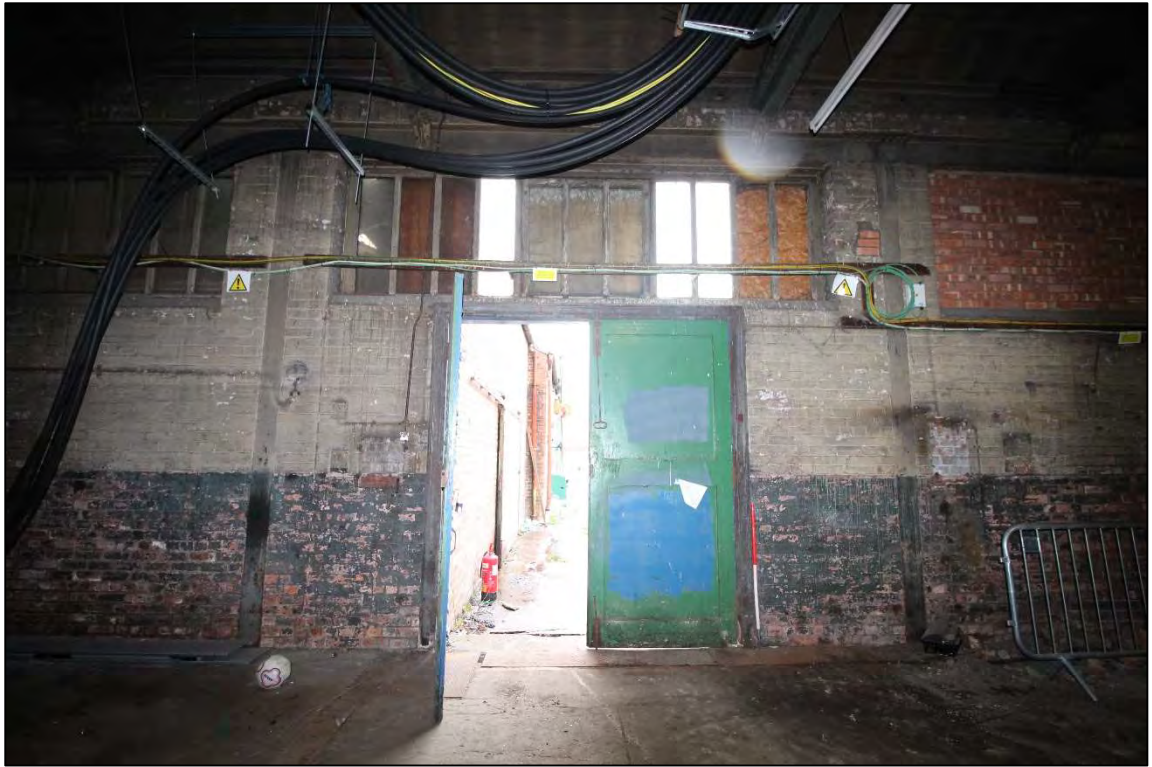
**Internal Description:** internally, the building was divided into four rooms (Fig 3). Principle access into Room 1 was afforded by the doorway within the eastern elevation of the shed (Fig 3). The 8'2½" (2.5m) wide doorway contained a panelled door and a timber louvered door were housed (Plate 25). The timber doorframe had been obscured by the moulded timber architraves (Plate 25).

*Plate 25: The doorway at the centre of the eastern wall*

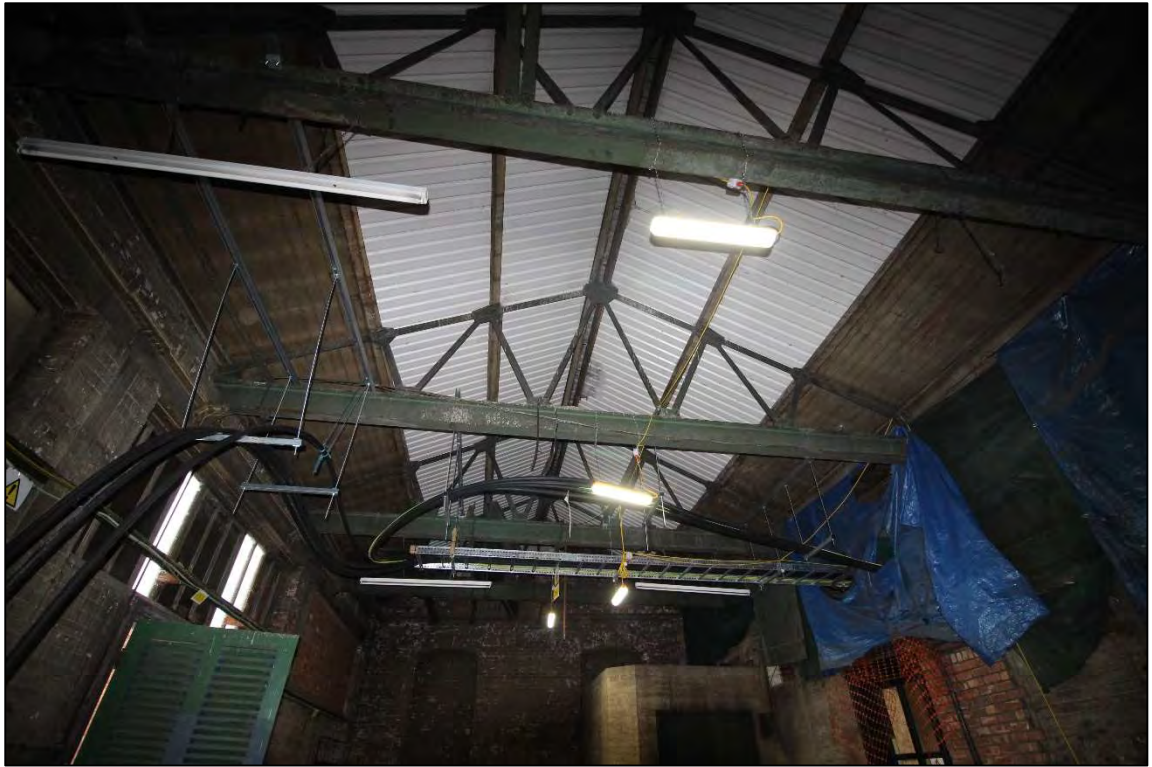
The room measured 53'10" (16.42m) by 25'11" (7.91m) and comprised stone flag floor, brick walls and an open ceiling exposing the double fink L-section angle fink trusses with l-section tie beams (Plates 26&27).

*Plate 26: General view of Room 1 within Shed 2, facing south-west*

*Plate 27: Detail of the fink trusses in Room 1*

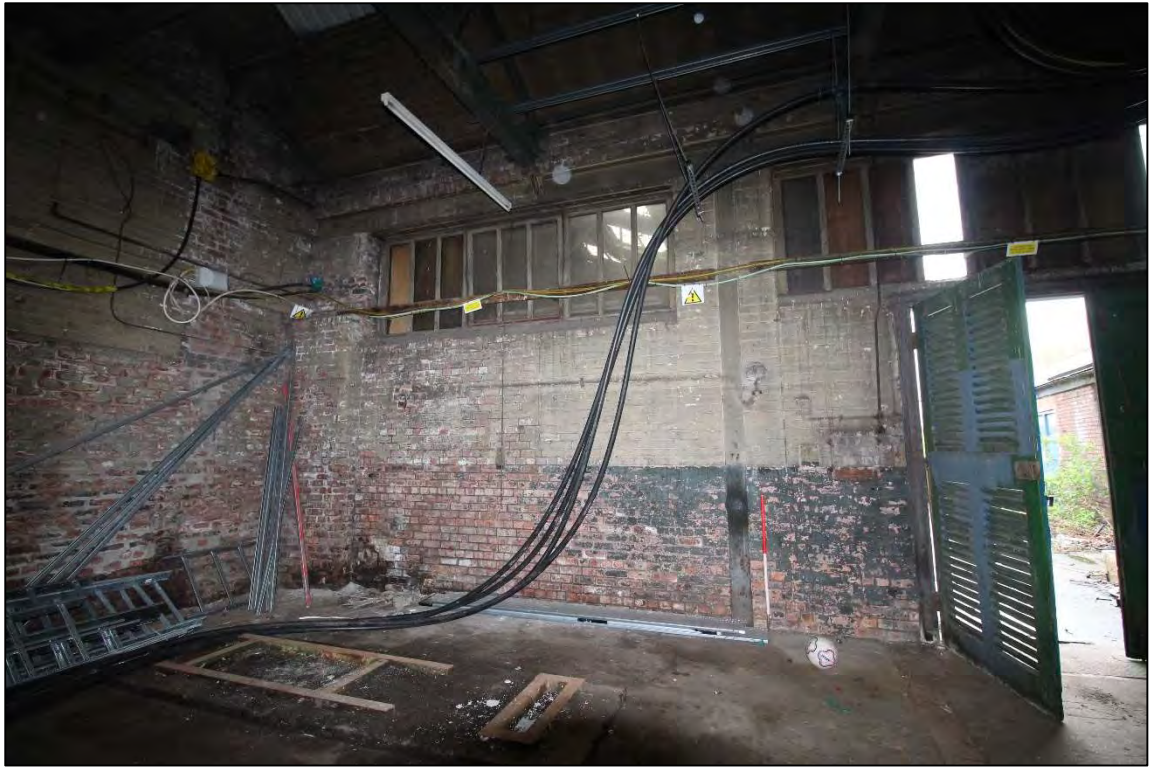
The eastern wall contained three horizontal windows situated above the door lintel. These comprised a riveted steel I-section with a concrete rendered brick internal sill. The central opening housed an 11-light timber window frame, while the northern aperture housed a nine-light window. The southern opening had been infilled with modern brick laid in a stretcher bond (Plates 25, 28&29).

*Plate 28: The window aperture to the northern end of the eastern wall of Room 1*

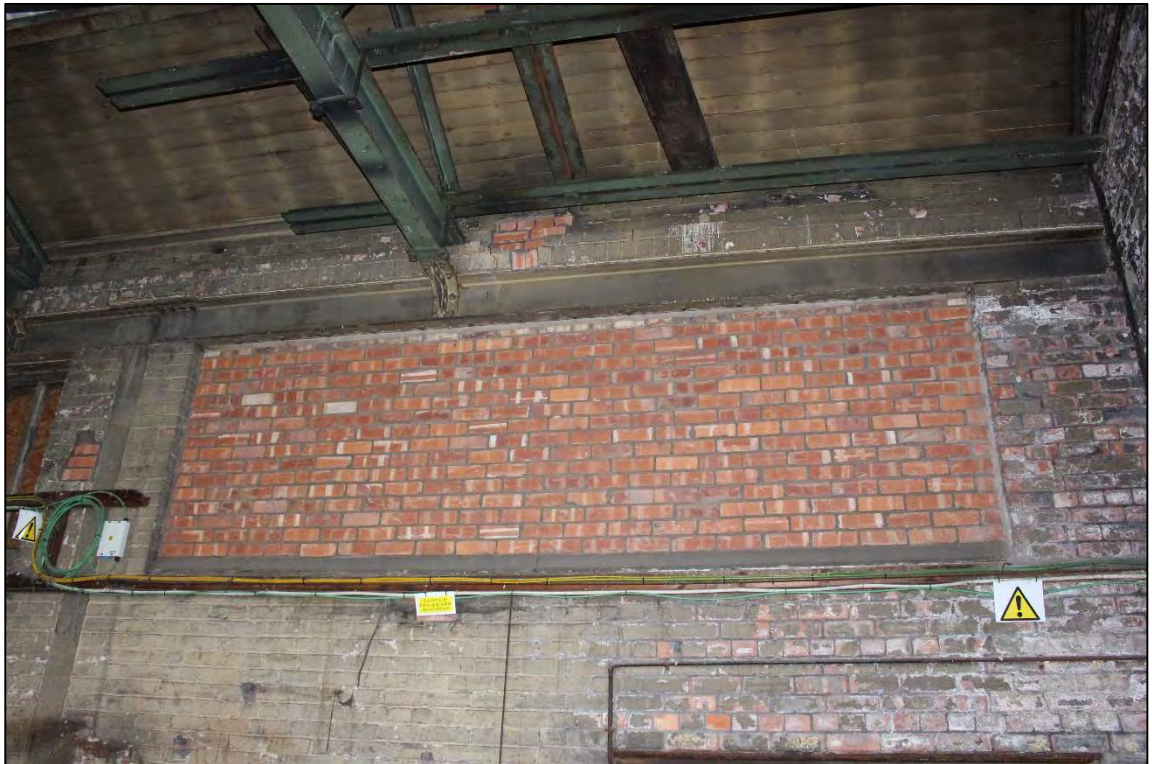
*Plate 29: The infilled window to the southern end of the eastern wall of Room 1*

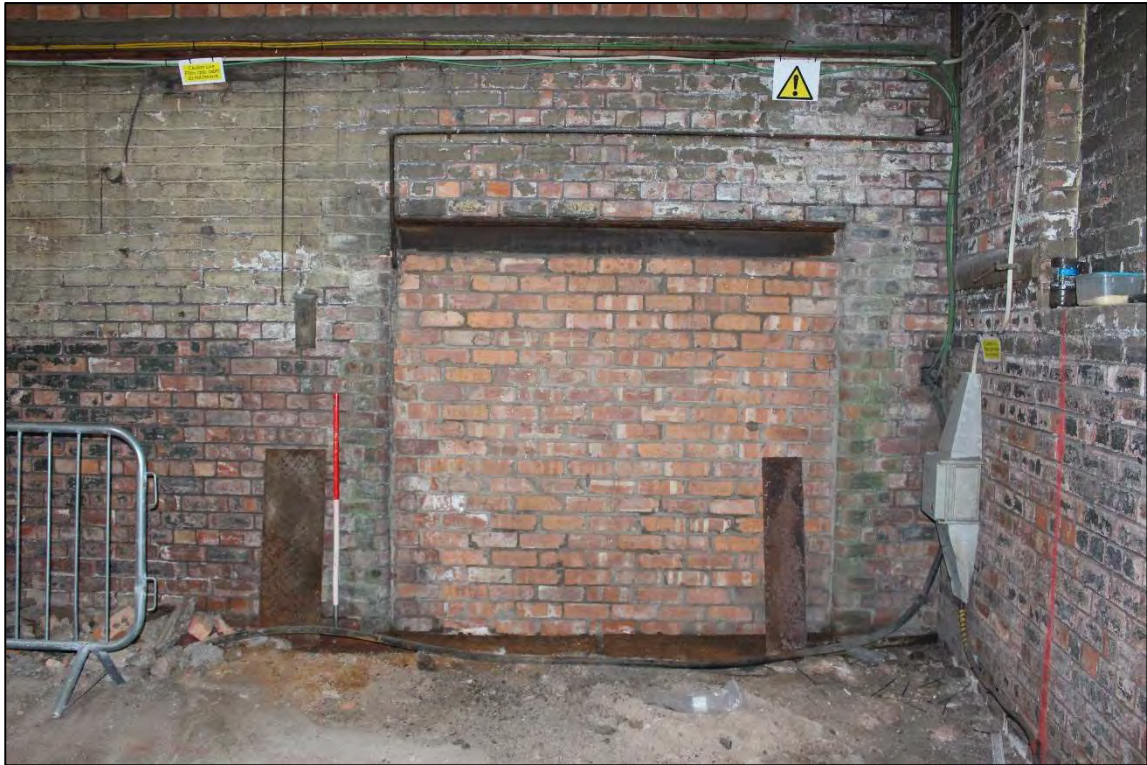
A blocked doorway was situated to the southern end of the eastern wall. This afforded access into a small lean-to that was constructed between the building and Shed 1 (Fig 3). The doorway consisted of a steel I-section lintel and a concrete threshold. The 6'11½" (2.12m) wide opening had been infilled with modern bricks laid in a stretcher bond arrangement (Plate 30).

*Plate 30: The blocked doorway within the eastern wall of Room 1*

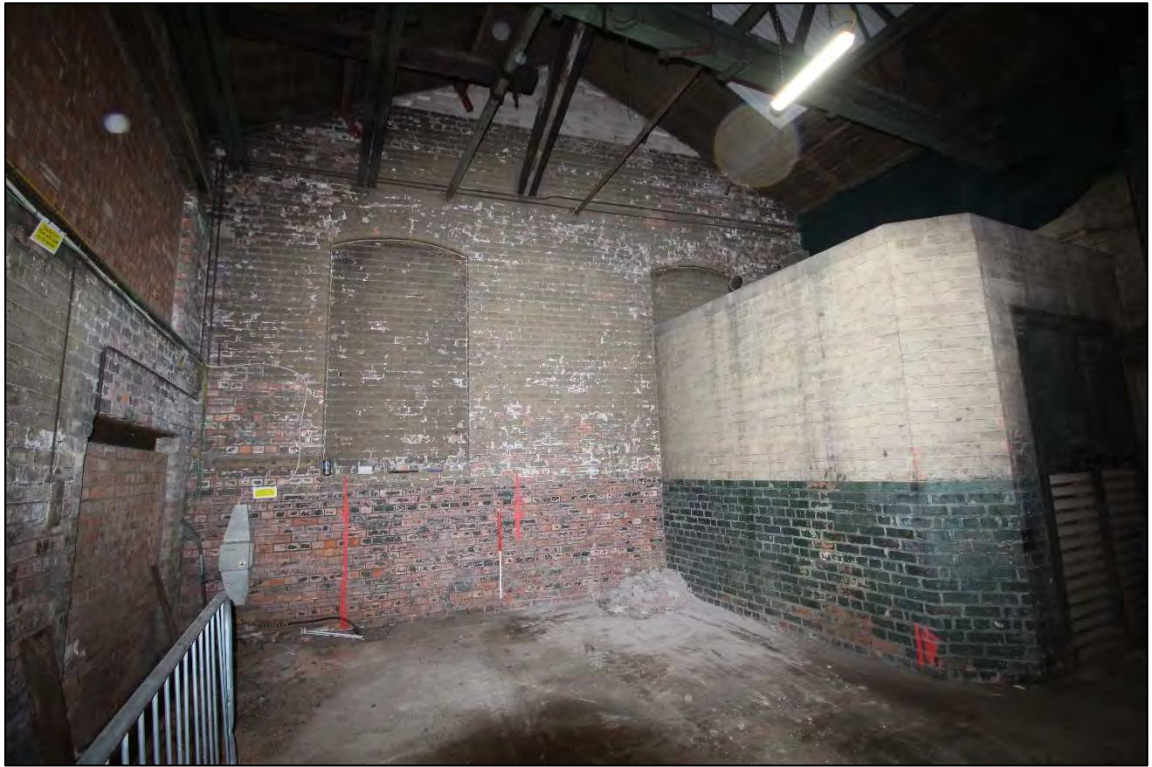
The eastern gable of the building formed the southern wall of the room. This contained two blocked 4'11" (1.5m) wide windows comprising a three-course segmental arched lintel and a flat brick internal sill. The openings were infilled with brick (Plate 31).

*Plate 31: The blocked windows to the southern wall of Room 1*
