## **Historic Building Investigation**

Hammerstone Road  
Depot, Gorton,  
Manchester

SA/2023/40

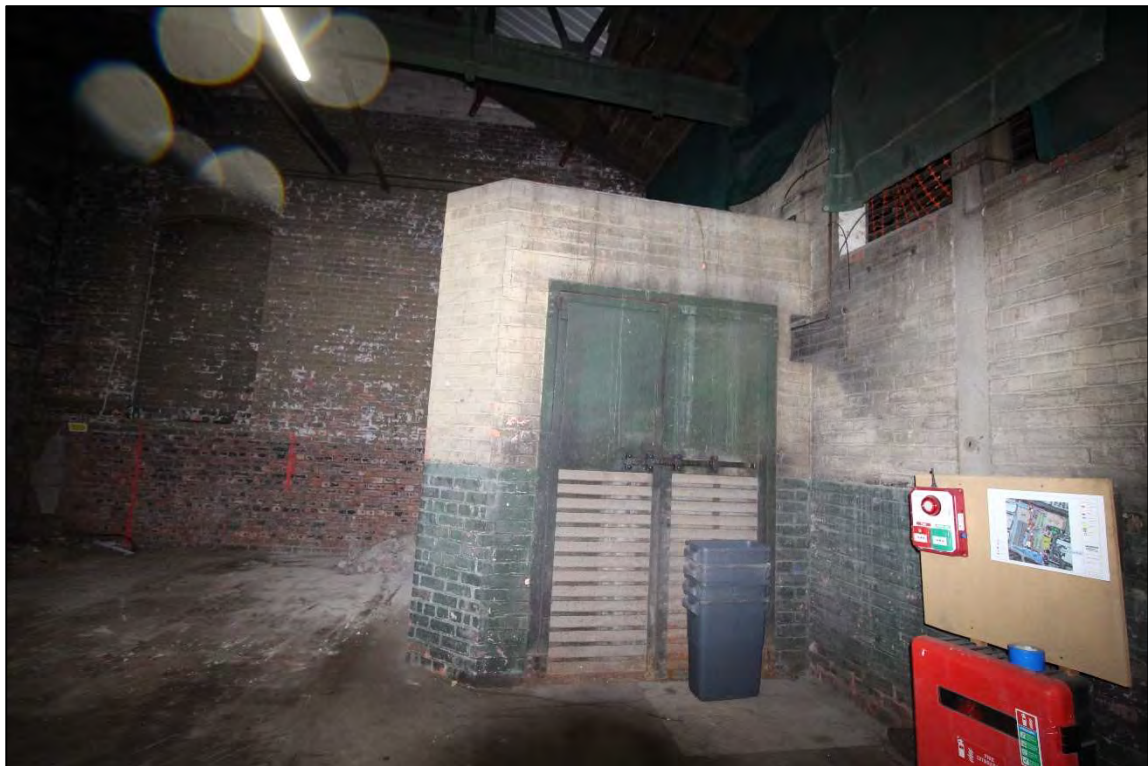
At the south-western corner of the room was a small brick constructed room, Room 2. The room measured 12' (3.65m) north/south by 911½" (2.78m) east/west. The room was entered by two louvered steel doors within the northern wall (Plate 33). Access into the room was not gained due to the room housing live electrical equipment.

*Plate 33: General view of the live electrical area, Room 2*

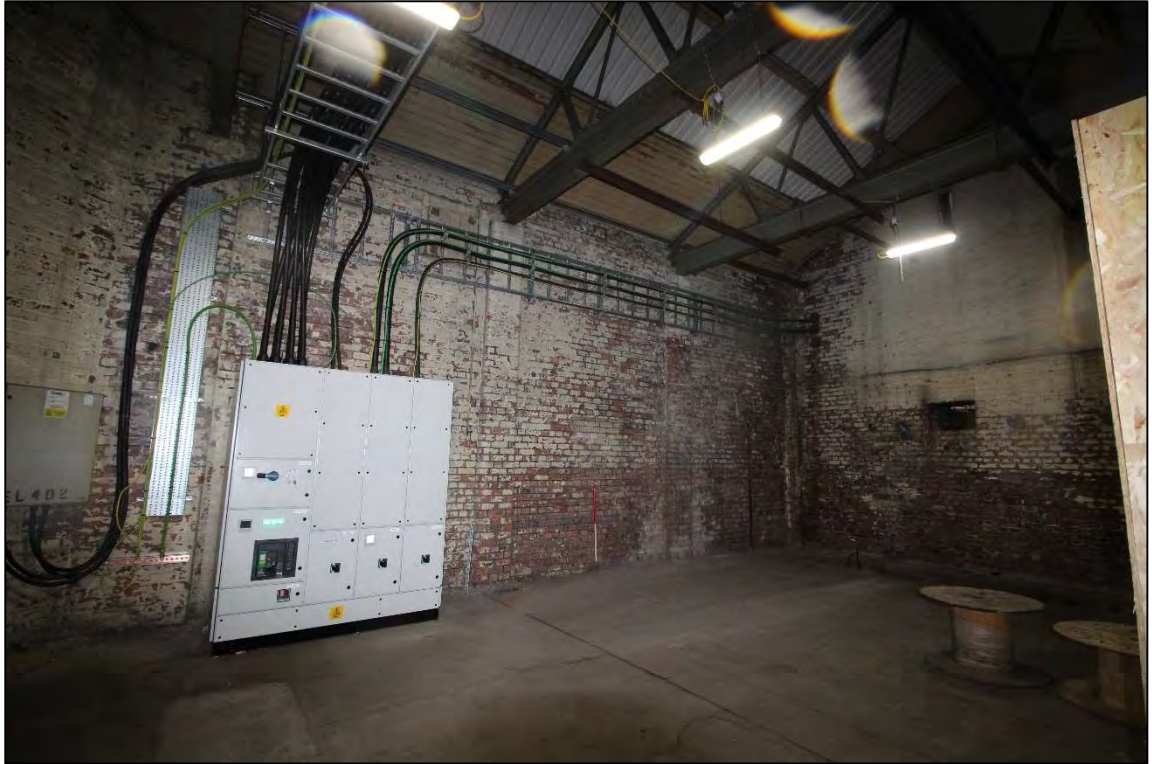
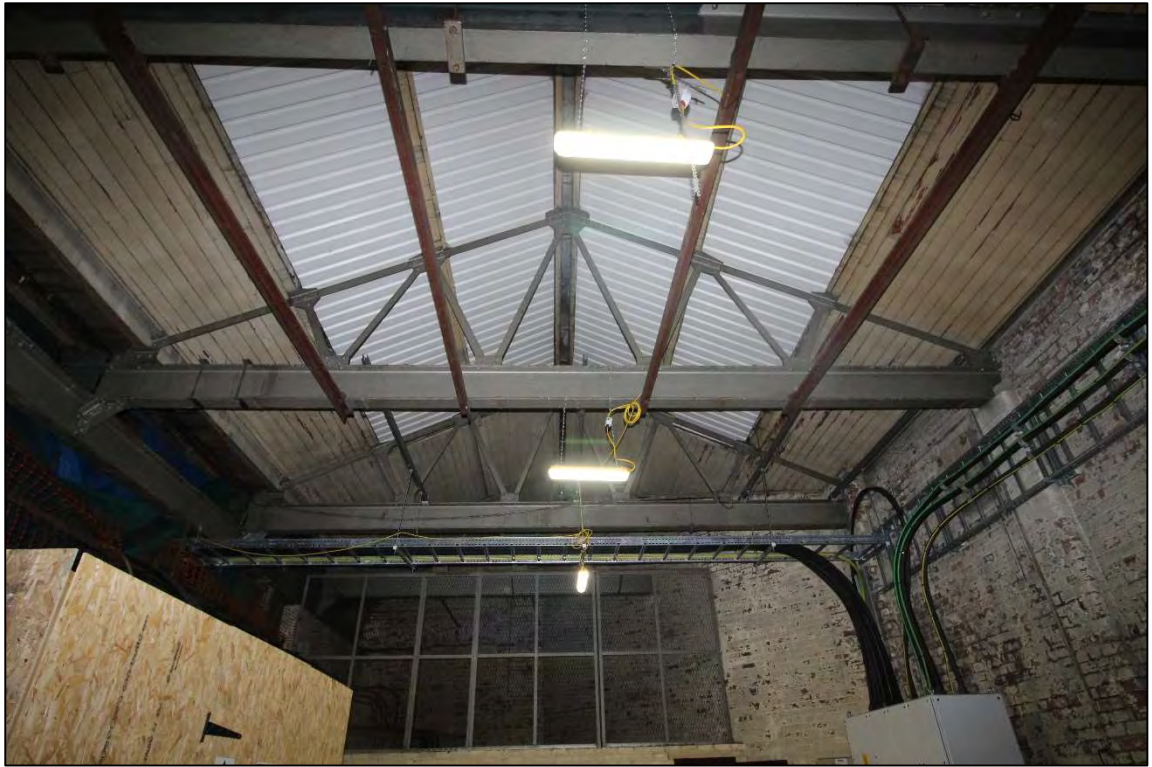
Room 3 was situated to the western end of the building and consisted of a single bay measuring 53'10" (16.42m) by 25'11" (7.91m) and comprised concrete floor, brick walls and an open ceiling exposing the double fink L-section angle fink trusses with I-section tie beams (Plates 34&35). The tie beams were also supported by brick buttress within the western wall.

*Plate 34: General view of Room 3, looking north-west*

*Plate 35: Detail of the fink trusses in Room 3*

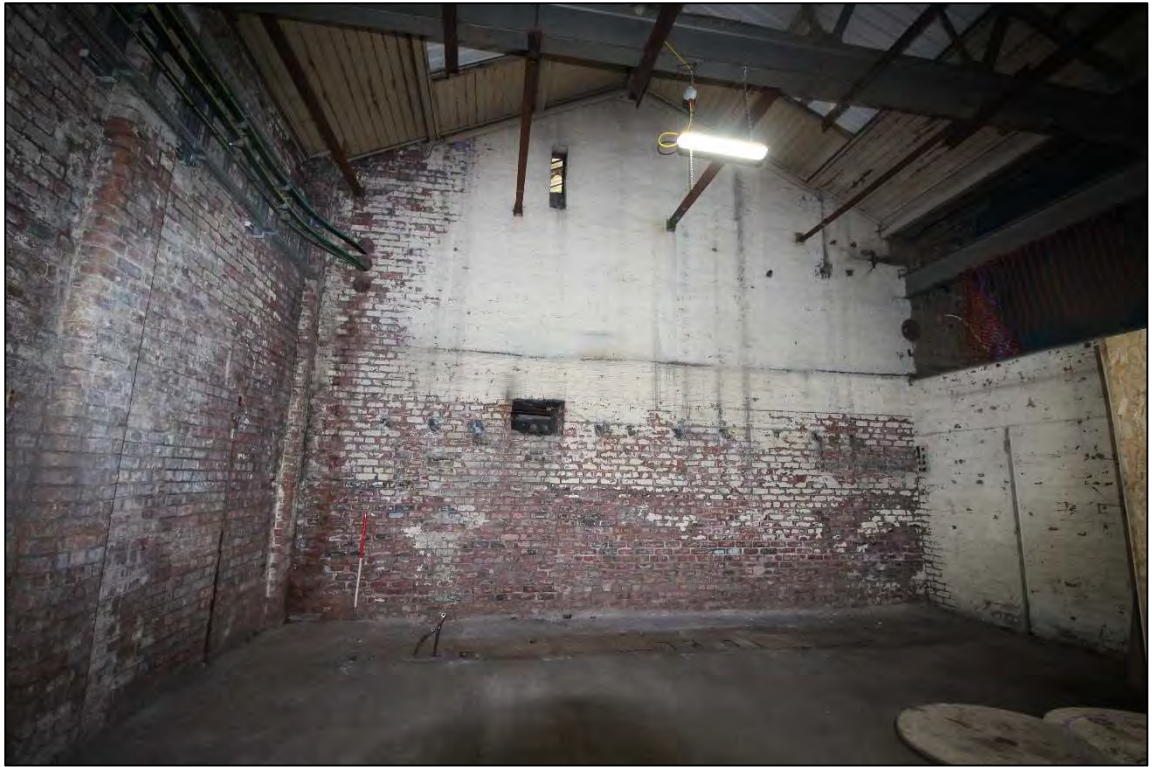
The room had been stripped of its historic fixtures and fittings however a pit within the floor contained the remains of electrical cables, was situated to the northern end. The pit was covered with steel sheeting with multiple holding down bolts around the edge. This suggests the original electrical fuse cabinet that powered the boiler shop was free standing with the cables entering the shop via a wall box set within the northern wall of the room. (Plate 36).

*Plate 36: The northern wall of Room 3 with an exposed wall box to the left of the photograph*

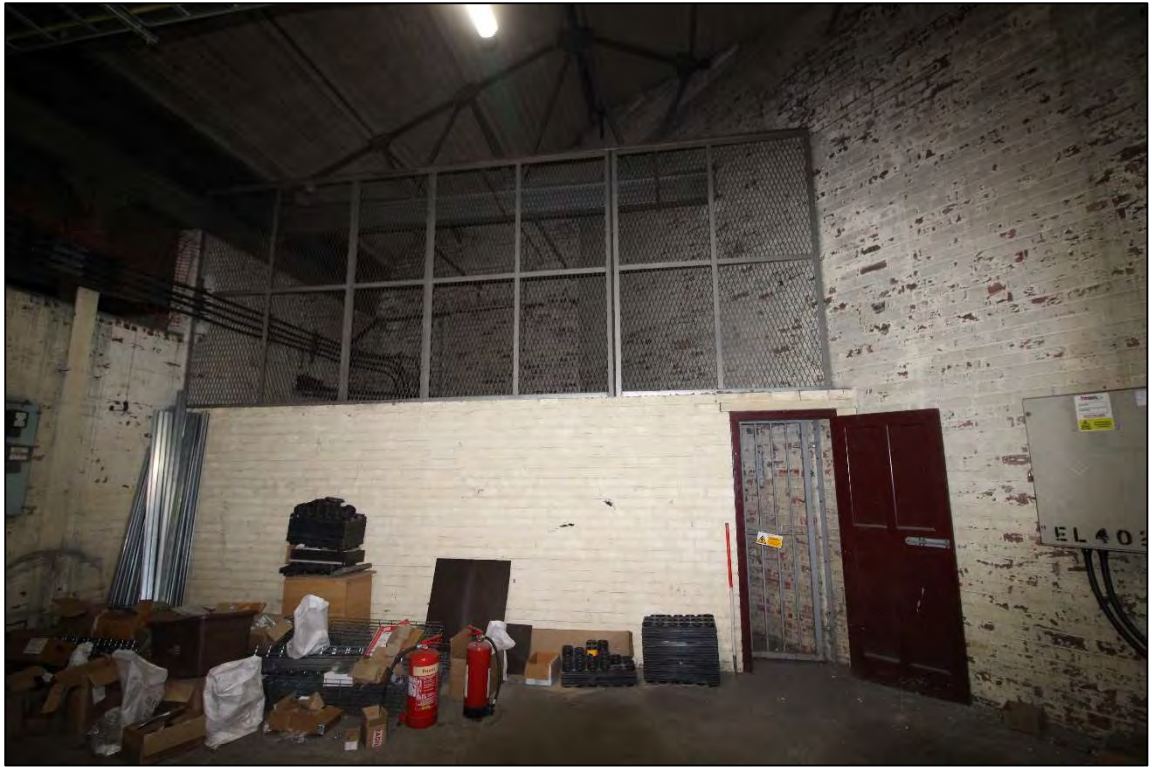
Room 4 was situated to the southern end of Room 3 (Fig 3). The brick partition wall between the two rooms was 2.21m high with a steel mesh frame above (Plate 37). Access was afforded by a doorway with rectangular timber architraves and a four panelled timber door situated at the western end of the wall. A modern steel gate was fixed to the internal face of the doorway restricting access into the room.

*Plate 37: The brick and steel mesh partition wall between Rooms 3 and 4, looking south*

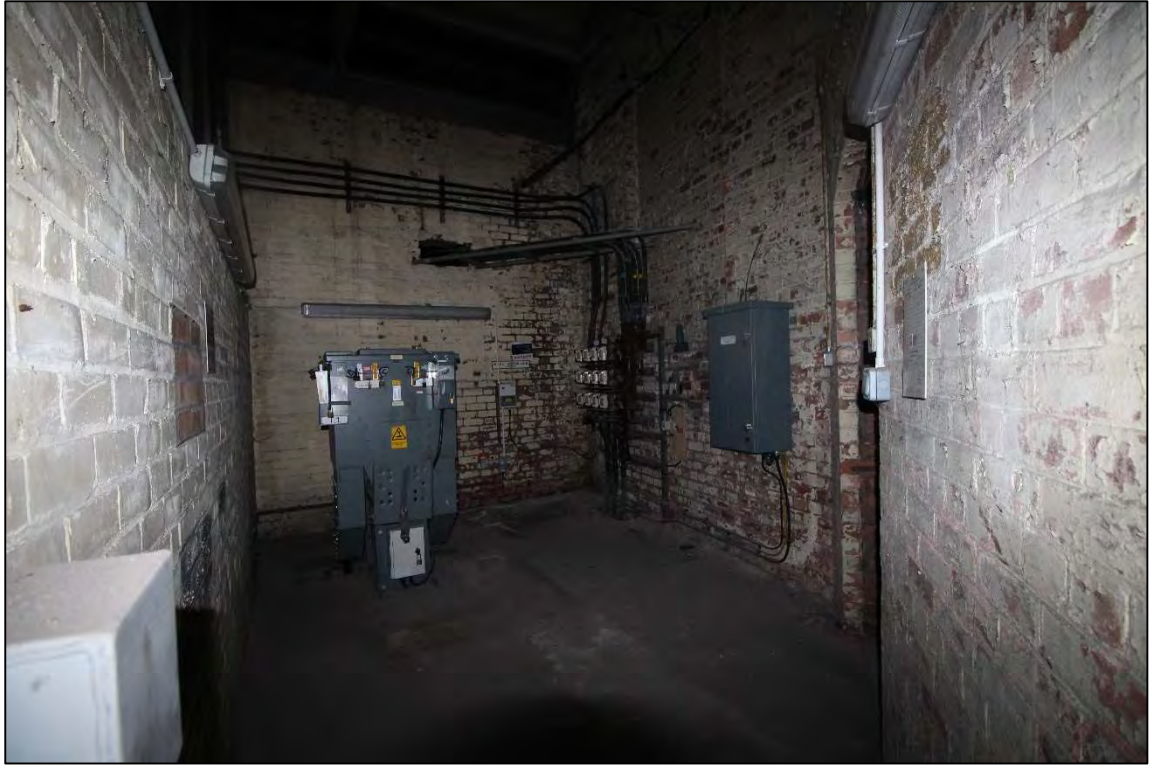
The room comprised a concrete floor, brick walls and an open ceiling that exposed the steel roof truss of the building (Plate 38). Access into the room was prohibited due to the room containing live electrical equipment, however parts of the original fabric was observed from the doorway. The southern wall contained a brick infilled 4'11" (1.5m) wide window with a gauged segmental arched lintel (Plate 38). A doorway was situated to the south-eastern end of the south-western wall. This had a flush concrete lintel and threshold.

*Plate 38: General view of Room 4 of Shed 2*

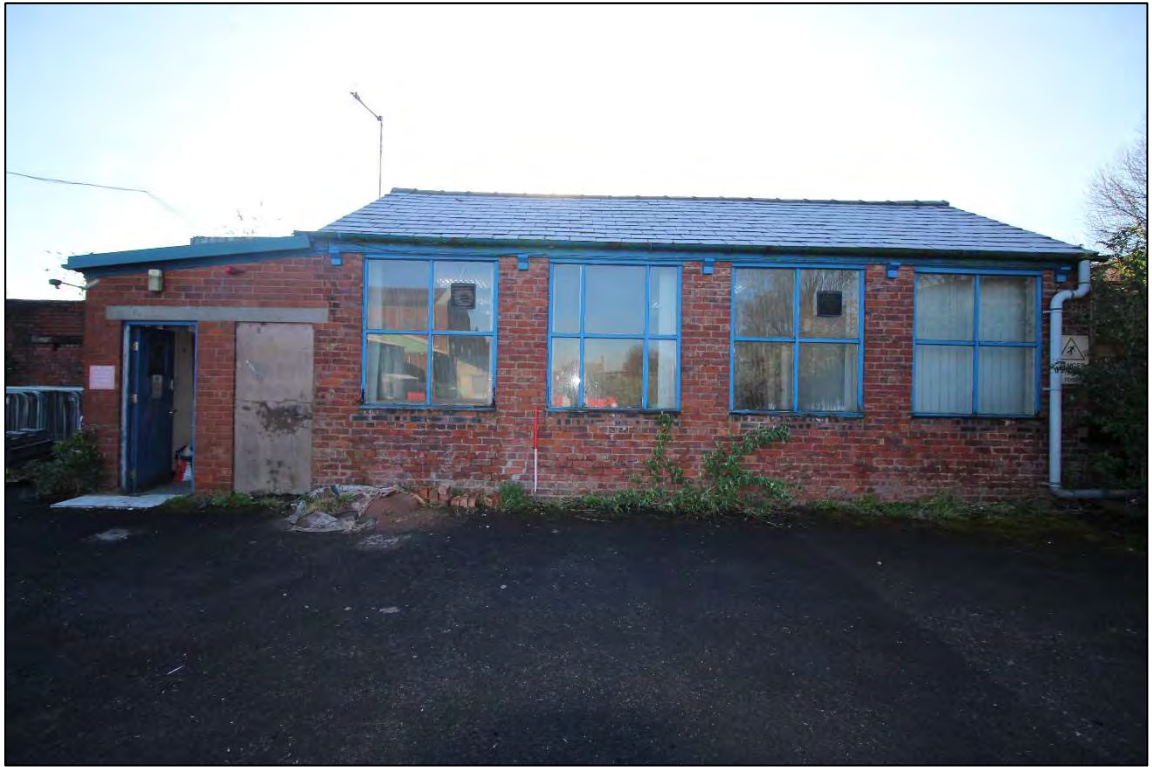
***External Description:*** the western elevation was constructed in a three-course English Garden Wall bond and comprised four window apertures to the original phase and two doorways within the lean-to (Plate 39; Fig 4).

*Plate 39: General view of the western elevation of the small office block*

The 5'2" (1.57m) wide window apertures were of a simple construction with the lintels obscured by the timber fascia board. The sills had been removed and replaced with brick infilling. Three of the openings housed a four-light timber window frame with the second opening from the northern end containing a six-light timber frame. The glazing to each frame was of modern clear wired glass (Plate 39).

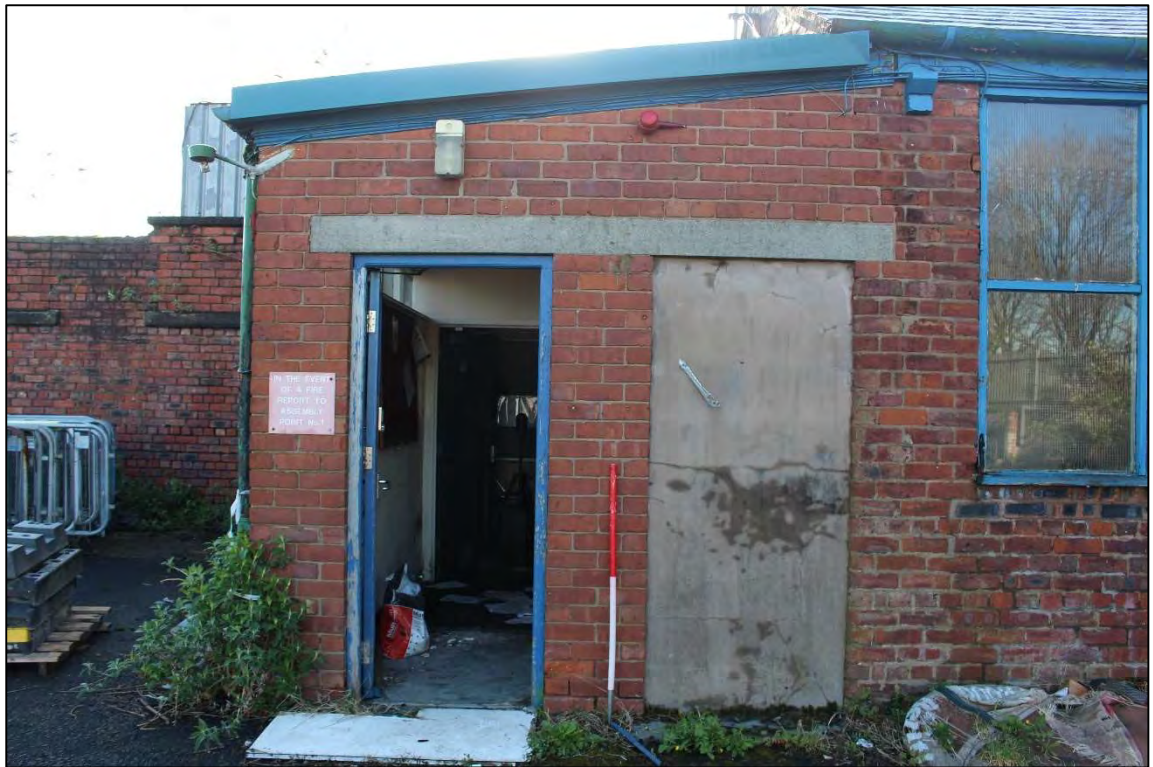
The doorways within the lean-to had shared a long flush concrete lintel with each having a concrete threshold (Plate 40). The northern opening contained a modern timber doorframe and a flush timber fire door, while the southern opening was brick infilled with a concrete render on the external face (Plate 40).

*Plate 40: The two doorways within the western elevation of the lean-to*

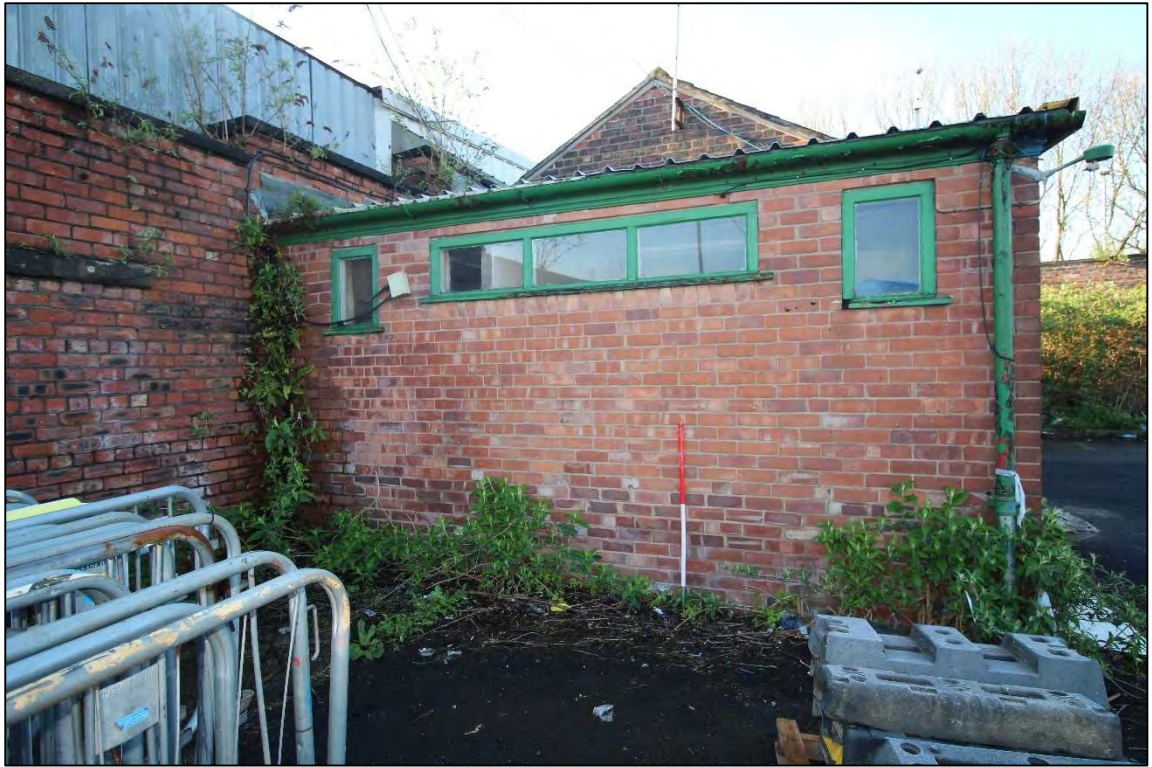
The northern elevation of the original phase was largely obscured by the lean-to extension. The lean-to elevation was constructed in a stretcher bond with three window apertures situated below the timber fascia board. The eastern and western windows housed a single fixed light timber window frame glazed in clear glass panes (Plate 41; Fig 4). The central apertures comprised a horizontal three-light timber framed window with clear glass panes (Plate 41).

*Plate 41: General view of the northern elevation of the office block*

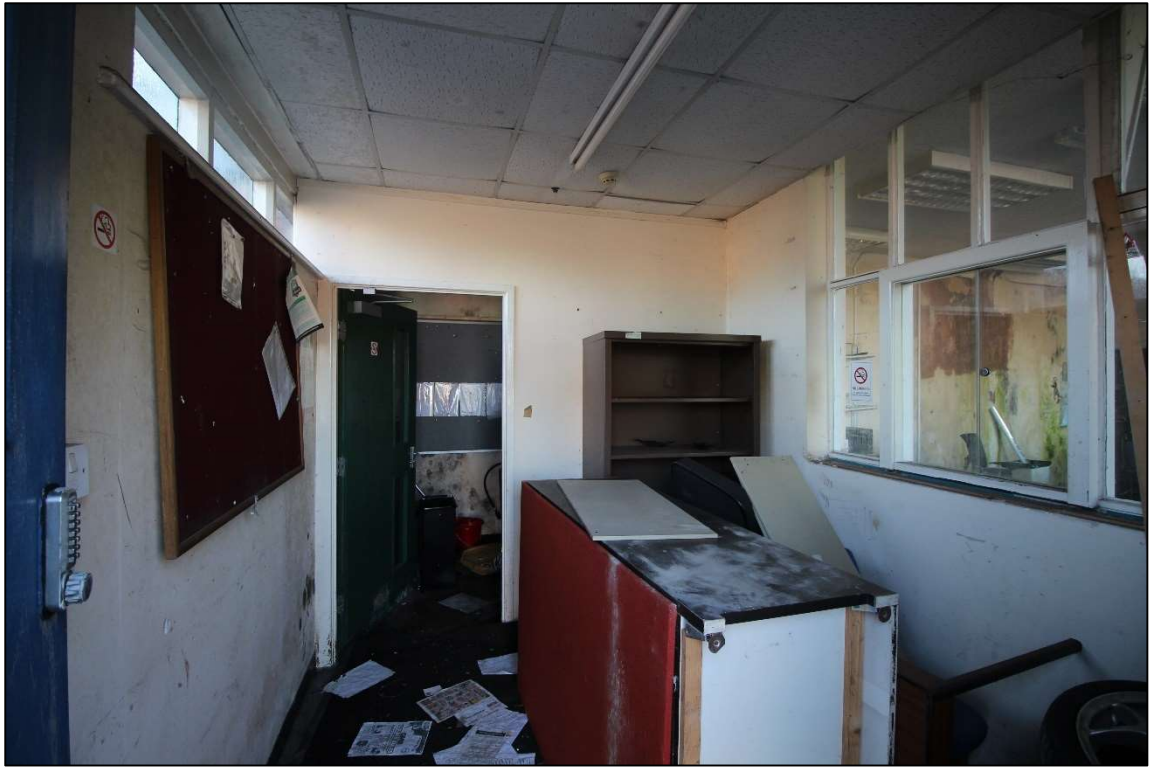
*Plate 42: General view of Room 1 of the office block, facing east*

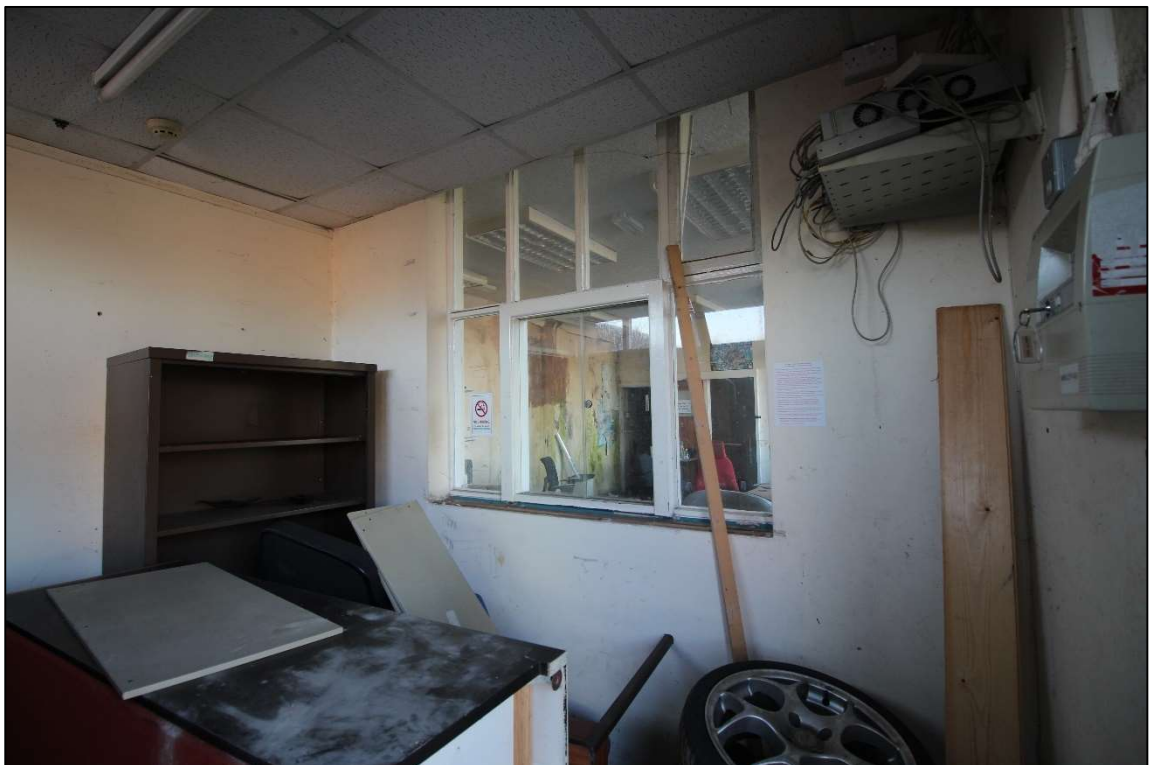
*Plate 43: The wide window within the southern wall of Room 1, facing south-east*

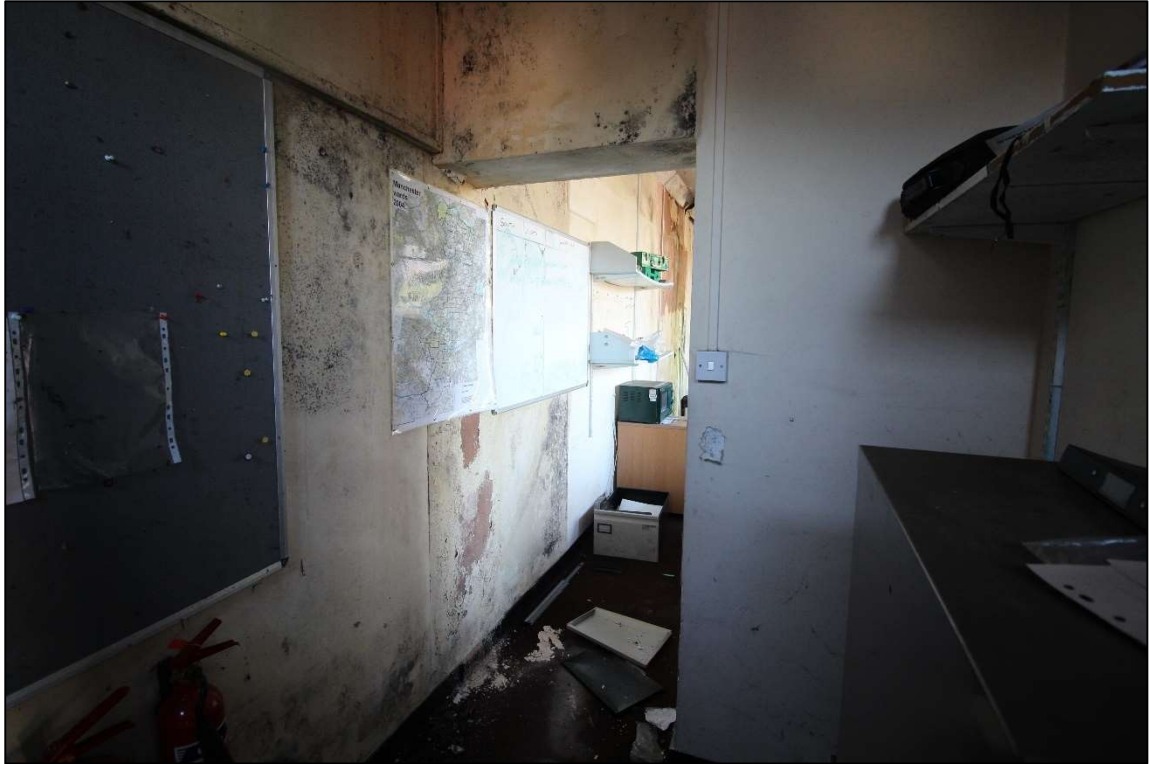
*Plate 44: General view of Room 2 of the office block, facing south-east*

Room 2 was a small vestibule affording access into Room 1 and Room 3 (Fig 4). This room comprised painted plasterboard walls, a carpet tiled floor and a false suspended ceiling (Plate 44). The doorway entering Room 1 had rectangular timber architraves and housed a modern timber fire door, while no door was situated within the opening entering Room 3.

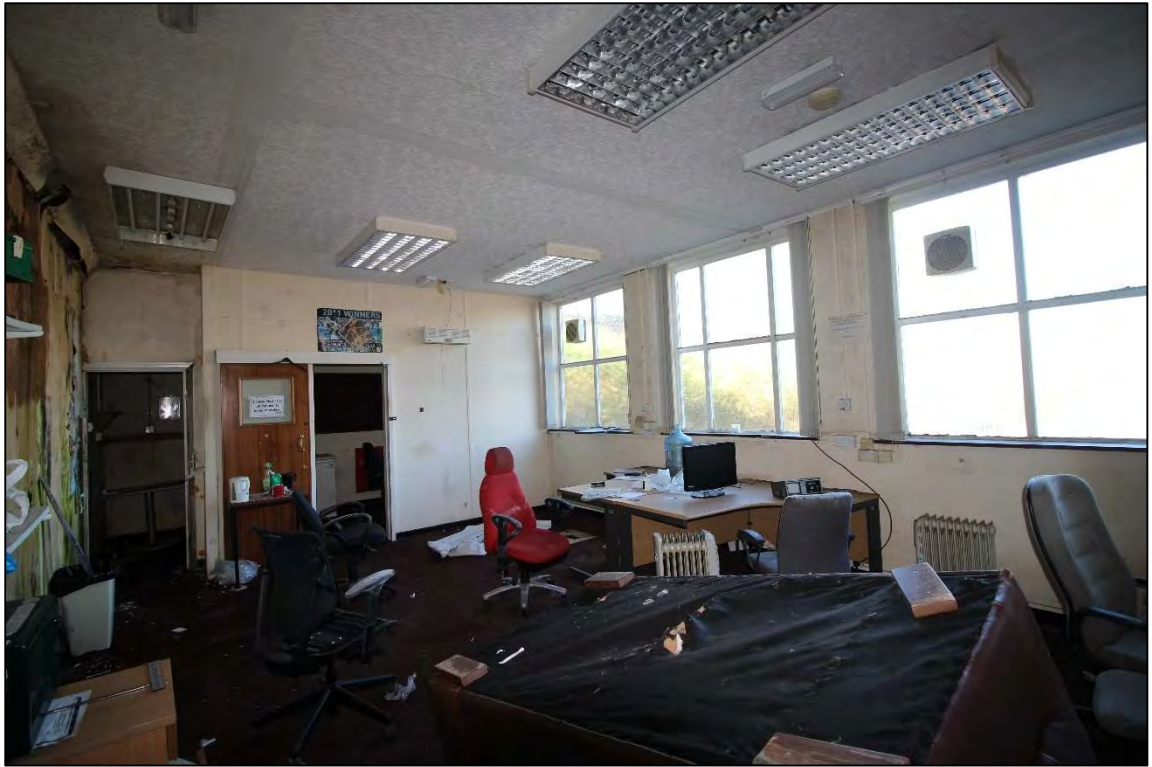
*Plate 45: General view of Room 3 of the office block, facing south-west*

Room 3 comprised painted plasterboard walls, a carpet tiled floor and a false suspended ceiling (Plate 45). The western wall contained three 5'2" (1.57m) wide windows with the central aperture housing a six-light timber framed window. The two flanking openings housed a four-light timber framed window (Plate 45).

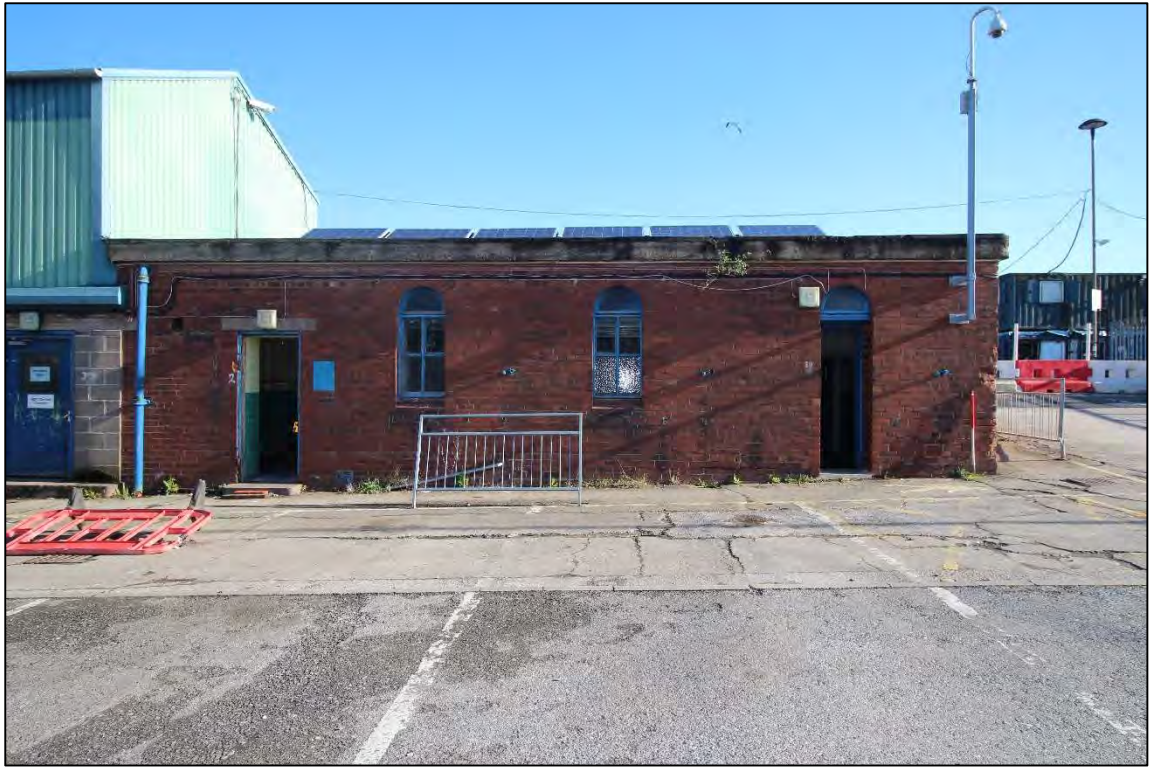
*Plate 46: General view of the southern elevation of the toilet block, looking north*

***External Description:*** the southern elevation was constructed in a three-course English Garden Wall bond and consisted of two central windows flanked by two doorways (Plate 46; Fig 5). The windows comprised gauged brick round-head lintels with recessed sloping terracotta sills. A five-light timber framed window with obscure glass to the lower lights and clear glass above was housed within the openings (Plate 47).

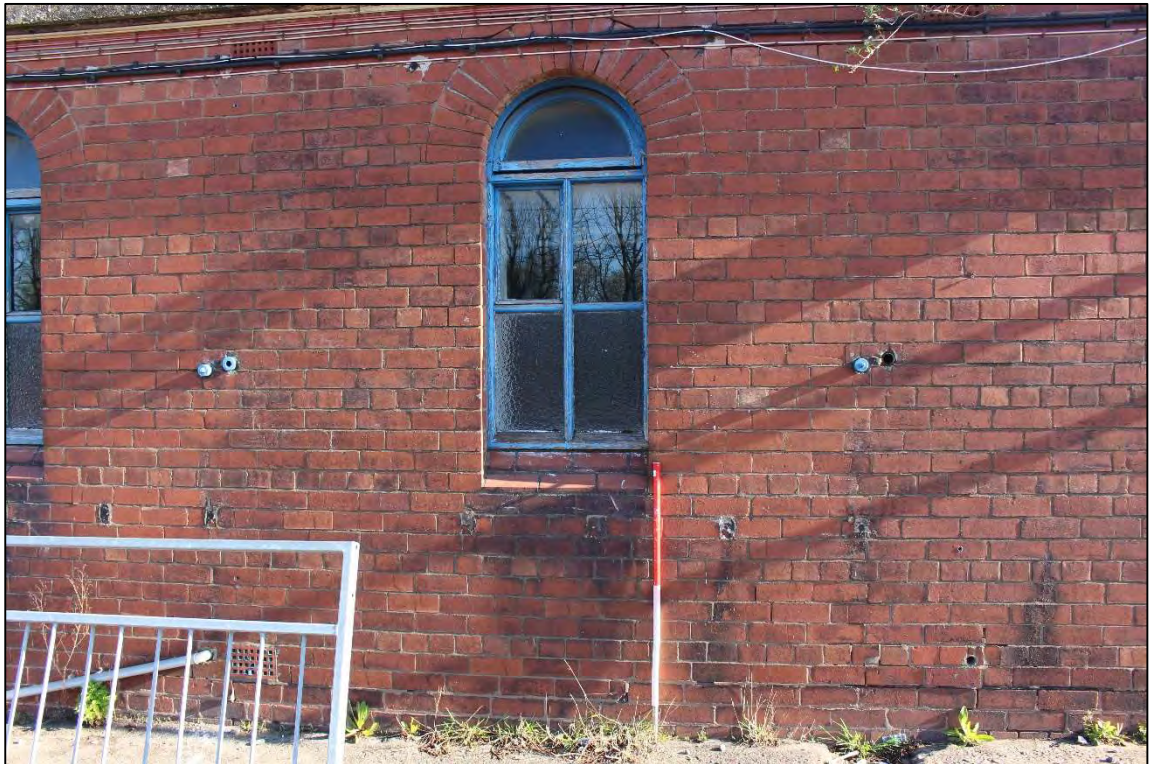
*Plate 47: Detail of the central windows within the southern elevation, looking north*

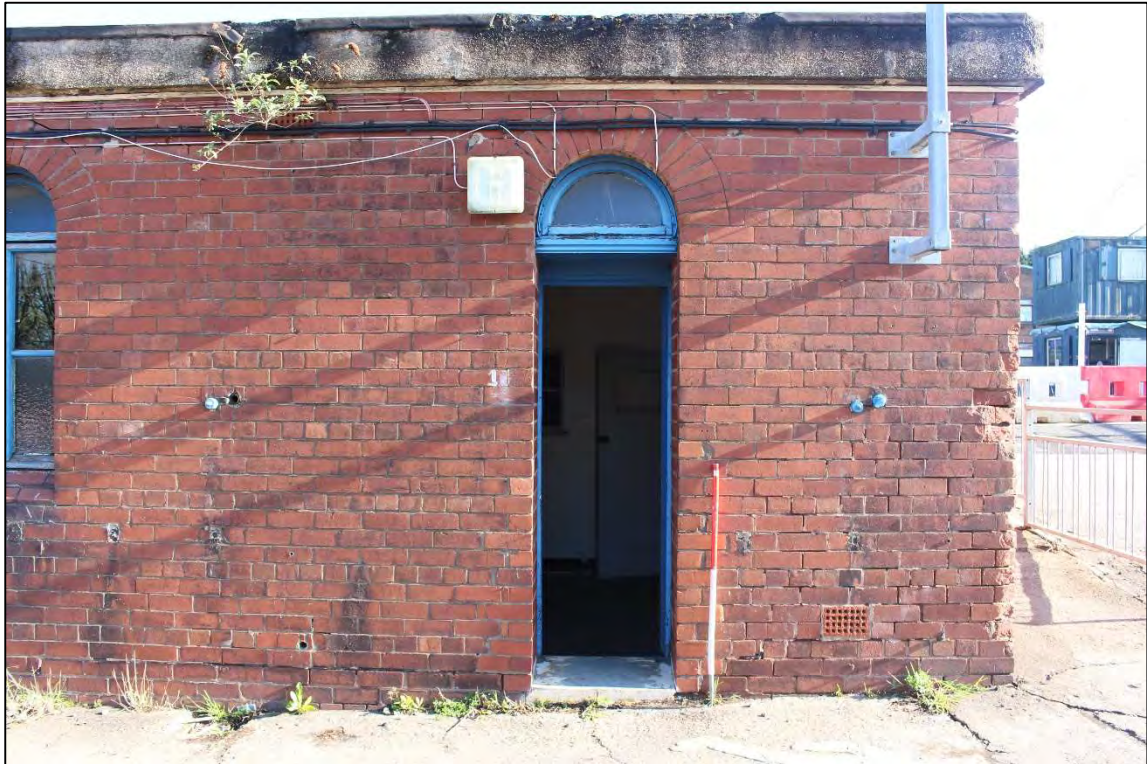
The eastern doorway afforded access into the building and comprised gauged brick round-head lintel with a concrete threshold. The opening housed a replaced timber door with a single fixed fan light with clear glass glazing (Fig 5; Plate 48). The western doorway afforded access into a small room to the western end of the building (Room 7). This consisted of a flush concrete lintel with the timber doorframe recessed within the opening and entered from a single concrete step. The door was removed, however the remains of two modern hinges had been retained (Fig 5; Plate 49).

*Plate 48: Detail of the eastern doorway within the southern elevation, looking north*

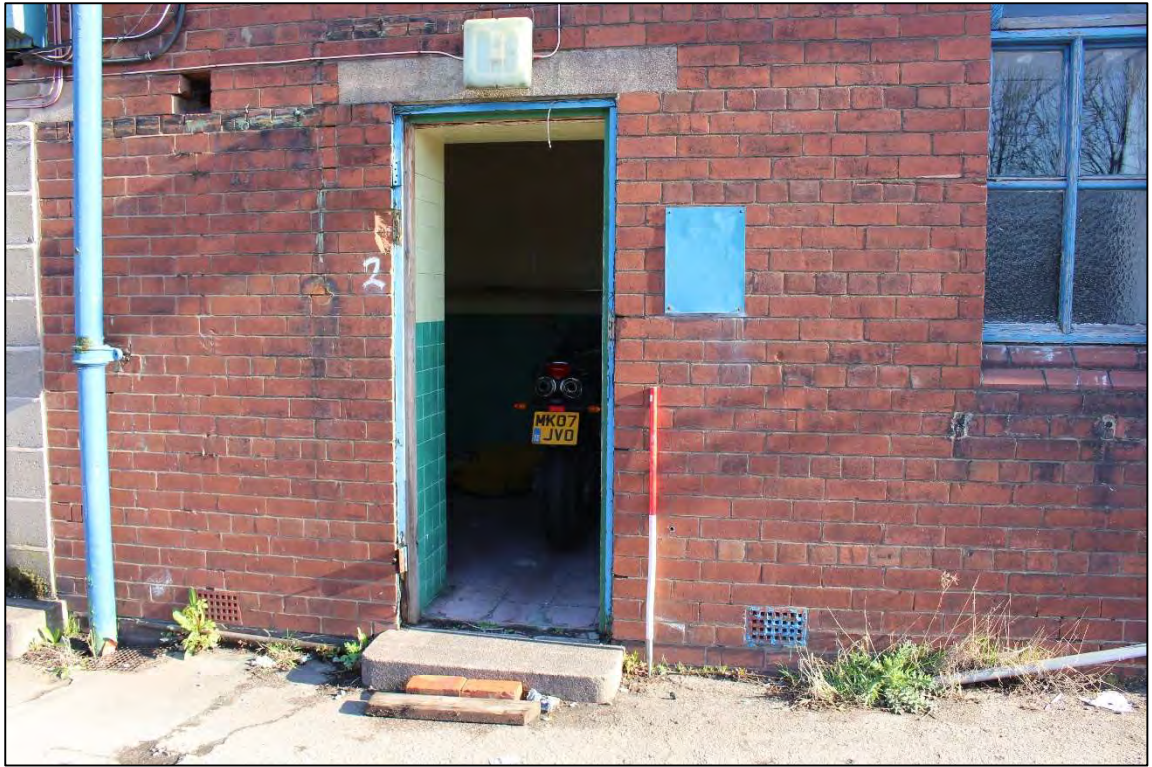
*Plate 49: Detail of the western doorway within the southern elevation, looking north*

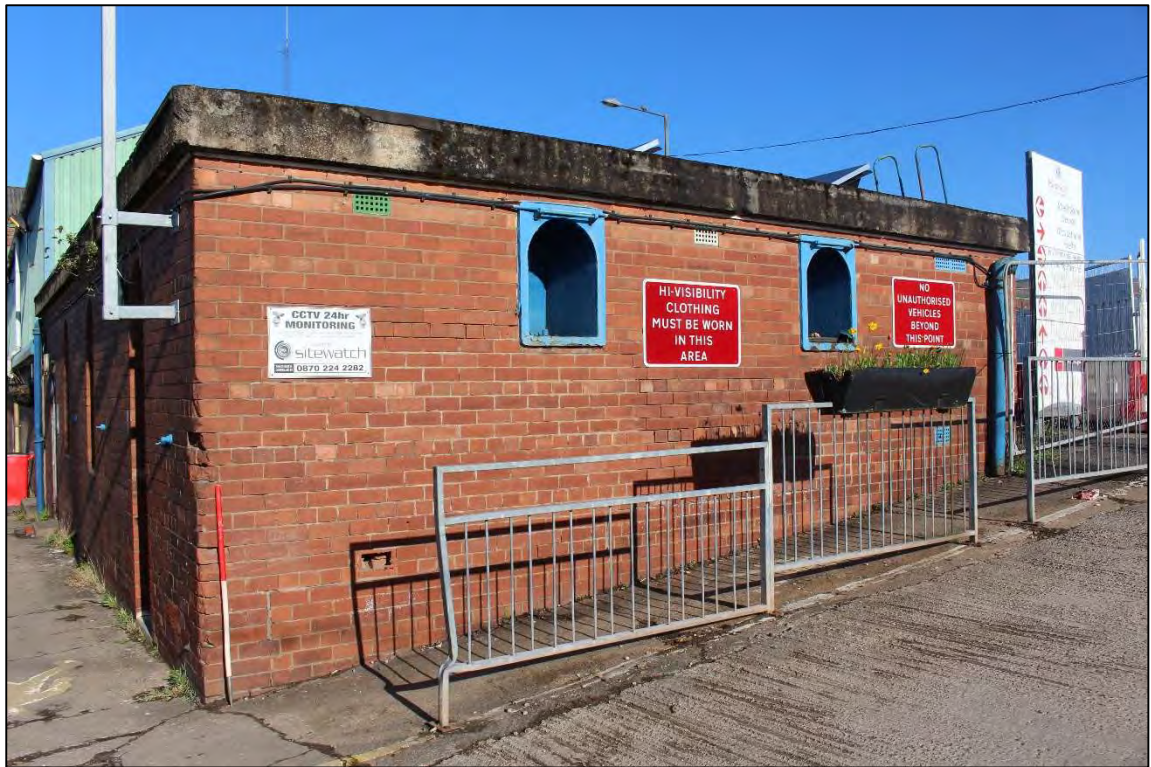
*Plate 50: General view of the eastern elevation, looking north-west*

The eastern elevation was constructed in a three-course English Garden Wall bond and consisted of two central recessed windows (Plate 50; Fig 5). The windows were set within a cast-iron housing with a pointed arch head. A cast-iron door with rising hinges was recessed within the opening and obscured the frames (Plate 51).

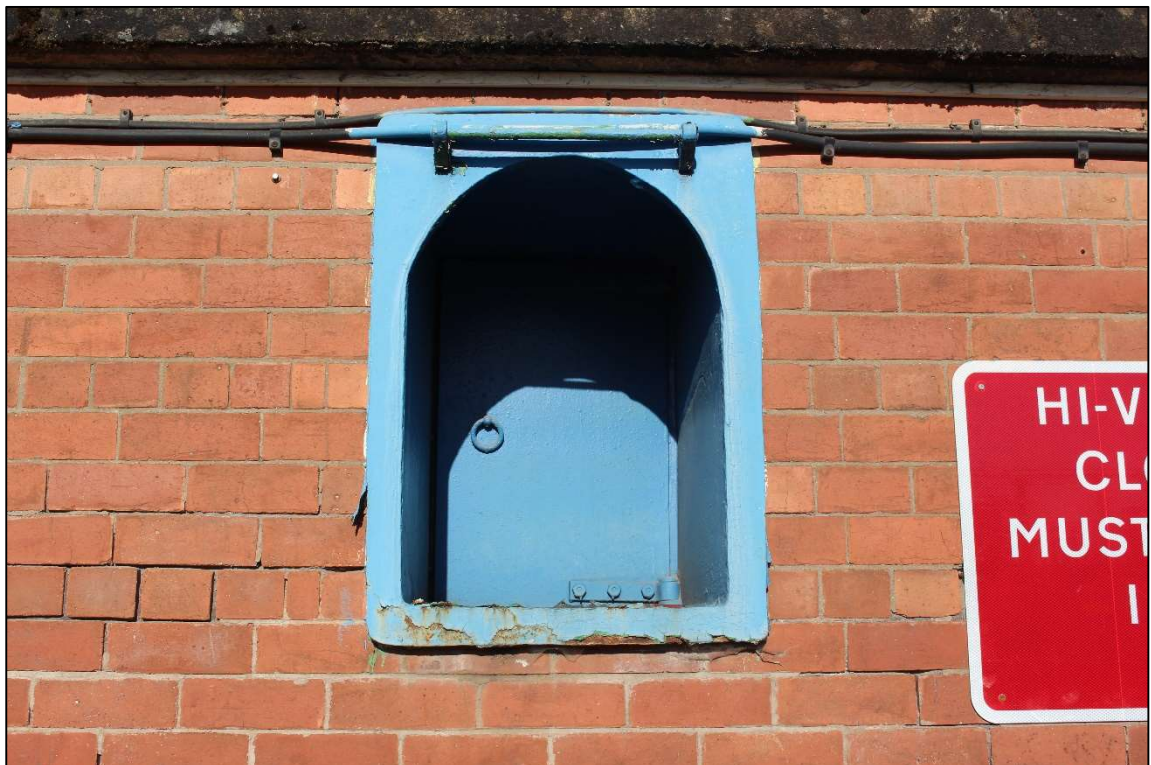
*Plate 51: Detail of the cast-iron surround window to the eastern elevation, looking west*
