**Redfern  
Building**

**NOMA  
Manchester**

## Heritage Statement: Significance & Impact

**10<sup>th</sup> September 2018**

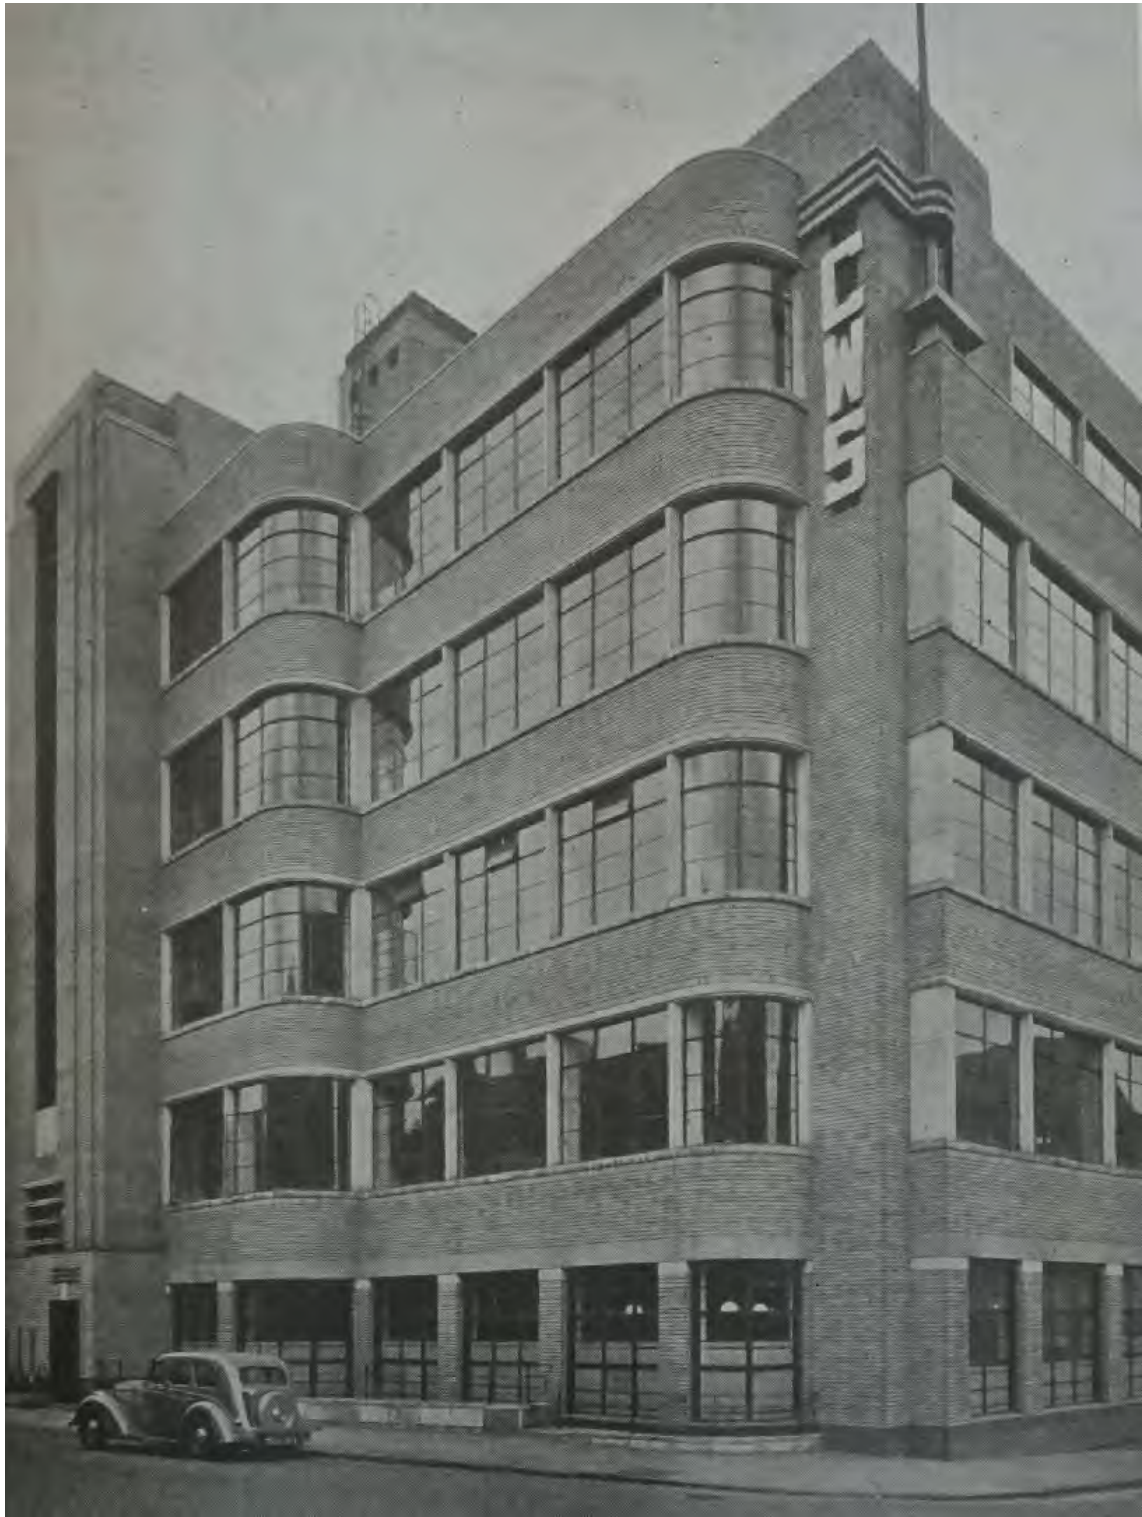
**1937:** The Redfern building, as completed, from Dantzic Street. The structure appears largely unchanged from its appearance in 2018, however the original windows with dark painted frames can be clearly seen. (The Architect and Building News).

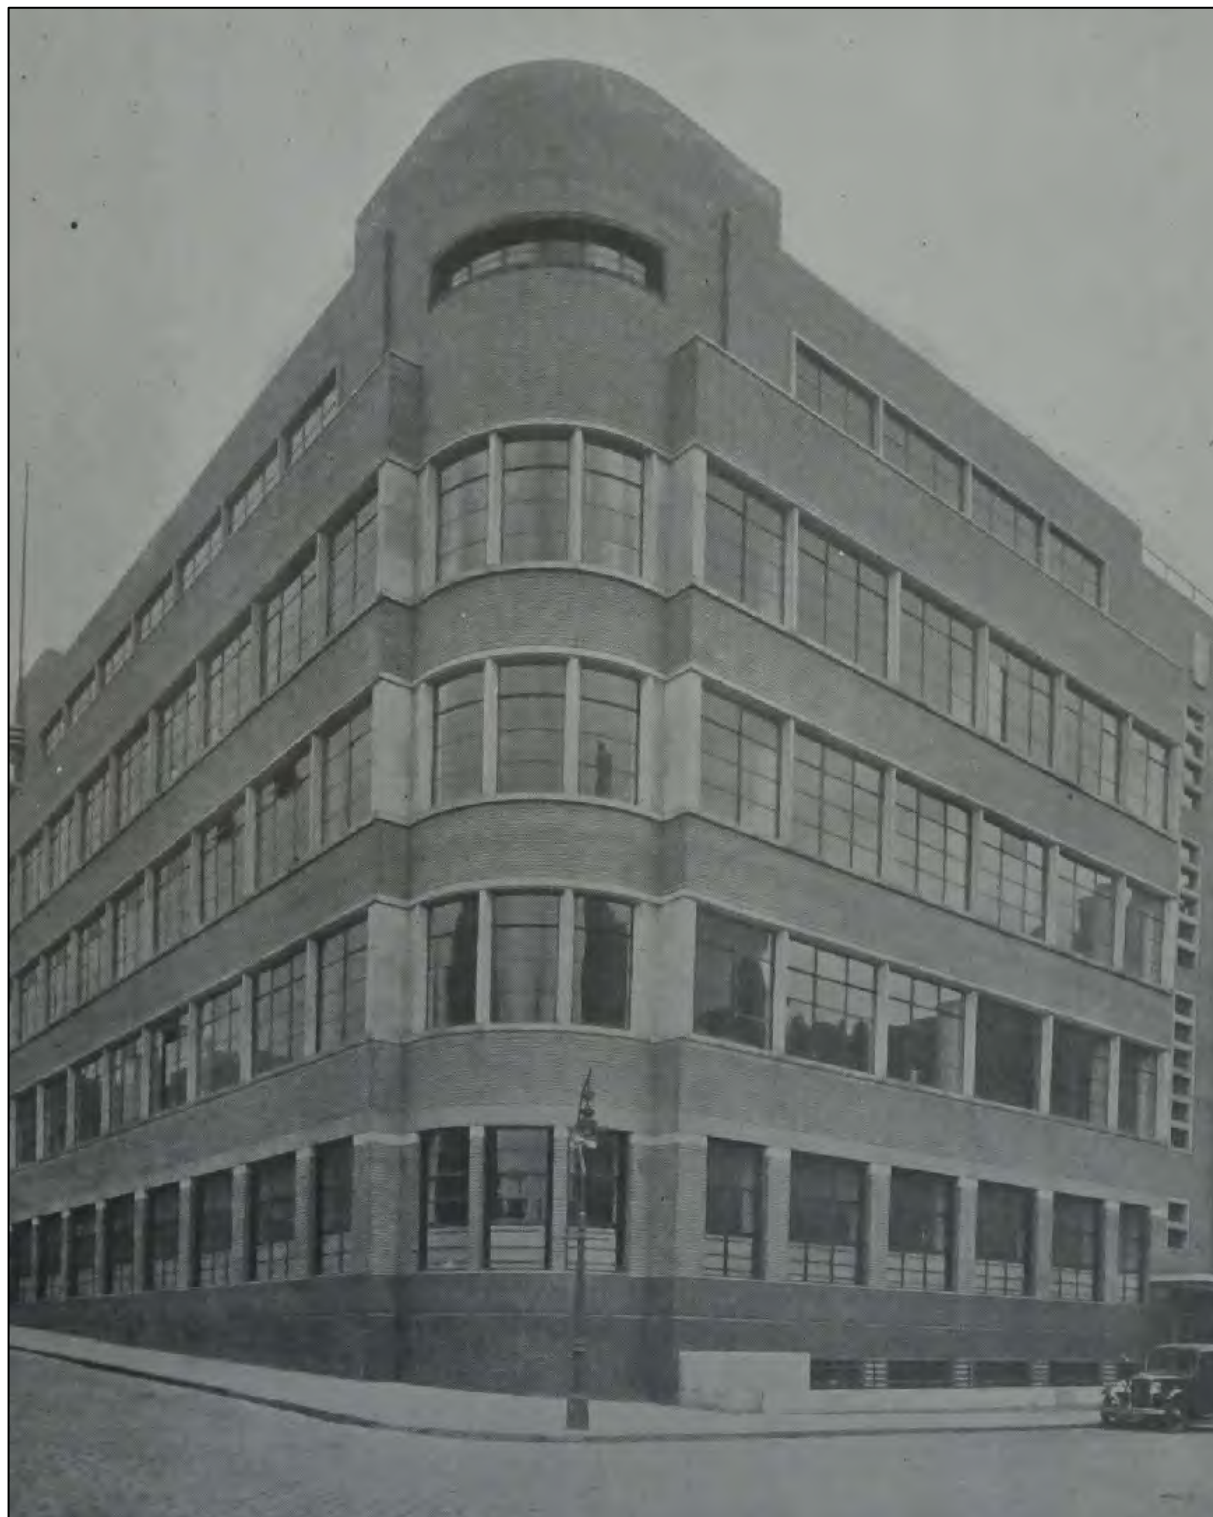
**1937:** A second view of the Redfern Building at completion, from the corner of Mayes Street and Redfern Street. Note the historic sloping ground level which has subsequently been removed by the completion of Sadlers Yard. (The Architect and Building News).

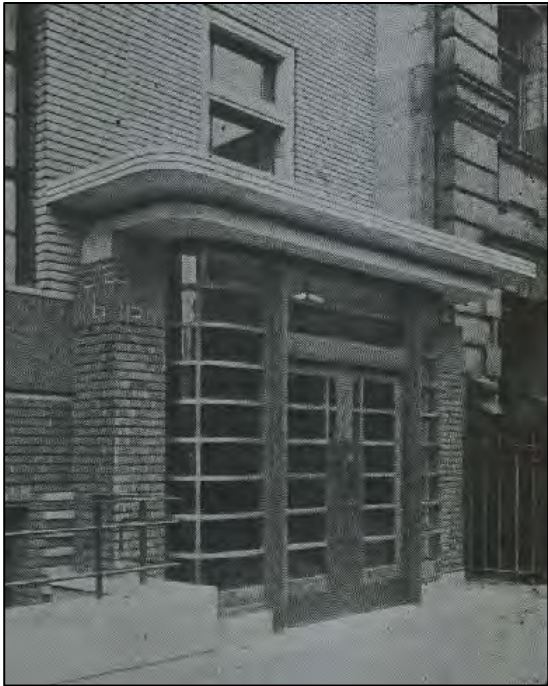
**1937:** External detail of the completed Redfern Building showing the entrance onto Mayes Street. The curved glazing sections, cantilevered concrete roof and double entrance doors all remain, albeit the entrance doors have since been moved into the entrance area to create a recessed sheltered opening. (The Architect and Building News).

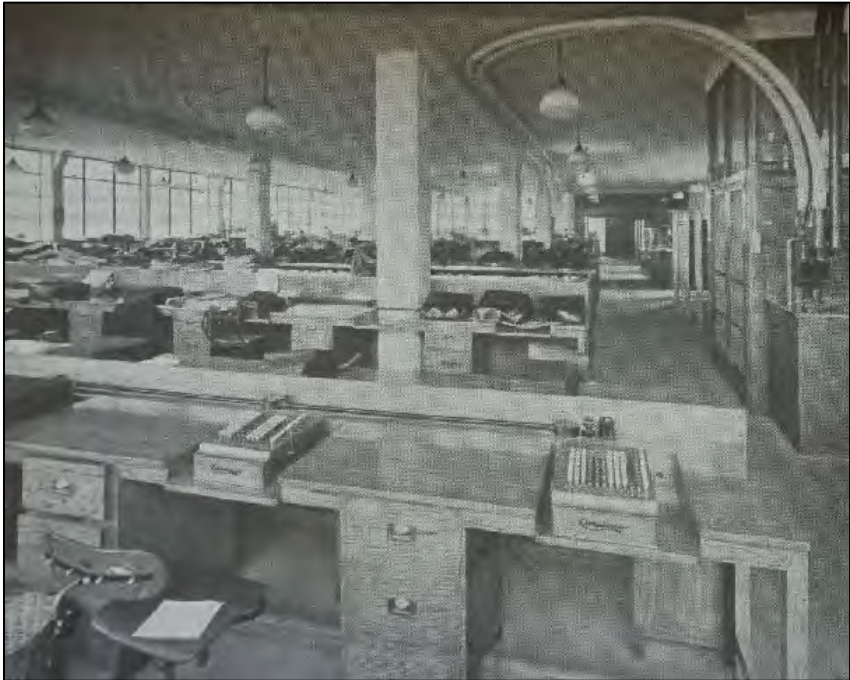
**1937:** Internal detail of the Redfern Building showing the invoicing department on the third floor. Each desk was provided with a comptometer, an early form of key driven mechanical calculator. The tubes of the internal postal system can also be seen in the top right-hand side of the image. (The Architect and Building News).

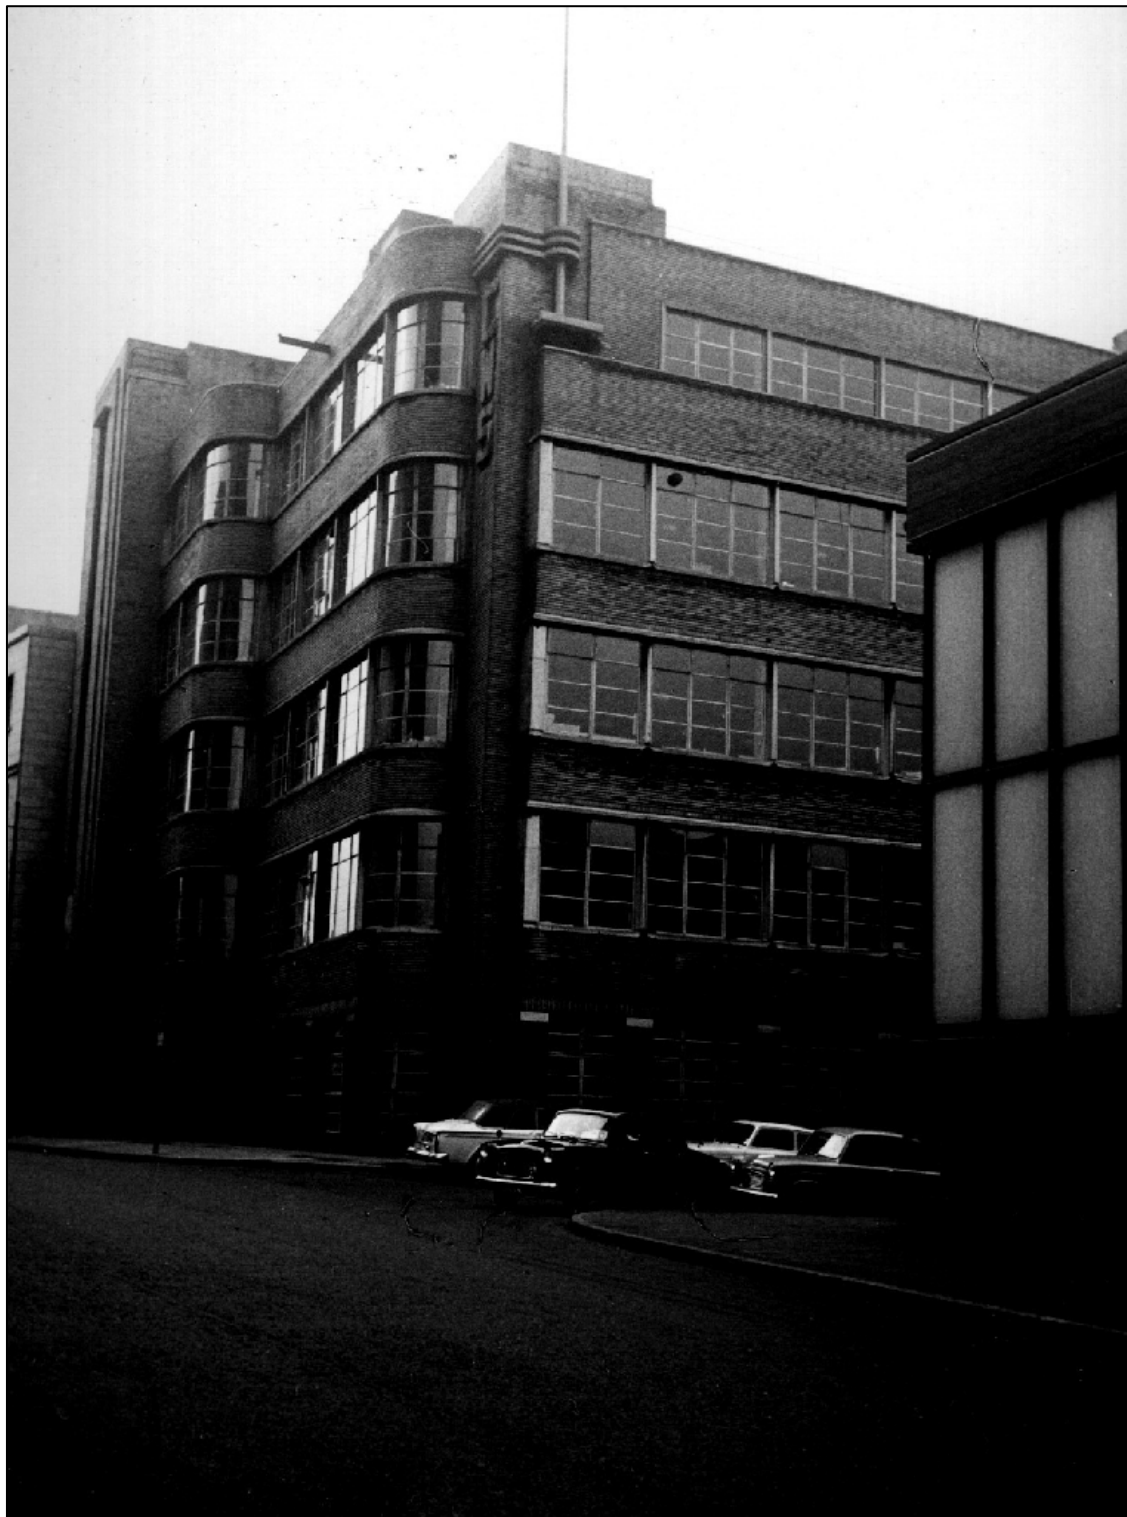
**c. 1960s:** This contemporary view of the Redfern Building from Dantzic Street shows limited change has occurred to the building since its completion in 1937. The window frames have been painted white and an extract fan fitted. (Manchester City Archives).

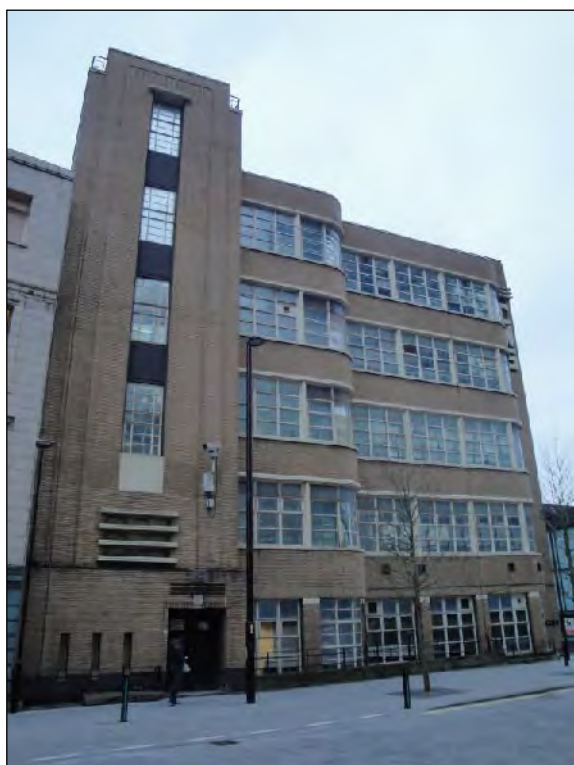
**Figure 3:** Principal east elevation facing Dantzic Street, 27.11.2015. The ancillary stair tower dominates the left (south) side of the composition, with recessed brickwork and large metal framed windows with side bars typical of the period. (High Significance)

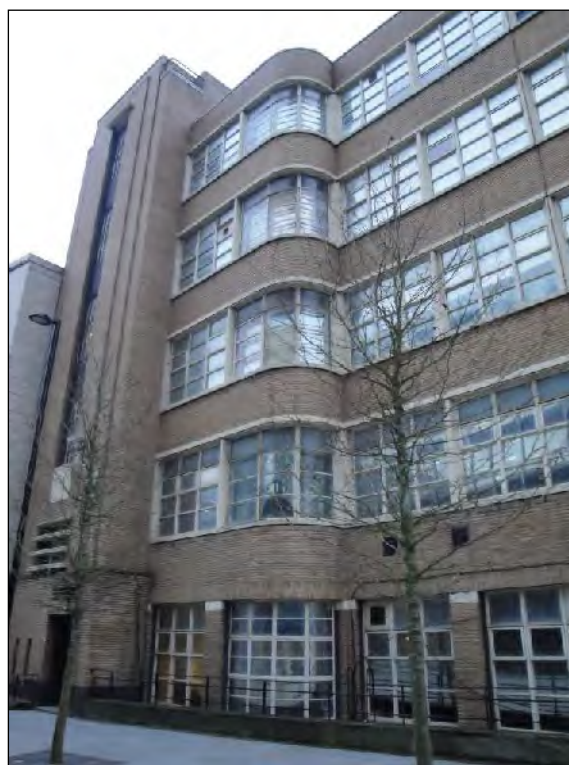
**Figure 4:** Principal east elevation facing Dantzic Street, 27.11.2015. This view shows the surviving original curved glazing and the more robust brick pilasters dividing the glazing sections at ground floor level, with reconstituted Portland stone pilasters. (High Significance) Later ventilation bricks can also be seen.

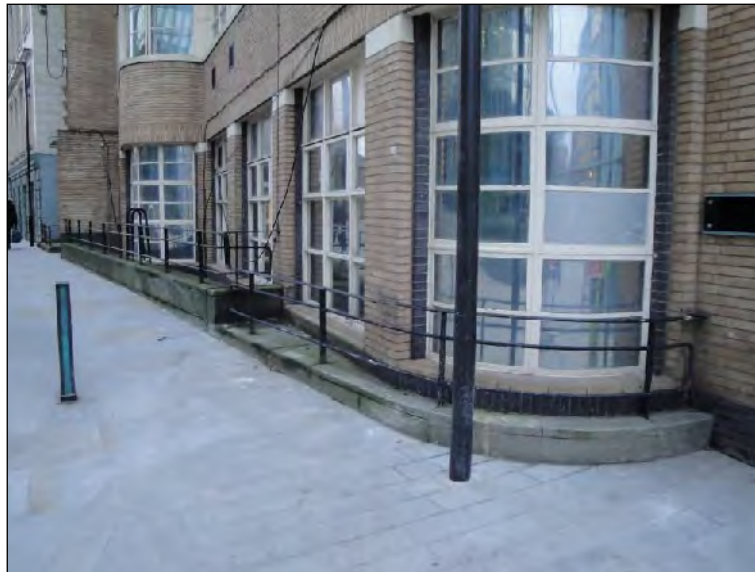
**Figure 5:** Retaining wall and railings to Dantzic street elevation, 27.11.2015. Below is a lightwell serving the basement areas. Recessed window reveals of buff blue engineering brick are also prominent here around the curved glass, a motif which appears throughout the building. (High Significance)

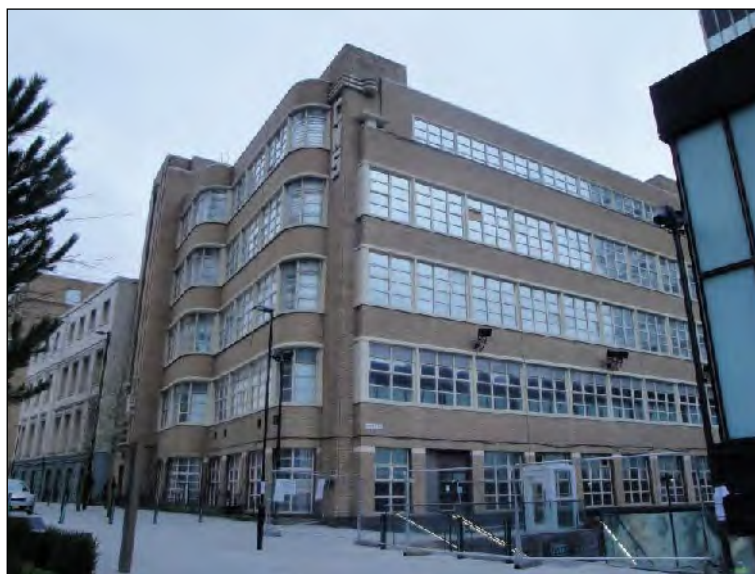
**Figure 6:** Oblique view of principal east elevation, with part of north elevation to Mayes Street, 27.11.2015. The Holyoake Building is visible to the south, and part of New Century Hall to the north. This view shows the cumulative visual effect of the two sections of curved glass on the principal elevation, and the lettering "CWS" along with the associated flagpole and decorative sections in reconstituted Portland Stone. (High Significance)

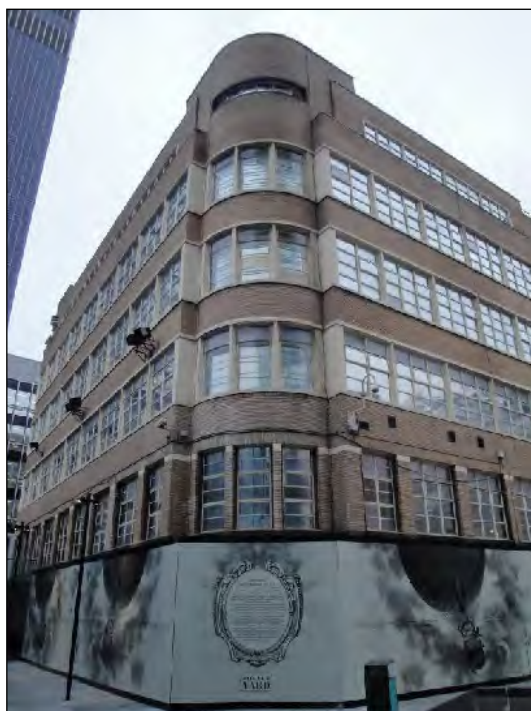
**Figure 7:** North and west elevations from Sadler's Yard, 27.11.2015. The two elevations are joined by an elegant section of original curved glazing terminated with brickwork and reconstituted Portland stone returns. (High Significance)

The west elevation follows the pattern of the north elevation with a rounded junction, including curved glass sections, at its northern corner adjoining Mayes Street. The fourth floor is also stepped back behind a parapet as before, and the glazed sections returned to the façade, according to the same pattern. At the southern end of the façade the principal staircase (Core A) is illuminated by a series of plain horizontal fixed light windows with side bars (Figure 8).

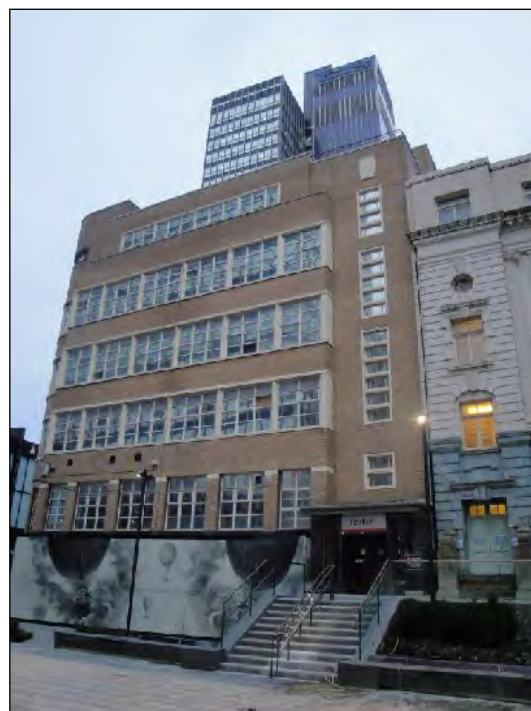
**Figure 8:** West elevation from Sadler's Yard, 27.11.2015. The CIS Tower may be seen in the background. The newly completed Sadler's Yard landscaping scheme has set the elevation considerably higher above ground level. (High Significance)

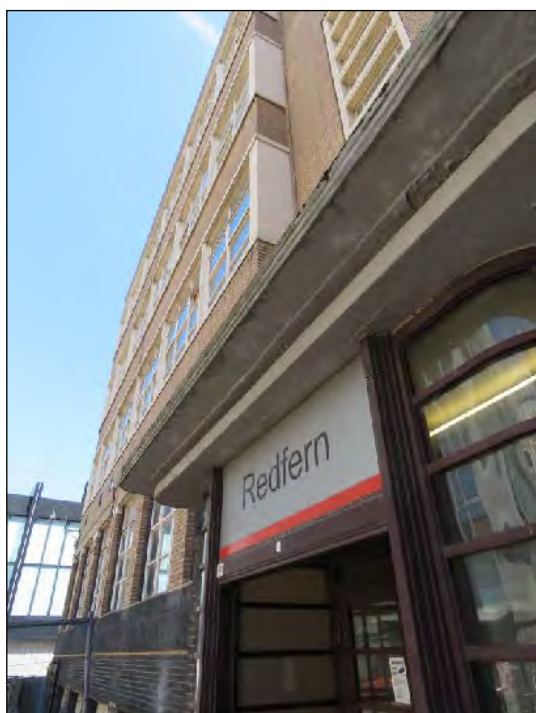
**Figure 9:** Main entrance doors with original timber and curved glazing screen, and concrete roof above. (High Significance) Recent signage can also be seen.

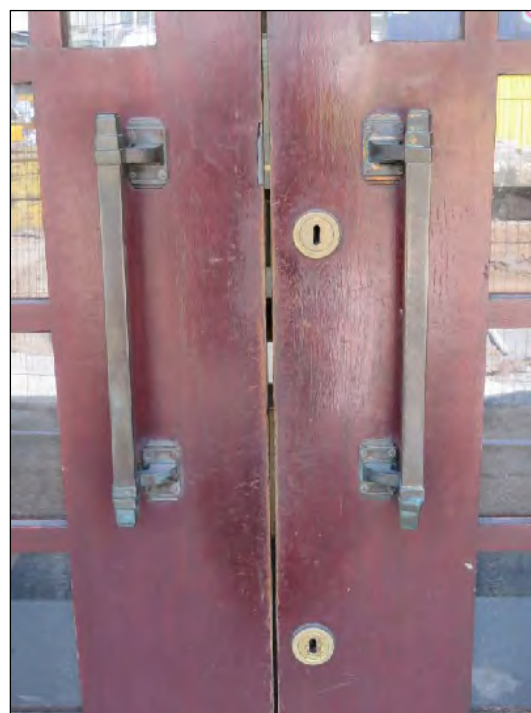
**Figure 10:** Main entrance doors showing original brass door handles. (High Significance)

The lower ground level on Redfern Street (now Sadlers Yard) partially exposes the basement to this elevation and consequently allows partial glazing of the form seen in the ground floor elsewhere, although here the surrounding facings are in blue engineering brick. Nearby, beneath the principal stair at the south end of the elevation is the main entrance to the building, composed of a curved glazed timber screen with partially glazed timber doors and a marble threshold. This survives intact albeit with recent signage additions and the doors having been moved inwards to create a sheltered recess or porch. This area also demonstrates the complex use of brickwork pattern within the plinth (Figures 9, 10, 11 & 12).

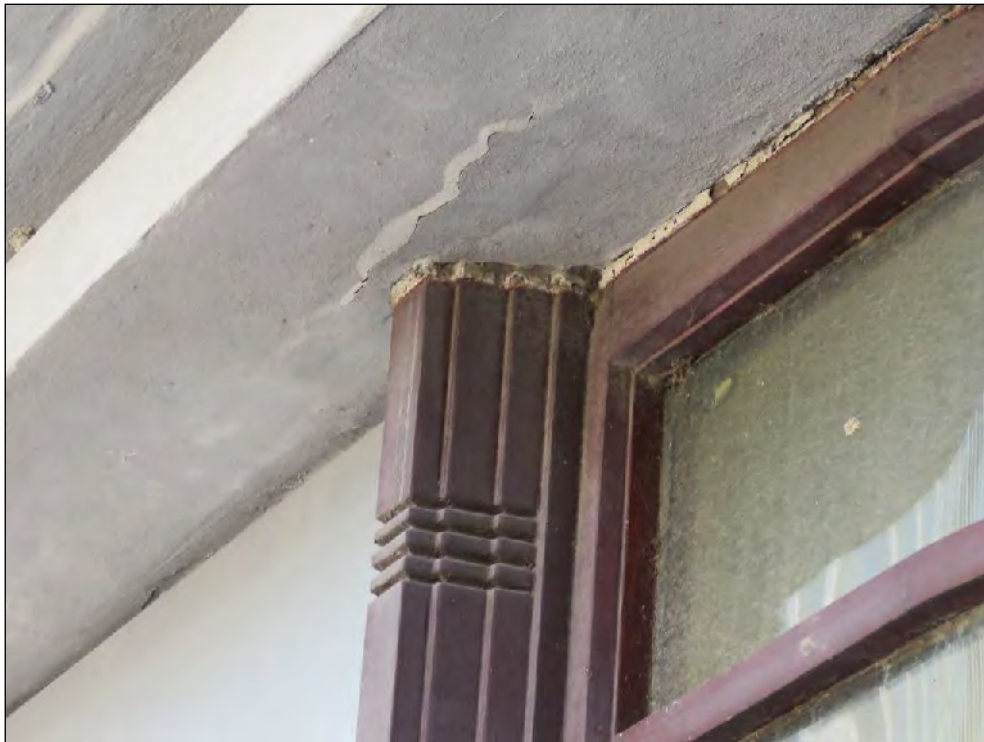
**Figure 11:** Main entrance doors showing original routed joinery detail.

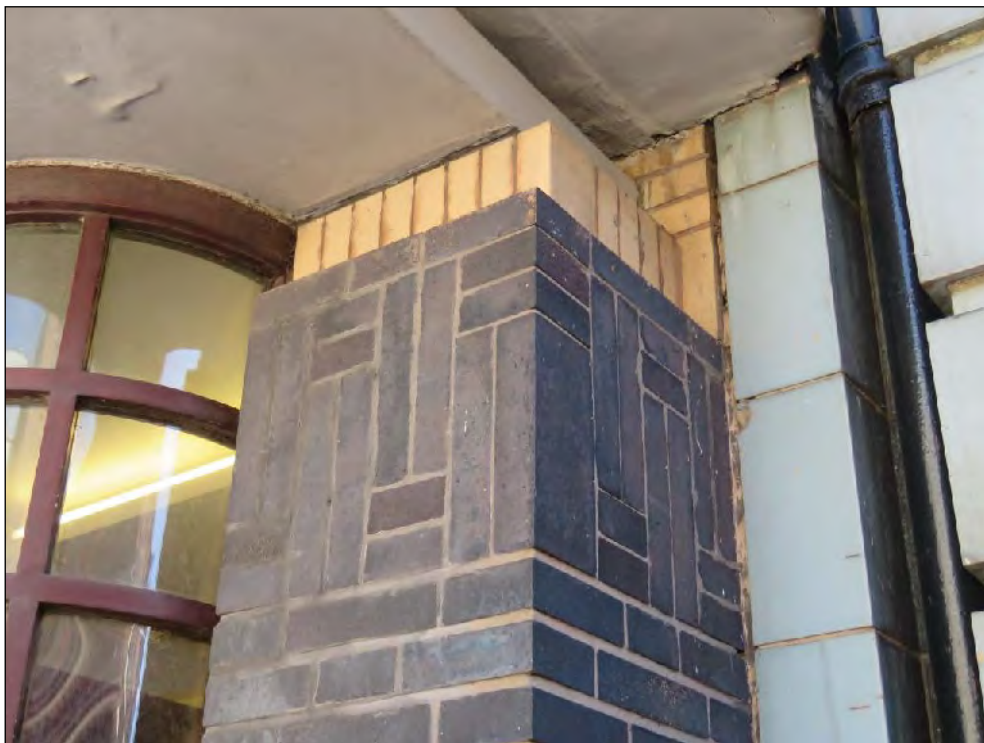
**Figure 12:** Capital of column adjacent to principal entrance formed of blue engineering brick with buff brick capping above.

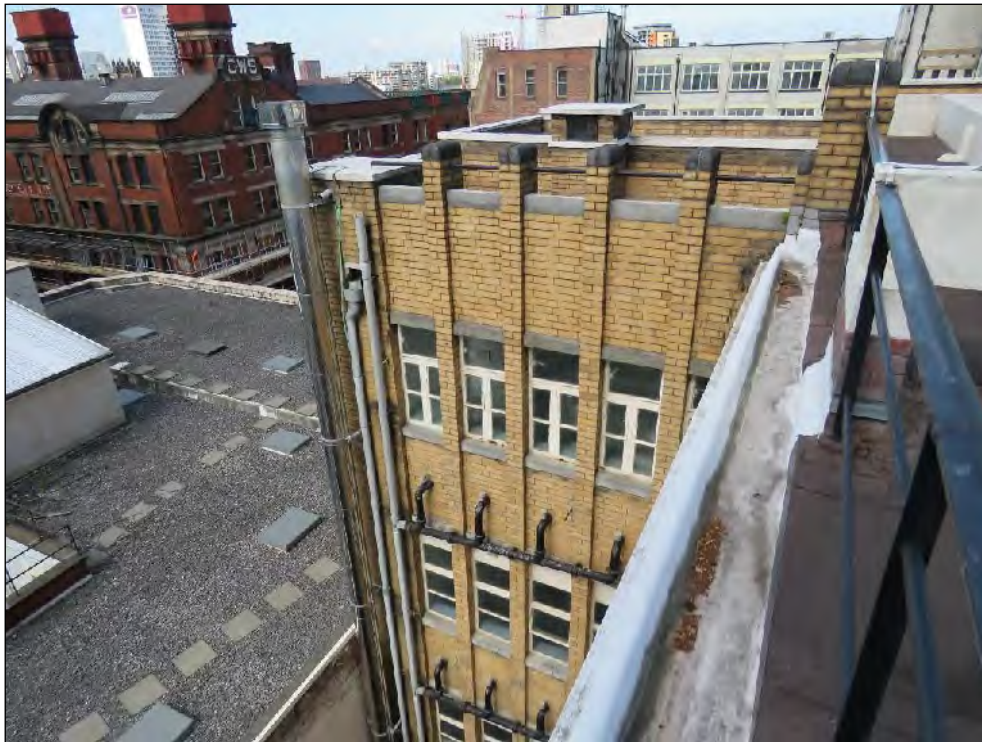
**Figure 13:** South elevation lightwell adjoining the Holyoake building. The CWS New Drapery Warehouse or E Block can be seen in the background, to the south-west of the site. The façade of the south elevation of the Redfern Building, although not designed to be seen, is marked by elegant recessed brickwork and original metal framed casement windows. (High Significance)

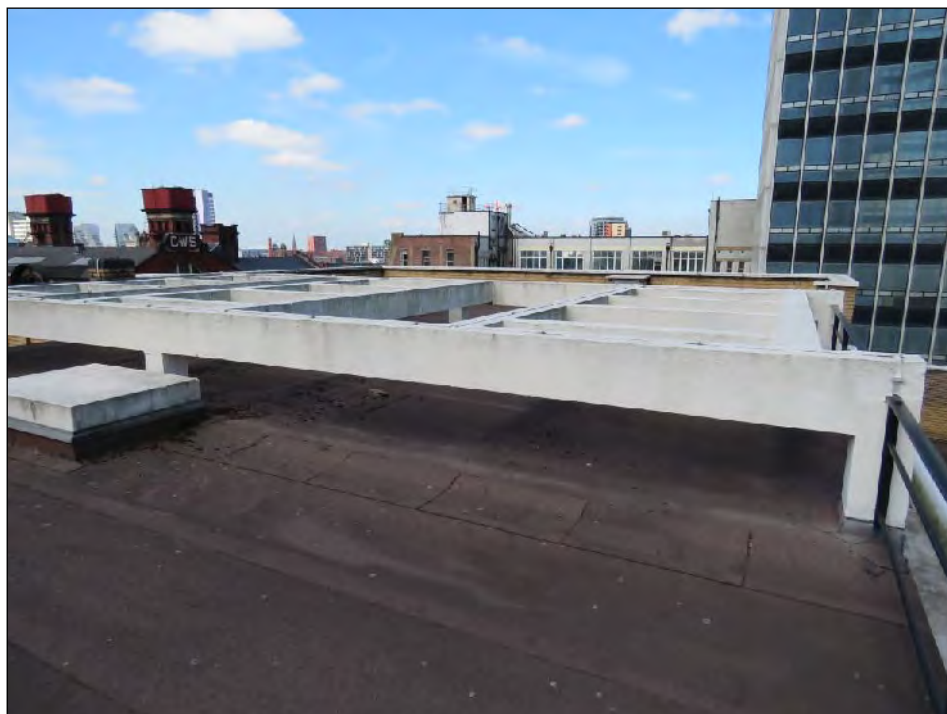
**Figure 14:** Fifth floor roof level with original brick parapets (High Significance) and later felt roof coverings and concrete web structure (Low Significance)

Considerable historic interest remains externally at roof level, most notably in the brick tower and glazed access lobby which protrude two stories and one storey respectively above the principal roof coverings. The roof itself serving the fifth floor is flat with replacement felt coverings surmounted by a web of concrete beams. The latter is thought likely to be a later addition, perhaps intended to support air conditioning plant. Elsewhere original parapets survive, of buff brick laid in Flemish bond with concrete copings as seen elsewhere (Figure 14).

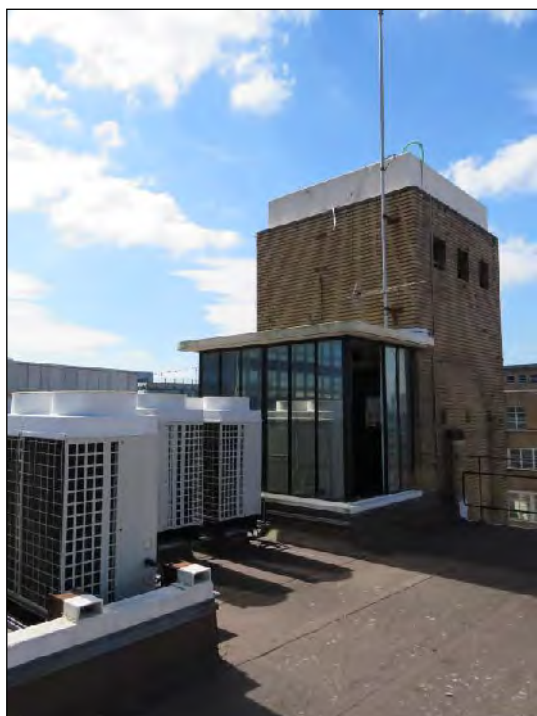
**Figure 15:** Brick lift overrun tower and glazed access lobby at roof level.

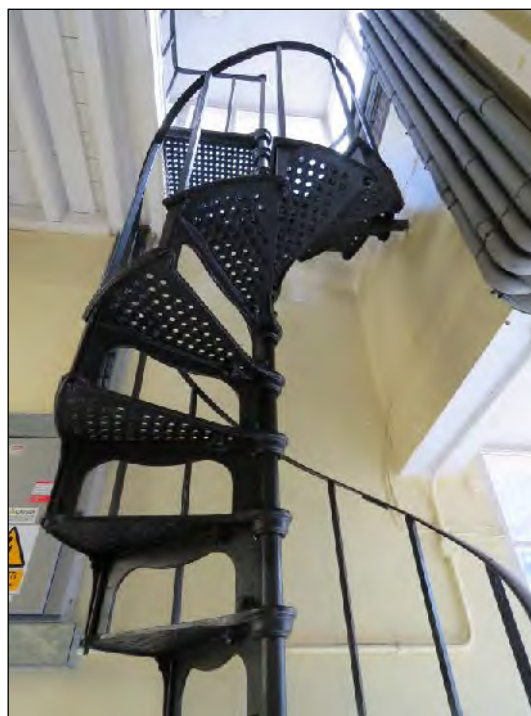
**Figure 16:** Painted steel spiral access stair to lift overrun tower and glazed access lobby.

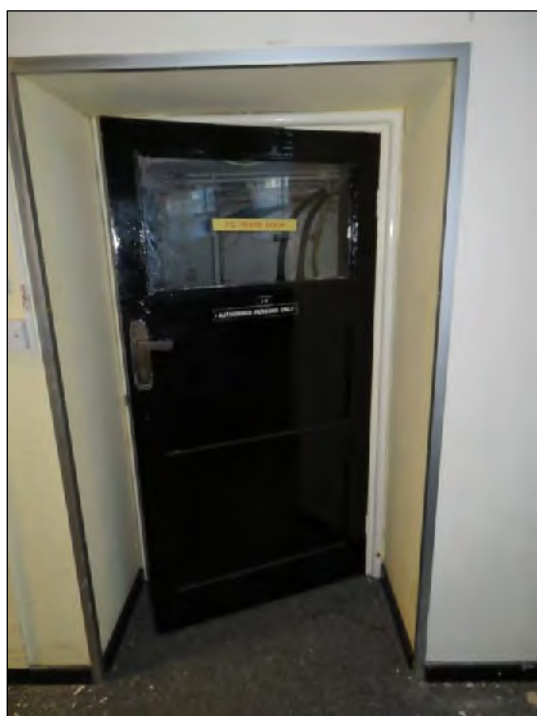
**Figure 17:** Original plant room door to basement, of typical 1930s form with three panels, the uppermost glazed. (Considerable Significance)

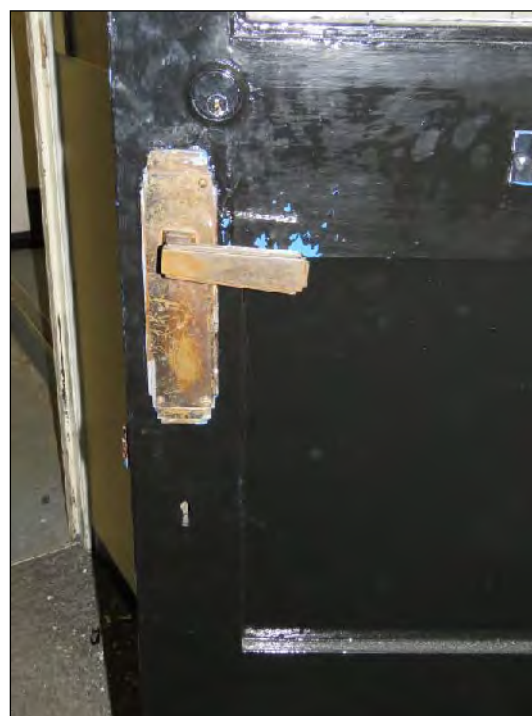
**Figure 18:** Plant room door with original brass door handle of typical 1930s form. (Considerable Significance)

The basement areas of the Redfern Building have been extensively subdivided into a network of small offices and store rooms with entirely modern suspended ceilings, floor coverings and other features. Generally very little survives of historic interest. An exception to this, however, is the original timber door to the plant room which also retains its original ironmongery. The door is of typical 1930s form with three recessed panels set above each other, the uppermost of which is glazed (Figures 17 & 18).

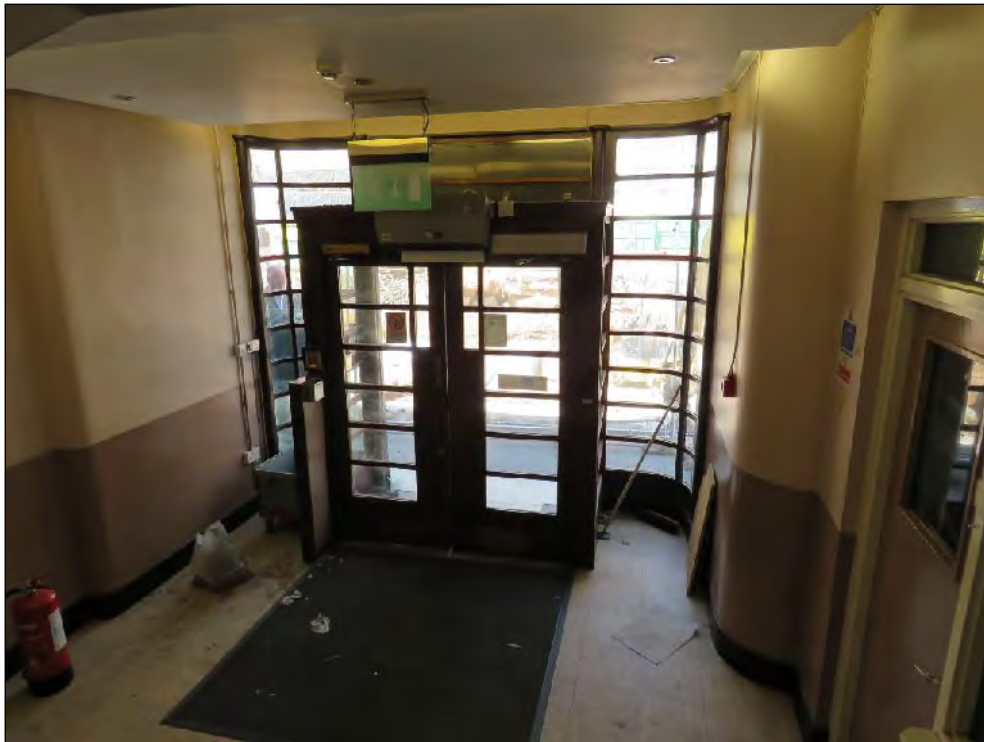
**Figure 19:** Ground floor entrance lobby with curved wall sections matching curved external glazed joinery screen.

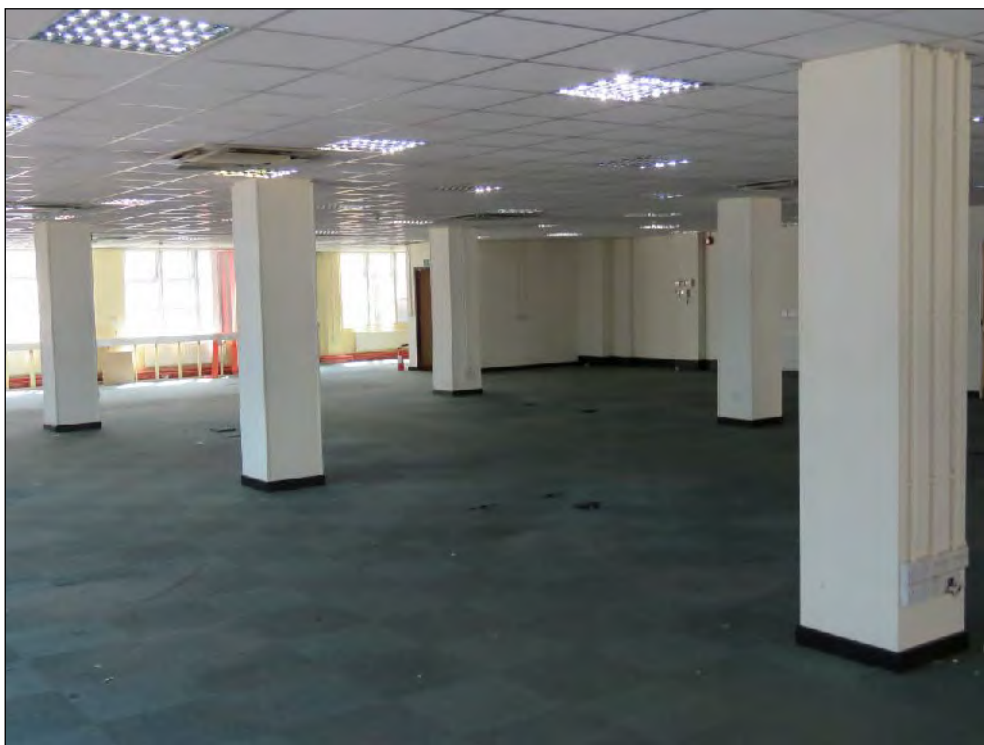
**Figure 20:** Typical view of ground floor interior (Disposition of windows, columns and open plan space dating to original build and of Considerable Significance, but all partitions, fixtures and finishes of Low Significance)

Setting this aside the essential form and layout of the open plan office interior, the locations of the ancillary facilities along with the locations of the structural columns and the natural lighting from strip windows, remain unchanged (Figures 20 & 21). The principal alteration affecting the wider form of the building is the double fire exit doors leading to Mayes Street which whilst likely to be of 1990s date have been designed substantially in line with the original internal doors. Nevertheless, the intervention has been poorly executed to the extent that the doors do not match the opening in terms of size and the remainder of the window opening has been crudely blocked up.

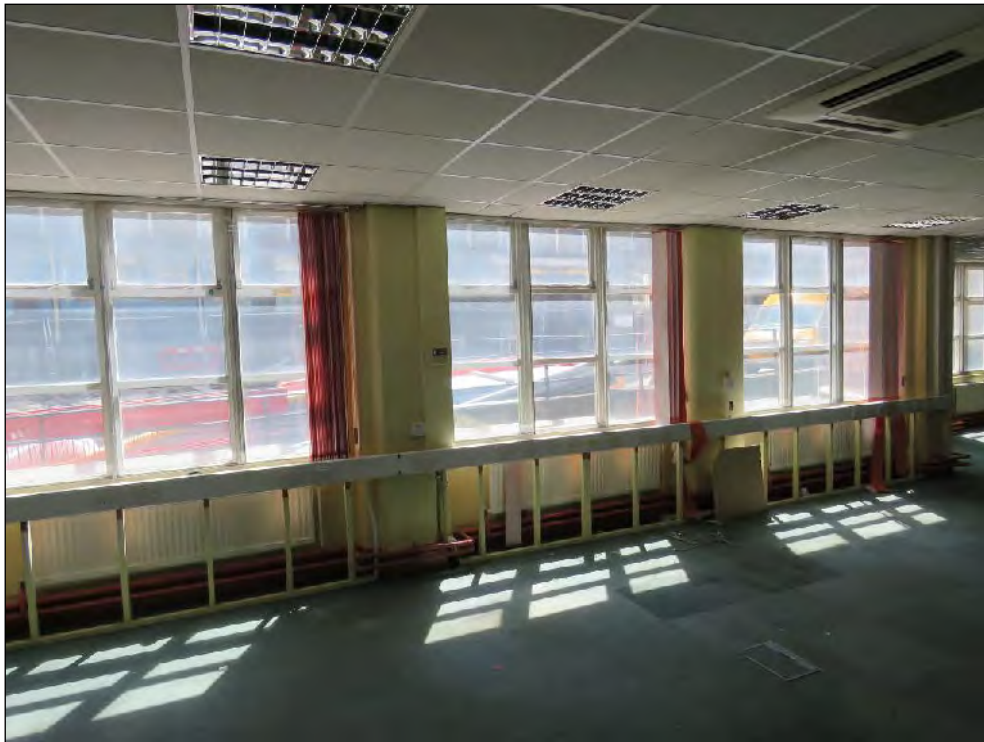
**Figure 21:** Typical view of ground floor interior. (Disposition of windows, columns and open plan space dating to original build and of Considerable Significance, but all partitions, fixtures and finishes of Low Significance)

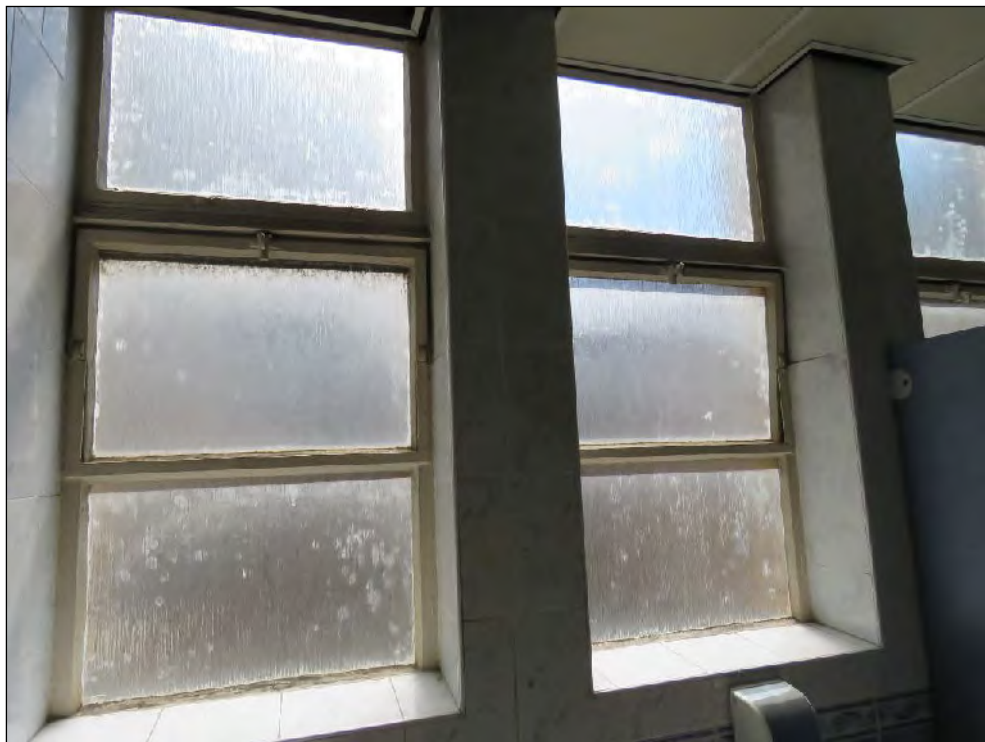
**Figure 22:** Typical original metal framed opening casement window to lavatories. (Considerable Significance)

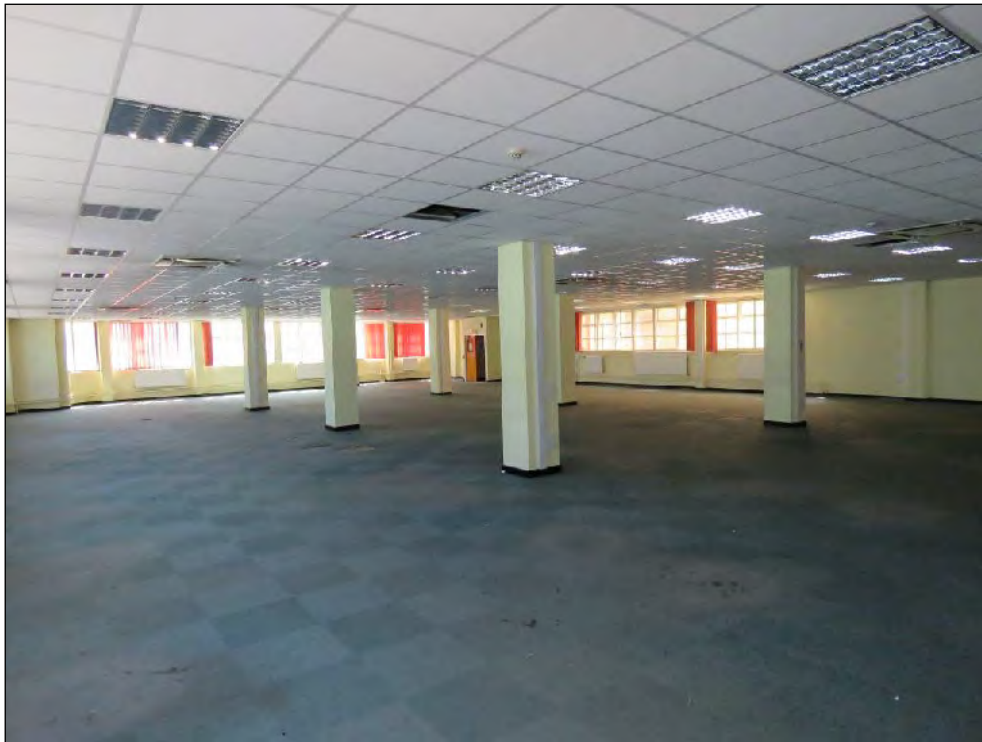
**Figure 23:** Typical view of first floor interior. (Disposition of windows, columns and open plan space dating to original build and of Considerable Significance , but all partitions, fixtures and finishes of Low Significance)

The interior of the first, second, third and fourth floors follow the pattern set by the ground floor with a large open former office along with ancillary kitchen and lavatory facilities in which no features of historic interest have been retained excepting the original metal framed casement windows (Figure 22). As in respect of the ground floor, the essential form and layout of the open plan office interior, the locations of the ancillary facilities along with the locations of the structural columns and the natural lighting from strip windows, remain unchanged in terms of form but retain very little, if any, historic fixtures and finishes (Figures 23, 24, 25, & 26).

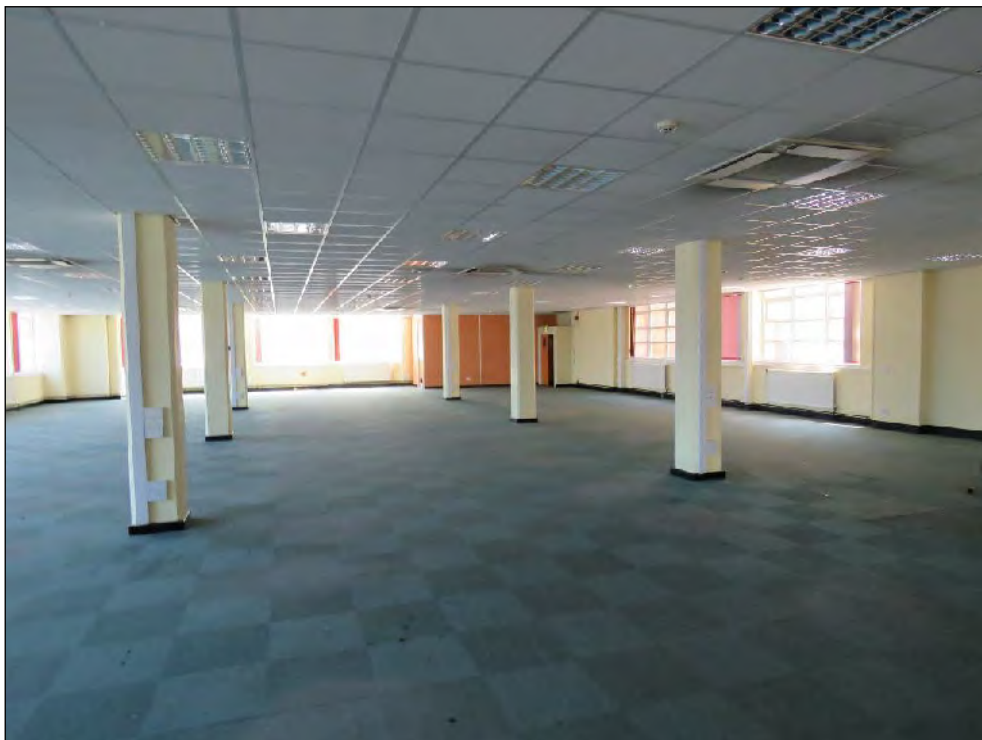
**Figure 24:** Typical view of second floor interior. (Disposition of windows, columns and open plan space dating to original build and of Considerable Significance, but all partitions, fixtures and finishes of Low Significance)

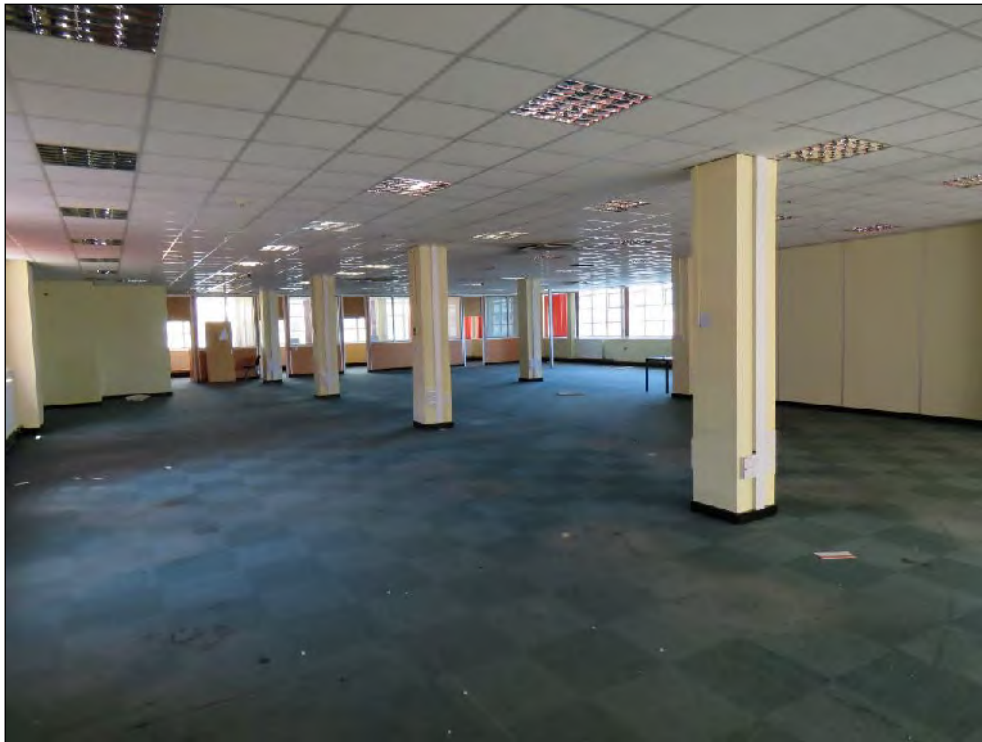
**Figure 25:** Typical view of third floor interior. (Disposition of windows, columns and open plan space dating to original build and of Considerable Significance, but all partitions, fixtures and finishes of Low Significance)

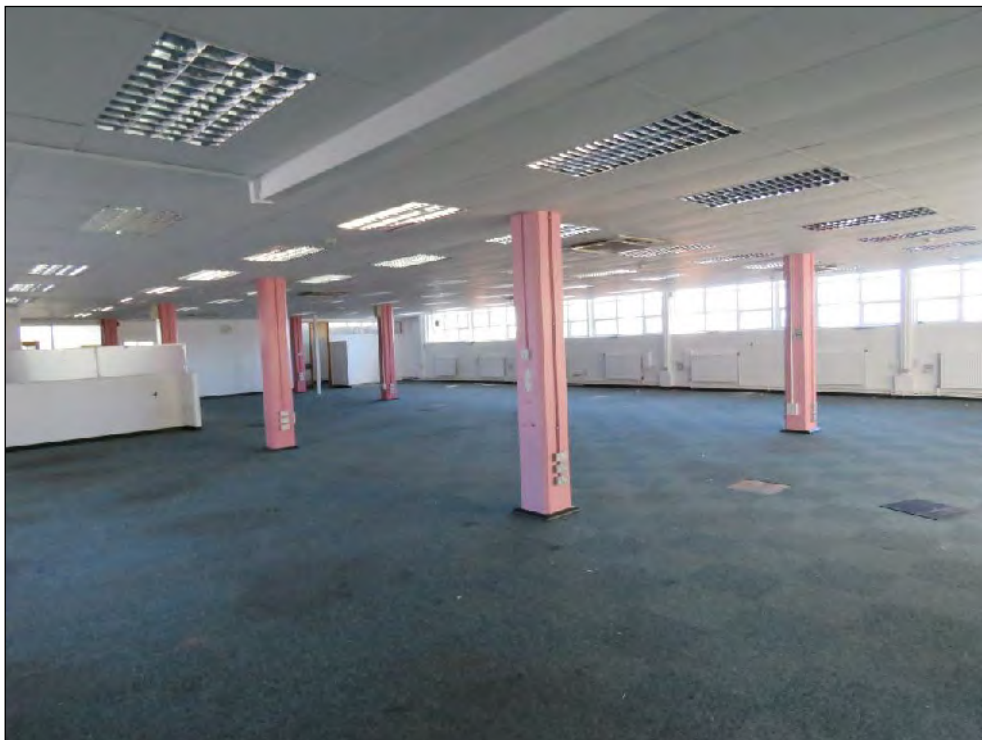
**Figure 26:** Typical view of fourth floor interior. (Disposition of windows, columns and open plan space dating to original build and of Considerable Significance, but all partitions, fixtures and finishes of Low Significance)
