**Redfern  
Building**

**NOMA  
Manchester**

## Heritage Statement: Significance & Impact

**10<sup>th</sup> September 2018**

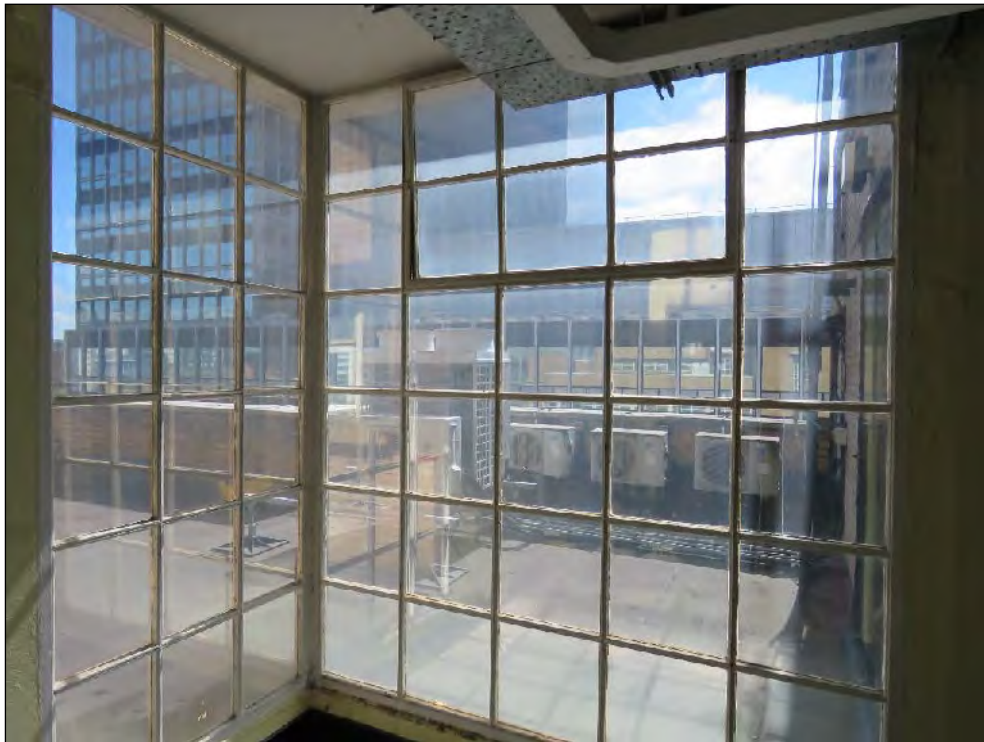
**Figure 27:** Steel framed glazing sections to fifth floor beneath lift overrun tower. (High Significance)

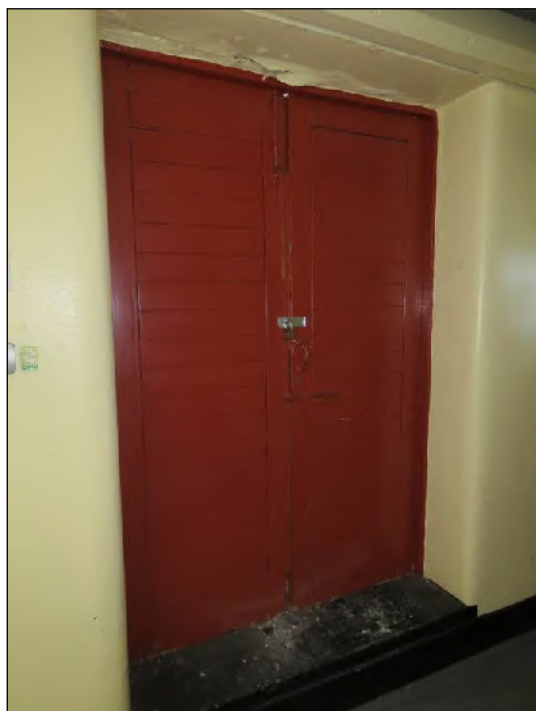
**Figure 28:** Timber double doors to fifth floor external roof area. (Considerable Significance)

the lift overrun tower at the west end of the floor plate. Here there is a large quantity of fixed light metal framed glazing, with a single opening casement section, illuminating the spiral access stair which gives access to the tower and the roof level areas (Figure 27). Nearby at the entrance to the secondary fire exit stair there is a pair of timber double doors giving access to the external roof areas above the fourth floor and dating to the original build (Figure 28). A corrugated steel door to the adjacent goods lift dates to the c. 1960s (Figure 29).

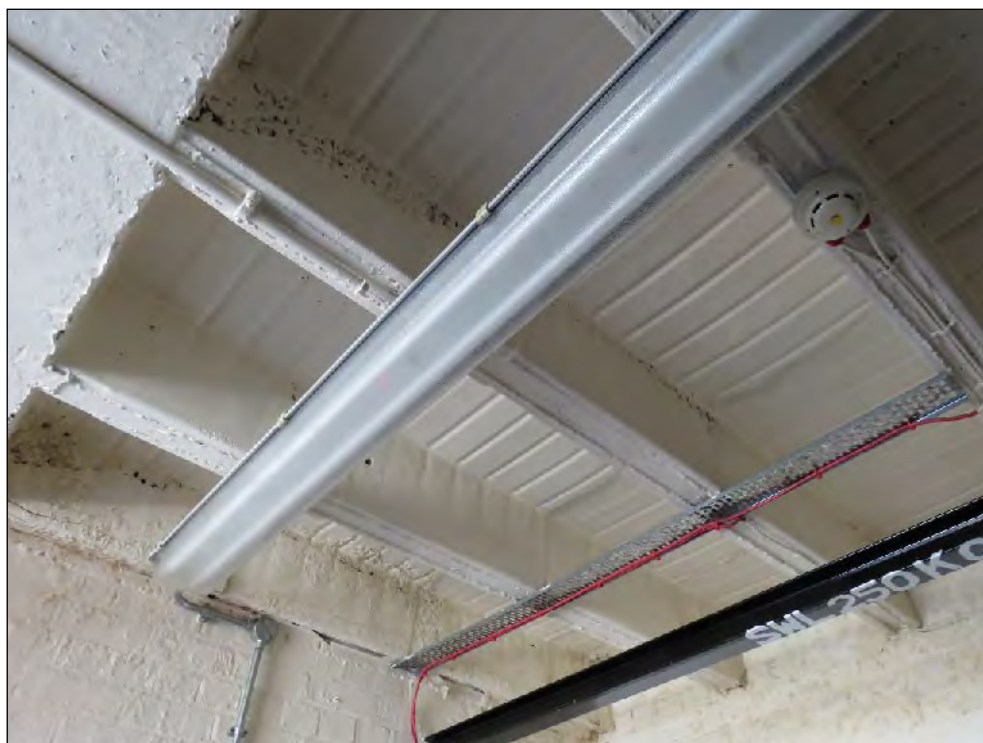
**Figure 30:** Concrete beam and block structure visible above passenger lift overrun to fifth floor, revealing structure of original build. (Considerable Significance)

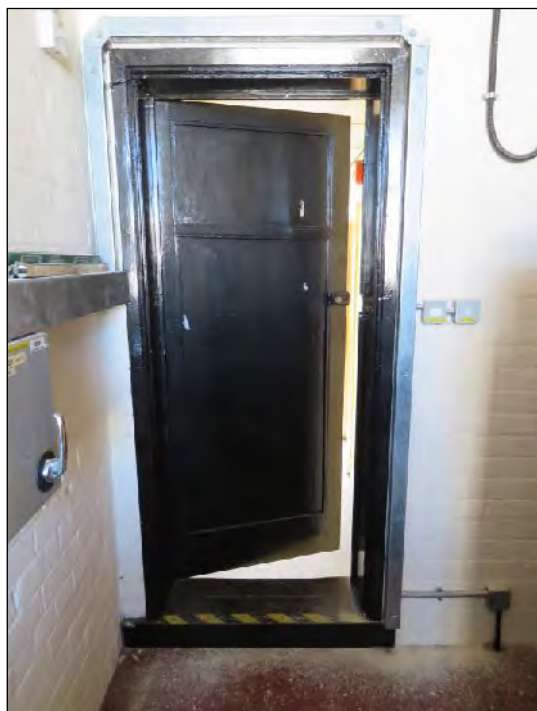
**Figure 31:** Timber door and frame to ancillary areas above passenger lift at fifth floor level. (Considerable Significance)

At the corresponding location at the east end of the floor plate, there is an ancillary area above the two passenger lift shafts. In this area the concrete floor slab construction may be seen above, and original timber and partially glazed timber doors survive giving access both back to the open plan office areas and to the external terrace forming part of the roof of the fourth floor, respectively (Figures 30, 31 & 32). In other respects the interior of the fifth floor remains very much comparable with the lower floors, albeit on a smaller floor plan, and of little historic interest (Figure 33).

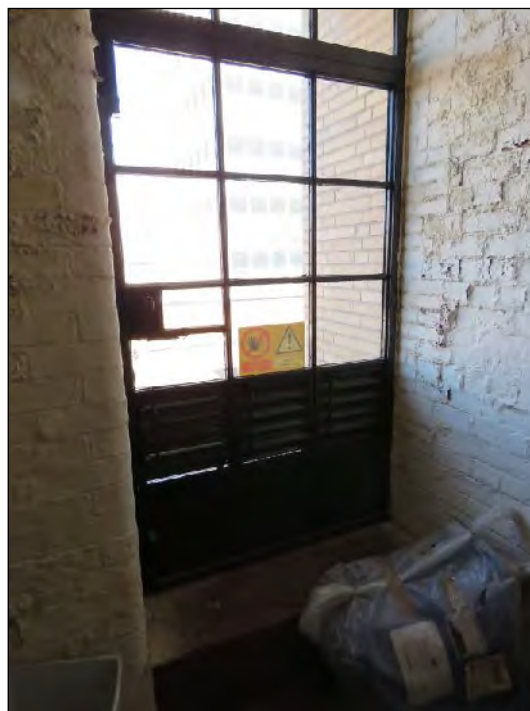
**Figure 32:** Partially glazed timber door at fifth floor level giving access to roof terrace areas. (High Significance)

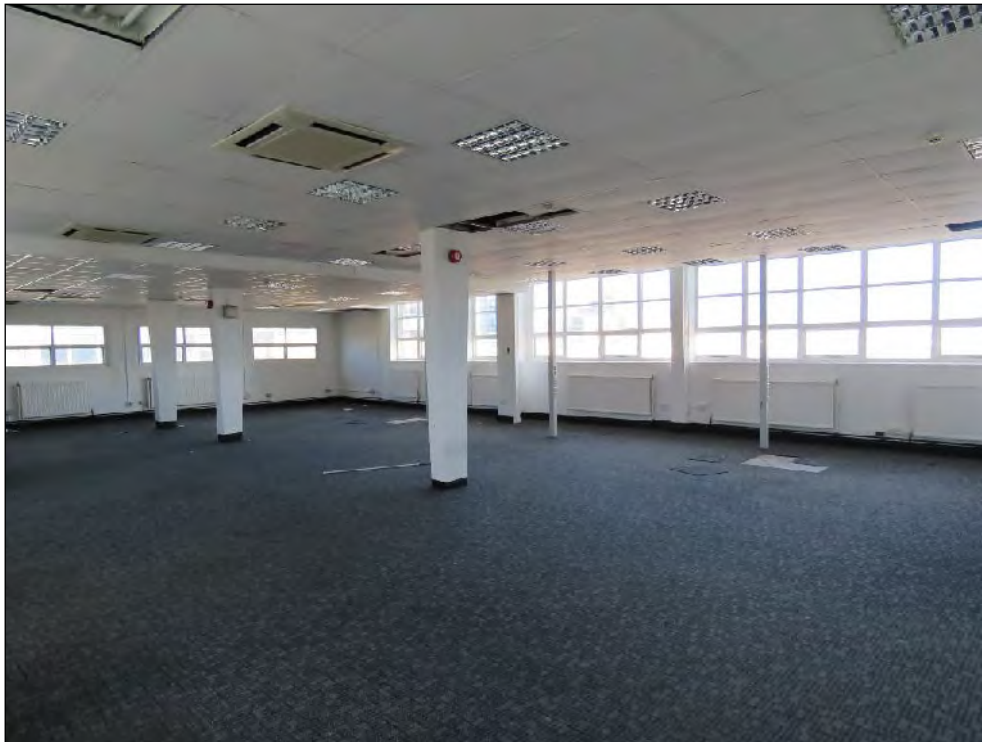
**Figure 33:** Typical view of fifth floor interior, note the widened columns. (Disposition of windows, columns and open plan space dating to original build and of Considerable Significance, but all partitions, fixtures and finishes of Low Significance)

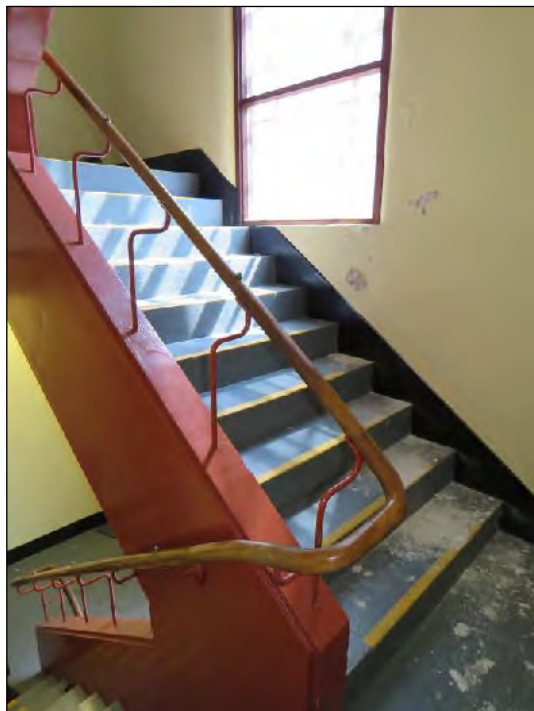
**Figure 34:** Secondary staircase (Core B) balustrade of timber with elegant steel fixings and brass caps on balustrade above. (High Significance)

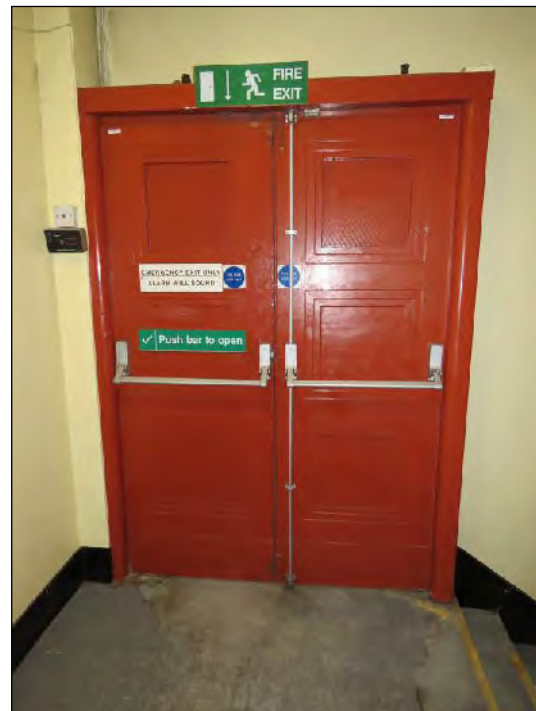
**Figure 35:** Secondary staircase (Core B) timber exit doors to Dantzic Street of typical 1930s form with recessed panels. (High Significance)

are of a form typical of the period and often seen in larger commercial buildings of the 1930s (Figures 34, 35, 36 & 37).

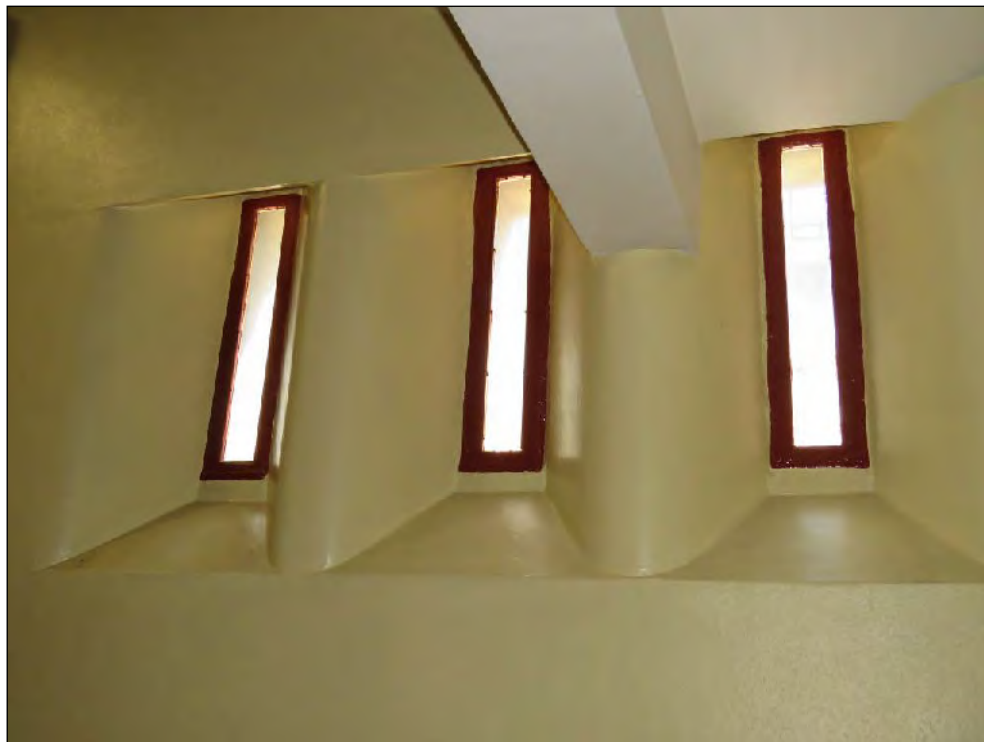
**Figure 36:** Secondary staircase (Core B) vertical slit windows deeply recessed into masonry wall thickness. (High Significance)

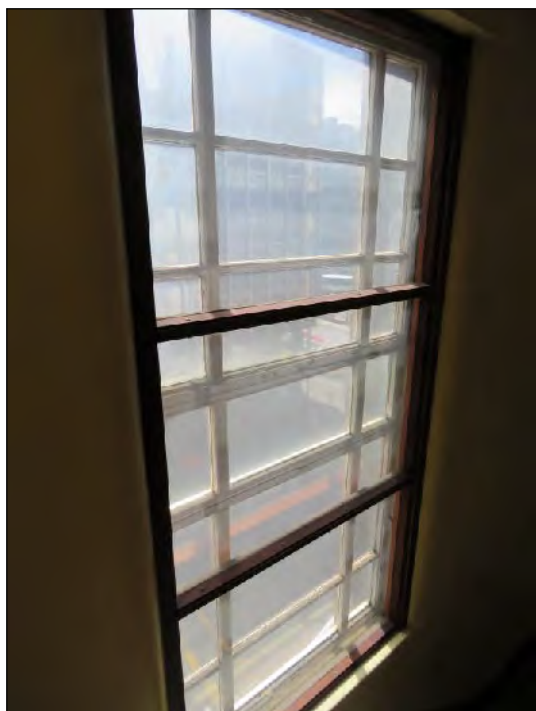
**Figure 37:** Secondary staircase (Core B) typical metal framed upper level window with side bars and later secondary glazing. (High Significance)

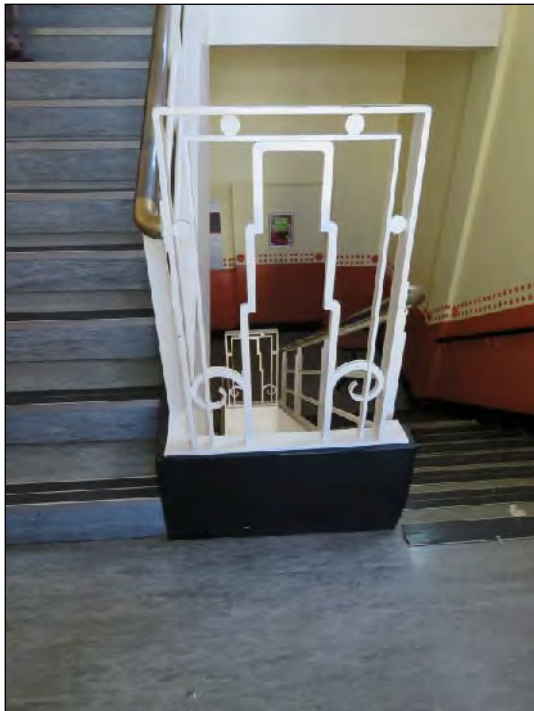
**Figure 39:** Principal staircase (Core A) decorative balustrade section. (High Significance)

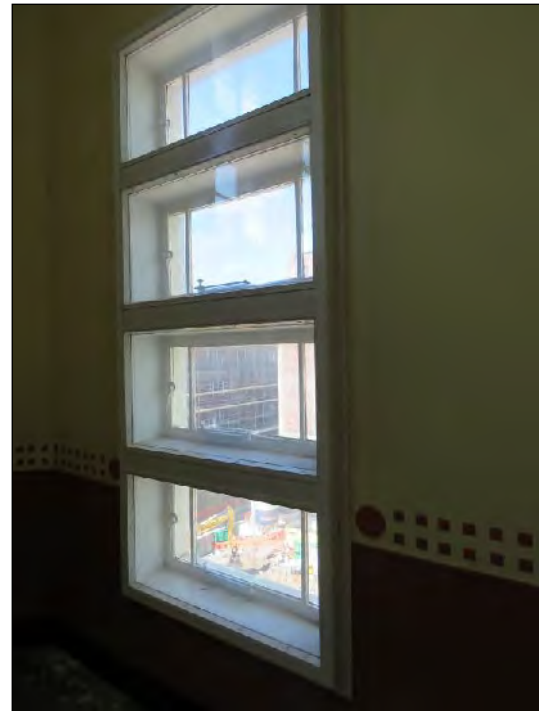
**Figure 40:** Principal staircase (Core A) side opening metal framed casement windows and later secondary glazing. (High Significance).

Also contemporary with the original build are the grouped sets of side opening casement windows with side bars, although these have been supplemented with later secondary glazing (Photographs 40 & 41). The two adjacent passenger lifts serving the same floors, whilst retaining their original positions, have been removed with one replaced another blocked up, although the lift car of the latter survives. Nearby, within the office floorplate, the building was served with a “dumb waiter” service lift which remains in situ.

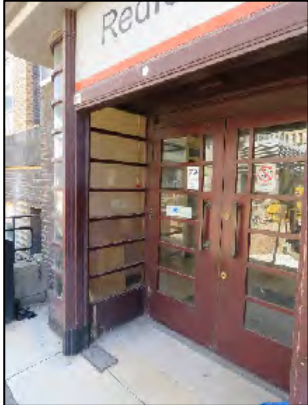
| Area / feature | Photograph | Existing Significance | Proposals | Type and scale of impact |
|---|---|---|---|---|
| Principal entrance door to Sadlers Yard | | Medium-high | Reinstatement of original entrance door arrangement, flush with external screen. | Major beneficial |

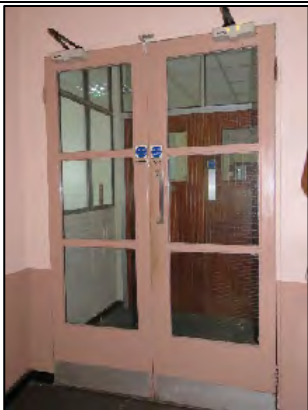
| Area / feature | Photograph | Existing Significance | Proposals | Type and scale of impact |
|---|---|---|---|---|
| Core A - doors | | Medium-High | Replacement of doors serving Core A to each floor plate with appropriately graded fire doors | Moderate adverse |

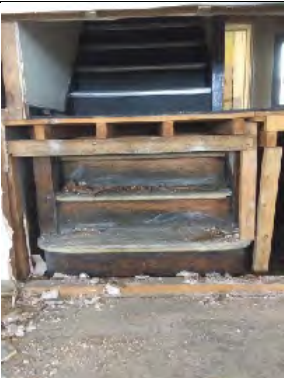
| Area / feature | Photograph | Existing Significance | Proposals | Type and scale of impact |
|---|---|---|---|---|
| Fourth – fifth floor stair | | Medium-low | Removal of surviving parts of heavily altered stair between fourth and fifth floors. | Minor adverse |

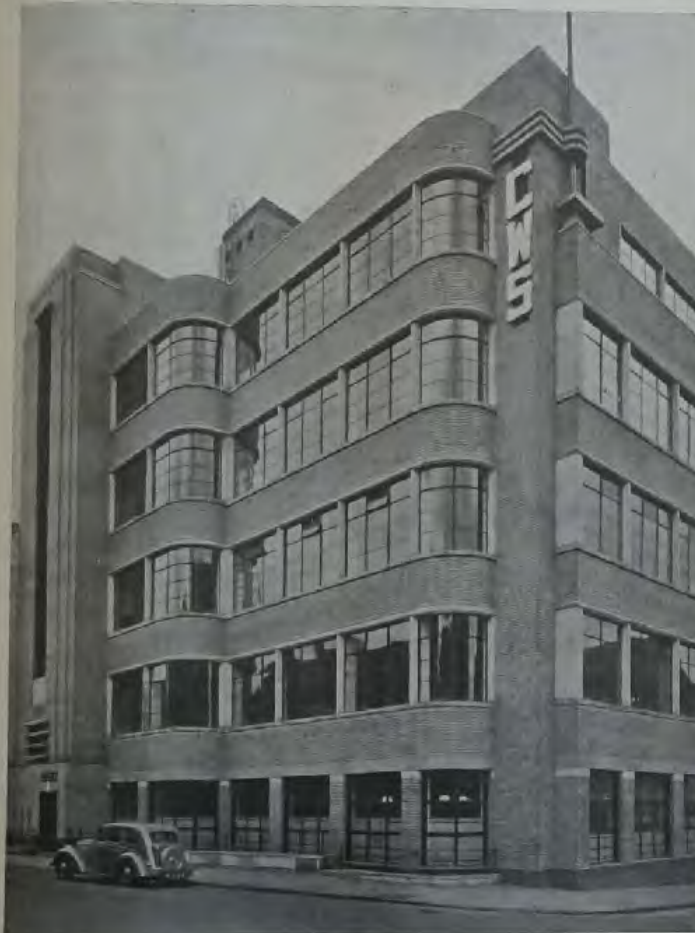
*The exterior is finished in buff facing bricks, with 1/2-in. recessed joints.*

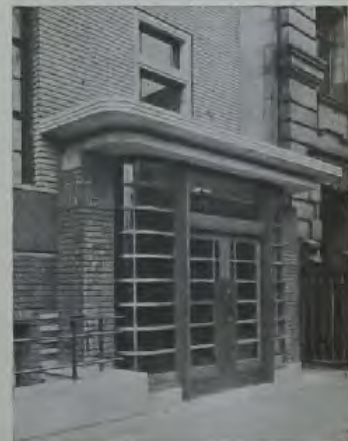
*A detail of the main entrance, with blue brick piers.*
