Phase II Geoenvironmental Site Assessment  
Sulby Street, Manchester

Reference: 15-395-R2-1  
Date: February 2023

Land off Sulby Street  
Manchester  
M40 5HY

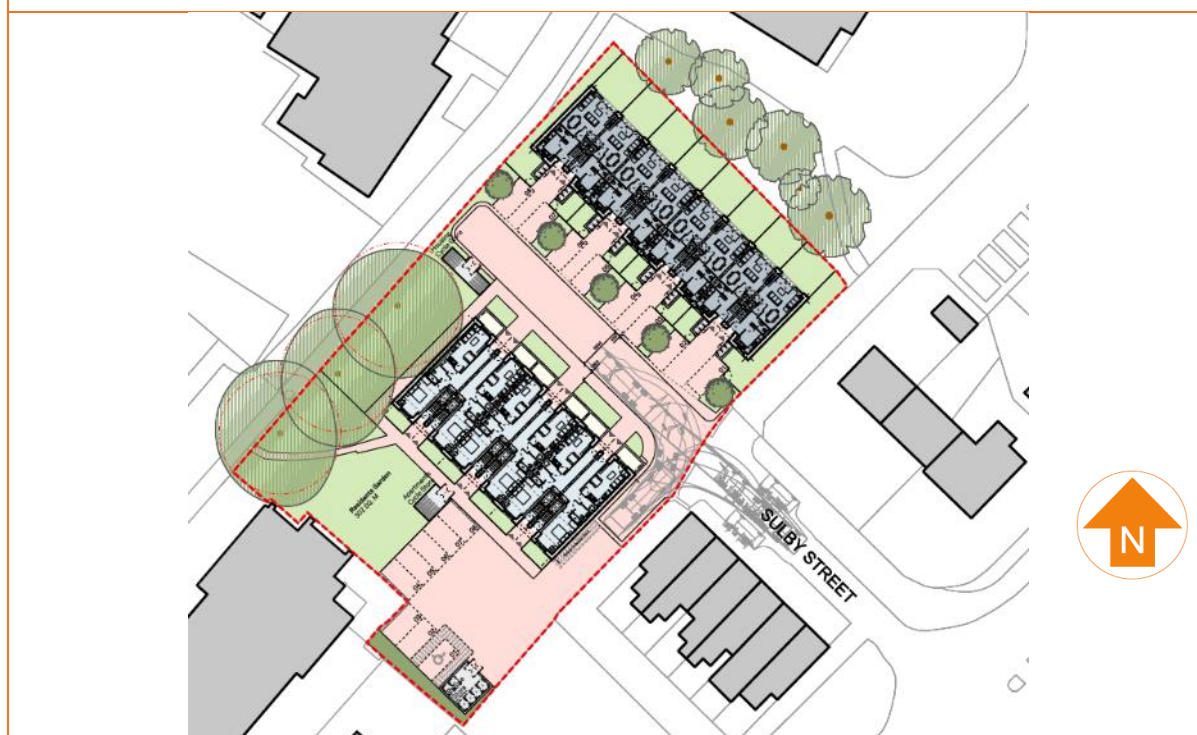
FIGURE 1.1 SNAPSHOT OF PROPOSED DEVELOPMENT

A snapshot of the proposed development layout is indicated in Figure 1.1.

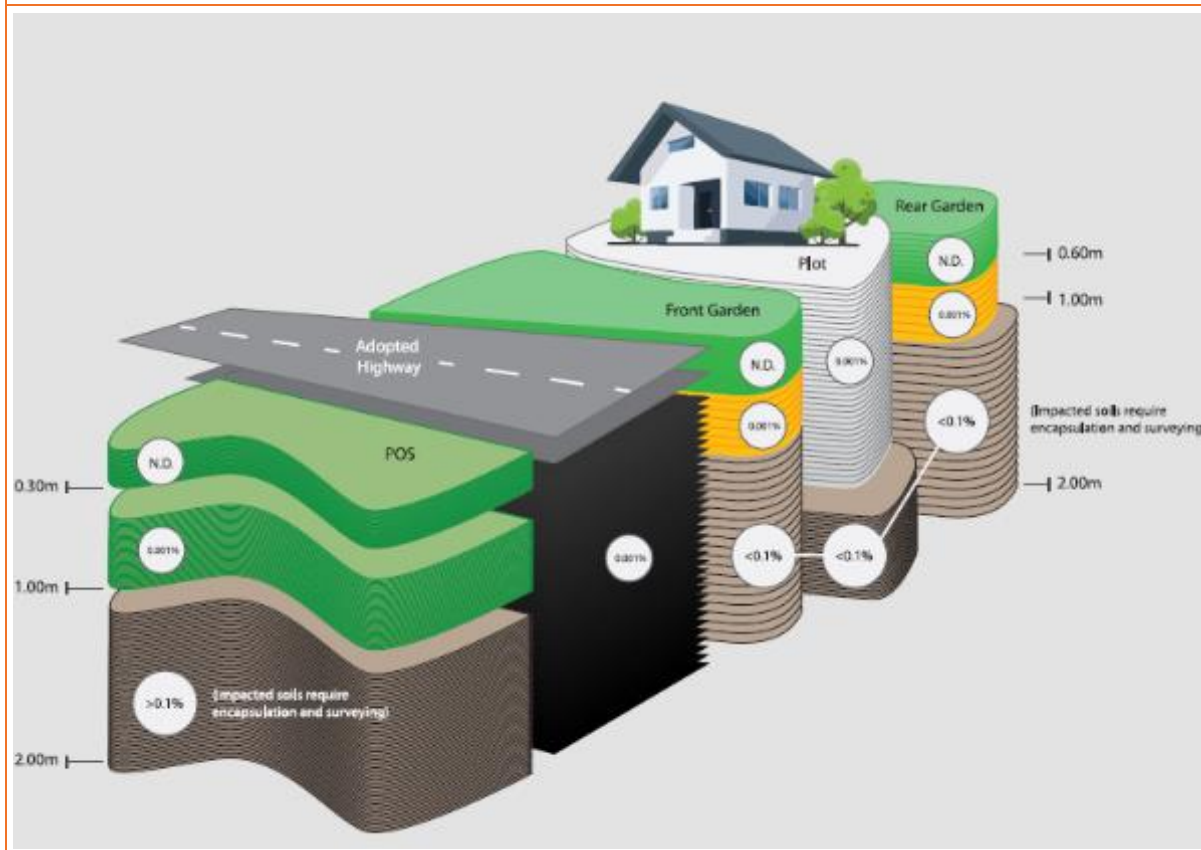
FIGURE 4.1 ASBESTOS RISK MITIGATION CONCEPTUAL SITE MODEL

Impacted soils should be managed according to the asbestos risk mitigation conceptual site model shown in Figure 4.1.

Evidence of potential asbestos sheeting has been noted within the roofing of the club house in the north-eastern sector of the site. Given the age of the buildings, it is likely ACM is present within the building fabric. Visible pieces of asbestos will require specialist removal and disposal to a licenced waste facility in accordance CAR (2012) and waste management legislation.
