Project: **ORMOND BUILDING, MANCHESTER**

Orig Title: **PROPOSED PLAN ON GINNEL GROUND FLOOR INDICATING STRUCTURE BELOW**

| 078665 - CUR - XX - GF - DR - S - 2000 | P03 | |

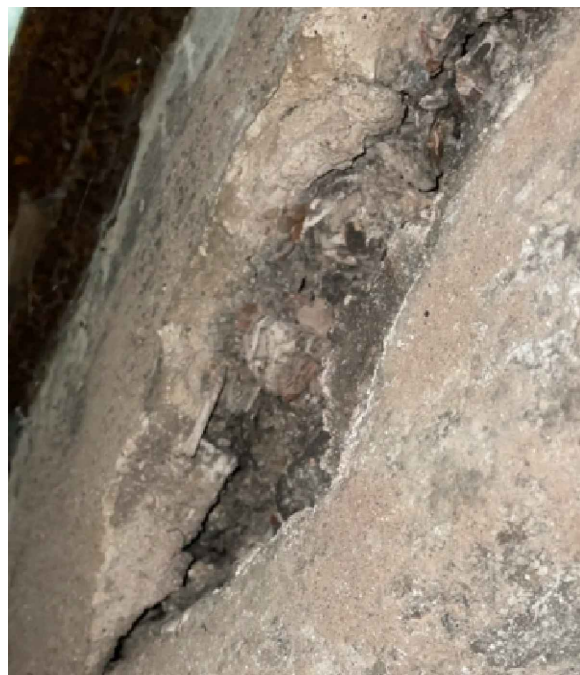
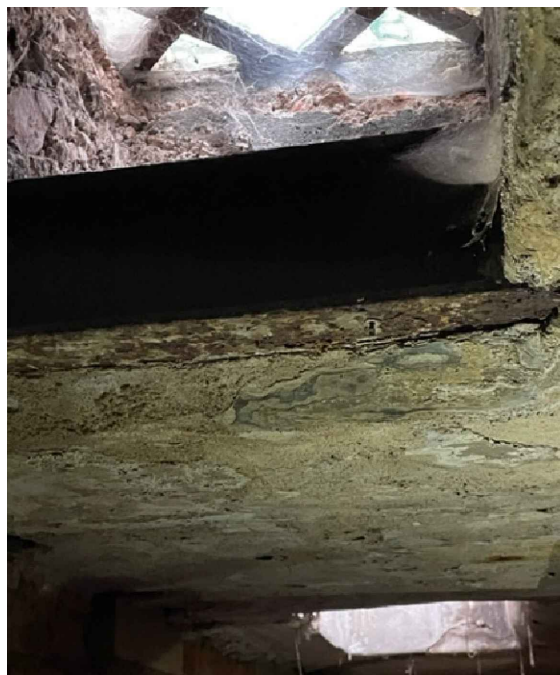
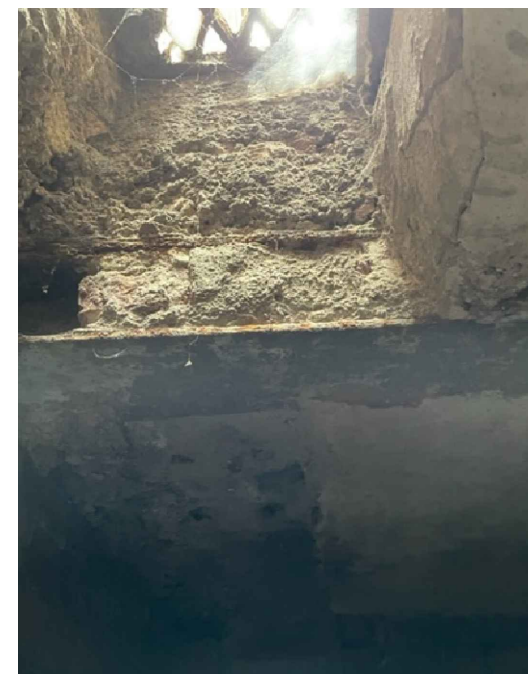
TYPICAL SLAB SOFFIT PHOTO RECORDS

GENERALLY SLAB SOFFIT AND BEAMS ARE VARYING DEGREES / LEVELS OF LOCALISED MINOR DEGRADATION WHICH IS PRIMARILY DUE TO MOISTURE LEVELS EITHER NATURAL POORLY VENTILATED SPACE COMPOUNDED BY EVIDENT WATER WATER THUS CAUSING LOCAL MINOR CORROSION OF STEEL FILLER JOIST BEAMS LOCALLY AS APPARENT FROM VISUAL SURVEY AND INTRUSIVE WORKS UNDERTAKEN.

- PERFORMANCE SPECIFICATION FOR CONCRETE / BEAMS REPAIR TREATMENT
- HAMMER TEST TO BE UNDERTAKEN ACROSS SOFFIT TO REMOVE ANY LOOSE DELETERIOUS MATERIAL/CONCRETE AS REQUIRED
- CONCRETE TO BE REMOVED LOCALLY TO UNDERSIDE OF ALL FILLER JOIST BEAMS FOR EXTENT OF BEAMS ONLY
- ALL CORRODED LOOSE STEELWORK TO BE REMOVED VIA SANDING TO PREPARE BEAMS FLANGE FOR PAINT TREATMENT.
- ALL BEAMS FLANGES TO BE PAINTED AS REQUIRED - REFER TO CURTAIN STEELWORK PAINT PERFORMANCE SPEC FOR DETAILS
- ALL SPALLED/LOOSE CONCRETE REMOVED TO SOFFIT TO BE REINSTATED WITH FOLLOWING MORTAR REPAIR OR SIMILAR APPROVED (NOTE ALL CONCRETE TO SOFFIT TO BE REPAIRED AS IDENTIFIED IN TYPICAL PHOTOS, NOT JUST AREAS REMOVED DURING HAMMER TEST. PHOTOS SHOW A TYPICAL SNAP SHOT FOR CONTRACTOR TO ENSURE ALL SOFFITS ARE REPAIRED AS REQUIRED.

DEEPER DEFECTS 10-80mm;  
RENDEROC HB45 POLYMER MODIFIED, FIBRE REINFORCED, REINSTATEMENT MORTAR. REFER TO RENDEROC PERFORMANCE SPECIFICATION AND PRODUCT DATA SHEET PROVIDED AS SEPARATE DOCUMENT
