# Geo-Environmental Investigation & Assessment

Woodhouse Lane, Wythenshawe

| <b>Report Title:</b> | <b>Woodhouse Lane, Wythenshawe<br/>Geo-environmental Investigation and Assessment</b> |
| <b>Report Reference:</b> | <b>11047G-WML-XX-ZZ RP-G-0002</b> |

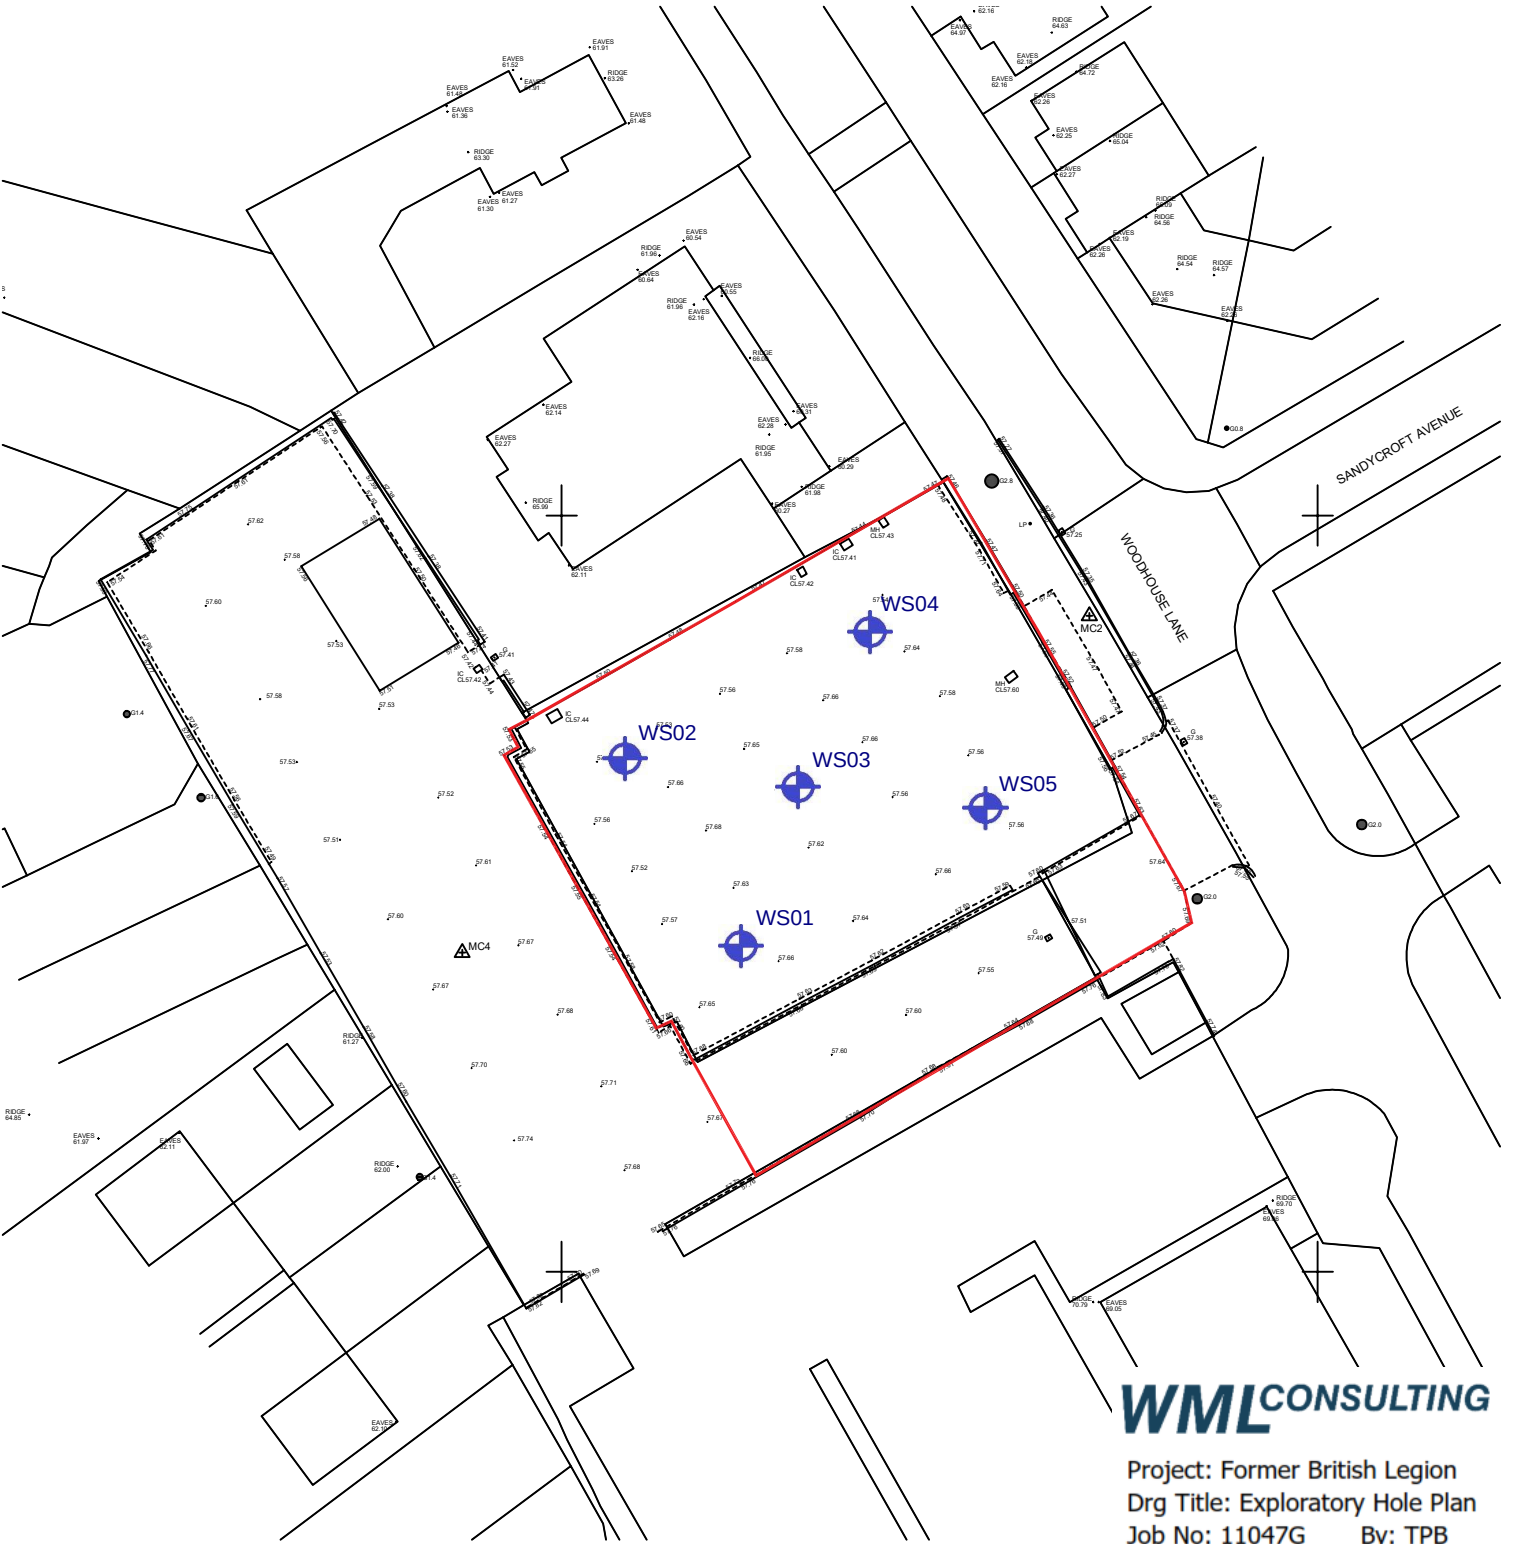
Project: Former British Legion  
Drg Title: Exploratory Hole Plan  
Job No: 11047G By: TPB  
Drg No: SK-01 Rev: -  
Date: 24/04/2023 Scale: NTS

- 4.5 The ground investigations were undertaken by LOT Geotechnics Ltd on 20<sup>th</sup> April 2023. This comprised the formation of 5no window sample probeholes to a maximum depth of 3.70 metres below ground level (mbgl).
- 4.6 The exploratory hole records are presented in Appendix 02 of this report whilst the exploratory hole locations are shown on drawing 11047G-SK01 in Appendix 01.
