# Piling Risk Assessment

Plot 10b, First Street

**Project No.:** 252966-R01

**Title:** Piling Risk Assessment: Plot 10b, First Street

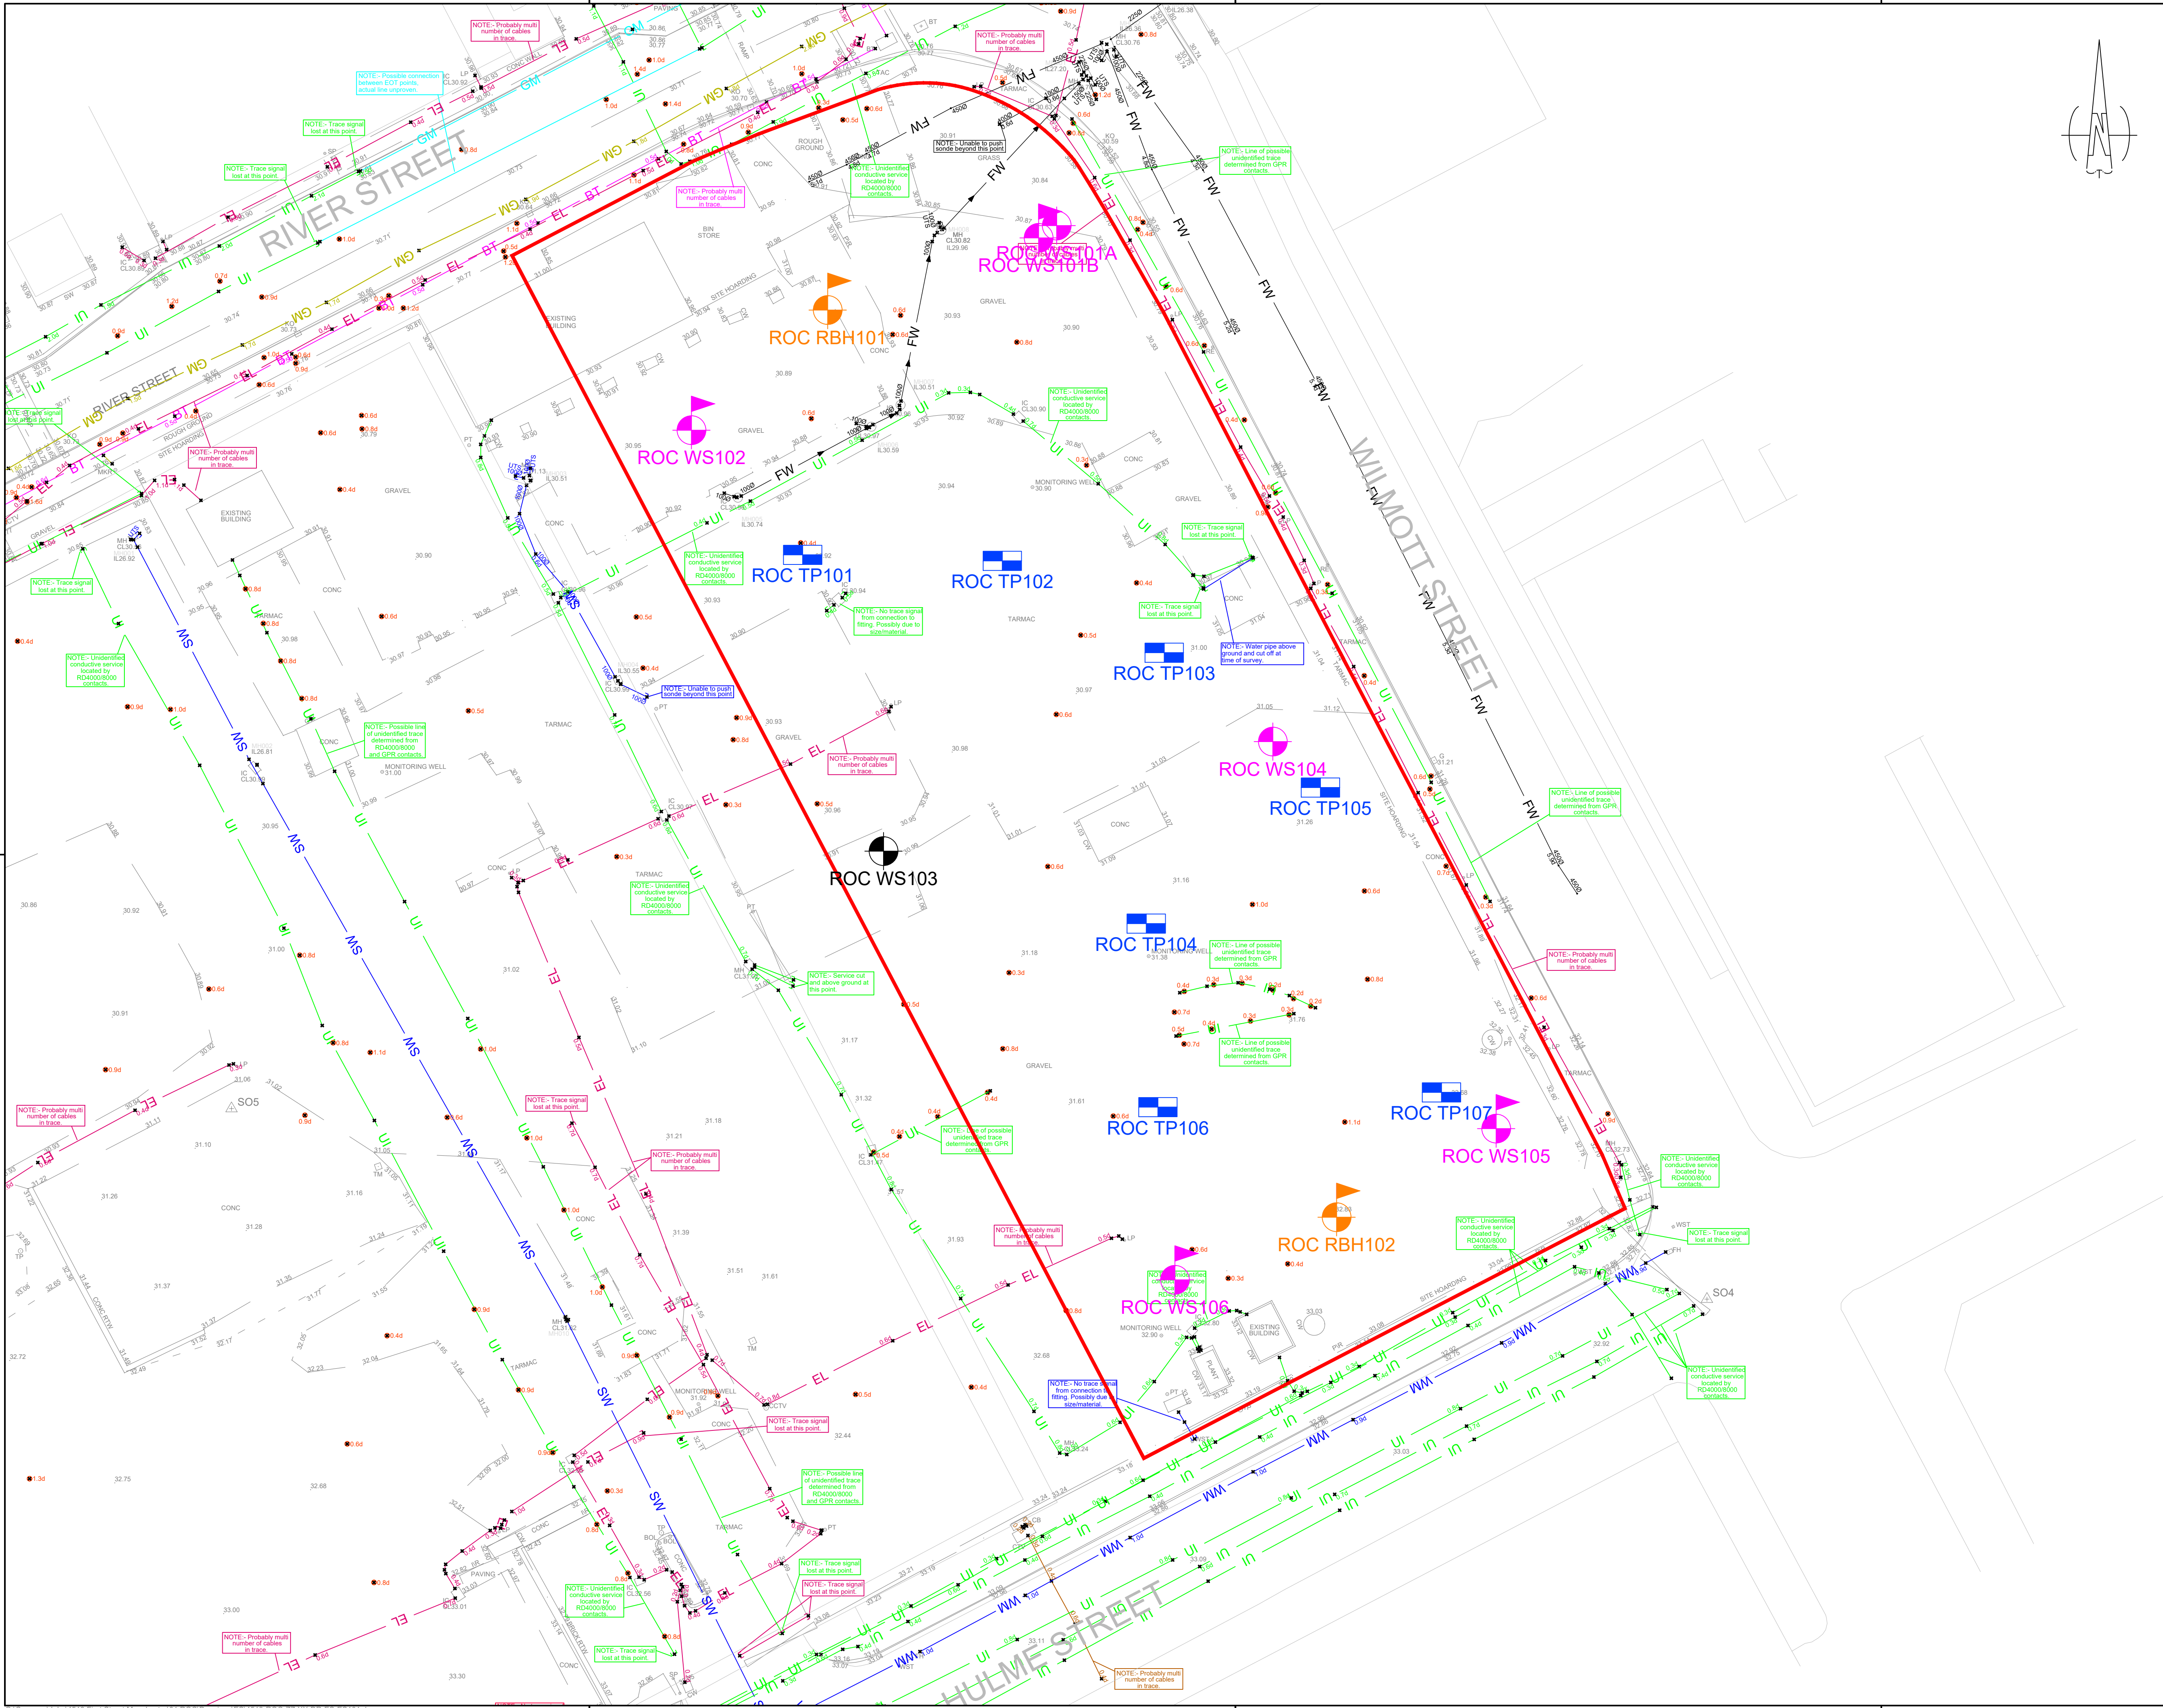
| DRAWING No. | 4513-ROC-ZZ-XX-DR-ES-ES101 | REV. | 02 |

LATERAL CONNECTIONS  
EXTENT OF SURVEY BY SURVEY OPERATIONS LTD.  
EXTENT OF SURVEY BY SURVEY OPERATIONS LTD (OVER 22)  
BURIED FEATURE FOUND USING RADAR

UNIDENTIFIED - A buried feature or utility that has been located, but we are unable to state what it is.  
UNPROVEN - The assumed location of a reported feature or utility, usually taken from records, but not found during the utility trace (due to various conditions).  
CAUTION - Electric and water cables, even when they are live, are unable to be detected or traced.

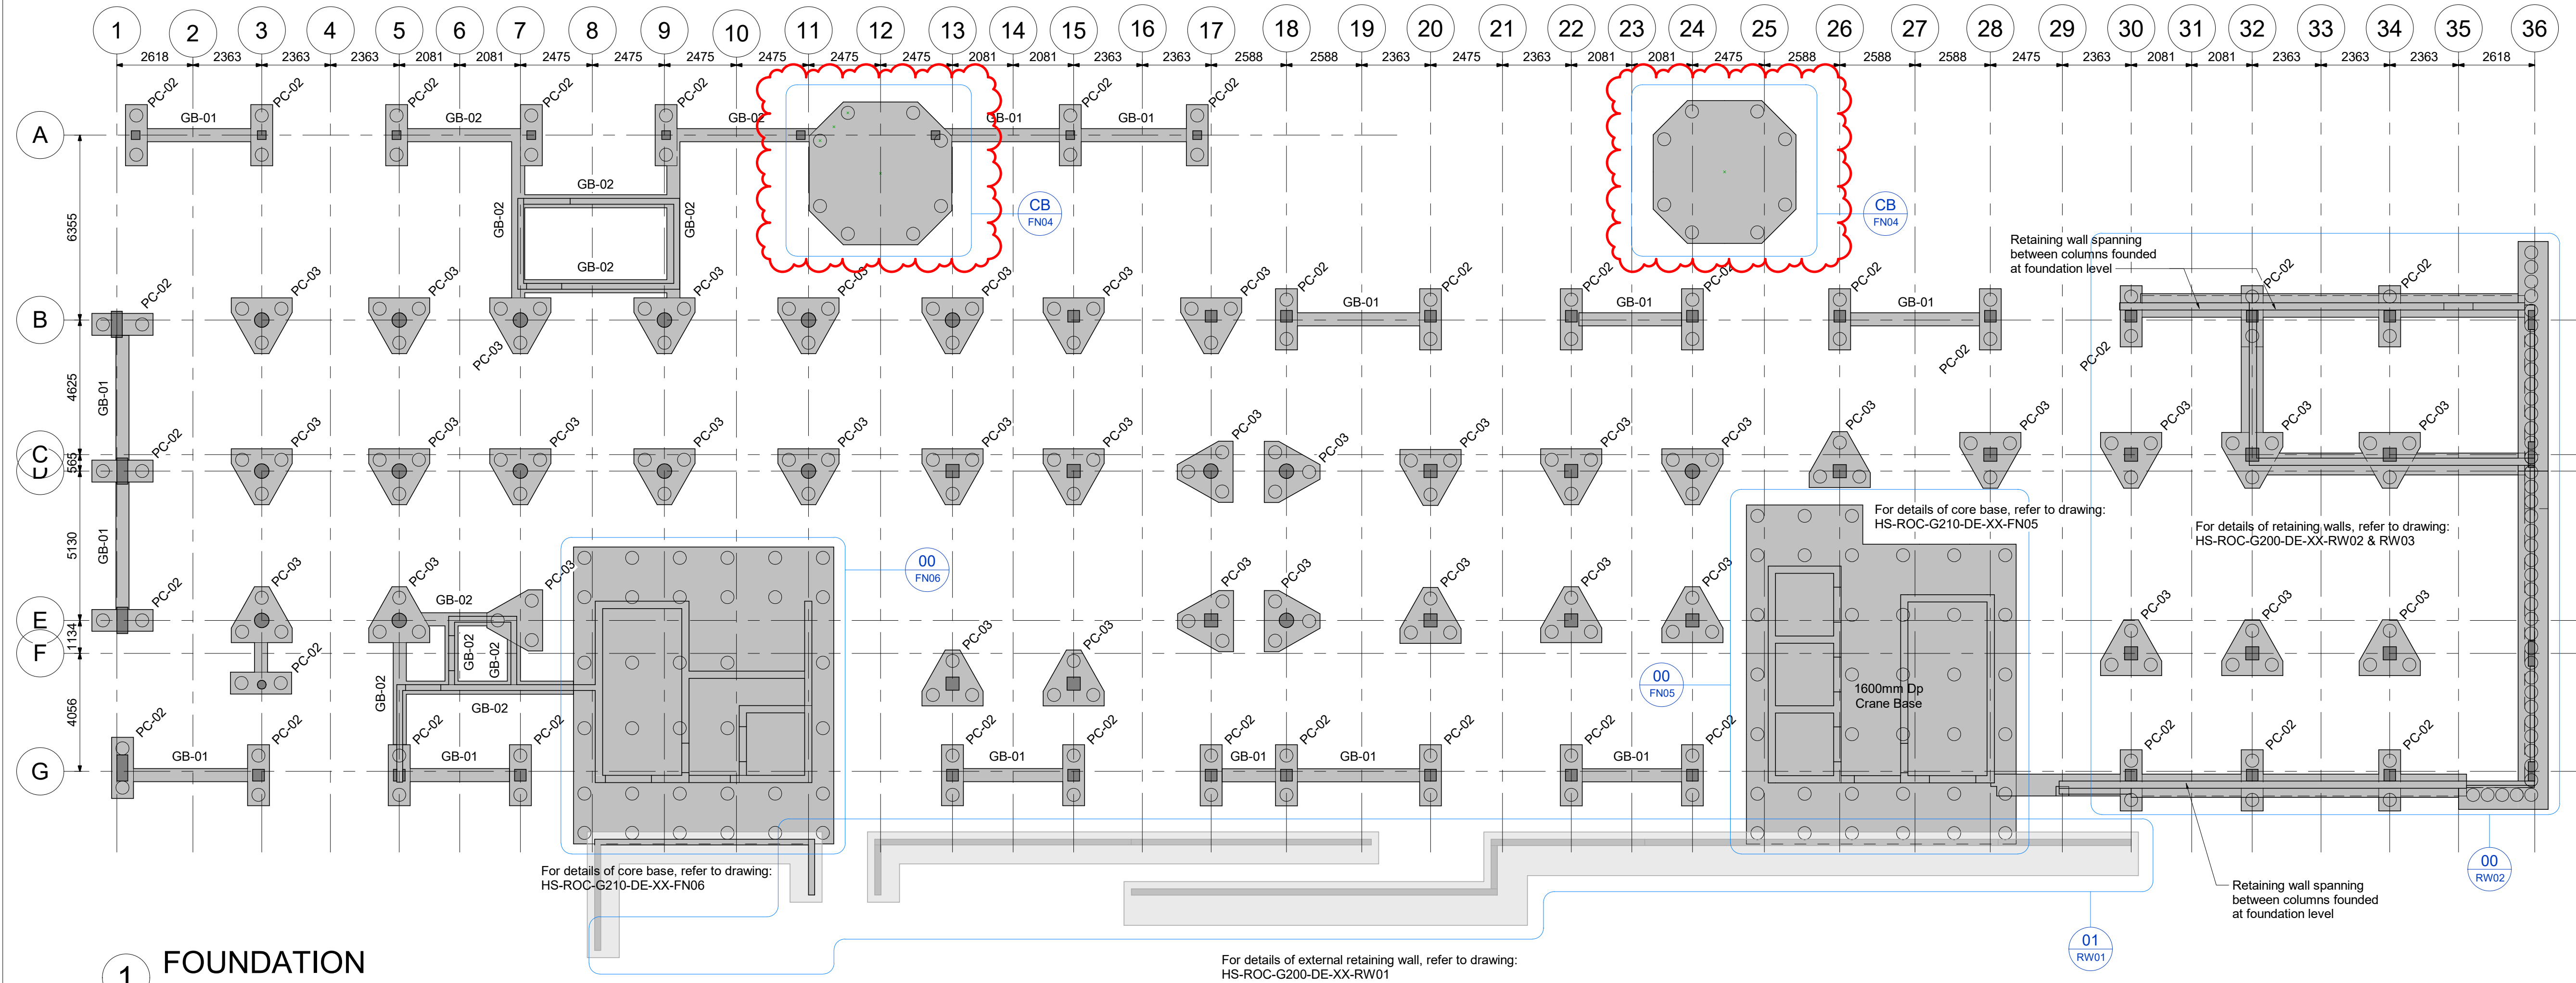
1 FOUNDATION  
1 : 125

- NOTES:
- All Piles to be 450mm Dia
  - Min spacing of piles to be 1350 U.N.O
  - Mid edge distance of piles 150mm
  - All ground beam sizes:
    - GB-01 450wd x 450dp
    - GB-02 450wd x 750dp
  - All foundation concrete to be grade C32/40

For details of typical foundations refer to Drawing:  
HS-ROC-G210-DE-XX-FN04

Foundations for the development are proposed to consist of piles (likely 450mm diameter) advanced using Continuous Flight Auger (CFA) piling techniques. It is currently proposed that piles will be advanced to depths between 15 and 20m and will socket approximately 7m into the underlying Chester Sandstone.
