## Museum of Science & Industry

### Fire Compartmentation Survey Report

Proposed Basement

## **Fire Stopping Report**

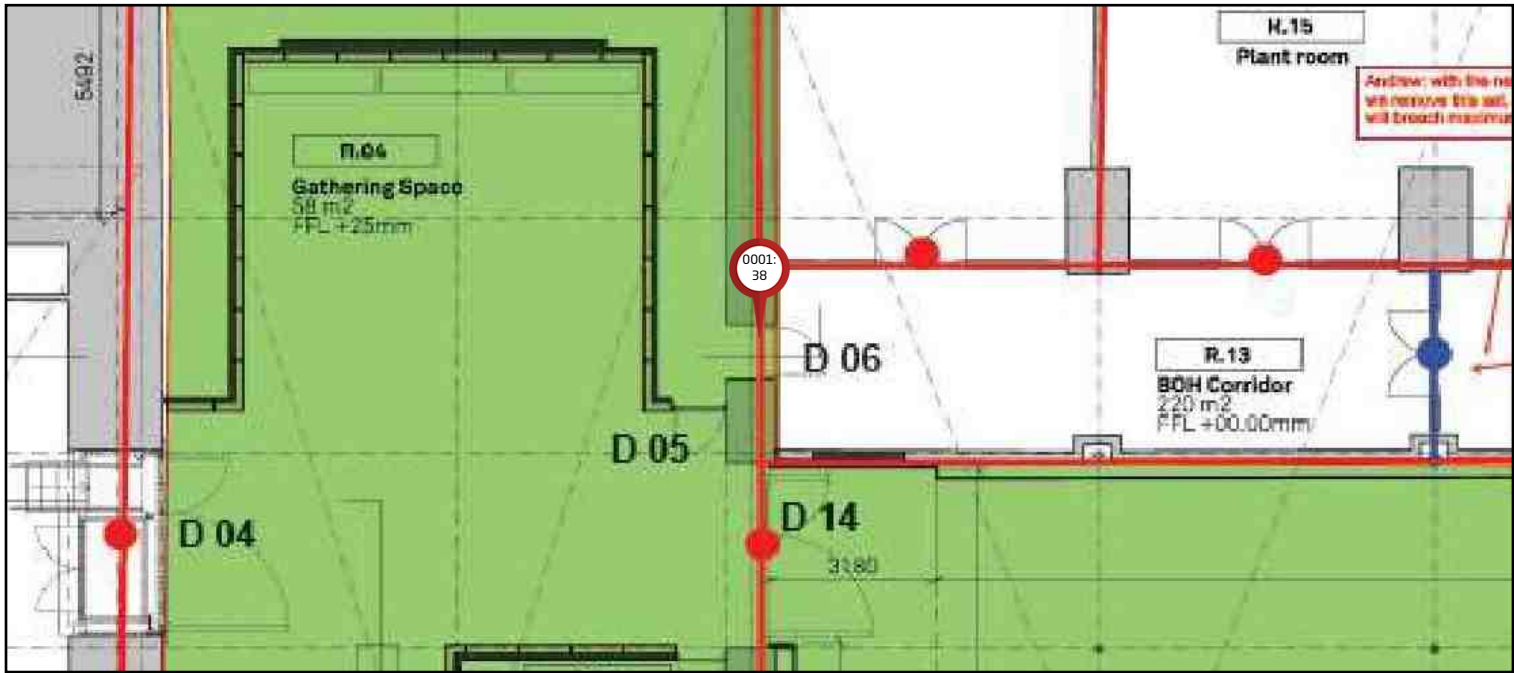
**Pin Number:** 0001:38  
**Company:** Neo Property Solutions  
**Contractor:** Tony Narkevicius - 30

| Survey | |
|---|---|
| 50mm metal pipe through brick wall. SD-128-RDW | |
| Breach identified: | Pipe |
| Priority: | Red |

| Survey | |
|---|---|
| Installation type: | SD-128-RDW |
| Once back sealed | |

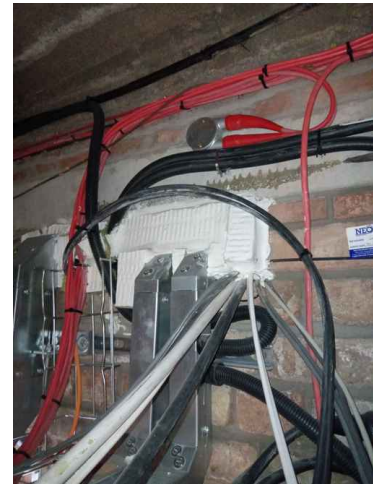
Survey  
1 of 1

| Survey | |
|---|---|
| Multiple services including trunking through brick wall. Existing firestop needs removing as dry fitted. | |
| Breach identified: | Multiple Services, Trunking |
| RWA-45 will need to be used inside trunking. | |

| Survey | |
|---|---|
| RWSD-ACB-0104 | |

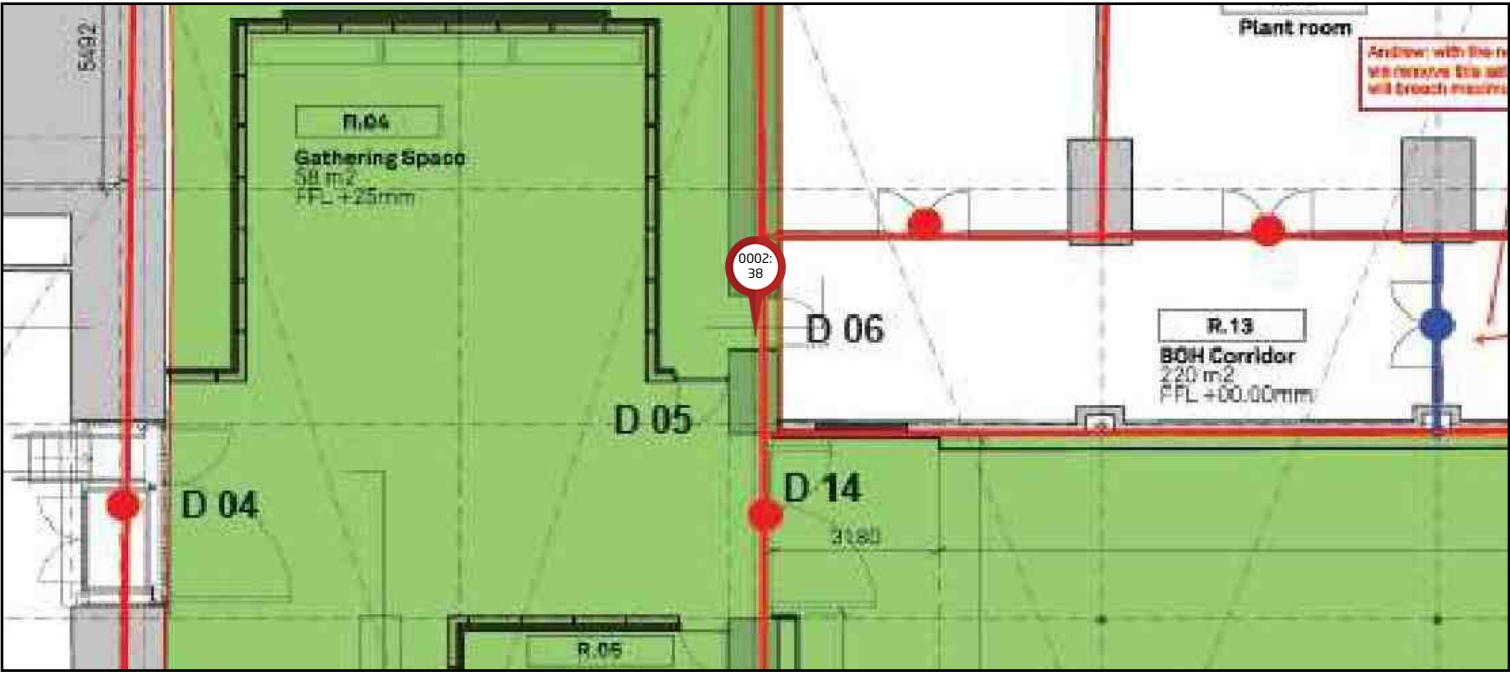
**Pin Number:** 0002:38  
**Company:** Neo Property Solutions  
**Contractor:** Tony Narkevicius - 30

| Survey | |
|---|---|
| Priority: | Red |

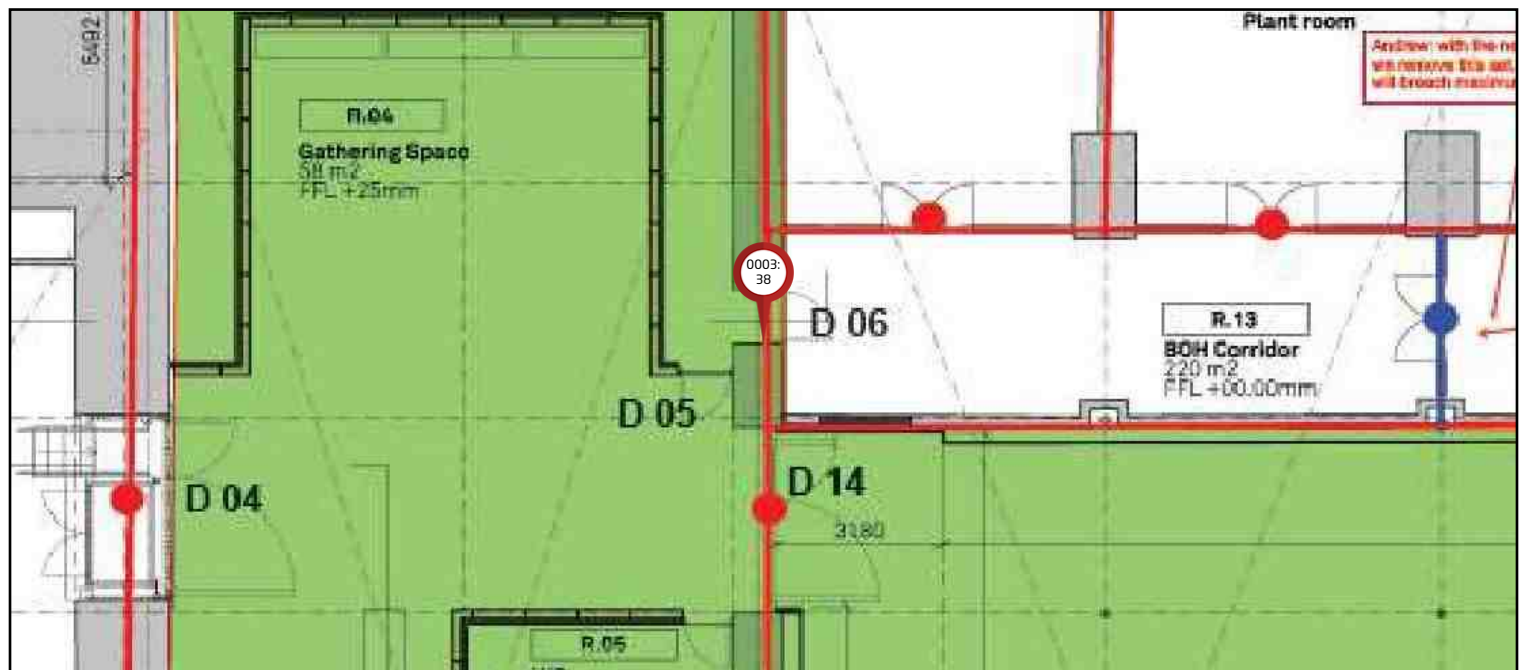
**Pin Number:** 0003:38  
**Company:** Neo Property Solutions  
**Contractor:** Tony Narkevicius - 30

| Survey | |
|---|---|
| Multiple services including trunking through brick wall. | |
| <b>Breach identified:</b> | Multiple Services, Trunking |
| Existing firestop needs removing as dry fitted. | |
| <b>Priority:</b> | Red |

| Survey | |
|---|---|
| <b>Installation type:</b> | SD-122-RDW |
| RWA45 is needed inside the trunking. | |

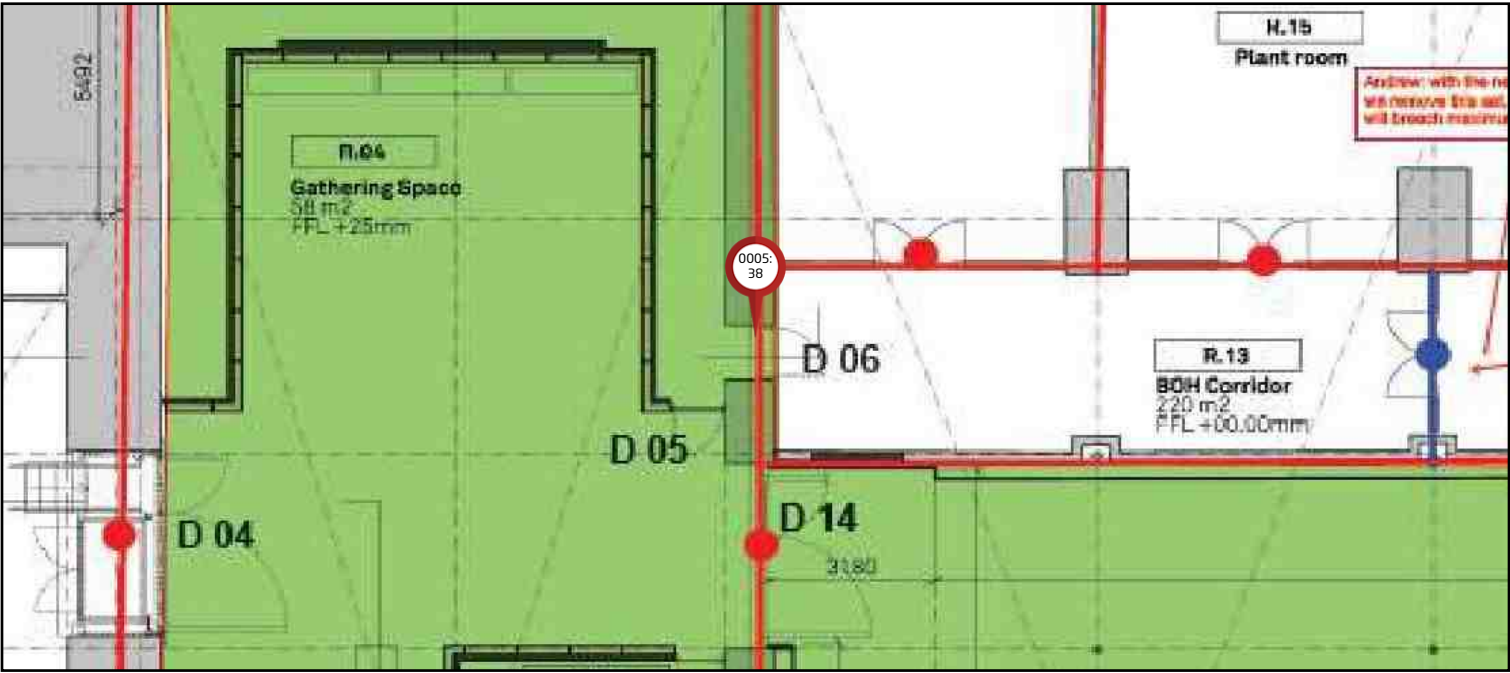
**Pin Number:** 0005:38

| 100mm metal pipe going through ceiling. | |
| Breach identified: | Pipe |
| Priority: | Red |

| Cap off end of redundant pipe and seal to slab. | |
| Installation type: | SD-123-RDW |

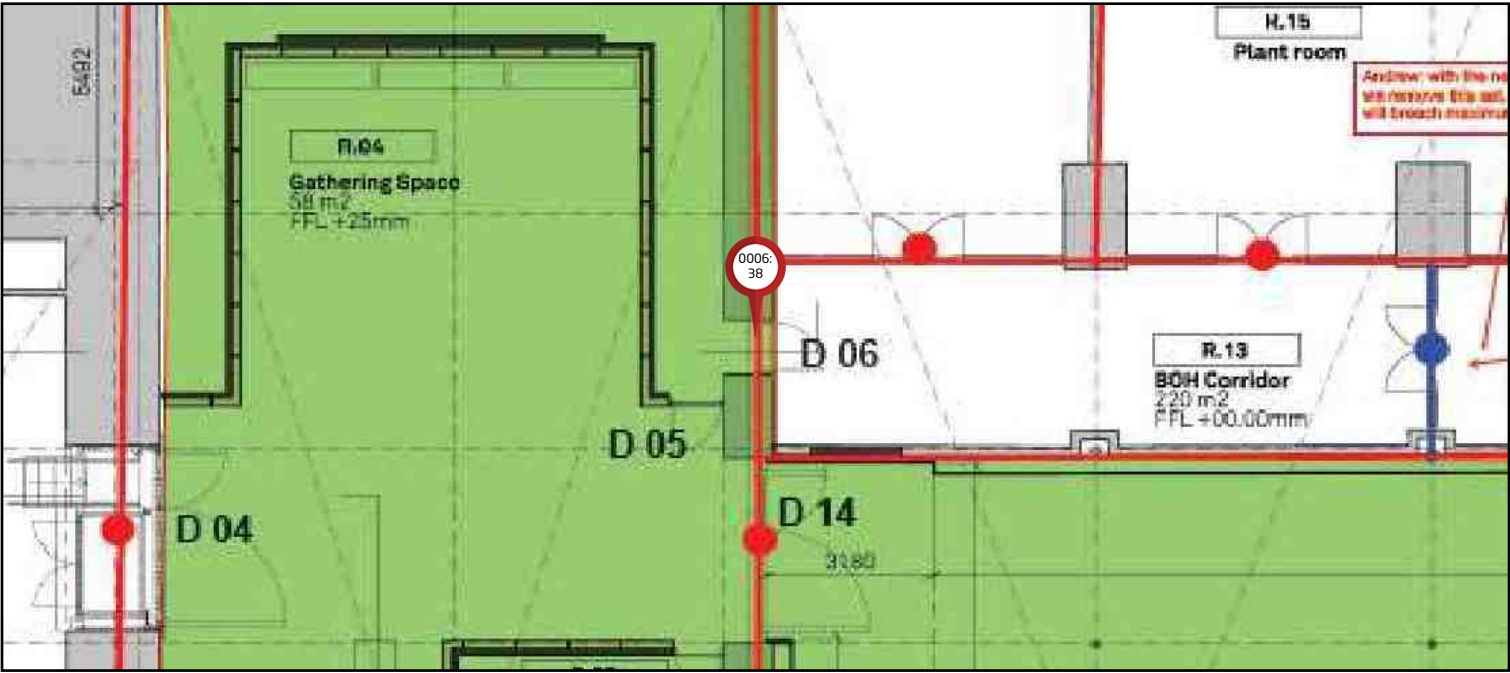
**Pin Number:** 0006:38

| Breach identified: | Cable |
| Priority: | Red |

| Remove existing mastic. | |
| Installation type: | SD-128-RDW |

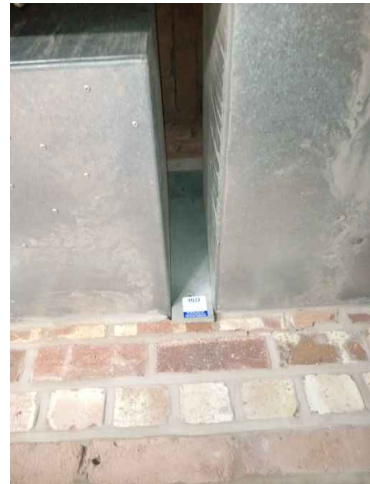
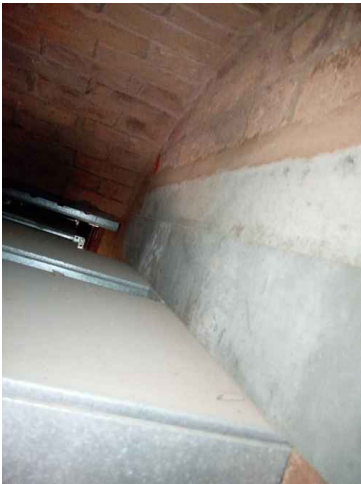
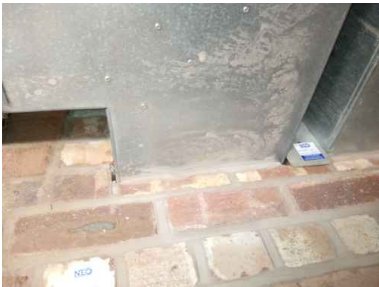
Survey  
1 of 3

| No fire dampers installed | |

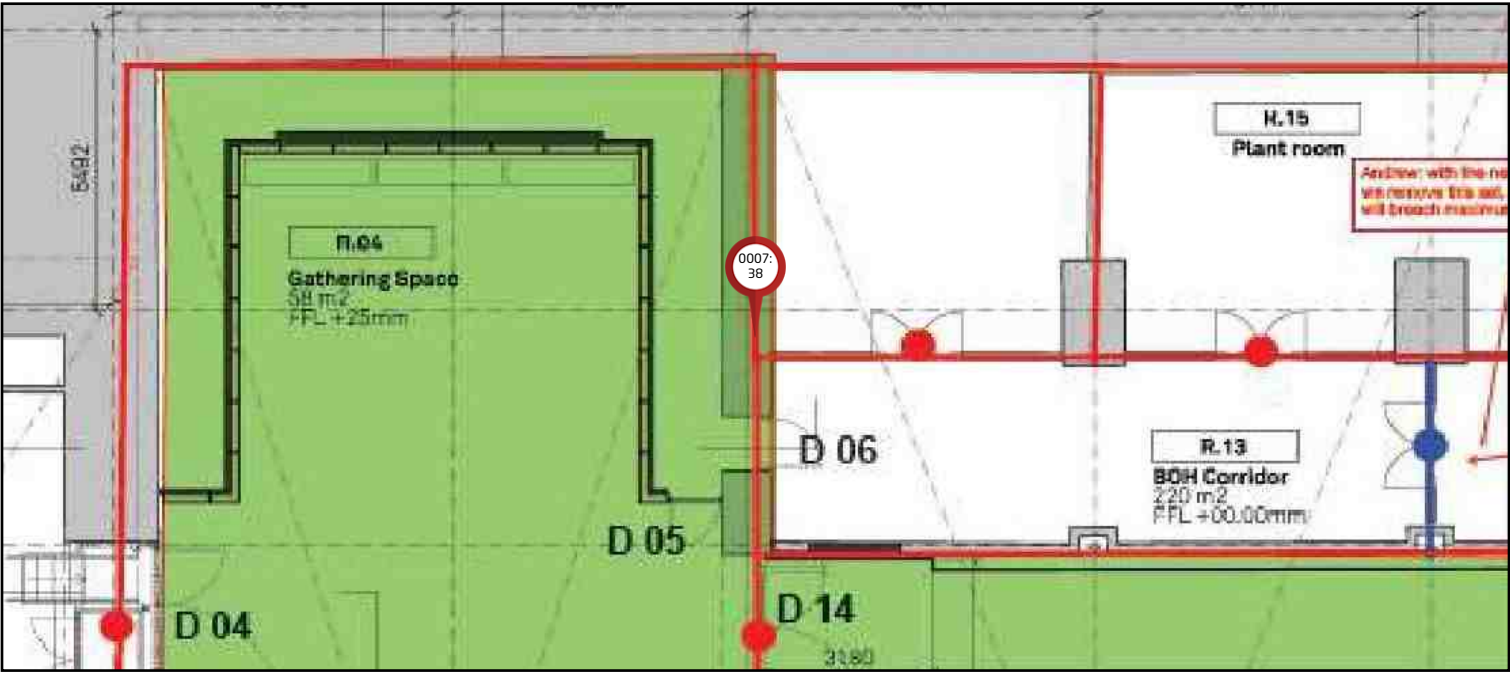
**Pin Number:** 0007:38

| X2 ducting in blockwork wall with wooden pattress installed. No visible fire dampers installed in ductwork. | |
| Breach identified: | Duct |
| Priority: | Red |

| Remove chipboard pattress. No visible fire dampers installed on ducting so dampers will need to be installed. | |
| Installation type: | SD-122-RDW |

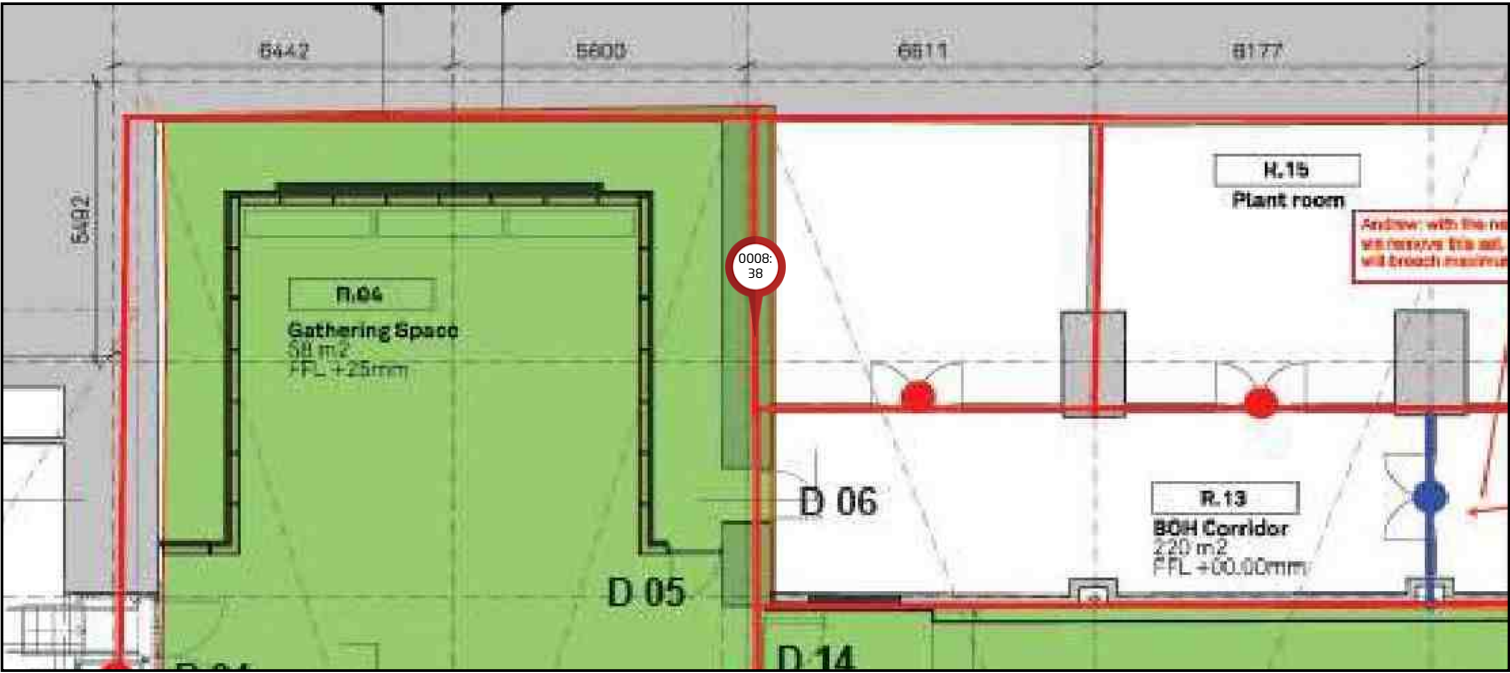
**Pin Number:** 0008:38

| X2 50mm pipes | |
| Breach identified: | Pipe |
| Priority: | Red |

| Installation type: | SD-128-RDW |

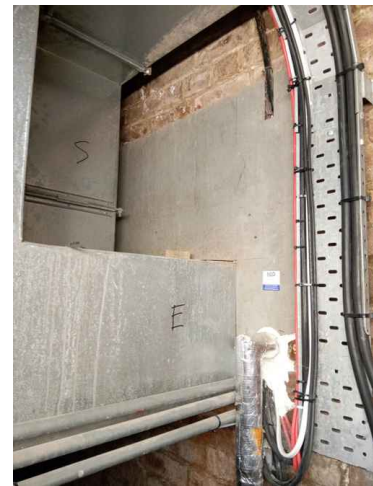
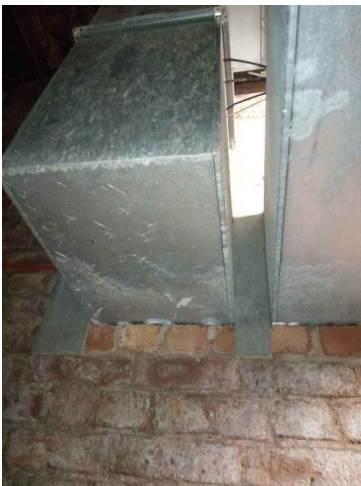
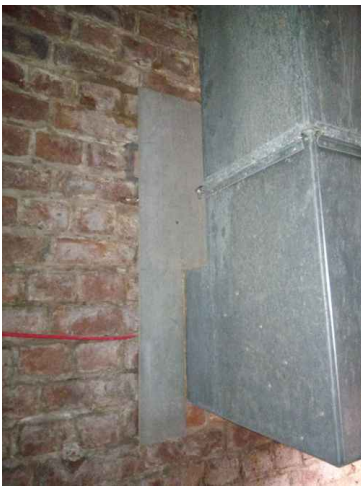
Survey  
1 of 3

| Survey | |
|---|---|
| No firedampers installed in ducting. | |

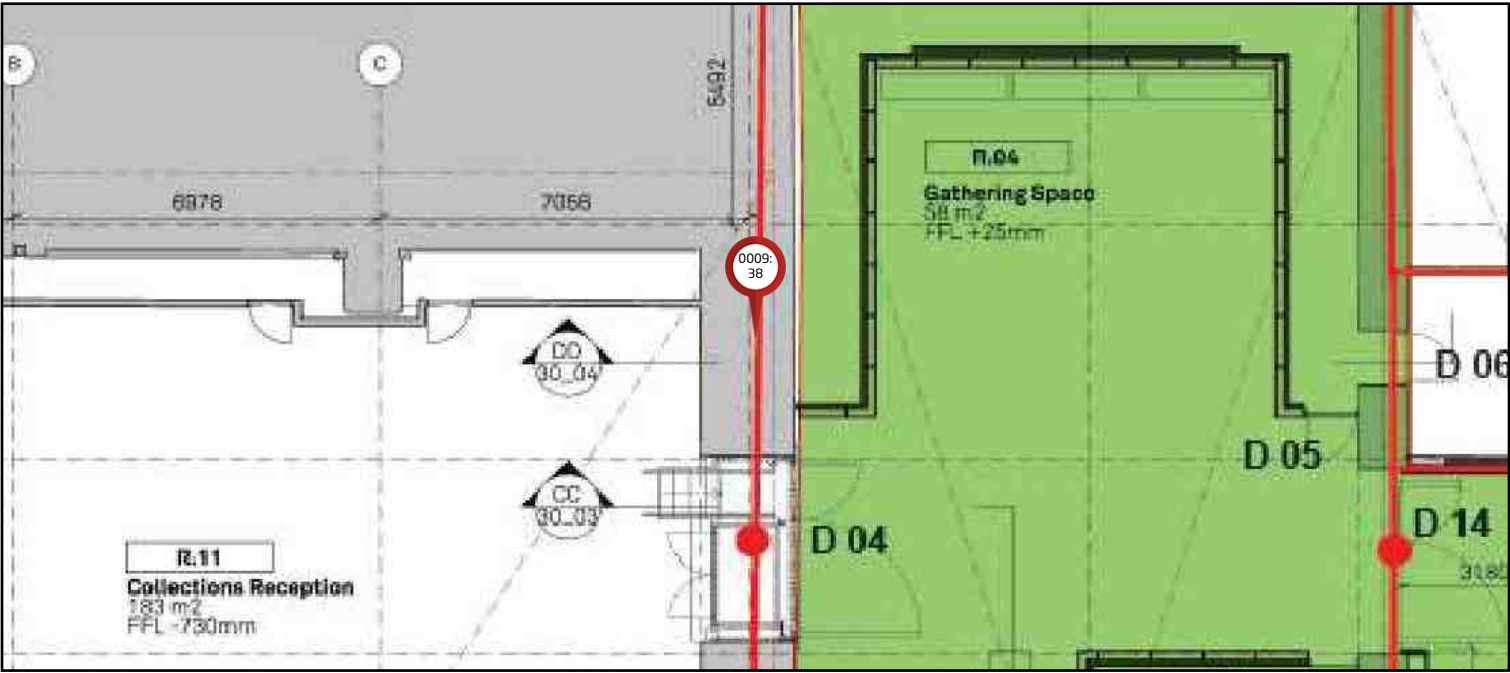
**Pin Number:** 0009:38  
**Company:** Neo Property Solutions  
**Contractor:** Tony Narkevicius - 30

| Survey | |
|---|---|
| X2 ducting and multiple services through brickwork. No visible fire dampers installed. | |
| Breach identified: | Multiple Services, Duct |

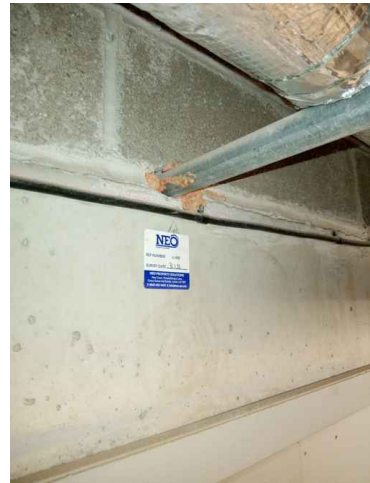
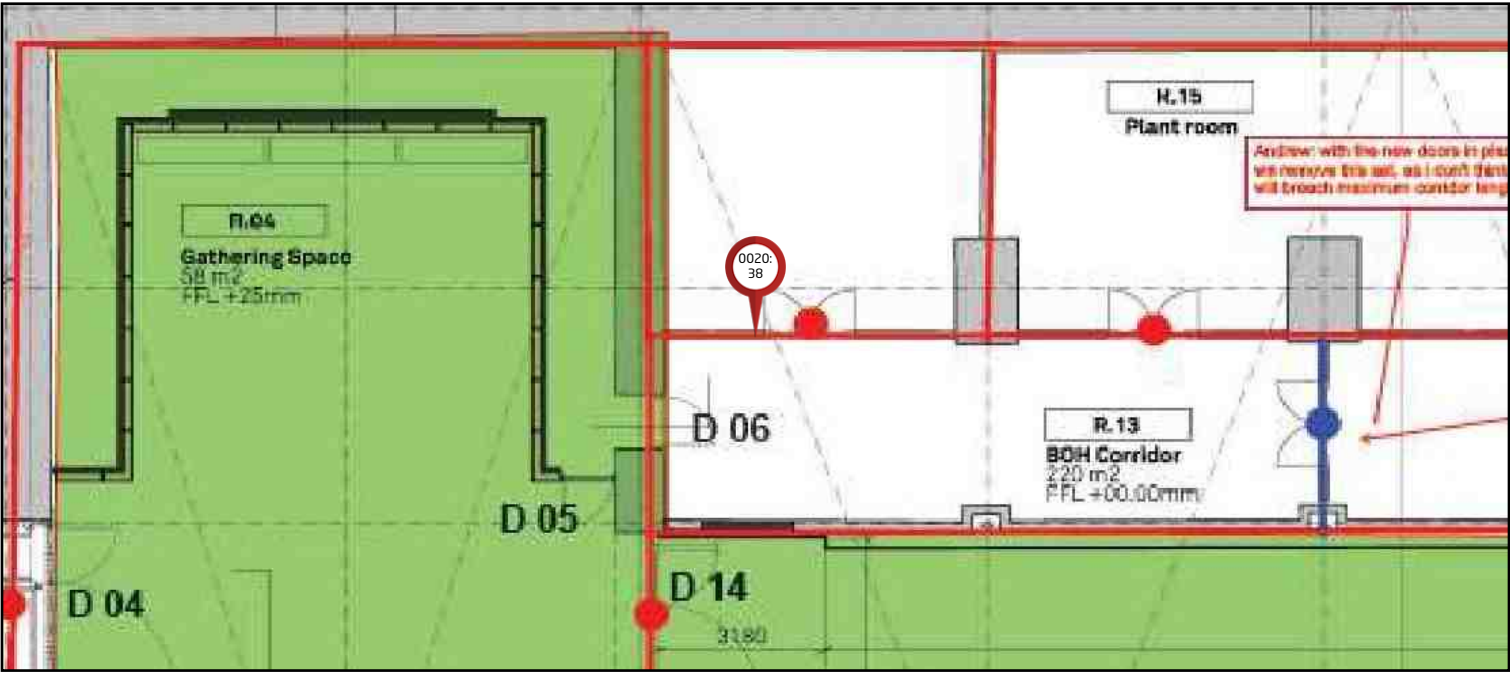
**Pin Number:** 0021:38

| Client/tag reference: | LL488 |
| Metal Conduit | |
| Breach identified: | Conduit |
| Fire rating: | 60 minutes (not suitable if > 11m to top floor above ground) |
| Substrate: | Concrete / Brick / Block |
| Dim Y - Height (mm): | 30 |
| Dim X - Width (mm): | 30 |
| Priority: | Red |

| Installation type: | SD-128-RDW |
| Once back sealed | |

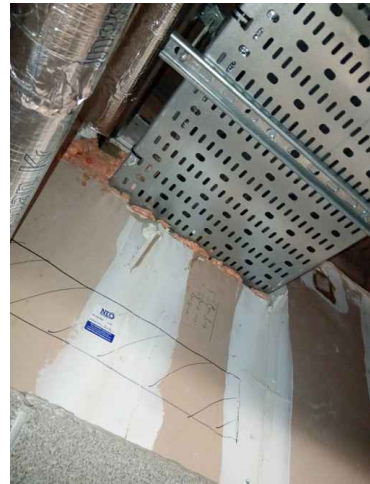
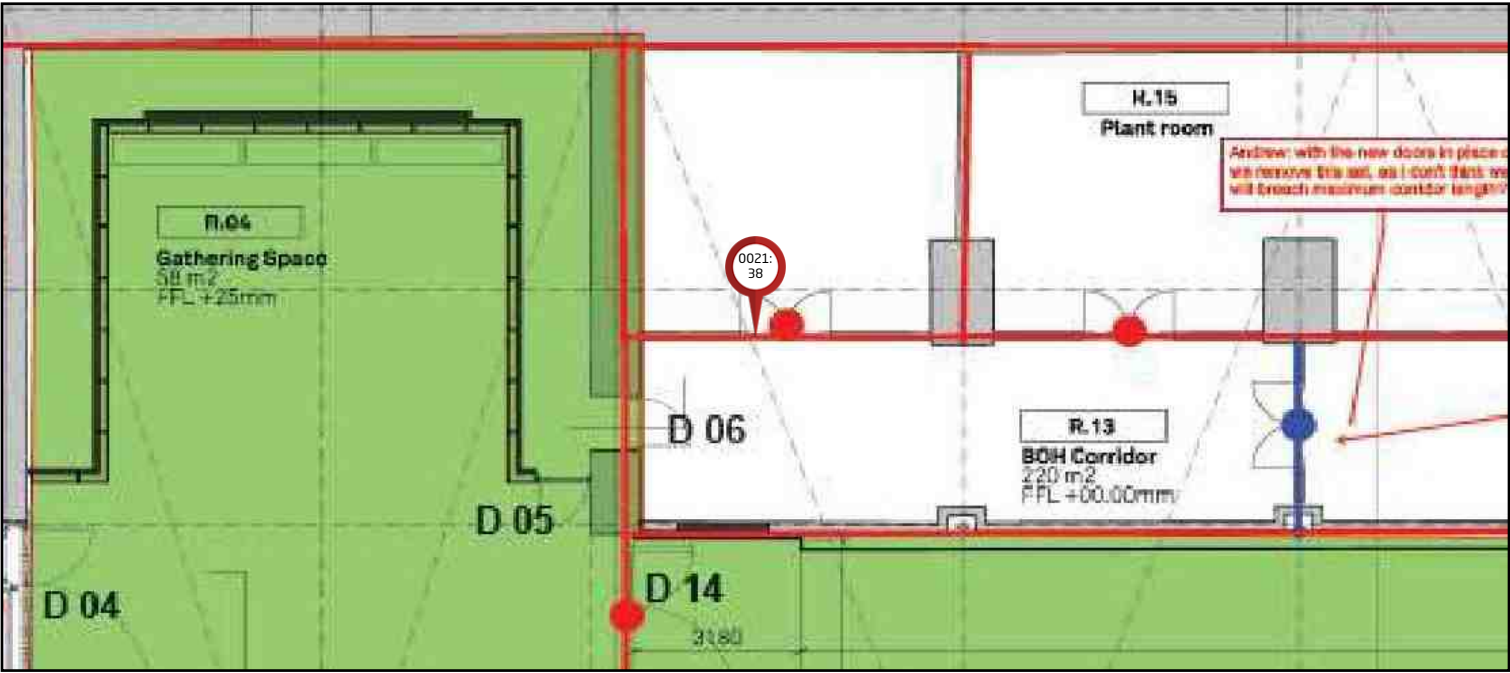
**Pin Number:** 0022:38

| Client/tag reference: | LL489 |
| Cable tray with lagged pipes above | |
| Breach identified: | Insulated metal pipes x 2, Cable Tray |
| Fire rating: | 60 minutes (not suitable if > 11m to top floor above ground) |
| Substrate: | Drywall |
| Dim Y - Height (mm): | 300 |
| Dim X - Width (mm): | 600 |
| Priority: | Red |

| Installation type: | SD-190-RDW |
| Pipes will need wrapping | |
| Allow for the same seal on the opposite side of the wall | |

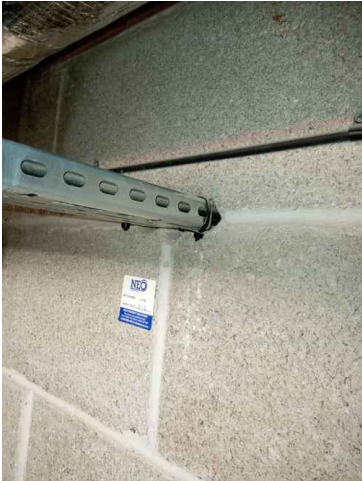
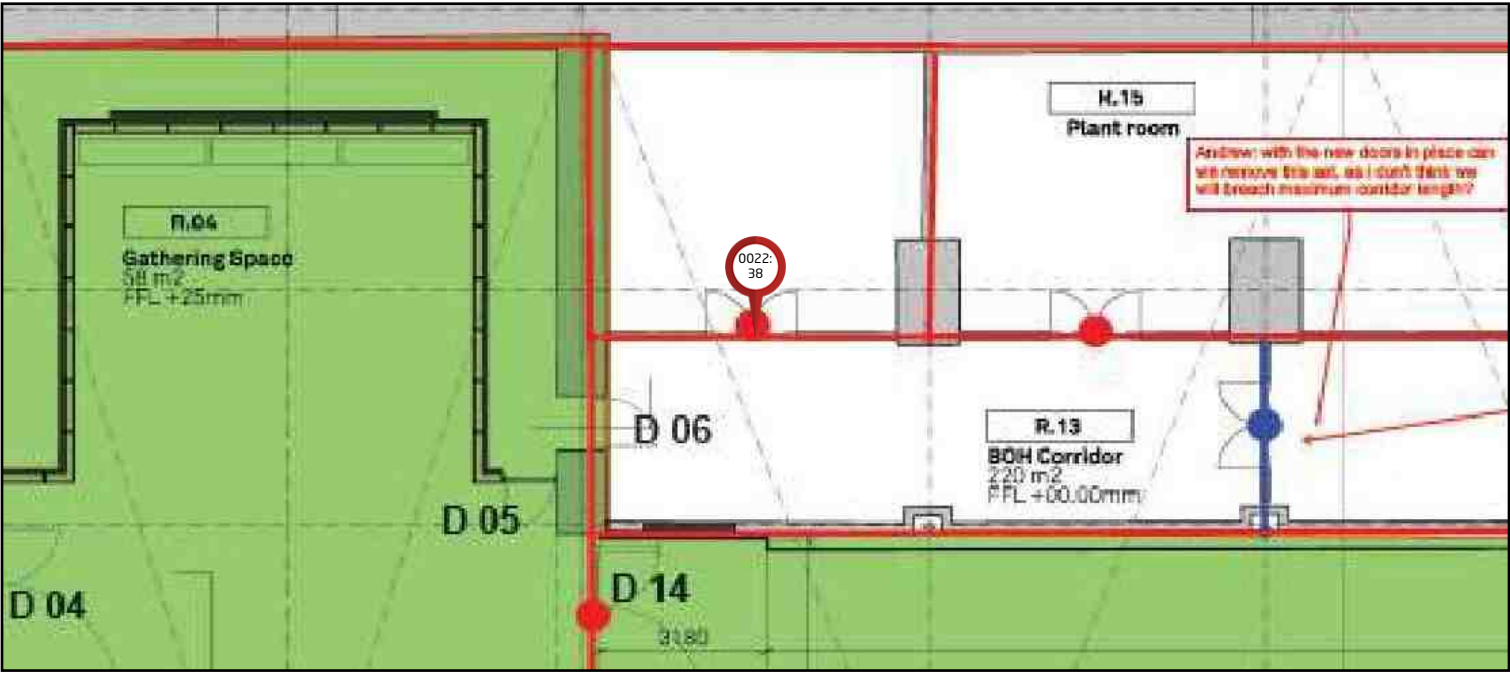
**Pin Number:** 0023:38

| Survey | |
|---|---|
| Client/tag reference: | LL490 |
| Cable tray | |
| Breach identified: | Cable Tray |
| Fire rating: | 60 minutes (not suitable if > 11m to top floor above ground) |
| Substrate: | Concrete / Brick / Block |
| Dim Y - Height (mm): | 30 |
| Dim X - Width (mm): | 110 |
| Priority: | Red |

| Survey | |
|---|---|
| Installation type: | SD-128-RDW |
| Once back sealed | |

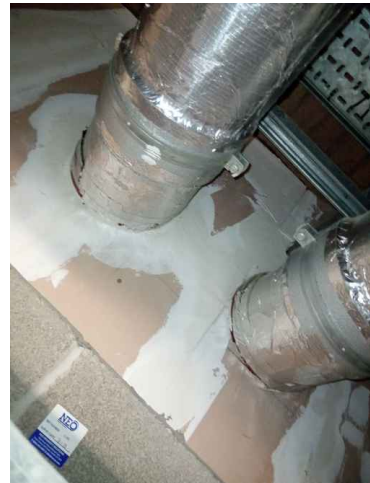
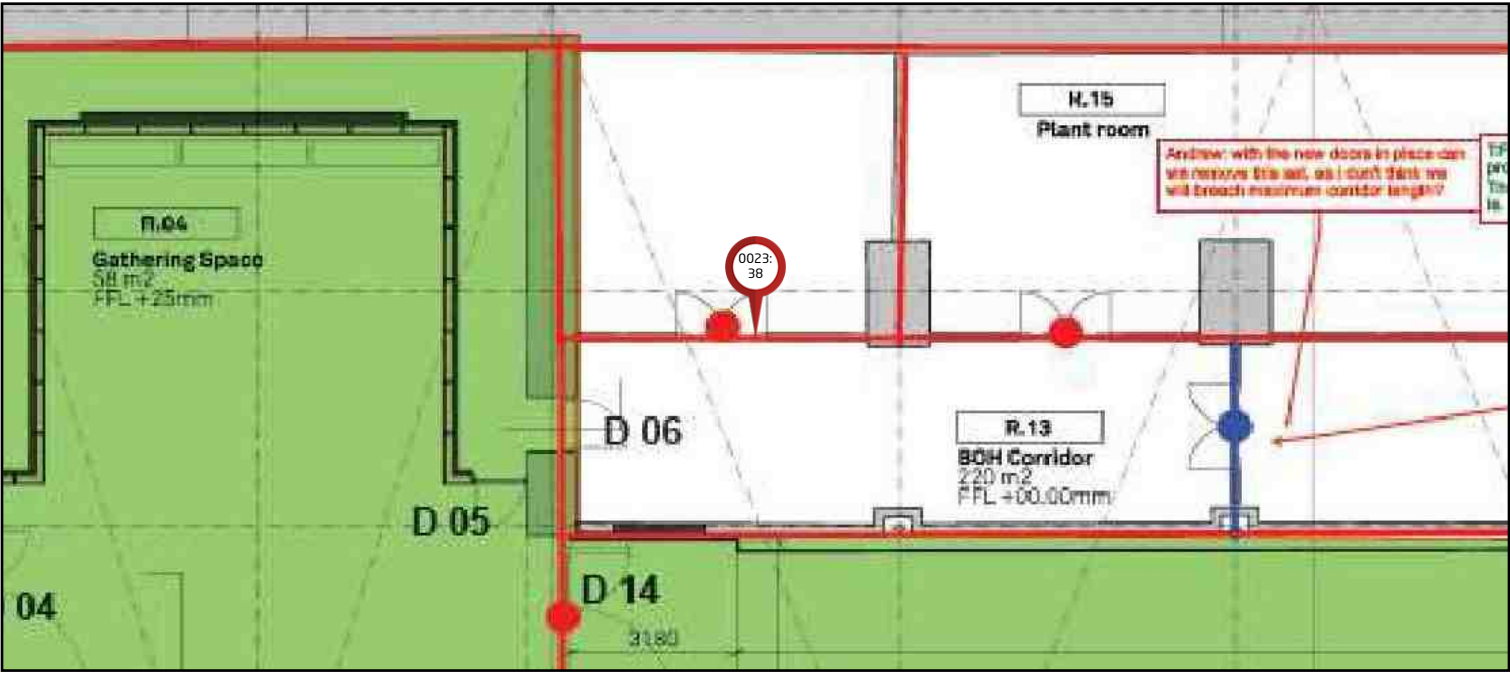
**Pin Number:** 0024:38

| Survey | |
|---|---|
| Client/tag reference: | LL491 |
| 200mm metal pipes | |
| Breach identified: | Pipe |
| Fire rating: | 60 minutes (not suitable if > 11m to top floor above ground) |
| Substrate: | Drywall |
| Dim Y - Height (mm): | 200 |
| Dim X - Width (mm): | 200 |
| Priority: | Red |

| Survey | |
|---|---|
| Installation type: | SD-128-RDW |
| Once back sealed | |

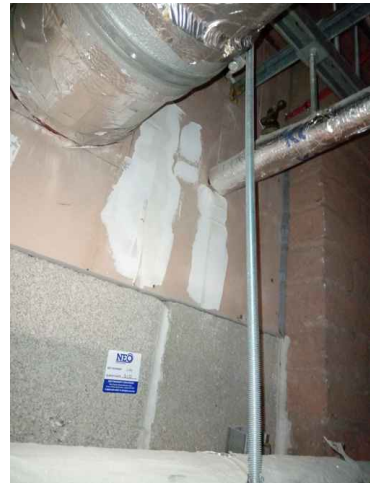
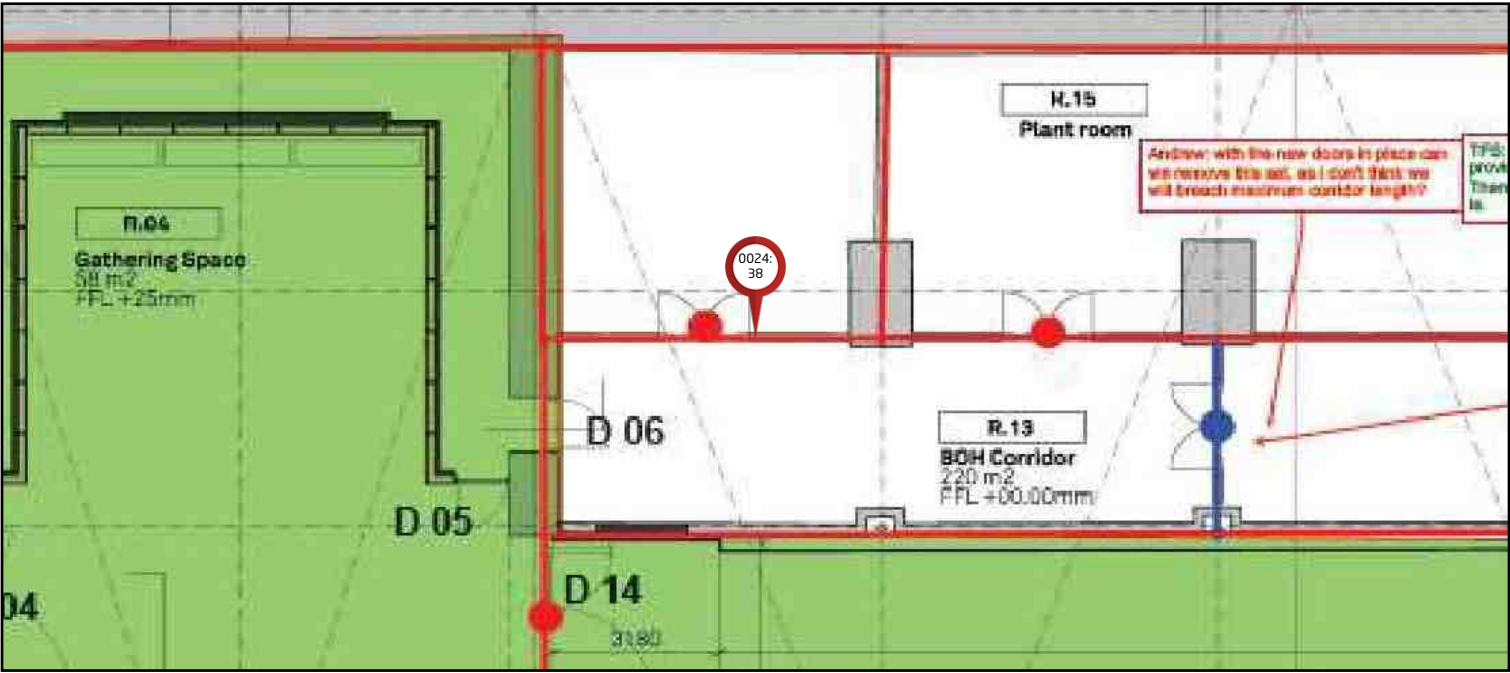
**Pin Number:** 0025:38

| Client/tag reference: | LL492 |

| Once back sealed | |

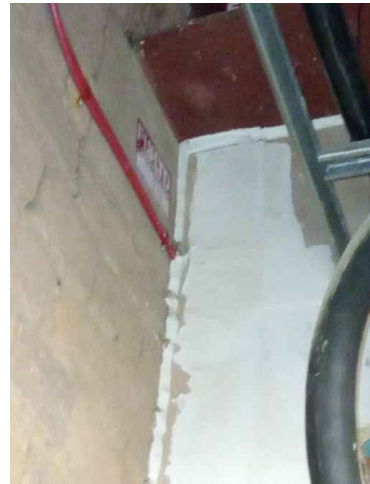
| Client/tag reference: | LL514 |

| Fire alarm cable | |
| Breach identified: | Cable |
| Fire rating: | 60 minutes (not suitable if > 11m to top floor above ground) |
| Substrate: | Drywall |
| Priority: | Red |

| Installation type: | SD-128-RDW |
| Once back sealed | |

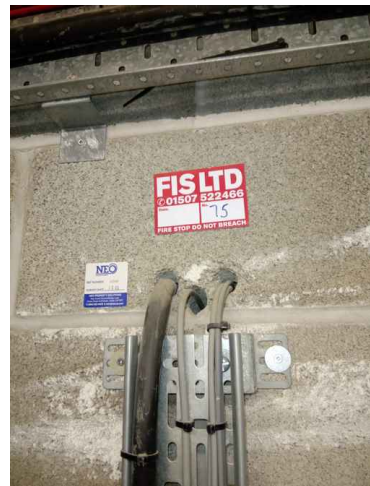
| Survey | |
|---|---|
| Client/tag reference: | LL516 |

| Survey | |
|---|---|
| X3 30mm cable bunches | |
| Breach identified: | Cable x 2 |
| Substrate: | Concrete / Brick / Block |
| Priority: | Red |

| Survey | |
|---|---|
| Installation type: | SD-128-RDW |
| Once back sealed | |

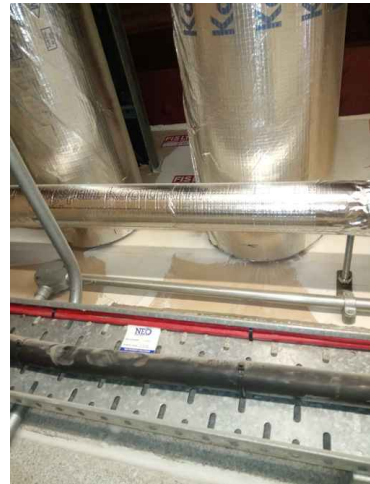
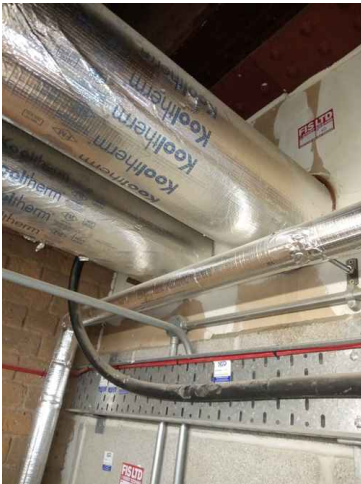
| Client/tag reference: | LL515 |

| X2 200mm lagged pipes. Lagging doesn't pass through wall | |
| Breach identified: | Insulated metal pipes x 2 |
| Substrate: | Concrete / Brick / Block |
| Priority: | Red |

| Installation type: | SD-128-RDW |
| Once back sealed | |

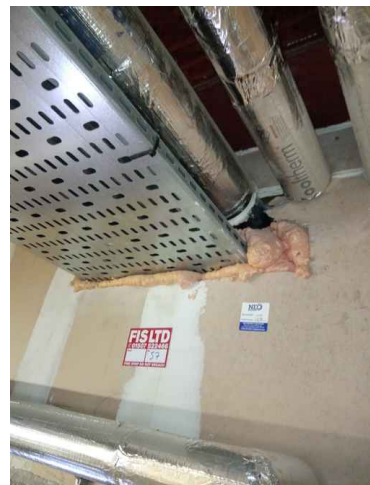
| Client/tag reference: | LL518 |

| Cable tray with X3 lagged pipes. | |
| Breach identified: | Cable Tray, Insulated metal pipes x 3 |
| Remove foam | |

| Installation type: | SD-190-RDW |
| Pipes will need wrapping. | |
| Allow for the seal on the opposite side of the wall so two in total | |

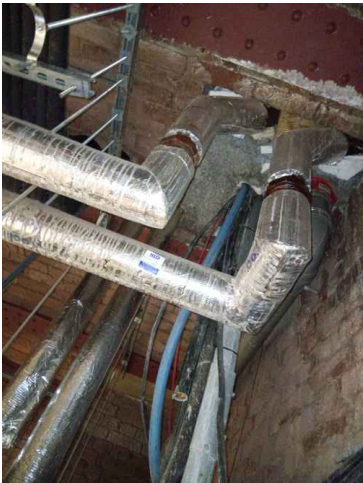
Survey  
2 of 2

| Plastic water pipe. Remove polystyrene | |
| Breach identified: | Plastic Pipe |
| Fire rating: | 60 minutes (not suitable if > 11m to top floor above ground) |
| Priority: | Red |

| Installation type: | SD-172-RDW |

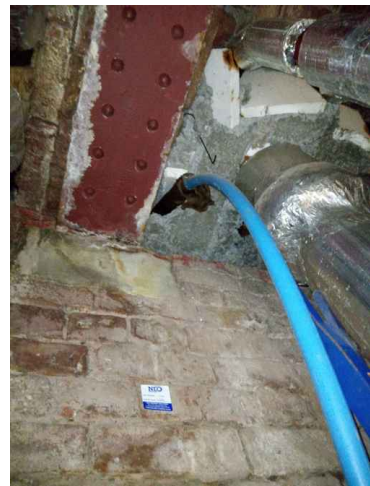
Survey  
1 of 1

| Survey | |
|---|---|
| Pipes through ceiling slab. Wood and polystyrene needs removing. | |
| Breach identified: | Insulated metal pipes, Multiple Services |
| Fire rating: | 60 minutes (not suitable if > 11m to top floor above ground) |
| Priority: | Red |

| Survey | |
|---|---|
| Installation type: | SD-128-RDW |

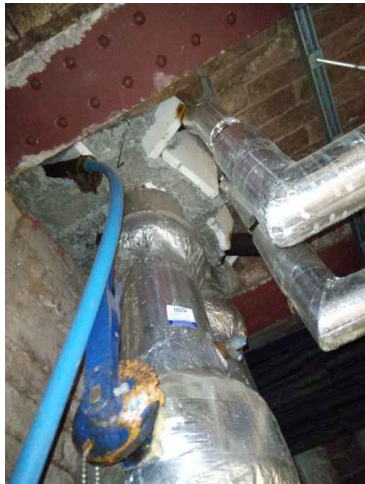
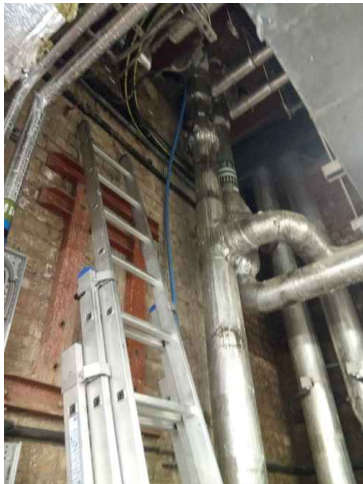
| Survey | |
|---|---|
| Armaflex cables through ceiling soffit | |
| Breach identified: | Multiple Services |
| Fire rating: | 60 minutes (not suitable if > 11m to top floor above ground) |
| Priority: | Red |

| Survey | |
|---|---|
| Installation type: | SD-123-RDW |

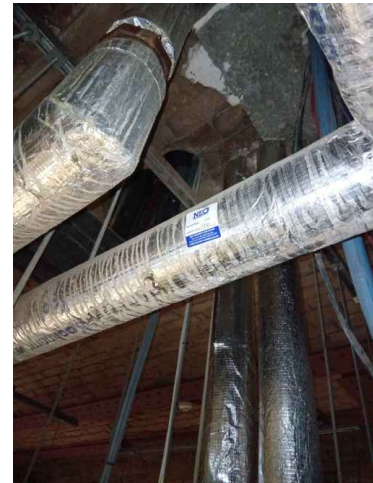
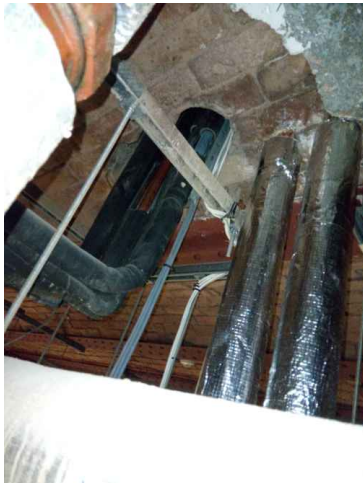
| Survey | |
|---|---|
| Armaflex pipes through brickwork. | |
| Breach identified: | Multiple Services |
| Fire rating: | 60 minutes (not suitable if > 11m to top floor above ground) |
| Priority: | Red |

| Survey | |
|---|---|
| Installation type: | SD-122-RDW |

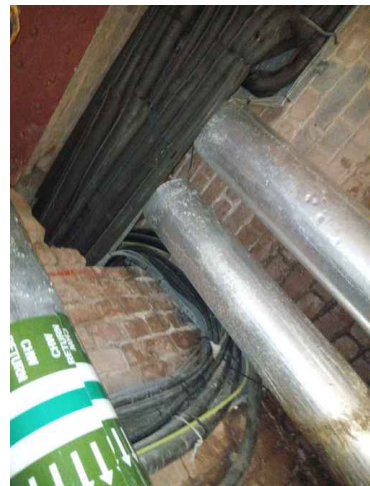
Survey  
1 of 1

| X2 30mm copper pipes. | |
| Breach identified: | Pipe x 2 |
| Fire rating: | 60 minutes (not suitable if > 11m to top floor above ground) |
| Priority: | Red |

| Installation type: | SD-128-RDW |
| Once back sealed | |

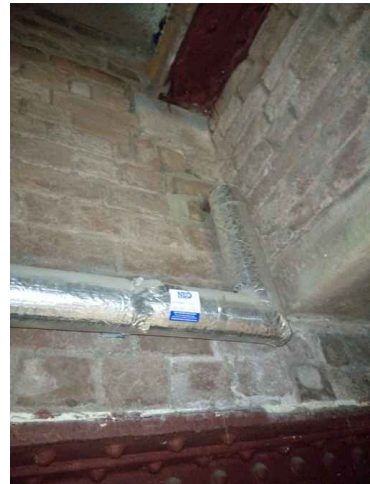
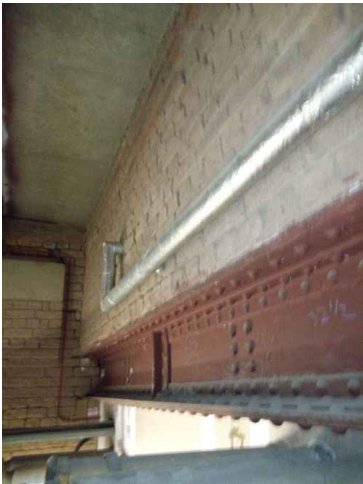
| Survey | |
|---|---|
| Metal trunking | |
| Breach identified: | Trunking |
| Fire rating: | 60 minutes (not suitable if > 11m to top floor above ground) |
| Priority: | Red |

| Survey | |
|---|---|
| RWSD-ACB-0104 | |

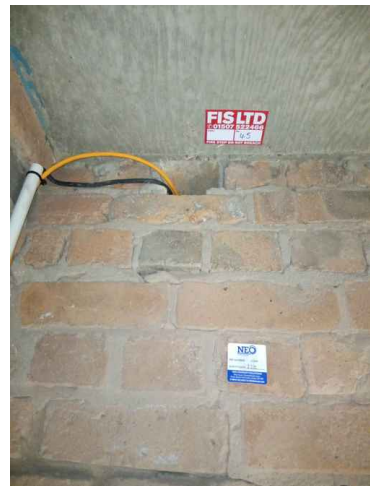
Survey  
1 of 1

| Cables in hole in brickwork. | |
| Breach identified: | Cable, Hole |
| Fire rating: | 60 minutes (not suitable if > 11m to top floor above ground) |
| Dim Y - Height (mm): | 60 |
| Dim X - Width (mm): | 120 |
| Priority: | Red |

| Installation type: | SD-128-RDW |
| Once back sealed | |

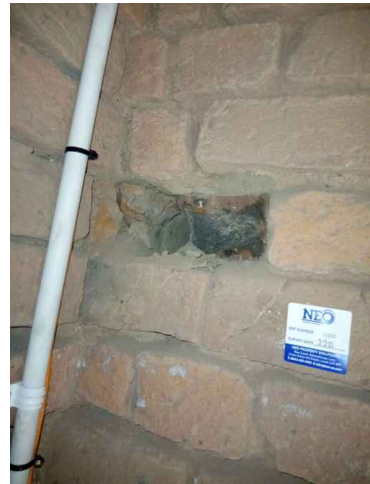
Survey  
1 of 1

| Survey | |
|---|---|
| Hole in bricks | |
| Breach identified: | Hole |
| Dim Y - Height (mm): | 60 |
| Dim X - Width (mm): | 60 |
| Priority: | Red |

| Survey | |
|---|---|
| Installation type: | SD-128-RDW |
| Once back sealed | |

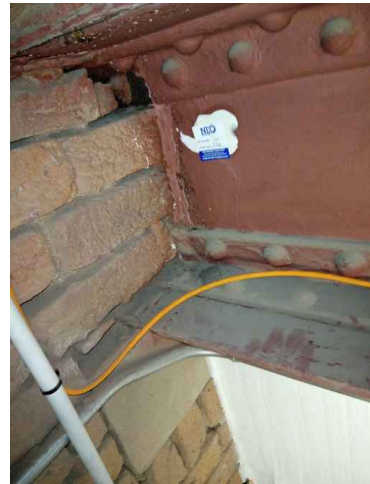
Survey  
1 of 1

| Survey | |
|---|---|
| Steel beam | |
| Breach identified: | Beam |
| Dim Y - Height (mm): | 400 |
| Dim X - Width (mm): | 20 |
| Priority: | Red |

| Survey | |
|---|---|
| Installation type: | RWSD-AIS-0001 |
| Allow for the same seal to be installed on the opposite side of the wall | |

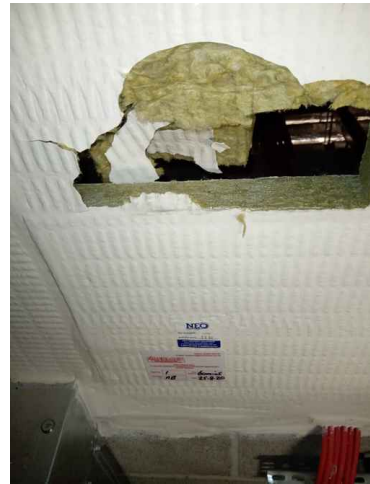
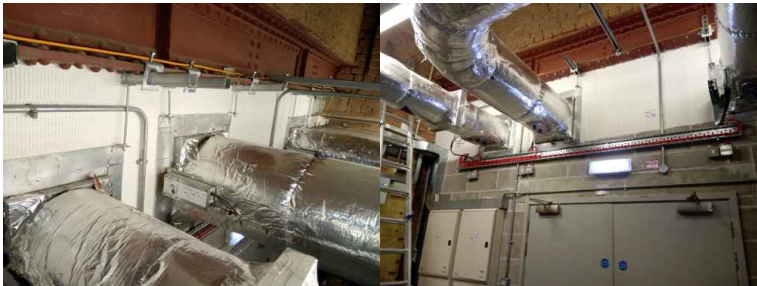
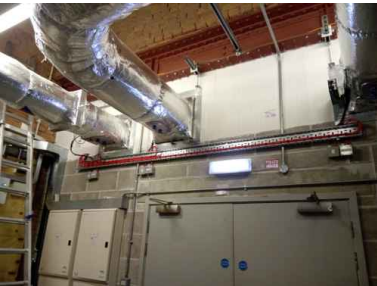
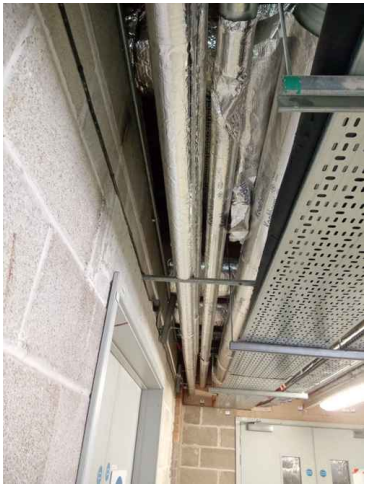
| Survey | |
|---|---|
| Exisiting battwork needs removing as dry fitted. See photos. X3 dampers and multiple services. | |
| Breach identified: | Damper x 3, Multiple Services |
| Dim Y - Height (mm): | 4400 |
| Dim X - Width (mm): | 750 |
| Priority: | Red |

| Survey | |
|---|---|
| Remove existing battwork. | |
| Installation type: | SD-145-RDW |
| Single side install as cannot access corridor side due to services overhead. See photos. | |

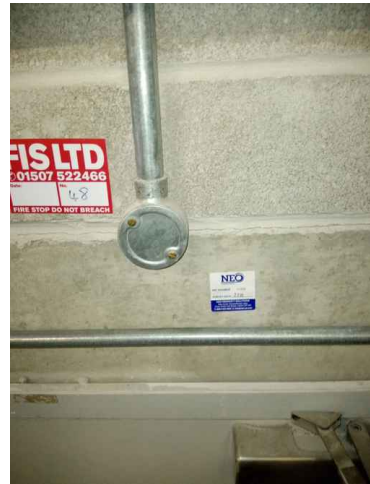
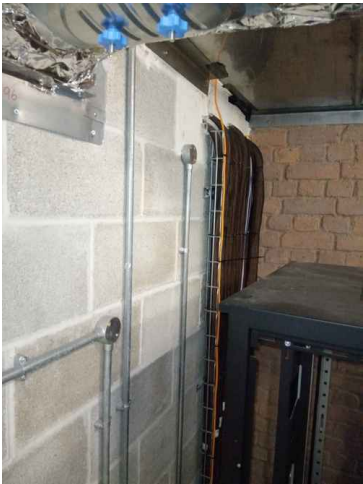
| Metal conduit x3 | |
| Breach identified: | Conduit x 3 |
| Quantity : | 3 |

| Installation type: | SD-128-RDW |
| Once back sealed | |

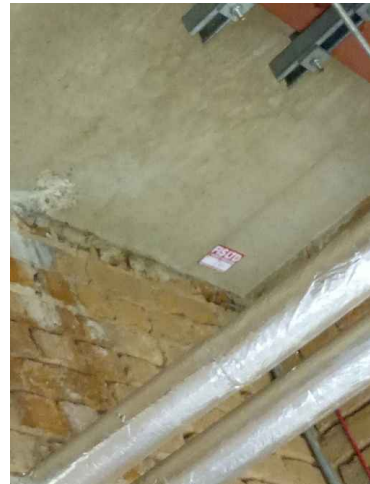
Survey  
1 of 2

| 20mm cable | |
| Breach identified: | Cable |
| Priority: | Red |

| Installation type: | SD-128-RDW |
| Once back sealed | |

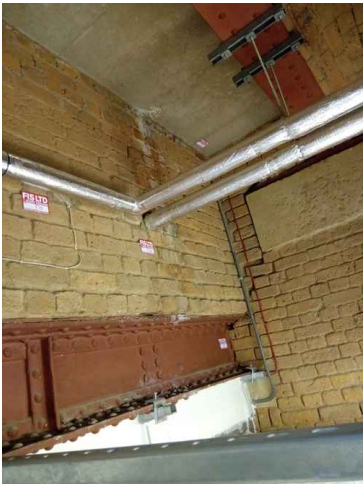
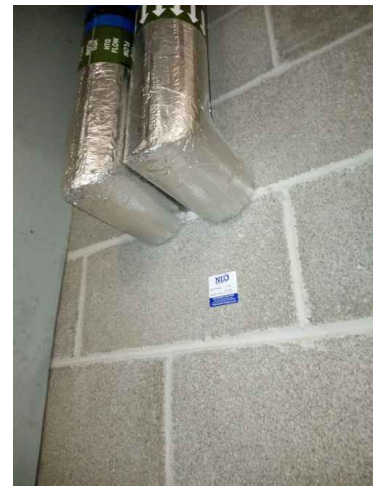
Survey  
2 of 2

| Survey | |
|---|---|
| 80mm pipes | |
| Priority: | Red |

| Survey | |
|---|---|
| Pull lagging back and seal to blockwork. | |
| Installation type: | SD-128-RDW |
| Once back sealed | |

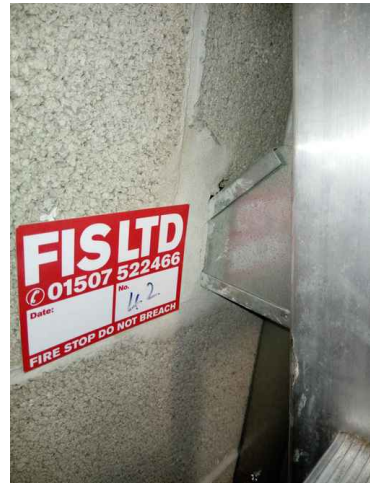
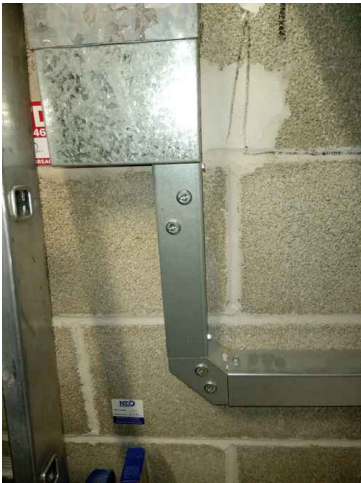
Survey  
1 of 2

| Metal trunking | |
| Breach identified: | Trunking |
| Priority: | Red |

| RWSD-ACB-0104 | |

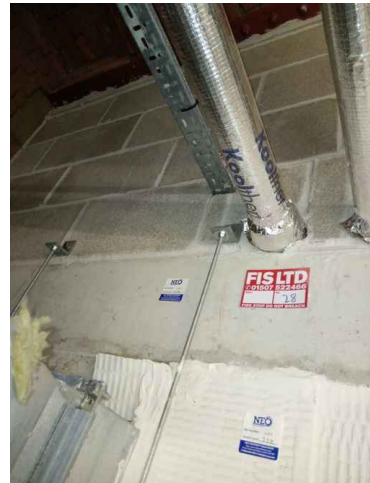
Survey  
1 of 1

| Survey | |
|---|---|
| Cable tray | |
| Breach identified: | Cable Tray |
| Priority: | Red |

| Survey | |
|---|---|
| Installation type: | SD-128-RDW |
| Once back sealed | |
