## Museum of Science & Industry

### Fire Compartmentation Survey Report

Proposed Basement

## **Fire Stopping Report**

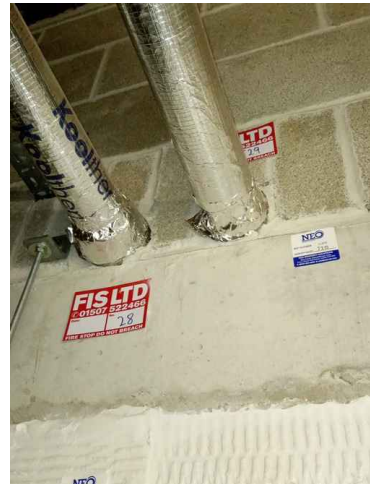
| X2 80mm lagged pipes. Lagging continues through wall | |
| Breach identified: | Insulated metal pipes x 2 |

| Installation type: | SD-191-RDW |
| Ensure to use the same seal on the other side of the wall so 4 number total | |

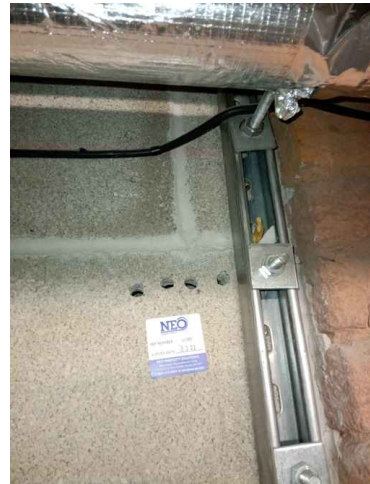
**Pin Number:** 0107:38  
**Company:** Neo Property Solutions  
**Contractor:** Matthew Brown - 38

| Survey | |
|---|---|
| Void in block. Remove existing battwork as not fitted to specifications. Single sided install as other side of block wall is gallery, and cannot access due to exhibitions. | |
| Breach identified: | Duct |
| Priority: | Red |

| Survey | |
|---|---|
| Installation type: | SD-145-RDW |
| Will need to be single side install as the gallery is other side of wall and cannot access due to exhibitions. | |

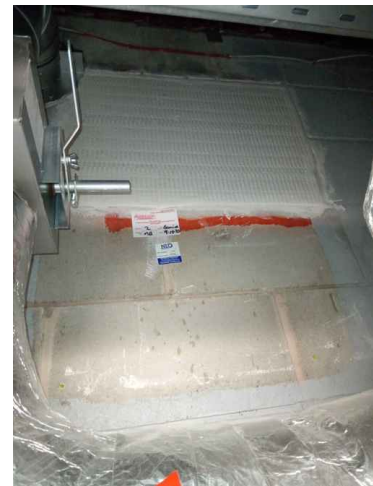
Survey  
1 of 1

| Survey | |
|---|---|
| Dampers. Has firebatt installed but can see dryfitted so needs removing and installing to specifications. In order to do this you will need access from the gallery side but a dressing wall is there currently. | |
| Breach identified: | Damper x 5 |
| Priority: | Red |

| Survey | |
|---|---|
| Installation type: | RWSD-AIS-0001 |

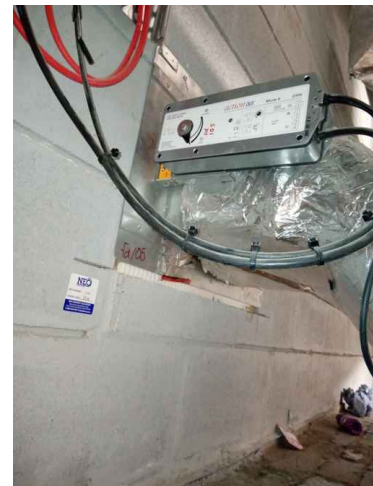
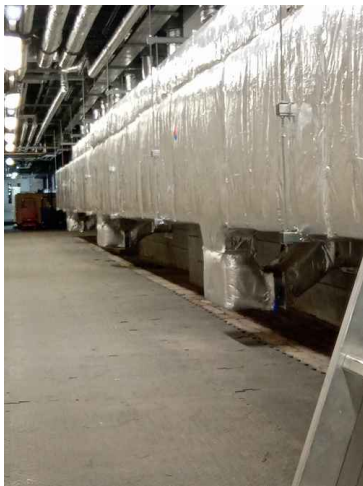
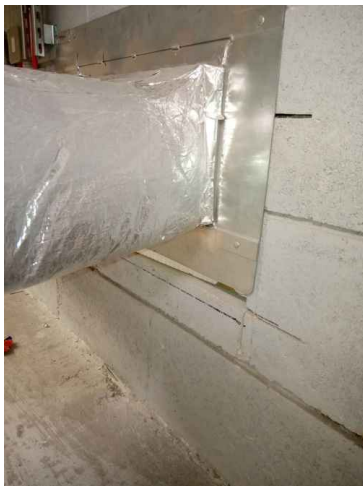
**Pin Number:** 0109:38

| Void in blockwork. Single sided install or needs access from gallery side. | |
| Breach identified: | Hole |
| Priority: | Red |

| Installation type: | SD-145-RDW |

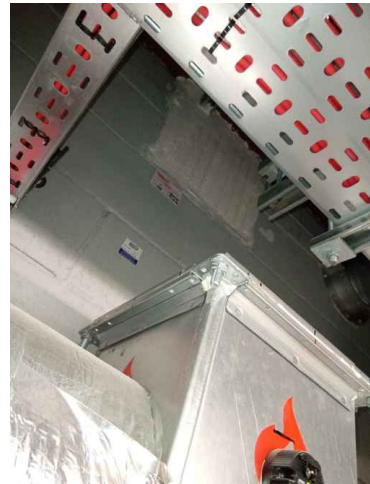
**Pin Number:** 0110:38  
**Company:** Neo Property Solutions  
**Contractor:** Tony Narkevicius - 30

| Survey | |
|---|---|
| Door frame. | |
| Breach identified: | Other, Joint |
| Remove existing dry fitted batt | |
| Priority: | Red |

| Survey | |
|---|---|
| Installation type: | SD-122-RDW |

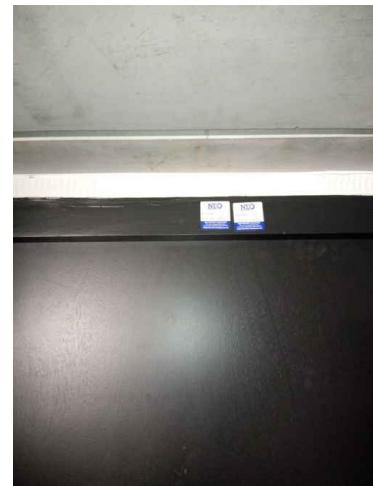
**Pin Number:** 0111:38  
**Company:** Neo Property Solutions  
**Contractor:** Matthew Brown - 38

| Survey | |
|---|---|
| Vertical door frame gap. Both sides of door | |
| Breach identified: | Joint |
| Priority: | Red |

| Survey | |
|---|---|
| Installation type: | RWSD-AIS-0001 |
| Both sides of door frame. | |

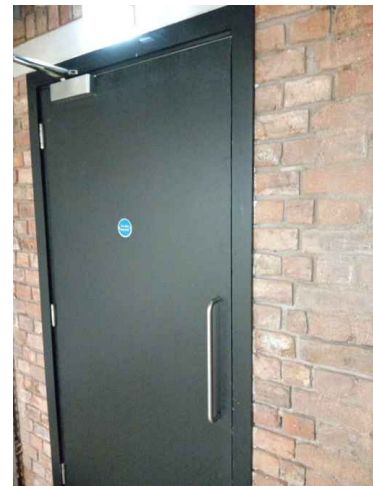
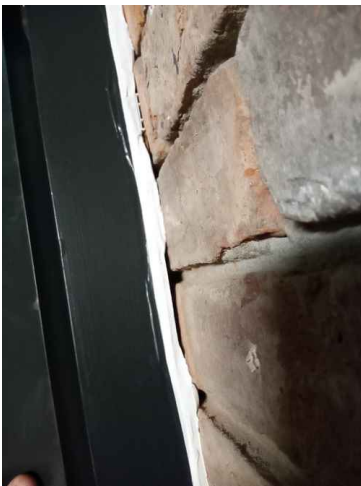
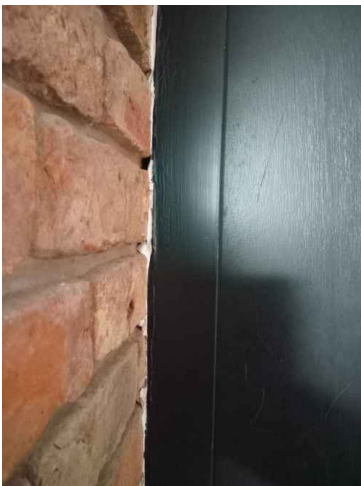
**Pin Number:** 0112:38  
**Company:** Neo Property Solutions  
**Contractor:** Matthew Brown - 38

| Survey | |
|---|---|
| Doorframe needs sealing corridor side and inside. | |
| Breach identified: | Joint |
| Priority: | Red |

| Survey | |
|---|---|
| Installation type: | RWSD-AIS-0001 |

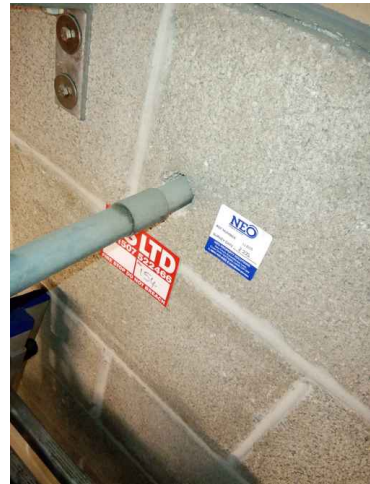
Survey  
1 of 1

| 30mm metal conduit | |
| Breach identified: | Conduit |
| Fire rating: | 60 minutes (not suitable if > 11m to top floor above ground) |
| Priority: | Red |

| Installation type: | SD-128-RDW |
| Once back sealed | |

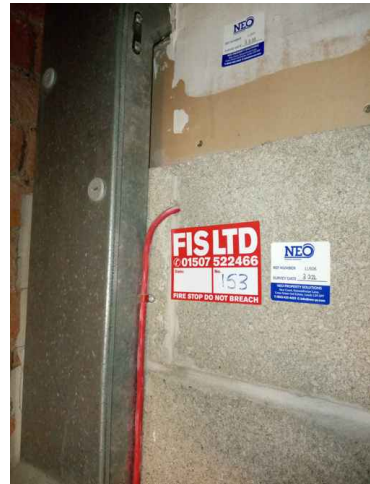
Survey  
1 of 1

| Survey | |
|---|---|
| Fire alarm cable | |
| <b>Breach identified:</b> | Cable |
| <b>Fire rating:</b> | 60 minutes (not suitable if > 11m to top floor above ground) |
| <b>Priority:</b> | Red |

| Survey | |
|---|---|
| <b>Installation type:</b> | SD-128-RDW |
| Once back sealed | |

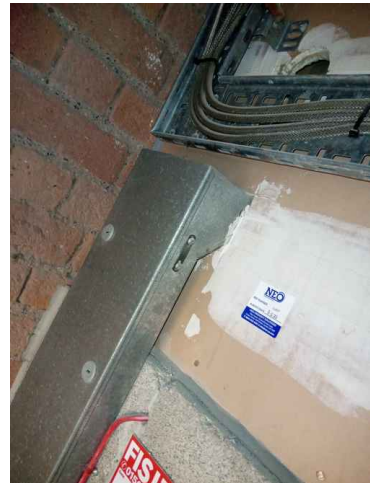
Survey  
1 of 1

| Metal trunking | |
| Breach identified: | Trunking |
| Fire rating: | 60 minutes (not suitable if > 11m to top floor above ground) |
| Priority: | Red |

| RWSD-ACB-0104 | |

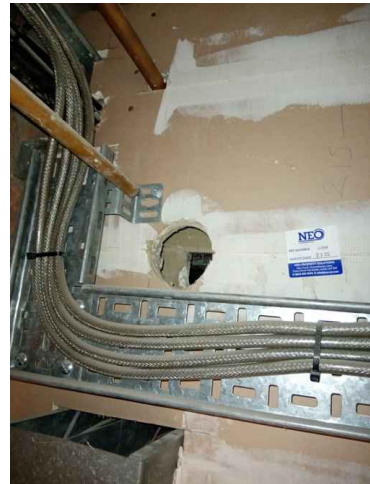
Survey  
1 of 1

| Hole in drywall | |
| Breach identified: | Hole |
| Fire rating: | 60 minutes (not suitable if > 11m to top floor above ground) |
| Priority: | Red |

| Installation type: | SD-122-RDW |
| The aperture needs to be framed and lined using fire rated plasterboard as per white book then install the SD-122-RDW so allow for the frame and lining of the aperture | |

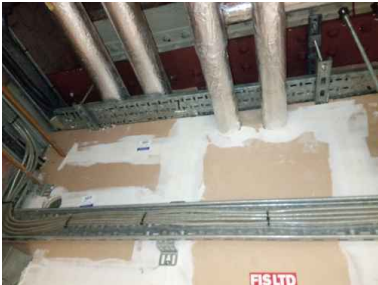
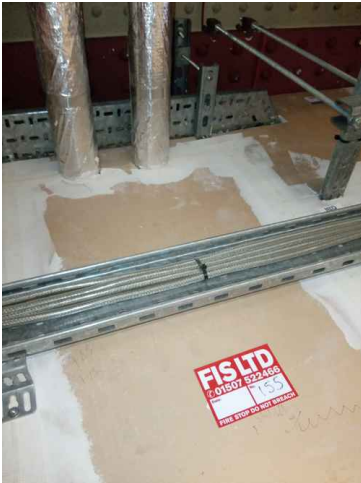
| Survey | |
|---|---|
| Cable tray with X4 lagged pipes. Needs facefixing. | |
| Breach identified: | Multiple Services, Cable Tray, Insulated metal pipes x 4 |
| Fire rating: | 60 minutes (not suitable if > 11m to top floor above ground) |

| Survey | |
|---|---|
| Installation type: | SD-191-RDW |

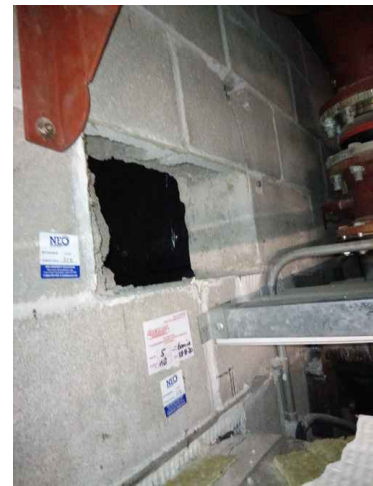
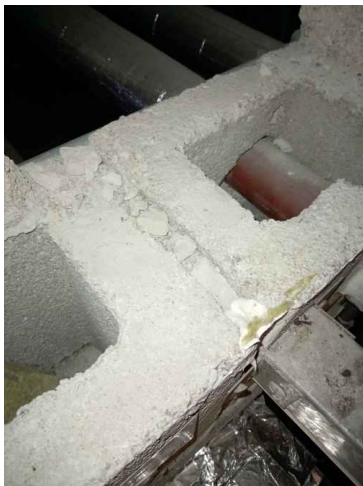
| Survey | |
|---|---|
| Block missing in wall. Will need SD-112-RDW installing both sides of wall to face of block. Blocks are hollow. | |

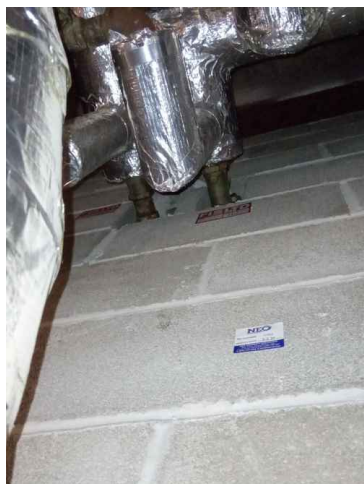
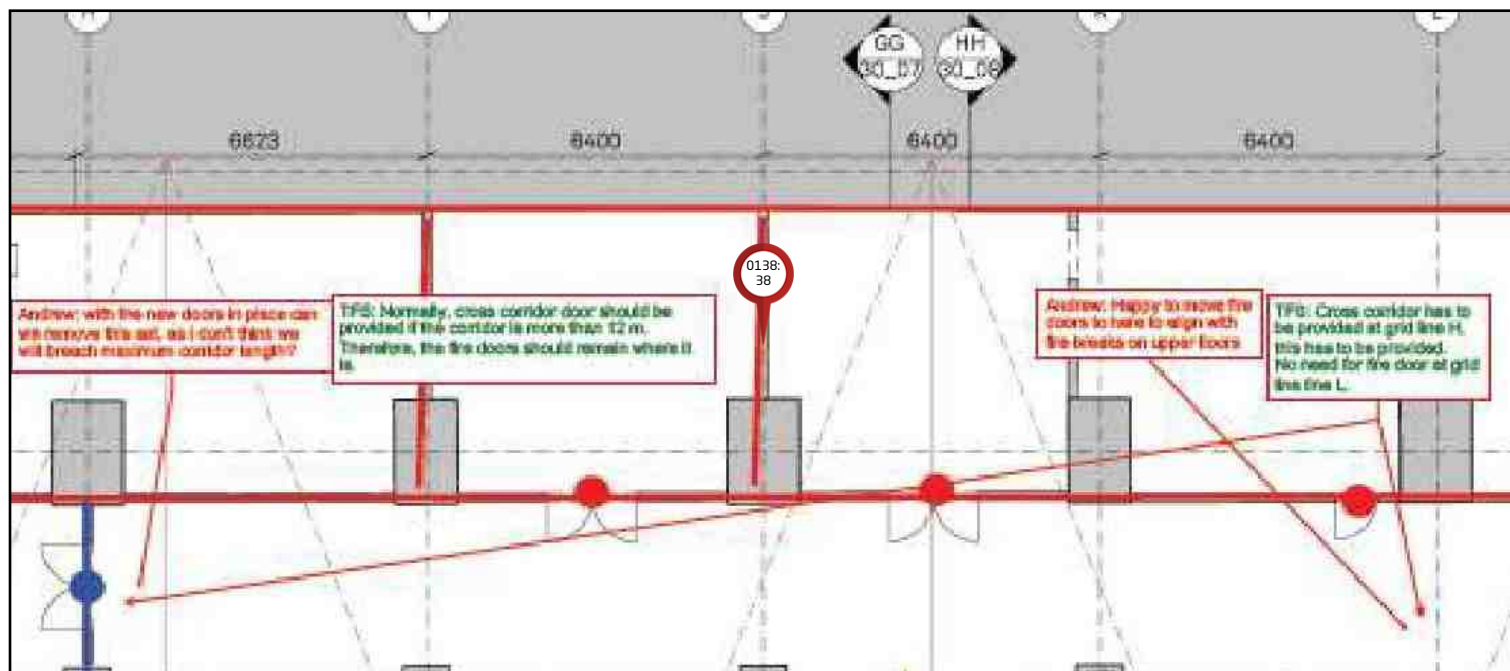
**Pin Number:** 0139:38

| Pipe in hole in block. Seal both sides. | |
| Breach identified: | Pipe, Hole |
| Priority: | Red |

| Installation type: | SD-112-RDW |
| One for each side of the wall | |

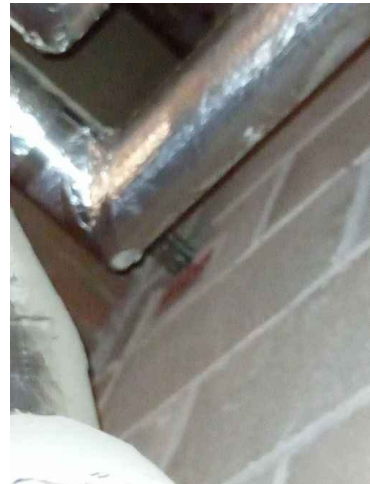
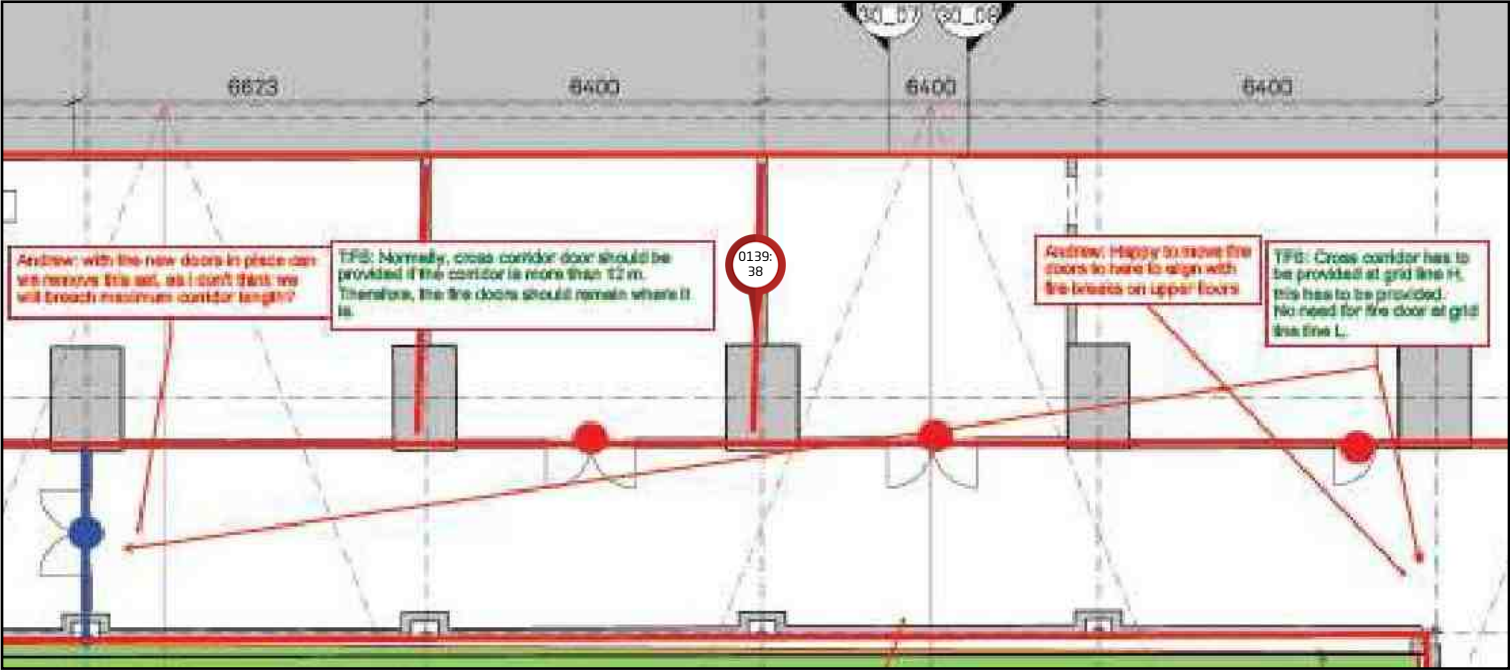
**Pin Number:** 0140:38

| Survey | |
|---|---|
| Trunking | |
| Breach identified: | Trunking |
| Priority: | Red |

| Survey | |
|---|---|
| RWSD-ACB-0104 | |

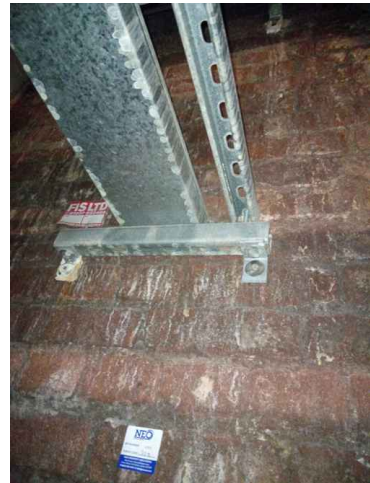
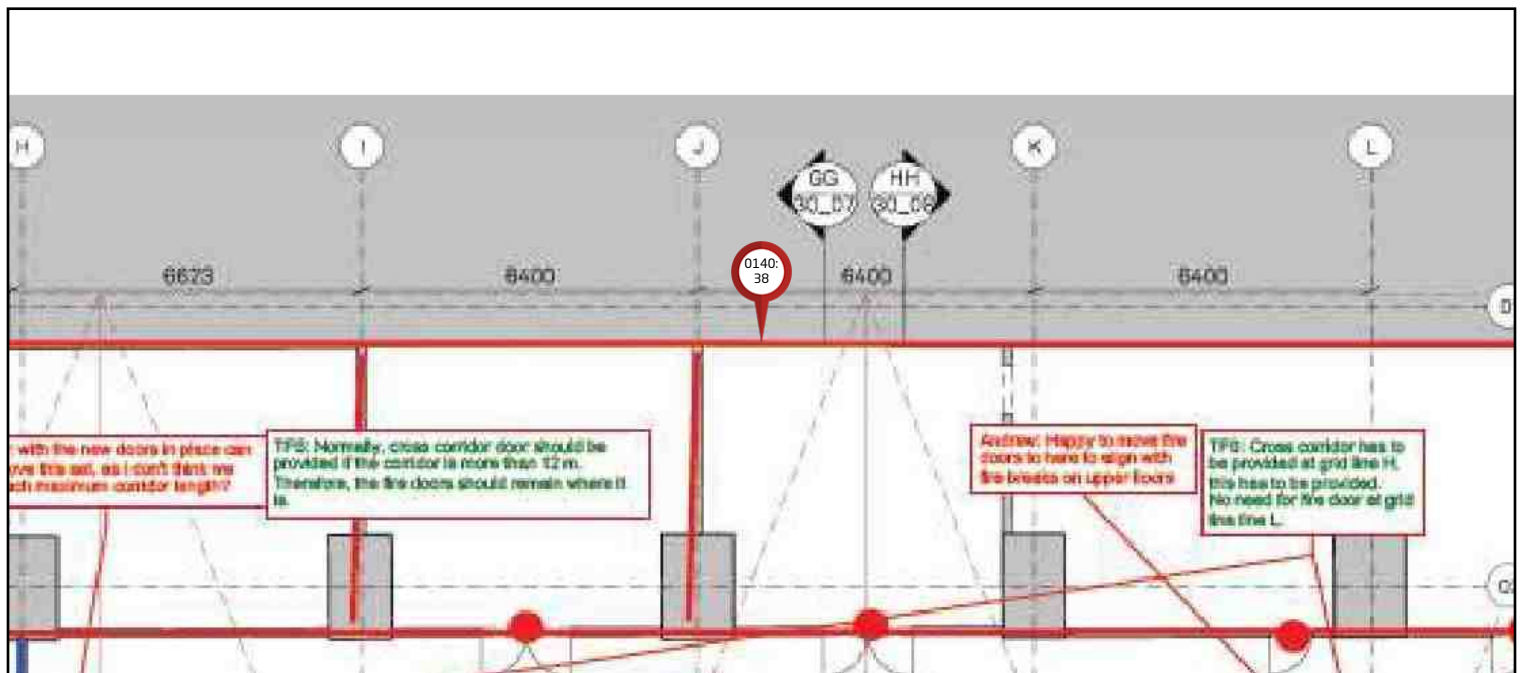
**Pin Number:** 0141:38  
**Company:** Neo Property Solutions  
**Contractor:** Tony Narkevicius - 30

| Survey | |
|---|---|
| Hole in block | |
| Breach identified: | Hole |
| Priority: | Red |

| Survey | |
|---|---|
| Installation type: | SD-128-RDW |

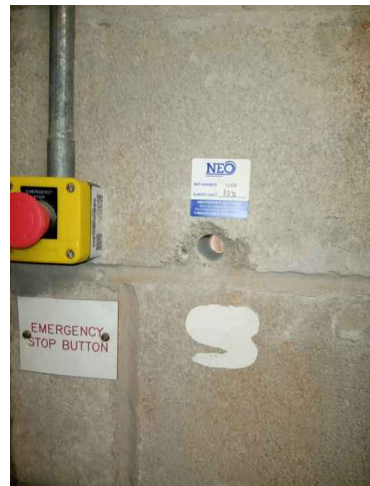
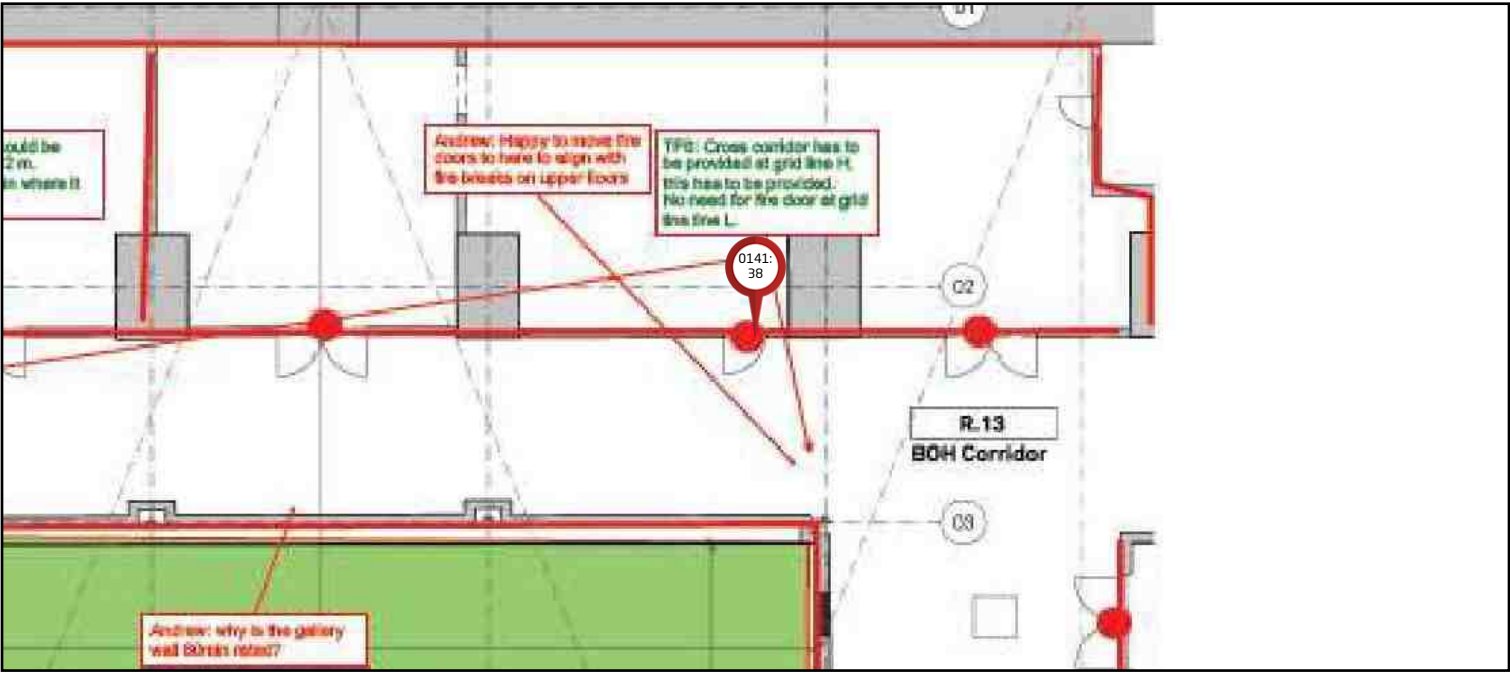
**Pin Number:** 0142:38

| Doorframe. Seal both sides of wall | |
| Breach identified: | Joint |
| Priority: | Red |

| Installation type: | RWSD-AIS-0001 |

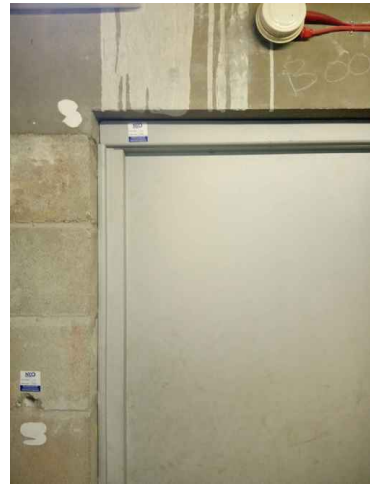
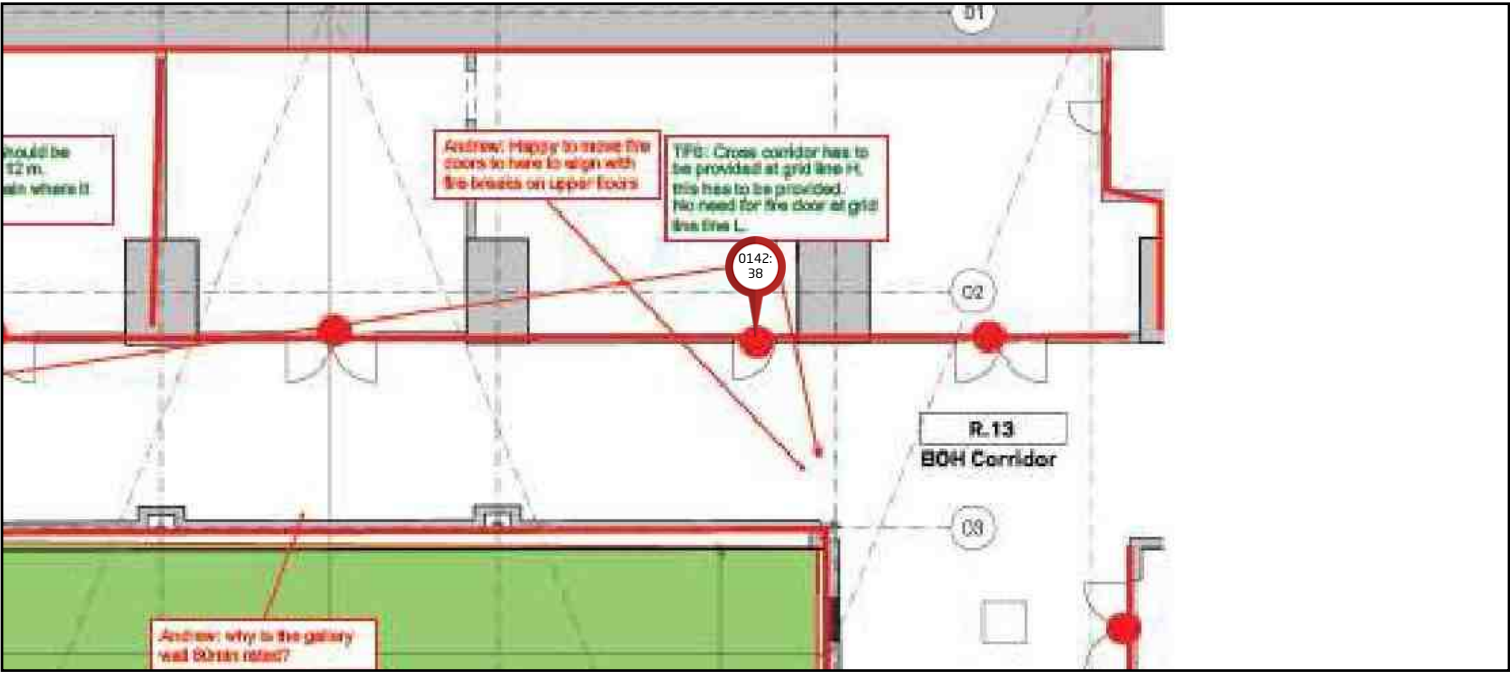
**Pin Number:** 0143:38

| Survey | |
|---|---|
| Hole in block. Scrape out foam | |
| Breach identified: | Hole |

| Survey | |
|---|---|
| Installation type: | SD-128-RDW |

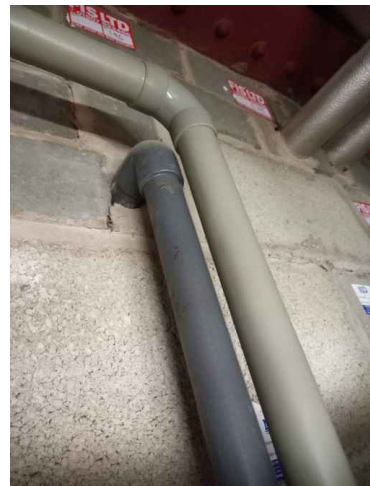
**Pin Number:** 0157:38

| 40mm plastic pipe | |
| Breach identified: | Plastic Pipe |
| Fire rating: | 60 minutes (not suitable if > 11m to top floor above ground) |
| Priority: | Red |

| Installation type: | SD-179-RDW |
| Once back sealed | |

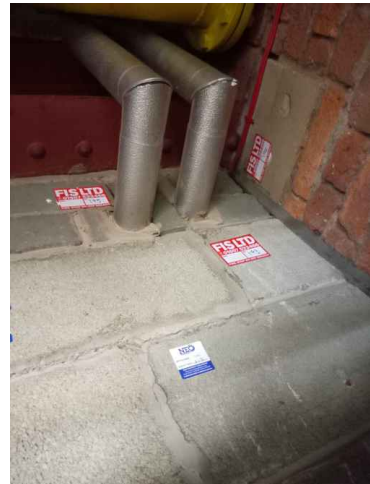
**Pin Number:** 0158:38

| X2 80mm lagged pipes | |
| Breach identified: | Insulated metal pipes x 2 |
| Fire rating: | 60 minutes (not suitable if > 11m to top floor above ground) |
| Priority: | Red |

| Installation type: | SD-128-RDW |
| Once back sealed | |

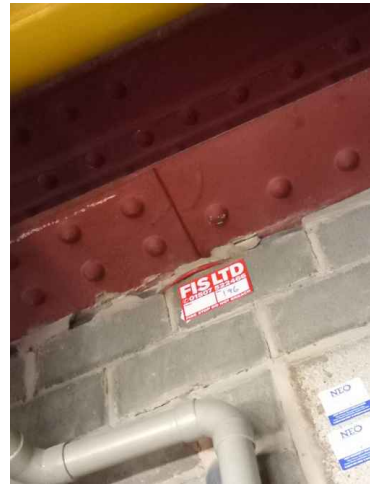
**Pin Number:** 0159:38

| Survey | |
|---|---|
| Head of wall/ fire alarm cable | |
| Breach identified: | Head of wall, Cable |
| Fire rating: | 60 minutes (not suitable if > 11m to top floor above ground) |
| Priority: | Red |

| Survey | |
|---|---|
| Installation type: | RWSD-AIS-0001 |

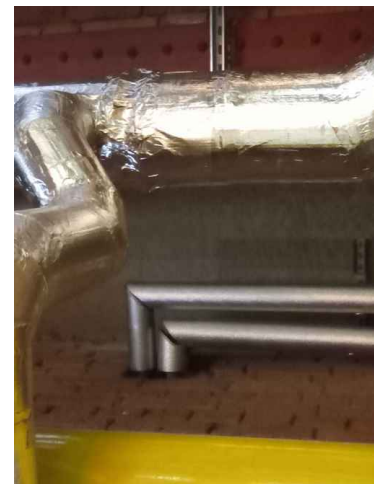
**Pin Number:** 0160:38  
**Company:** Neo Property Solutions  
**Contractor:** Matthew Brown - 38

| Survey | |
|---|---|
| High level pipes going through brickwork. | |
| <b>Breach identified:</b> | Pipe x 2 |
| <b>Fire rating:</b> | 60 minutes (not suitable if > 11m to top floor above ground) |
| <b>Priority:</b> | Red |

| Survey | |
|---|---|
| <b>Installation type:</b> | SD-145-RDW |
| Cannot access from other side of wall. | |

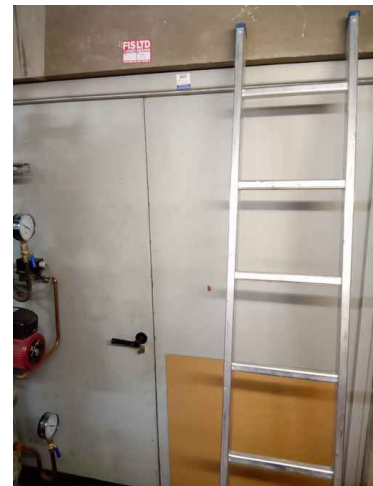
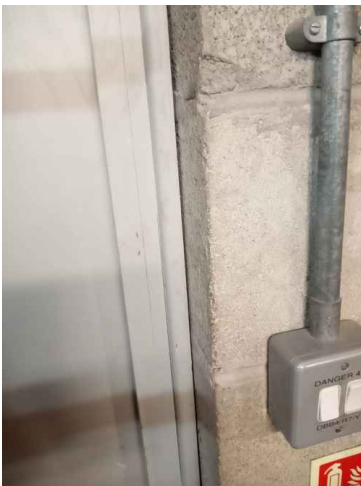
**Pin Number:** 0161:38  
**Company:** Neo Property Solutions  
**Contractor:** Matthew Brown - 38

| Survey | |
|---|---|
| Doorframe needs sealing. | |
| Breach identified: | Joint |
| Fire rating: | 60 minutes (not suitable if > 11m to top floor above ground) |
| Priority: | Red |

| Survey | |
|---|---|
| Installation type: | RWSD-AIS-0001 |
| Seal both sides of wall | |

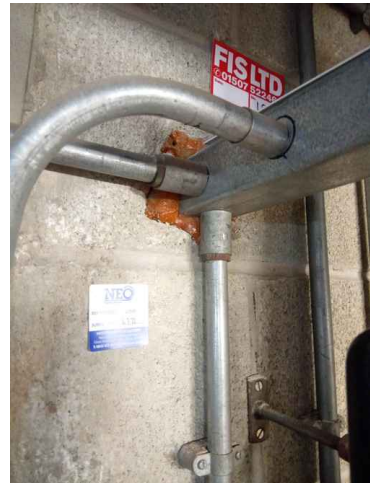
**Pin Number:** 0162:38  
**Company:** Neo Property Solutions  
**Contractor:** Matthew Brown - 38

| Survey | |
|---|---|
| Metal trunking. Foam needs removing. | |
| Breach identified: | Trunking |
| Fire rating: | 60 minutes (not suitable if > 11m to top floor above ground) |

| Survey | |
|---|---|
| RWSD-ACB-0104 | |

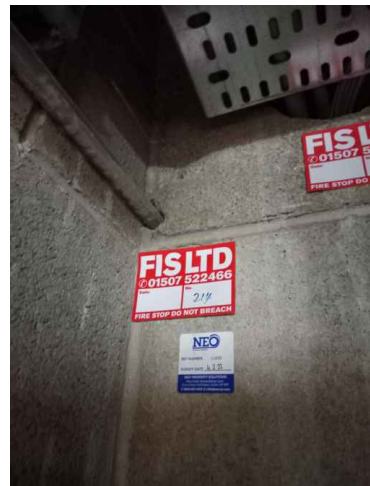
**Pin Number:** 0176:38

| Survey | |
|---|---|
| 30mm conduit | |
| Breach identified: | Conduit |
| Priority: | Red |
| Once back sealed | |

| Survey | |
|---|---|
| Installation type: | SD-128-RDW |

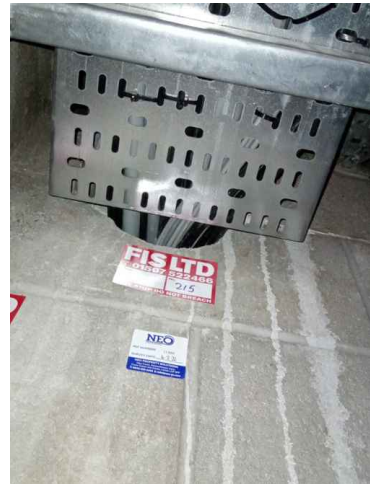
**Pin Number:** 0177:38

| Survey | |
|---|---|
| 140mm cable bunch | |
| Breach identified: | Cable |
| Priority: | Red |

| Survey | |
|---|---|
| Installation type: | CFS-F-FX |

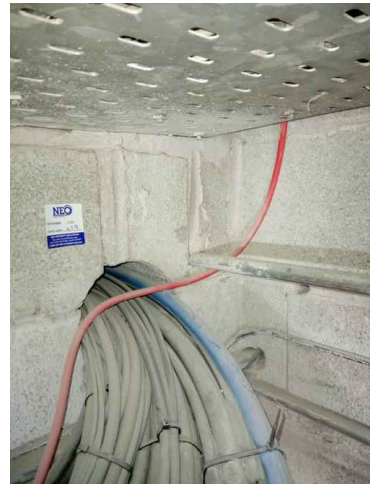
**Pin Number:** 0178:38

| Conduit. Needs doing from corridor as cant access inside plantroom | |
| Breach identified: | Conduit |
| Priority: | Red |
| Only access one side | |

| Installation type: | SD-128-RDW |

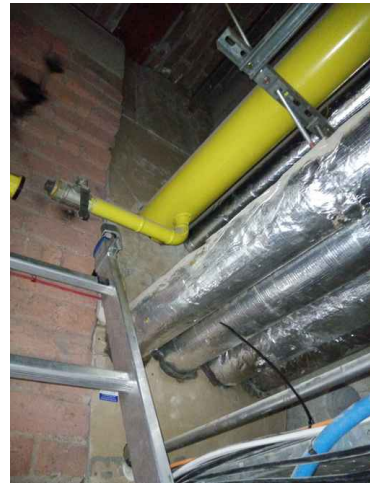
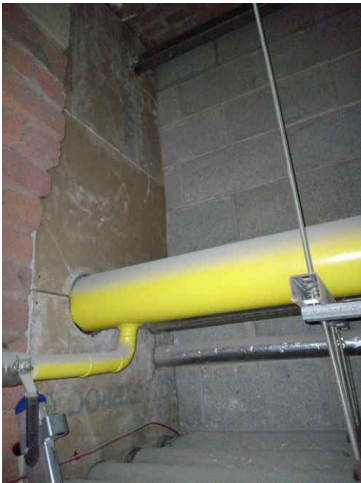
**Pin Number:** 0179:38

| Plasterboard needs removing and refitting with fire lined board. Frame and line penetrations | |
| Breach identified: | Board Missing |
| Priority: | Red |
| Cannot access seals from inside plantroom. Needs frame and lining. | |

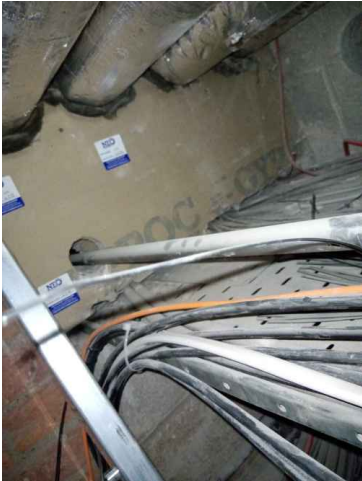
| <b>Pin Number:</b> | 0180:38 | <b>Date Added:</b> | 04/02/2022 - 11:47 |

| Survey | |
|---|---|
| Cable tray | |
| <b>Breach identified:</b> | Cable Tray, Cable |
| Single side install cant access from plantroom side | |

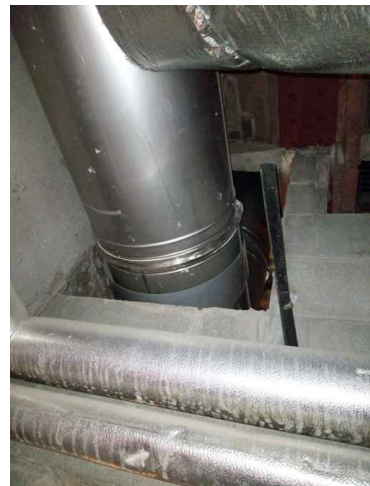
**Pin Number:** 0193:38

| No damper installed on ducting. | |

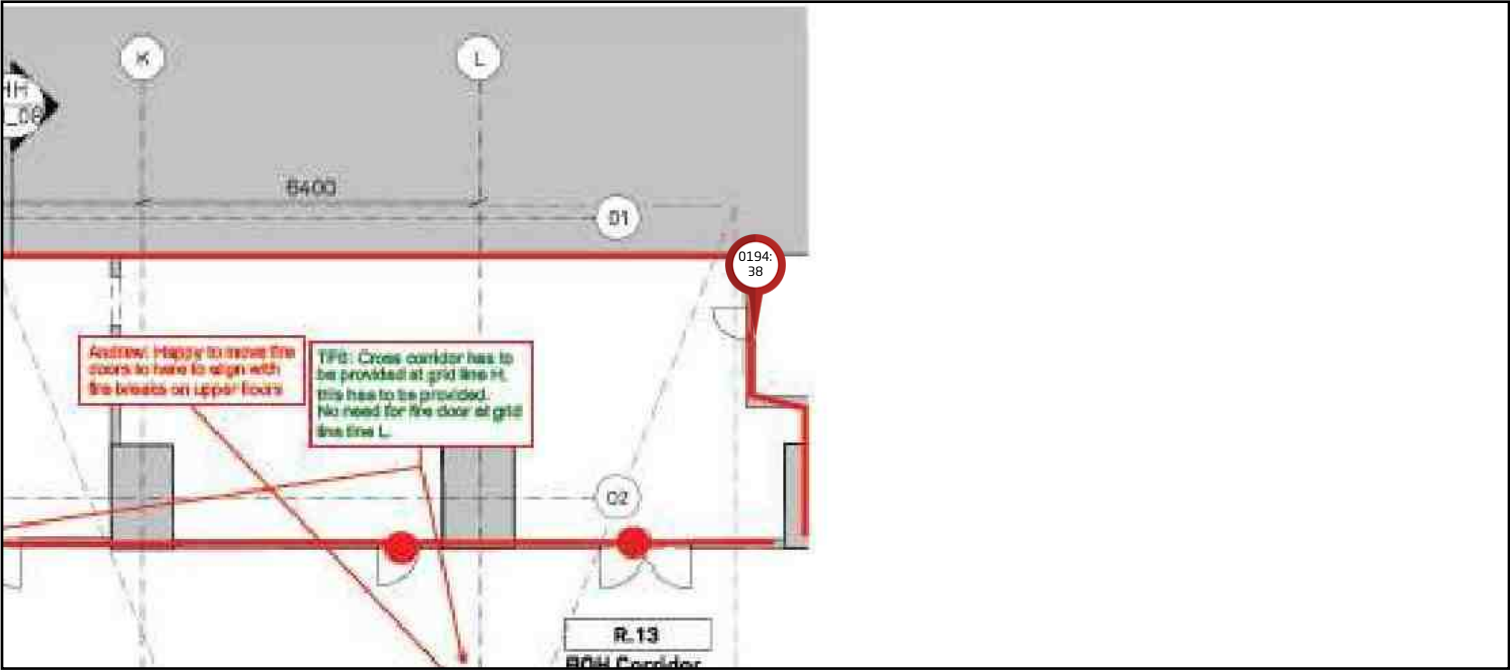
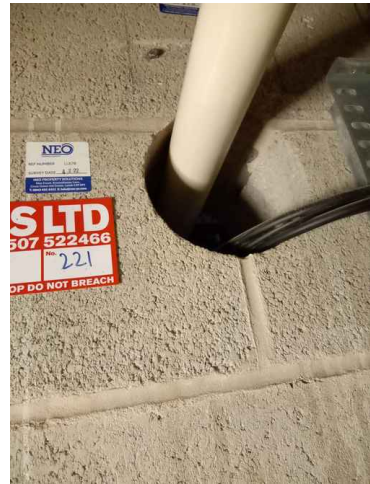
**Pin Number:** 0195:38

| Survey | |
|---|---|
| Plastic pipe in hole | |
| Breach identified: | Plastic Pipe, Hole |
| Fire rating: | 60 minutes (not suitable if > 11m to top floor above ground) |
| Priority: | Red |

| Survey | |
|---|---|
| Installation type: | SD-192-RDW |

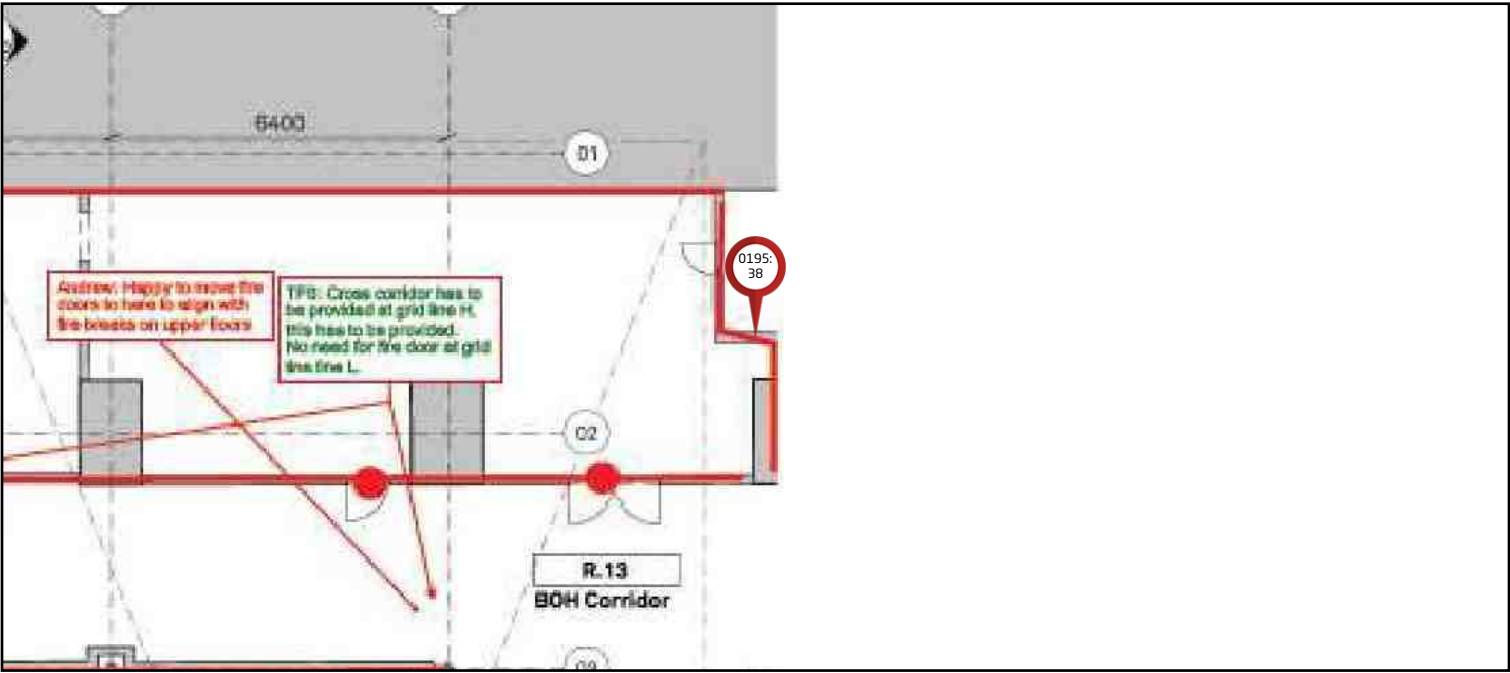
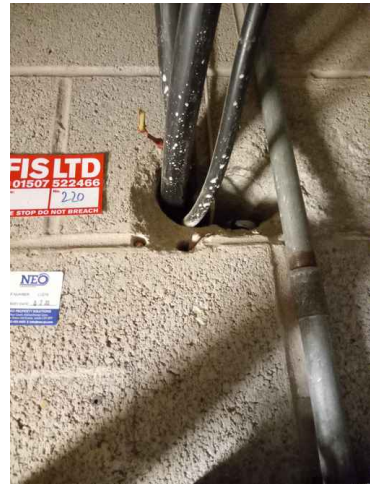
**Pin Number:** 0196:38

| Survey | |
|---|---|
| Cables in hole | |
| Breach identified: | Cable, Hole |
| Fire rating: | 60 minutes (not suitable if > 11m to top floor above ground) |
| Priority: | Red |

| Survey | |
|---|---|
| Installation type: | SD-128-RDW |
| Once back sealed | |

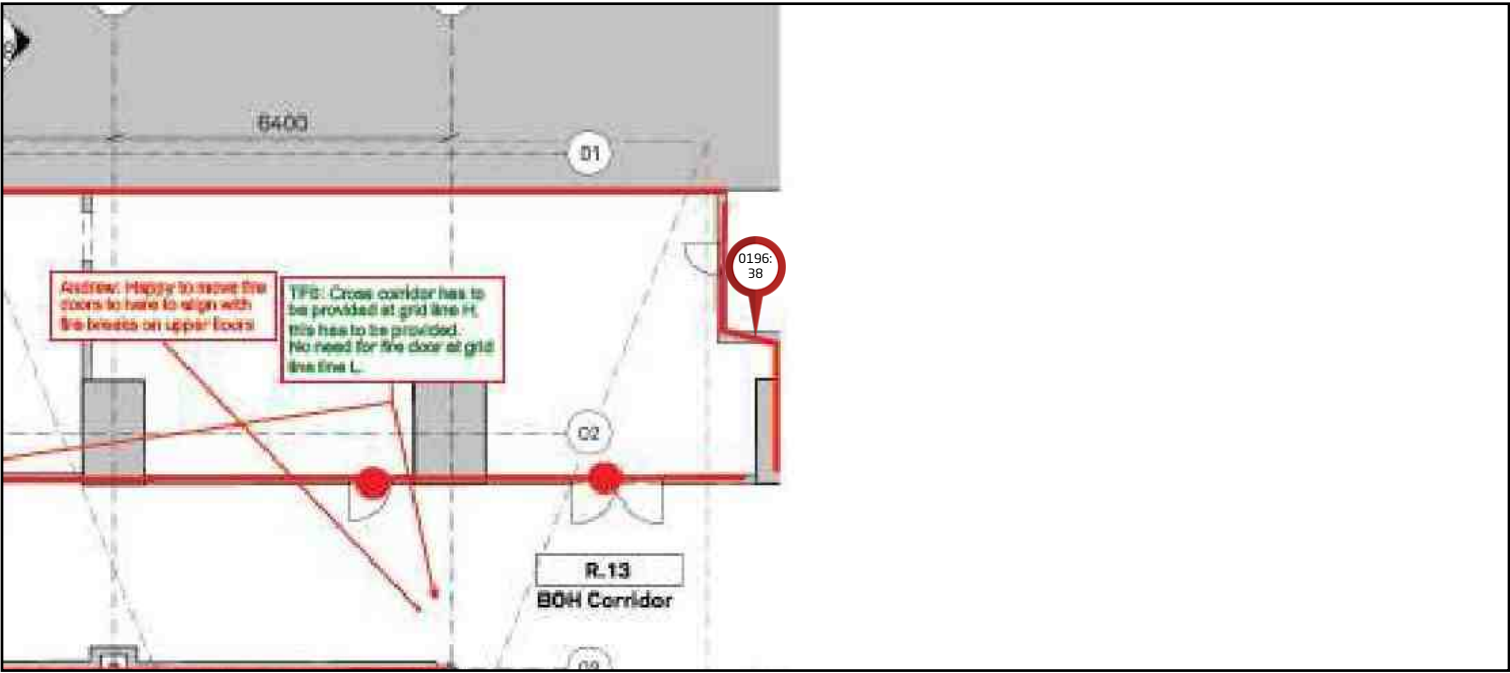
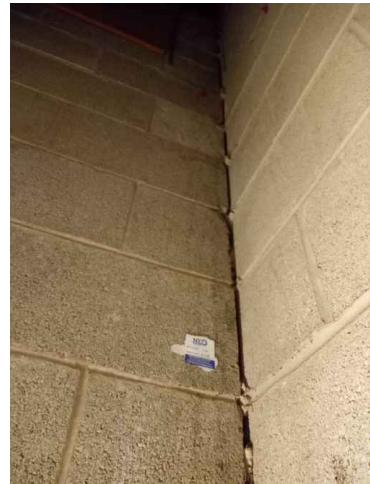
**Pin Number:** 0197:38

| Survey | |
|---|---|
| Linear joint in corner of blockwork | |
| Breach identified: | Joint |
| Fire rating: | 60 minutes (not suitable if > 11m to top floor above ground) |
| Priority: | Red |

| Survey | |
|---|---|
| Installation type: | RWSD-AIS-0001 |
