Our ref: R3186-L02  
Your ref:

**Northenden College, Wythenshawe, Manchester  
Post-Demolition Site Investigation 2**

Post-Demolition Site Investigation

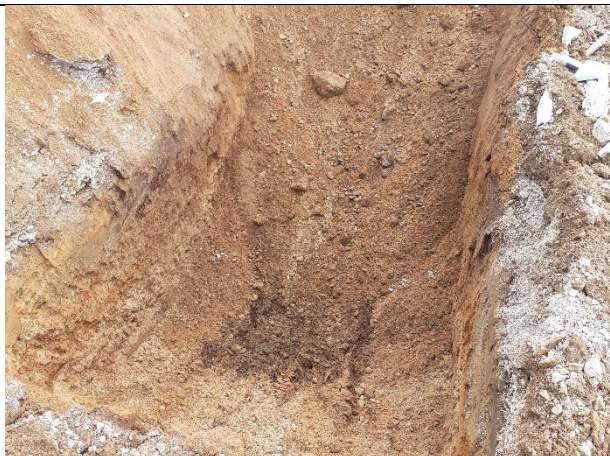
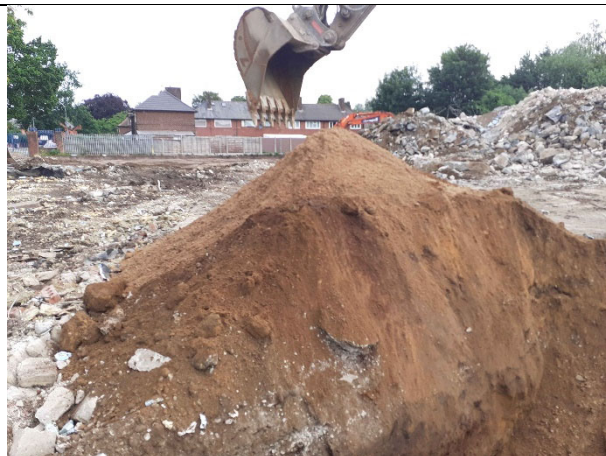
- Coarse sub-angular limestone gravel within a sandy matrix assumed to relate to sub-base material placed during the construction of the building slab. This made ground was encountered within TP11 (at the surface due to slab removal) or beneath the slab in TP15, TP16, TP17 and TP19 ranging from 0.1m (TP17) to 0.6m (TP15) thick.
- Black gravelly ashy sand at 0.25-0.5m beneath the slab in TP13 and TP14.
- Dark brown clay (possible reworked natural) with occasional cobbles of brick. This was limited to TP12 from 0.0-0.4m bgl.

Natural soils were consistent across the site and were located at shallow depth beneath the made ground soils. Depth to natural ranged from 0.3m bgl in TP11 and TP17 to 0.8m in TP15. Natural soils consisted of a light brown to yellow clayey sand with fine to coarse sub-rounded gravel. Typically, the soils become gravellier with increased depth turning to a sandy gravel.

| 1 of 1 | | EXCAVATED BY:<br><b>Tracked Volve 350</b> | CLIENT:<br><b>URL</b> | DATE:<br><b>22nd June 2023</b> | <b>TP11</b> |
|---|---|---|---|---|---|
| | | | 0.00 | MADE GROUND: Coarse sub-angular limestone GRAVEL (sub base) in sand | |
| | | | 0.3 | Light brown to yellow gravelly clayey SAND with fine to coarse sub-rounded gravel from 1.1m bgl | |
| | | | 2.00 | Coarse rounded to sub-rounded GRAVEL in a dark brown sand | |
| | | | | Trial-Pit terminated at 2.0m within natural soils | |

Trial-pit Dry

Sidewalls Stable; PID < 0.1ppm

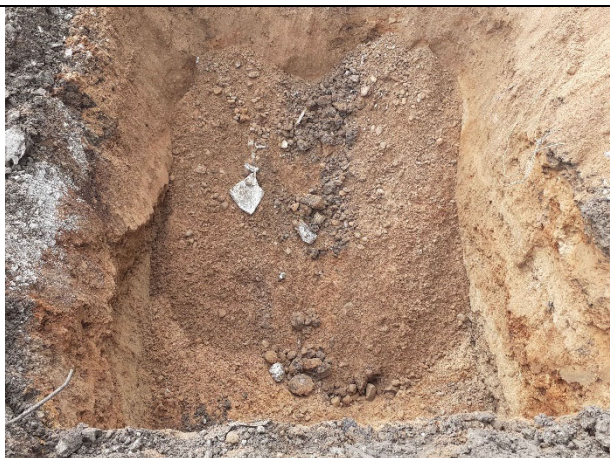
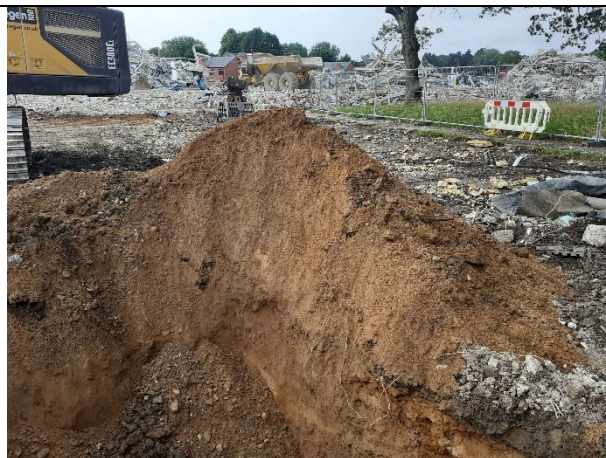
A horizon of a more cohesive soil was observed within TP12 from 1.9m bgl consisting of a soft wet sandy clay with coarse rounded gravel. The full thickness of this horizon was not confirmed with the trial-pitting terminating at 2m bgl.

No groundwater ingress was observed during the investigation although wet strata was observed within TP12 at 1.9m which could be attributed to the more cohesive strata and where drainage is slightly more restricted compared to that of the more granular soils.

| 1 of 1 | | EXCAVATED BY:<br><b>Tracked Volve 350</b> | CLIENT:<br><b>URL</b> | DATE:<br><b>22nd June 2023</b> | <b>TP12</b> |
|---|---|---|---|---|---|
| | | | 0.00 | Dark brown CLAY with occasional cobbles of red brick | <br> |
| | | | 0.4 | Light brown to yellow gravelly clayey SAND with fine to coarse rounded gravel | |
| | | | 1.9 | Dark brown soft wet sandy CLAY with coarse rounded gravel | |
| | | | 2.00 | Trial-Pit terminated at 2.0m within natural soils | |

Sidewalls Stable; PID < 0.1ppm

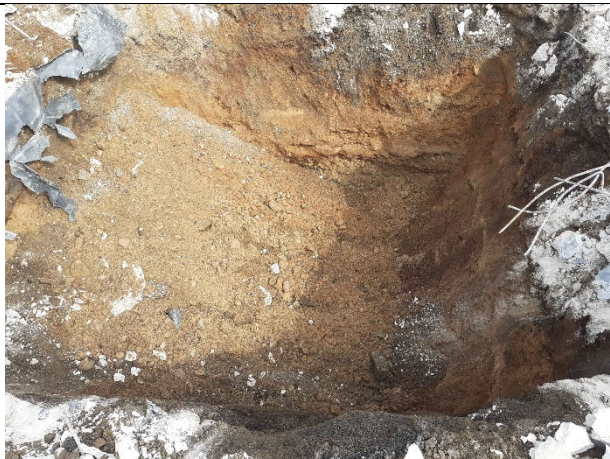
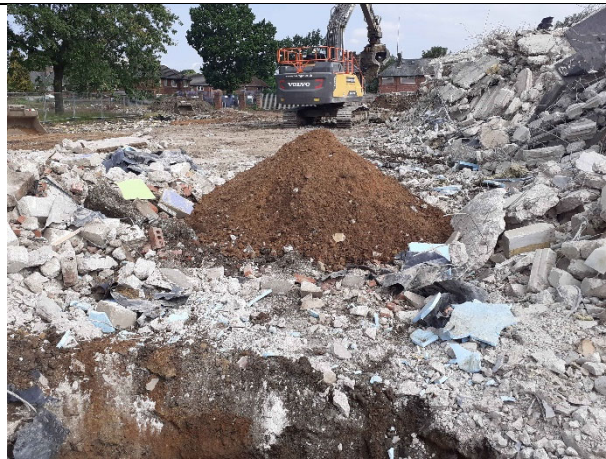
Surface hardstanding was present within entries TP13-TP18 associated with the slab of the former college building; the slab had been broken out within TP11-TP12 prior to SGP attendance. The slab was approximately 0.2m thick and reinforced.

Beneath the slab a black geotextile and blue polystyrene board was present, these were limited to TP13 and TP14 only.

Contaminant inclusions were limited to ashy soils observed within TP13 and TP14. The presence of which are mitigated by the prescribed garden cover system as detailed within the approved Strategy.

| 1 of 1 | | EXCAVATED BY:<br><b>Tracked Volve 350</b> | CLIENT:<br><b>URL</b> | DATE:<br><b>22nd June 2023</b> | <b>TP13</b> |
|---|---|---|---|---|---|
| | | | 0.00 | MADE GROUND: Reinforced Concrete Slab | |
| | | | 0.25 | Black terram and blue insulation board | |
| | | | | MADE GROUND: Black gravelly ashy SAND | |
| | | | | Light brown to yellow gravelly clayey SAND with fine to coarse sub-rounded gravel | |
| | | | | Coarse rounded to sub-rounded GRAVEL in a light brown sand | |
| | | | | Trial-Pit terminated at 1.8m within natural soils | |

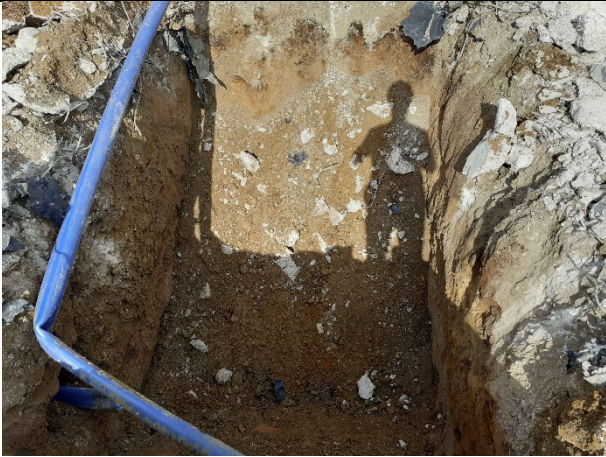
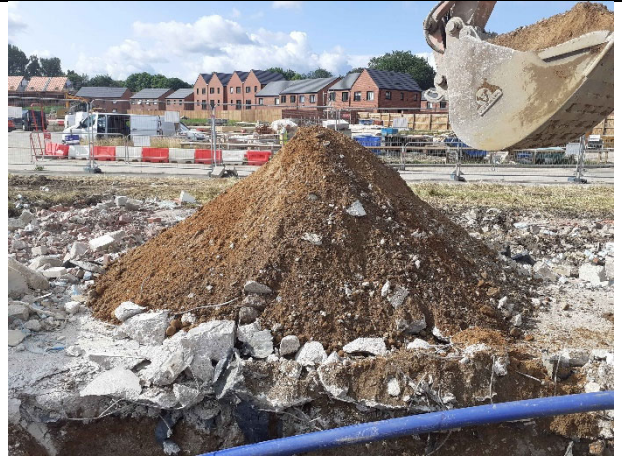
TP17

| 1 of 1 | | EXCAVATED BY:<br><b>Tracked Volve 350</b> | CLIENT:<br><b>URL</b> | DATE:<br><b>29th June 2023</b> | <b>TP17</b> |
|---|---|---|---|---|---|
| | | | 0.00 | MADE GROUND: Reinforced Concrete Slab | |
| | | | 0.2<br>0.3 | MADE GROUND: Coarse angular limestone GRAVEL (sub base) in sandy soil<br>Light brown to yellow gravelly clayey SAND with fine to coarse sub-rounded gravel. Relict water pipe at 1m bgl | |
| | | | 1.4 | Coarse rounded to sub-rounded GRAVEL in a light brown sand | |
| | | | 1.8 | Trial-Pit terminated at 1.8m within natural soils | |

Sidewalls Stable; PID < 0.1ppm

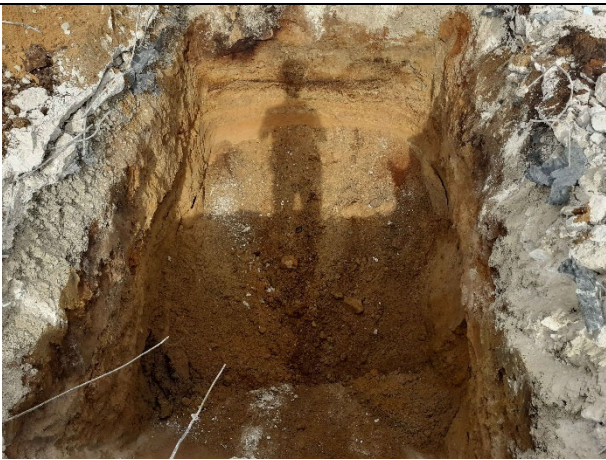
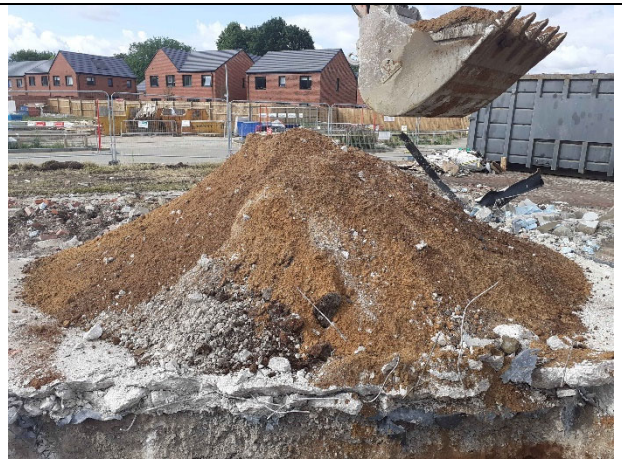
TP18

| 1 of 1 | | EXCAVATED BY:<br><b>Tracked Volve 350</b> | CLIENT:<br><b>URL</b> | DATE:<br><b>29th June 2023</b> | <b>TP18</b> |
|---|---|---|---|---|---|
| | | | 0.00 | MADE GROUND: Reinforced Concrete Slab | |
| | | | 0.2 | MADE GROUND: Coarse angular limestone GRAVEL (sub base) in sandy soil | |
| | | | 0.45 | Light brown to yellow gravelly clayey SAND with fine to coarse sub-rounded gravel. Relict water pipe at 1m bgl | |
| | | | 2.00 | Coarse rounded to sub-rounded GRAVEL in a light brown sandy clay | |
| | | | 2.22 | Trial-Pit terminated at 2.2m within natural soils | |

Slight sidewall spalling
