# Renaissance Hotel Manchester

## Remediation Strategy

August 2023

1602-A2S-XX-XX-RP-Y-0003-06

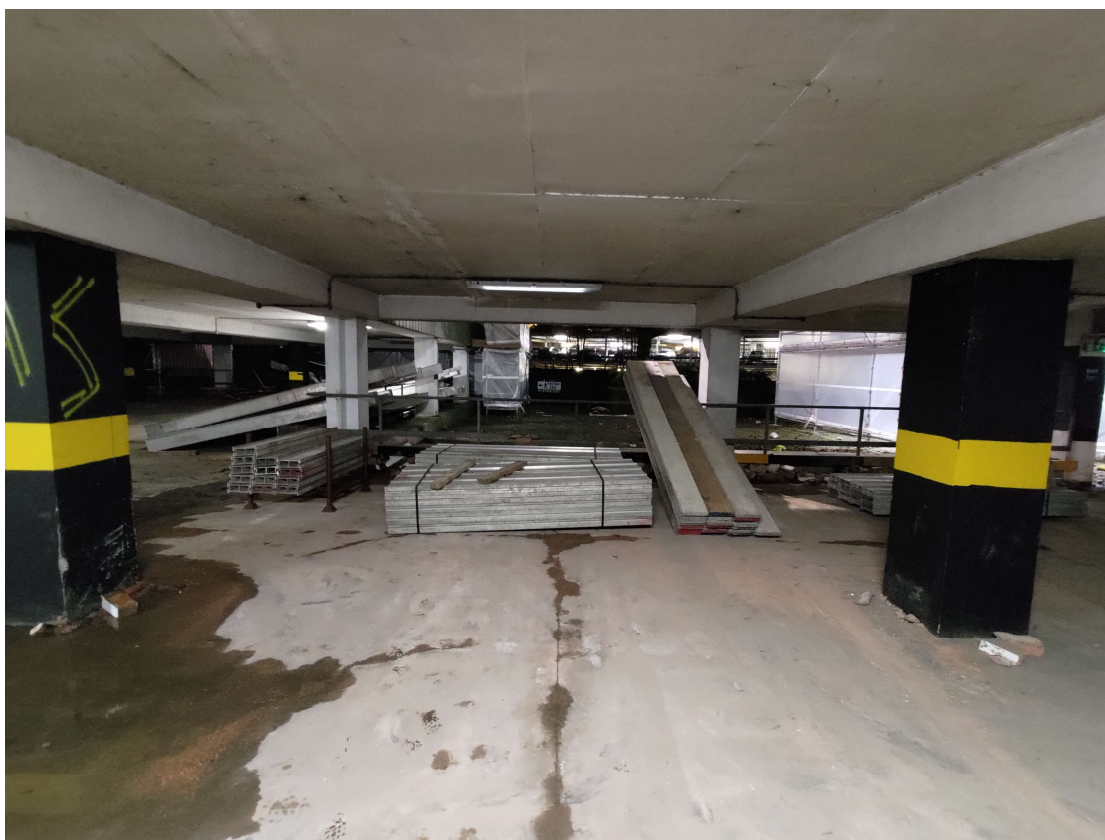
During the site walkover, all previous installed wells at the basement car park level were identified with the exception of RBH102, which at the time of the walkover had heavy pallets, possibly obstructing the headworks as shown in the photo 7.4.1.

**Figure 7.4.1 Possible RBH102 location with obstruction.**
