# Hangar 4, Manchester Airport

Geo-Environmental Desk Study Assessment

# Geo-Environmental Desk Study Assessment

Report Reference: B041631.DS.1

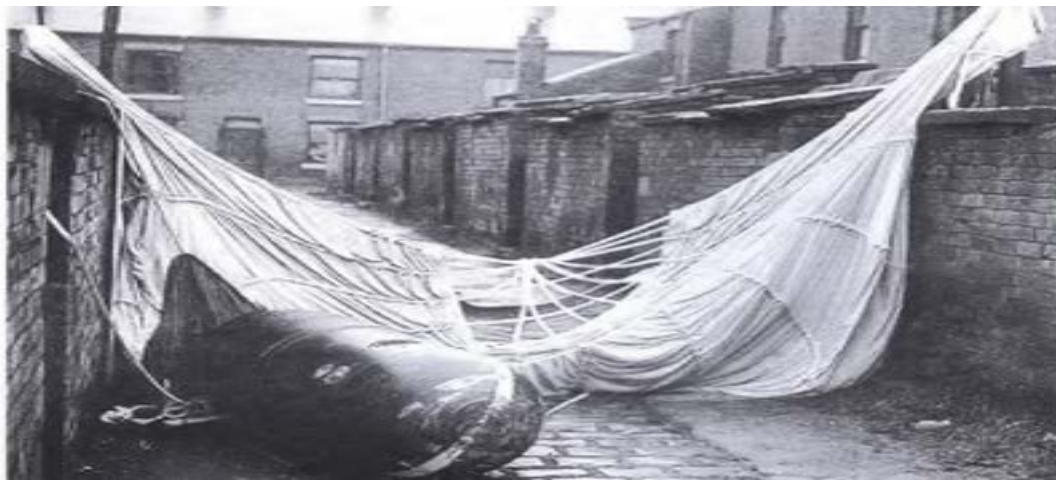
### Parachute & Ground Mines

Note; all mine fuzes were designed to arm after deployment from the ship, submarine or aircraft, some fuze designs incorporated anti-removal booby traps. Unexploded mines found today are the result of a failure within the arming mechanism or procedure whereby the mine never fully armed. Sudden shock or jarring of a weapon in this state has the potential to complete the arming sequence and could result in the mine detonating with lethal consequences.
