Preliminary Roost Assessment and Ecological Walkover

Islamic High School for Girls, Chorlton-cum-Hardy

Reference: 80-997-R1-1

Date: September 2022

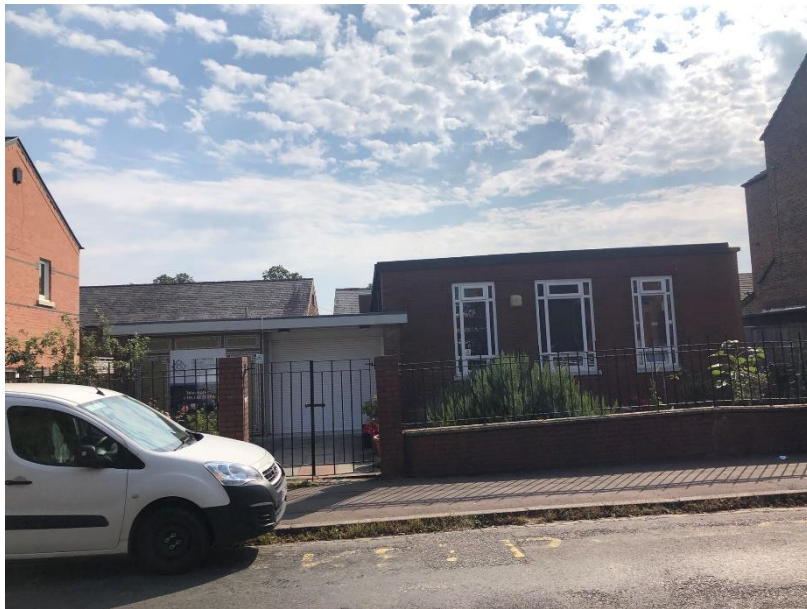
Building 1 comprised a long narrow building present along the majority of the western site boundary, with an extension leading west towards Stockton Road. The western extension contained the main entrance to the school and was made from red brick walls with a slightly pitched roof.

PLATE 1 SHOWING ENTRANCE ON WESTERN ASPECT OF BUILDING 1

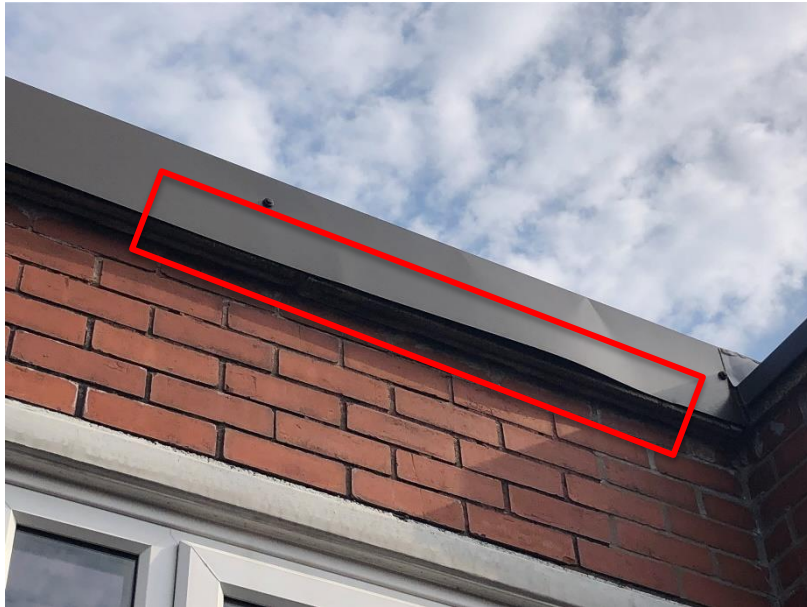
The brick walls were in good condition on all aspects, with no features present that could support roosting bats. Plastic sheeting folded over from the roof, and was present on all aspects, with gaps between the plastic sheeting and wall present on the southern and western aspect. This feature could be used by crevice dwelling bat species on an occasional basis.

PLATE 2      SHOWING GAPS PRESENT ON SOUTHERN ASPECT OF WESTERN EXTENSION

Overall, Building 1 was assessed as having **LOW** bat roosting potential, due to the crevices present under roof and ridge tiles along the roof that could support crevice dwelling bat species on an occasional basis.

Building 1 and Building 2 were assessed as having Low and Moderate bat roosting potential respectively. As such, one nocturnal bat survey is required on Building 1 between May and August and two surveys required on Building 2 between May and September, with at least one survey being undertaken between May and August.

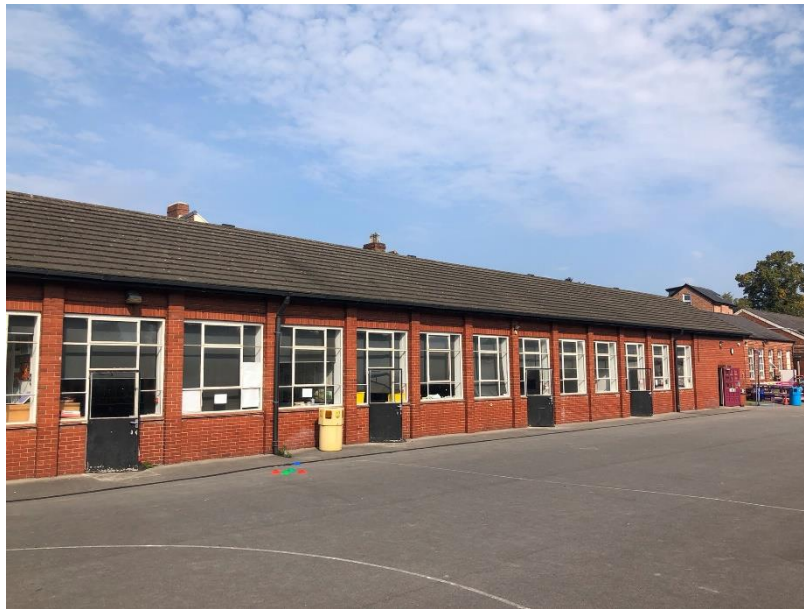
The remainder of the building comprised a long, narrow building with red brick walls and a pitched roof. The western aspect of the building could not be viewed as it backed onto adjacent residential properties. The eastern aspect of the building was adjacent to a large hardstanding playground, with a series of windows and doorways associated with classrooms within the building. The brick walls were in good condition and an overhang was present along the eastern aspect of the building, however, it was in good condition with no features present that could support roosting bats.

PLATE 4      SHOWING EASTERN ASPECT OF BUILDING 1

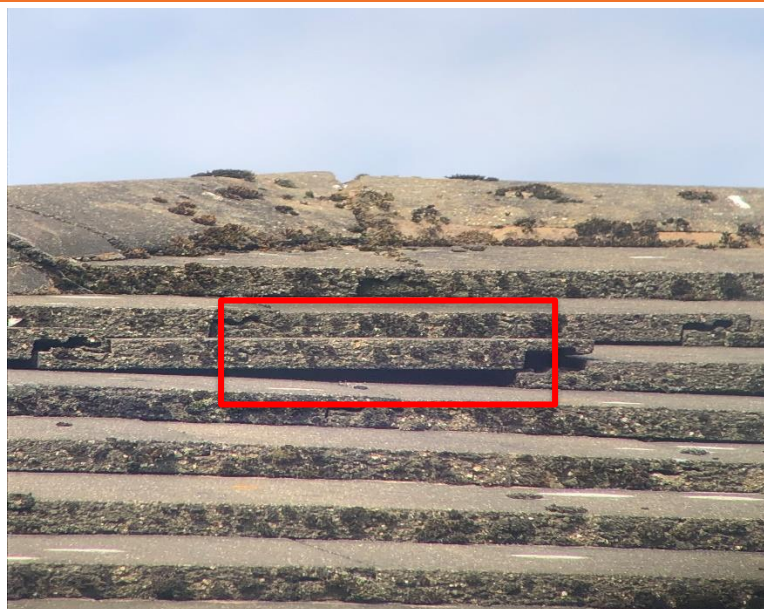
The majority of roof tiles along the section were in good condition, however, occasional gaps were present under lifted tiles and damaged ridge tiles. The majority of features were present at the southern end of the roof.

PLATE 5      SHOWING GAP UNDER TILE AT SOUTHERN END OF BUILDING 1

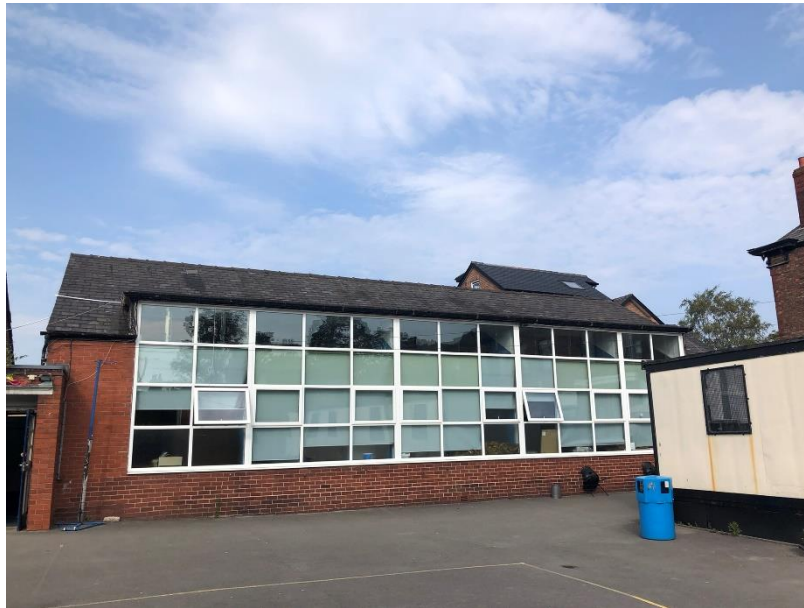
Two extensions joined onto the north of the long narrow building and comprised black slate roof tiles and a pitched roof. One of the extensions contained classrooms and the second extension contained the main school hall.

PLATE 6      SHOWING SCHOOL HALL SECTION OF BUILDING 1

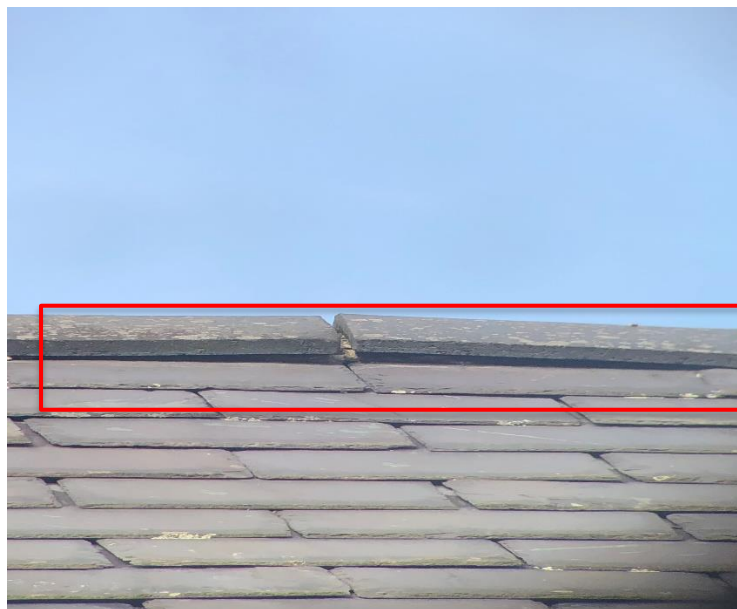
Small gaps were present under the ridge tiles along the slate roof extensions which could provide suitable roosting features for crevice dwelling bat species on an occasional basis.

PLATE 7      SHOWING GAPS UNDER RIDGE TILES

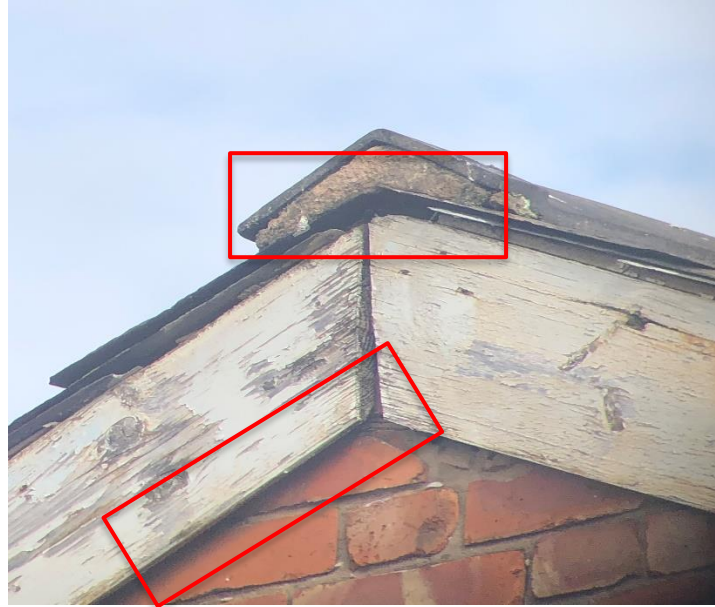
A hole was also present on the south facing gable end of the school hall building underneath the end ridge tile. Gaps were also present underneath wooden bargeboards along this aspect. These features have the potential to support crevice dwelling bat species on an occasional basis.

PLATE 8      SHOWING GAPS AT SOUTHERN GABLE END OF SCHOOL HALL

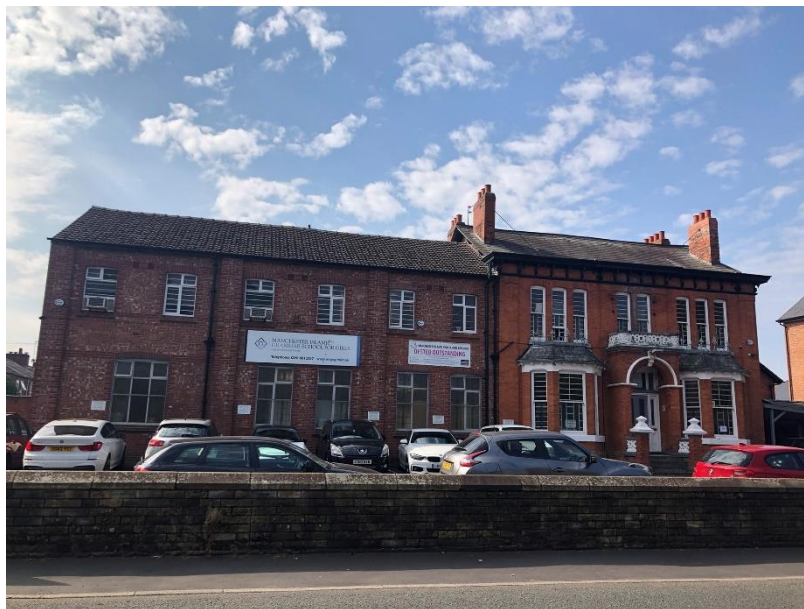
A large building was present in the northern area of the site, comprising a red brick building with two joined pitched roofs. The roofs comprised a black slate roof and a concrete slate roof, with the black slate roof containing four large red brick chimney stacks. The building contained the main reception for the school and a series of offices and classrooms. The northern aspect faced onto High Lane and the southern aspect overlooked the hardstanding school playground.

PLATE 9      SHOWING NORTHERN ASPECT OF BUILDING 2

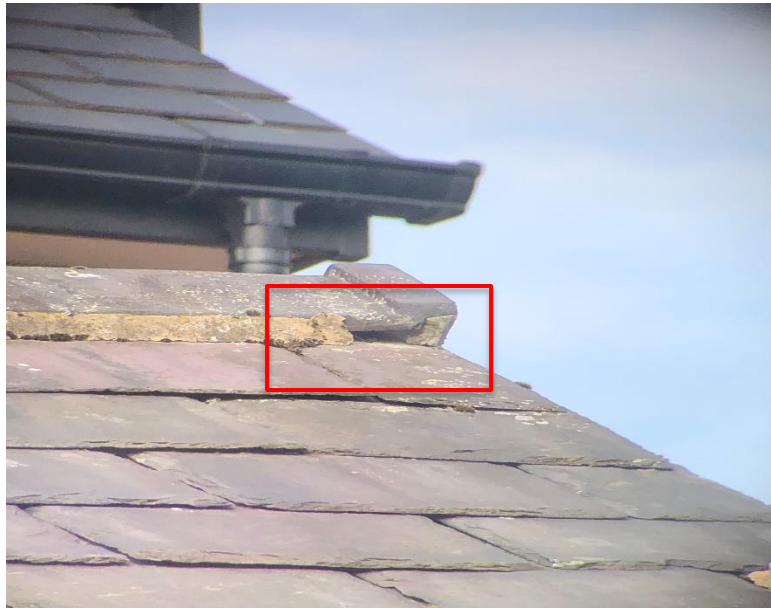
The section of the roof containing concrete tiles was in good condition, with no features observed that could support roosting bats. Multiple gaps were present along the slate tile roof section on the northern and southern aspects with gaps under roof tiles and along the ridge tiles where cement was missing.

PLATE 10      SHOWING GAP UNDER RIDGE TILE ON BUILDING 2

Building 2 was assessed as having **MODERATE** bat roosting potential on a precautionary basis, due to the presence of a large split in the roof that could provide internal access into the roof for larger numbers of bats on a regular basis. In addition, a number of crevices and features were present on all aspects of the roof.

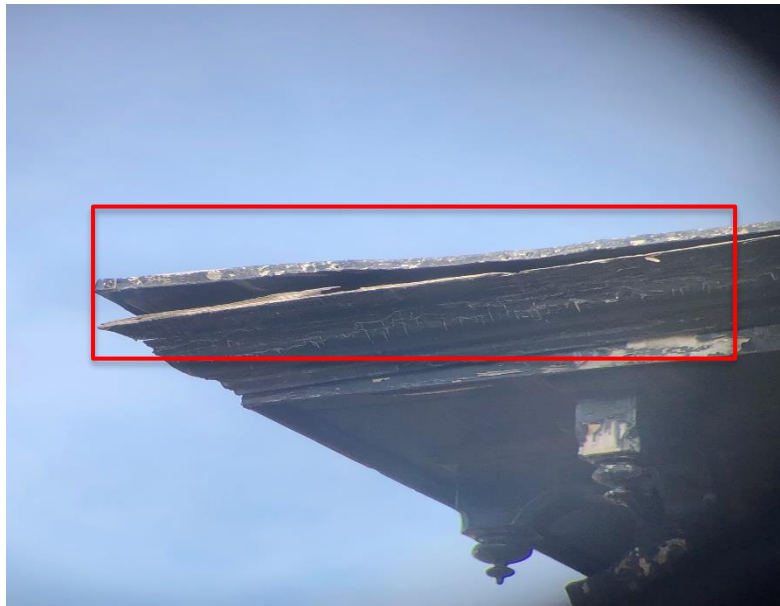
A large split was present on the south-western corner of Building 2 where the wooden fascia boards had broken from the roof. The feature could potentially provide an access point for bats into the roof of the building creating a suitable roost for bats on a regular basis.

PLATE 11      SHOWING SPLIT ON SOUTH-WESTERN ASPECT OF BUILDING 2

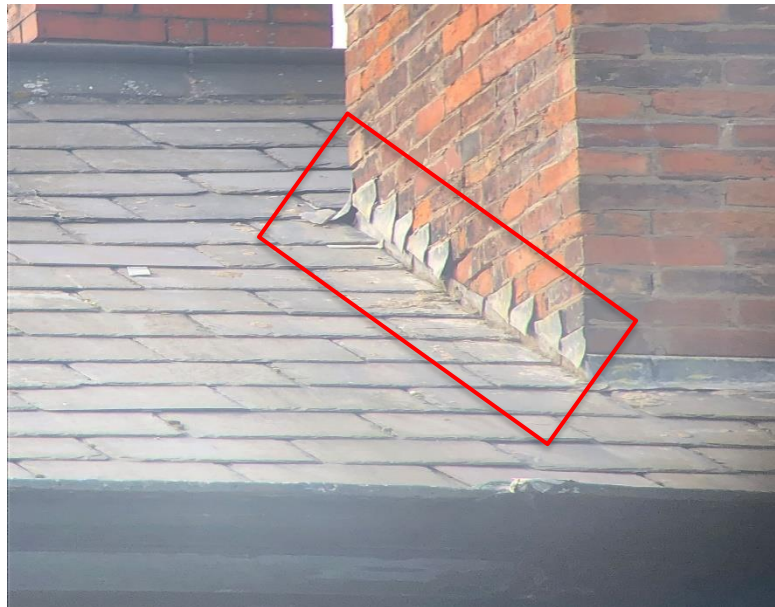
Small gaps were present around the lead flashing at the base of the chimney stacks on all aspects.

PLATE 12      SHOWING SPLIT ON SOUTH-WESTERN ASPECT OF BUILDING 2

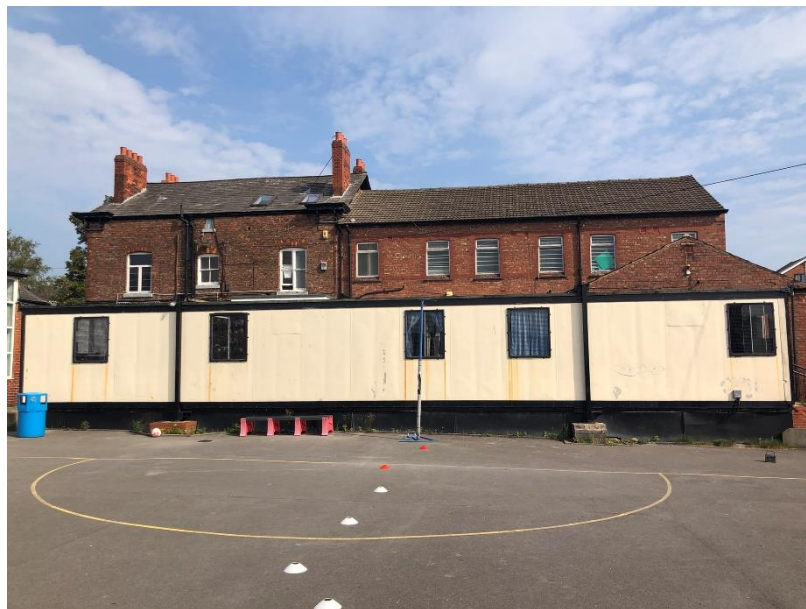
Building 3 comprised a mobile classroom which was present in the centre of the site, made from plastic and wooden walls. The building was assessed as having Negligible value for roosting bats as no features were present.

PLATE 13      SHOWING BUILDING 3

Building 3 was assessed as having **NEGLIGIBLE** bat roosting potential due to a lack of suitable roosting features.

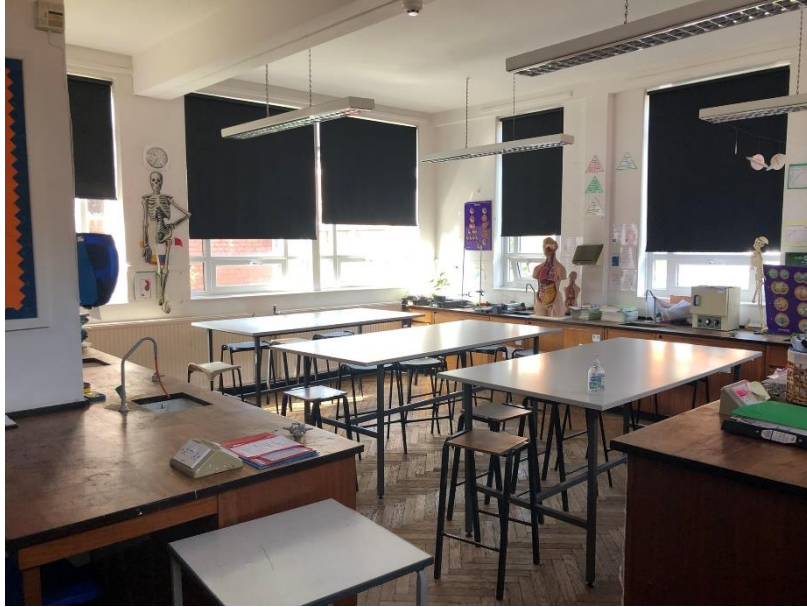
The inside of Building 1 and Building 2 mainly comprised a series of classrooms with corridors connecting them. The rooms were all modernised, well-used and did not contain any features that could support roosting bats.

PLATE 14      SHOWING CLASSROOM WITHIN BUILDING 1

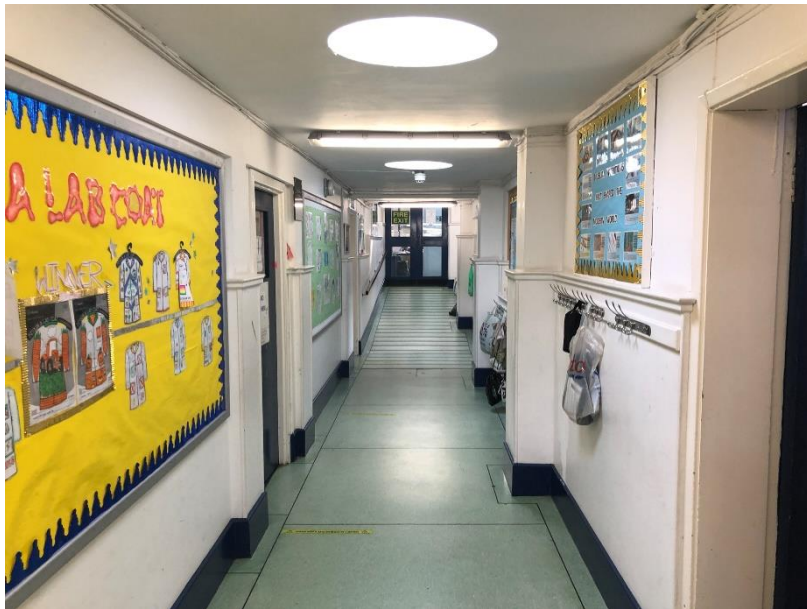
PLATE 15      SHOWING CORRIDOR WITHIN BUILDING 1

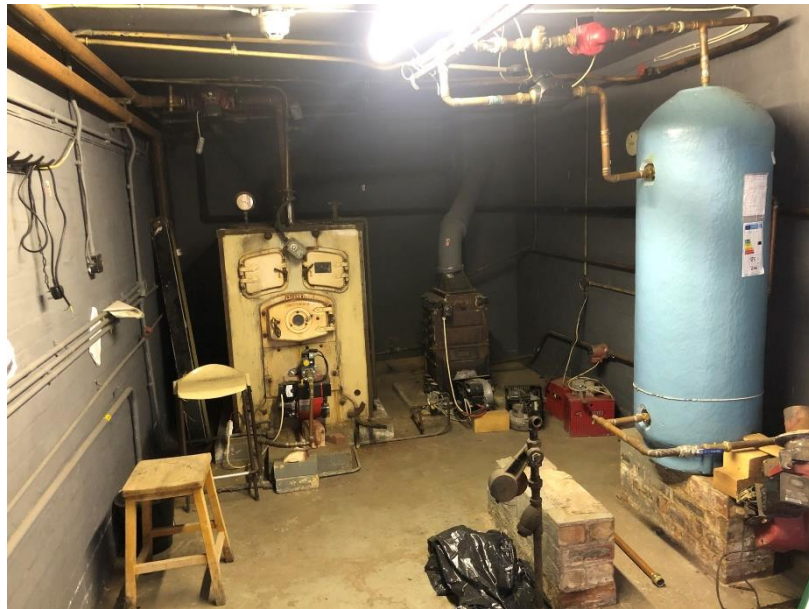
A cellar was present in the western extension of Building 1, however, the roof and walls were well sealed and no access points for bats were observed.

PLATE 16      SHOWING CELLAR INSIDE BUILDING 1
