Remediation Strategy

Victoria Avenue East

Moston

**Report A3469/23/RMS**

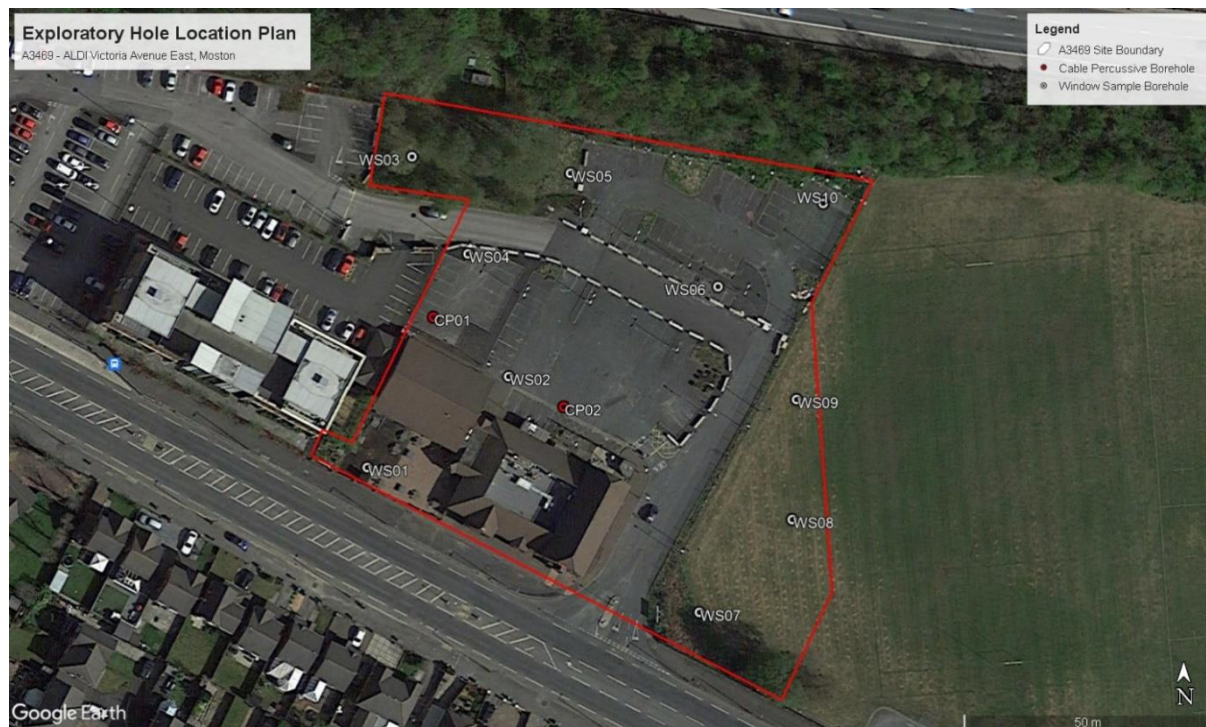
**Figure 3: Exploratory Hole Location Plan (A3469/21/SI, April 2022)**

An exploratory hole location plan is presented as Figure 3, below.

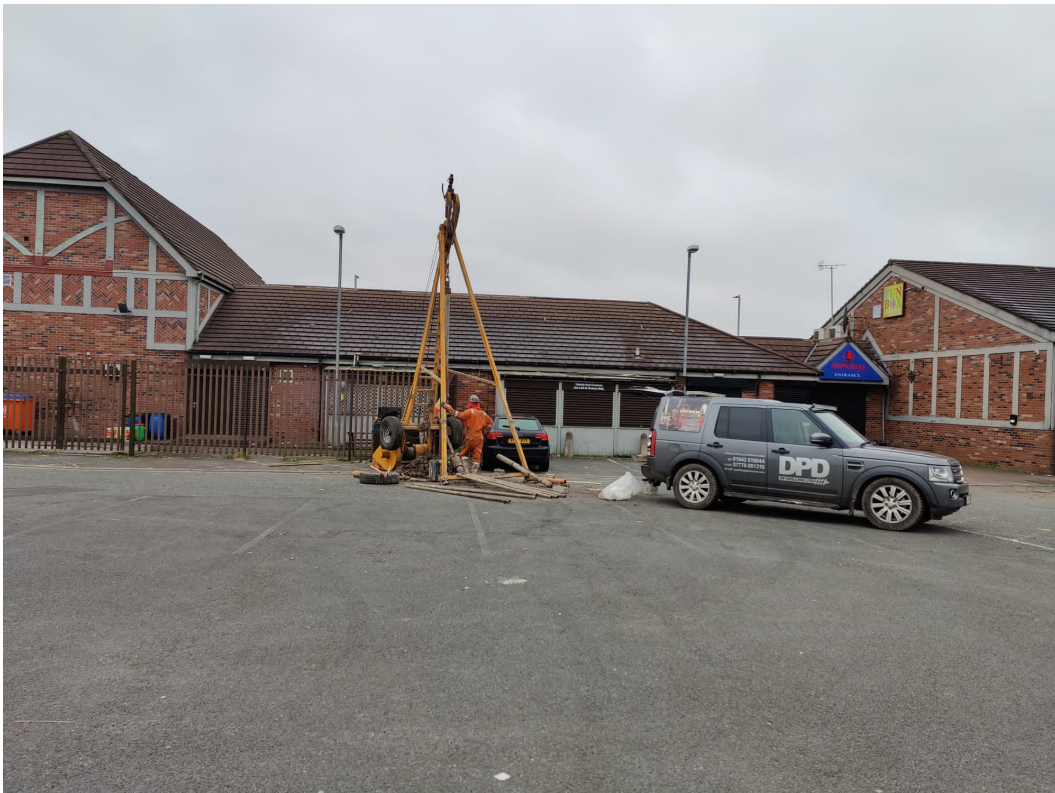
**Figure 3 View Facing South Showing the Cable Percussive Borehole Rig Setup**

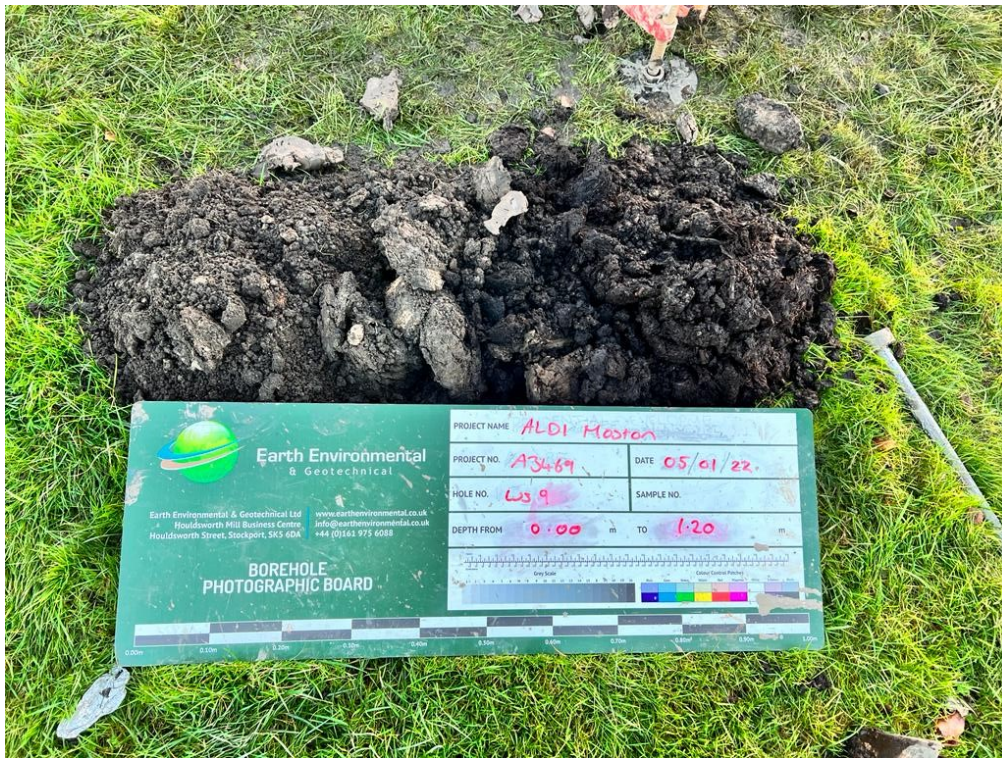
Figure 4 Topsoil and Peat Deposits Encountered in WS09

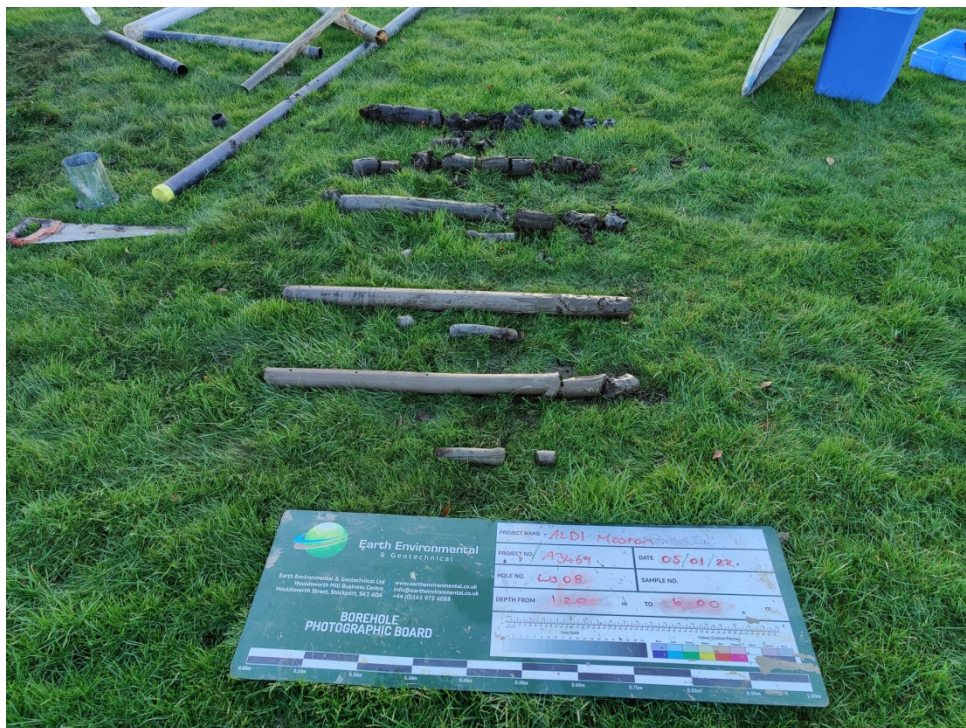
Figure 5 Peat Deposits and Devensian Till Deposits Encountered in WS08

During the ground investigation, variable Made Ground containing gravel of concrete, red brick and clinker were observed in the exploratory holes. Ash was also encountered within the Made Ground at location WS08. Rare glass and wire were encountered within the Made Ground at locations WS06 and WS10.

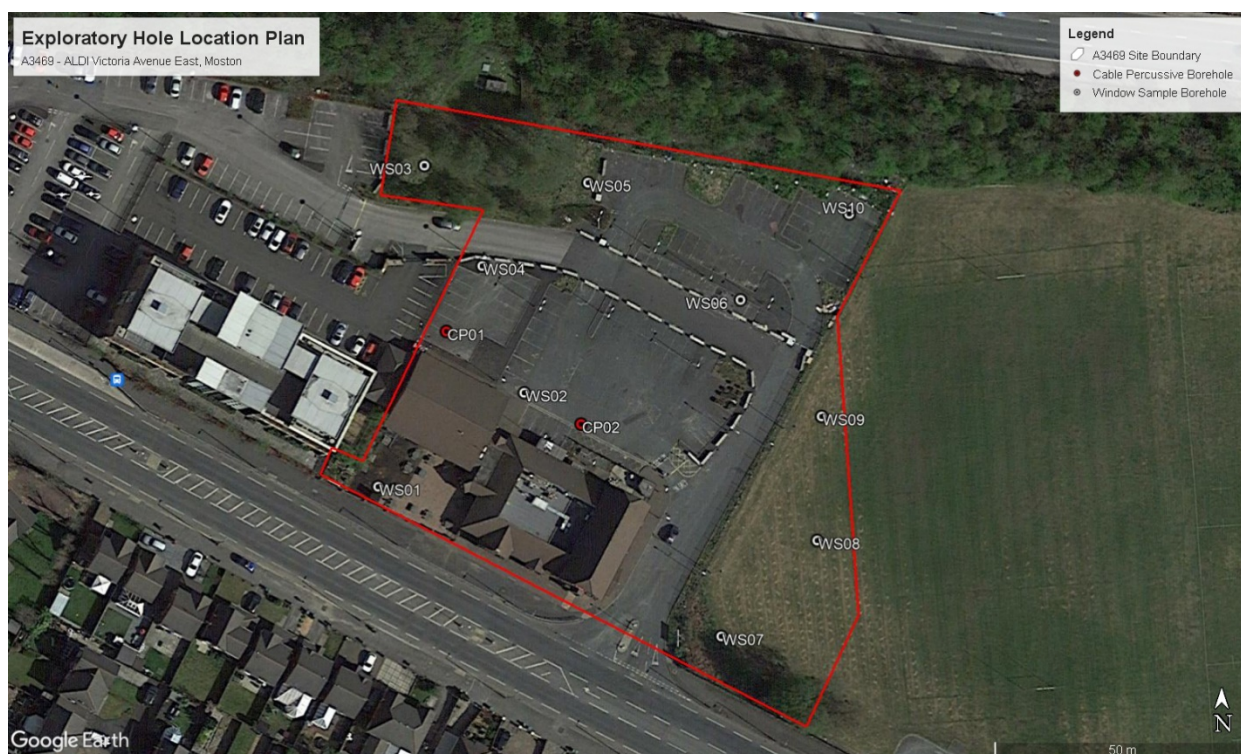
**Figure 7: Exploratory Hole Location Plan**

An Exploratory Hole Location Plan is presented as Figure 7, below.
