As part of the roof survey prepared by OBI, detailed consideration into the various options for roof covering was given. A summary of our findings is detailed below:

Lower Campfield – Roof Replacement

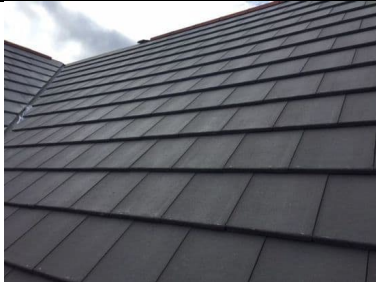
| Option | Description / Aesthetics | Example Image | Durability / Longevity | Structure | Heritage (Stephen Levrant Heritage Architecture LTD) |
|---|---|---|---|---|---|
| No.3 | <p>Cement tiles come in various shapes and sizes however they are thicker and heavier than man made slate.</p> <p>Installing cement tiles would significantly alter the current appearance and build up of the roof.</p> | | The roof covering would last circa 50-60 years provided it is adequately maintained. | The Tier structural report confirms that a cement tile roof covering would overload the roof and damage the property. | This option using inappropriate materials/appearance would result in an adverse impact. |

Option 3: Cement Tiles

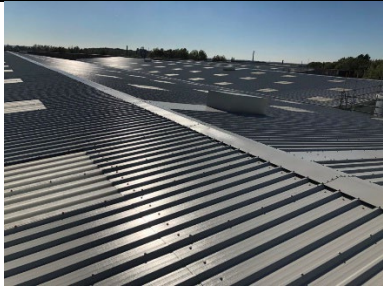
| Option | Description / Aesthetics | Example Image | Durability / Longevity | Structure | Heritage (Stephen Levrant Heritage Architecture LTD) |
|---|---|---|---|---|---|
| No.5 | <p>Metal cladding panels have been installed at Upper Campfield.</p> <p>Aesthetically, they are not in keeping with the rest of the building and they are not typically installed to commercial office buildings.</p> <p>This would cause noise issues internally during heavy rain and significant insulation may be required internally to mitigate this nuisance.</p> | | <p>The roof covering would last between 40 – 70 years provided it has been adequately maintained.</p> | <p>Metal cladding panels are relatively light weight and therefore could be installed to the roof.</p> <p>However, this would alter the build up of the roof as insulation would be installed within the panels.</p> <p>It would also mean that the internal tongue and groove paneling would be removed which although not original we believe</p> | <p>This option uses inappropriate materials that are inappropriate for the date and style of the listed building and would result in an adverse impact.</p> |

Option 5: Corrugated metal cladding.

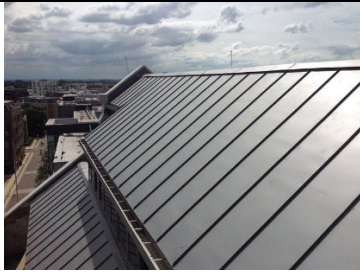
| Option | Description / Aesthetics | Example Image | Durability / Longevity | Structure | Heritage (Stephen Levrant Heritage Architecture LTD) |
|---|---|---|---|---|---|
| No.6 | <p>Zinc cladding is a modern material which has become more common in recent years.</p> <p>It is hard wearing but requires substantial preparation works including replacement of insulation which would significantly alter the build up and appearance of the roof.</p> | | The roof covering can last in excess of 100 years provided it is maintained. | The roof covering itself is relatively low in weight. However, the fixings and substrate required to install a zinc roof would overload the roof. | This option uses inappropriate materials that are inappropriate for the date and style of the listed building and would result in an adverse impact. |

Option 6: Zinc

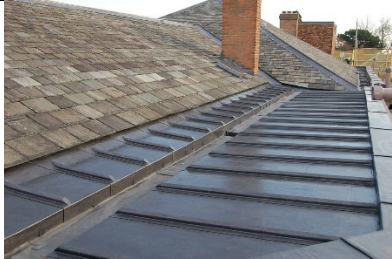
| Option | Description / Aesthetics | Example Image | Durability / Longevity | Structure | Heritage (Stephen Levrant Heritage Architecture LTD) |
|---|---|---|---|---|---|
| No.8 | <p>Like zinc, lead is very hard wearing. However, to cover the roof in lead would not be feasible due to size of the building.</p> <p>In addition, it would completely change the appearance of the building.</p> | | A lead roof will last circa 200 years with very little change in performance. | Not feasible as the weight would significantly overload the roof. | This option uses inappropriate materials that are inappropriate for the date and style of the listed building and would result in an adverse impact. |

Option 8: Lead

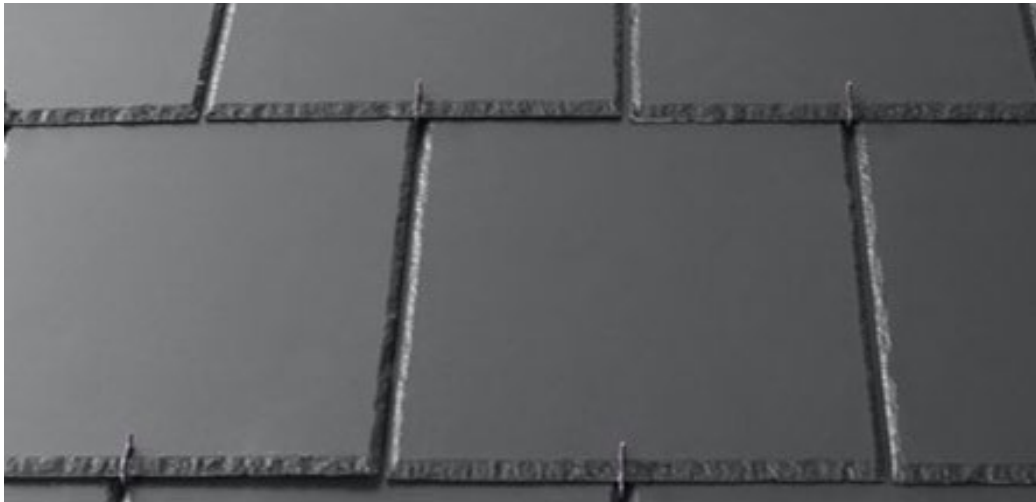
Photograph of Option 2, preferred tiles.

| Option | Description / Aesthetics | Example Image | Durability / Longevity | Structure | Heritage (Stephen Levrant Heritage Architecture LTD) |
|---|---|---|---|---|---|
| No.2 | <p>Man made slates are currently installed to the building.</p> <p>The existing are heavily weathered and contain asbestos.</p> <p>The new slates are light weight, durable tiles which will</p> | | The roof covering would last circa 50 years provided it is adequately maintained. | As the man made tiles are light weight, they can be installed to the roof without risk of any structural issues. | The existing tiles fitted with listed building consent in the 1980s are inappropriate for the date and style of the listed building. Replacing these with a modern equivalent would result in a neutral impact. |

| Option | Description / Aesthetics | Example Image | Durability / Longevity | Structure | Heritage (Stephen Levrant Heritage Architecture LTD) |
|---|---|---|---|---|---|
| | provide the closest possible match to those installed originally to the property. We believe these will be the best proposal for the building. | | | | |
