FIRST STREET, MANCHESTER

REMEDIATION COMPLETION REPORT  
FOR  
ALAN JOHNSTON PARTNERSHIP LLP

**Project Ref:**  
P10227

**Date:**  
June 2023

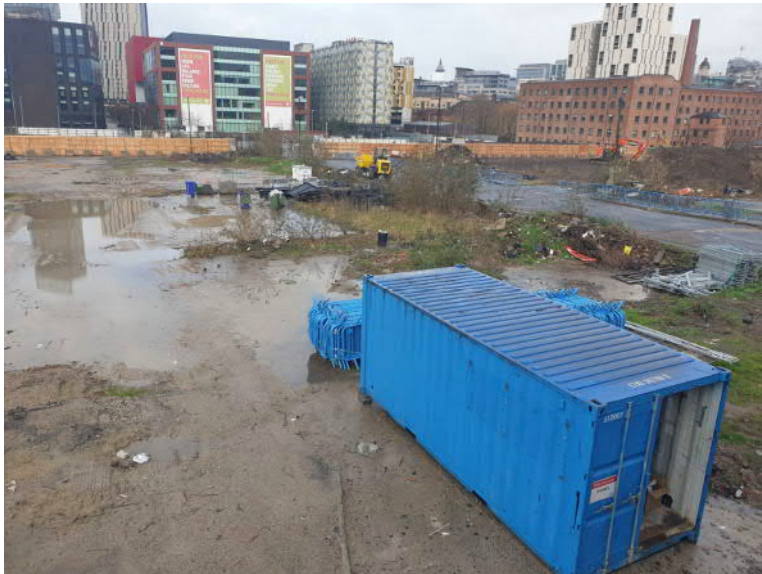
Photograph 1. Site overview – pre site works

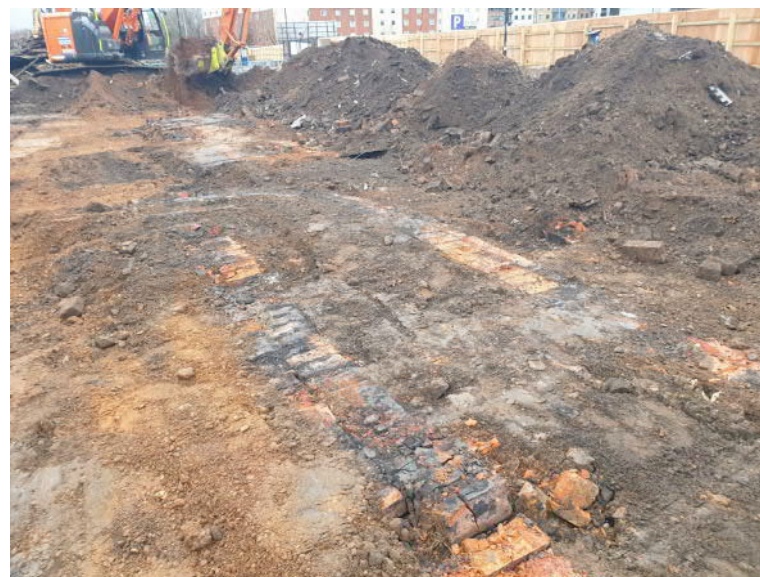
Photograph 4. Evidence of sub-surface obstructions

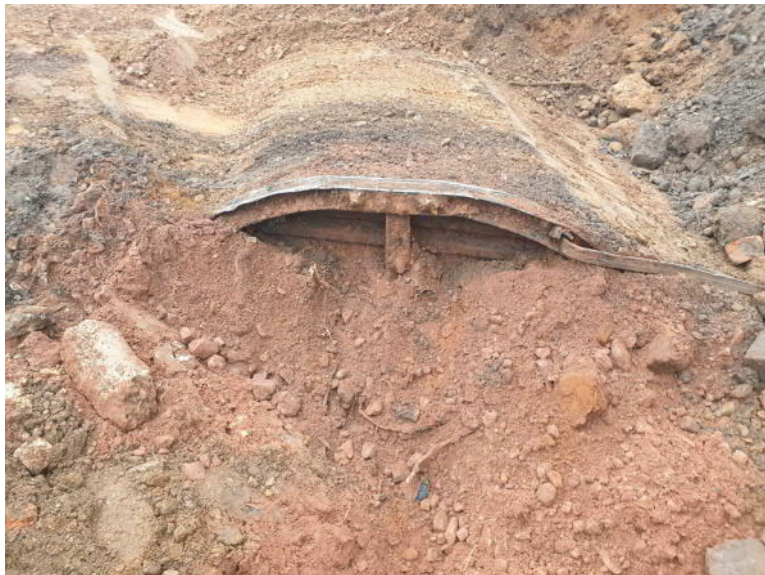
Photograph 5. Remnants of former air-raid shelter

When investigating these areas, the former air-raid shelter was found to have been infilled with a mixture of brick, concrete, sand and clay, and there were remnant artifacts uncovered, but no sub-surface slabs identified within this area.

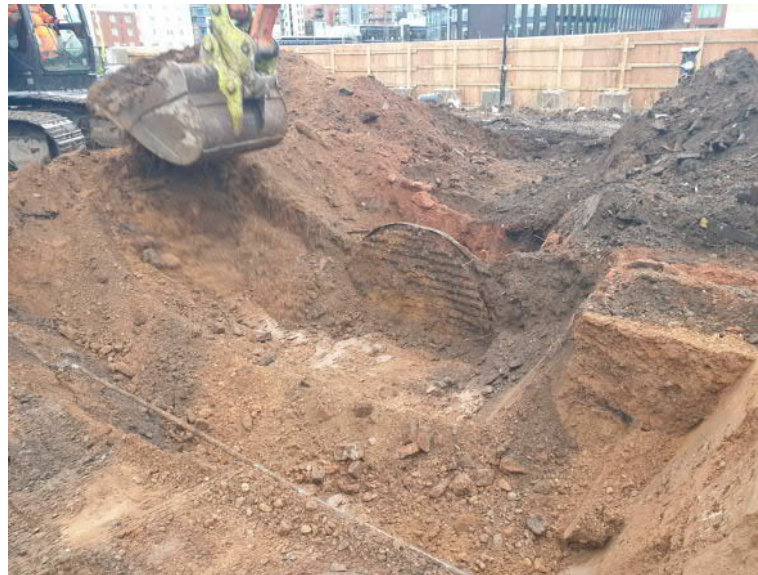
Photograph 6. Remnants of former air-raid shelter

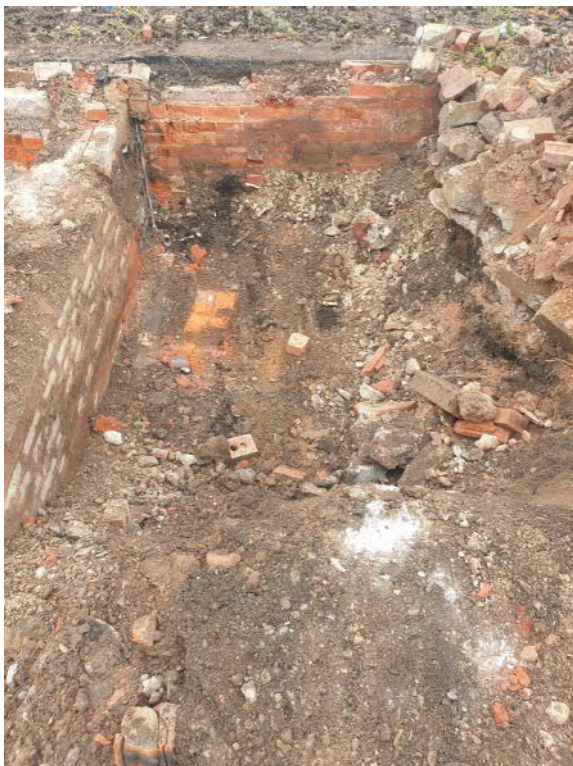
Photograph 7. Former basement area to the east

Within the area of the former basement to the east, the backfill materials were excavated, and the hardcore arisings were segregated and crushed for re-use. The full depth of the basement was exposed (c. 2.3m bgl) to the basement floor slab. The basement slab was broken out and the concrete was crushed. The basement area was then backfilled with the site-won crush.

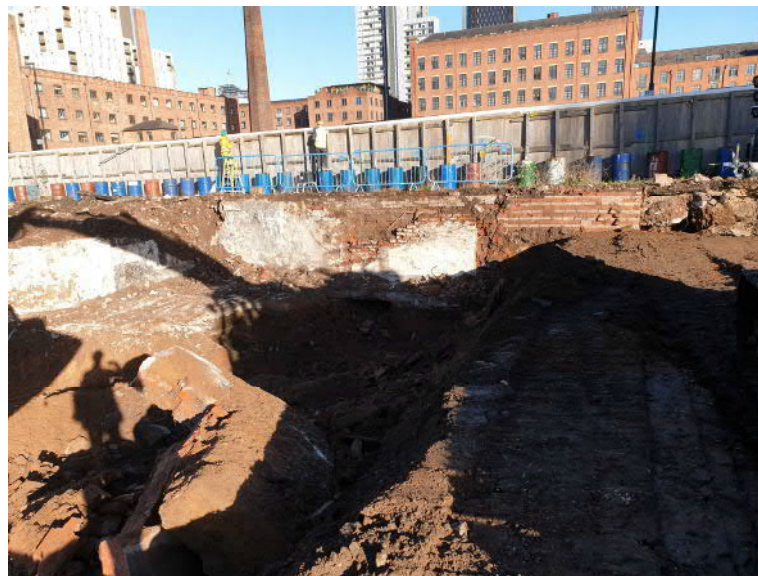
Photograph 8. Former basement area to the east

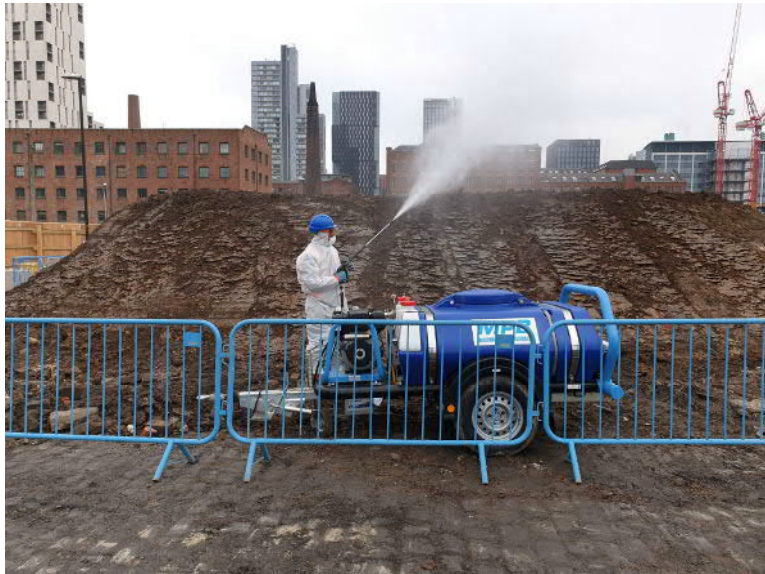
Photograph 9. Dust-suppression measures to dampen stockpiles

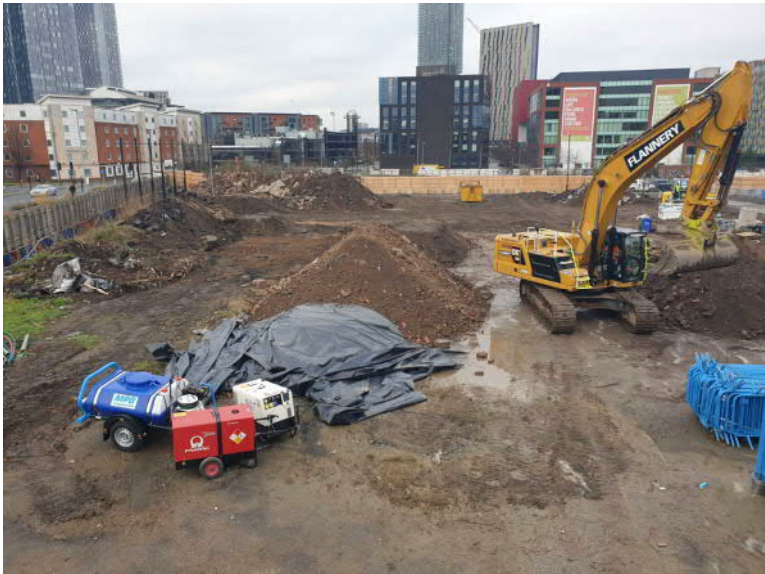
Photograph 10. Stockpile segregation

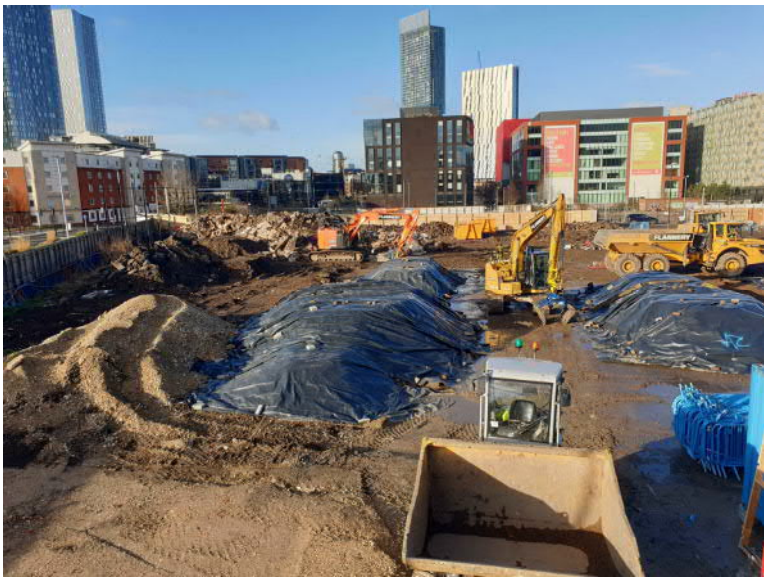
Photograph 11. Sheeted stockpiles

Photograph 12. Sheeted stockpiles

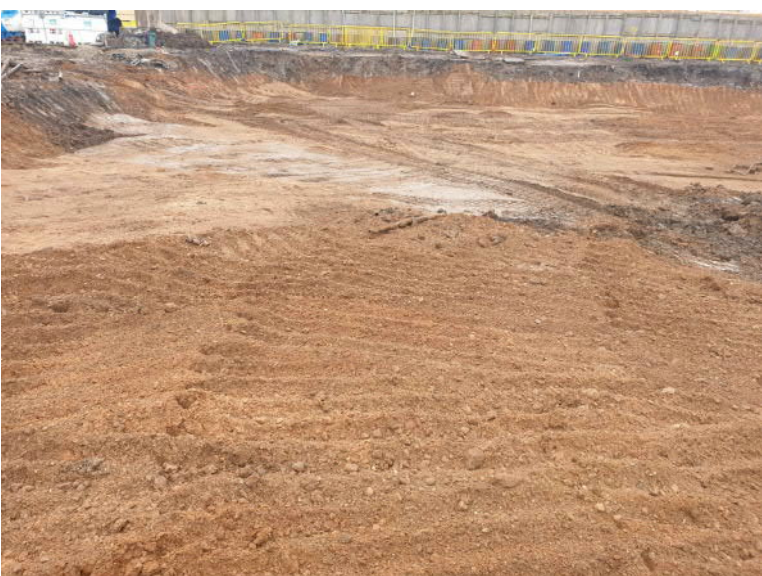
Photograph 14. Site-preparation, cut levels

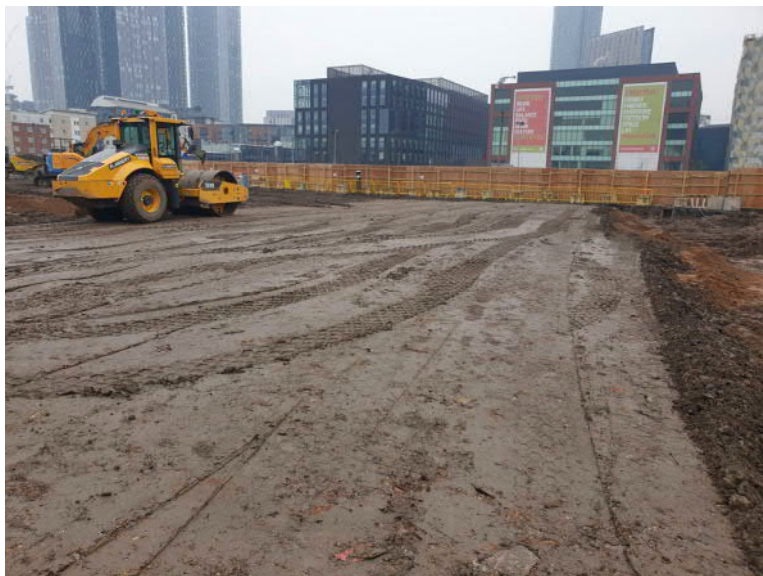
Photograph 15. Surface preparation for piling mat

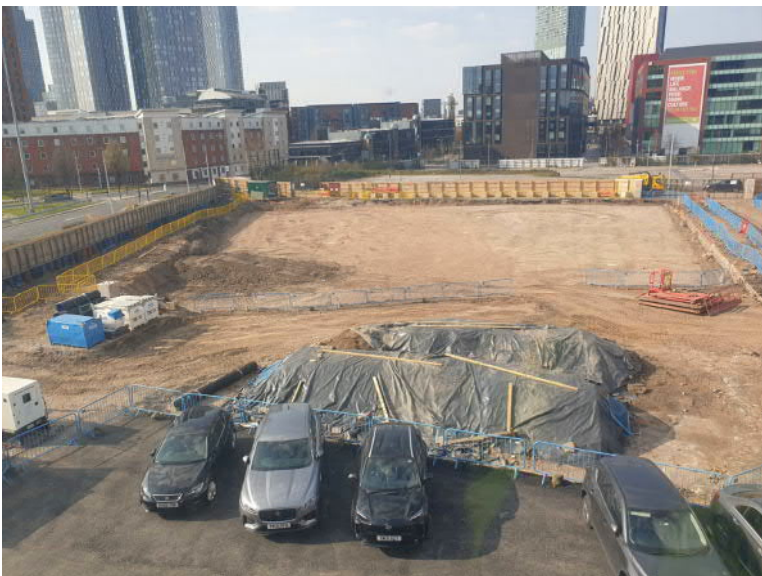
Photograph 12. Sheeted stockpile prior to off-site disposal

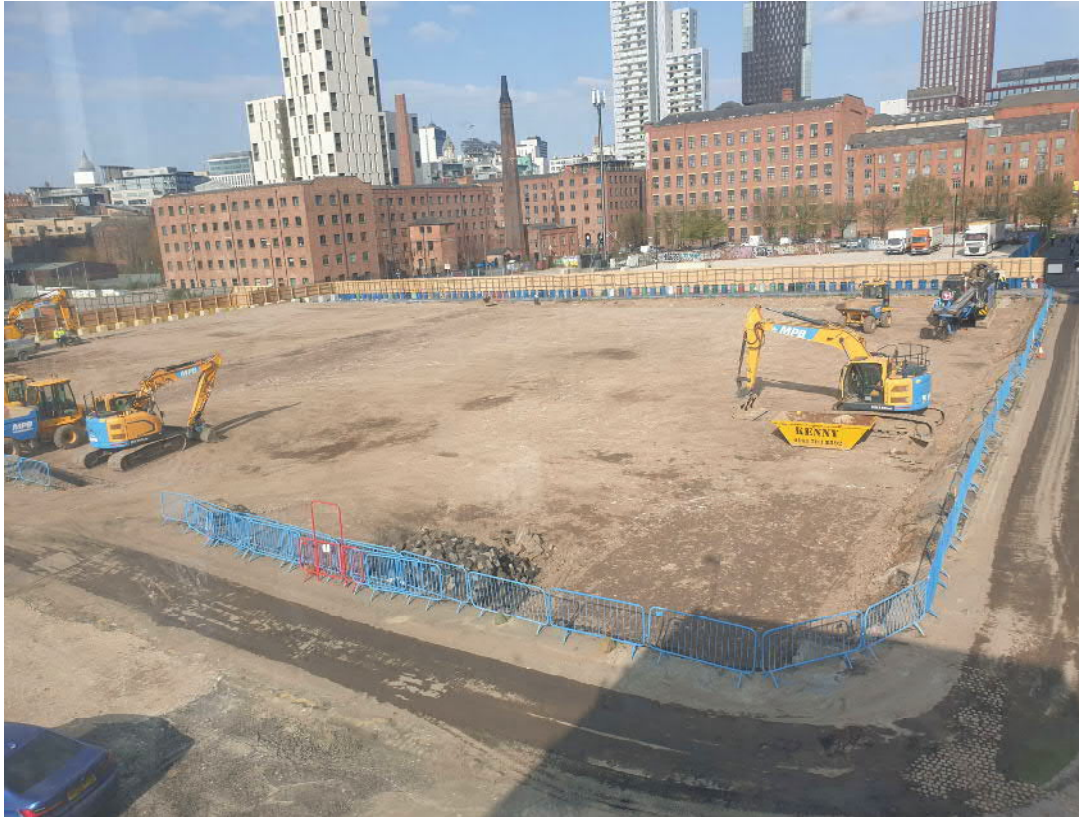
Photograph 13. Site overview - completed site works
