# POLLARD STREET MANCHESTER

## FINAL PHASE 2 GEO-ENVIRONMENTAL INVESTIGATION, RISK ASSESSMENT AND REMEDIATION STRATEGY

**Job Number:** LKC 20 1301

**Date:** December 2022

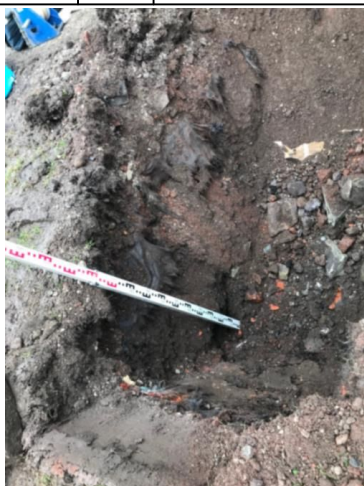
Trial pit terminated due to instability of side walls.  
Trial pit was dry.  
Location and elevation taken from GPS survey.  
Soakaway test carried out in trial pit, see separate sheet with corresponding location name.

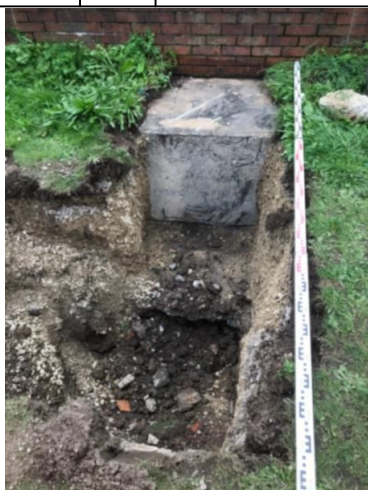
Detailed drawing can be found in figure 4.  
Concrete slab (possible capping beam) encountered at 0.07mbgl. Extending out from brick wall by 0.70mbgl.  
Additional concrete encountered at 1.01mbgl. Extending out from possible capping beam by 0.80m.  
Pit was noted to be stable and dry.  
Location and elevations taken from GPS survey.

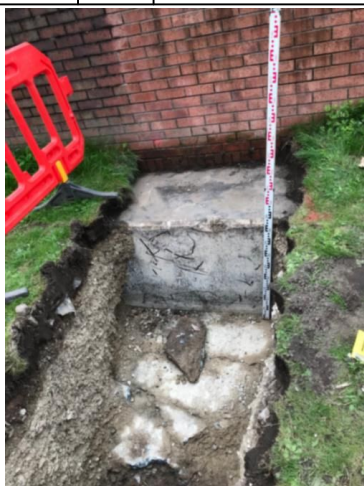
Concrete slab (possible capping beam) encountered at 0.21mbgl. Extending out from brick wall by 0.7mbgl.  
Additional concrete encountered at 0.80mbgl. Extending out from possible capping beam by 1.00m.  
Pit was noted to be stable and dry.  
Location and elevations taken from GPS survey.  
Detailed drawing can be found in figure 4.

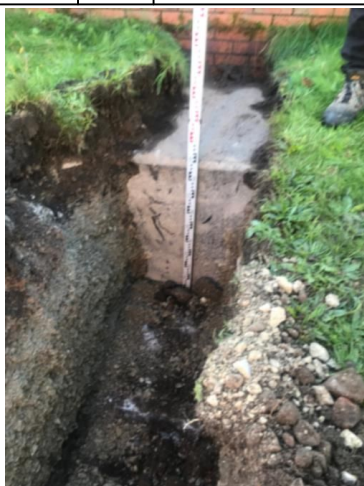
Detailed drawing can be found in figure 4.  
Concrete slab (possible capping beam) encountered at 0.21mbgl. Extending out from brick wall by 1.00m.  
Additional concrete encountered at 1.11mbgl. Extending out and rising to groundlevel from possible capping beam by minimum 2.50m, unable to located edge.  
Pit was noted to be stable and dry.  
Location and elevations taken from GPS survey.

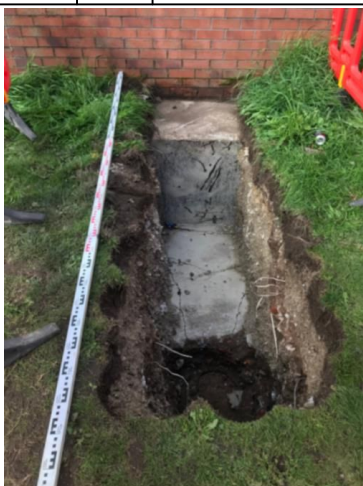
Detailed drawing can be found in figure 4.  
Concrete slab (possible capping beam) encountered at 0.10mbgl. Extending out from brick wall by 0.60m.  
Additional concrete encountered at 0.99mbgl. Extending out from possible capping beam by 1.00m.  
Pit was noted to be stable and dry.  
Location and elevations taken from GPS survey.

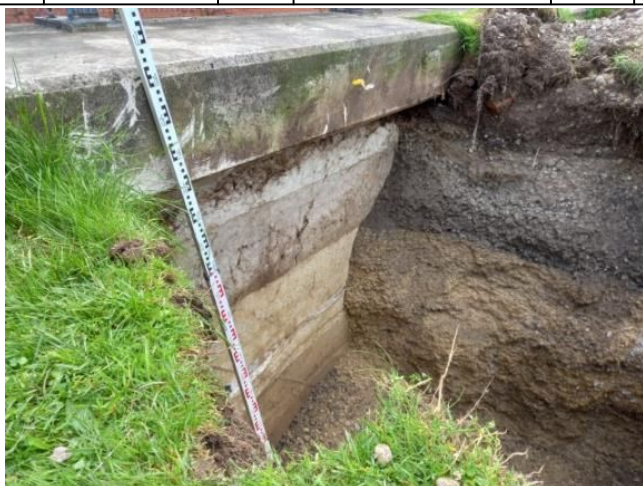
Detailed drawing can be found in figure 4.  
Concrete slab (possible capping beam) encountered at 0.10mbgl. Extending out from brick wall by 0.20m.  
Concrete foot encountered at 2.70mbgl. Extending out from possible capping beam by 2.00m.  
Pit was noted to be stable and dry.  
Location and elevations taken from GPS survey.

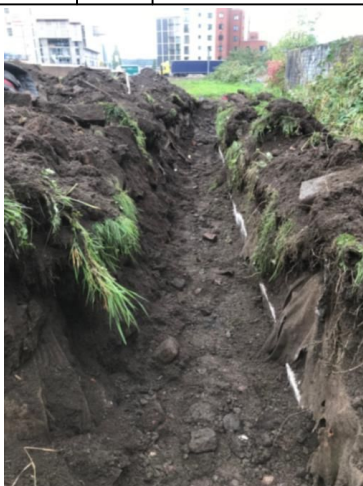
Detailed drawing can be found in figure 4.  
Location and elevation taken from GPS survey.  
Trial pit was dry and stable.  
Concrete slab encountered at 0.40mbgl from brick wall, extending 2.00mbgl away from wall.  
Lower concrete slab encountered at 0.6mbgl, extending to 10.90m away from brick wall.  
Pit extended parallel with brick wall by 16.0m. Edge of upper concrete slab encountered to the southwest, see separate diagram. Edge to the northeast not encountered.

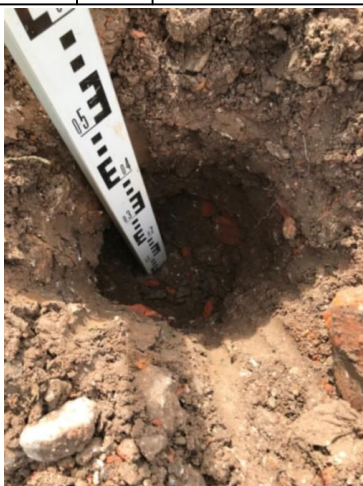
| Depth<br>(m) | Sample / Tests | Water<br>Depth<br>(m) | Field Records | Level<br>(mOD) | Depth<br>(m)<br>(Thickness) | Description | Legend | Water |
|---|---|---|---|---|---|---|---|---|
| 0.00-0.50 | ES PID=<0.1ppm | | | | <div><div></div><div>(0.70)</div><div>0.70</div></div> | <div>MADE GROUND: Dark brown sandy silty GRAVEL comprising predominantly brick and concrete with occasional ash, clinker, rare rootlets, tarmacadam and metal. Sand is fine to coarse. Gravel is fine to coarse, subangular.</div> <div>Complete at 0.70m</div> | <div></div> | |

Pit was dry and stable.  
Carried out in previously excavated area.

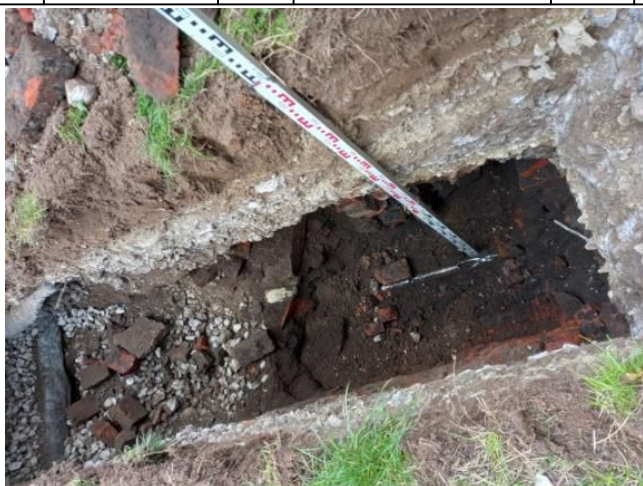
| Depth (m) | Sample / Tests | Water Depth (m) | Field Records | Level (mOD) | Depth (m) (Thickness) | Description | Legend | Water |
|---|---|---|---|---|---|---|---|---|
| 2.20-3.20 | SV 140kPa | | | | (1.50) | Concrete slab noted at 2.20mbgl. | | |
| | | | | | 3.70 | Terminated at 3.70m | | |

Trial pit was dry and stable.  
Location and elevation taken from GPS survey.

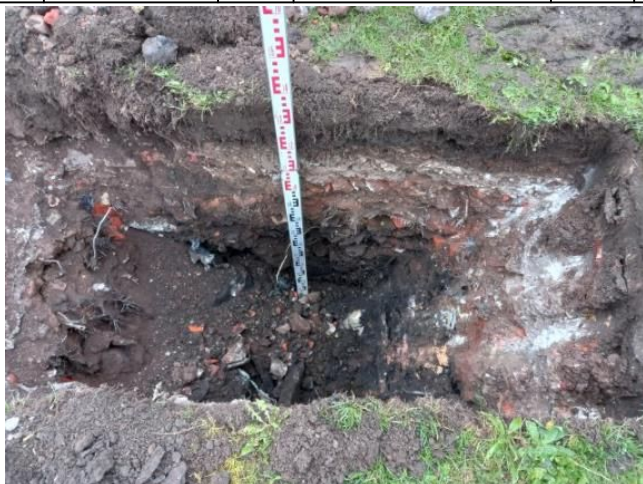
Trial pit was dry. Noted to be collapsing at 0.70mbgl.  
Terminated due to presence of metal pipe at 2.00mbgl.  
Location and elevation taken from GPS survey.
