**BAT PRESENCE / ABSENCE SURVEY**

**2 Turnpike Walk**

Beswick  
Manchester  
M11 3TH

| UES reference: | UES03961/02 |

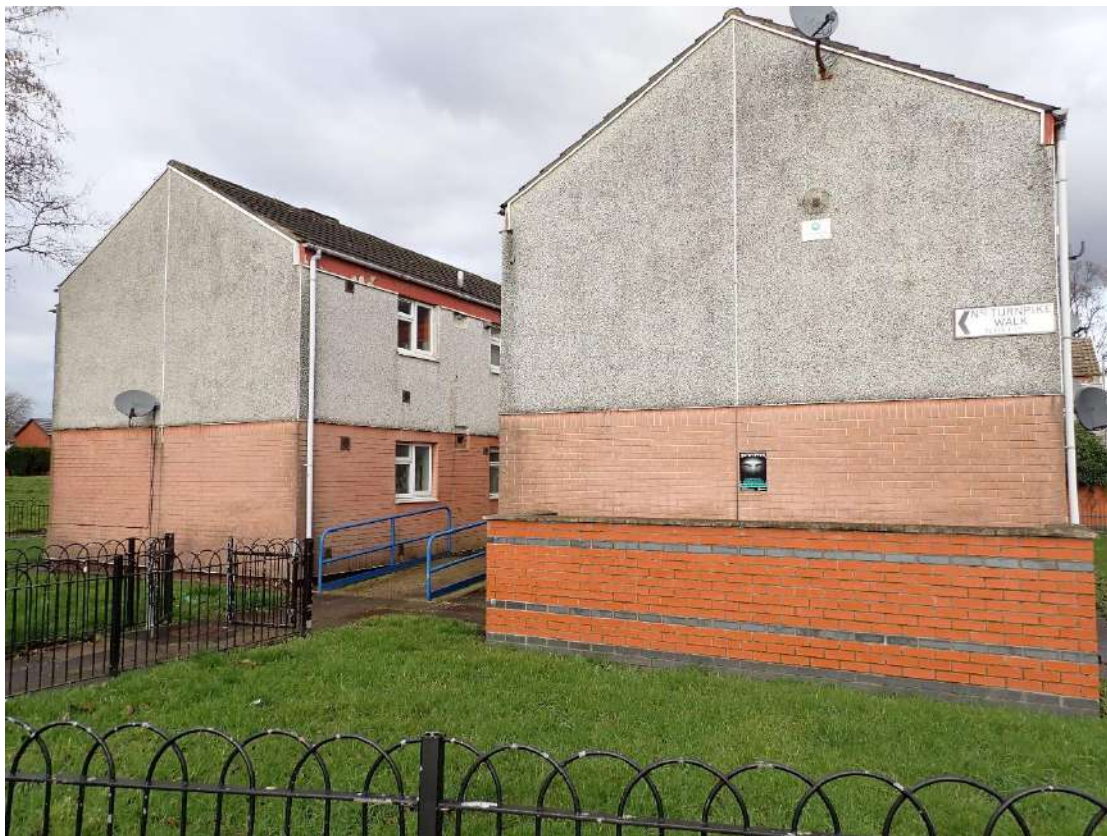
2 Turnpike Walk is a 'H' shaped block of residential flats that are currently unoccupied. The building consists of four ground floor and four first floor flats, and a central corridor that connects the two sides of the building (Photographs 1 to 3).

Photograph 1. The southern aspect of the building.

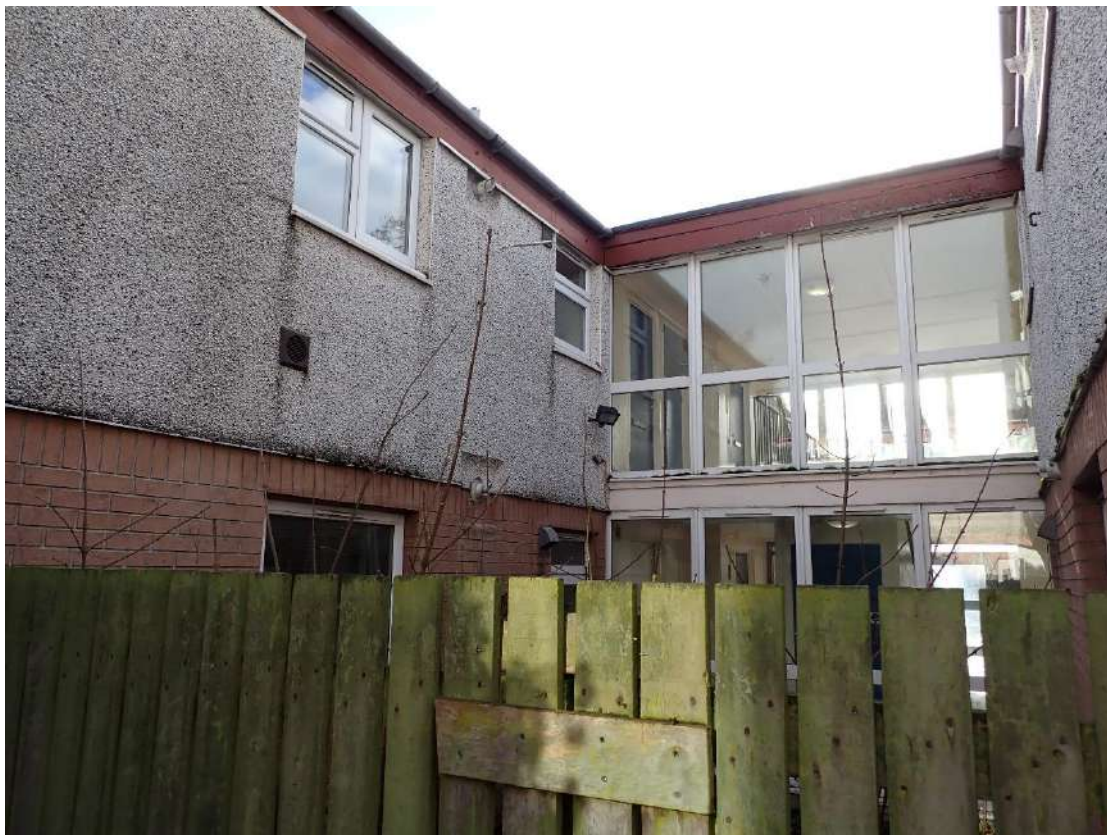
of Flat 15, that measures approximately 10mm (Photograph 6). A bird's nest was also identified in a gap underneath the wooden barge board on the eastern aspect of Flat 13 (Photograph 7). There was an additional gap in the barge board on the northern facing side of the central corridor section that provides a PRF (Photograph 2).

Photograph 2. The northern aspect of the central corridor.

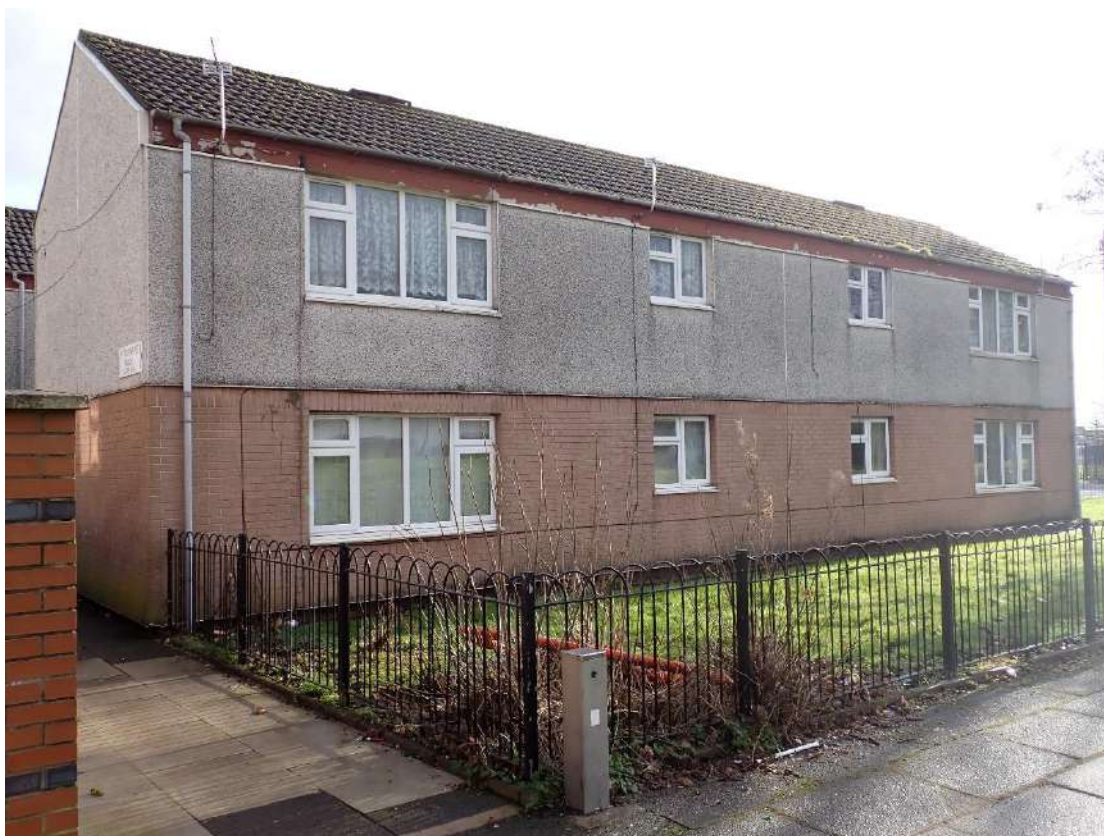
Photograph 3. The western aspect of the building.

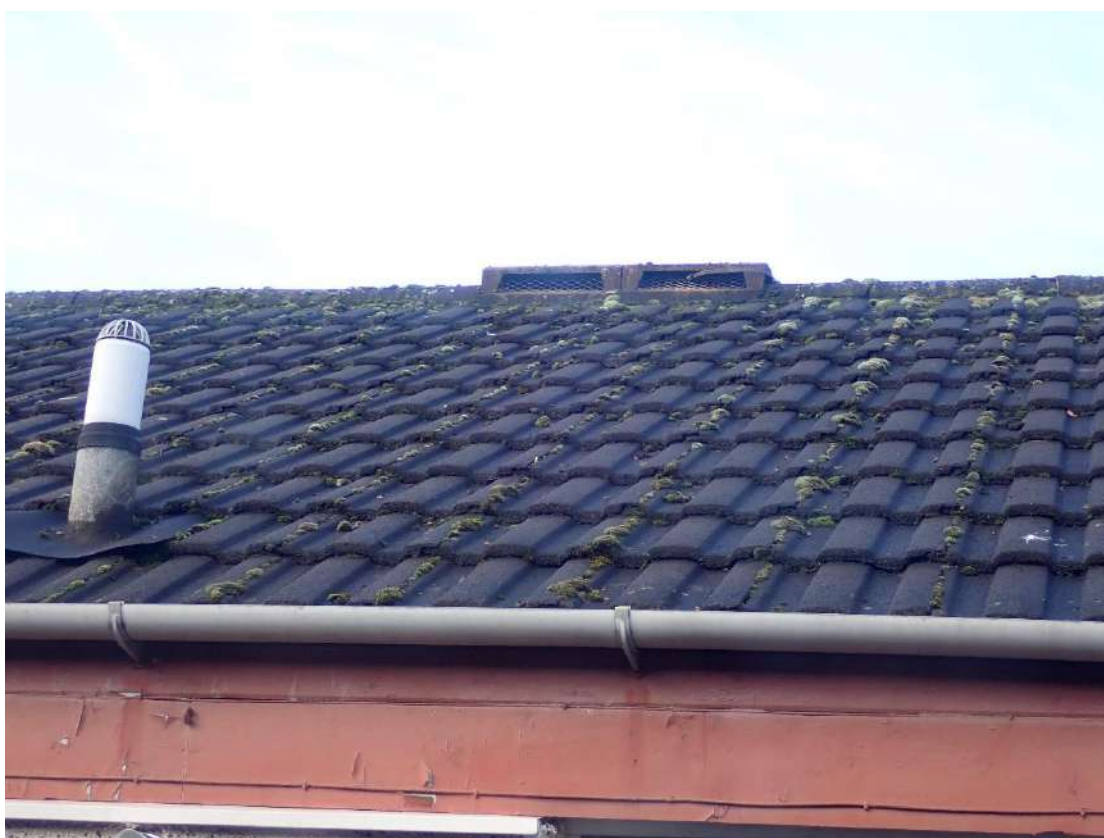
The building has a pitched roof structure, with interlocking roof and ridge tiles. Both the tiles and the mortar along the ridge tiles are in good condition with minimal gaps (Photograph 4). There are grills covering the ventilation shafts on the roof of Flats 9 and 13, however, they have gaps on the side of them which could provide potential access to the loft space (Photograph 4). There are also ventilation covers on the roof of Flats 11 and 15 that have gaps which may also provide a potential access point into the loft spaces (Photograph 5). There are four ventilation tubes on the roof of the building, one above each of the first-floor flats, that are surrounded by a plastic polyethylene membrane. The membrane is slightly raised which could provide a PRF or access point to the loft space (Photographs 4 and 5).

Photograph 4. The grills covering the ventilation shaft above Flat 13.

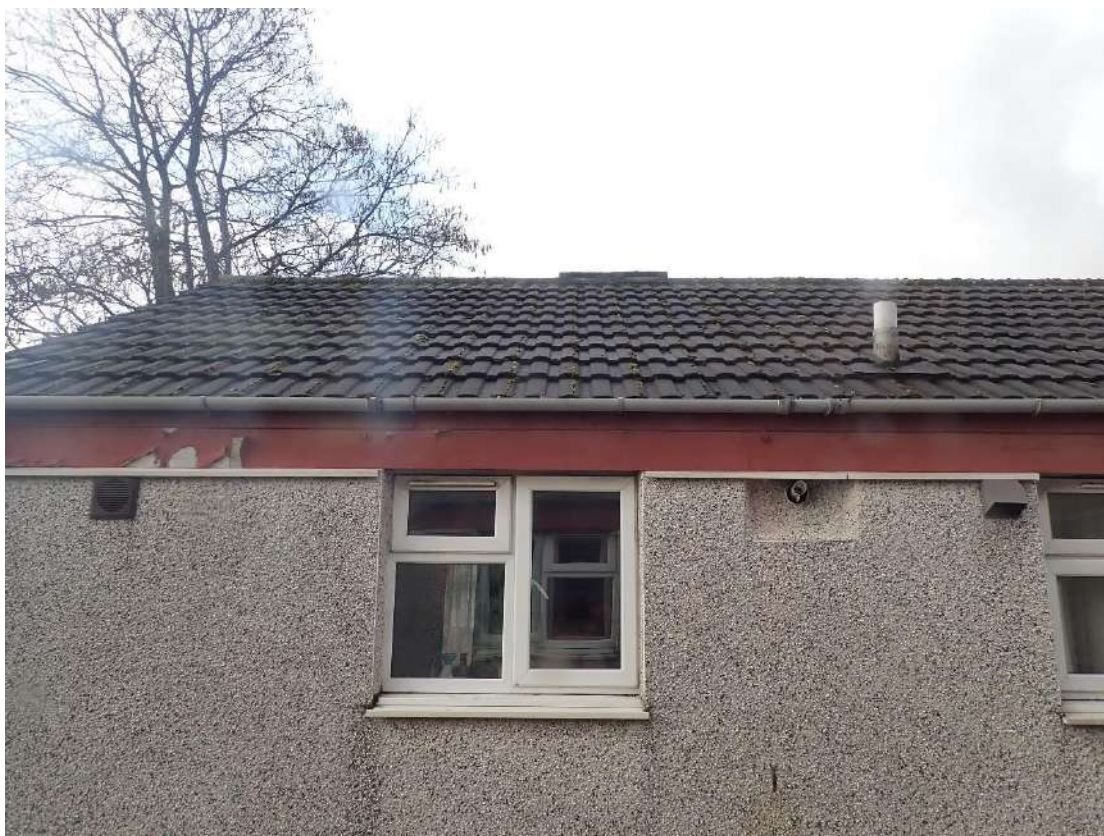
Photograph 5. The cover over the ventilation shaft above Flat 15, the eastern aspect of the building.

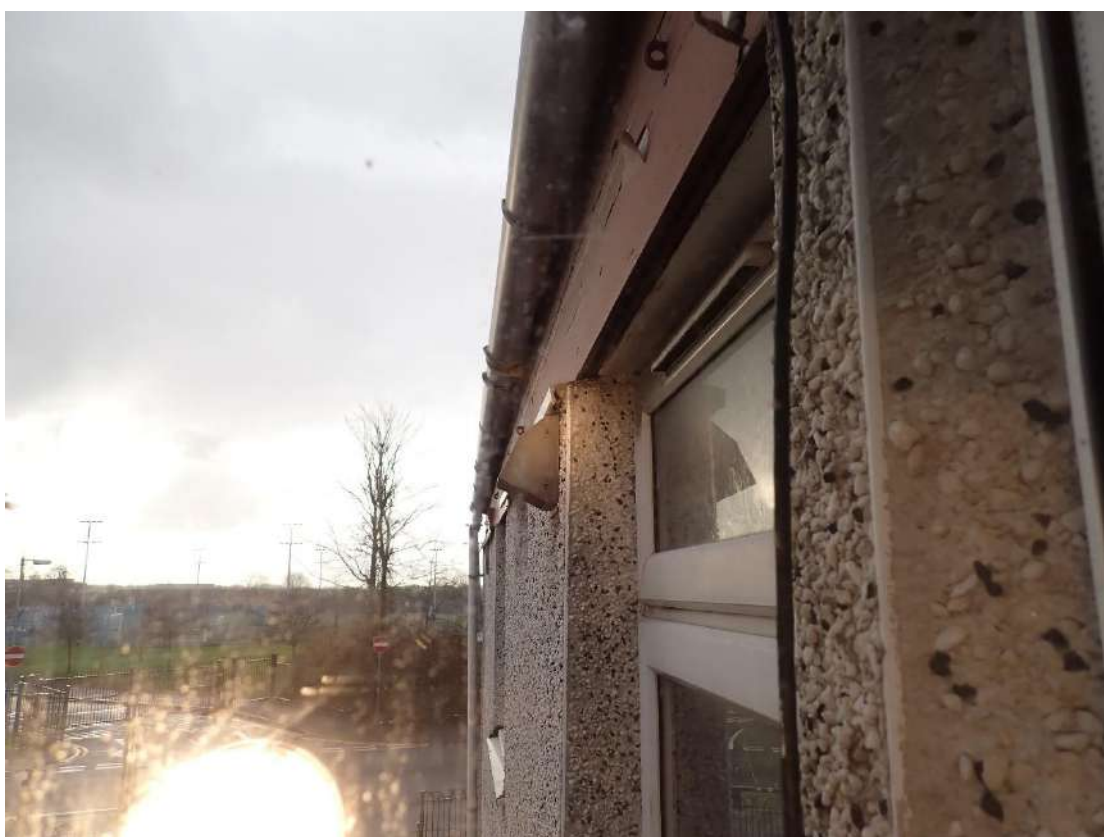
There are wooden barge boards at the eaves of the building that provide multiple PRFs, including a gap between the barge board and the top of the wall plate on the eastern aspect

Photograph 6. The gap between the wooden barge board and the top of the wall plate on the eastern aspect of Flat 15. Also, the gap between the PVC capping and the ventilation cover.

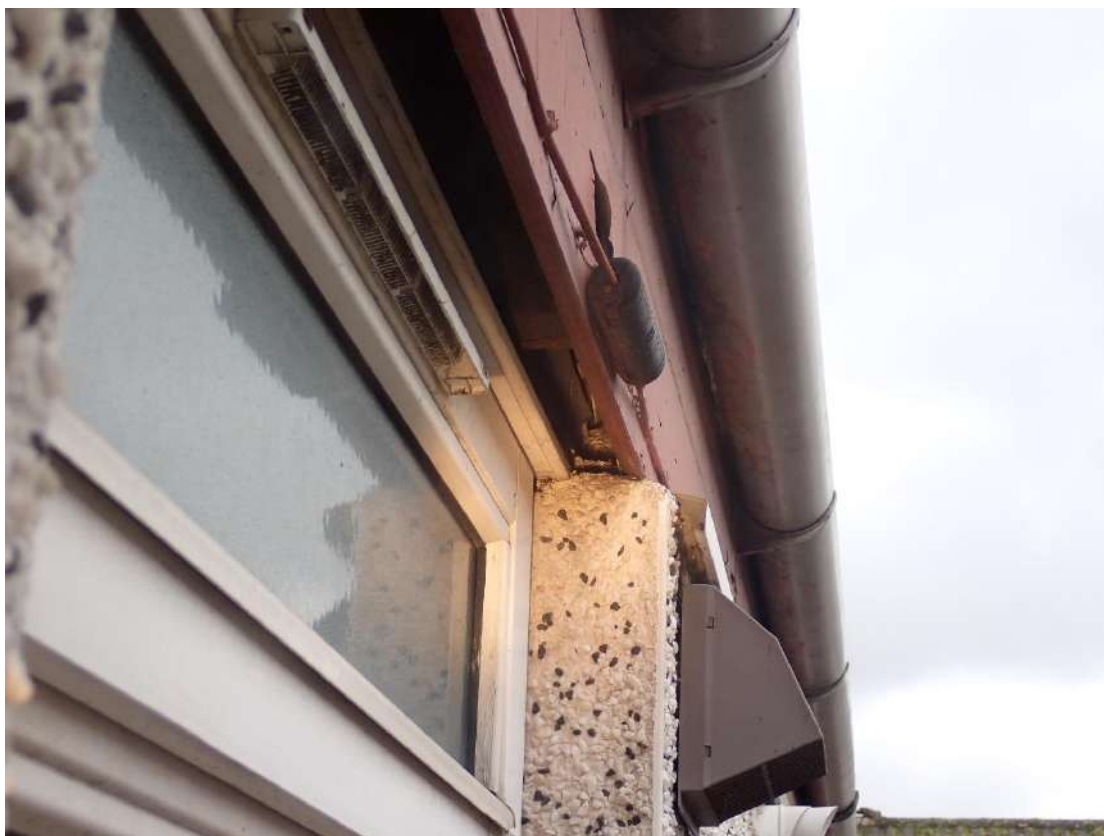
Photograph 7. The bird's nest and gap under the barge board on the eastern aspect of Flat 13.

Due to the potential presence of breeding birds within the building at the time of development, it is recommended that the works take place outside of the breeding bird season and should not be undertaken from March to August inclusive. If this is not possible, a breeding bird nest check should be undertaken prior to the commencement of works by a suitably experienced ecologist, and an ecological clerk of works appointed if considered necessary.

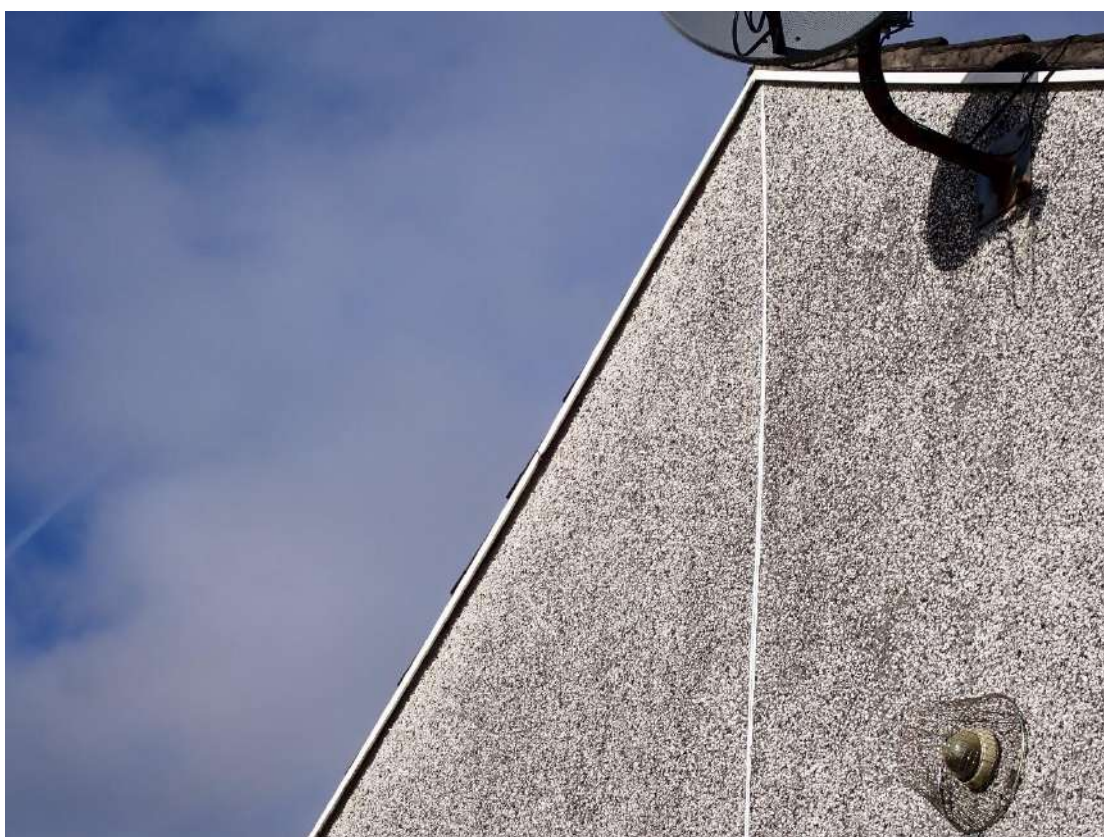
The wall plates have a PVC capping which has small gaps underneath it on the southern aspect of the building, approximately 2m west of the apex that provides a PRF (Photograph 8). There is also a gap between the PVC capping and a ventilation cover on the eastern aspect of Flat 15 that provides a PRF (Photograph 6). The walls are constructed from redbrick, and the upper half of the wall has a pebble dash render. Several PRFs were identified at the top of the wall plate on the eastern aspect of the building, including two gaps between the wall plate and wooden barge boards at the corner of two separate windows (Photographs 9 and 10).

Photograph 8. The gaps underneath the PVC capping on the southern aspect of the building.

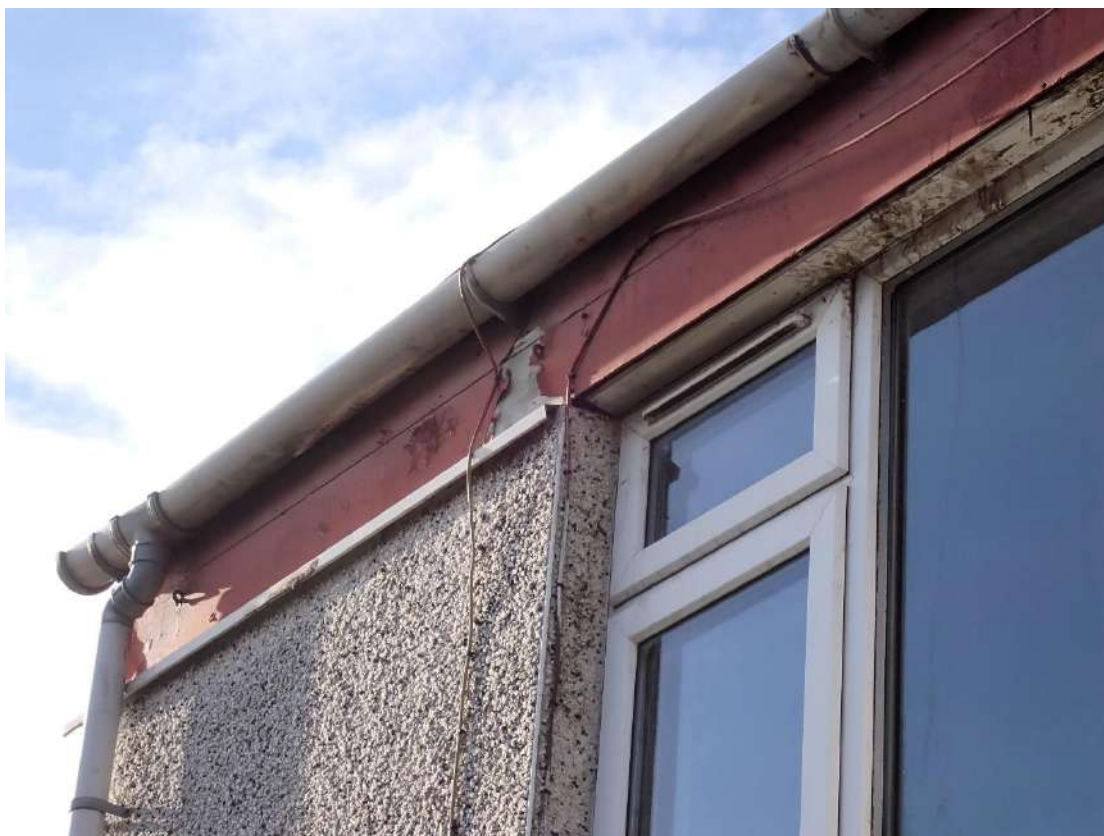
Photograph 9. A small gap between the wooden barge board and the top of the wall plate on the eastern aspect.

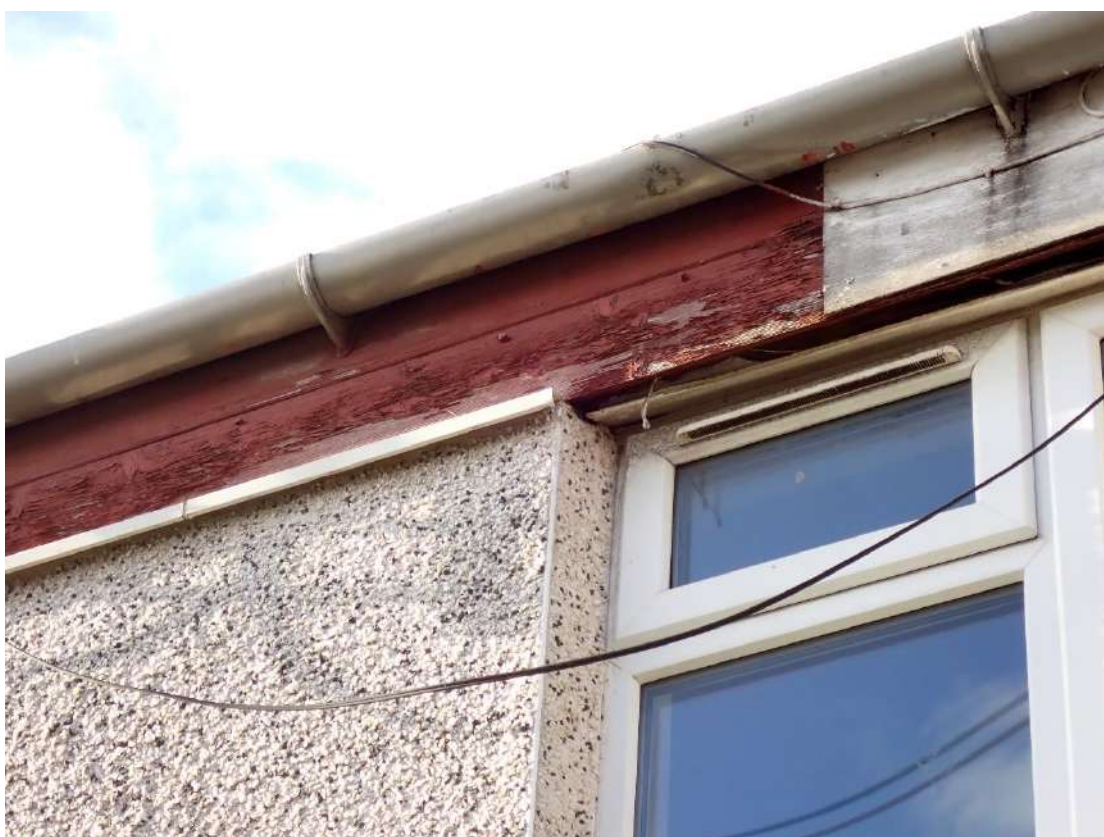
Photograph 10. A gap between the top of the wall plate and barge board on the eastern aspect.

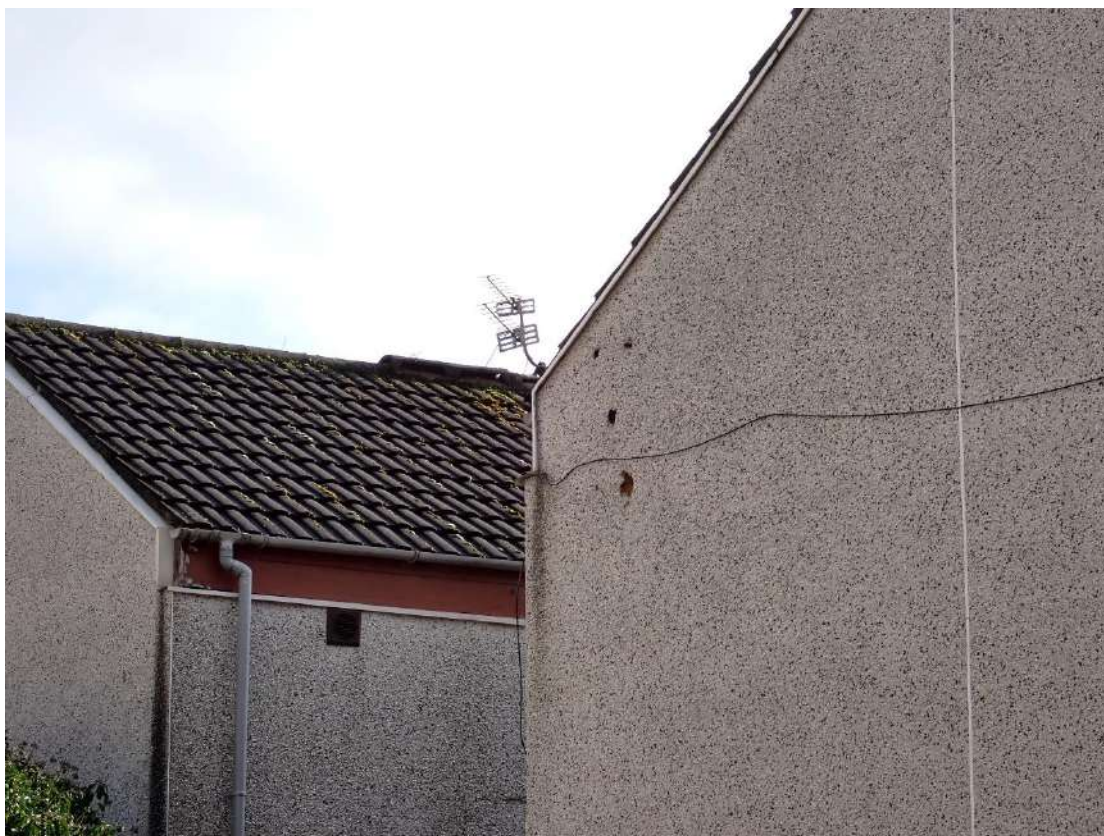
The walls are in relatively good condition except for the wall on the northern aspect of the building. This is due to the presence of four holes in the render that provide PRFs (Photograph 11). The features could not be inspected from the ground level due to their height.

Photograph 11. Four holes located on the northern aspect of the building.

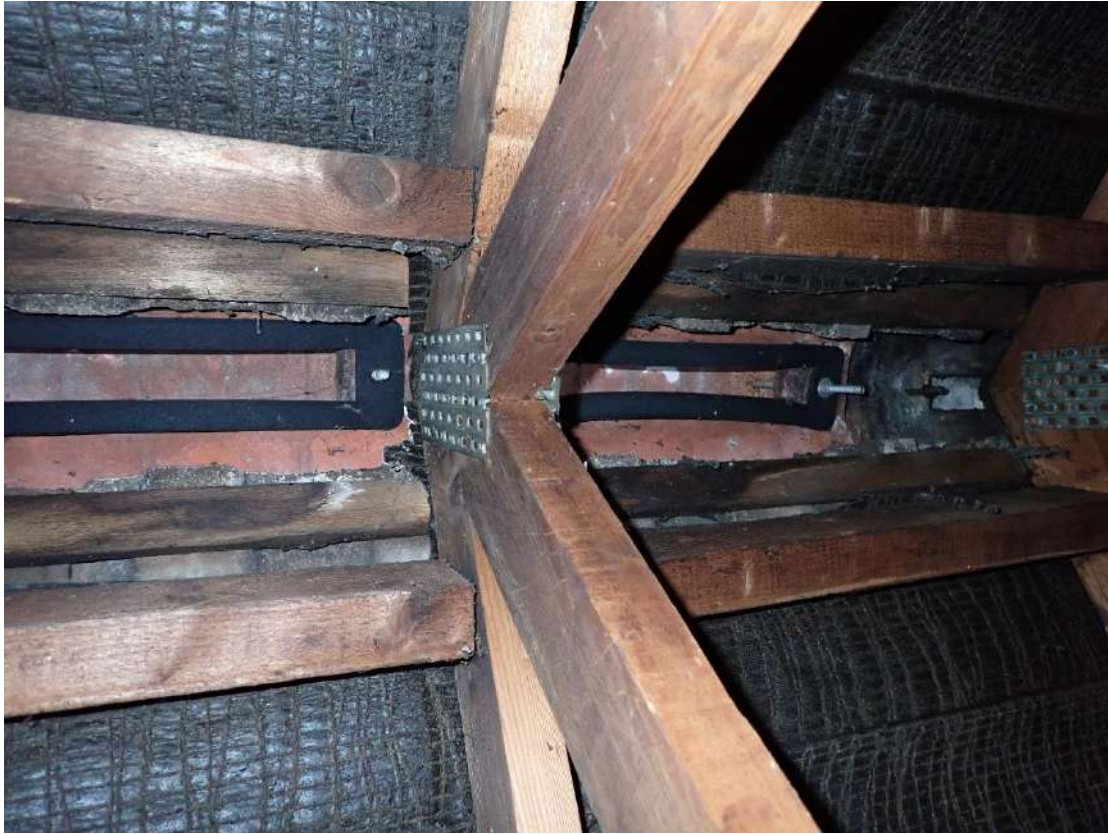
The structure of the internal loft space is the same across Flats 9, 11, 13 and 15, consisting of a queen's post truss with a maximum height of 1.7m from floor to ridge beam (Photograph 12). The roof is lined with bitumen felt and the floor is insulated with mineral wool insulation. All of the loft spaces have a central ventilation system that has a gap around it, with a viewpoint of the ridge tiles (Photograph 13). These features could provide a potential access point into the loft space.

Photograph 13. The viewpoint of the ridge tiles from the centre of the loft space in Flat 9.

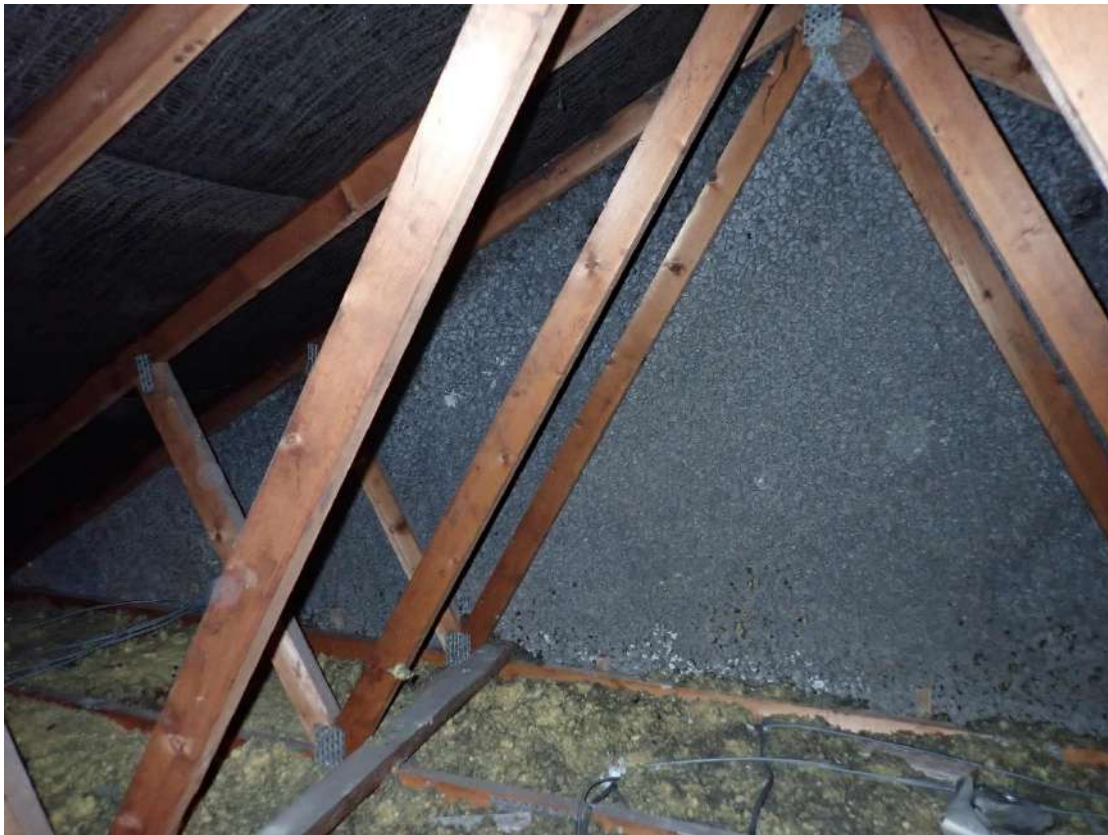
Each loft space contains two internal stone render walls, on the northern and southern aspects that separate the adjacent lofts (Photograph 14). The walls are in good condition in Flats 11 and 13, but several cavities were identified in Flats 9 and 15.

Photograph 14. The internal stone render wall in Flat 9.

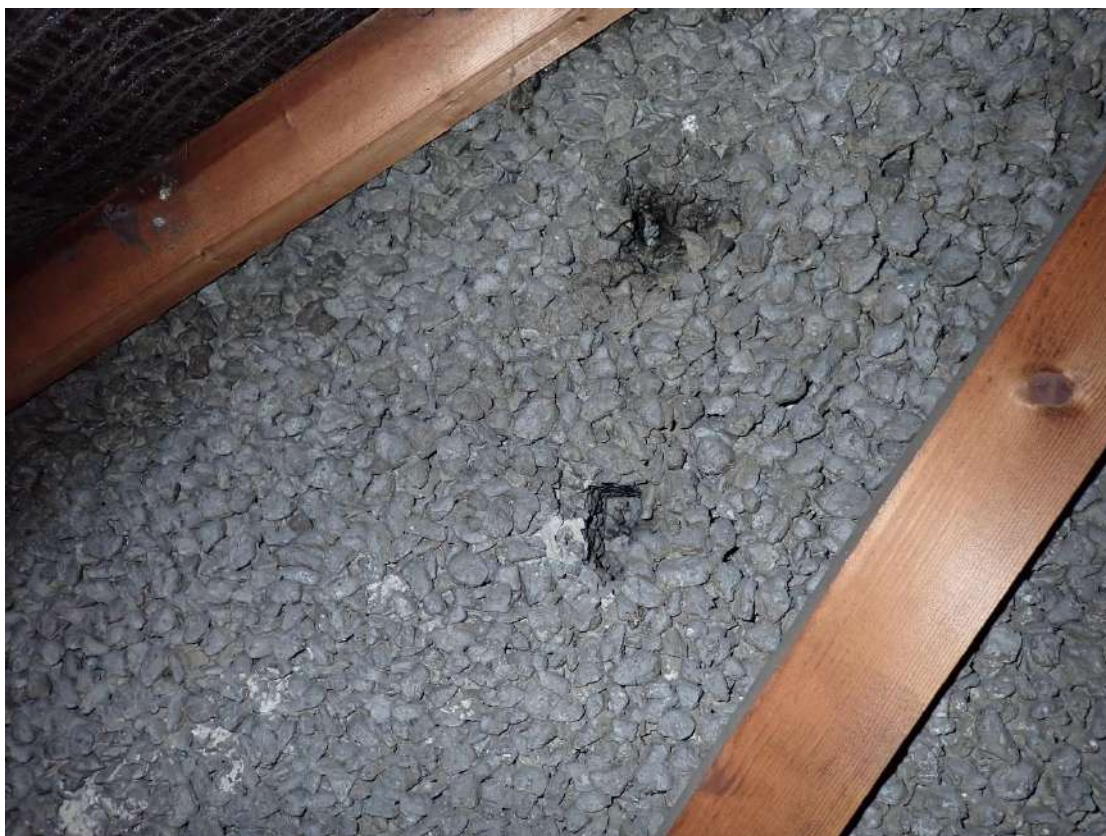
**Flat 9** is located on the north-eastern aspect of the building. The internal stone render wall on the northern aspect of the loft space had multiple cavities (Photograph 15). One cavity measures approximately 3 x 3 x 15cm and provides a PRF. There is a potential access point in the loft space where the bitumen felt lining should be. Bird droppings and a starling *Sturnus vulgaris* or house sparrow *Passer domesticus* nest were identified within the loft space during the survey (Photographs 16 and 17). Mouse droppings were also identified (Photograph 18), but there was no evidence of roosting bats.

Photograph 15. The cavities in the stone render wall, in the loft space of Flat 9.

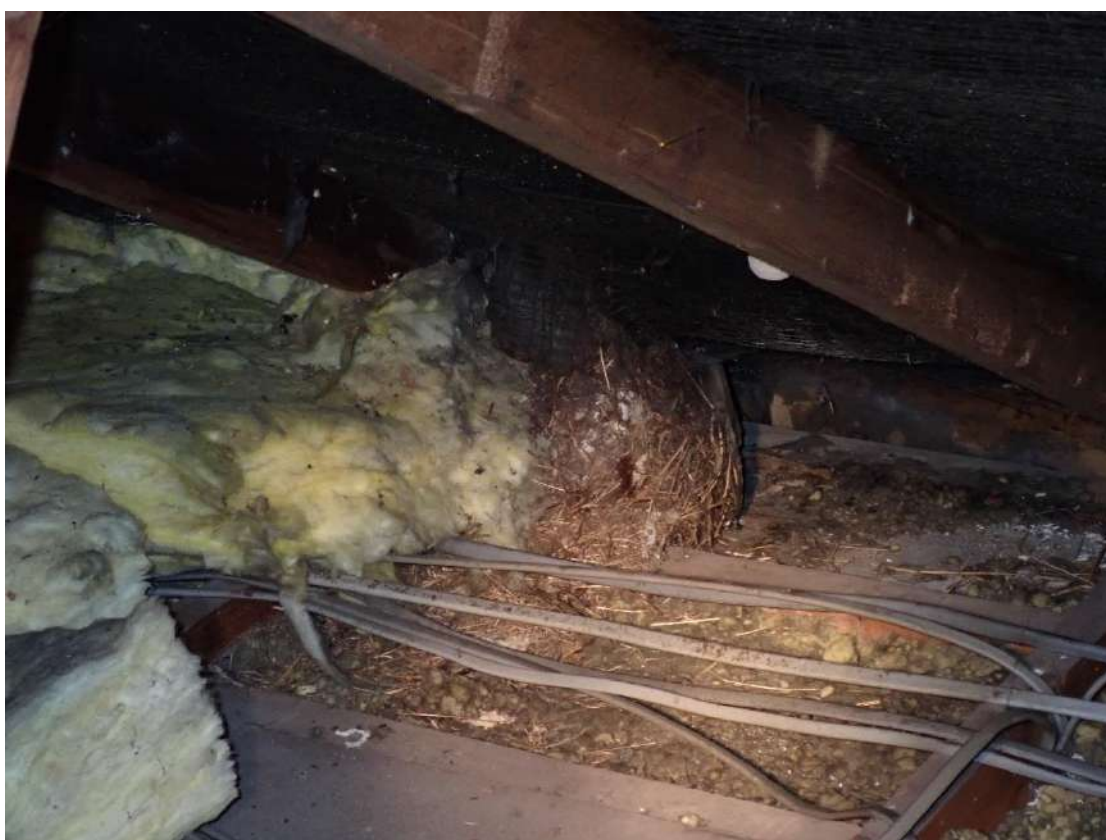
Photograph 16. The bird's nest identified in the loft space of Flat 9.

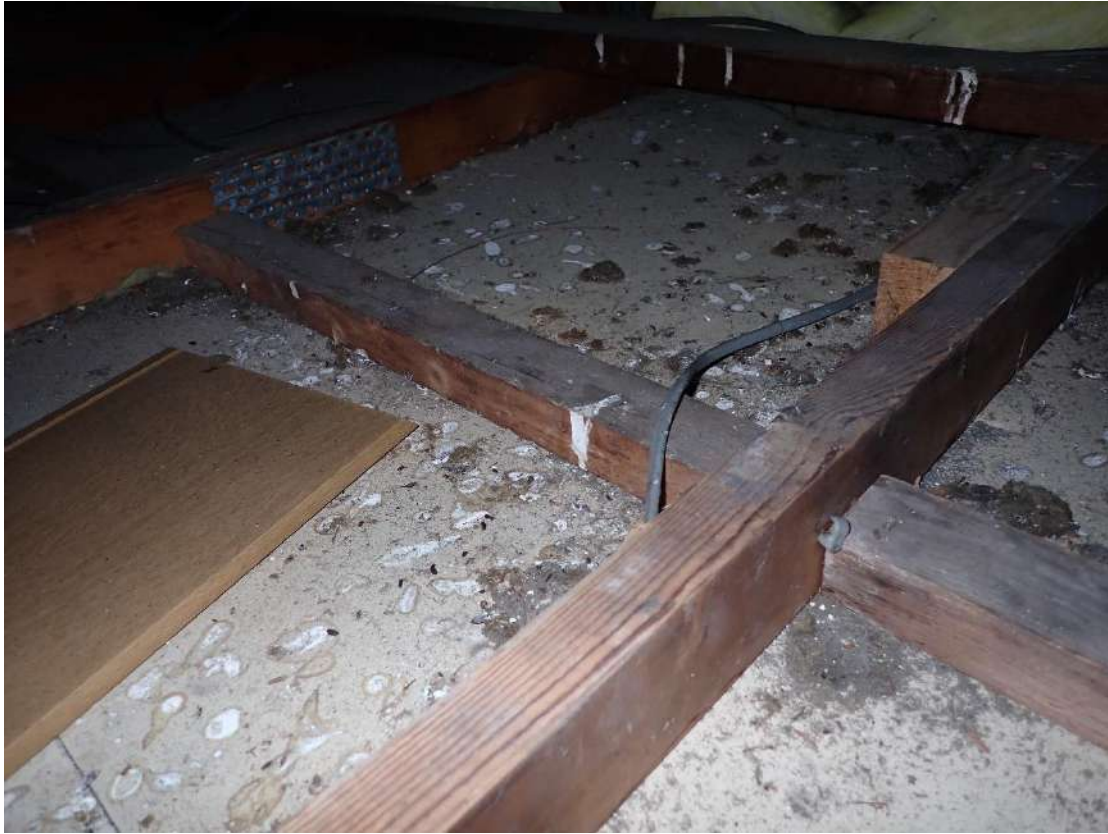
Photograph 17. The bird droppings in the loft space of Flat 9.

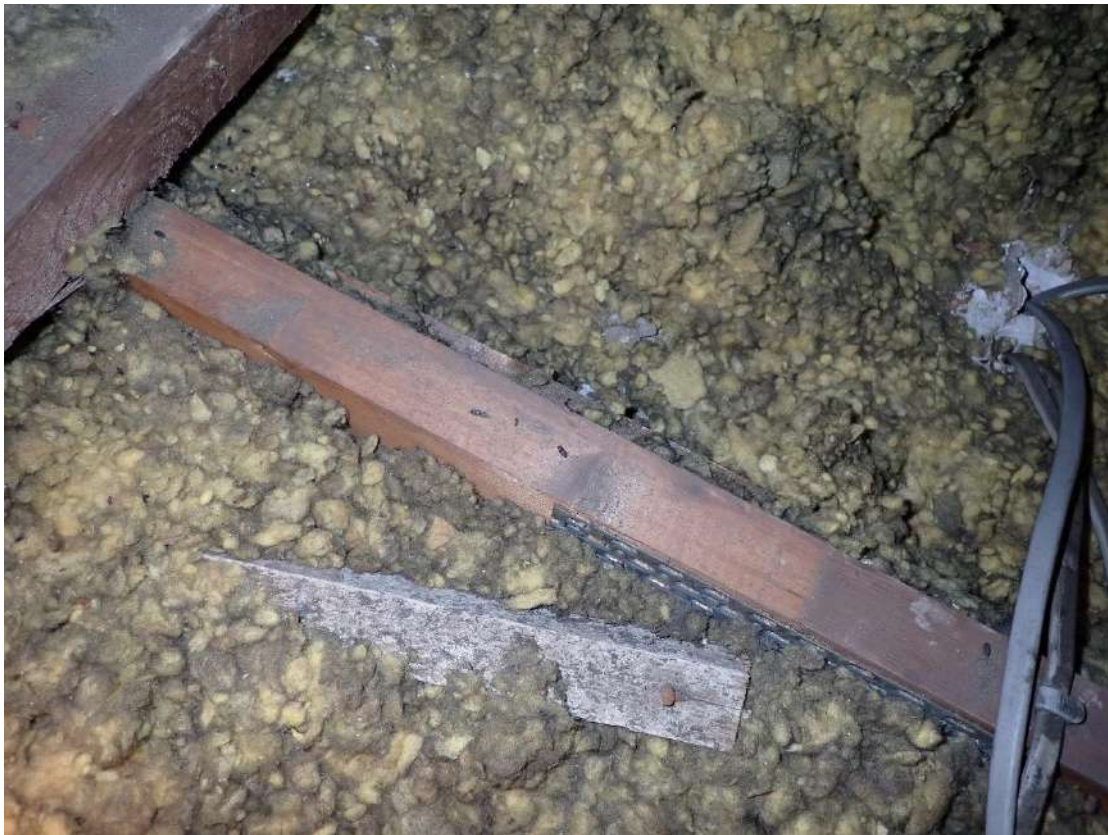
Photograph 18. The mouse droppings found in the loft space of Flat 9.

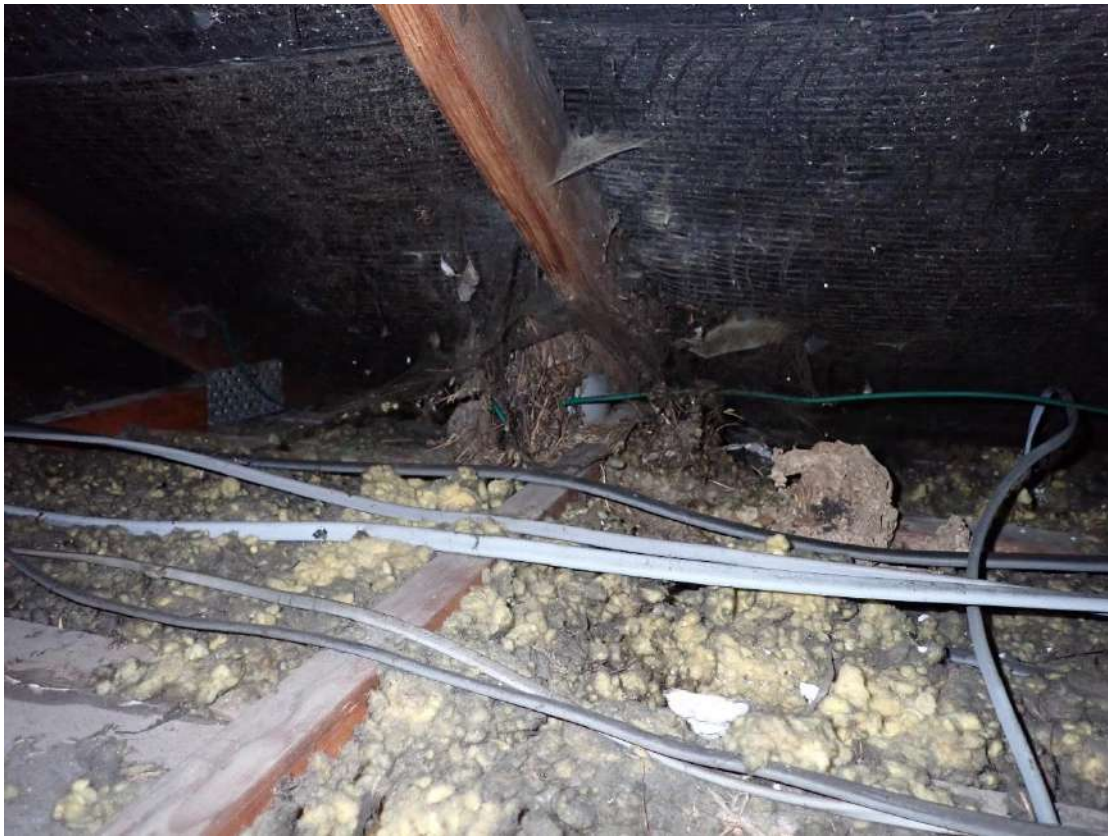
**Flat 11** is located on the south-eastern aspect of the building. There is a potential access point by the external polyethylene flashing around the ventilation tube on the western aspect of the loft space. A house sparrow nest was located near the ventilation tube on the western aspect of the loft space and a wasp nest was located on the eastern aspect (Photographs 19 and 20). In addition, a single old mouse dropping was identified (Photograph 21). The loft space was fully inspected, but no evidence of roosting bats was found.

Photograph 19. House sparrow nest identified in the loft space of Flat 11.

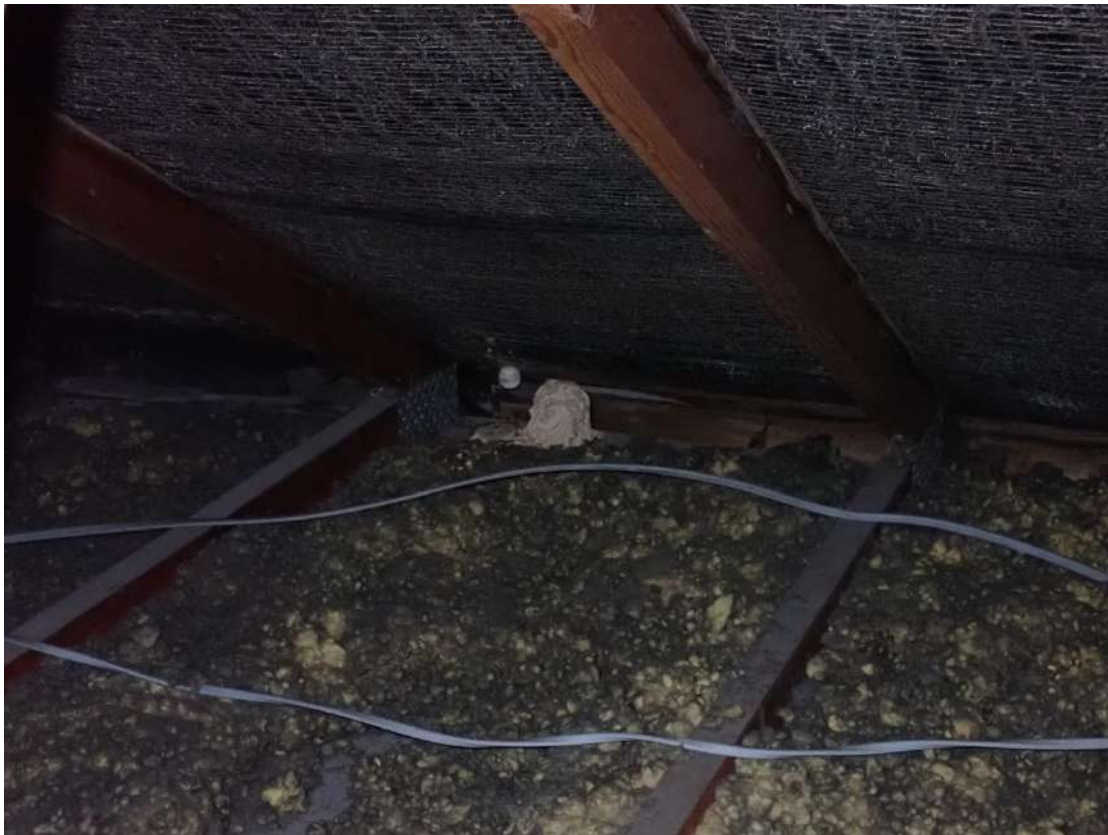
Photograph 20. Wasp nest identified in the loft space of Flat 11.

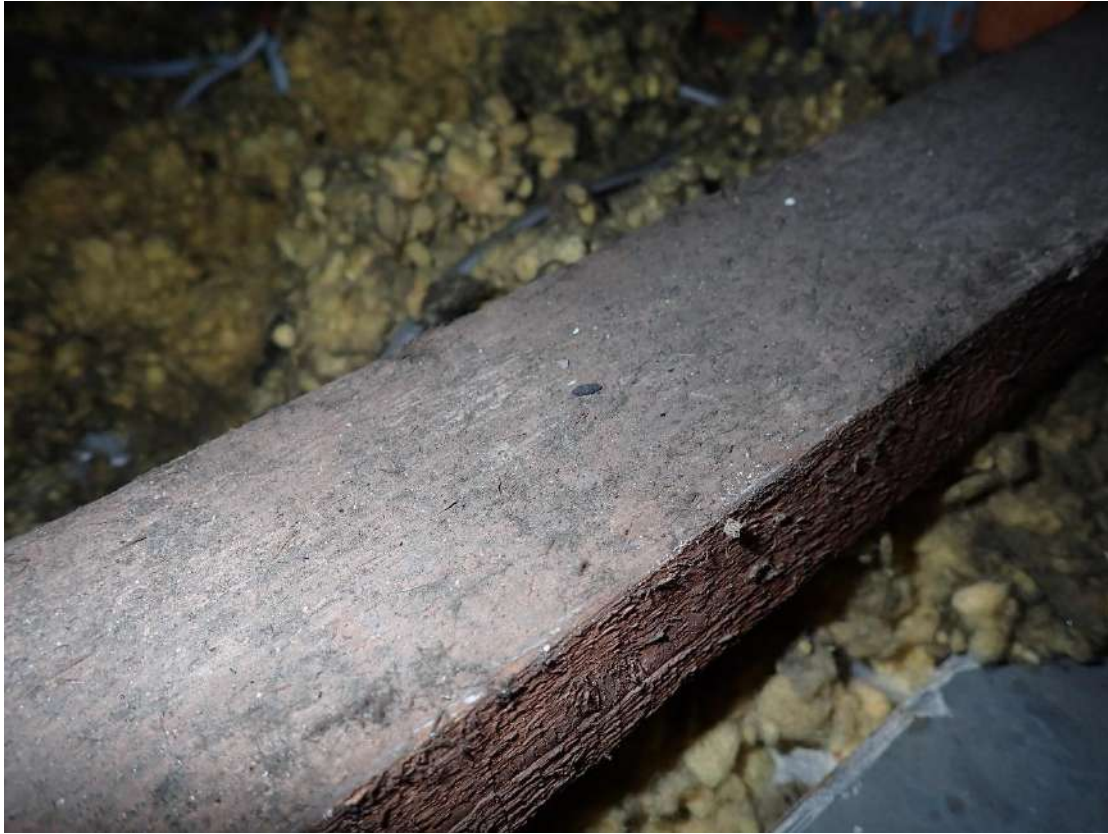
Photograph 21. Mouse droppings identified in the loft space of Flat 11.

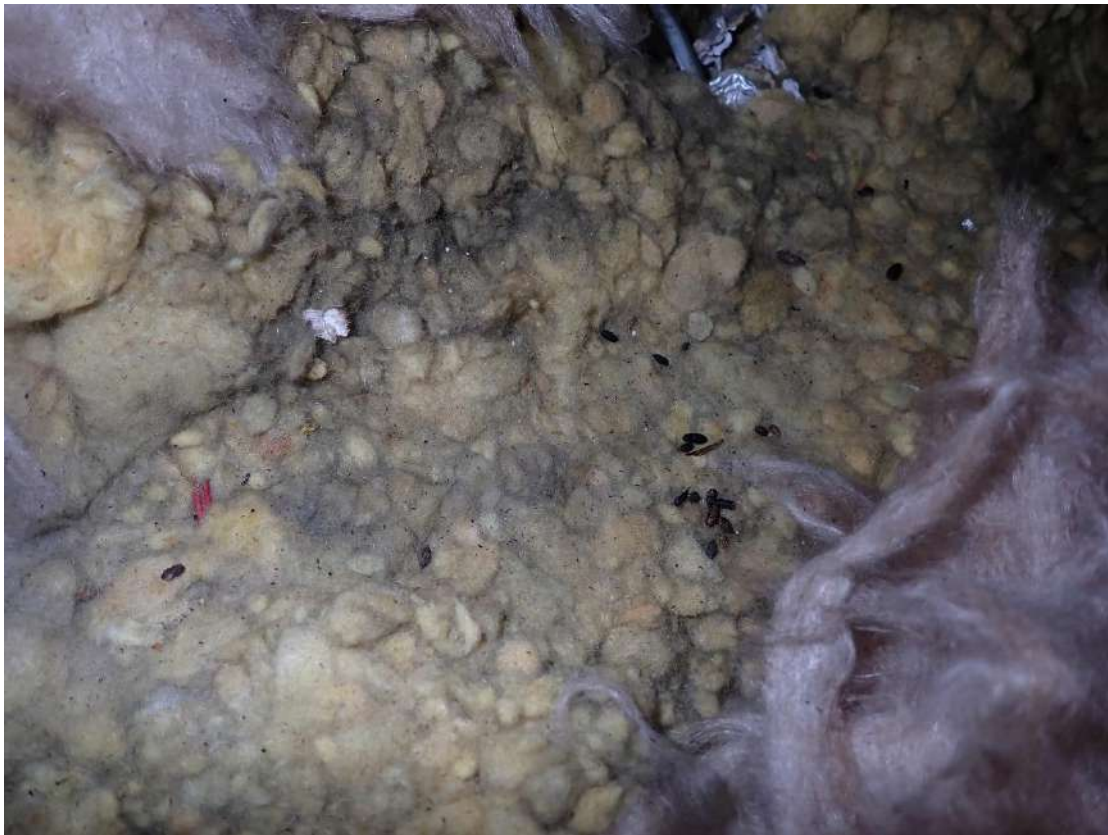
**Flat 13** is located on the north-western aspect of the building and was fully inspected but no evidence of roosting bats was found. A small number of mouse droppings were identified in the loft space (Photograph 22).

Photograph 22. Mouse droppings identified in the loft space of Flat 13.

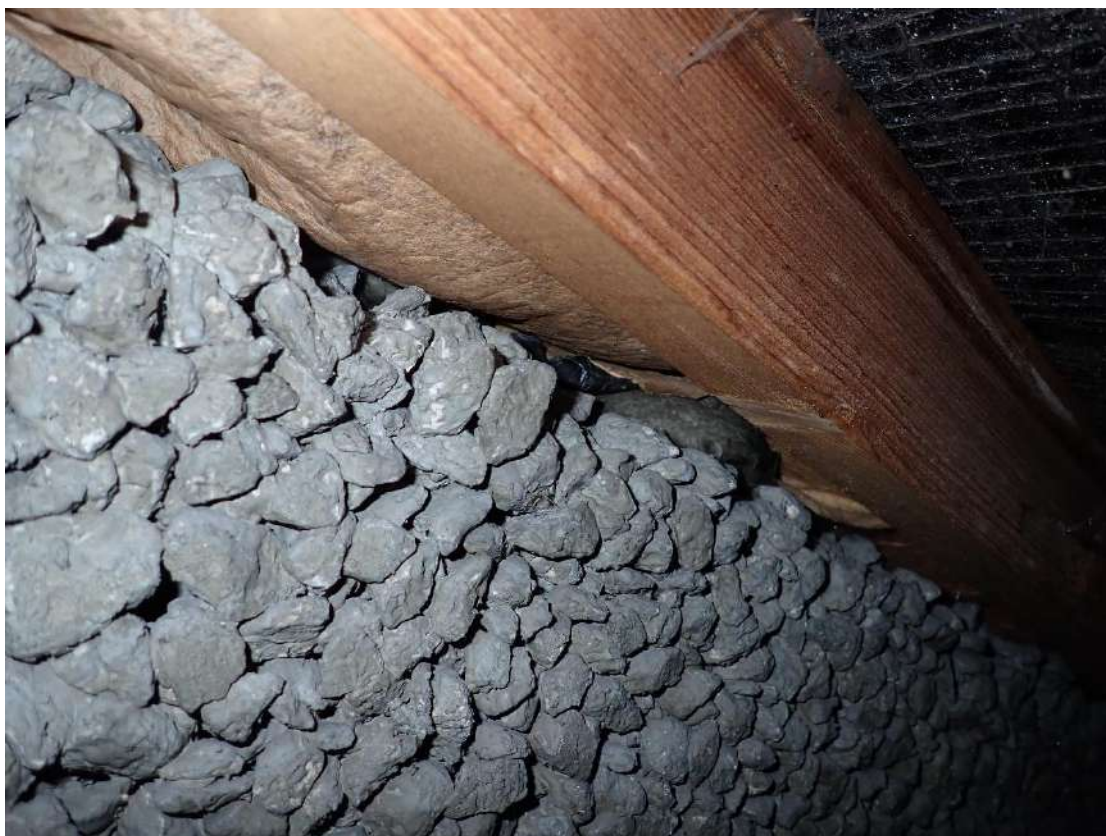
**Flat 15** is located on the south-western aspect of the building. Multiple cavities were identified in the stone render wall on the northern aspect of the loft space (Photographs 23 and 24). One of the cavities measures approximately 3.5 x 3.5 x 40cm and was identified as a suitable PRF. The loft space was fully inspected but no evidence of roosting bats was found.

Photograph 23. The gap around the top of the wall plate in the loft space of Flat 15.
