# PHASE 3A REMEDIATION STRATEGY

Mayfield Park  
Mayfield, Manchester

Mayfield Partnership Ltd

18 / 12 / 2020

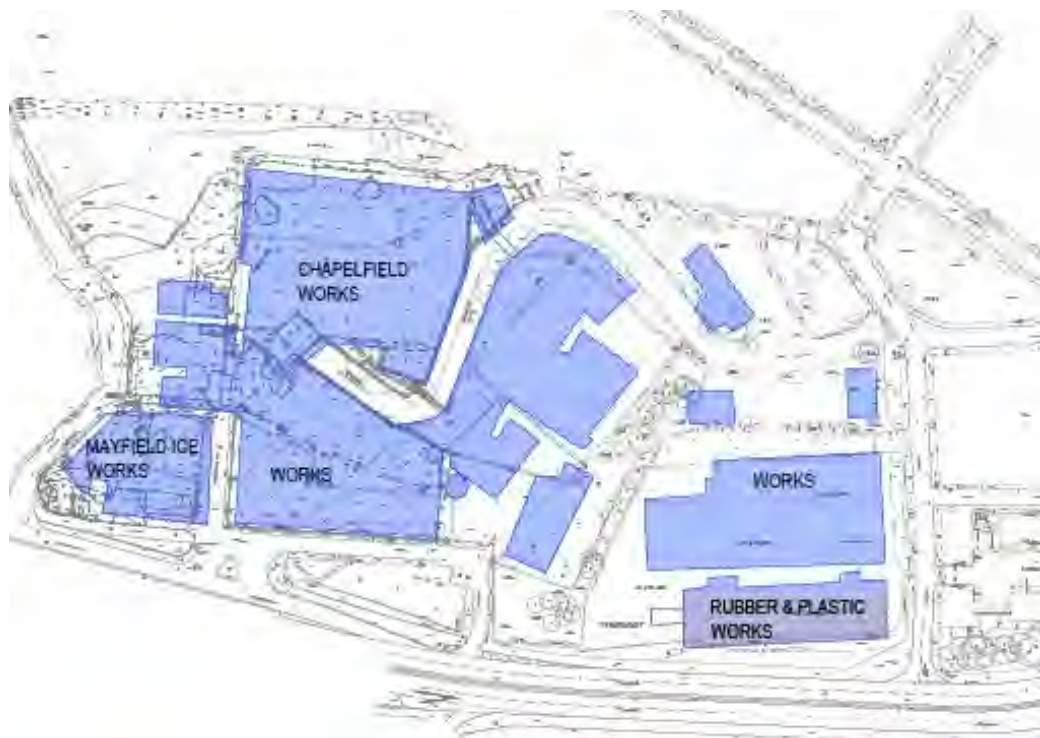
**Excerpt from ES102; Figure 4: 1970**

2.3.9 With reference to RoC Consulting drawing ES103, redevelopment of the site was undertaken during the 1950's to clear the bomb damage; with key feature being the expansion of Chapelfield Rubber works to the north side of the river. By the 1970's it was referred only as 'works', however the south eastern corner still produces rubber and plastic. To the northeast corner a vehicle maintenance yard is present.

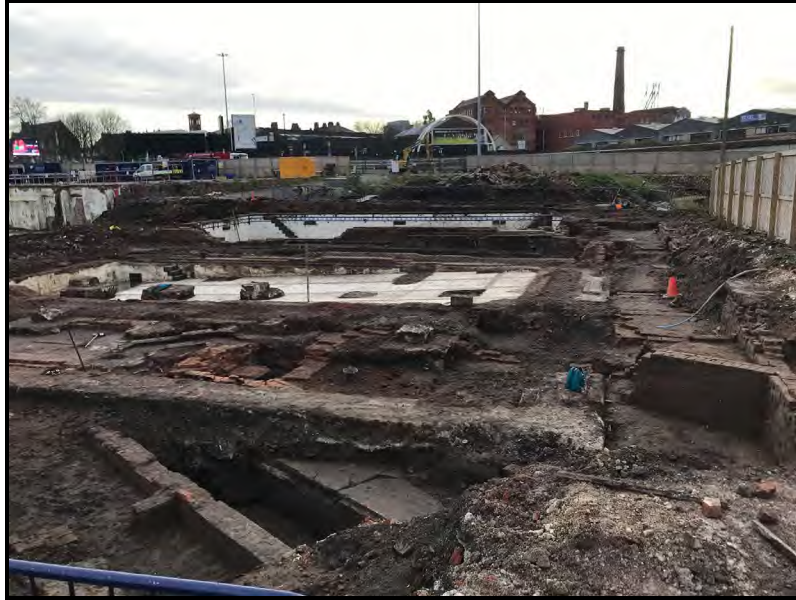
**Plate 2.0: Mayfield Baths site following excavation**

- 2.6.6 The former Mayfield Baths' site was subsequently fully exposed and excavated by Salford Archaeology as part of the pre-commencement planning condition discharge relating to archaeological surveys. These works have revealed the majority of the swimming baths structure and ancillary walls / drainage are still largely intact. A visual inspection of the area was completed by engineers from RoC Consulting to assess what (if any) areas of potential contamination had been revealed, although no visual or olfactory evidence of significantly impacted soils was noted during this inspection.

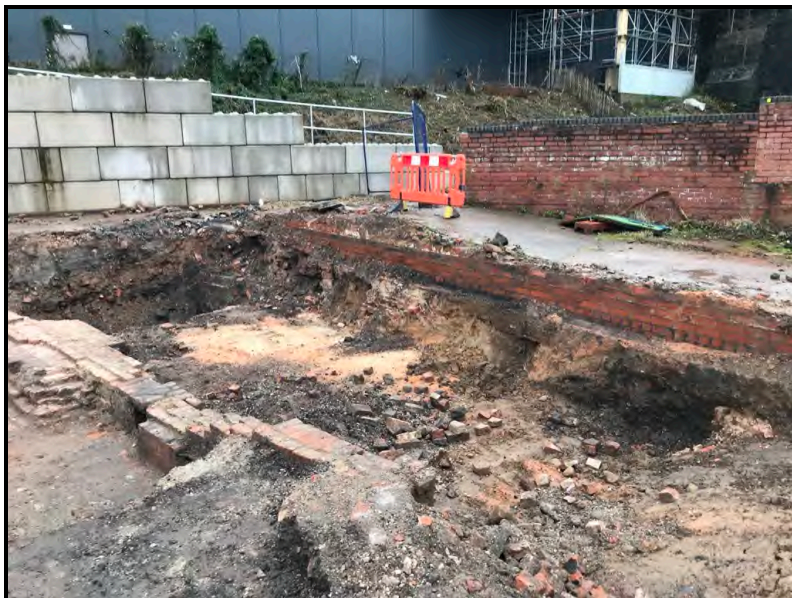
**Plate 2.1: Chapelfield Dye Works Excavation**

2.6.7 An extensive area within Zone 1 “Lawns” has been excavated as part of a pre-commencement planning condition discharge relating to archaeological surveys. These excavations have revealed numerous below ground structures relating to numerous phases of development at this area of the site.

2.6.8 It is believed that structures relating to the initial phase of development have been uncovered, and therefore it is likely these structures are founded within natural soils or the sandstone bedrock.

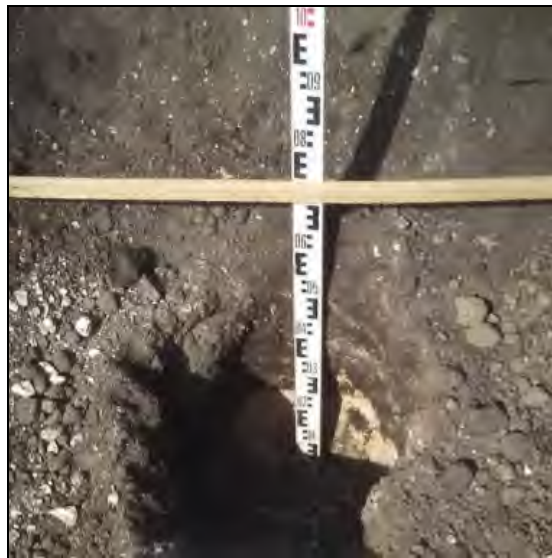
**Fig 3.0 Example of soil capping depth validation photograph**

- 6) If clean site won natural strata is used for capping information regarding the location and origin of materials should be recorded.

3.2.8 Both photographic validation pit records, locations and associated soil chemical testing certificates should be collated for inclusion within an appropriate section of the Phase 3b Site Validation report to support pre-operational planning condition discharge.

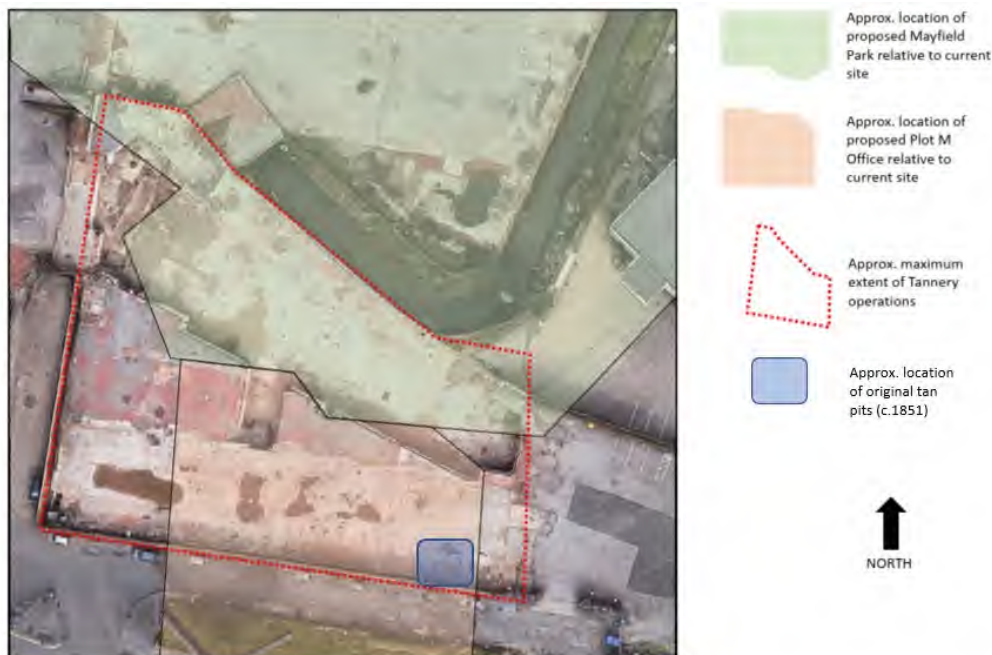
**Fig 3.1: Approx. former Tannery Extent (red dashed line)**  
**General Remedial Comments**

- 3.6.2 The potential for residual tannery wastes has been identified across a small portion of the proposed Park / Plot M office development to the central and southern extent. A technical note relating to the control and mitigation of tannery wastes that may be uncovered in this area has been prepared and included within the RoC Consulting Phase 2 SI report. A copy of this note (TN1.1) has also been included in the current report (see Appendix D) and should be reviewed by all contractors working in the area indicated below.

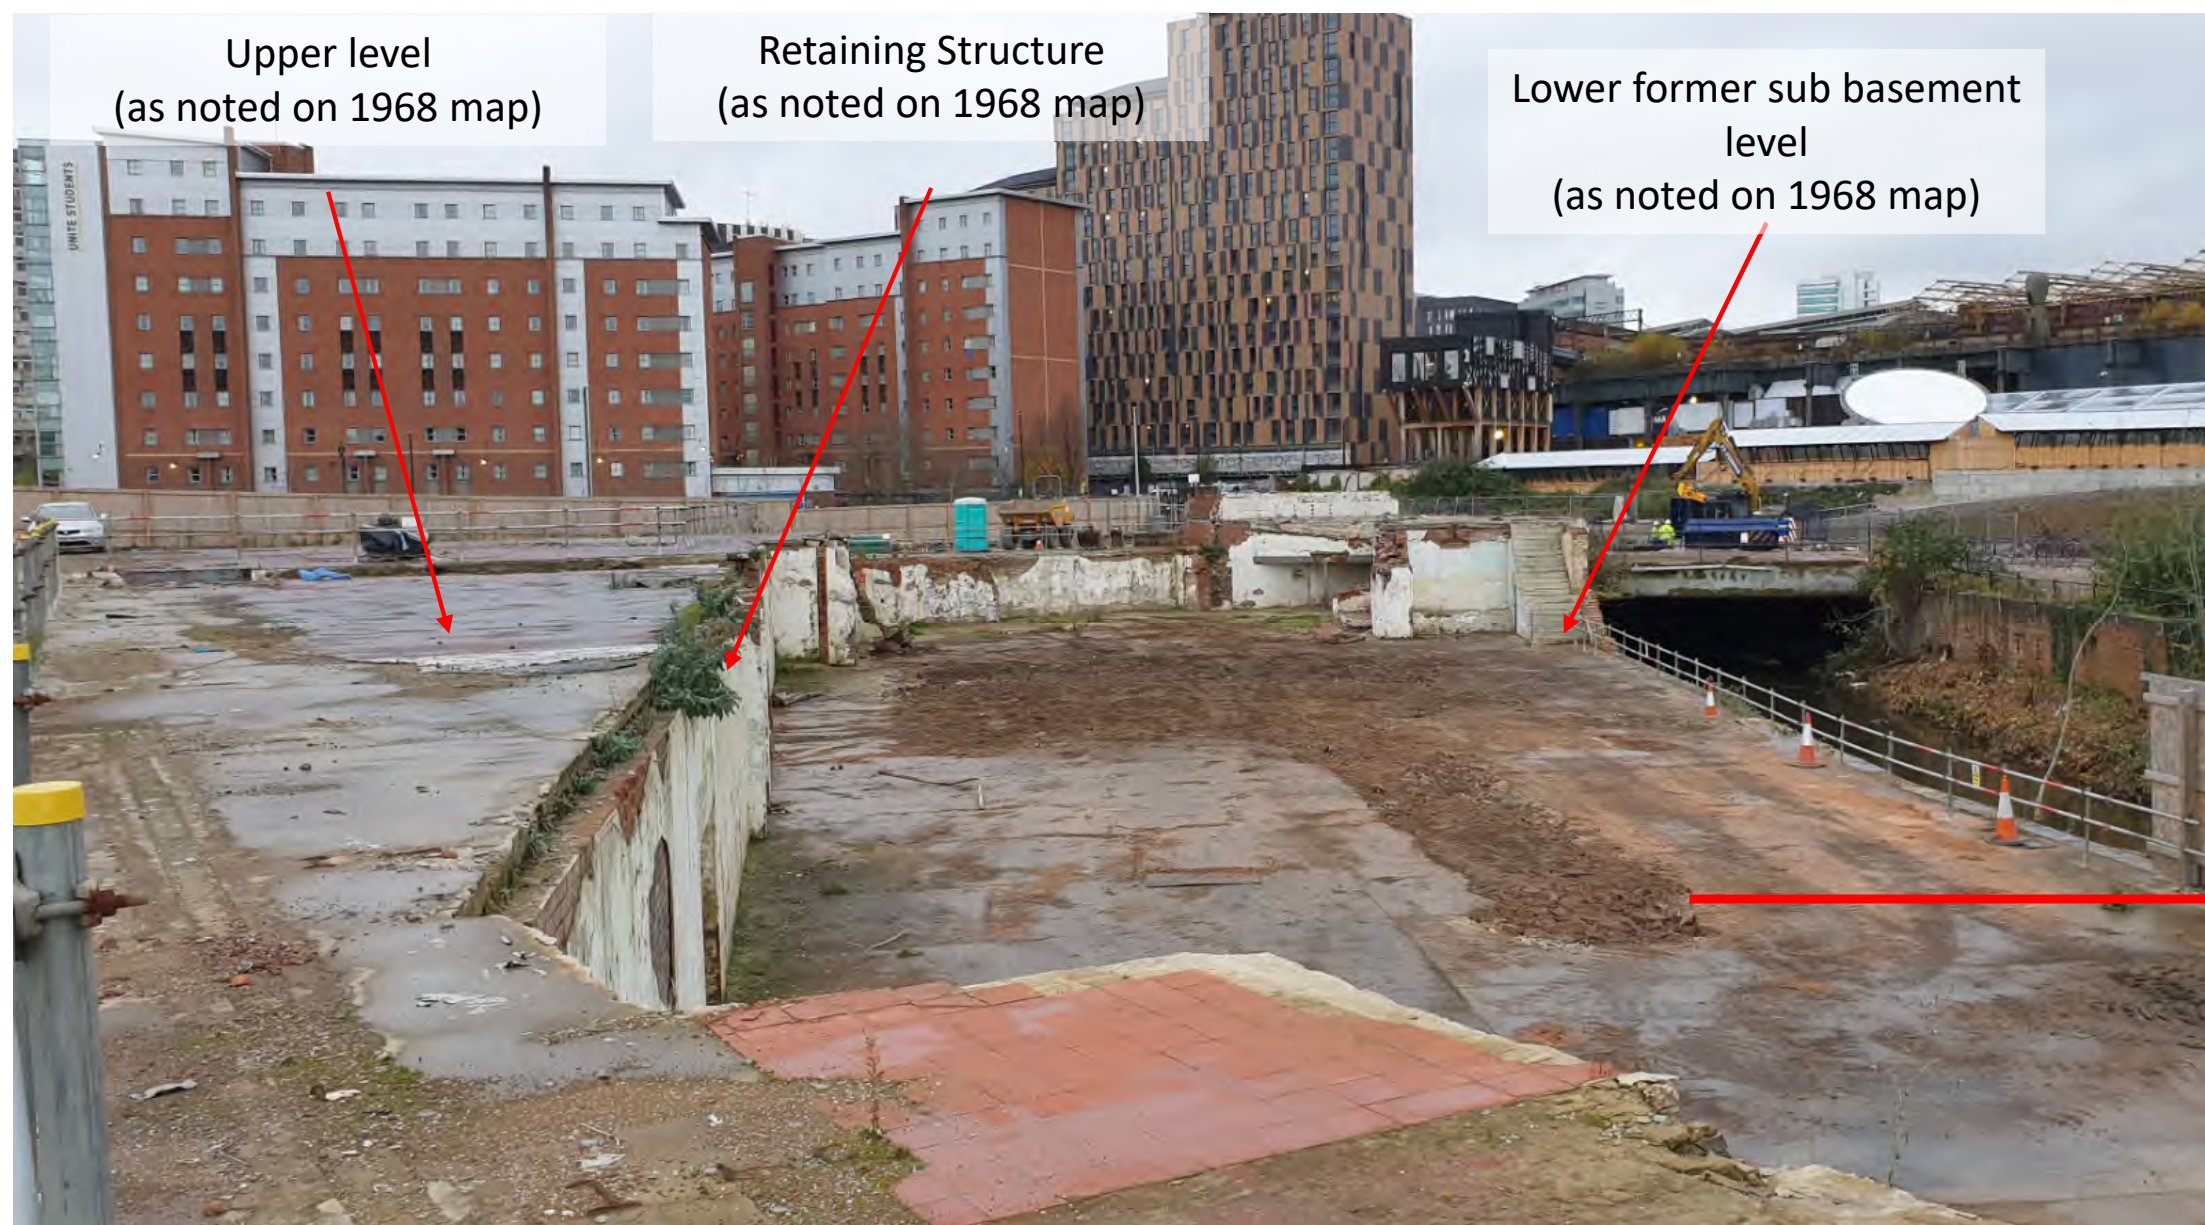
Looking west across the former Tannery site in October 2020 showing extent of upper and lower levels & recently completed archeological trenches

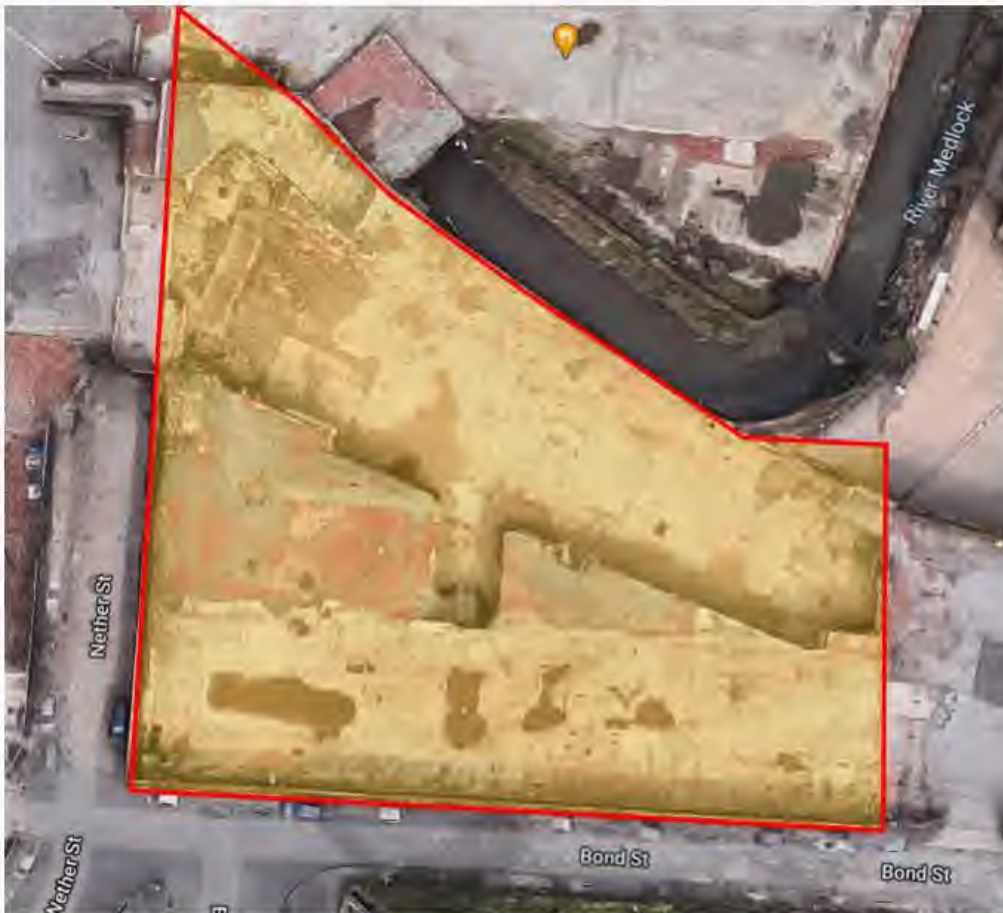
**Fig 1.0 : Portion of site containing former Tannery operation.**

Ground contamination assessments have identified this portion of the site was formerly used as a Tannery and a residual risk of animal by product encounter may be present in this area. Investigations completed to date in this area have failed to identify any such presence, however all contractors are obliged to follow the requirements of this briefing note and adopt a Tannery Contamination **Watching Brief & Discovery Strategy** the scope of which is provided overleaf.

The following note has been prepared for all contractors to review and adhere with when completing any excavations or works that may break ground in the area of the former Ardwick Tannery (see Fig 1.0 below for location).

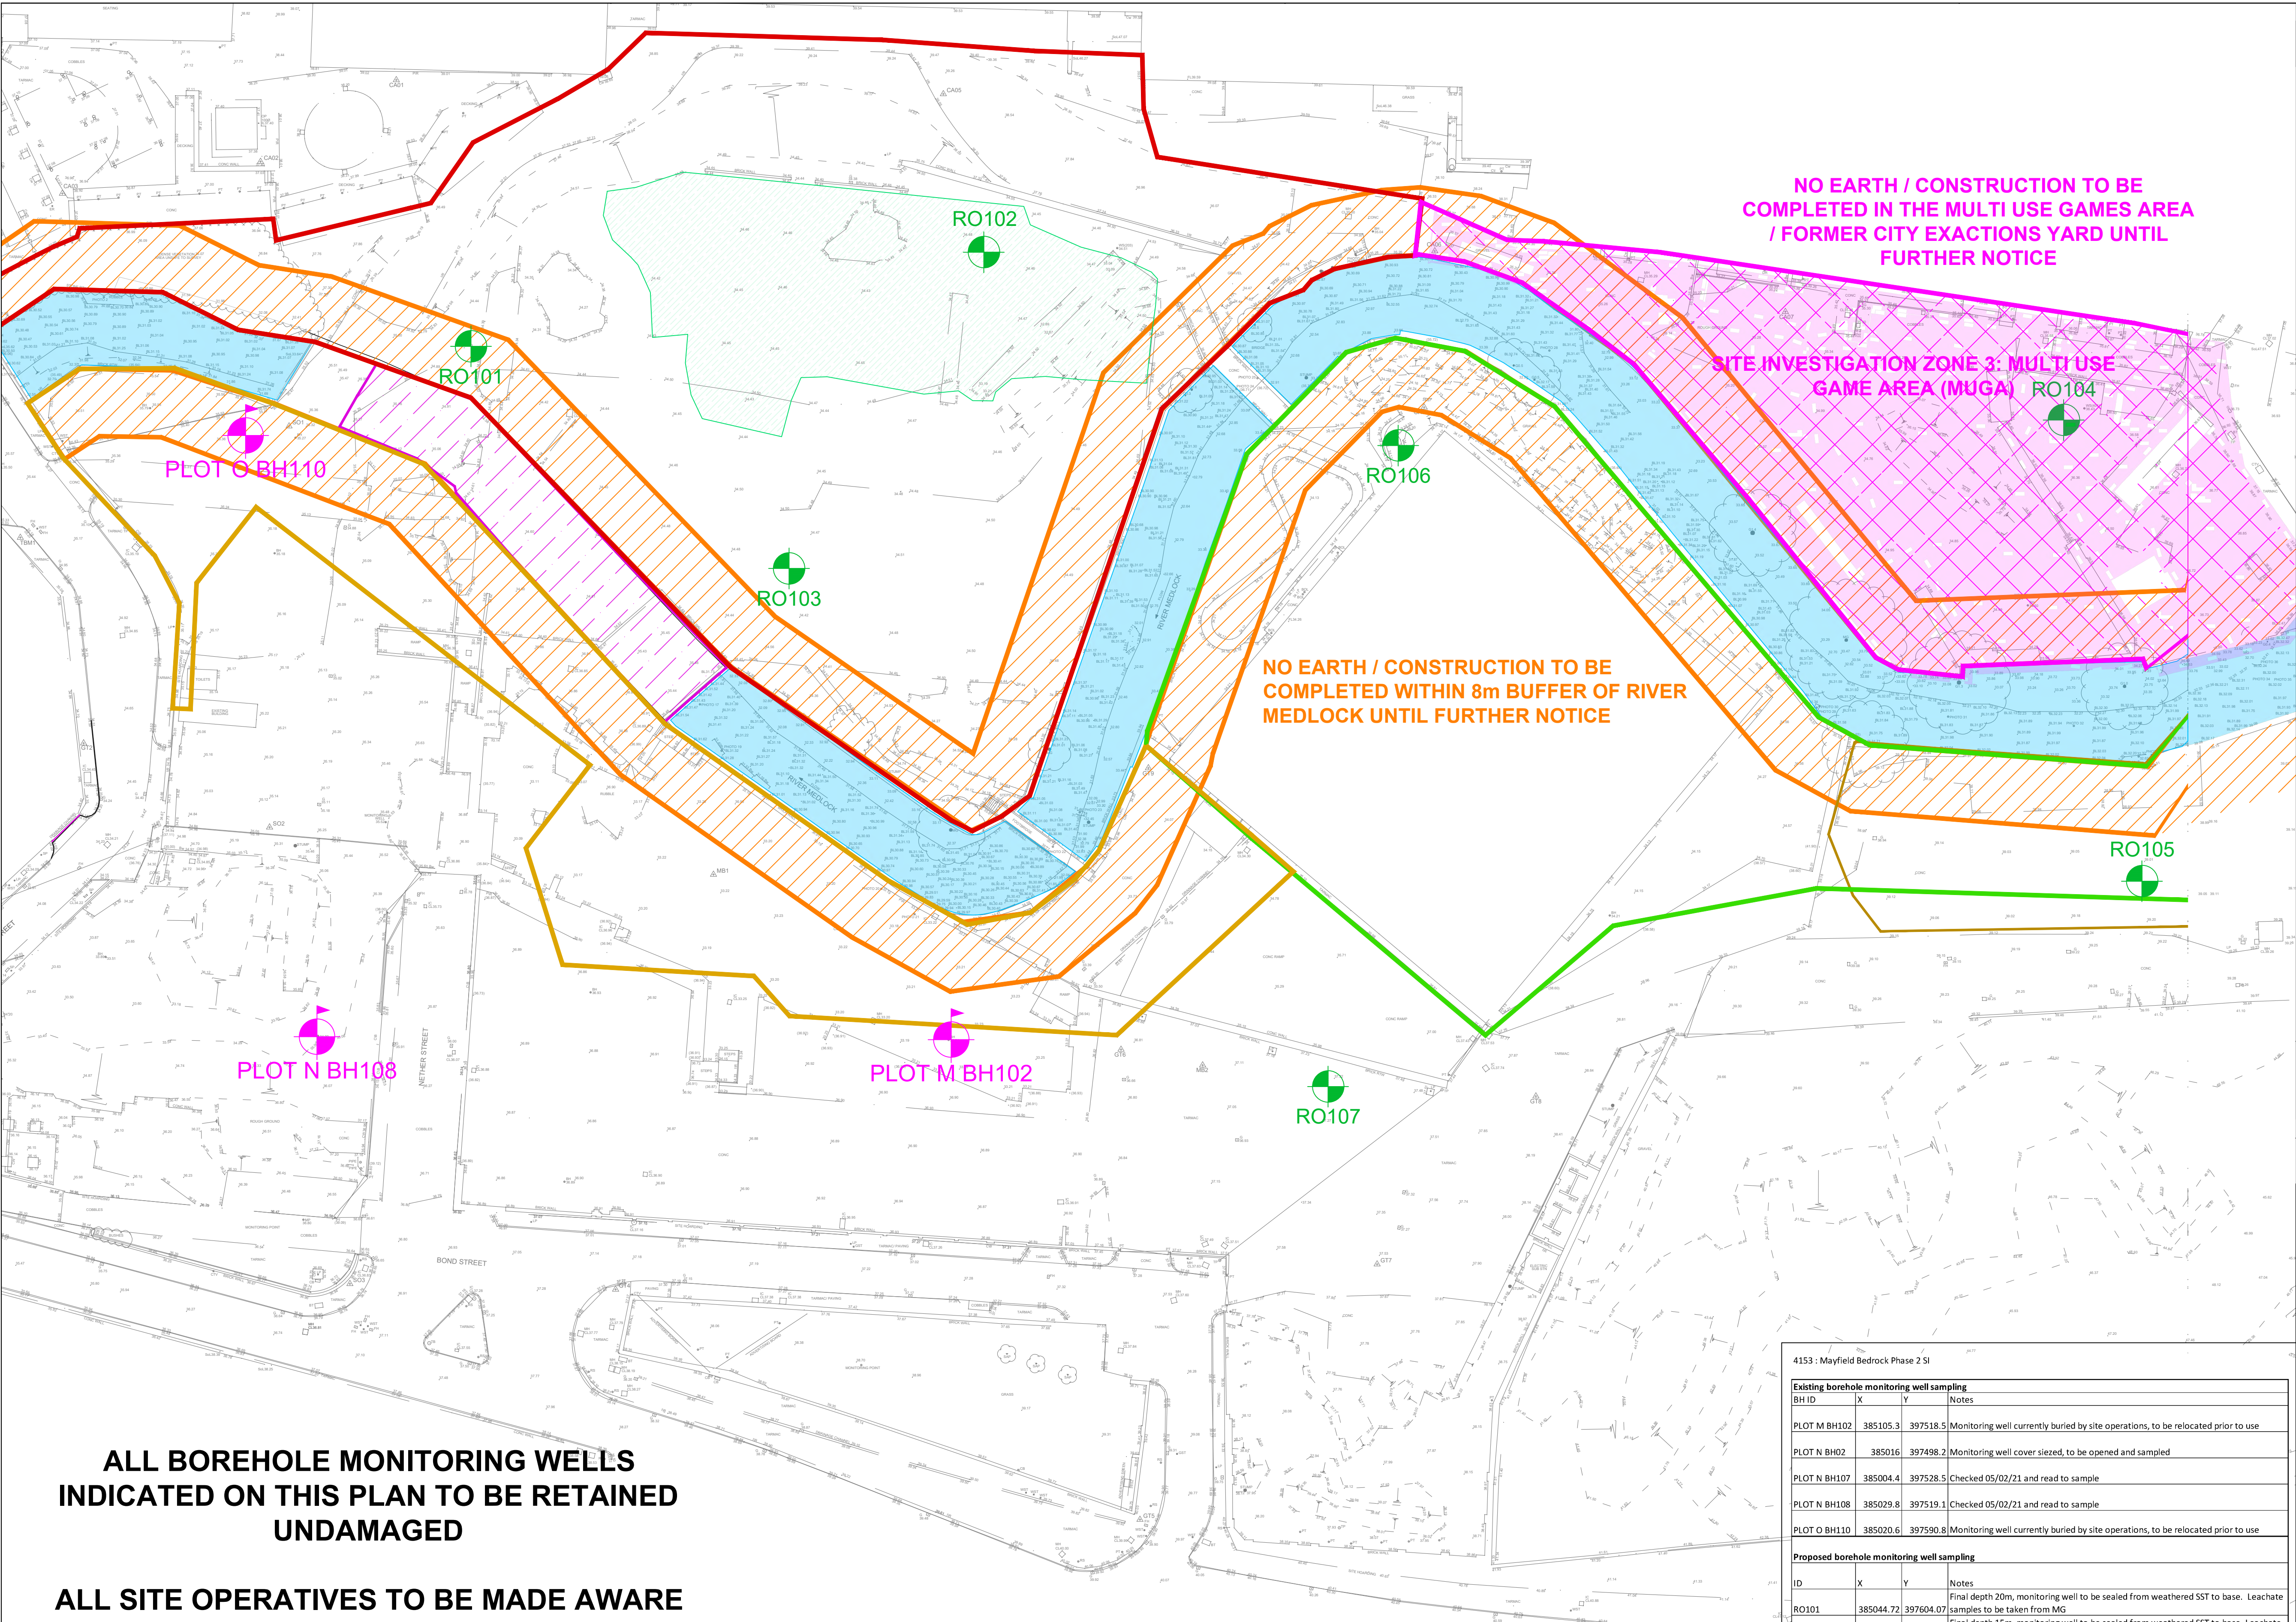
ALL BOREHOLE MONITORING WELLS  
INDICATED ON THIS PLAN TO BE RETAINED  
UNDAMAGED

ALL SITE OPERATIVES TO BE MADE AWARE  
OF MONITORING WELL LOCATIONS AND  
ADJUST WORKING PRACTICE ACCORDINGLY
