JW-MCC-XX-XX-DR-S-0010-S2

## EXISTING WALL DETAILS

St James Church & Stenner Lane boundary wall

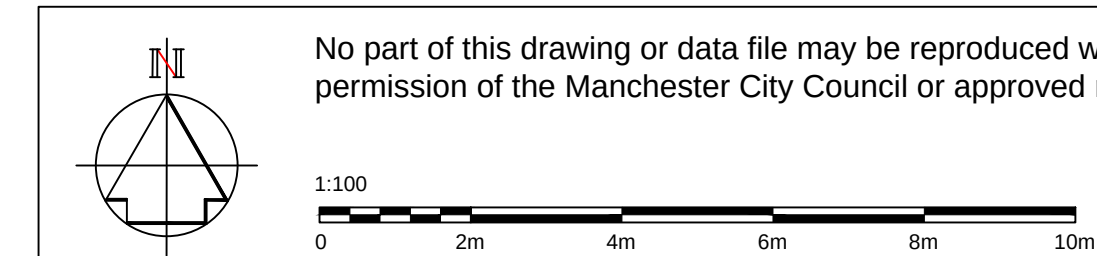
**EXISTING ELEVATION**  
From road side

Retaining boundary wall

Coping Stone

Cast iron original railings

Position of Cedar tree behind wall in St James's Church grounds

Approximate level of retained ground behind wall

Approx 9460mm section of retaining/boundary wall to be removed and rebuilt, including 7 Nr coping stones

Location of cracking to wall and bulging of wall stones

Existing retaining boundary wall
