**St Margarets Chambers**  
For Charlotte Street Estates

Back Piccadilly Elevation -  
Proposed Repairs and  
Conditions

| drwg no. | <b>P(226)</b> |

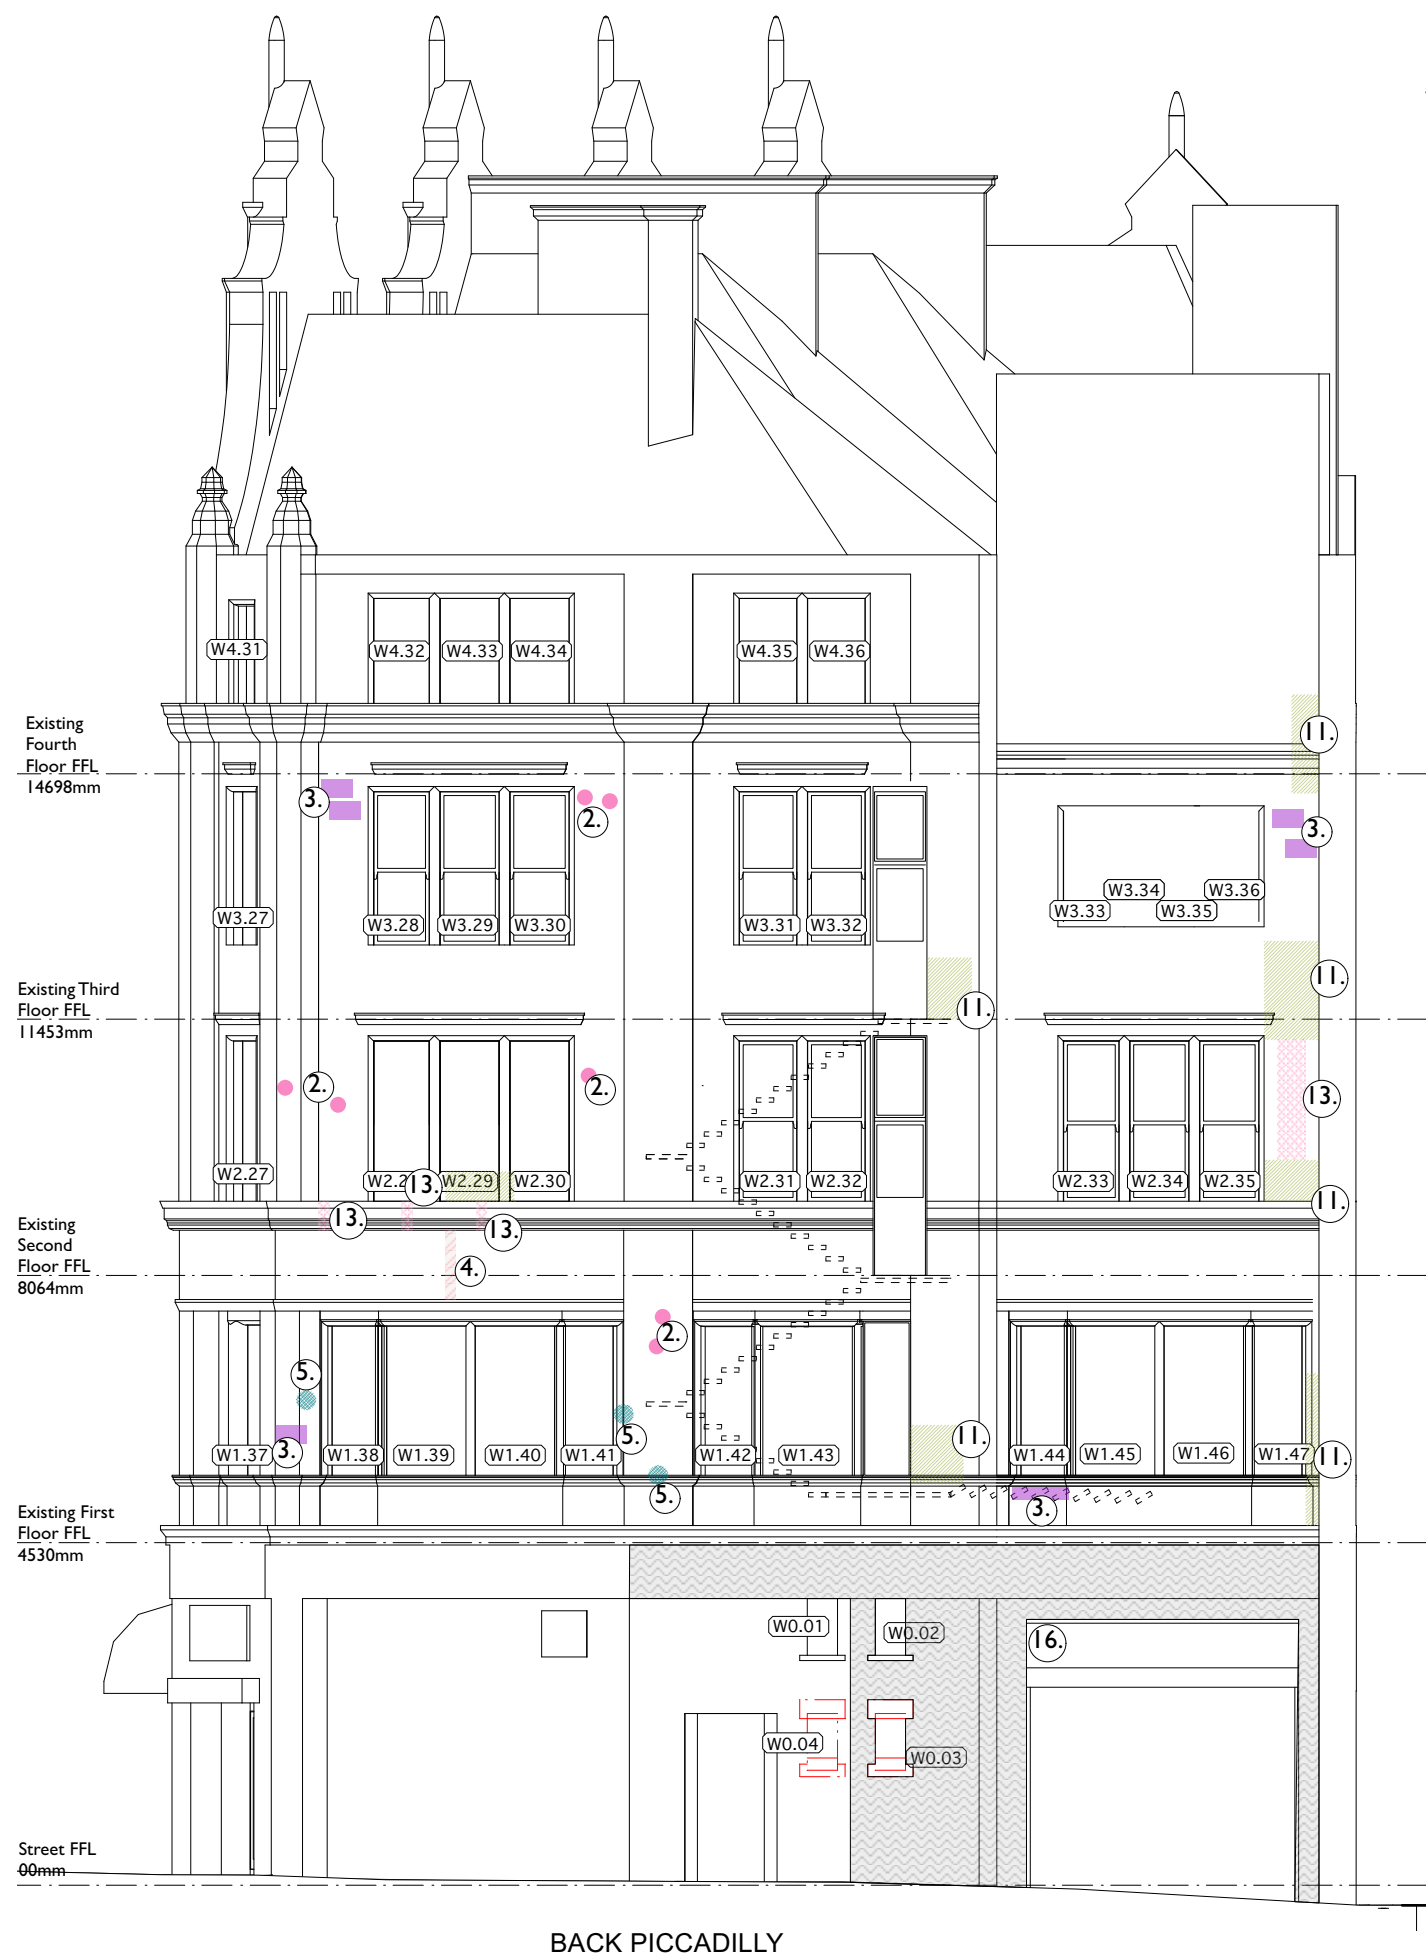
- 1 Sandstone erosion - close inspection required.
- 2 Holes left by redundant fixings - mortar fill in accordance with specification.
- 3 Gaps in brickwork. Close inspection required to inform replacement with matching material.

- 4 Missing pointing between frieze panels. Reinstatement in accordance with specification.
- 5 Redundant plant equipment carefully remove and make good fabric in accordance with specification.

- 6 Eroded sandstone coping. Close inspection required. Replacement matching stone inserts may be required to prevent further deterioration.
- 7 Rusting lintels Clean off and repaint in accordance with specification.

- 8 Biological growth to be removed from roof level.
- 9 Coping water staining. May require repointing. Close inspection required.
- 10 Previous repairs to sandstone. Poorly matched aesthetic and presumed composition, but no evidence repairs are causing damage to surrounding historic fabric. Add to building maintenance plan for regular monitoring.

- 11 Biological growth to stone to be cleaned in accordance with specification.
- 12 Water staining may be caused by missing pointing. Close inspection required to inform repair strategy.

- 13 Signs of cracking. Further inspection required on site.
- 14 Redundant cables/lights/alarm box. Carefully remove
- 15 Residue from former sign to be cleaned off sandstone. Method pending site trials.

- 16 Non-original paintwork to be carefully removed.

All notes based on pavement level inspection only. Close inspection required following receipt of Listed Building Consent to inform final scope of repair works package.

General atmospheric dirt to masonry faces. No sign of causing damage to underlying fabric. Propose no action.
