# Television Baseline Survey Report

Fusion Manchester Devco Ltd

Student Accommodation Manchester

May 2023

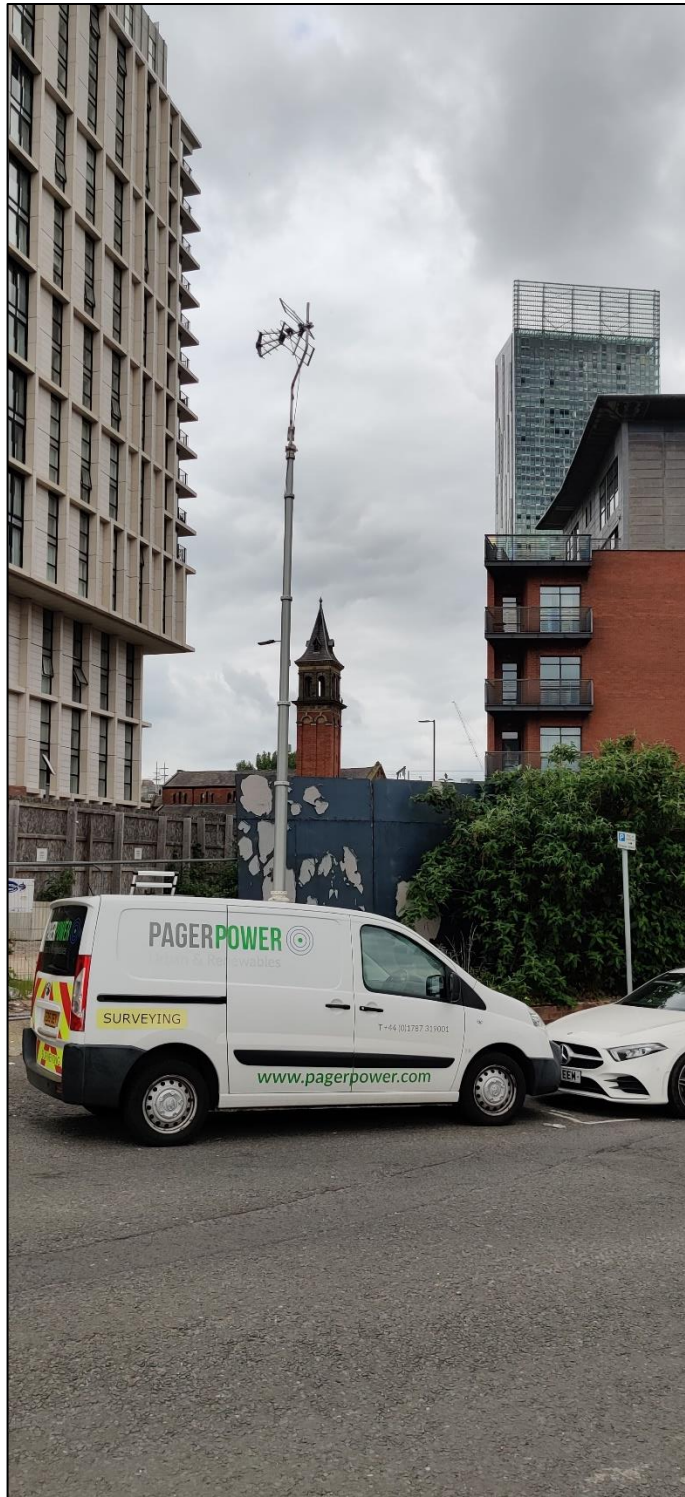
### Location 1

Notes: No aerials or satellite dishes were observed.

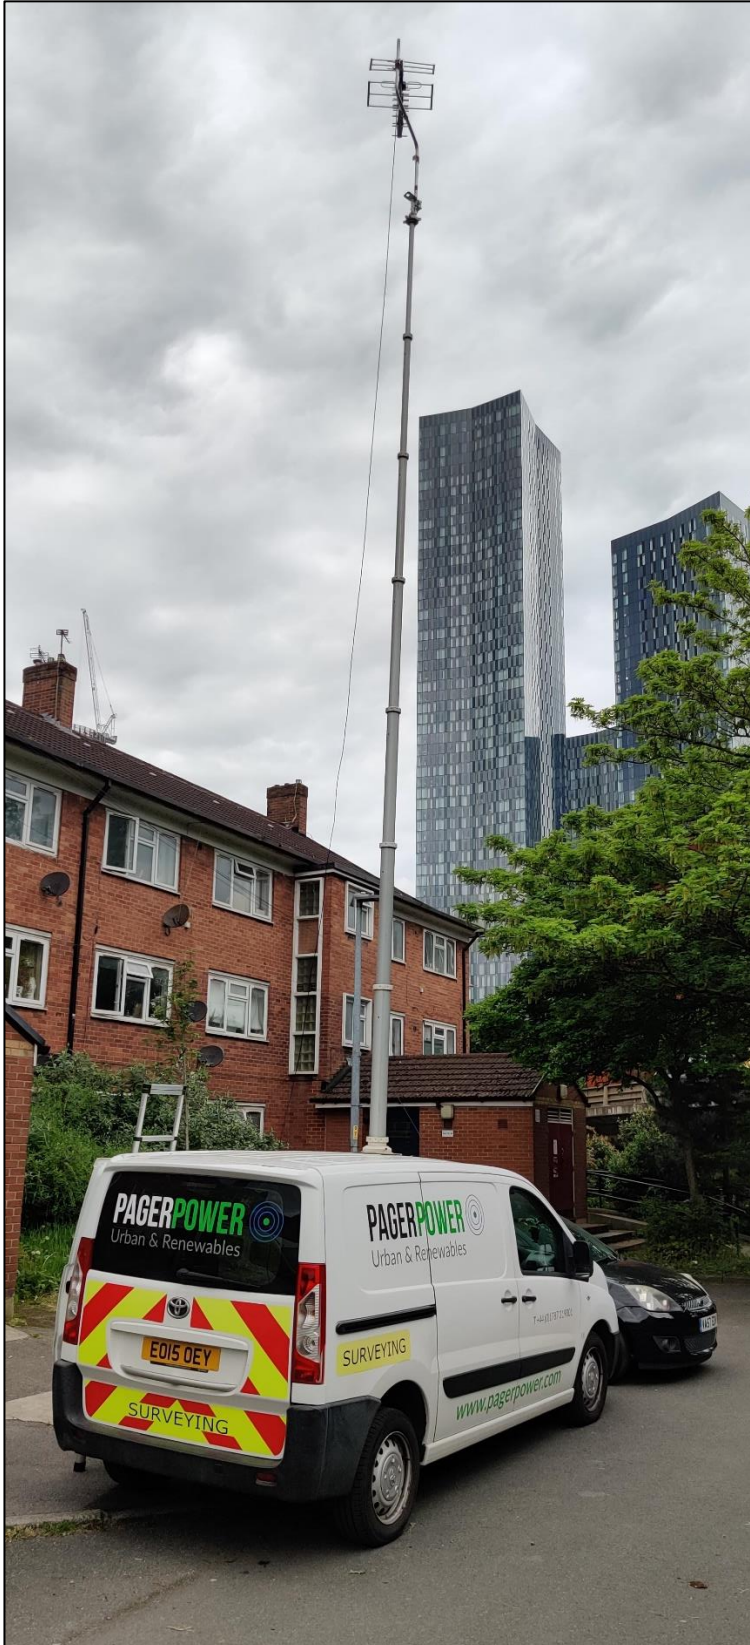
Location 2

Notes: Multiple HP<sup>11</sup> UHF<sup>12</sup> aerials, facing towards the Winter Hill transmitter, located on three-storey residential properties adjacent to location 2 were observed. Multiple satellite dishes were observed.

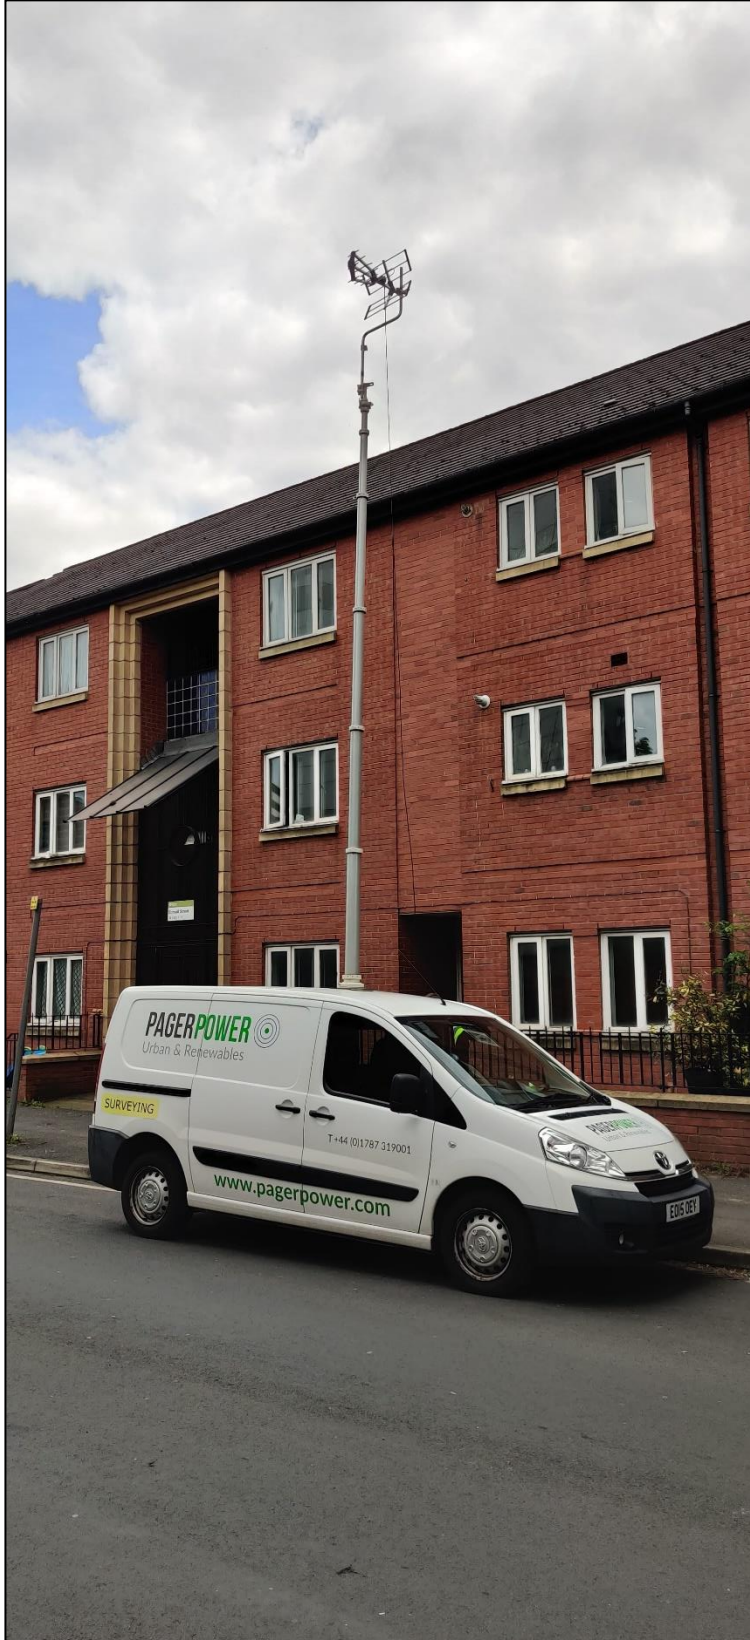
### Location 3

Notes: No aerials or satellite dishes were observed during survey. Three satellite dishes, on three-storey residential properties adjacent to location 3, are observed following a review of street view imagery.

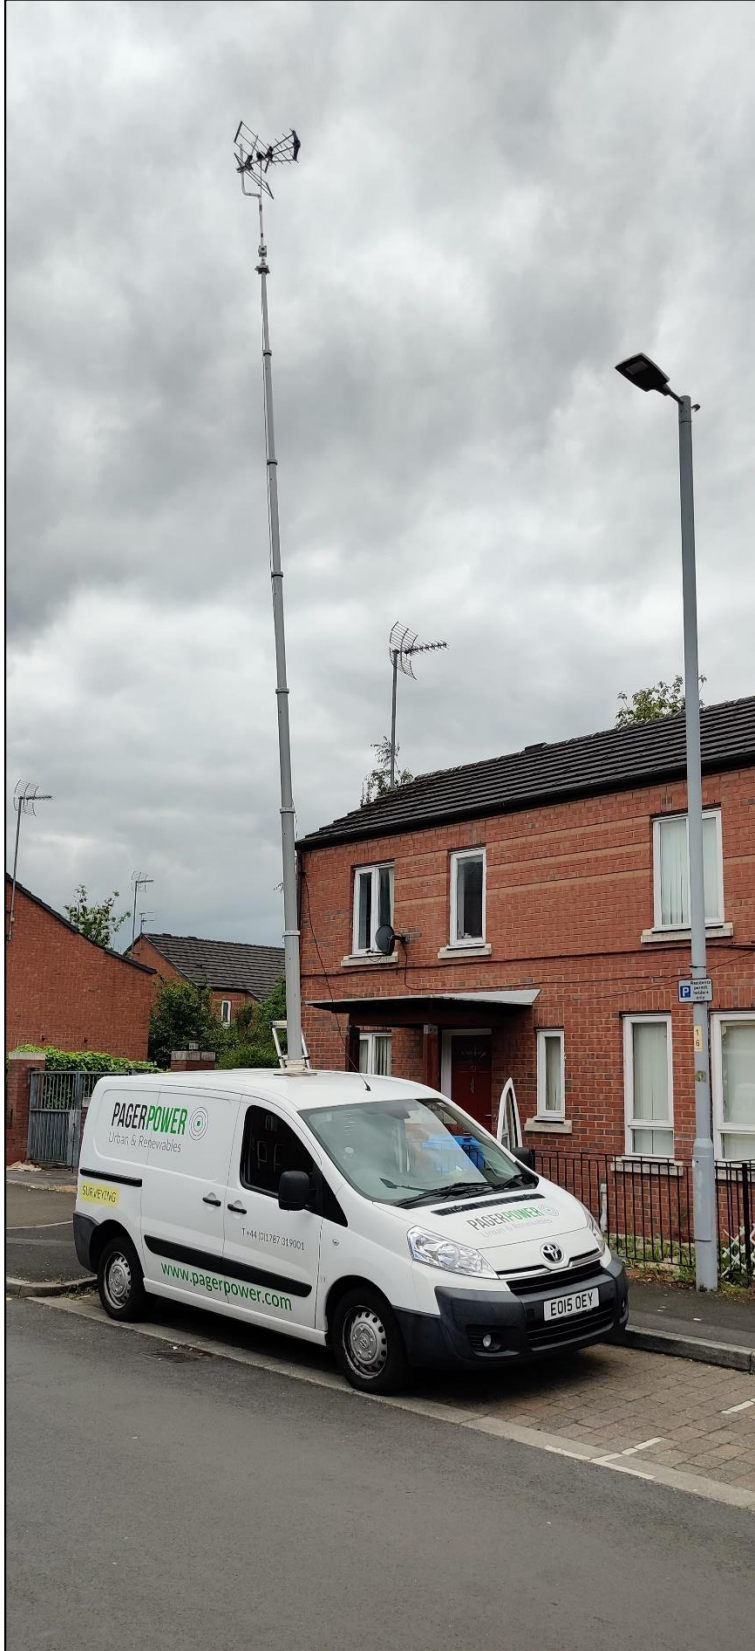
#### Location 4

Notes: Multiple HP UHF aerials, facing towards the Winter Hill transmitter, located on two to three-storey residential properties adjacent to location 4 were observed. Multiple satellite dishes were observed.

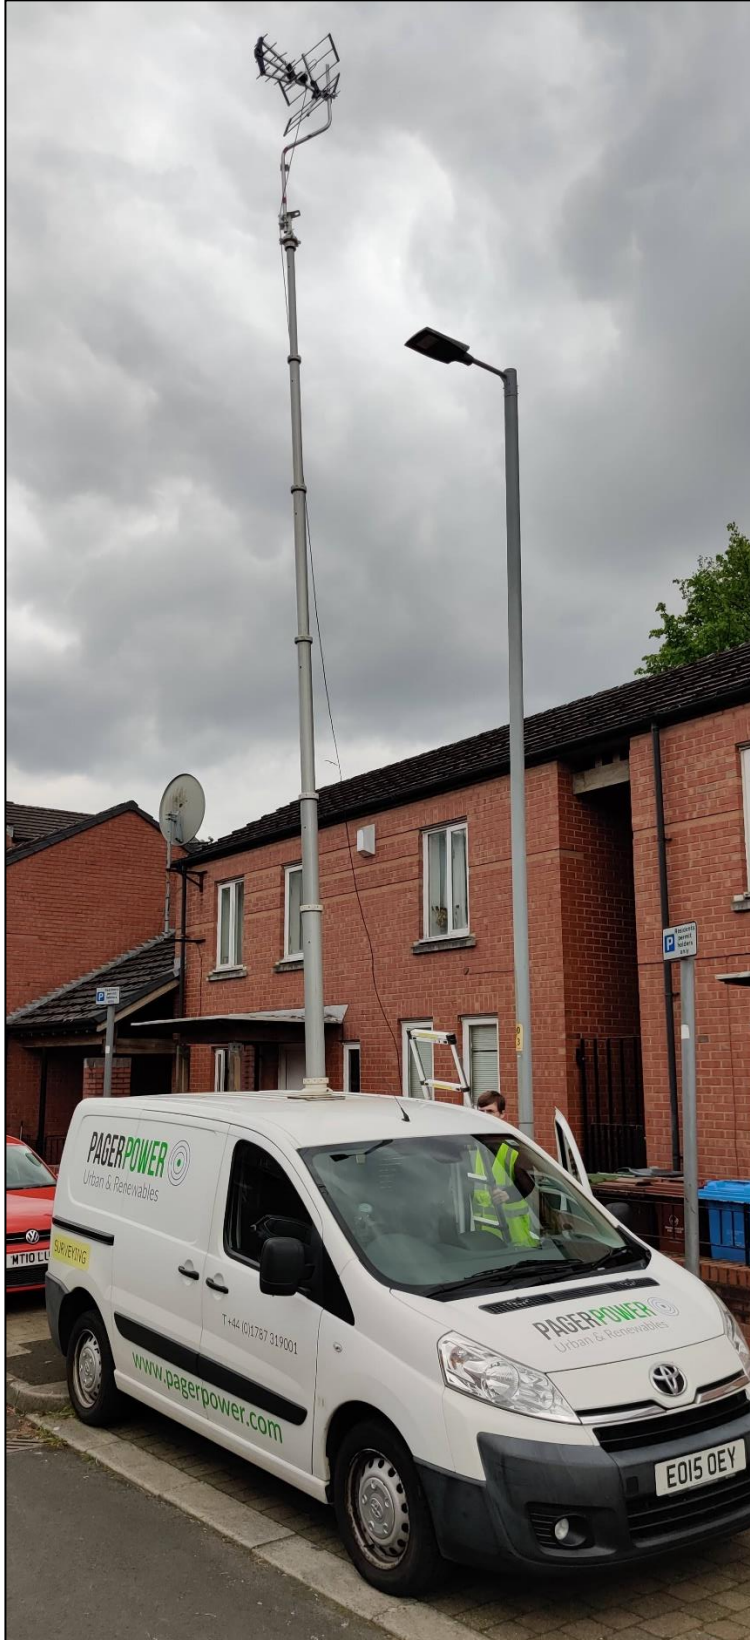
## Location 5

Notes: Multiple HP UHF aerials, facing towards the Winter Hill transmitter, located on two to three-storey residential properties adjacent to location 5 were observed. Multiple satellite dishes were observed.

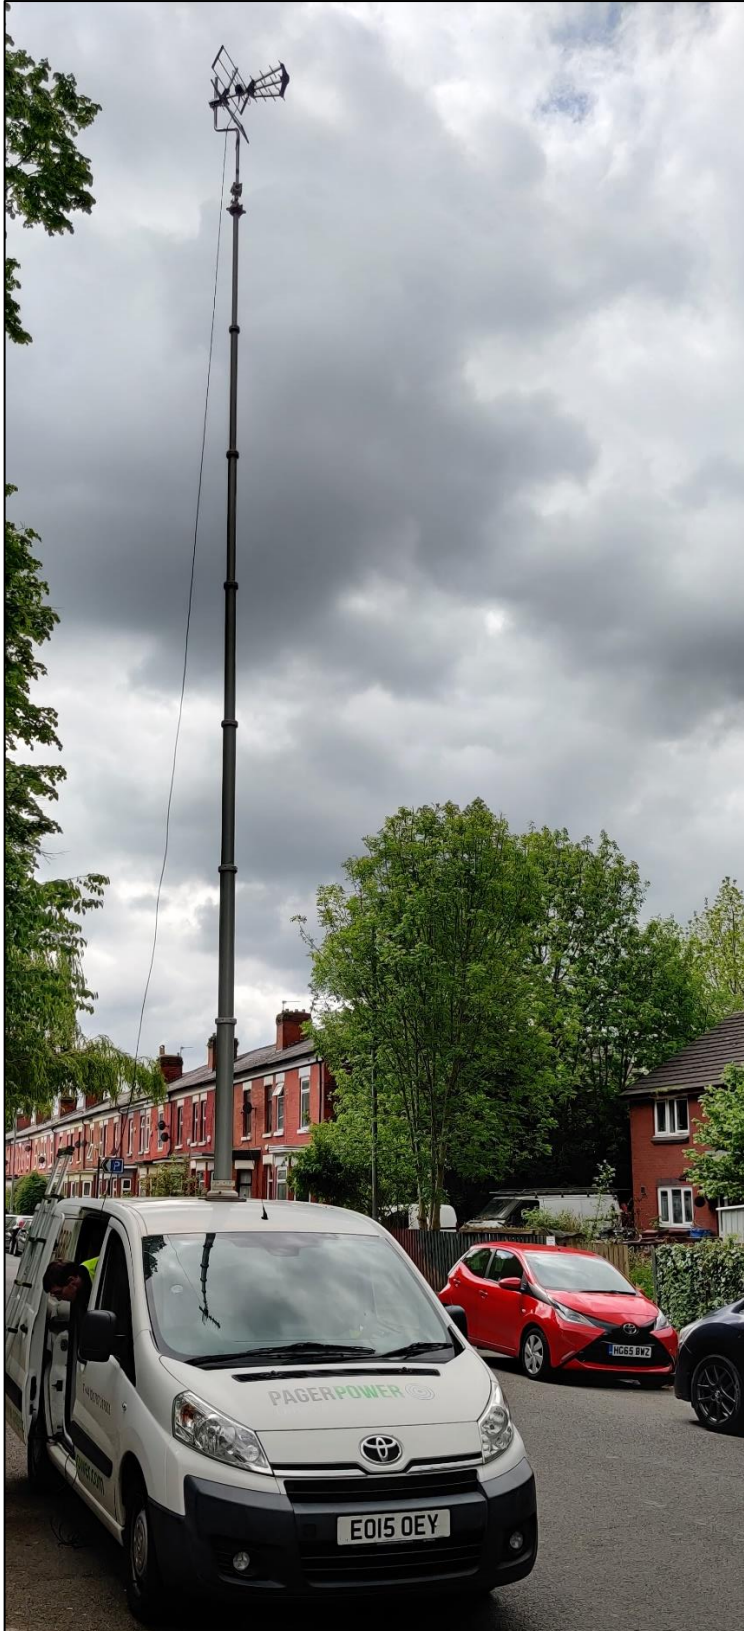
Location 6

Notes: No aerials were observed. One satellite dish was observed on a two-storey residential property adjacent to location 6.

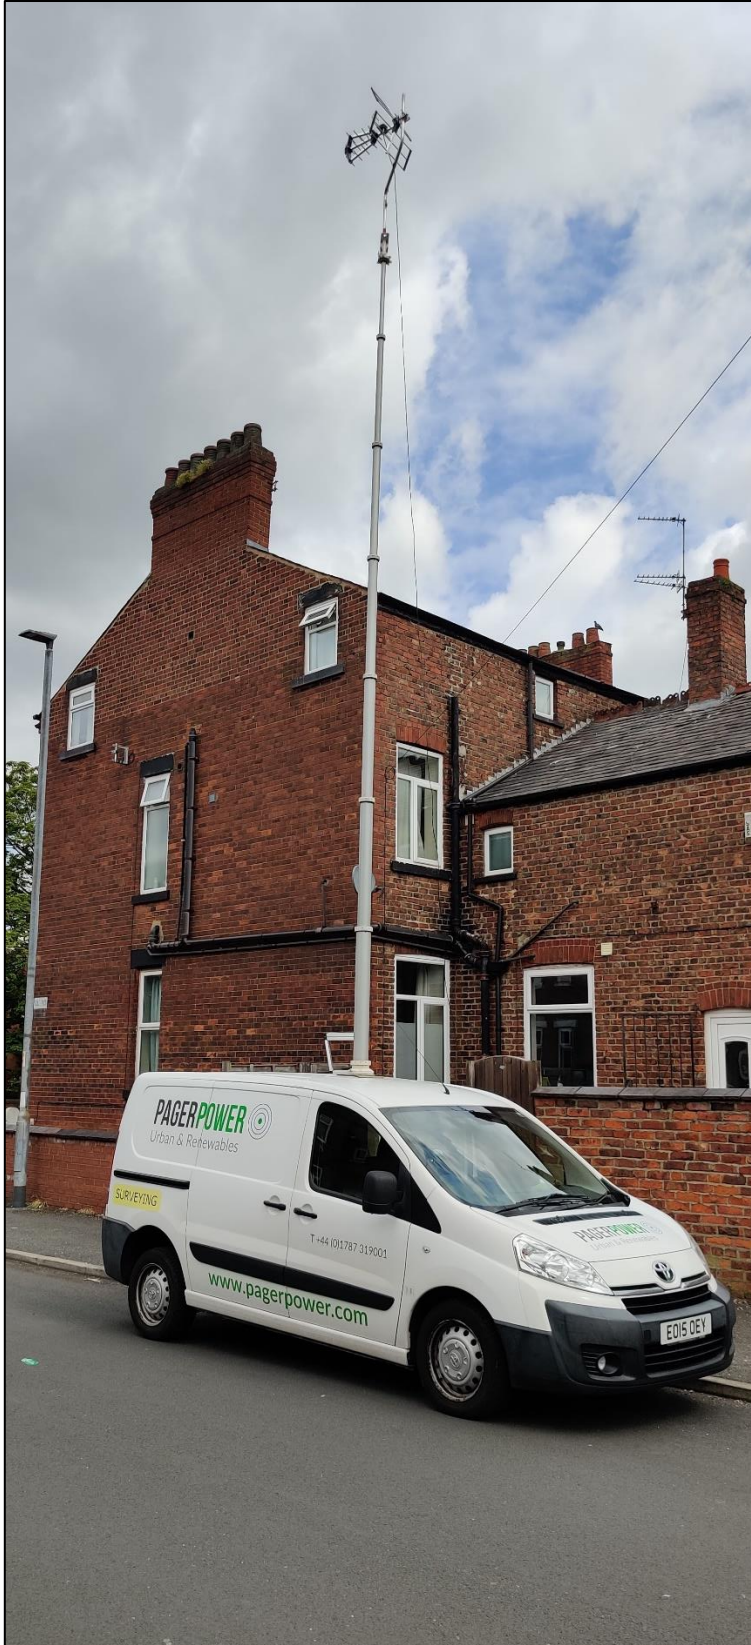
Location 7

Notes: Multiple HP UHF aerials, facing towards the Winter Hill transmitter, located on two to three-storey residential properties adjacent to location 7 were observed. Multiple satellite dishes were observed.

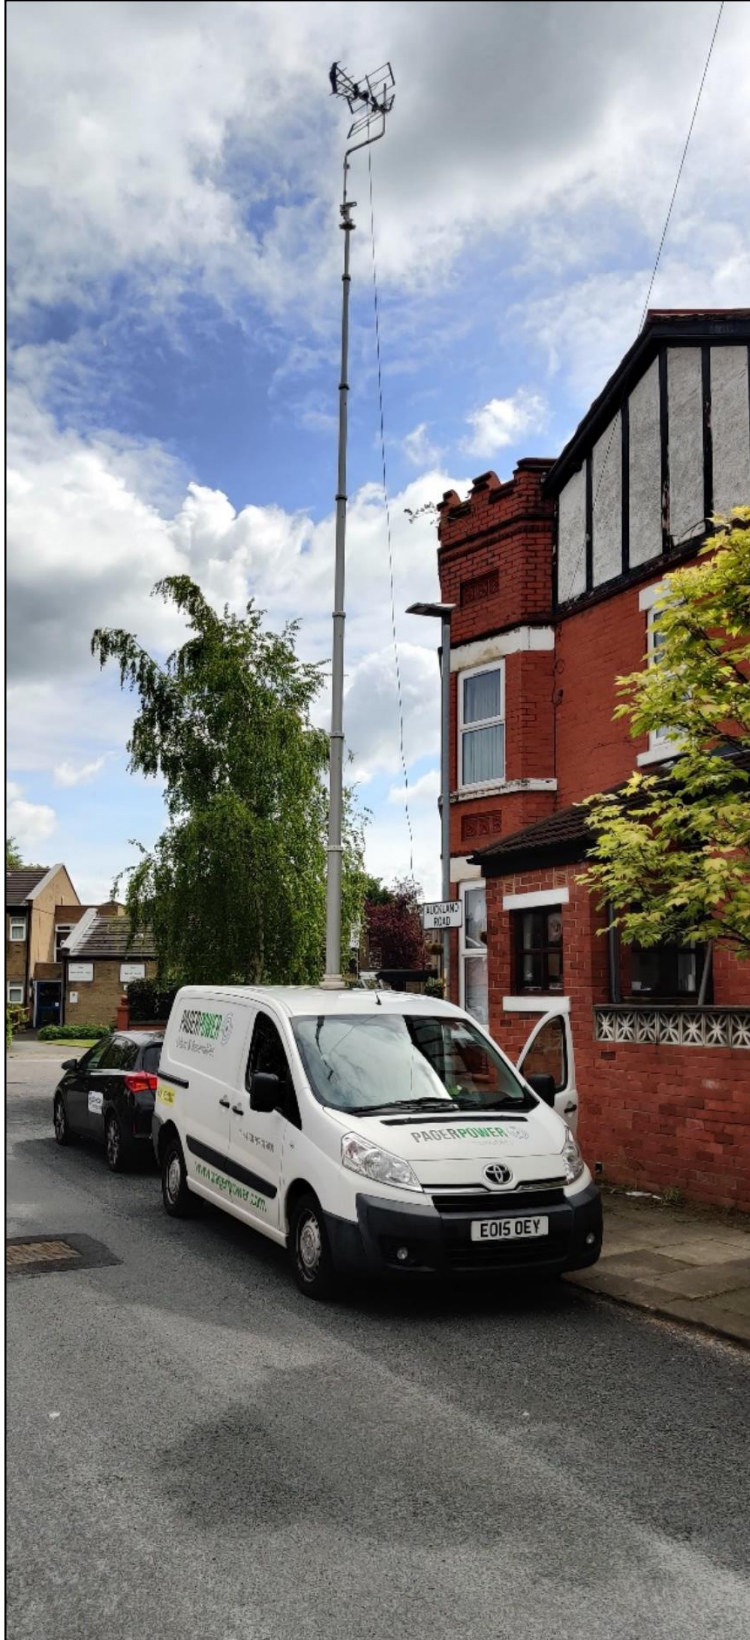
Location 8

Notes: Multiple HP UHF aerials, facing towards the Winter Hill transmitter, located on two storey residential properties adjacent to location 8 were observed. Multiple satellite dishes were observed.
