Westchurch Homes

# Louisa Street Works, Openshaw, Manchester

## Historical Building Investigation Report

| <b>Report Number:</b> | SA/2023/68 |

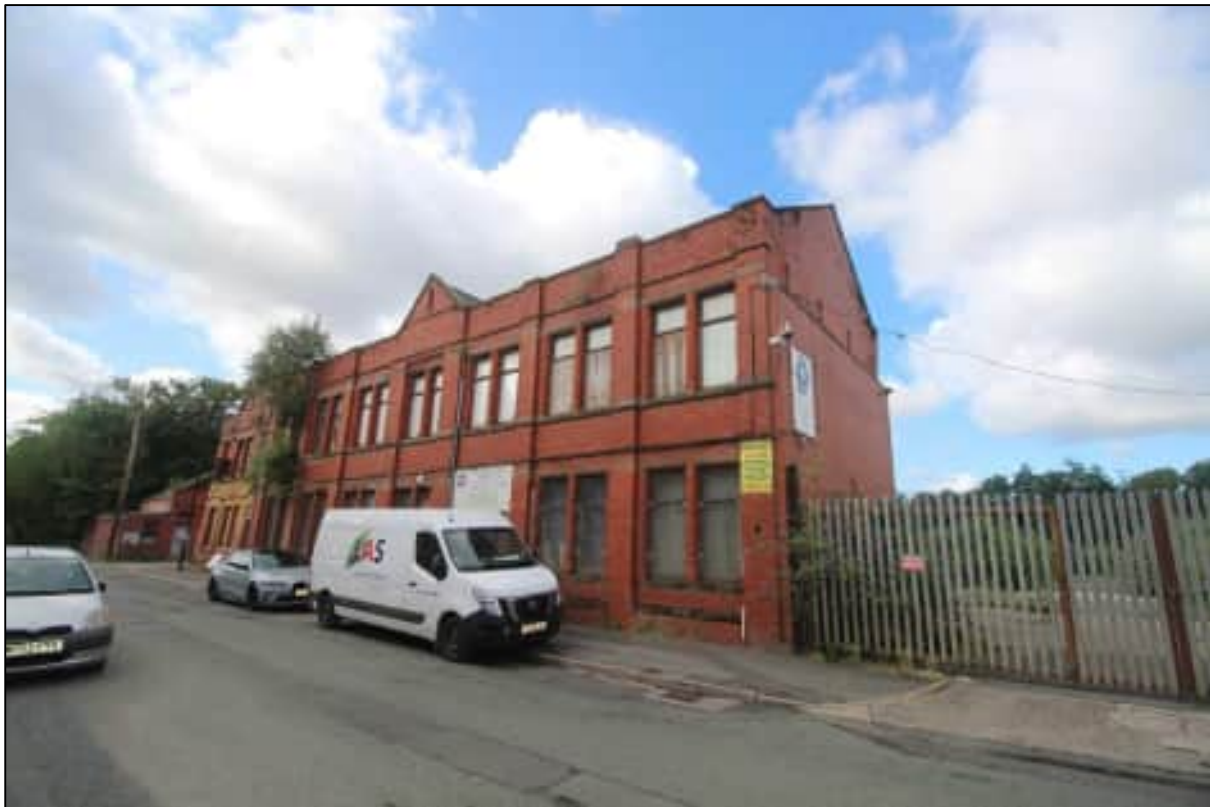
The site comprised a two-storey office and warehouse building fronting Louisa Street (Plate 6), the former casting and pattern store workshop to the northern end of the site, a single-storey gatehouse and a single storey warehouse to the south-eastern corner. The office building and the former casting and pattern store workshop form the basis of this report as the other two buildings were outside the scope of this investigation.

*Plate 6: General view of the office building fronting Louisa Street, facing south-west*

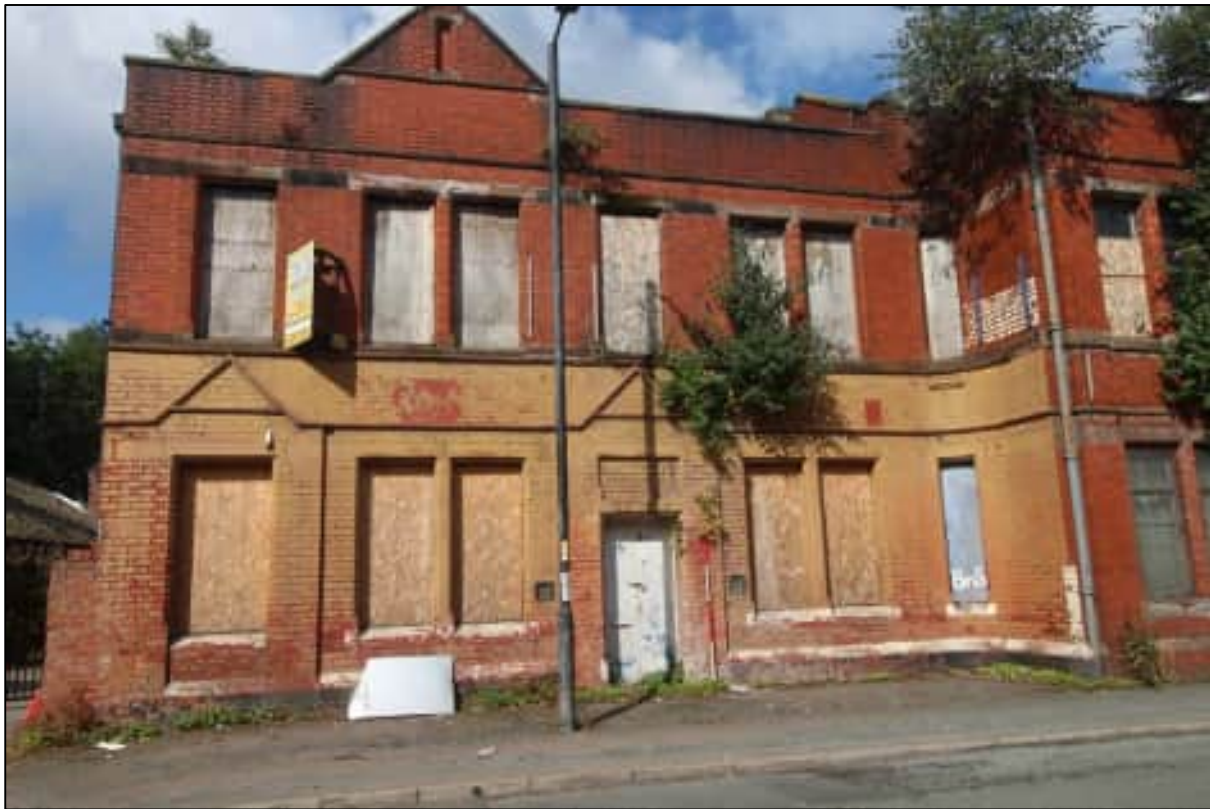
The office building was of 12 bays wide and constructed in two phases. The southern five bays formed earliest phase designed in c.1892, with the northern bays built in the early-20<sup>th</sup> century (Fig 2). The eastern elevation of the 1892 office was of red brick construction in Flemish bond rising to two-storeys (Fig 2; Plate 7). The ground floor comprised six window apertures with a central doorway. The doorway was flanked by a pair of windows with a single opening to the north and south ends (Plate 7). Each of the windows measured 3' (0.91m) wide and consisted of chamfered edged sandstone lintels and sills with a simple stone banding above. Directly above was a decorative projecting terracotta string course with an inverted V above the southern aperture and the central doorway. The openings had been blocked with timber sheeting (Plate 7 and 8).

*Plate 7: General view of the 1892 office building fronting Louisa Street, looking west*

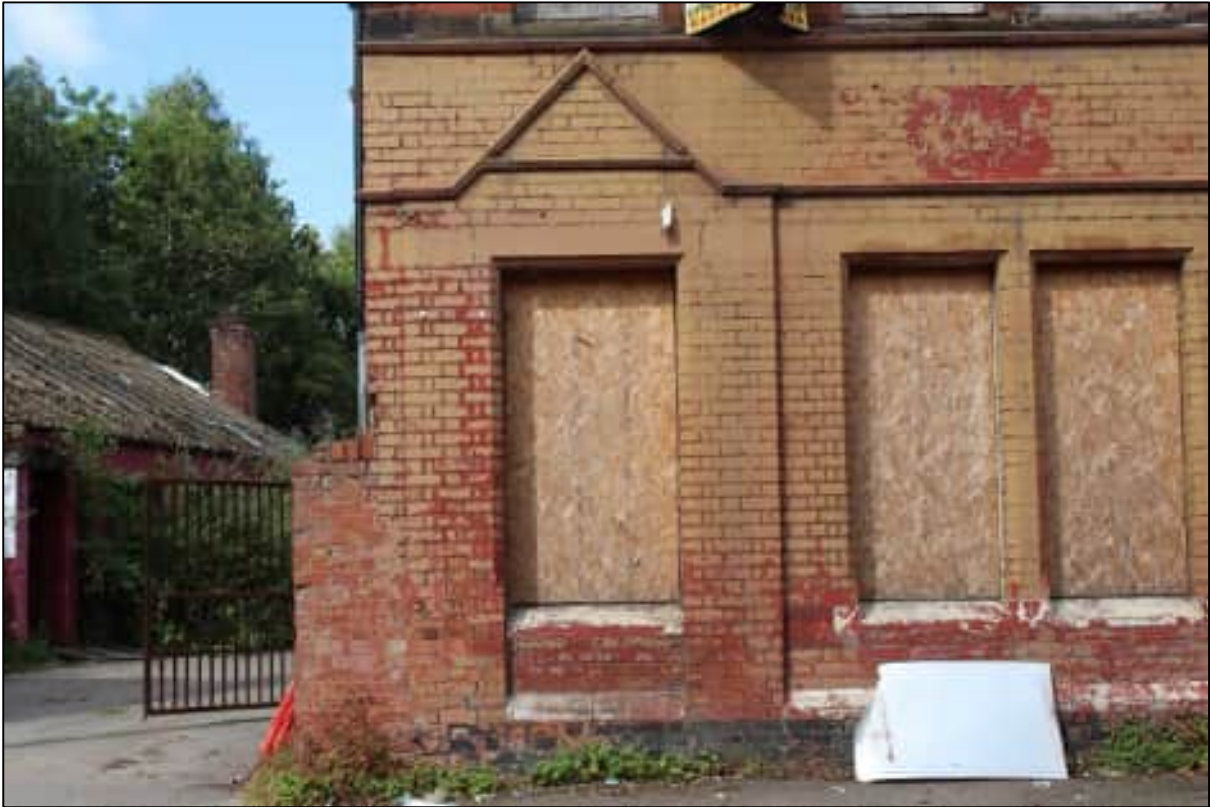
*Plate 8: Detail of the southern ground floor window of the office building, looking west*

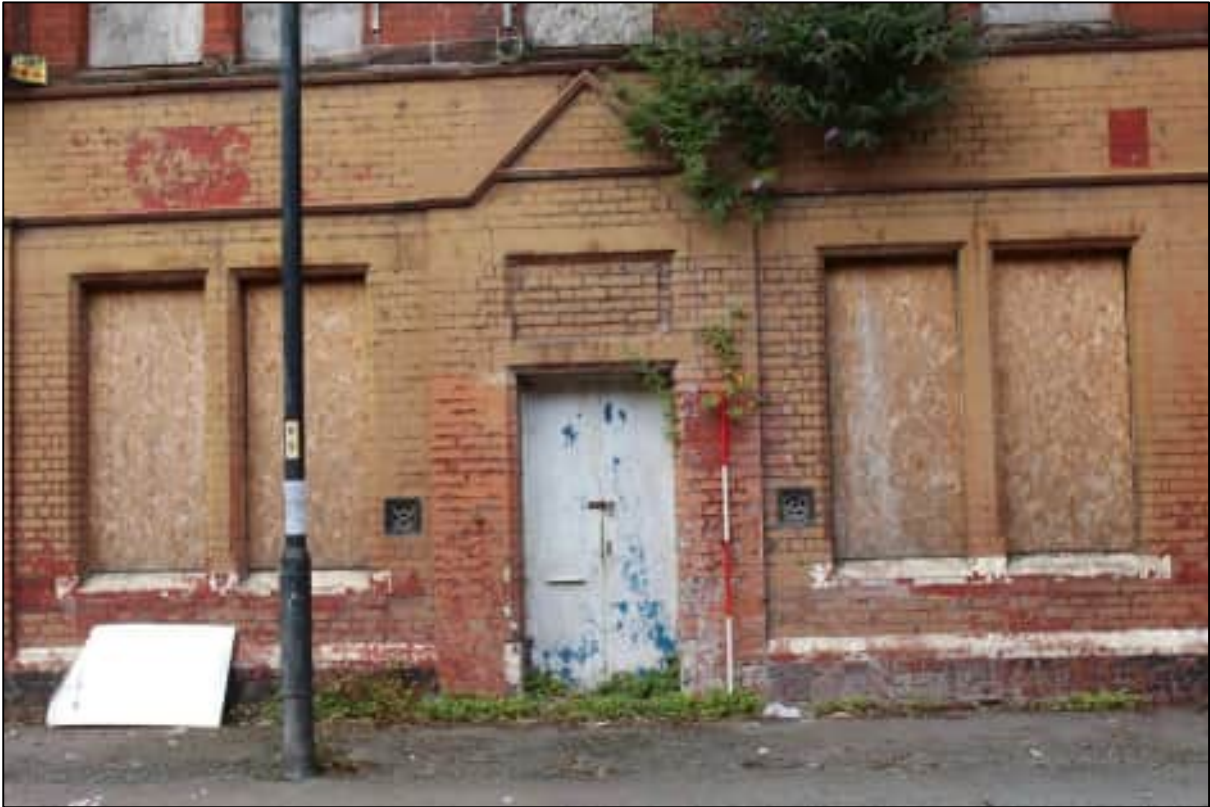
The doorway was recessed within a projecting panel with brick pilasters (Plate 9). The 3'6" (1.07m) wide opening comprised a chamfered sandstone lintel with a recessed brick frieze above and housed a replaced timber door with late-20<sup>th</sup> century door furniture (Plate 9).

*Plate 9: Detail of the central doorway within the eastern elevation of the office building, looking west*

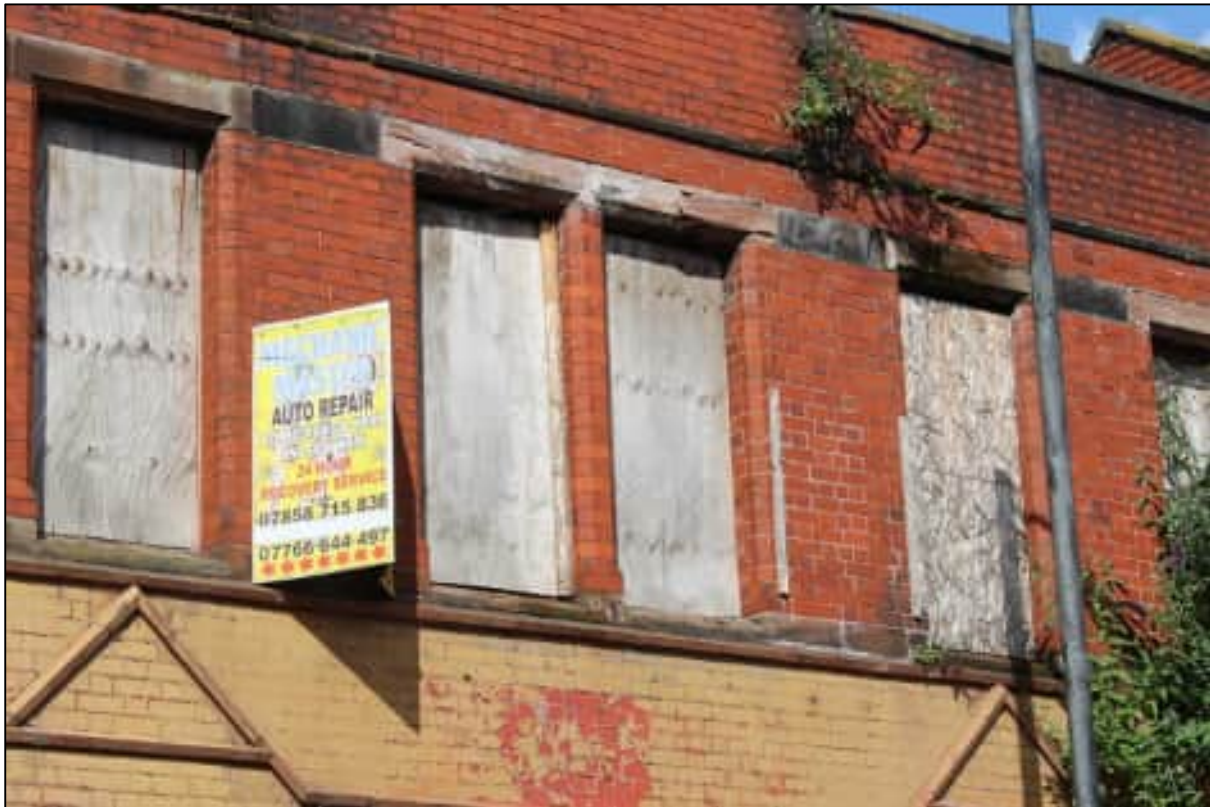
The first floor comprised seven 3' (0.91m) wide window apertures with the northern window situated within the curvature of the wall measuring 1'6" (0.45m) wide. The windows consisted of chamfered edged sandstone lintels and sills with a simple stone banding above. The openings had been blocked with timber sheeting (Plate 10).

*Plate 10: Detail of the first floor windows to the eastern elevation of the original office building, looking north-west*

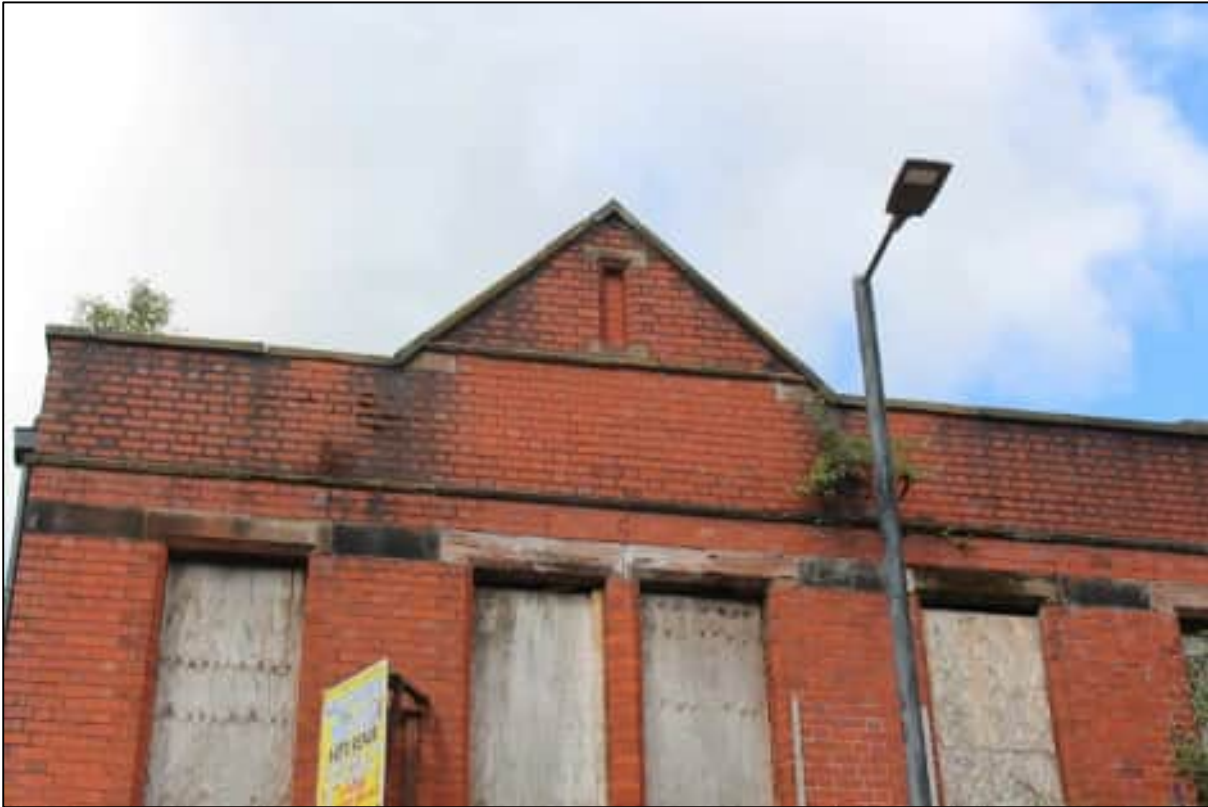
The pitched roof with a gablet to the second bay from the southern end was obscured by a simple parapet wall topped with copings stones. The gablet contained a blocked slit window with a sandstone lintel and sill and was infilled with bricks (Plate 11).

*Plate 11: Detail of the gablet to the original office buildings eastern elevation, looking west*

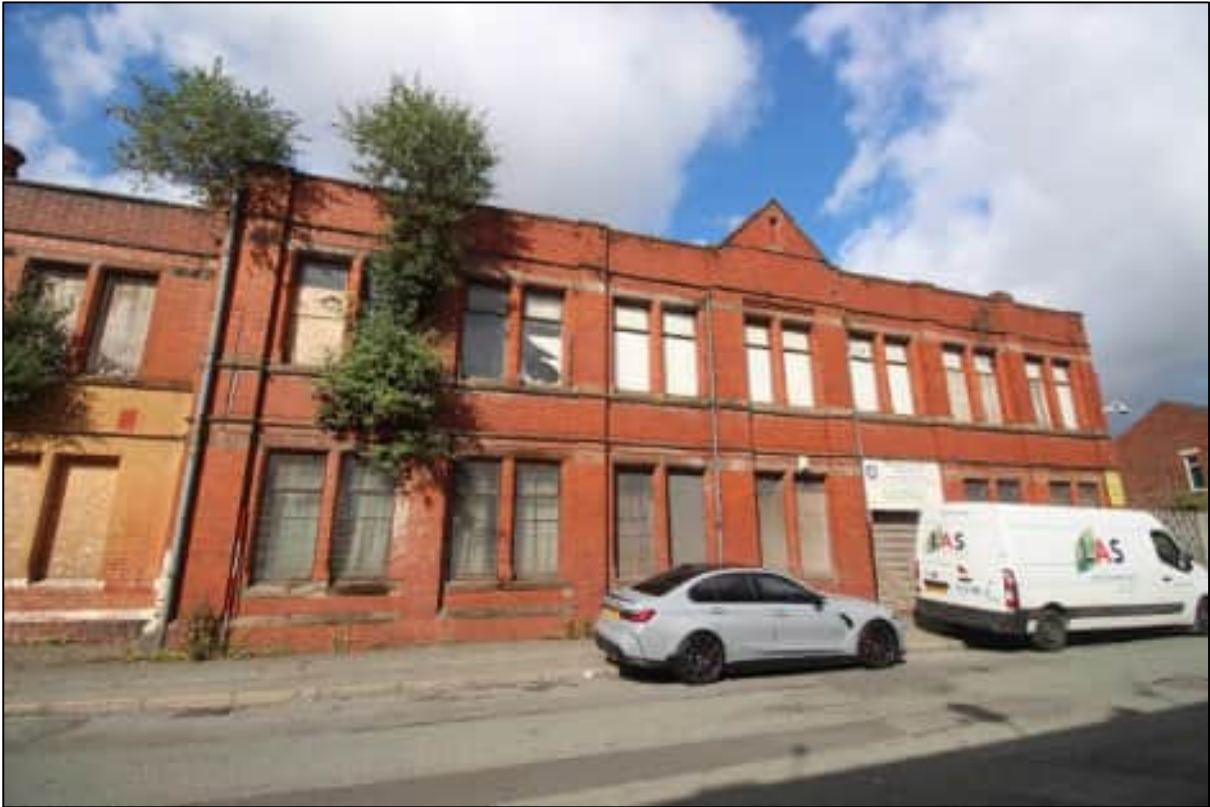
The early 20<sup>th</sup> century extension to the northern end of the building consisted of seven bays rising to two-storeys. The ground floor consisted of six pairs of windows with a doorway within the fifth bay from the southern end (Fig 2; Plate 12). The windows comprised chamfered edged sandstone lintels and sills with a simple stone banding above. Housed within the 2'9" (0.83m) wide openings was a two-light timber framed window with the upper light forming the outward awning opening (Plate 13). A modern steel mesh security panel had been bolted to the quarter bat reveals during the latter half of the 20<sup>th</sup> century. The northern doorway had been remodelled with the inclusion of a roller shutter door and a modern timber door affording access into the northern half of the ground-floor (Plate 14). A single terracotta tiled step afforded access into the opening (Plate 14).

*Plate 12: General view of the 20<sup>th</sup>-century extension to the office building fronting Louisa Street, looking west*

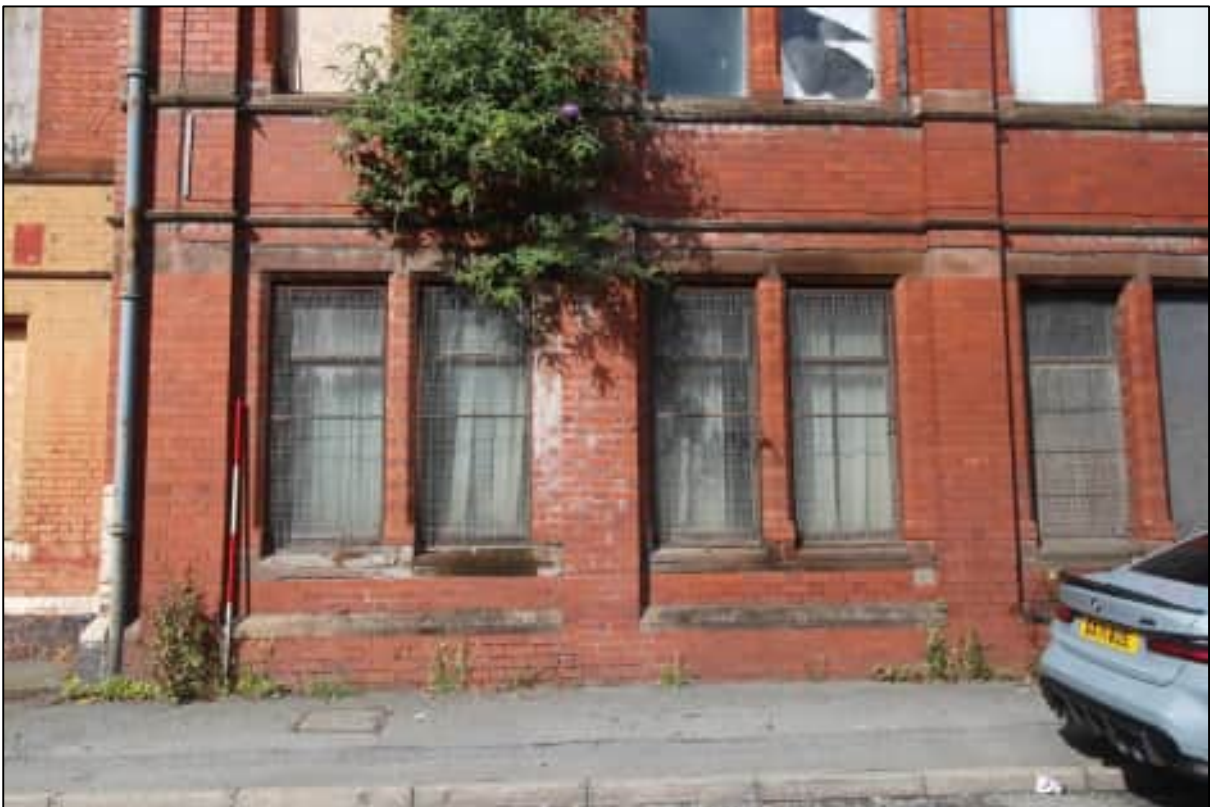
*Plate 13: Detail of the ground floor windows to the Louisa Street office building, looking west*

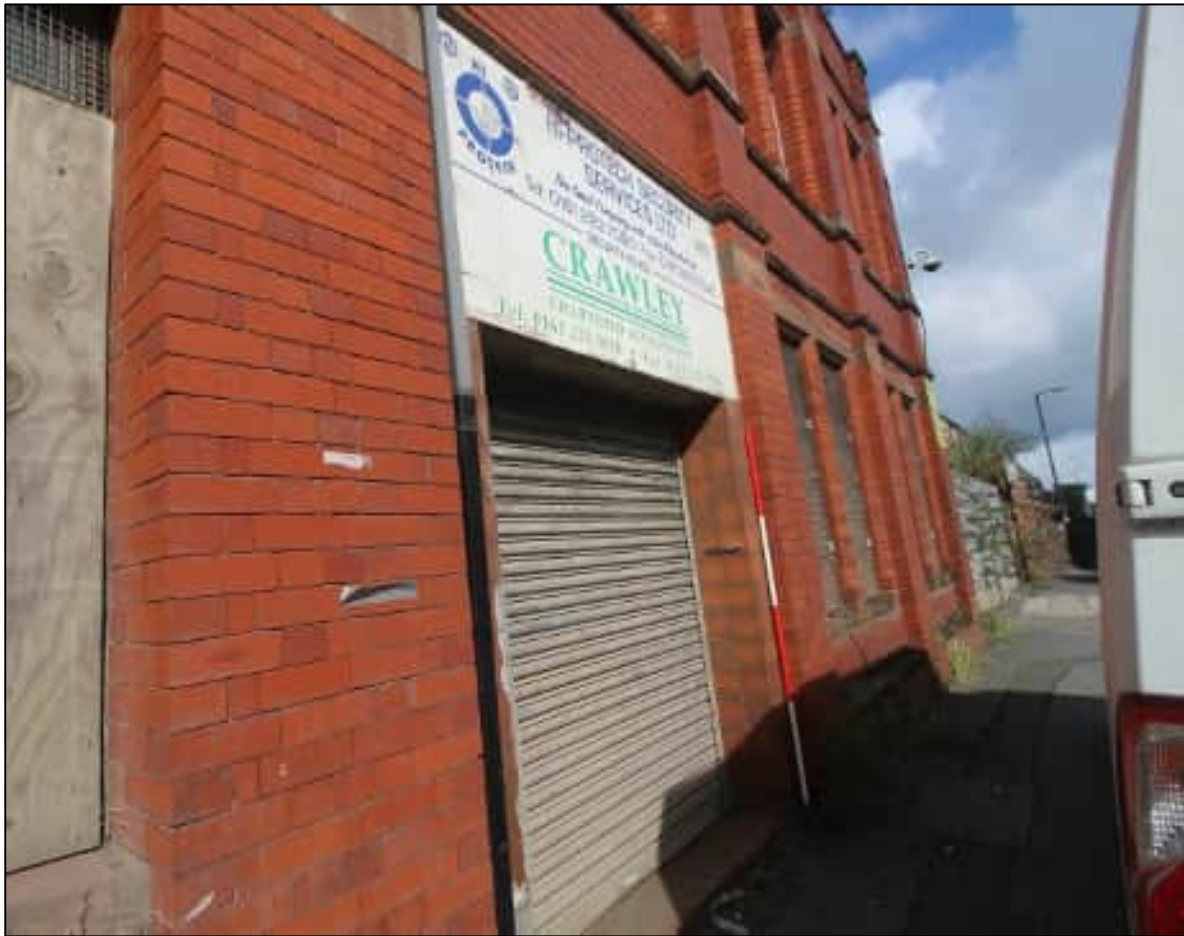
*Plate 14: The northern doorway within the eastern elevation, looking north-west*

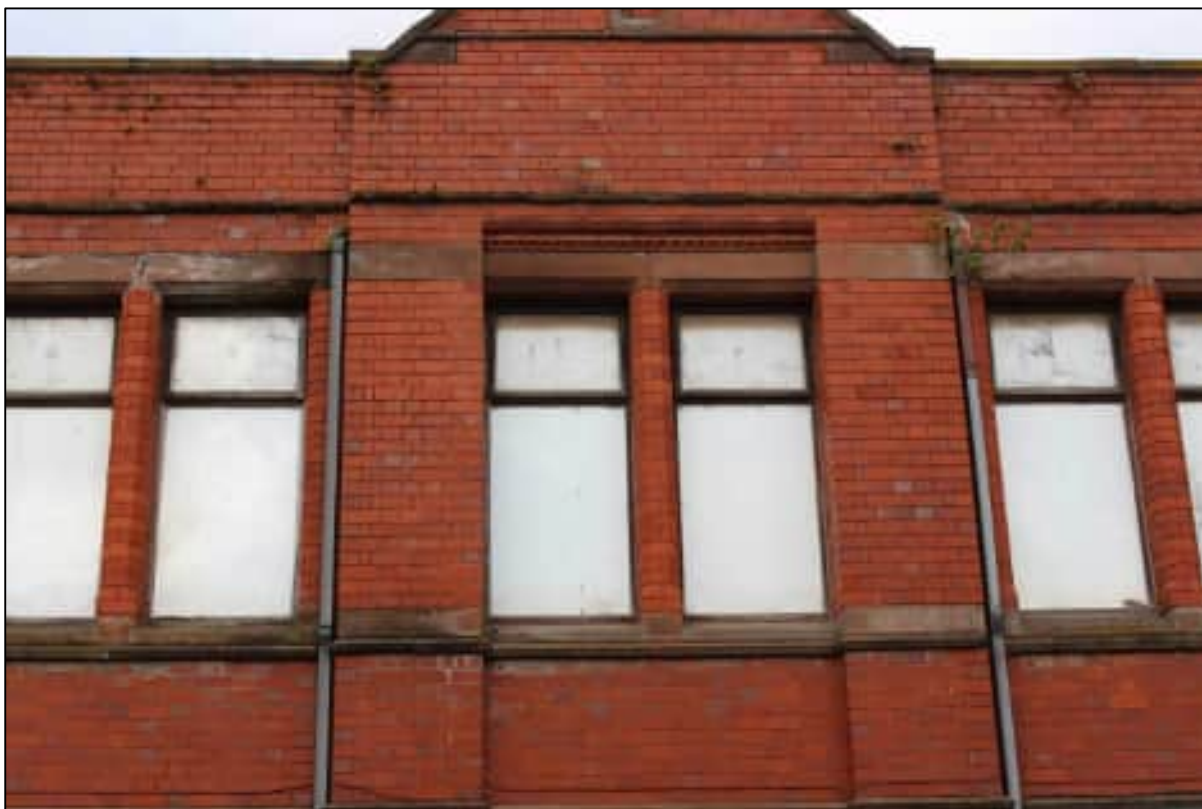
The first floor comprised seven pairs of window apertures and consisted of chamfered edged sandstone lintels and sills with a simple stone banding above. As with openings on the ground floor, a two-light timber framed window with the upper light forming the outward awning opening was housed within the 2'9" (0.83m) wide openings (Plate 15). The glazing had been removed and replaced with plywood timber sheeting.

*Plate 15: Detail of the first floor windows to the eastern elevation of the office extension, looking west*

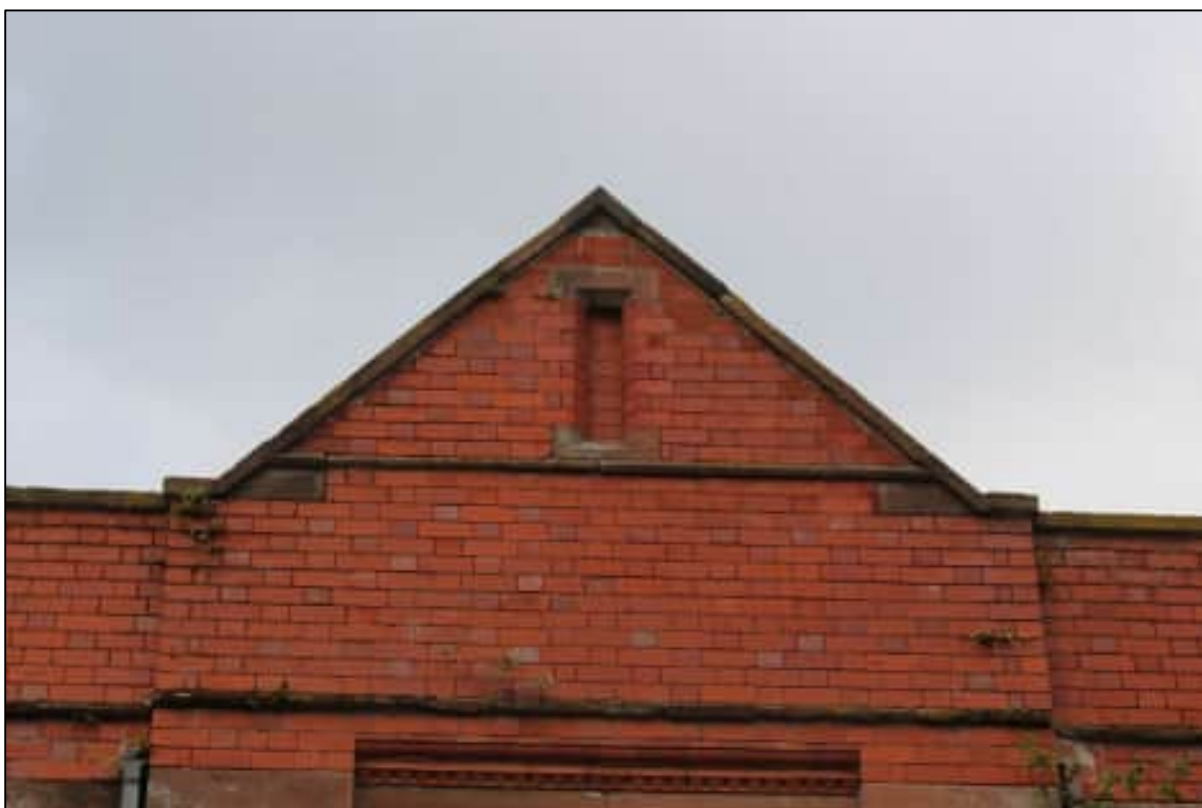
The pitched roof contained a gablet to the central bay and was obscured by a simple parapet wall topped with copings stones. The gablet contained a blocked slit window with a sandstone lintel and sill and was infilled with bricks (Plate 16).

*Plate 16: Detail of the gablet to the eastern elevation, looking west*

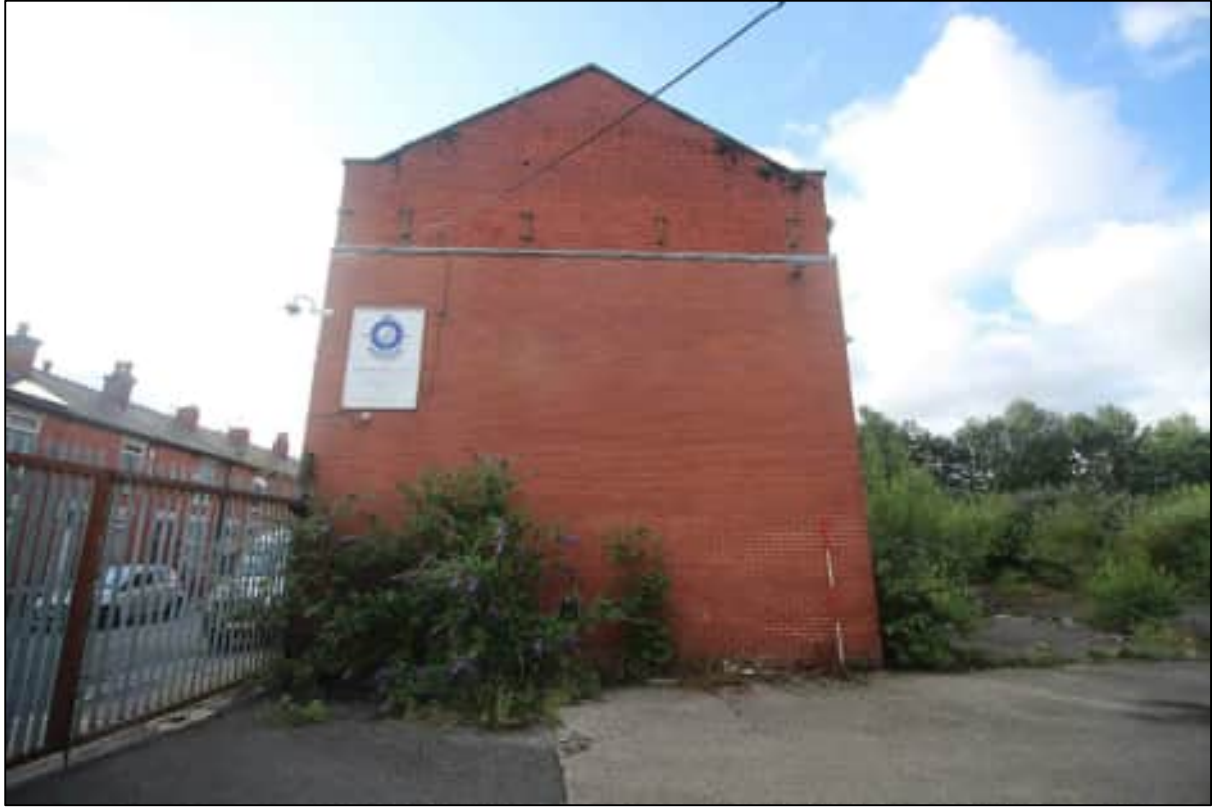
The northern elevation was of a simple design forming the northern gable of the 20<sup>th</sup>-century extension (Fig 3). The elevation was constructed in a stretcher bond until ceiling height of the first floor then Flemish bond to the apex. The roof was capped with stone copings (Plate 17). The elevation was stepped at the intersection with lead flashings (Plate 17). Four T-shaped tie rod plates with square bolts were situated at ceiling height of the first floor (Plate 18).

*Plate 17: The northern elevation of the 20<sup>th</sup>-century office extension, looking south*

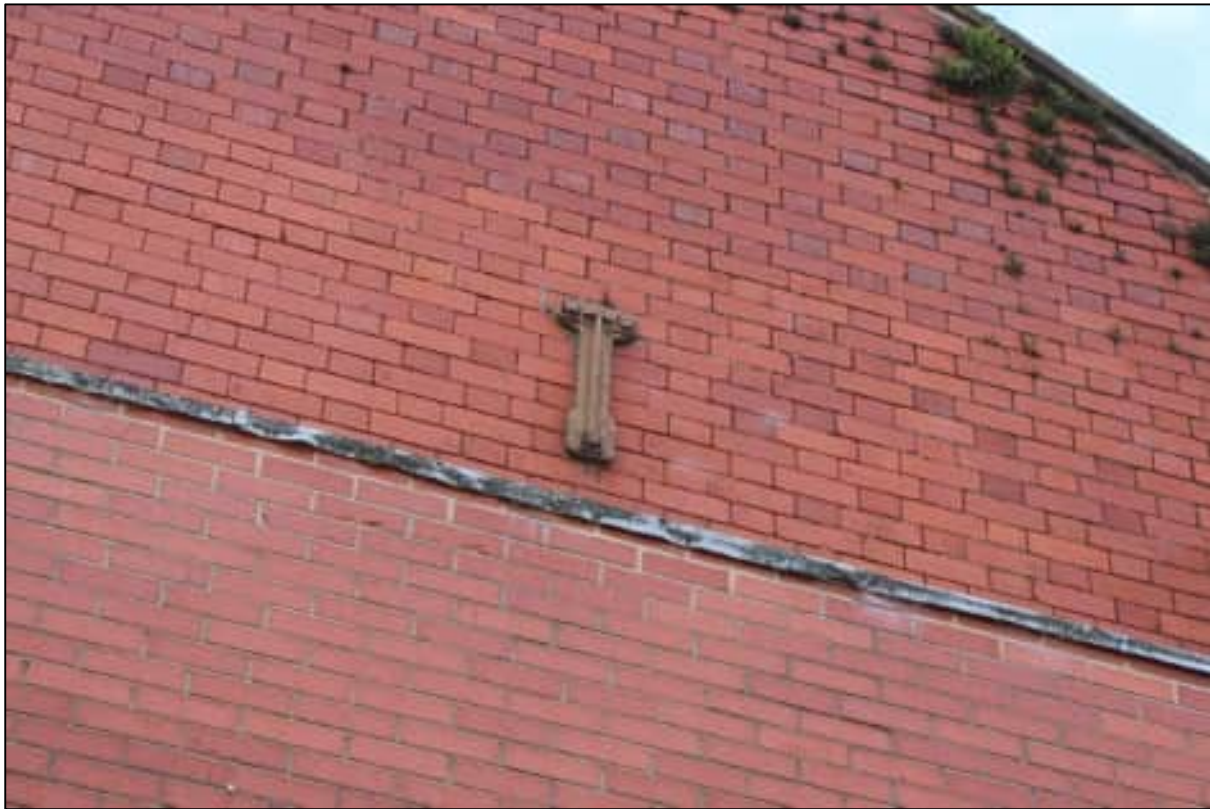
*Plate 18: Detail of tie rod plates to the northern elevation*

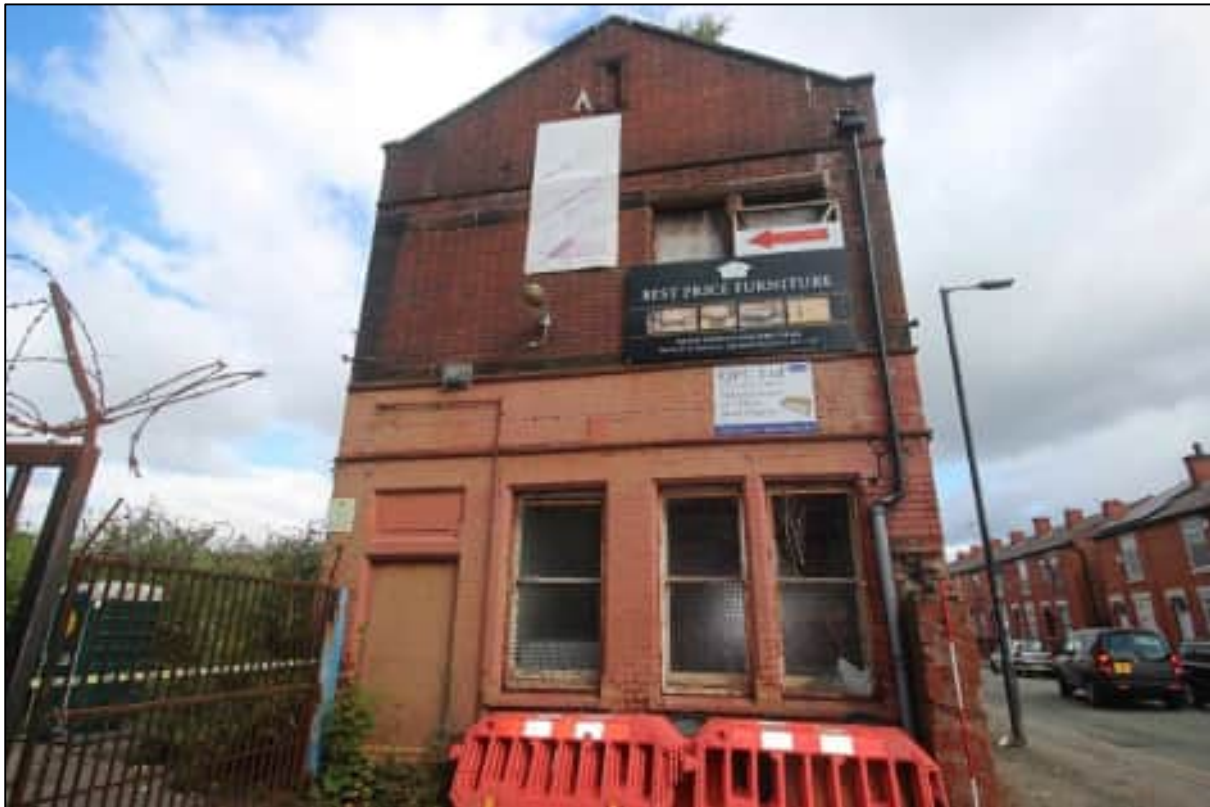
The southern elevation was associated with the original 1892 office and was of two storeys built in Flemish bond (Fig 3, Plate 19). The ground floor comprised three windows apertures with a single doorway to the western end (Fig 3; Plate 19). As with the windows to the principal eastern elevation, the windows comprised chamfered edged sandstone lintels and sills with a simple stone banding above. Housed within the 3' (0.91m) wide openings was a two-light timber framed window with the upper light forming the outward awning opening (Plate 19). A modern steel mesh security panel had been bolted to the quarter bat reveals during the latter half of the 20<sup>th</sup> century.

*Plate 19: The southern elevation of the 1892 office building, looking north*

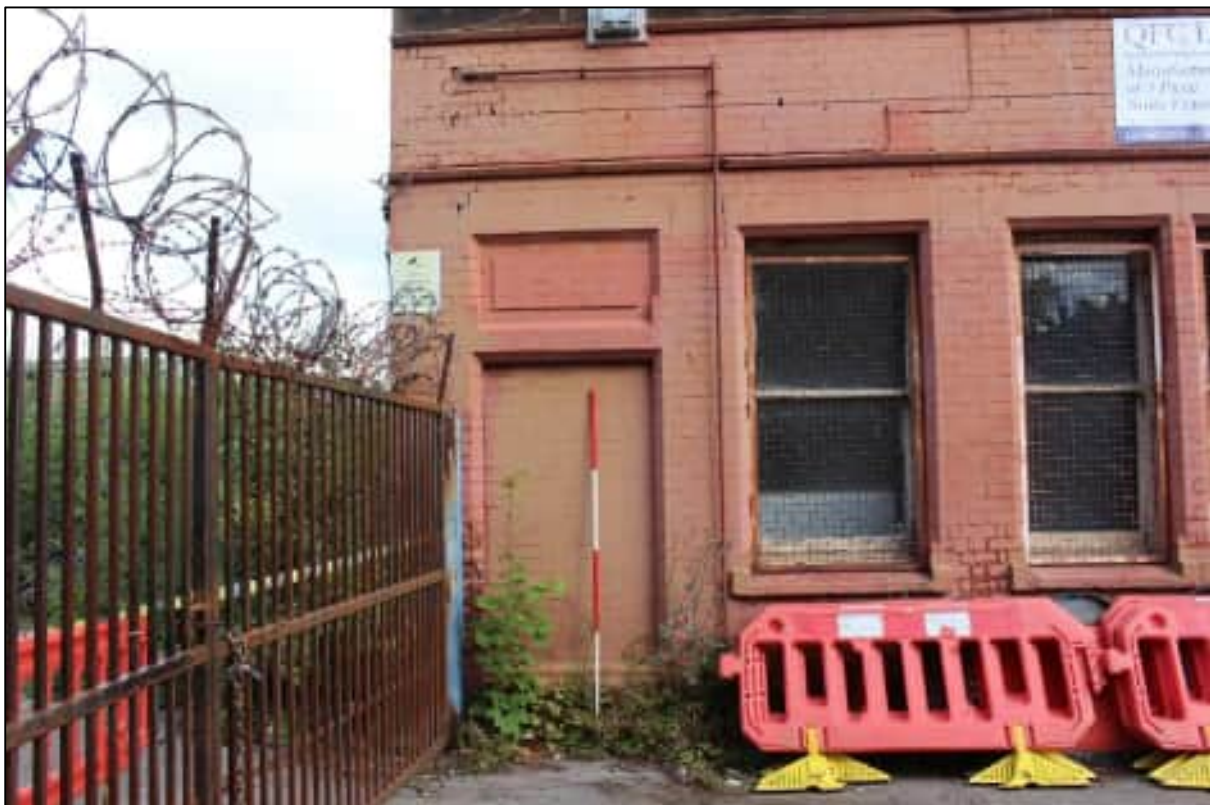
The doorway comprised a chamfered sandstone lintel with a recessed brick frieze above. The 3'6" (1.07m) wide opening had been infilled with brick and a sloping brick plinth had been inserted above the concrete threshold (Plate 20).

*Plate 20: Detail of the blocked doorway to the western end of the southern elevation, looking north*

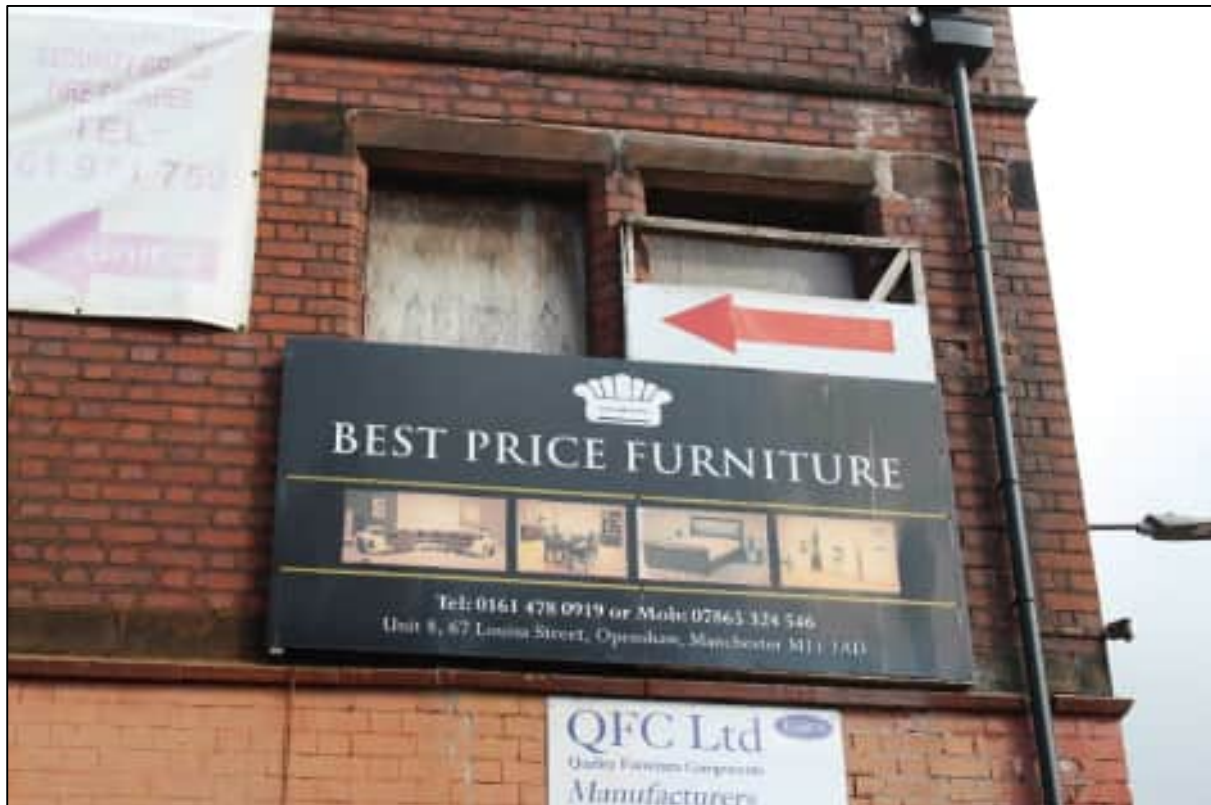
The first floor contained a pair of window apertures to the eastern end with a simple stone string band that continued from the eastern elevation. The windows had largely been obscured with modern signage; however, the chamfered sandstone lintel was observed. The 3' (0.91m) wide openings had been blocked with modern plywood sheeting (Plate 21).

*Plate 21: Detail of the blocked windows to the first floor of the elevation, looking north*

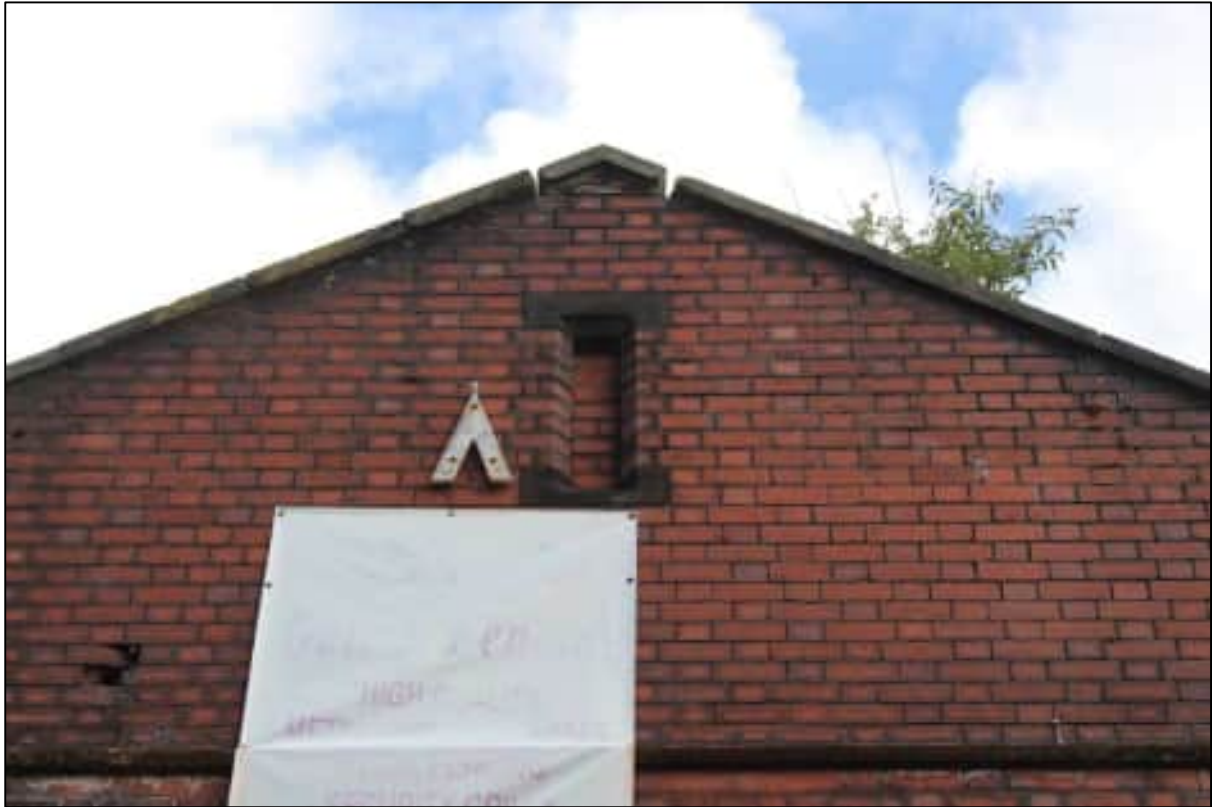
The parapet wall that concealed the roof to the eastern elevation continued around and was topped with stone copings. At the centre was a blocked slit window with a sandstone lintel and sill and infilled with bricks (Plate 22).

*Plate 22: Detail of the blocked widow to the attic of the original 1892 office, looking north*

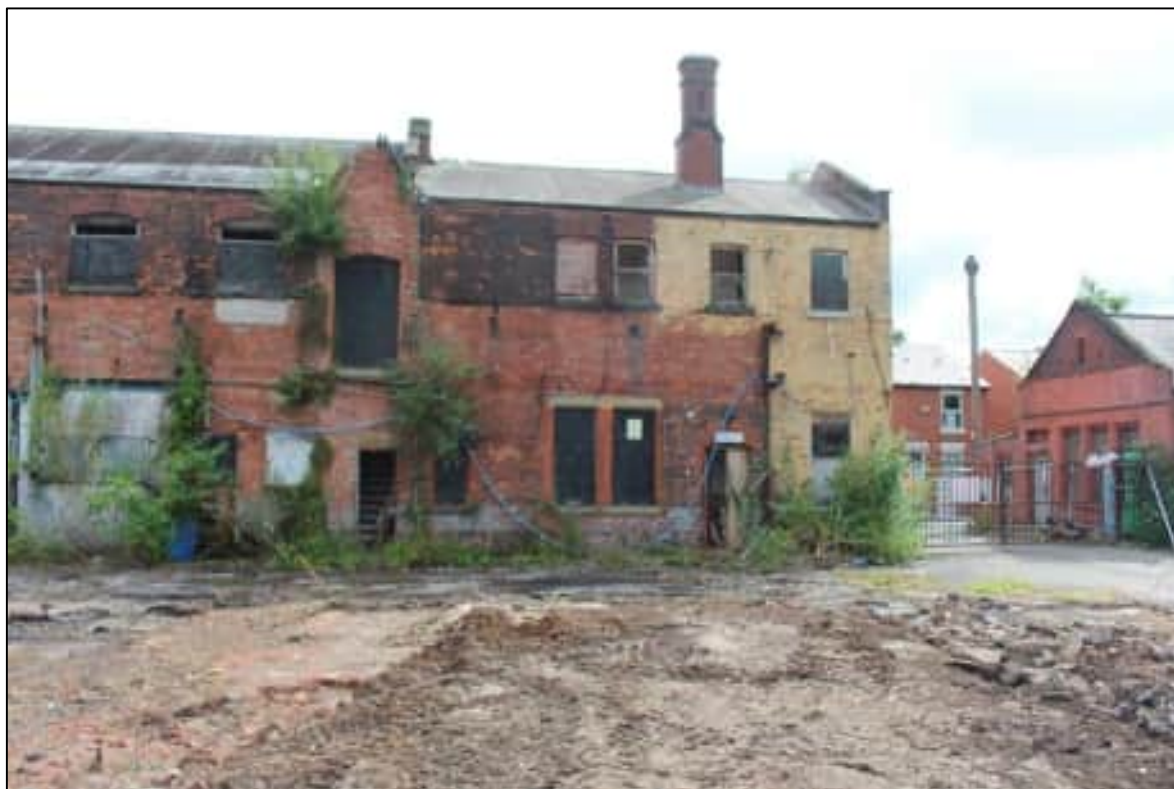
The western elevation of the original phase was constructed in a three stretcher English Garden Wall bond rising to two-storeys with a pitched slate roof terminating at the eaves. At the southern end was a brick chimney (Fig 4; Plate 23). At the southern end of the elevation was the remains of a steel hoist arm.

The ground floor comprised a pair of windows to the north with a single window to the south which flanked a single doorway (Plate 23). The 3' (0.91m) wide windows consisted of chamfered sandstone sills and lintels with the original windows frames removed and the openings blocked with modern plywood sheets. The doorway comprised a segmental arched head with a concrete threshold. The original timber doorframe had been retained, although the door was a modern replacement (Plate 24).

*Plate 23: The western elevation of the 1892 office building, looking east*

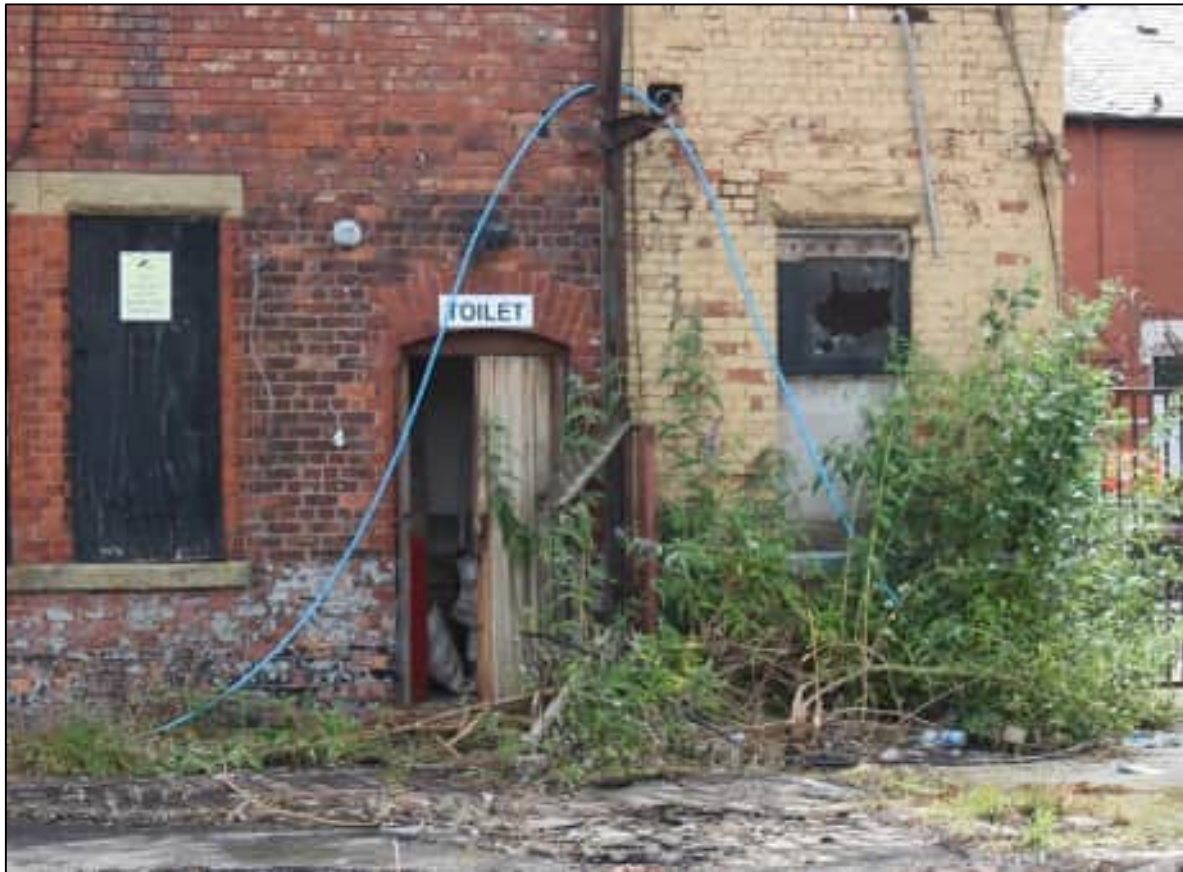
*Plate 24: The doorway to the southern end of the western elevation of the 1892 office building, looking east*

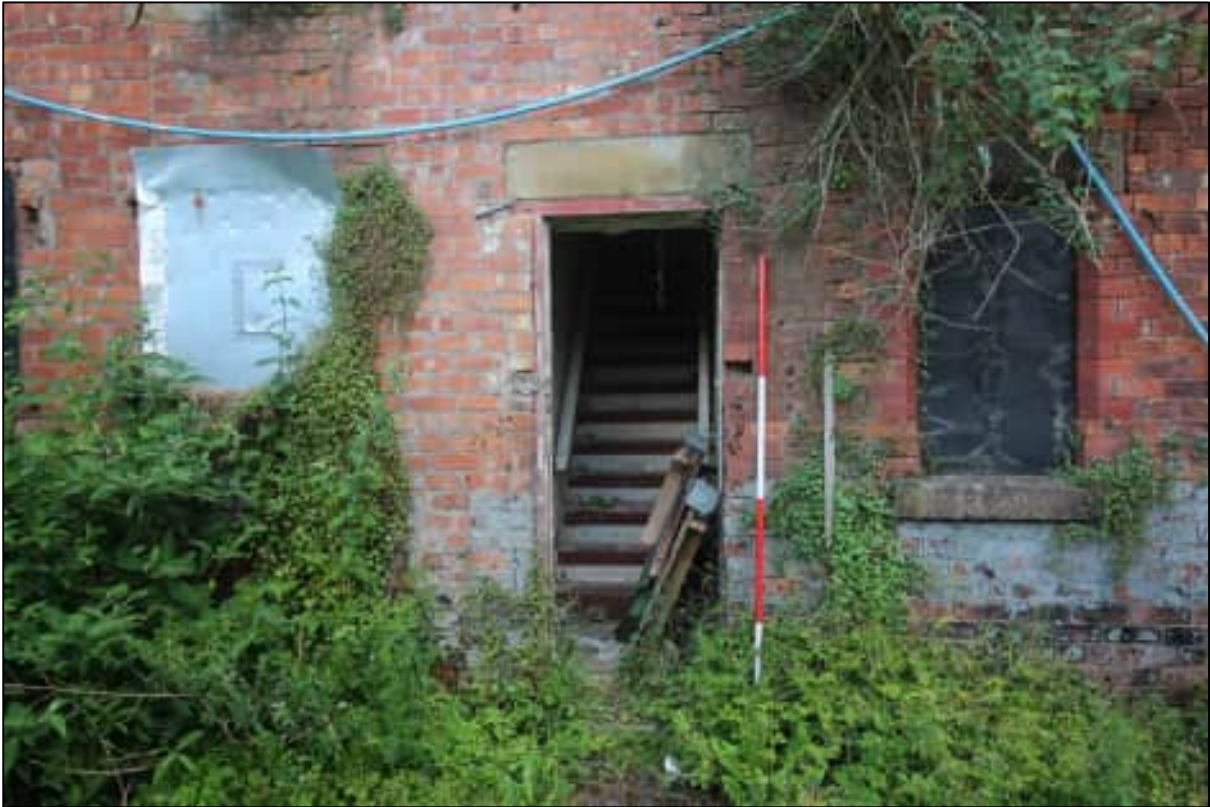
Access into the building was afforded by a single doorway to the northern end of the elevation (Fig 4). The doorway consisted of a flush sandstone lintel, a concrete threshold and had retained the original timber doorframe. The door had recently been removed (Plate 25).

*Plate 25: The doorway to the northern end of the western elevation, looking east*
