Westchurch Homes

# Louisa Street Works, Openshaw, Manchester

## Historical Building Investigation Report

| <b>Report Number:</b> | SA/2023/68 |

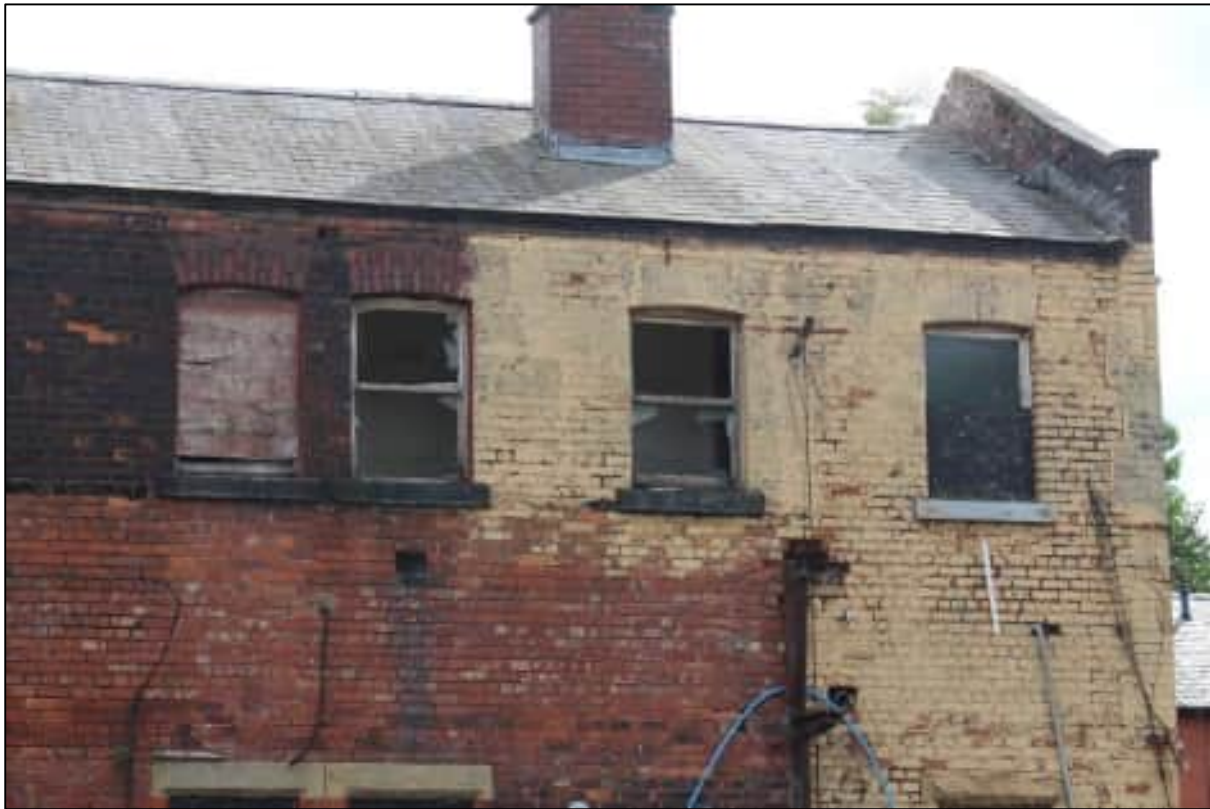
The first floor was of four single windows comprising gauged brick segmental arched heads with protruding sandstone sills (Plate 26). The 3' (0.91m) wide openings housed a replaced two-light timber framed window. The glazing had largely been removed; however, several shards of clear glass had been observed (Plate 26).

*Plate 26: The first floor windows on the western elevation of the 1892 office building, looking east*

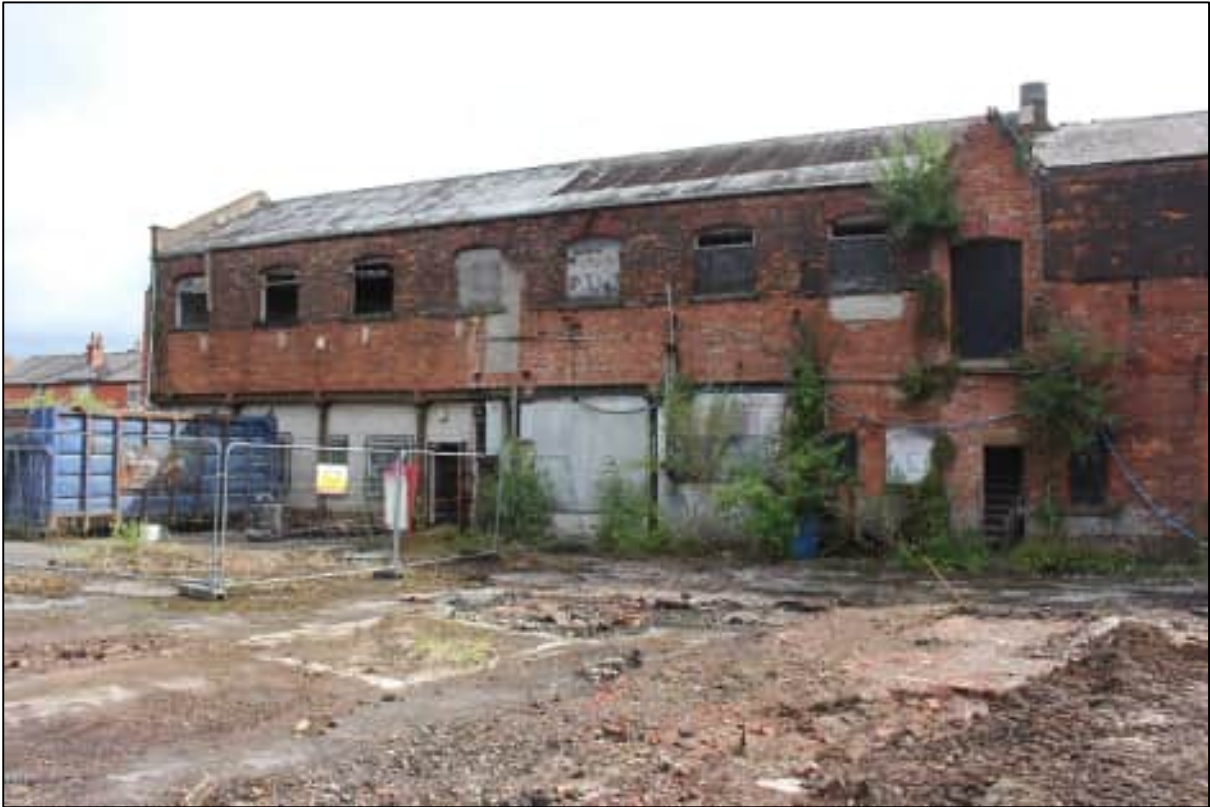
The western elevation of the 20<sup>th</sup> century extension was of two-storeys with a pitched roof that also terminated at the eaves (Plate 27). The elevation was of eight bays with the ground floor having a six bays formed by astragal iron columns with Doric order capitals. The bolting plate of each column was fixed to the lower flange of the I-section rolled iron beams with square headed bolts (Plate 28). The bays were originally open, affording access between the office building and the adjoining building as noted on the Ordnance Survey map of 1915-16. Further evidence of an attached building was observed on the first floor at sill height in the form of the remains of lead flashings and scaring. During the latter half of the 20th-century the bays were infilled with pale cream bricks with modern windows inserted into the first, second and third bays.

*Plate 27: The western elevation of the 20<sup>th</sup>-century extension, looking north-east*

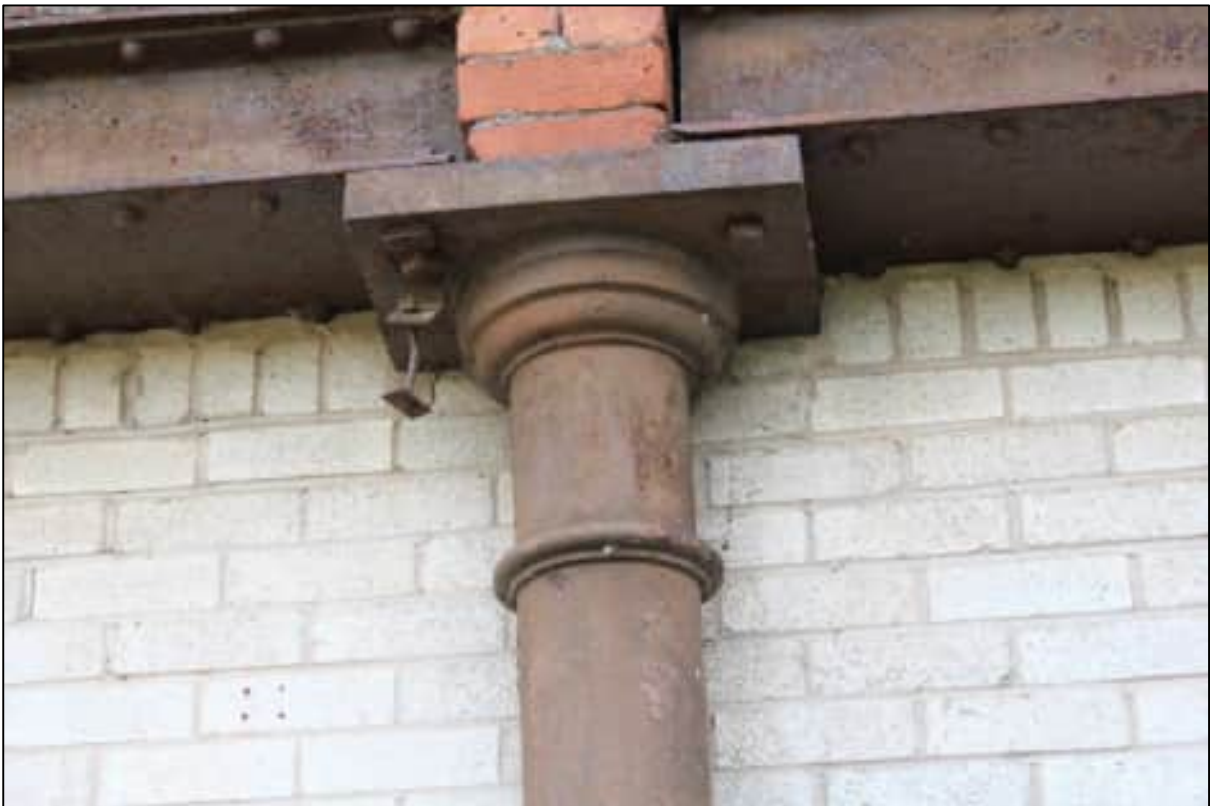
*Plate 28: Detail of the column capital to the ground floor bays*

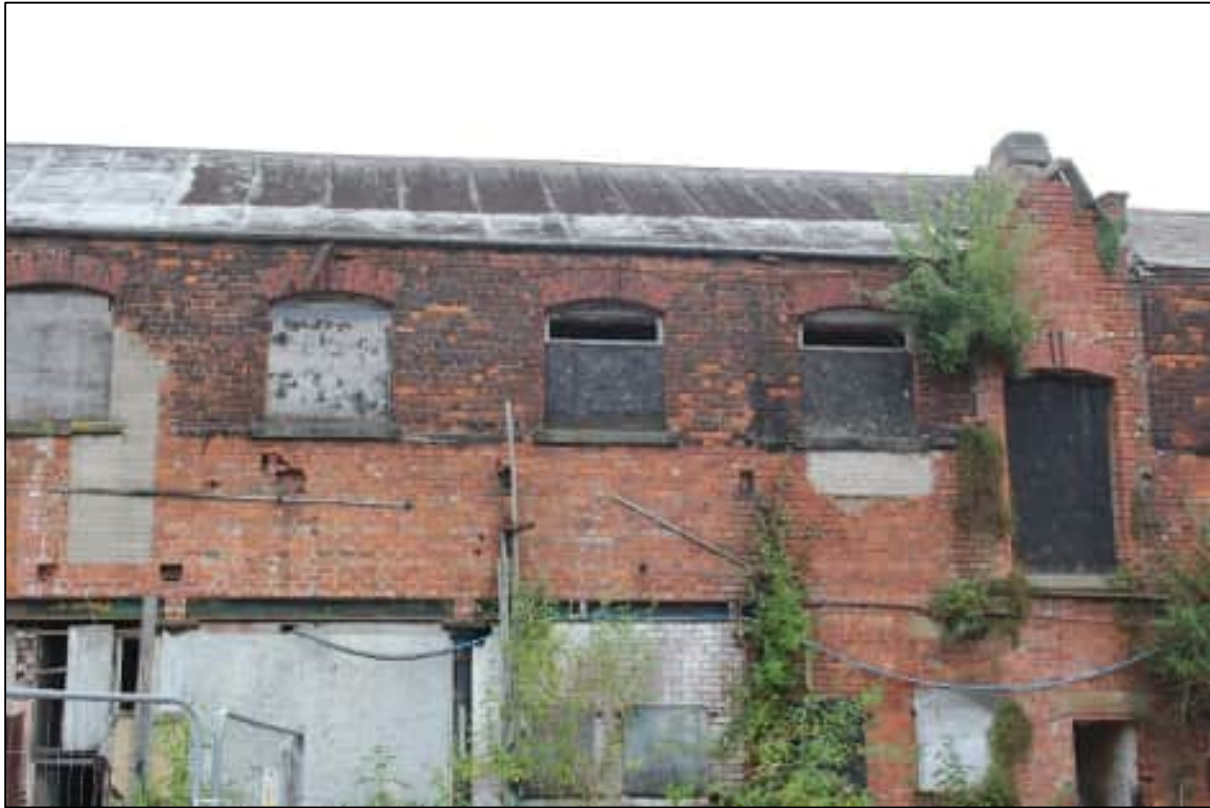
The first floor was constructed in a three stretcher English Garden Wall bond and consisted of seven window apertures with a loading bay doorway to the southern end (Fig 4, Plate 26). The windows comprised segmental arched heads with sandstone sills and replaced timber framed windows (Plate 29).

*Plate 26: The first floor windows on the western elevation of the office building extension, looking east*

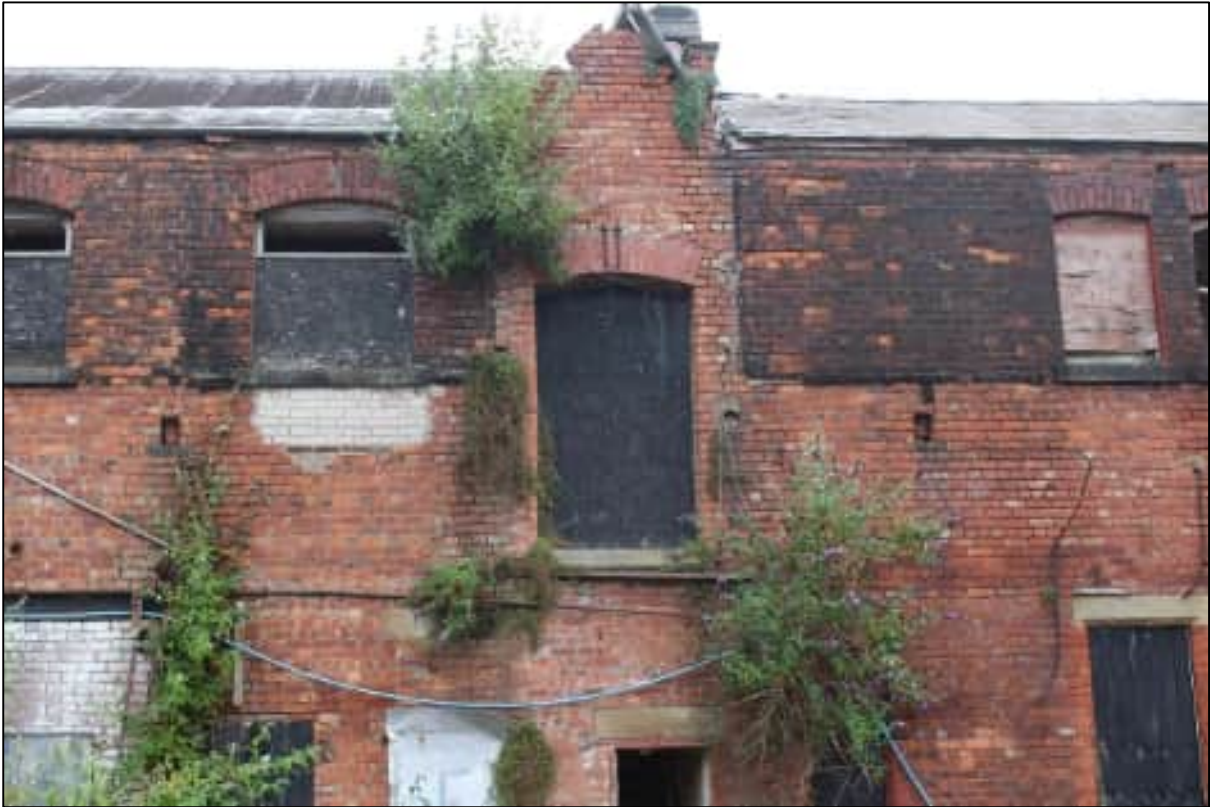
The loading bay doorway to the southern end of the first floor consisted of bullnose brick jambs a segmental arched head and a sandstone threshold set within a gablet. The remains of the hoist arm bracket had been retained at crown height of the lintel (Plate 27). The opening measured 4'6½" (1.38m) wide and was blocked externally with modern timber sheeting (Plate 27). A second loading bay was situated to the south of the fourth bay. This consisted of squared jambs with the arched head and threshold having been removed. The opening was infilled with modern concrete bricks and a concrete sill for the modified fourth bay window was later inserted (Plate 28).

*Plate 27: The first loading bay doorway at the southern end of the western elevation, looking east*

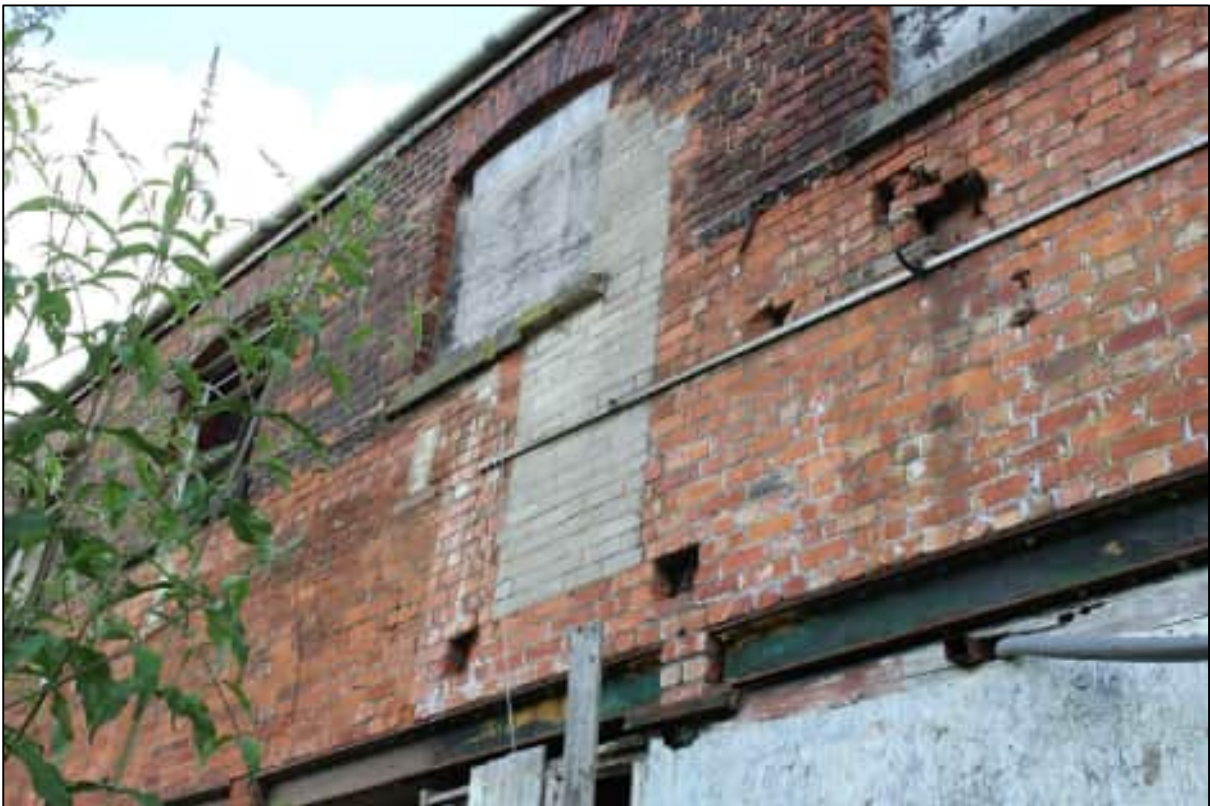
*Plate 28: Detail of the blocked loading bay on the first floor of the western elevation*

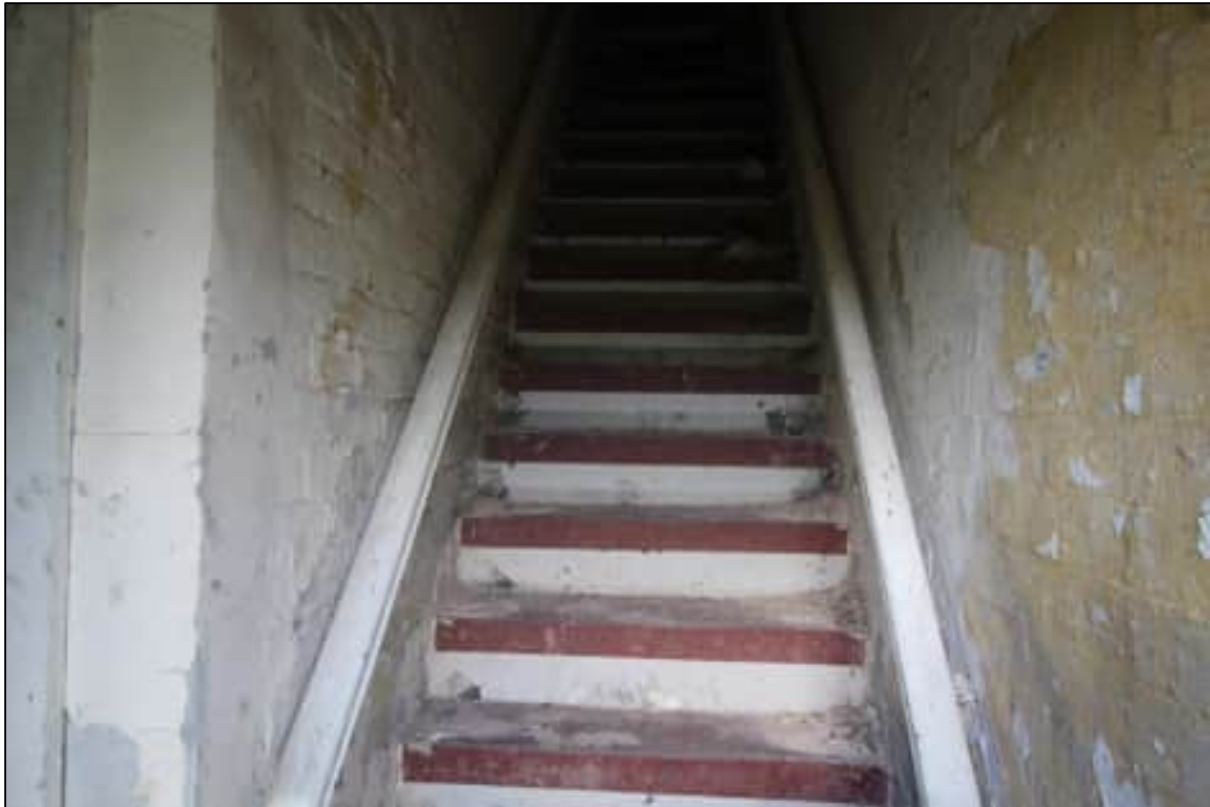
The ground floor was divided into 19 rooms, however five of these were inaccessible. Access was afforded by the doorway to the northern end of the original 1892 office building (Plate 25). The doorway entered a small vestibule which contained a doorway to the northern wall leading into Room 1 and the main staircase affording ascending access to the first floor (Fig 5; Plate 29). The stairs comprised a closed stringer with concrete risers and treads with timber loaf handrail fixed to the northern and southern walls (Plate 29).

*Plate 29: The concrete staircase affording access to the first floor*

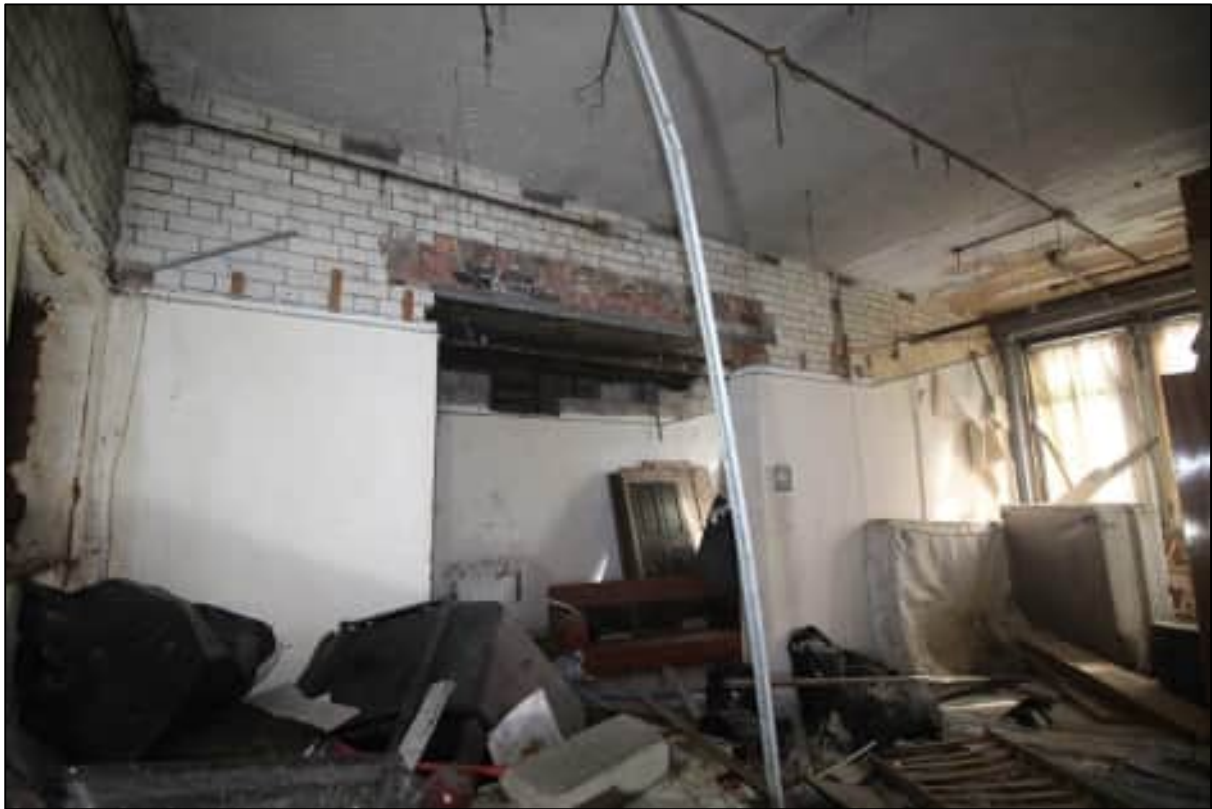
Room 1 measured 7.71m by 2.17m and was situated to the south-western corner of the 20<sup>th</sup> century extension. The room comprised a flat ceiling, a concrete rendered floor with plaster render to the walls (Plate 30). Behind the plaster render was the original glazed brick walls (Plate 30).

*Plate 30: General view of Room 1, looking north*

The northern wall had been modified with the insertion of a tall doorway that afforded access into Room 2. The 7'7 $\frac{3}{4}$ " (2.33m) wide opening had a steel lintel with brick repairs to the wall above (Plate 30).

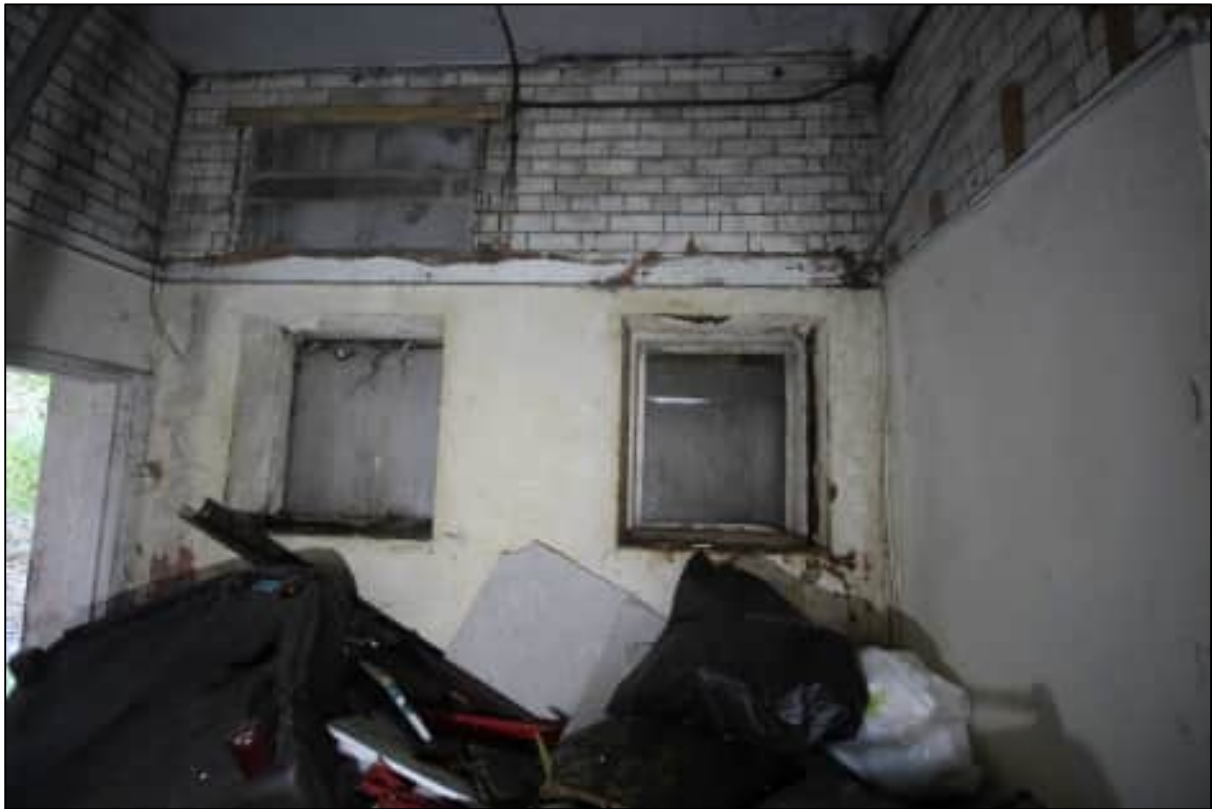
The western wall contained two modern windows measuring 3'7" (0.79m) wide and housed a modern timber framed window within the openings (Plate 31). An earlier window aperture was situated above the southern window. This had a flush sandstone lintel with the opening infilled with modern concrete blocks (Plate 31). The eastern wall contained a further two windows measuring 3' (0.91m) wide. The lintel and sill were obscured by the modern plaster render. The original timber framed window with clear glass glazing had been housed within the openings (Plate 32).

*Plate 31: The western wall of Room 1, looking west*

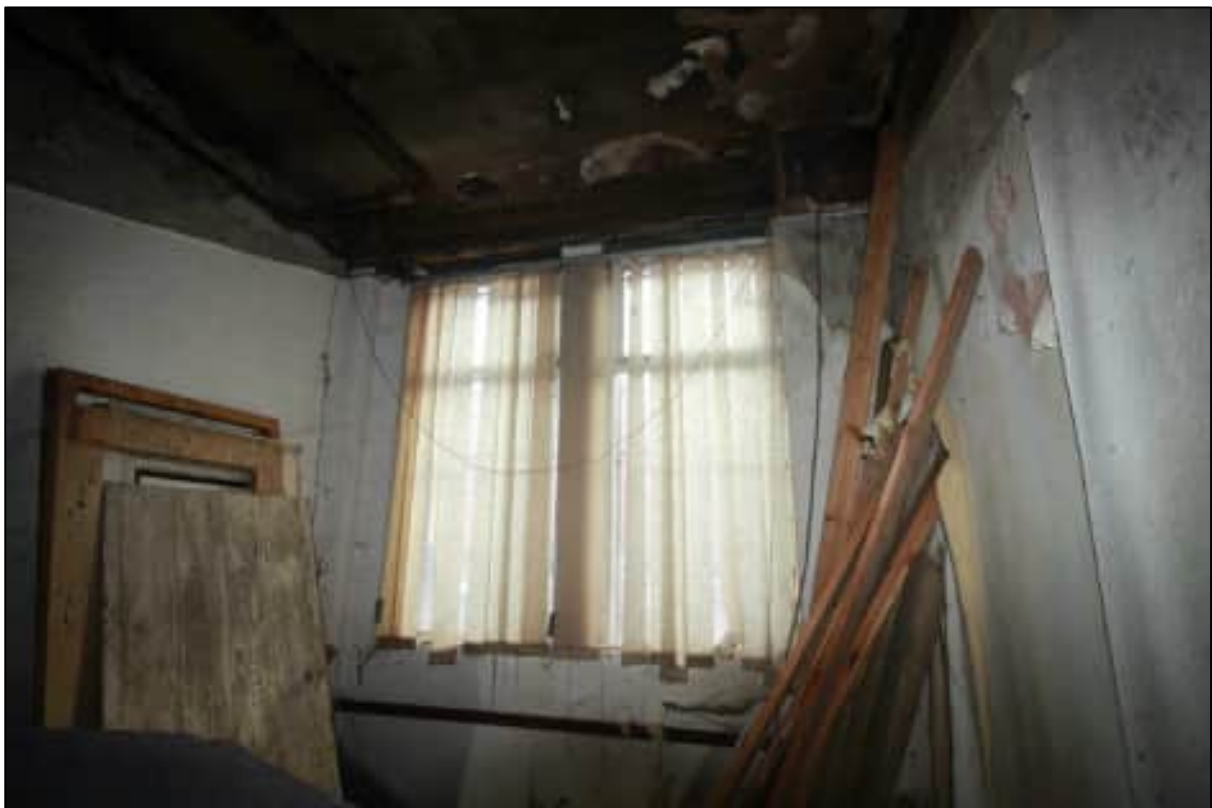
*Plate 32: The eastern wall of Room 1, looking east*

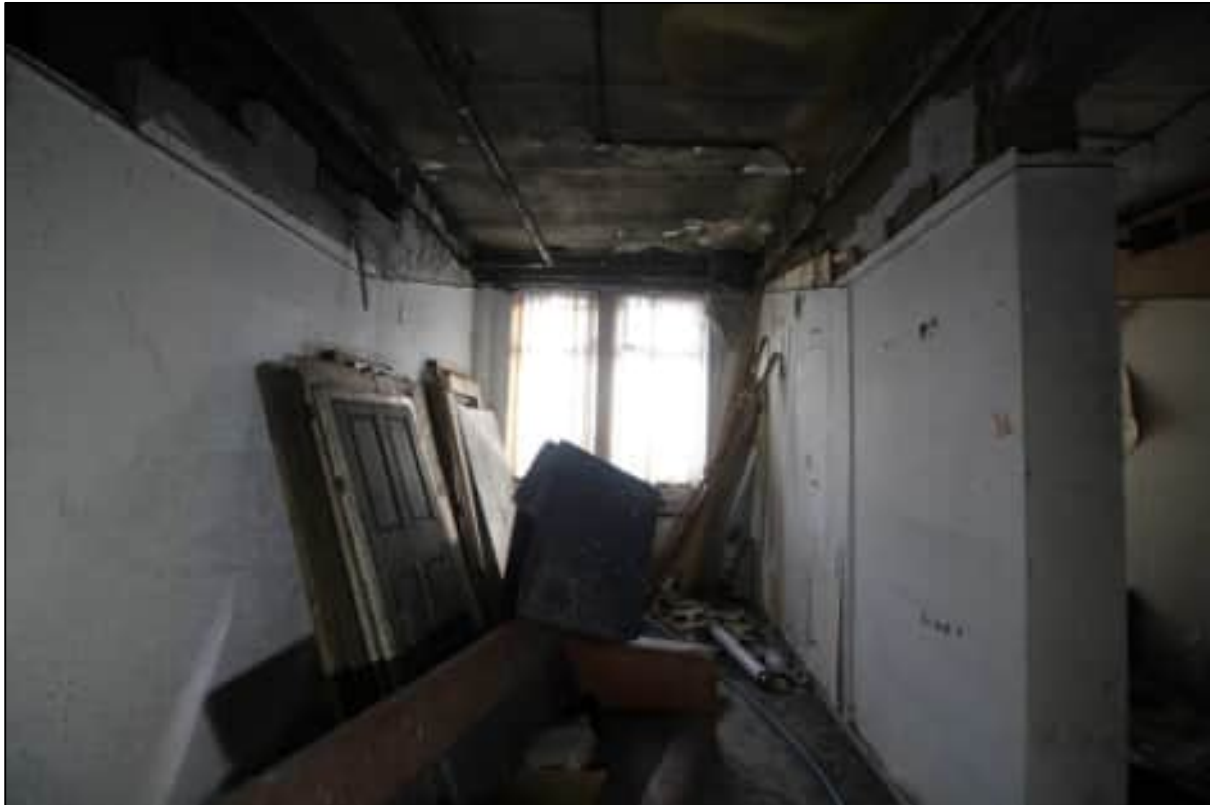
Room 2 measured 7.71m by 2.78m and was also heavily modified with plaster render to the walls, a concrete floor and ceiling (Plate 33; Fig 5). The eastern wall contained two windows measuring 3' (0.91m) wide. The lintel and sill were obscured by the modern plaster render. The original timber framed window with clear glass glazing had been housed within the openings (Plate 33).

*Plate 33: General view of Room 2, looking east*

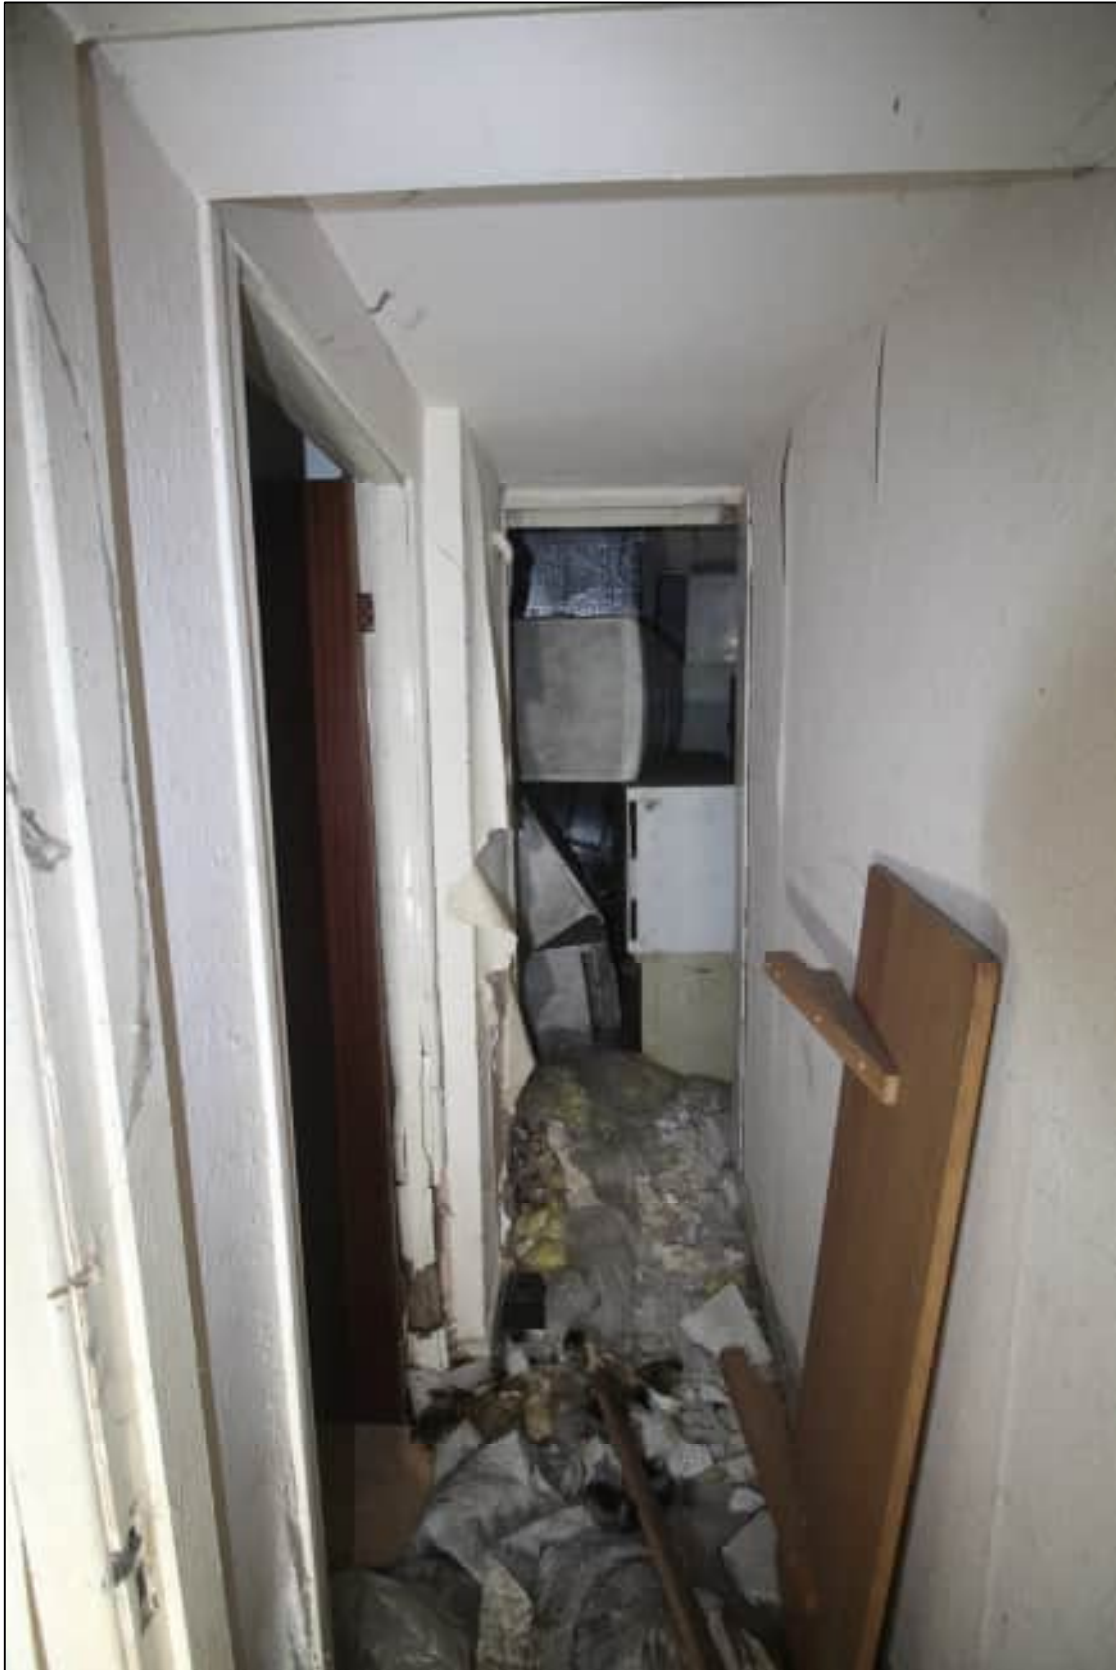
Room 3 was situated to the northern end of the original 1892 office building and was a modern corridor that afforded access into Room 1 to the north, Room 4 to the east and Room 5 to the south (Fig 5). This corridor had a flat plasterboard ceiling, plaster rendered walls and a concrete floor (Plate 34). The doorways comprised simple rectangular timber architraves with modern hollow timber doors.

*Plate 34: General view of Room 3, looking south*

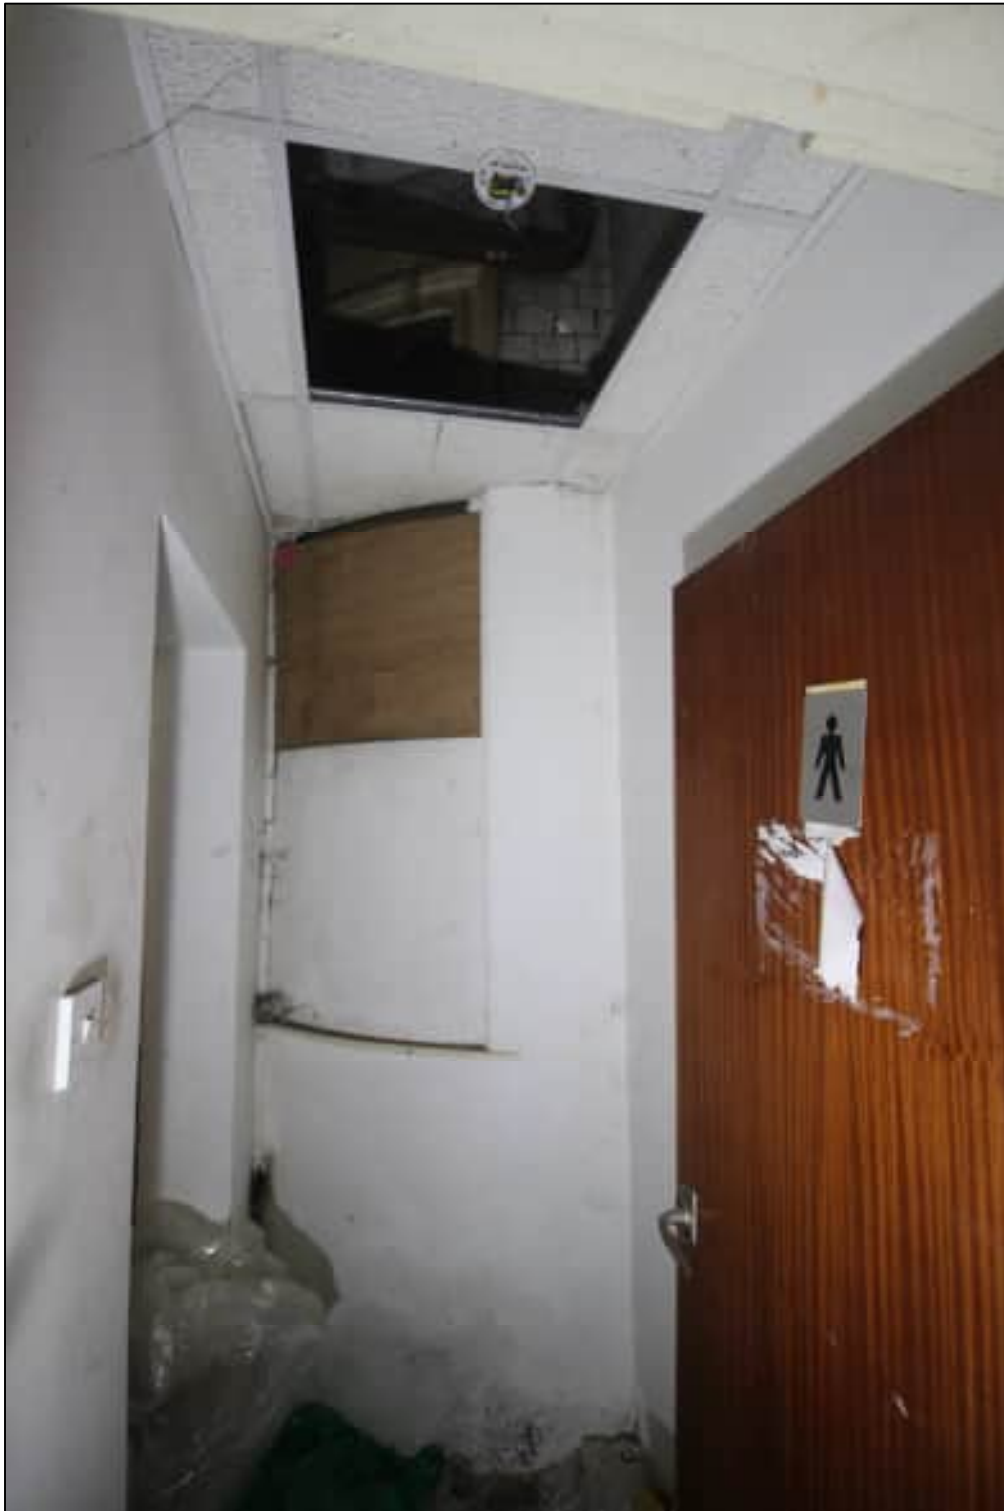
Room 4 was also a small corridor affording access into the male toilets at the southern end (Fig 5). The room consisted of a false suspended ceiling, plaster rendered walls and a concrete floor (Plate 35). The eastern wall was curved and after the removal of the ceiling tiles the original glazed brick wall with a small window had been uncovered (Plate 35).

*Plate 35: General view of Room 4, looking east*

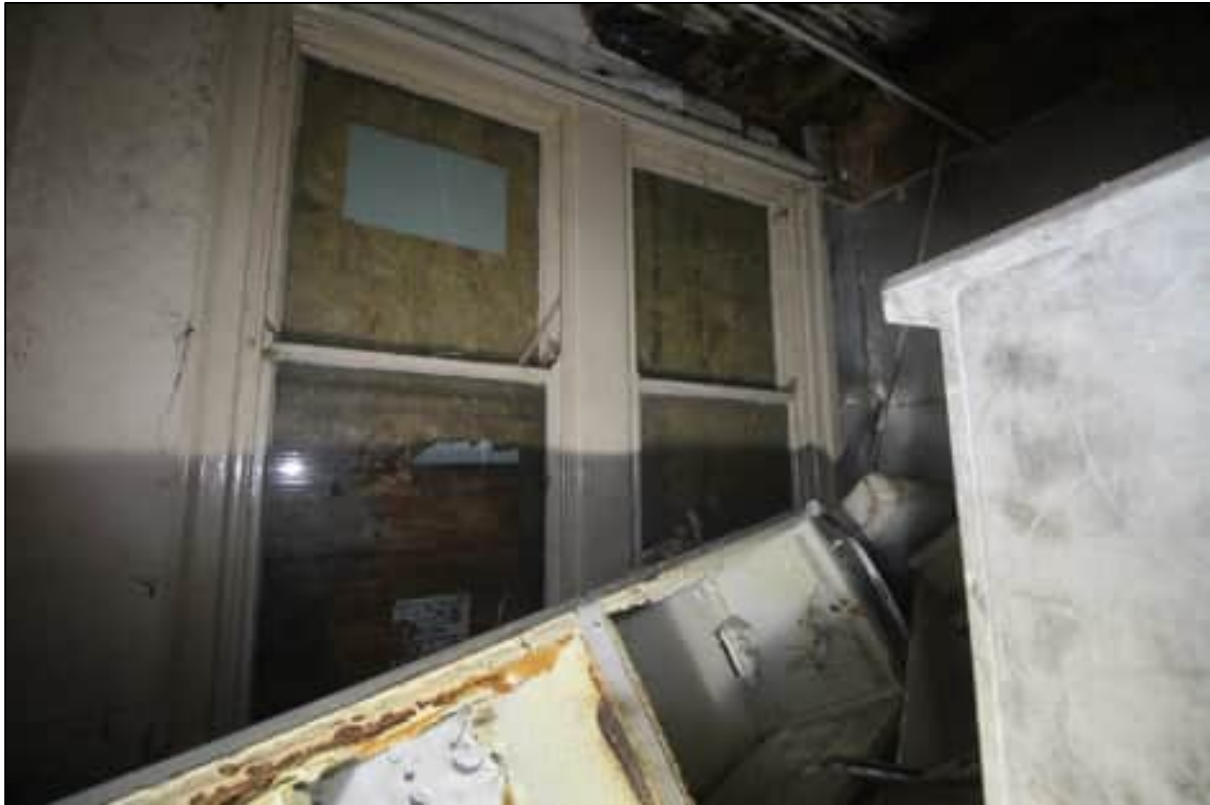
Room 5 could only be partially surveyed from the doorway due to the collapsing ceiling and was filled with modern debris. This room measured 4.23m by 2.52m and consisted of a false suspended ceiling, plaster rendered walls and a concrete floor (Fig 5). The eastern wall contained two windows measuring 0.91m wide. The lintel and sill were obscured by the modern plaster render; however, these had retained the original moulded timber architraves. The original timber framed window with clear glass glazing had been housed within the openings (Plate 36).

*Plate 36: The windows within the eastern wall of Room 5*

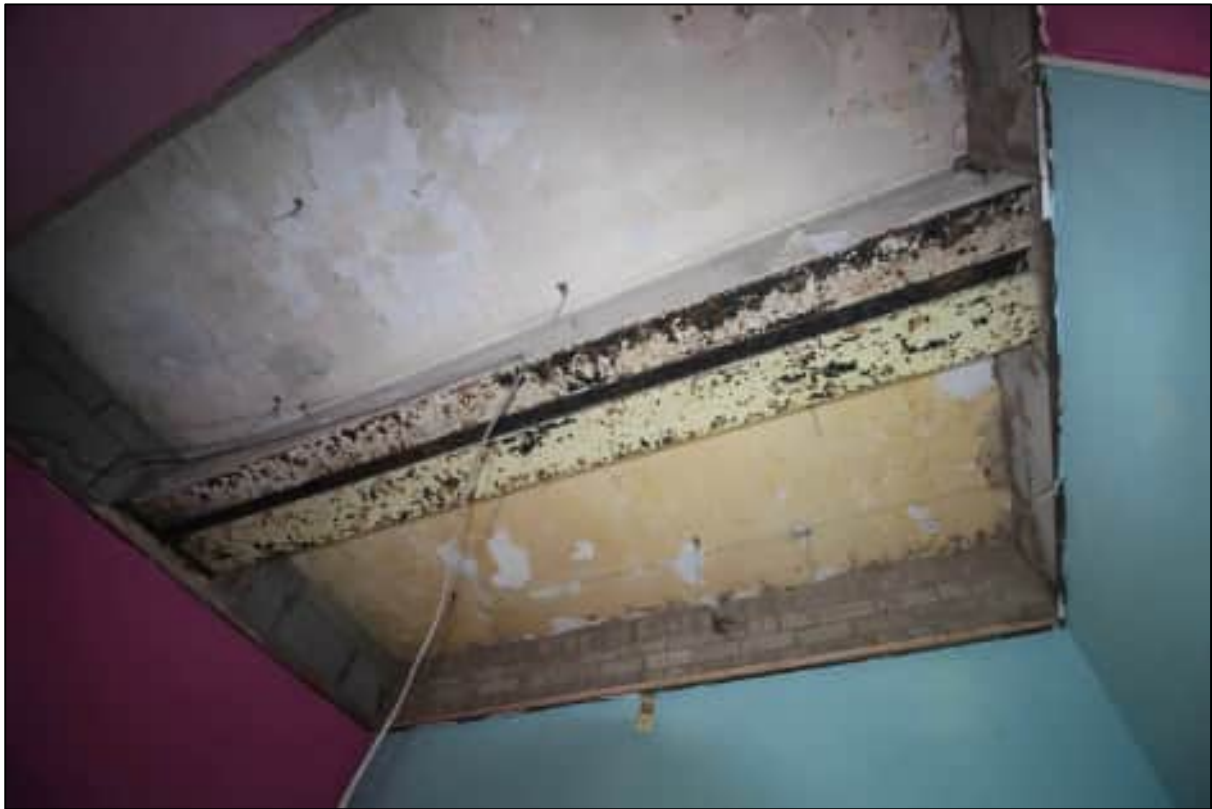
The only room of any historical value was Room 9. This contained a rolled iron beam at the centre of the ceiling and would have spanned the building transversely but was obscured within the adjoining rooms (Plate 37).

*Plate 37: The rolled iron beam within ceiling of Room 9*

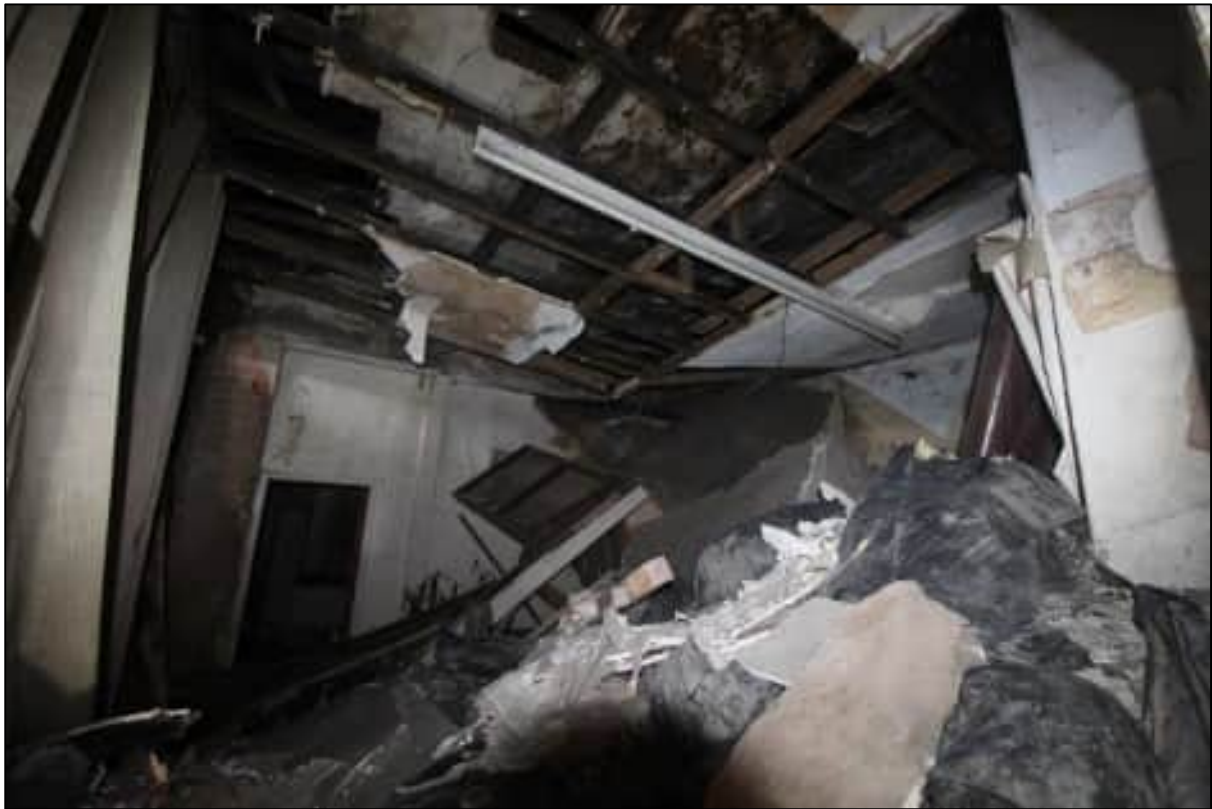
Room 15 and 16 were situated within the original office building and consisted of flat ceilings, plaster rendered walls and timber floors. It was not possible to observe the windows within the eastern and western walls due to safety concerns (Plate 38; Fig 6).

*Plate 38: General view of Room 15, looking south*

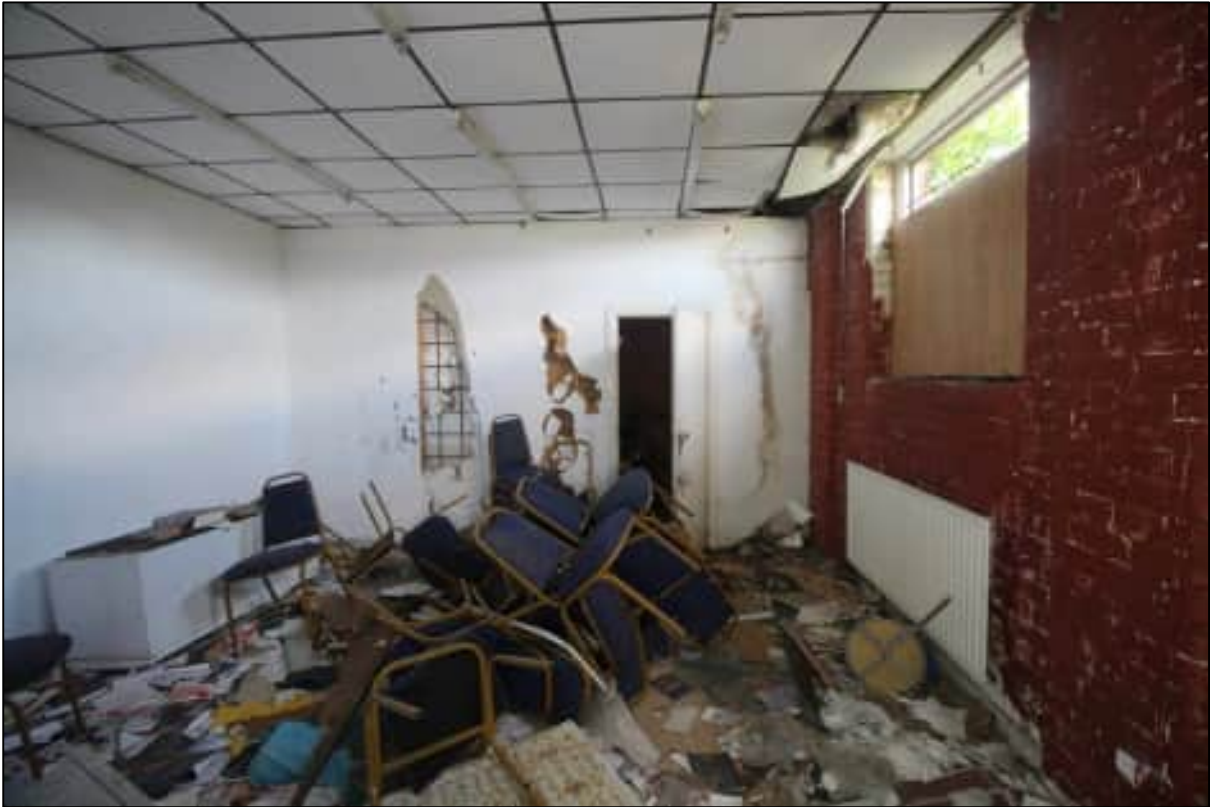
Rooms 17-24 had been comprised of plaster render to the walls, concrete floors and false suspended ceilings and were situated within the 20<sup>th</sup> century extension. The partition walls between the rooms were formed using modern concrete blocks (Plate 39). However, after the soft strip of the building and the removal of the partition walls some of the historical features had been uncovered (Fig 6).

*Plate 39: General view of Room 18, prior to the soft strip, looking south*

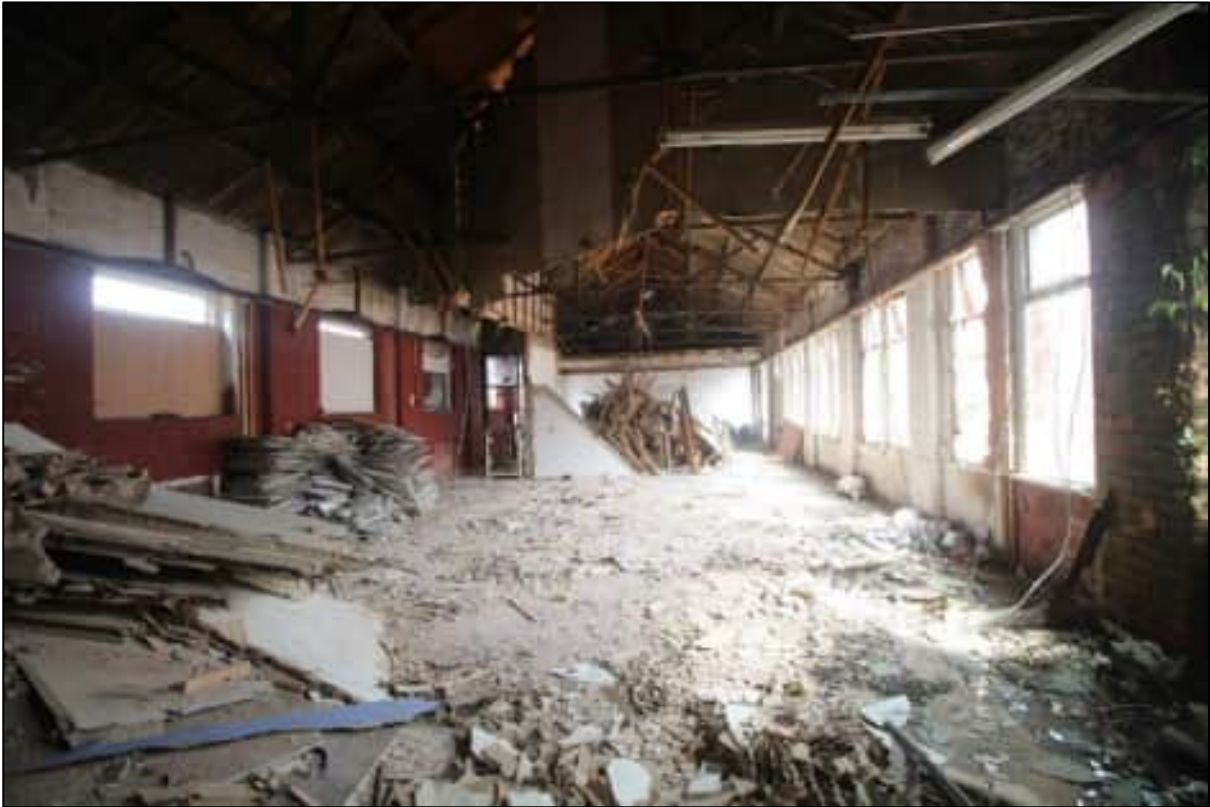
The internal construction of the extension was of brick with a concrete floor (Plate 40). The original ceiling was flat with timber beams socketed into the eastern and western walls (Plate 41). The original bolted L-section angle iron fan trusses and timber purlins had also been uncovered (Plate 41).

*Plate 40: General view of the first floor of the 20<sup>th</sup>-century extension, during the soft strip, looking north*

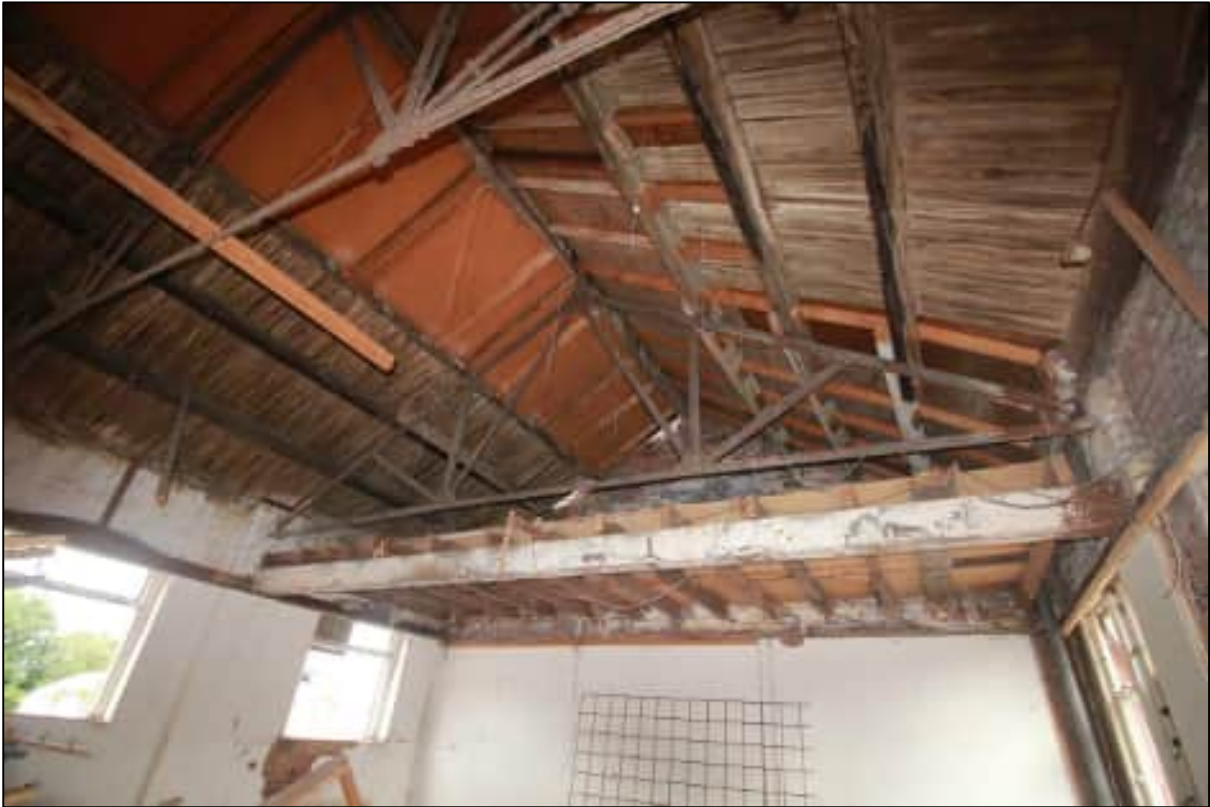
*Plate 41: Detail of the original ceiling to the first floor of the extension*
