Westchurch Homes

# Louisa Street Works, Openshaw, Manchester

## Historical Building Investigation Report

| <b>Report Number:</b> | SA/2023/68 |

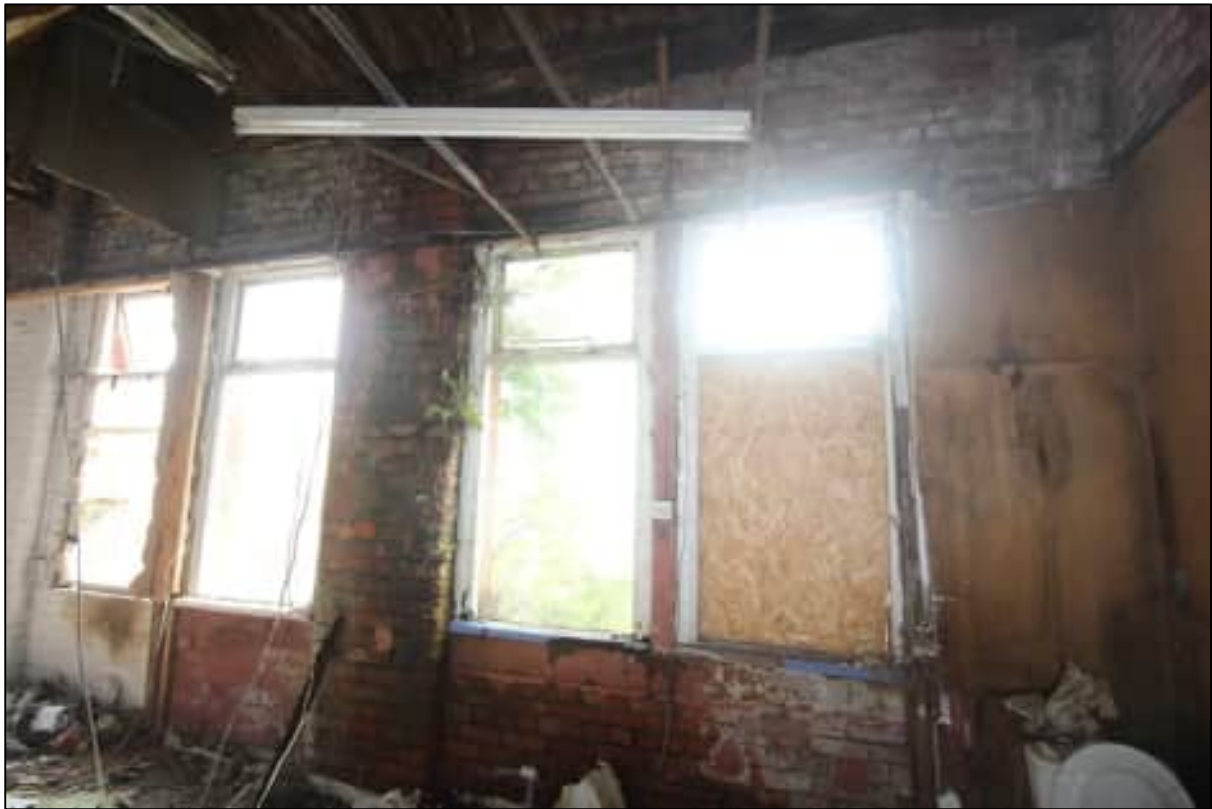
The paired windows within the eastern wall measured 3' (0.91m) wide and comprised bullnose brick reveals with a squared brick mullion, timber lintels and sills. The original timber framed windows had been uncovered prior to demolition (Plate 42). The 4'10" (1.47m) wide windows to the western wall had segmental arched heads with flat timber internal sills. The openings housed replaced timber framed windows (Plate 43).

*Plate 42: The windows to the eastern wall of the first floor*

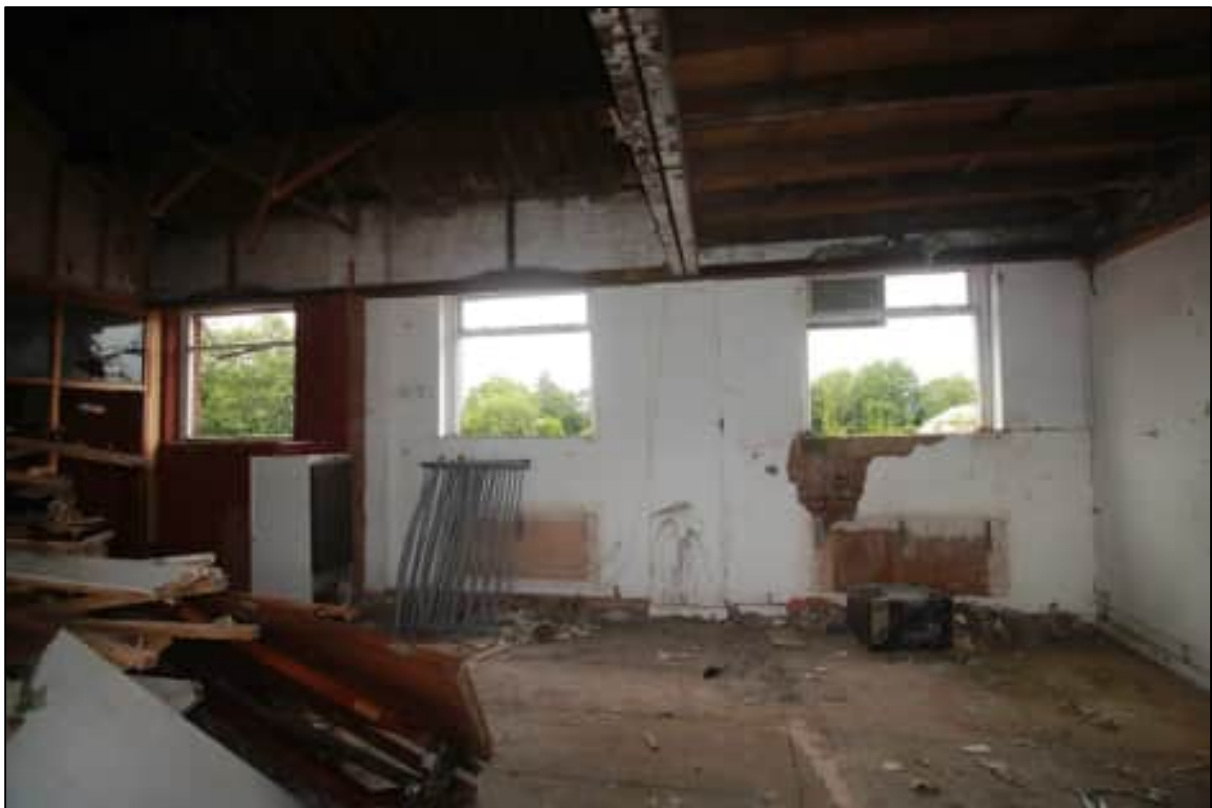
*Plate 43: The windows to the western wall of the first floor*

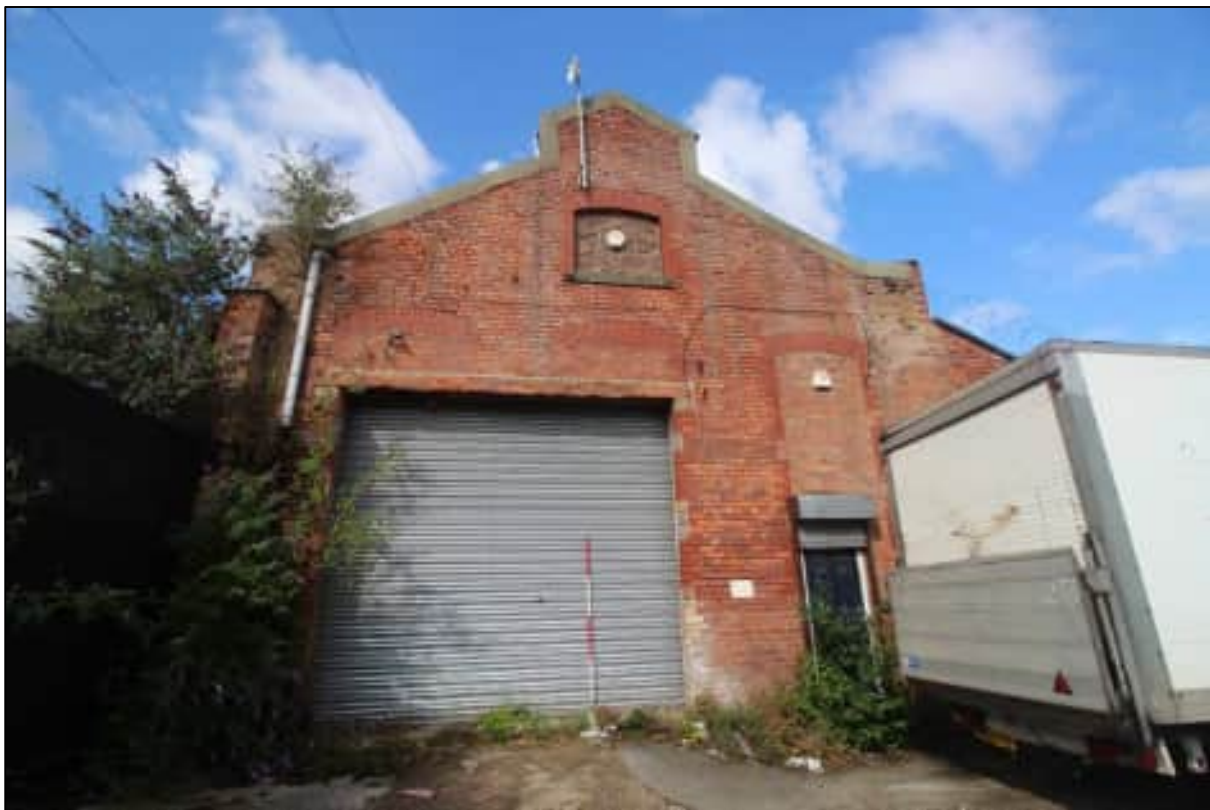
The eastern elevation fronted Ferris Street and formed the principal entrance into the original former casting and pattern workshop as designed by J. Nodal. The elevation was double-height gable, built in a three stretcher English Garden Wall bond with a lower northern bay. The copings to the roof had been obscured or possibly removed and replaced with modern steel flashings (Plate 44).

*Plate 44: General view of the eastern elevation of the former casting and pattern store, looking west*

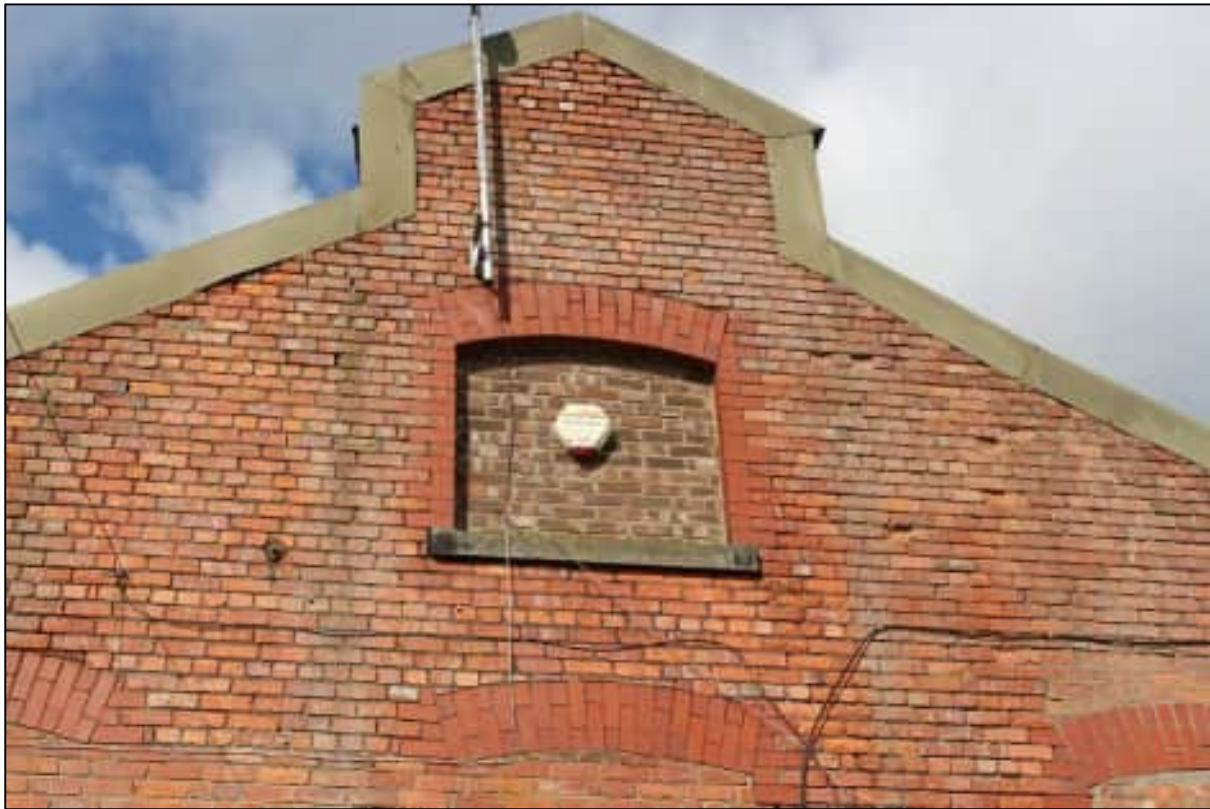
At truss height if the pitched roof was a single window aperture measuring 4'5" (1.34m) wide. This comprised Ruabon bricks to the reveals and segmental arched head with a chamfered sandstone sill. The opening was blocked with brick infilling (Plate 45).

*Plate 45: Detail of the blocked window and parapet wall to the lantern roof*

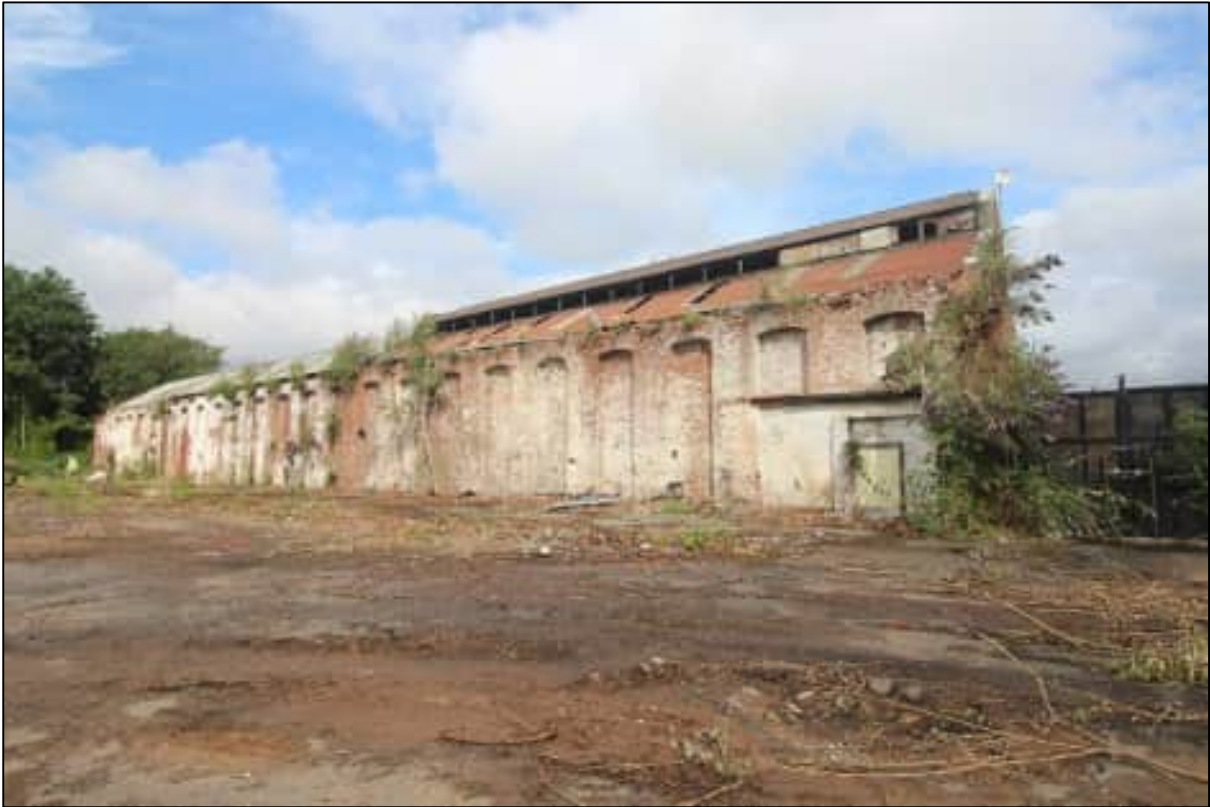
The southern elevation was of 22 bays long with tall blind recesses comprising shallow brick segmental arched heads and squared brick reveals (Plate 46). Each of the piers had a flush stone corbel situated at ceiling height with the brickwork above damaged or removed. These suggest that the beams of a demolished building were attached to the south of the workshop (Plate 47).

*Plate 46: General view of the southern elevation of the former casting and pattern store, looking north-west*

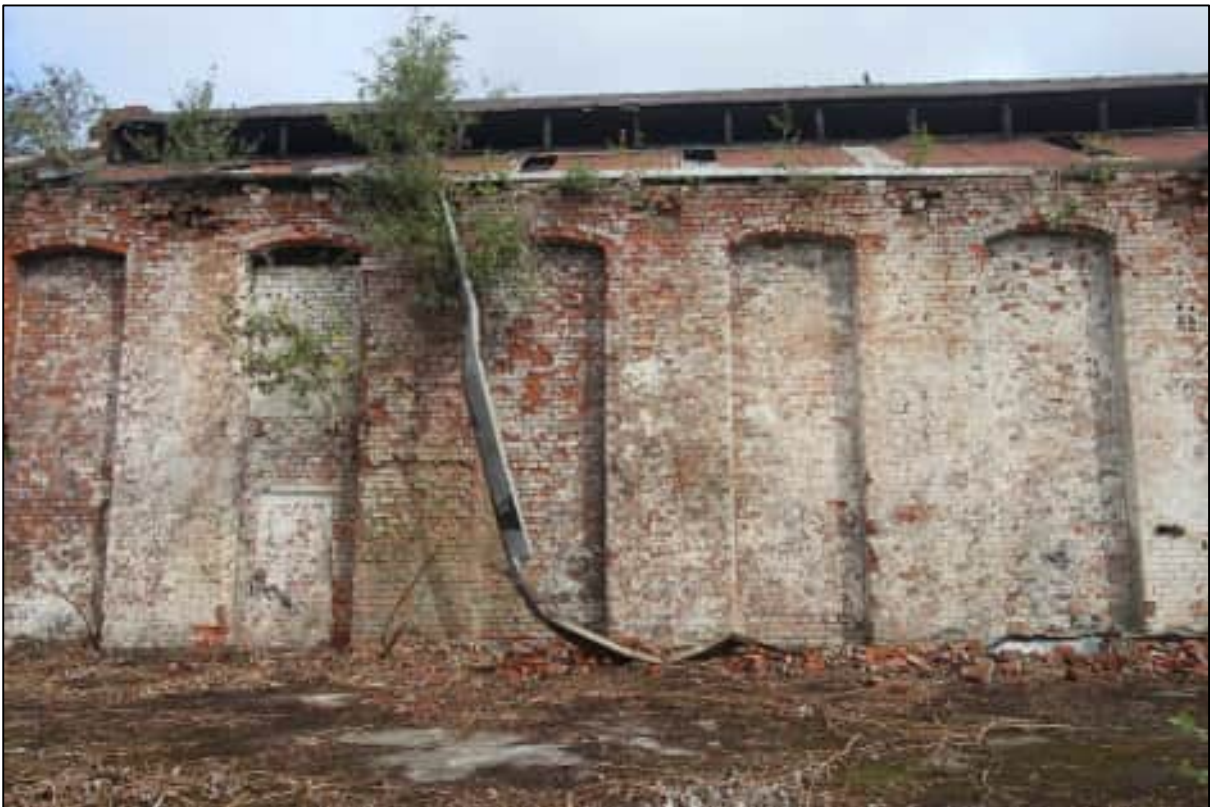
*Plate 47: Detail of the blind bays forming the southern elevation, looking north*

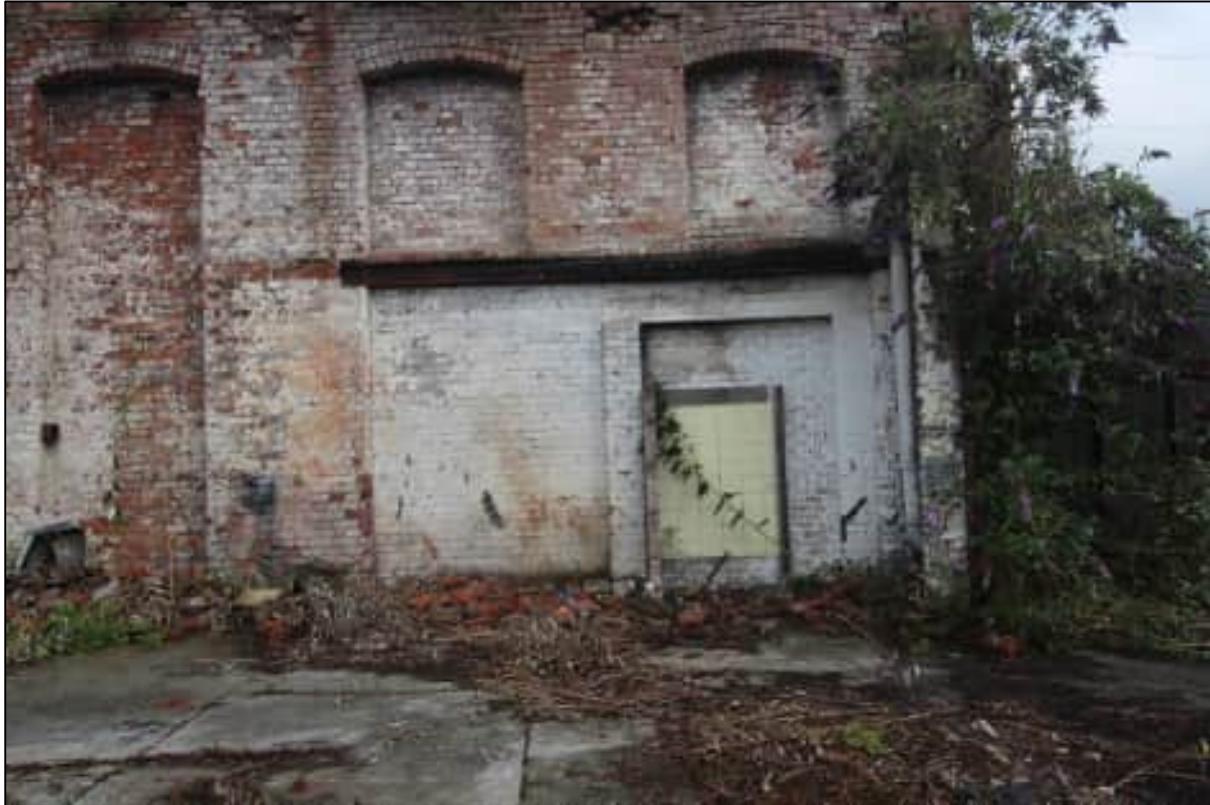
A doorway at the eastern end of the elevation was remodelled with a narrowed opening to the eastern end. The original opening measured 15'9" (4.82m) wide with a rolled steel I-section lintel (Plate 48). The western half of the original opening was infilled with brick and a later doorway with a concrete lintel and brick jambs was situated to the east. The 6'7" (2m) wide opening was later blocked with hollow bricks and glazed tiles with a timber frame, most likely for a toilet cubical, was situated to the western section (Plate 48).

*Plate 48: Detail of the remodelled doorway to the east of the southern elevation, looking north*

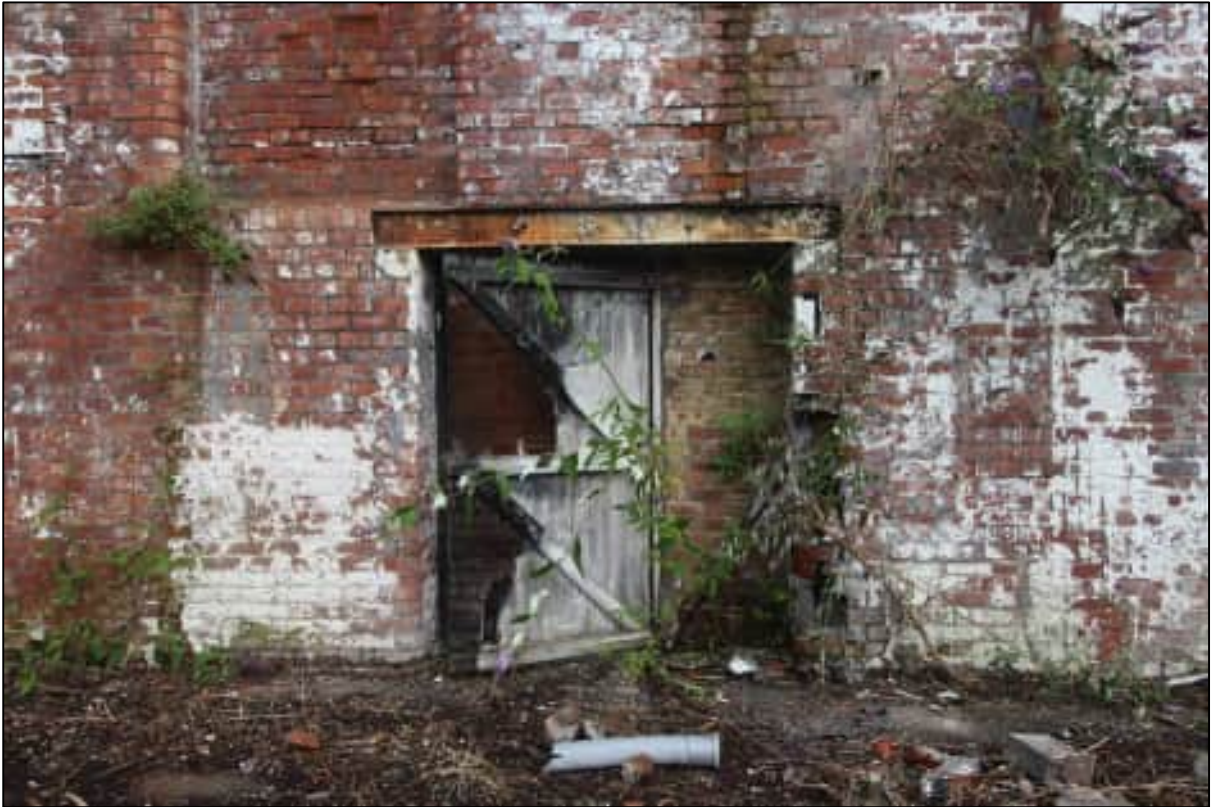
*Plate 49: The westernmost doorway within the southern elevation, looking north*

The elevation also contained several blocked doorways situated to the western end which afforded access between the workshop and the previously demolished building to the south. Each comprised rolled steel lintels with bullnose brick jambs. The openings were infilled with brick however the remains of a ledge and braced timber door had been retained within the westernmost opening (Plate 49).

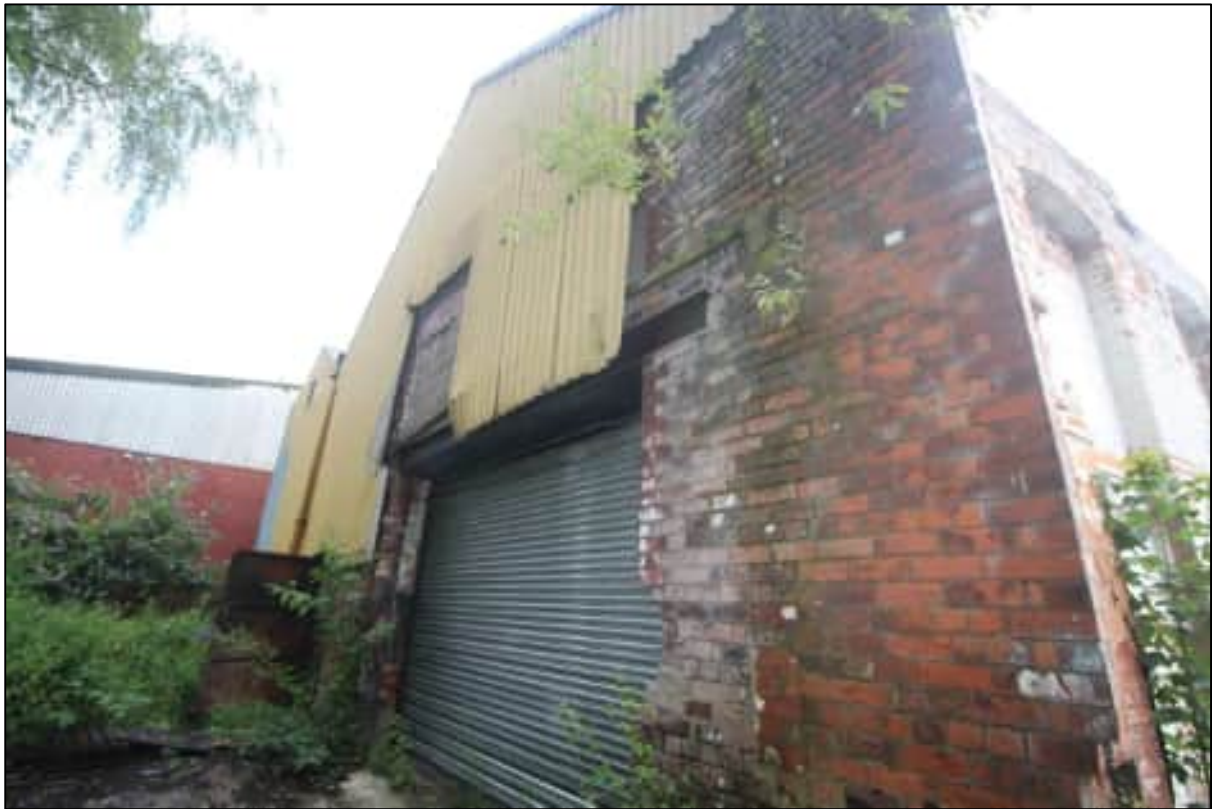
The western elevation consisted of two gables each constructed in a three stretcher English Garden Wall bond (Plate 50). The gables had largely been obscured by modern corrugated steel sheeting, however two doorways at the centres had been observed (Plate 50). Each comprised a rolled steel I-section lintel with bullnose brick jambs and remodelled with the insertion of a roller shutter door, affording vehicle access into the 1903 extension of the workshop (Plate 50). Pedestrian access was afforded by the inserted steel doorway at the northern end of the southern gable.

*Plate 50: General view of the western elevation, looking north-east*

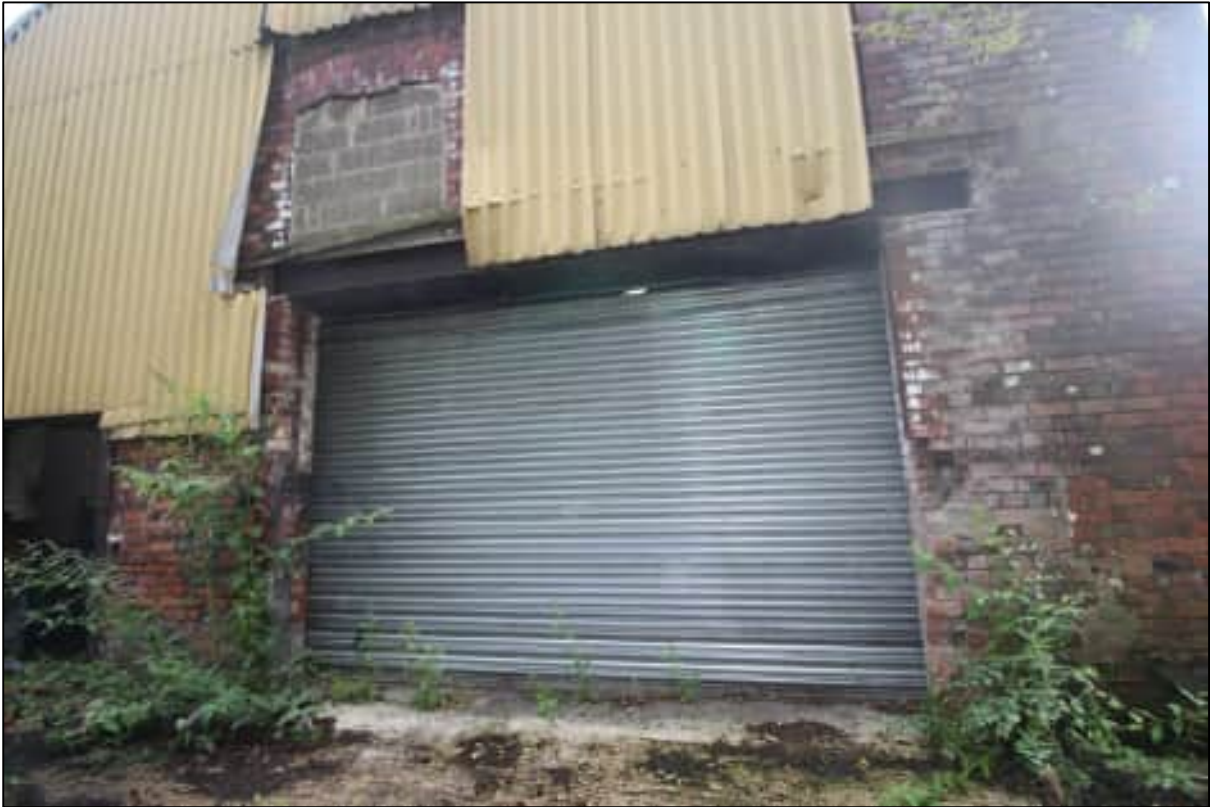
*Plate 51: The southern gable detailing the later inserted vehicle doorway with the blocked window aperture above, looking east*

The remnants of a blocked window aperture was located to the centre of the southern gable, directly above the vehicle entrance. This comprised a segmental arched head with squared reveals constructed in Ruabon bricks. The sill had been removed and the 4'6" (1.37m) wide opening was brick infilled (Plate 51). The alteration to this window suggests that the doorway was a later insertion.

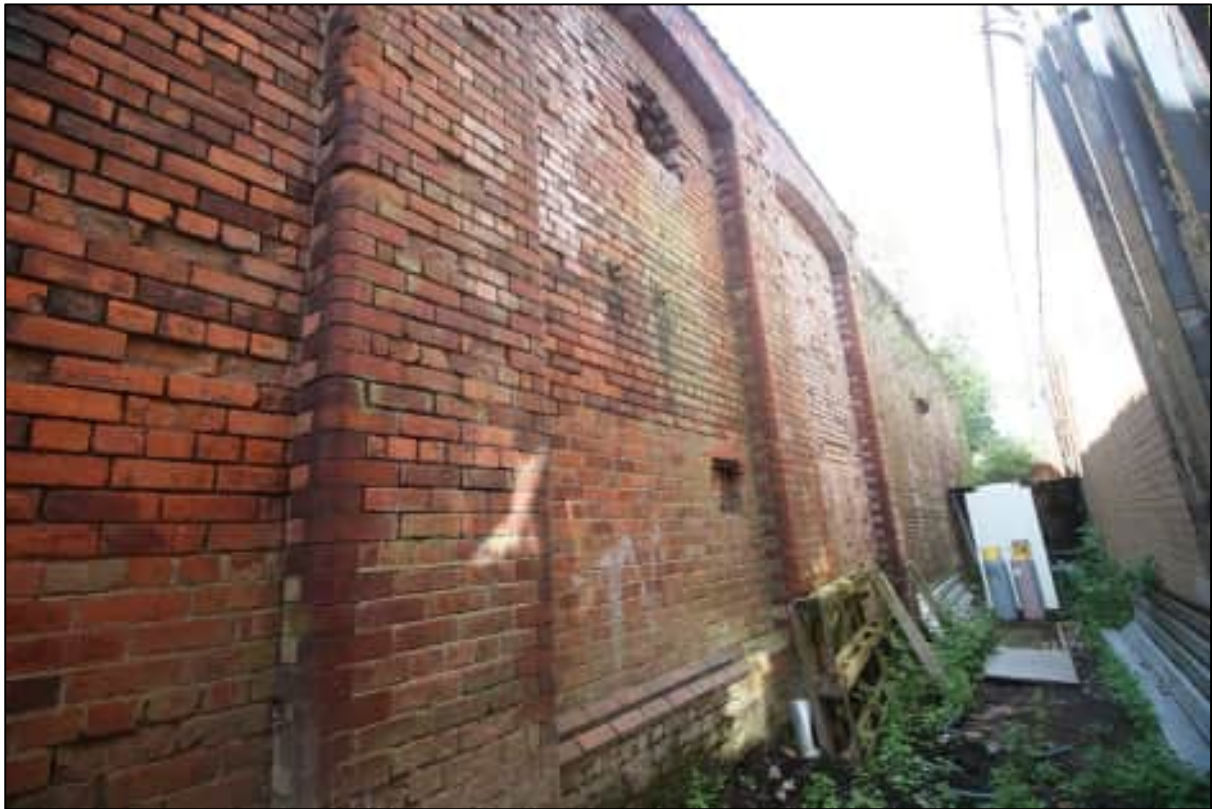
*Plate 52: The blind recesses to the northern elevation of the 1903 extension, looking south-west*

The northern elevation was 22 bays long with tall blind recesses to the 1903 extension comprised shallow brick segmental arched heads and squared brick reveals (Plate 52). The original building was largely devoid of features, although a bank of windows was situated to the western end with a blocked doorway and a later inserted doorway situated to the eastern end. The windows consisted of three apertures with segmental arched heads and reveals that were built with Ruabon bricks and sandstone sills. The openings were blocked with modern aerated bricks (Plate 53).

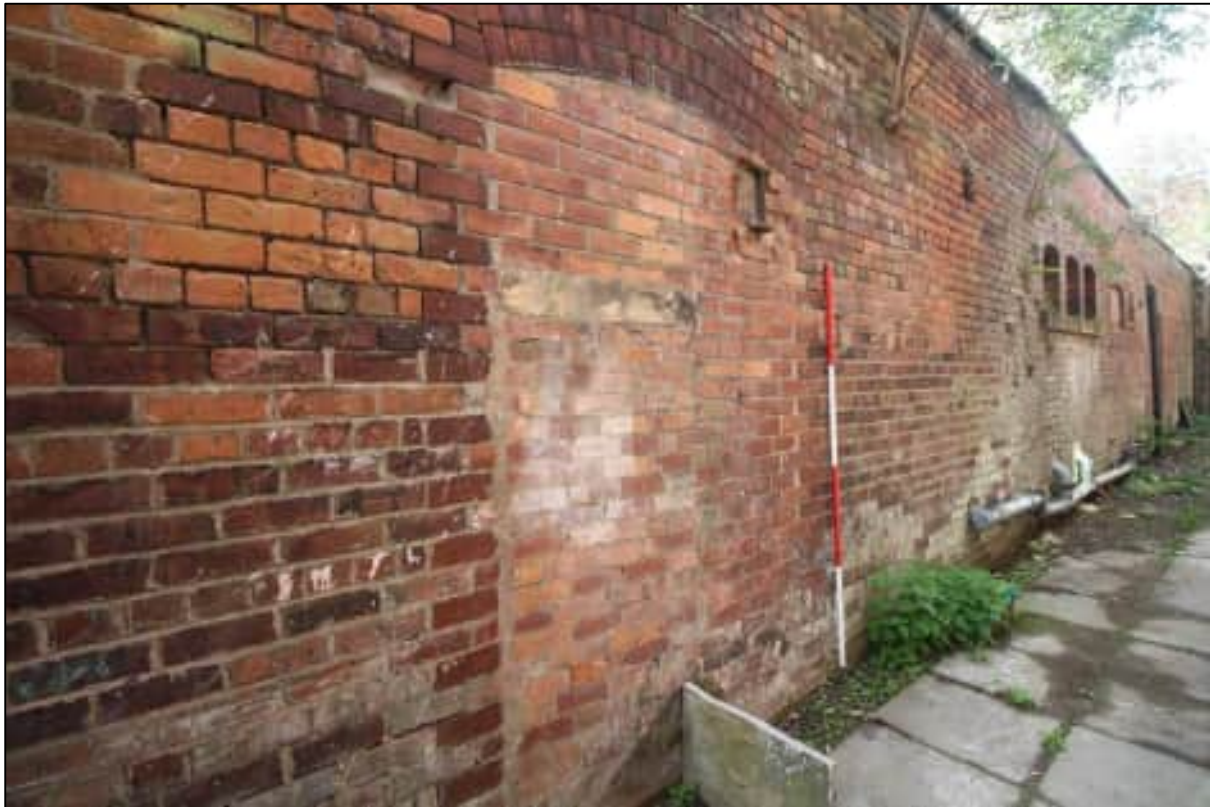
*Plate 54: Detail of the blocked doorway to the northern elevation of the original workshop, looking south-west*

A blocked doorway at the centre of the original workshop comprised a shallow brick segmental arched head and squared brick jambs that were also built using Ruabon bricks (Plate 54). The 5'3½" (1.61m) wide opening was infilled with bricks and a rolled steel I-section beam had projected out of the infilling at the eastern end (Plate 54).

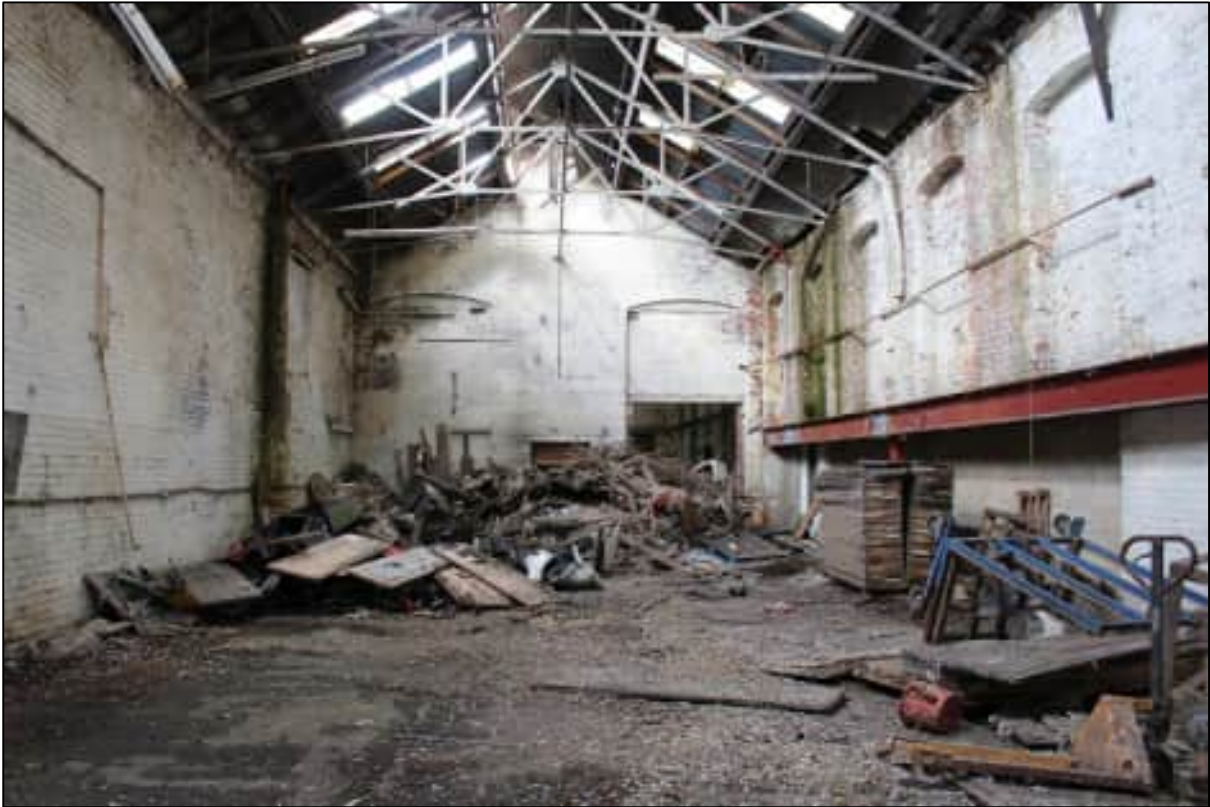
*Plate 55: General view of Room 1 within the original casting and pattern store workshop, looking west*

Access was afforded into Room 1 from the doorways within the eastern elevation. The room measured southern wall 28.67m by 8.9m and comprised a concrete floor and painted brick walls. The high open ceiling exposed the fan L-section angle iron trusses and the lantern roof above (Plate 55; Fig 7).

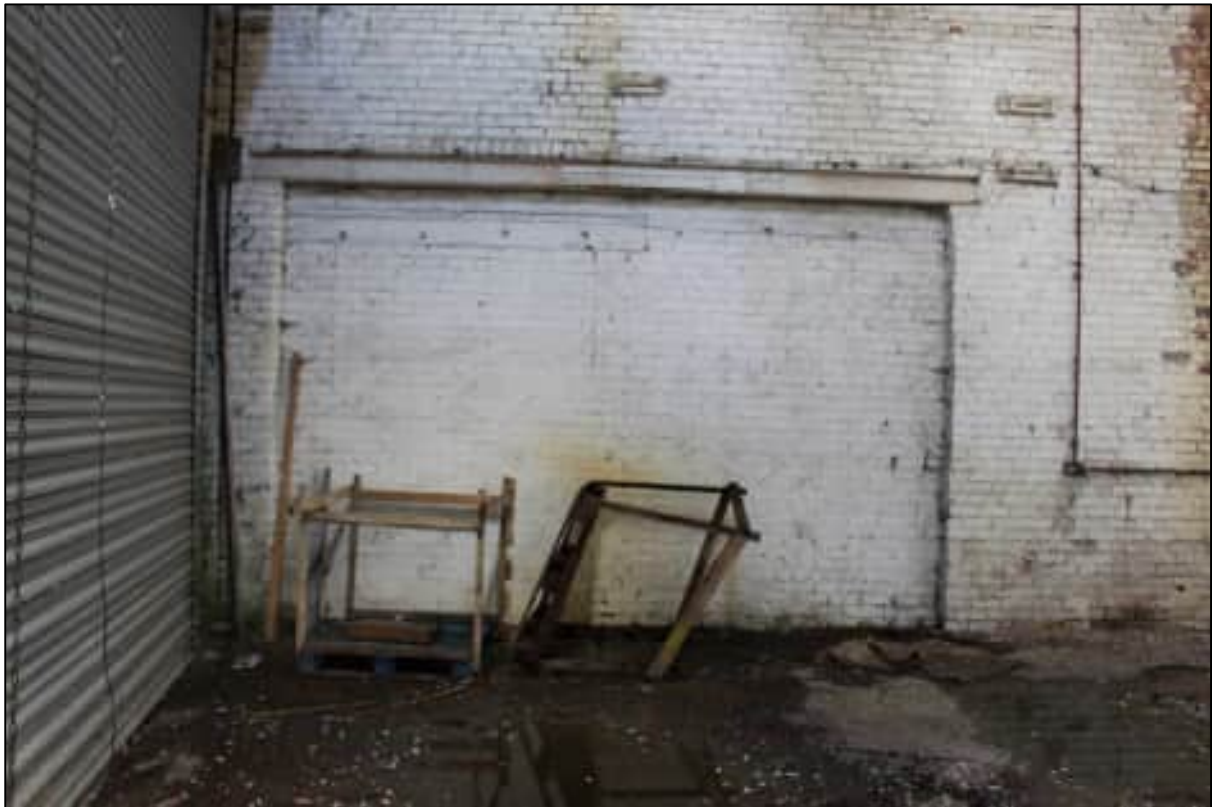
*Plate 56: The blocked doorway to the eastern end of the southern wall, looking south*

The southern wall of the room contained a single doorway at the eastern end. The opening was remodelled with a narrowed opening to the eastern end. The original opening measured 15'9" (4.82m) wide with a rolled steel I-section lintel. A sign with 'THE VAUGHAN CRANE CO LD MANCHESTER' embossing was riveted to the web of the beam. A second sign with '10 CWTS' situated to the eastern end of the webbing (Plate 56 and 57). The original opening was brick infilled with the later doorway having a steel lintel. The opening had subsequently been blocked with brick infilling (Plate 56).

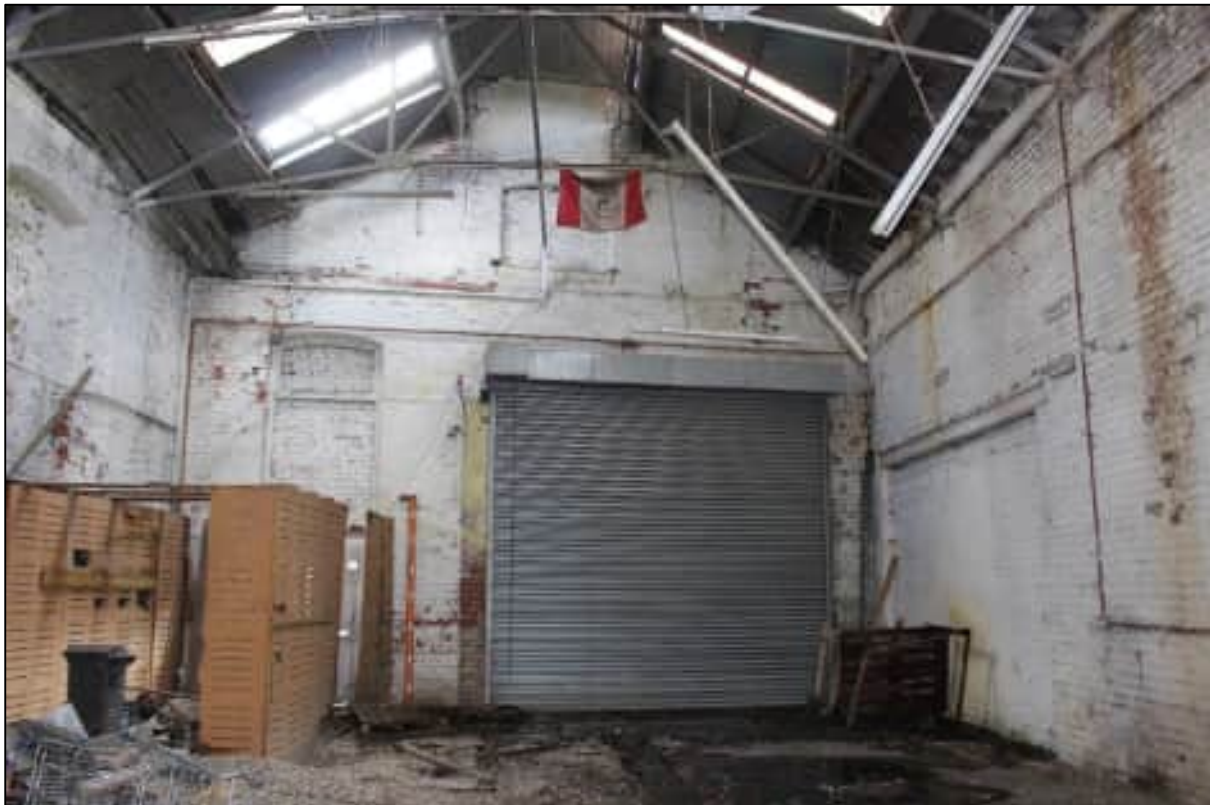
*Plate 58: General view of the eastern wall of Room 1, looking east*

At truss height of the pitched roof was a single window aperture measuring 4'5" (1.34m) wide. This comprised bullnose brick reveals and a segmental arched head with a flat sandstone internal sill. The opening was blocked with brick infilling (Plate 58).

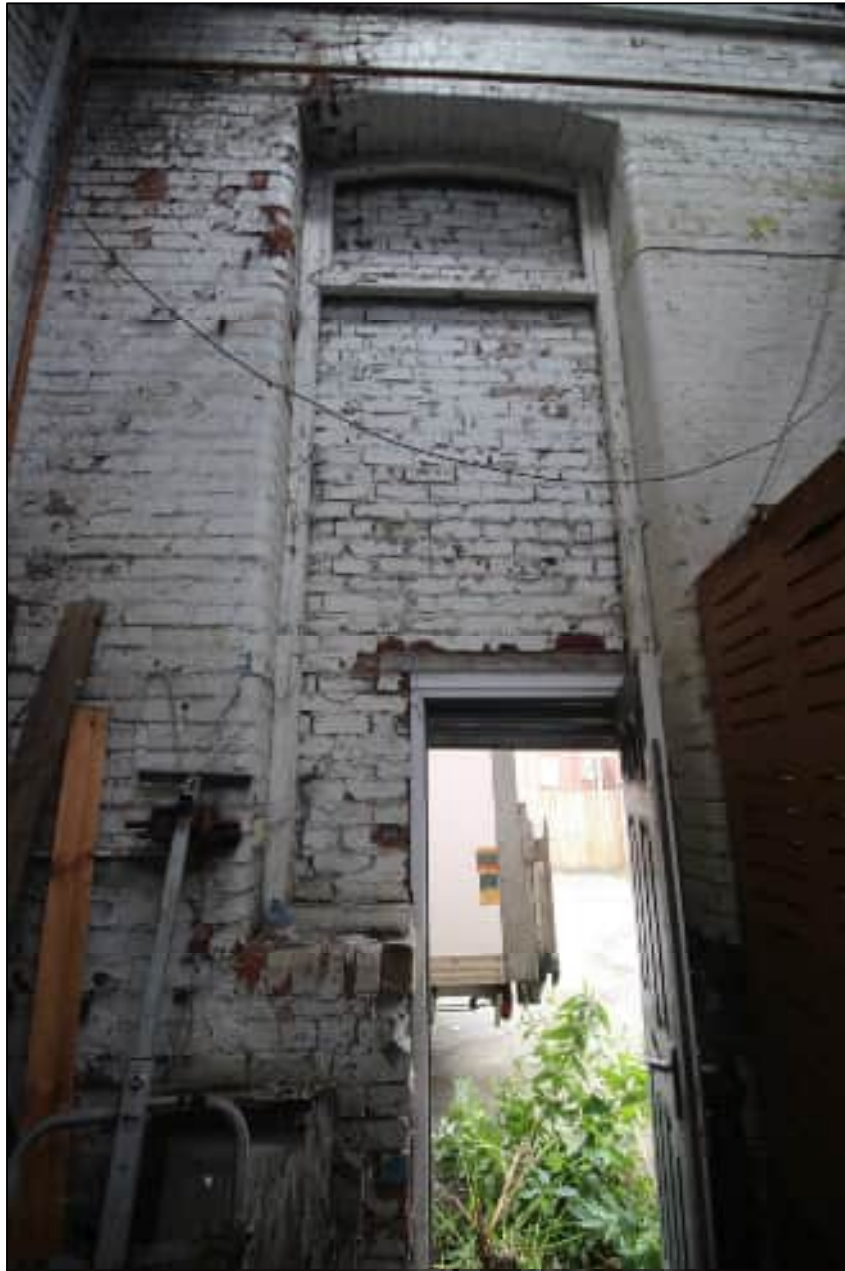
*Plate 59: The remodelled northern window within the eastern wall of Room 1, looking east*

The eastern wall remodelled with the insertion of a large roller shutter doorway to the southern end blocking two of the original window apertures. These consisted of segmental arched heads with squared reveals which were constructed in Ruabon bricks which had been painted white. The sills had been removed and the upper section of the 4'6" (1.37m) wide openings were brick infilled (Plate 58). A third window aperture to the northern end was also altered with the insertion of a modern doorway. The opening was also brick infilled, however the original tall two light timber framed window had been retained internally (Plate 59).

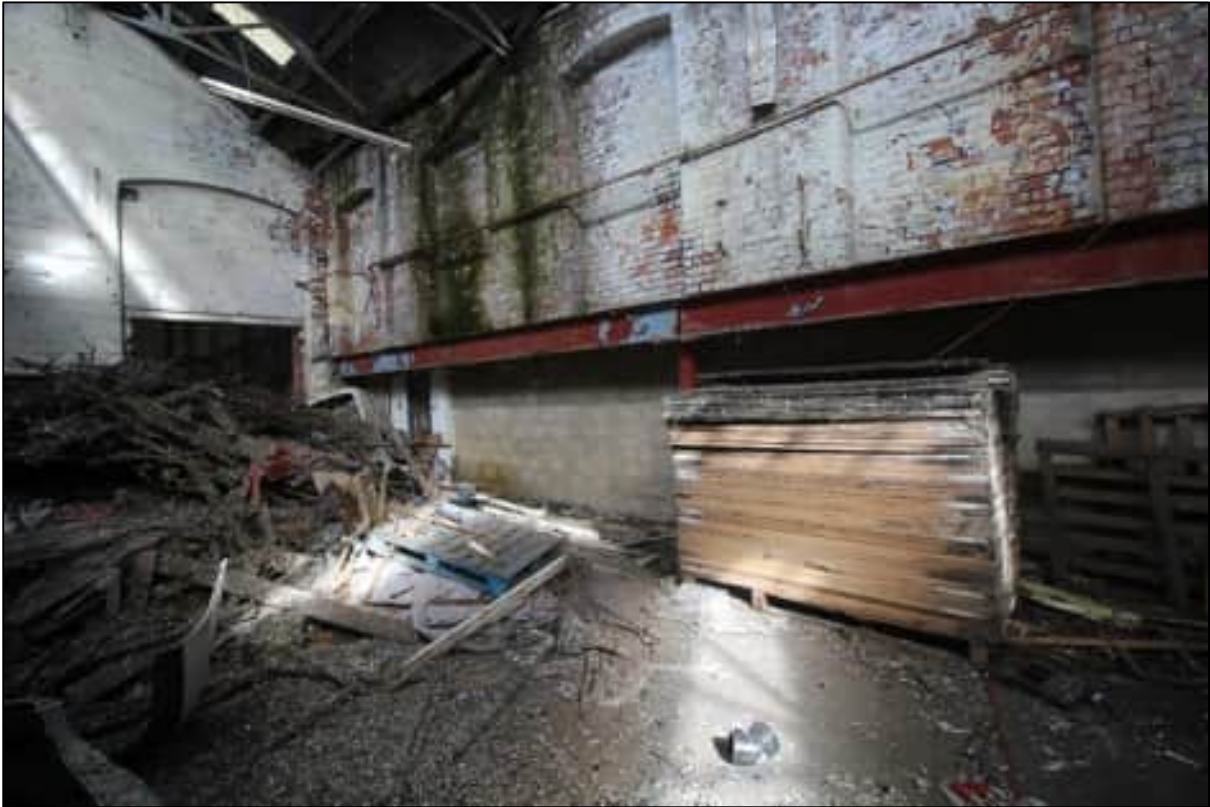
*Plate 60: The northern wall of Room 1, looking north-west*

The northern wall comprised nine bays of blind recesses with shallow segmental arched heads and bullnose brick jambs. The wall was supported by a rolled I-section steel beam with simple 8" (0.2m) diameter columns (Plate 60). A small doorway was inserted into the western end of the wall, affording access into Room 2.

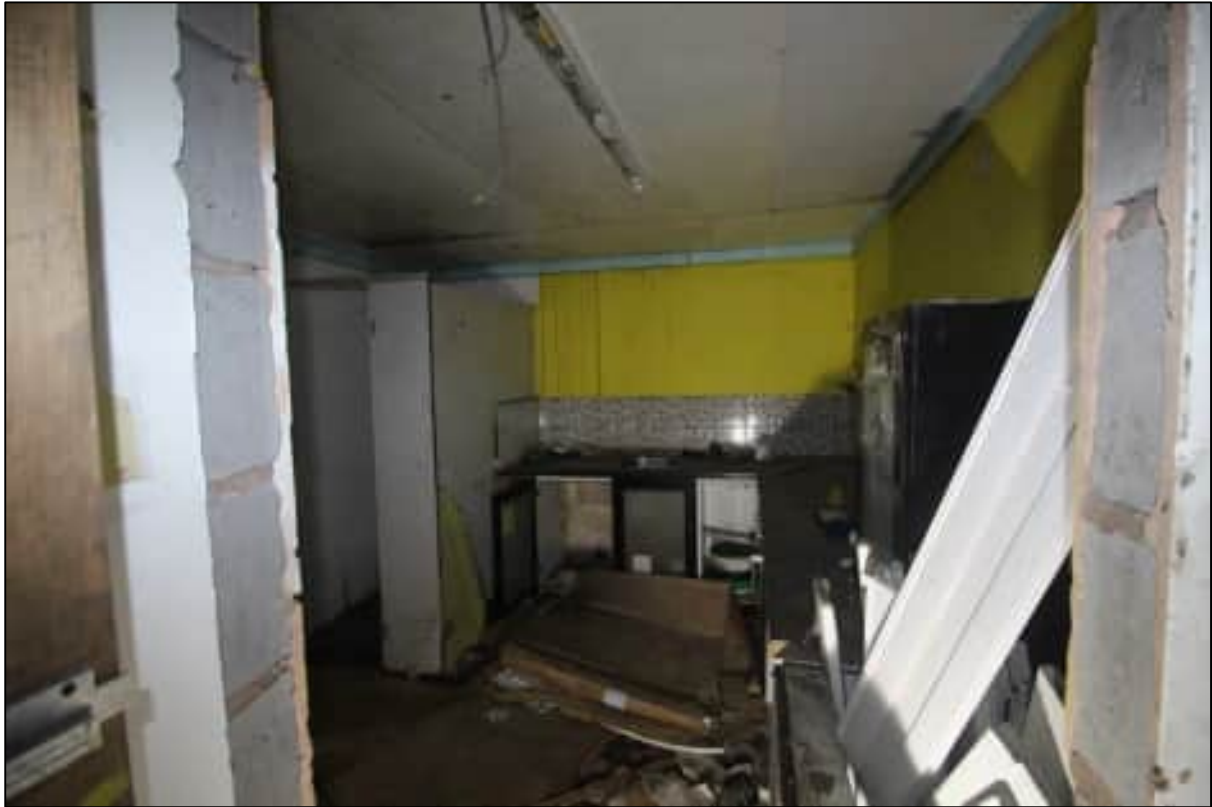
*Plate 61: General view of Room 2, looking north*

Room 2 was a small kitchenette within the northern wing of the original workshop (Fig 7). The room comprised a concrete floor, plaster render walls and a false suspended ceiling (Plate 61). A section of the ceiling had been removed uncovering the simple L-section angle iron roof truss of the long northern bay.

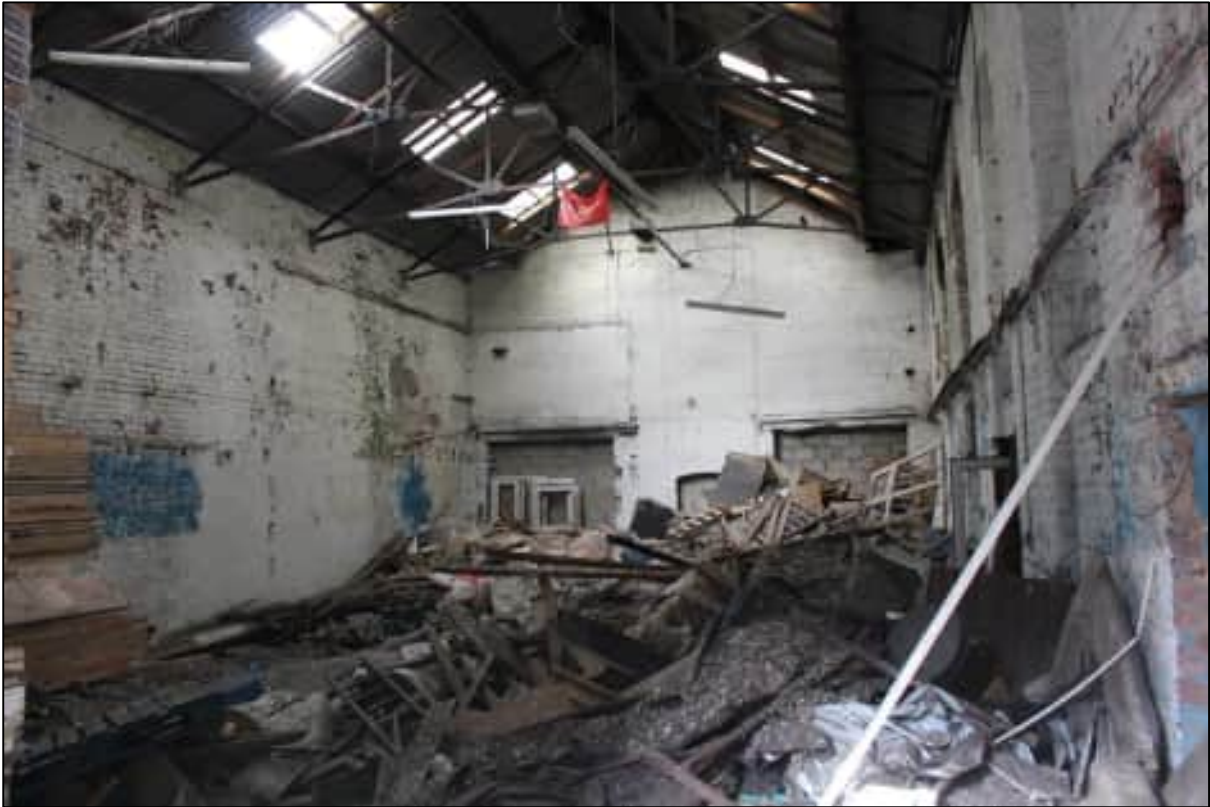
*Plate 62: General view of Room 3, situated within the 1903 extension*

Room 3 measured 18.3m by 8.9m and was situated to the eastern end of the 1903 extension. The room comprised a concrete floor, painted brick walls with a high open ceiling exposing the fan L-section angle iron trusses (Plate 62). The northern and southern walls contained six blind recessed bays with shallow segmental arched heads and bullnose brick jambs (Plate 62). The western wall contained two large doorways which had afforded access into Room 4. The openings measured 8'½" (2.45m) wide and contained a rolled steel I-section lintel and were recently infilled with modern concrete blocks (Plate 62).

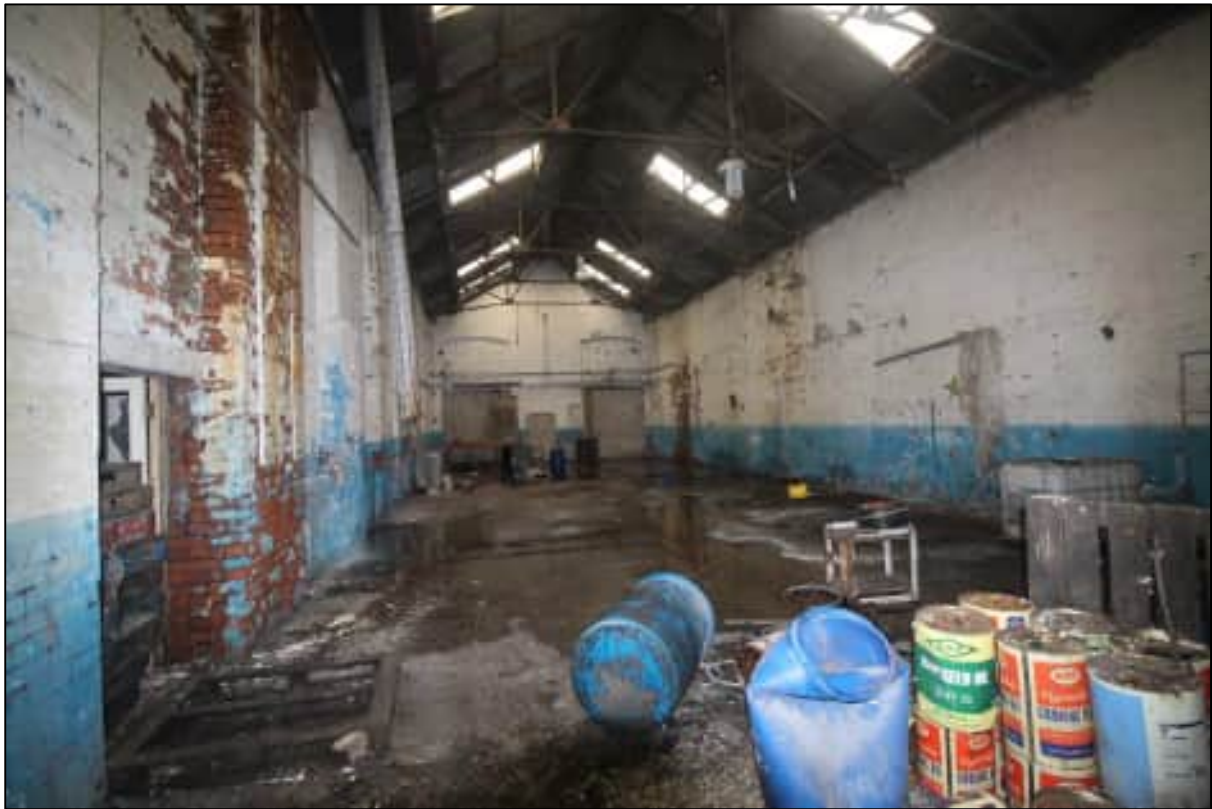
*Plate 63: General view of Room 4, situated within the 1903 extension, looking east*

Room 4 was situated to the western end of the 1903 extension and consisted of a concrete floor, painted brick walls with a high open ceiling exposing the fan L-section angle iron trusses (Plate 63; Fig 7). The northern wall contained eight blind recessed bays with shallow segmental arched heads and bullnose brick jambs (Plate 64). The wall also contains three doorways affording access into several rooms within the northern bay. The central doorway was constructed with a segmental arched head, while the two outer opening had simple timber lintels. All three openings had bullnose brick reveals (Plate 64).
