Westchurch Homes

# Louisa Street Works, Openshaw, Manchester

## Historical Building Investigation Report

| <b>Report Number:</b> | SA/2023/68 |

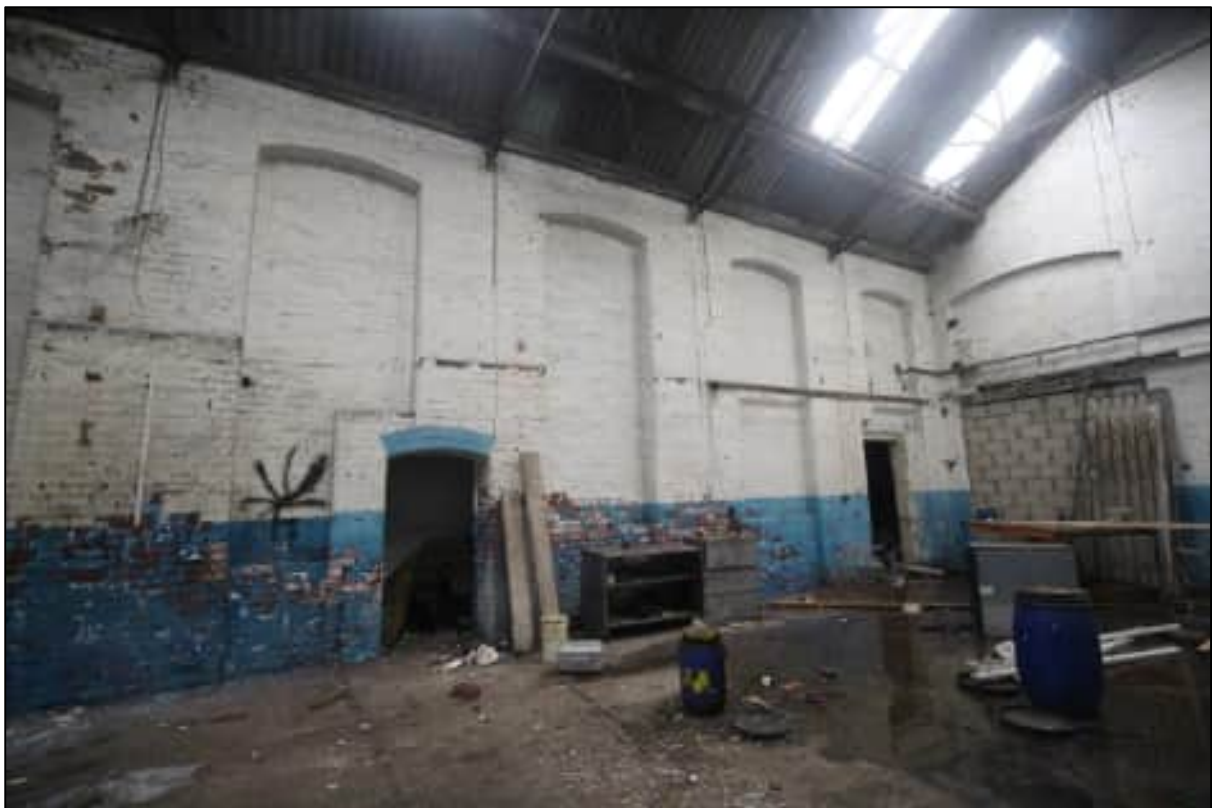
*Plate 64: The northern wall of the 1903 extension, looking north-east*

Room 4 was situated to the western end of the 1903 extension and consisted of a concrete floor, painted brick walls with a high open ceiling exposing the fan L-section angle iron trusses (Plate 63; Fig 7). The northern wall contained eight blind recessed bays with shallow segmental arched heads and bullnose brick jambs (Plate 64). The wall also contains three doorways affording access into several rooms within the northern bay. The central doorway was constructed with a segmental arched head, while the two outer opening had simple timber lintels. All three openings had bullnose brick reveals (Plate 64).

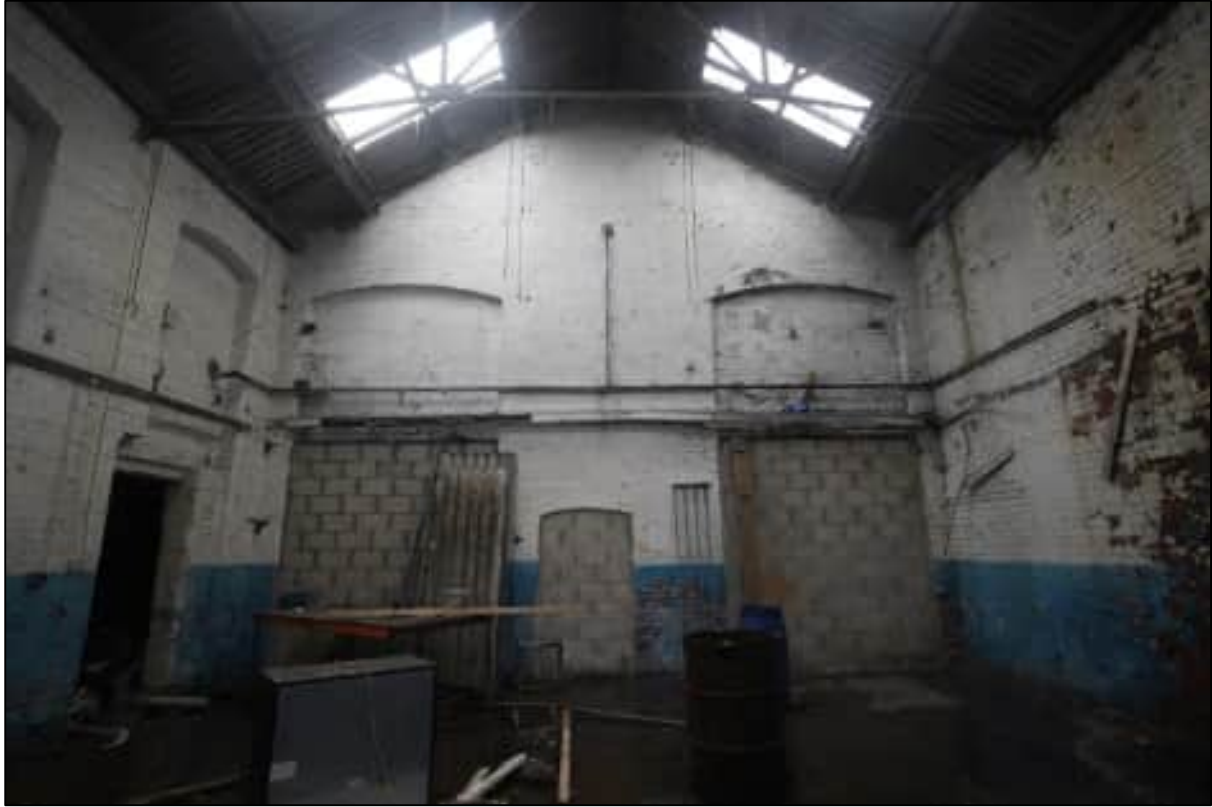
*Plate 65: The eastern wall of the 1903 extension, looking east*

The eastern wall contained two large doorways which afforded access into Room 3. The openings measured 8'½" (2.45m) wide and contained a rolled steel I-section lintel and were recently infilled with modern concrete blocks (Plate 65). An off-centre doorway with an opening of 3' (0.91m) with a segmental arched head was also blocked with modern concrete blocks (Plate 65).

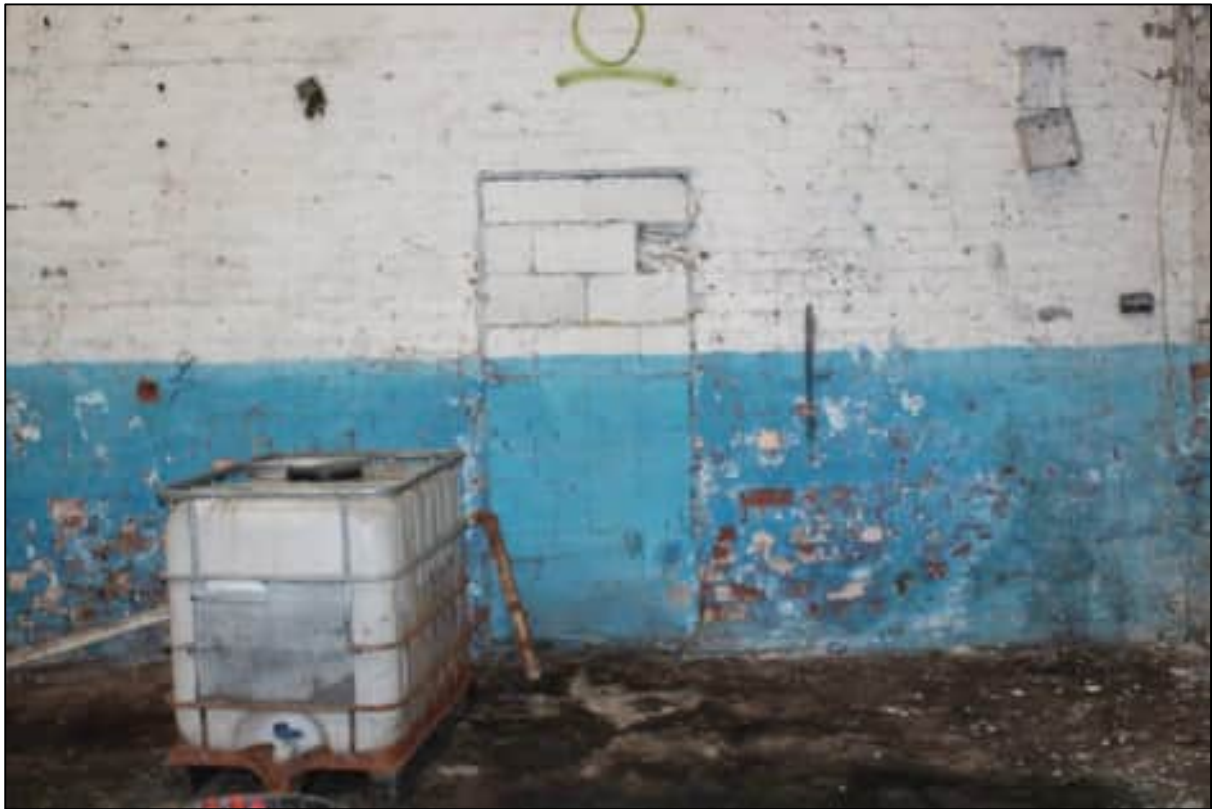
The southern wall was largely devoid of features with only a single doorway situated to the western end having been observed. This afforded access into the recently demolished building to the south and comprised a steel lintel and a concrete threshold. The opening had been infilled with modern concrete blocks (Plate 66). The simple nature of the lintel suggests this was a later insertion as the majority of doorways within the building have segmental arched heads.

*Plate 66: The blocked doorway within the southern wall, looking south*

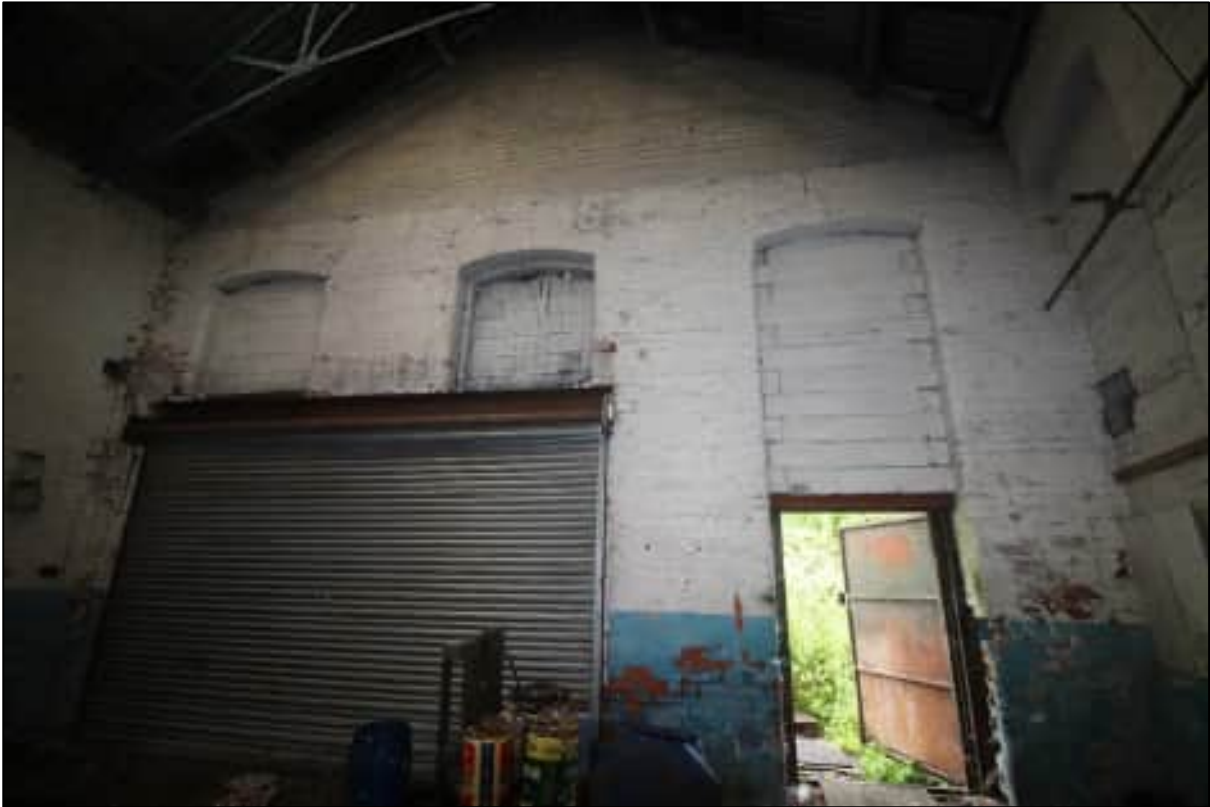
*Plate 67: The western wall of the 1903 extension, looking west*

The western wall contained three tall window apertures with segmental arch heads and bullnose brick reveals. The window frames had been removed and the openings had been infilled with brick (Plate 67). The southern two apertures were altered with the insertion of a modern roller shutter door while a modern pedestrian doorway was inserted into the northern window (Plate 67). The elevation was partially rebuilt with modern bricks at approximately eight courses above the window heads (Plate 67). This seems to be contemporary with the corrugated steel cladding that was attached to the western elevation.
