# TV RECEPTION SURVEY REPORT

**THIS POST CONSTRUCTION TV RECEPTION SURVEY WAS CONDUCTED BY:**

**DATE OF SURVEY:** 14th July 2023  
**REF NO:** TBAER057

University of Manchester  
Engineering Campus  
(MECD) Grosvenor Street  
Manchester

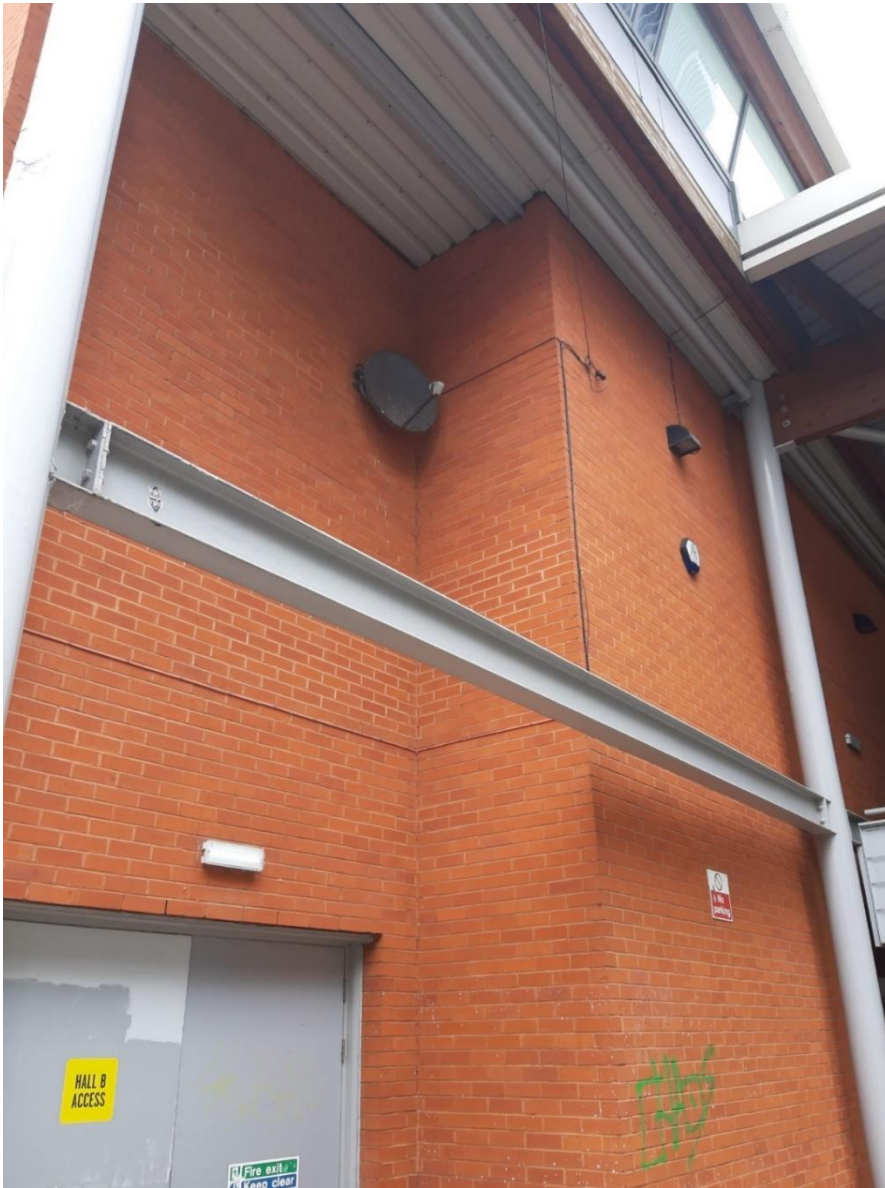
## **PHOTO 1: POTENTIAL IMPACT ZONES**

There was a satellite dish highlighted on the Preconstruction survey that would be affected to the north of the development, but when assessing this on the post construction survey it seems to no longer be in use.

### **SATELLITE DISH LOCATED ON THE SUGDEN SPORTS CENTRE (no longer in use)**
