# PHASE 3A REMEDIATION STRATEGY

Mayfield Park  
Mayfield, Manchester

Mayfield Partnership Ltd

| DESCRIPTION | DATE | AUTHORS | | APPROVED BY |
|---|---|---|---|---|
| Phase 3a Remediation Strategy Report | 18-12-20 | Elizabeth Stewart<br> | Alex Smiles<br> | Alex Smiles<br> |

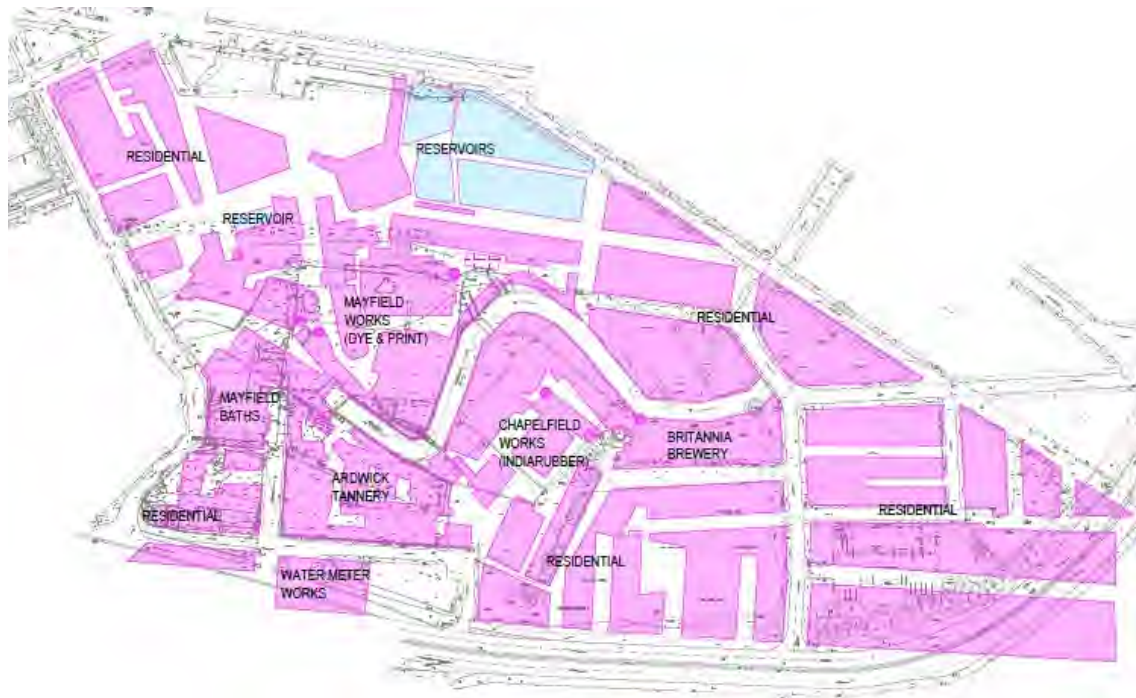
### Excerpt from ES102; Figure 1: 1891

- 2.3.2 The earliest mapping records for the site show a number of potentially contaminative sources these have been broken down by zone below.
- 2.3.3 **Zone 1 “Lawns”:** Earliest mapping dated 1891 indicates the zone to be occupied by the Mayfield dye and print works across the entire zone with associated filter pools, tanks and chimneys. Several reservoirs are located to the north of the zone associated with the dye and print works.

- 2.3.1 With reference to BuroHappold’s report and obtained historical records, RoC Consulting drawing ES101 (Appendix A) illustrates the key historical ‘phases’ of the site; an excerpt is included overleaf with commentary on key historical features within each zone. It is noted a key change occurred post WW2, following the widespread damage caused from aerial bombing (ES103; Appendix A).

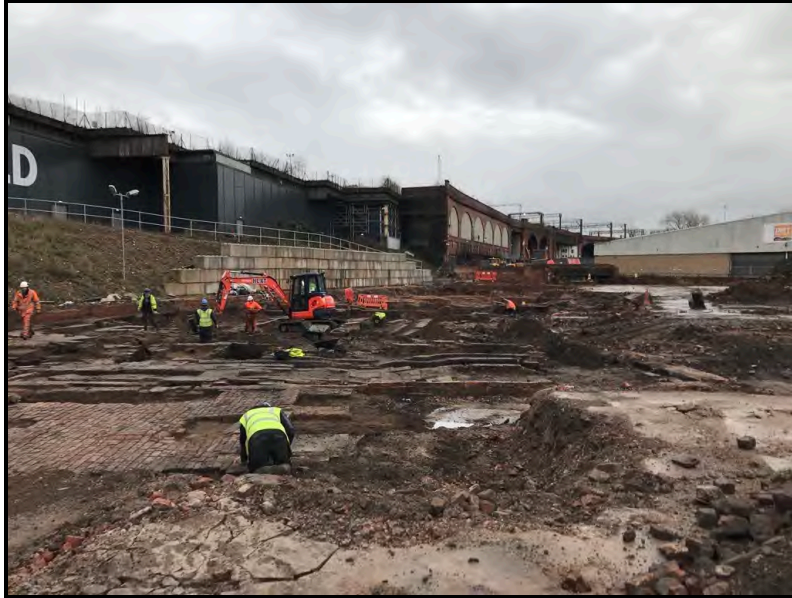
**Plate 2.2: Chapelfield Dye Works Excavations**

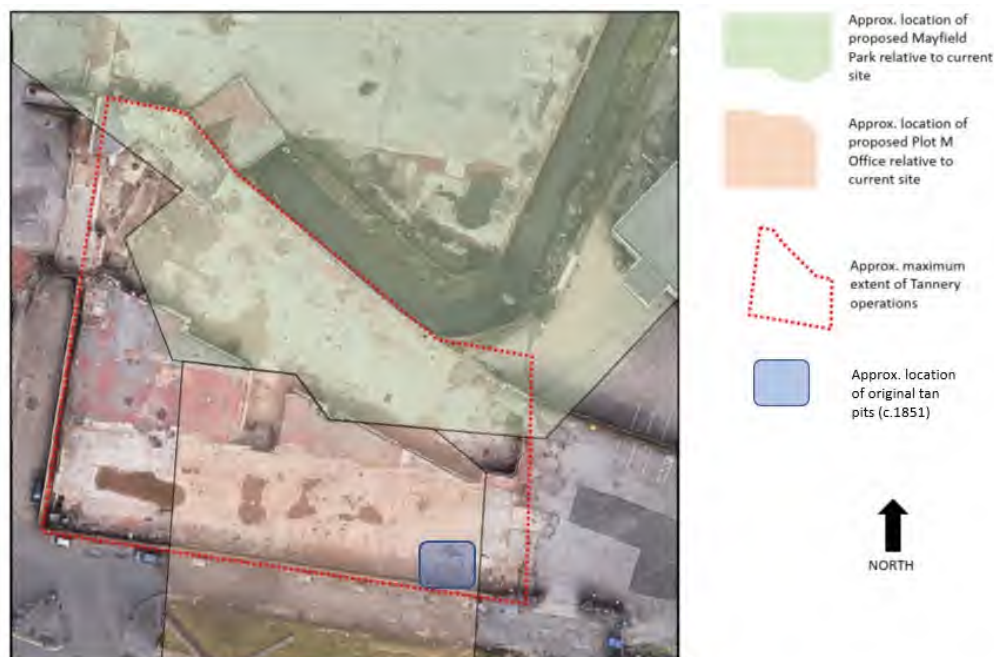
- 3.6.2 The potential for residual tannery wastes has been identified across a small portion of the proposed Park / Plot M office development to the central and southern extent. A technical note relating to the control and mitigation of tannery wastes that may be uncovered in this area has been prepared and included within the RoC Consulting Phase 2 SI report. A copy of this note (TN1.1) has also been included in the current report (see Appendix D) and should be reviewed by all contractors working in the area indicated below.

**Fig 3.1: Approx. former Tannery Extent (red dashed line)  
General Remedial Comments**

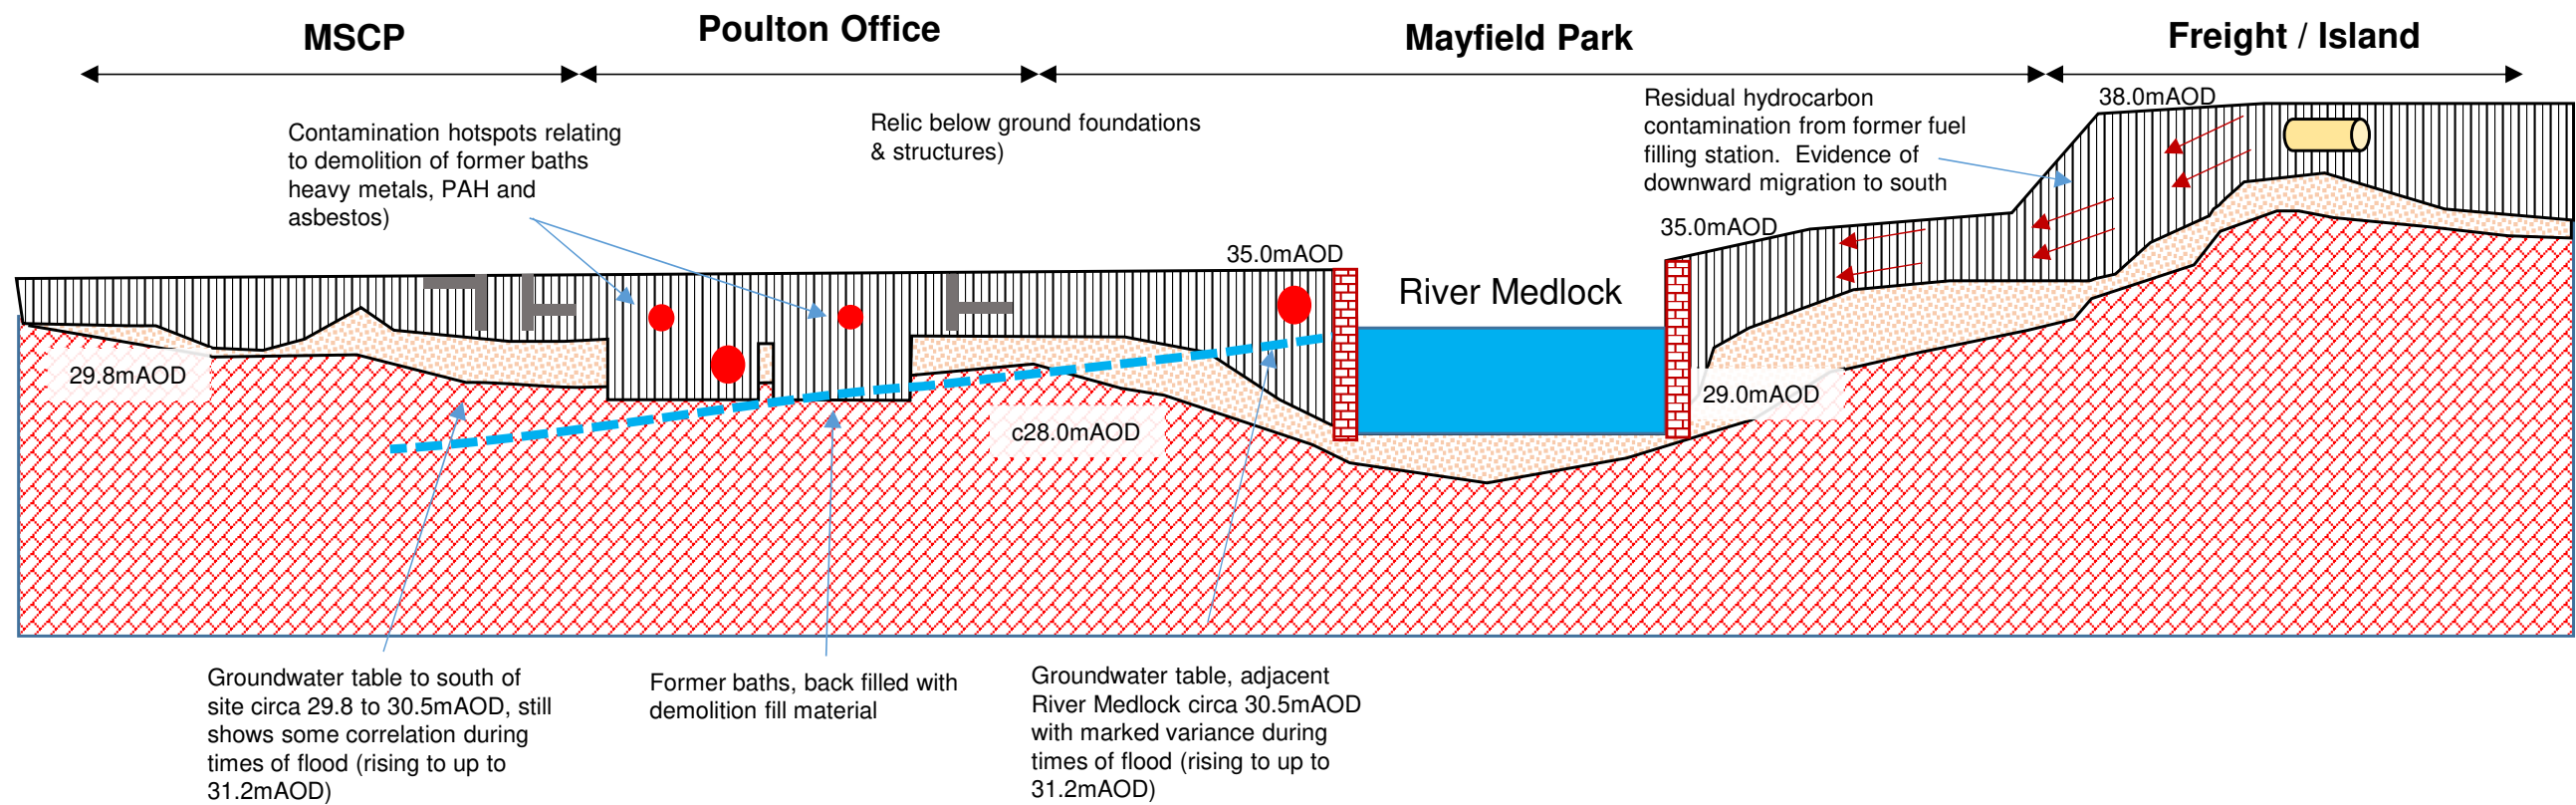
Section A-A : Western Conceptual Site Section

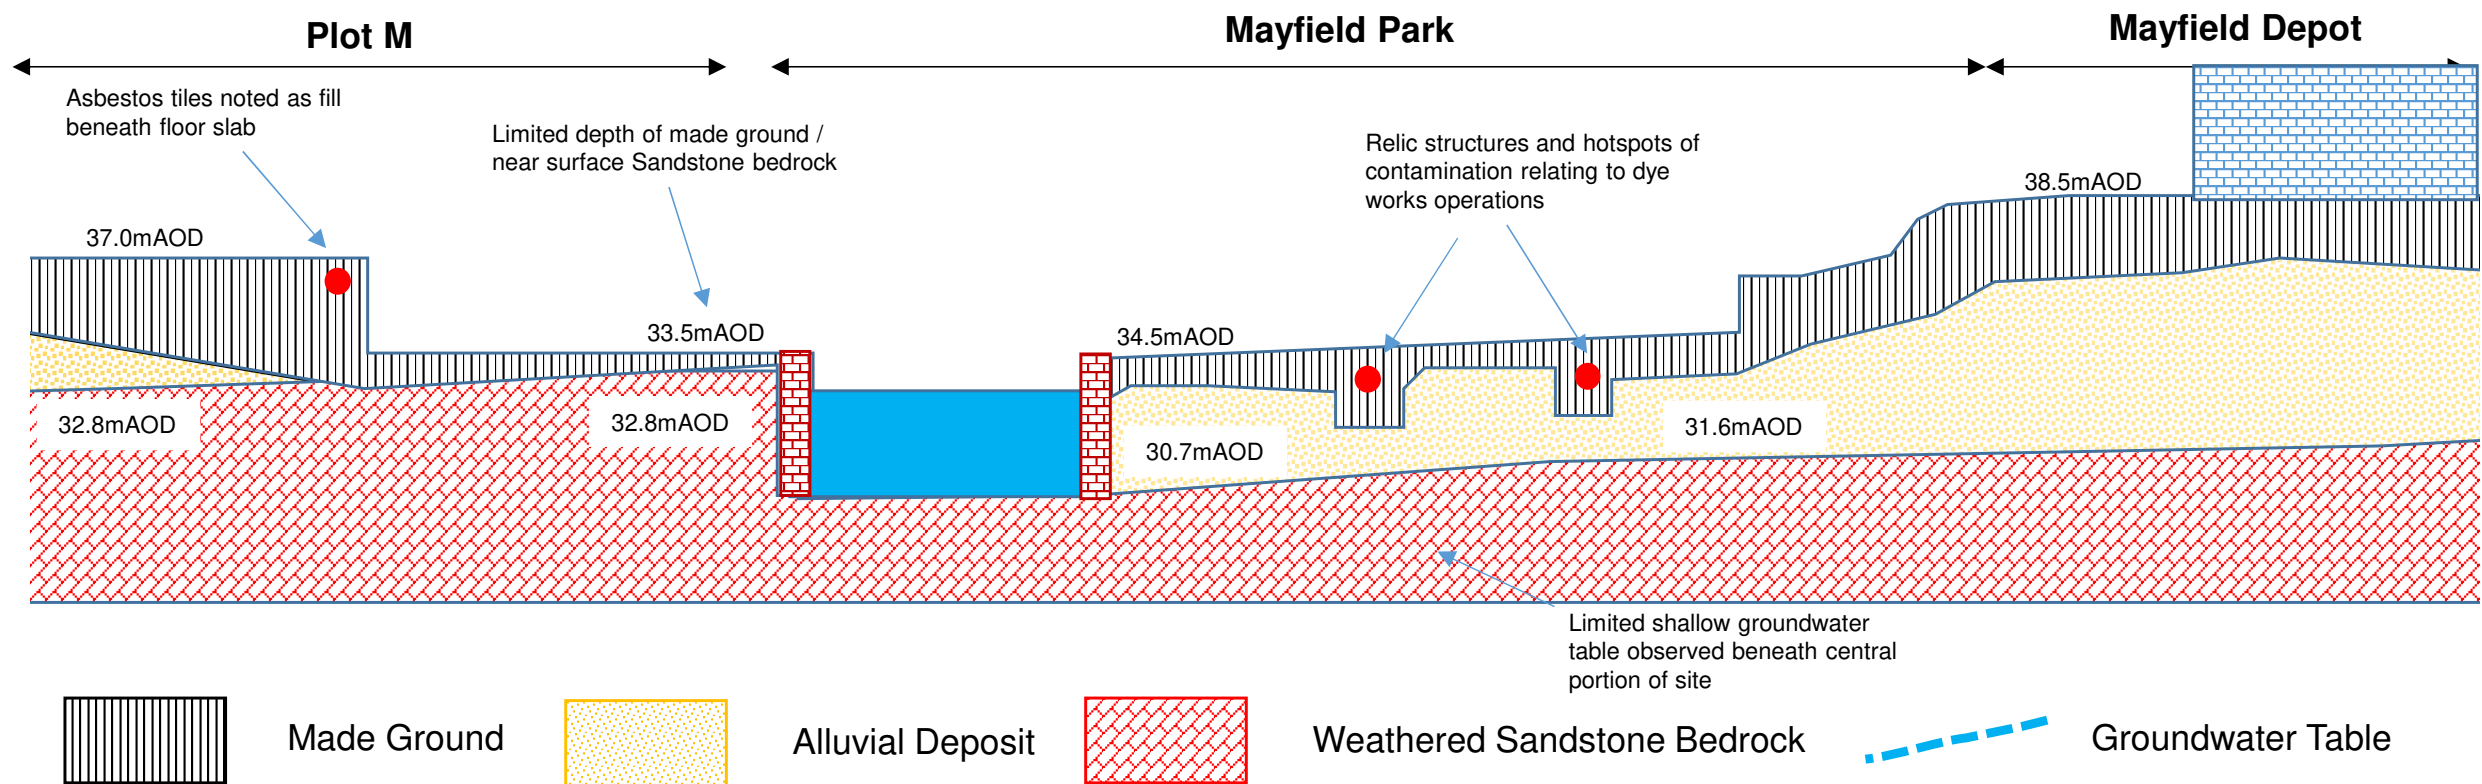
Section B-B : Central Conceptual Site Section

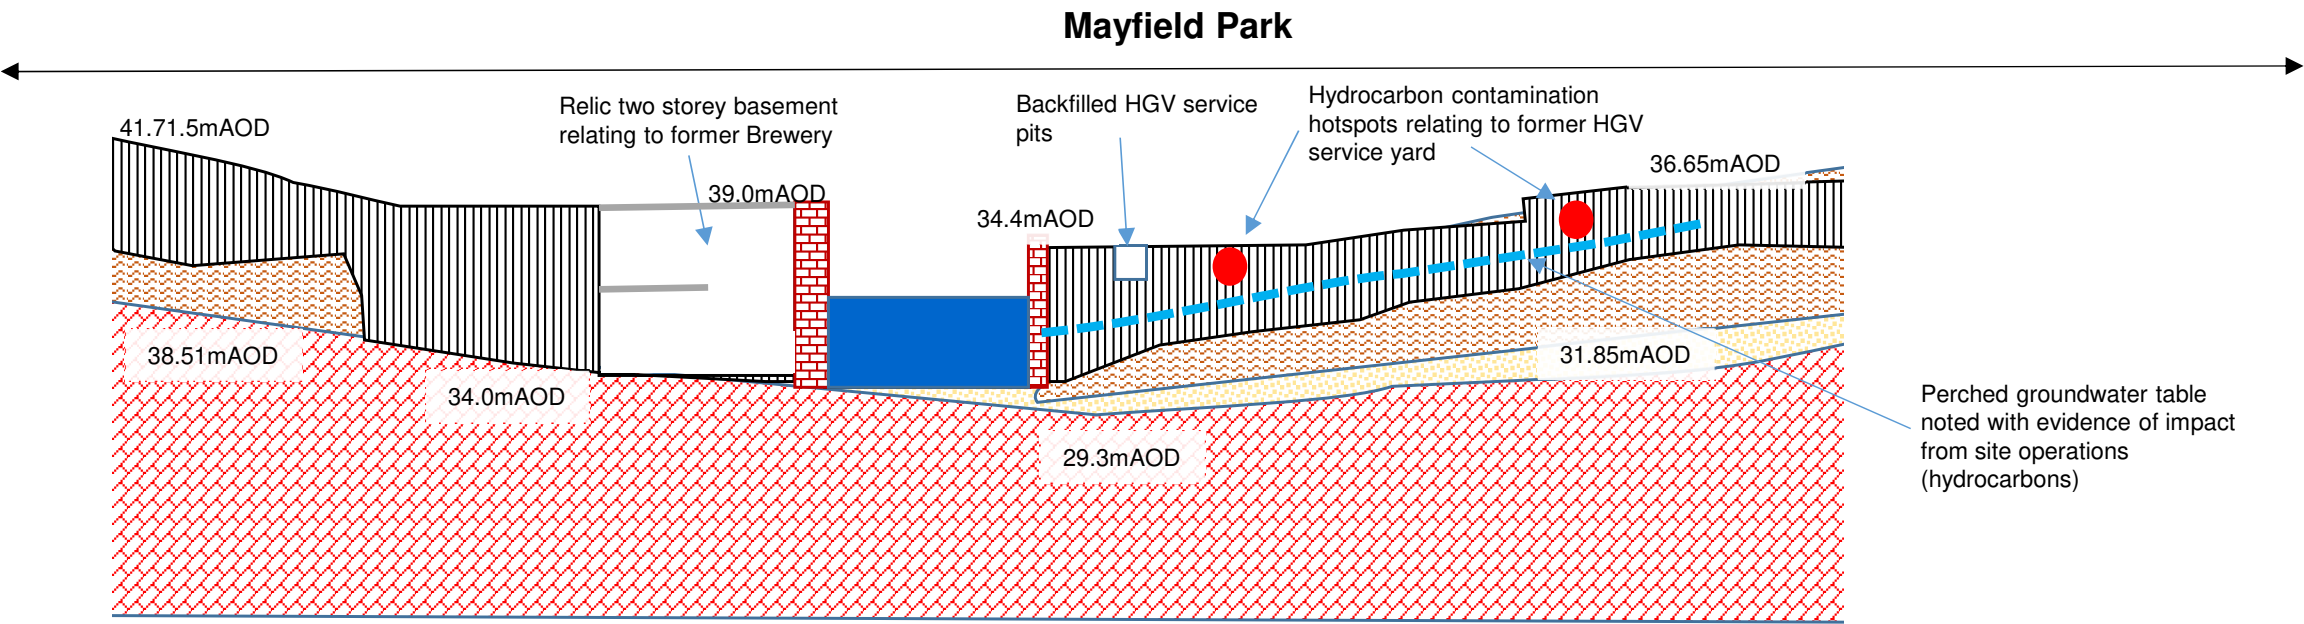
Section C-C : Eastern Conceptual Site Section

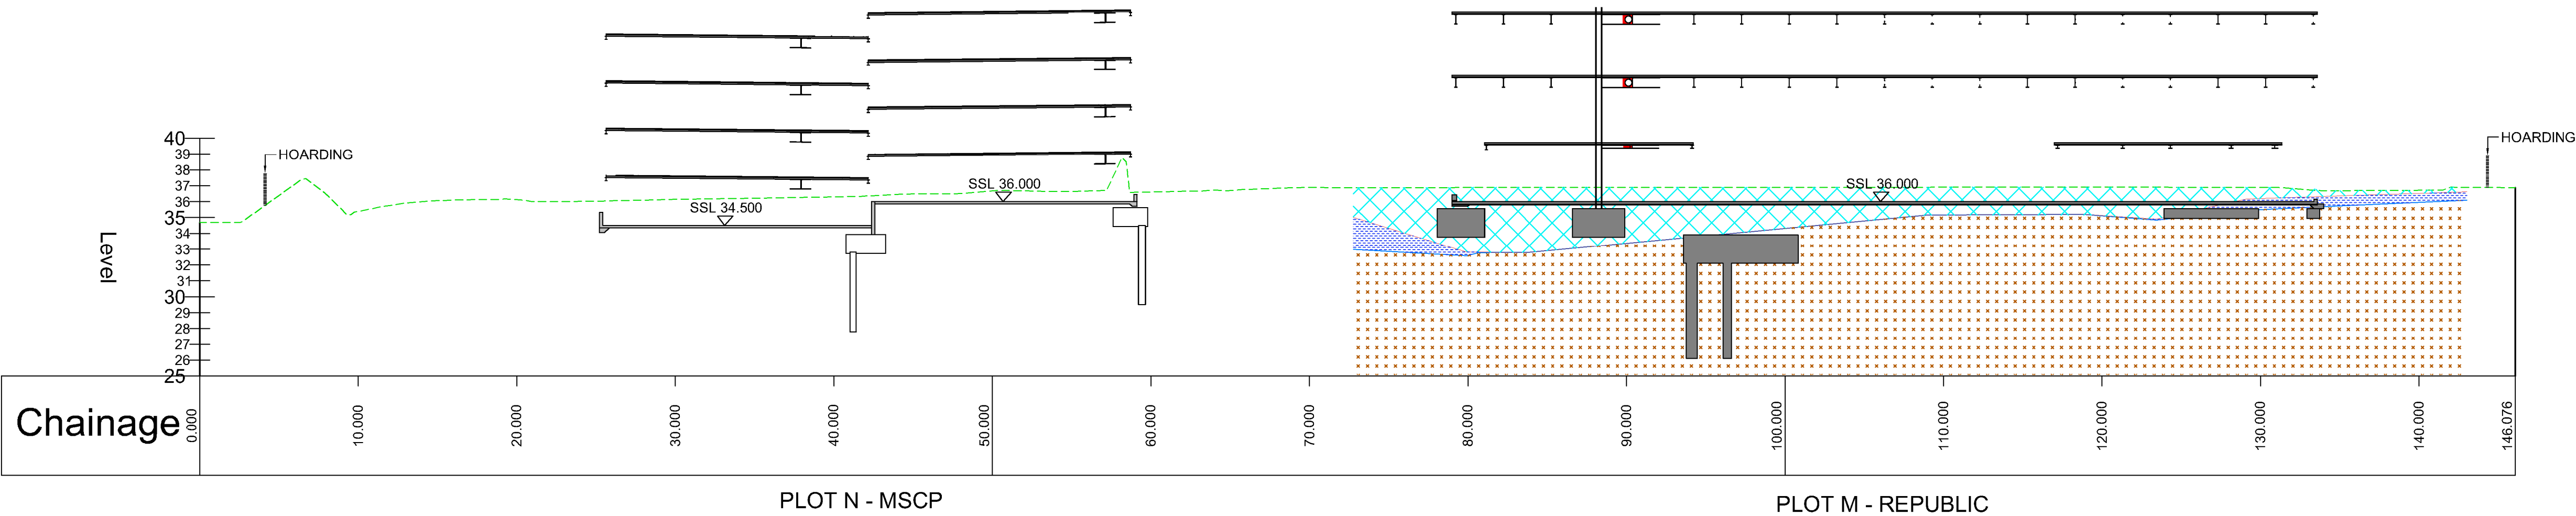
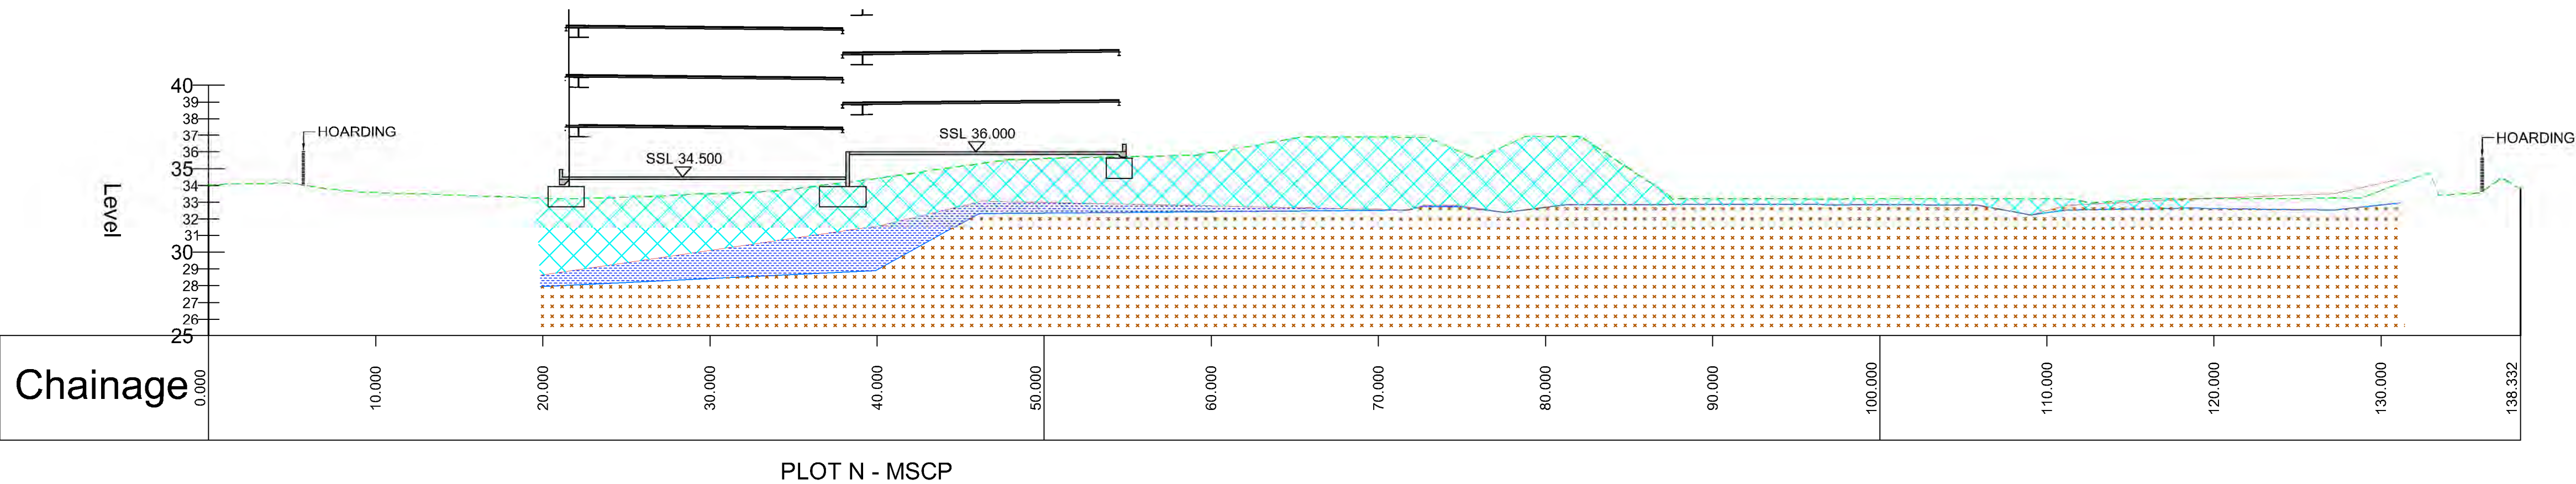
1-1 - LONGSECTION  
SCALE: H 1:250,V 1:250. DATUM: 25.000

2-2 - LONGSECTION  
SCALE: H 1:250,V 1:250. DATUM: 25.000

3-3 - LONGSECTION  
SCALE: H 1:250,V 1:250. DATUM: 25.000

MADE GROUND - COMPRISING A PREDOMINATELY GRANULAR FILL MATRIX OF BRICK, CONCRETE, ROOF SLATE ETC WITH OTHER DELETERIOUS INCLUSIONS SUCH AS DECAYED TIMBER, ASH AND ASBESTOS FRAGMENTS.

ALLUVIUM - COMPRISING A MIXTURE OF FINE TO COARSE SAND AND GRAVEL WITH FREQUENT FINER SILT INCLUSIONS AND OCCASIONAL CLAYS. VARIABILITY IN STRATA IS AT RANDOM ACROSS THE SITE BASED ON HISTORIC FLOOD PLAIN OPERATION

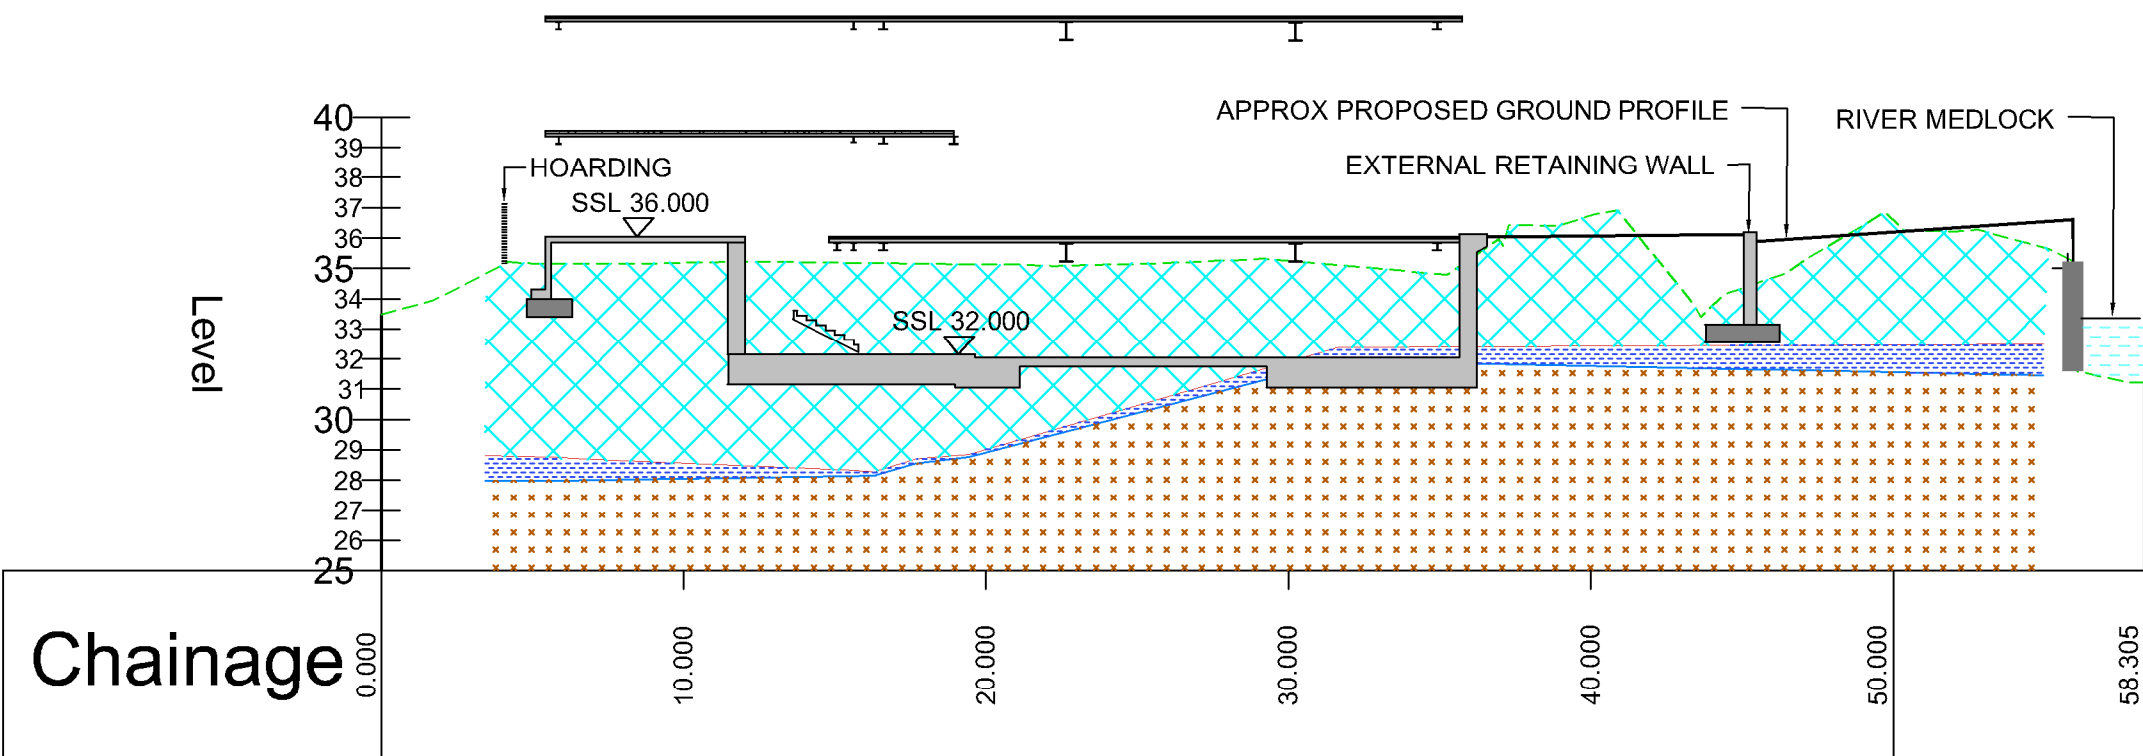
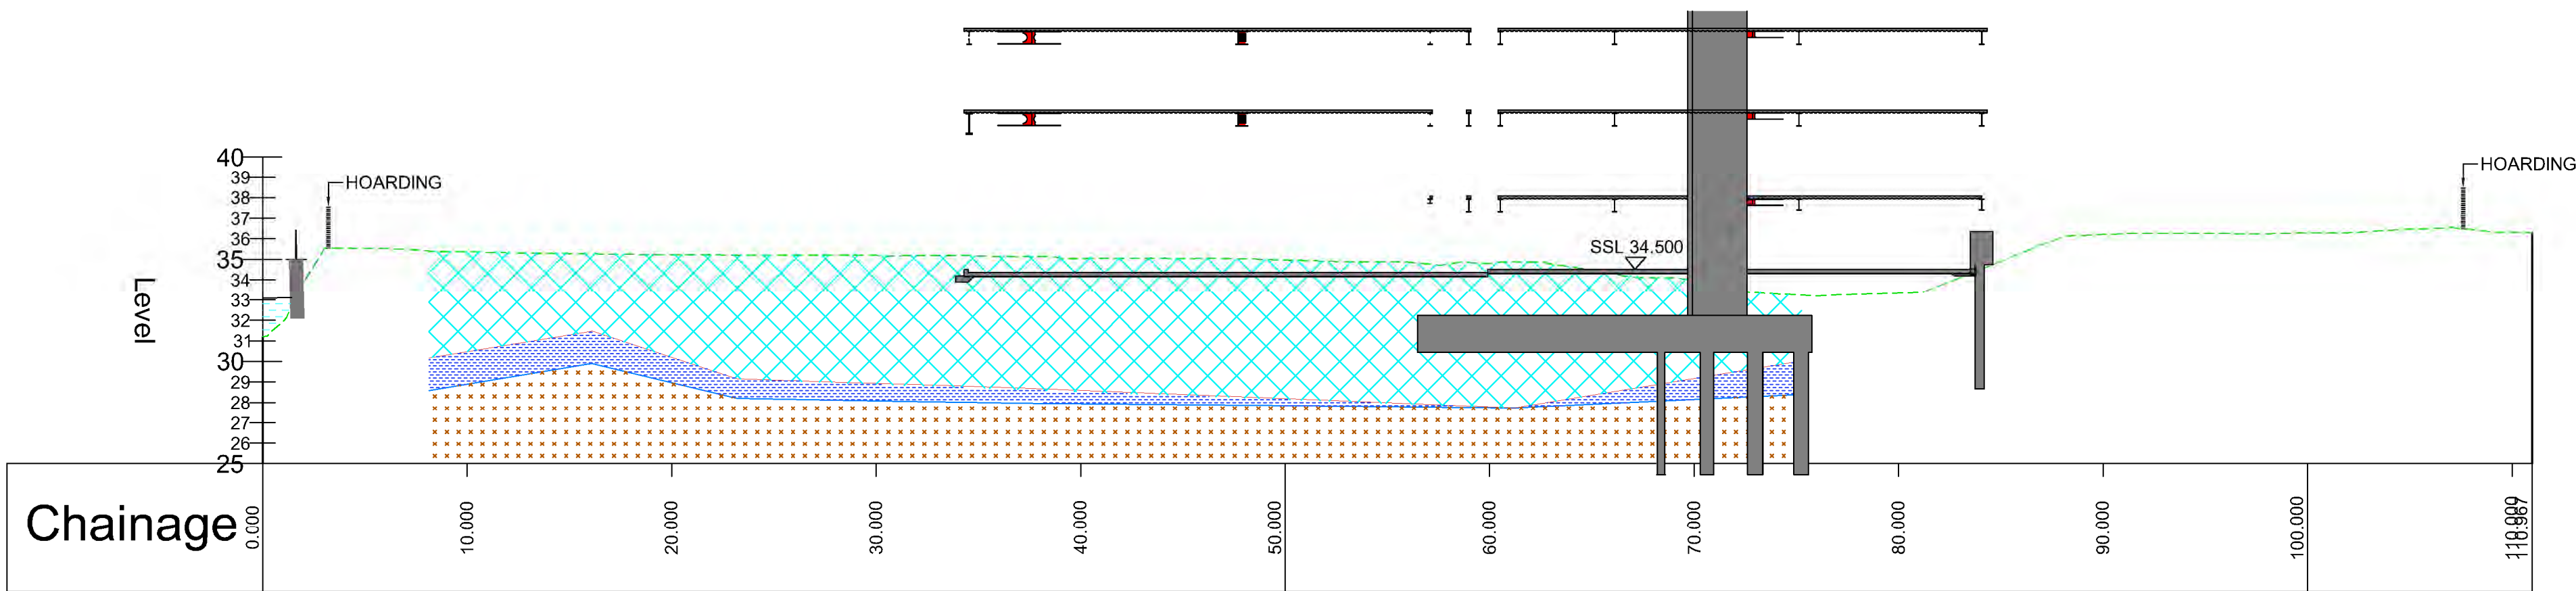
4-4 - LONGSECTION  
SCALE: H 1:250,V 1:250. DATUM: 25.000

5-5 - LONGSECTION  
SCALE: H 1:250,V 1:250. DATUM: 25.000

6-6 - LONGSECTION  
SCALE: H 1:250,V 1:250. DATUM: 25.000

**MADE GROUND** - COMPRISING A PREDOMINATELY GRANULAR FILL MATRIX OF BRICK, CONCRETE, ROOF SLATE ETC WITH OTHER DELETERIOUS INCLUSIONS SUCH AS DECAYED TIMBER, ASH AND ASBESTOS FRAGMENTS.

**ALLUVIUM** - COMPRISING A MIXTURE OF FINE TO COARSE SAND AND GRAVEL WITH FREQUENT FINER SILT INCLUSIONS AND OCCASIONAL CLAYS. VARIABILITY IN STRATA IS AT RANDOM ACROSS THE SITE BASED ON HISTORIC FLOOD PLAIN OPERATION

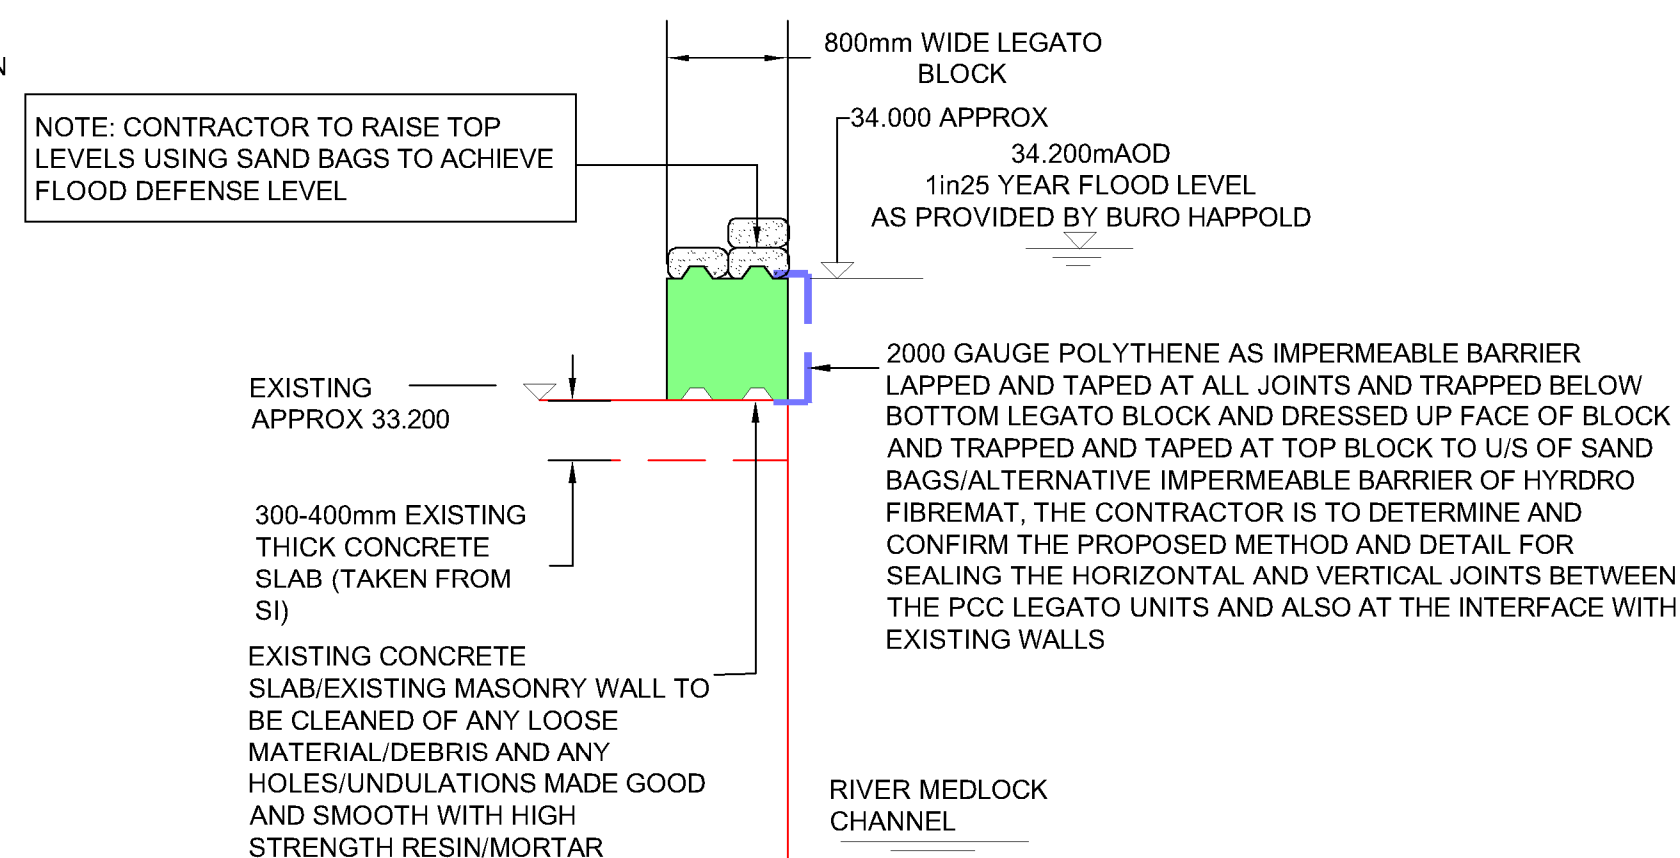
SECTION THROUGH WALL AT  
APPROX CHAINAGE 20 ON  
ELEVATION 1

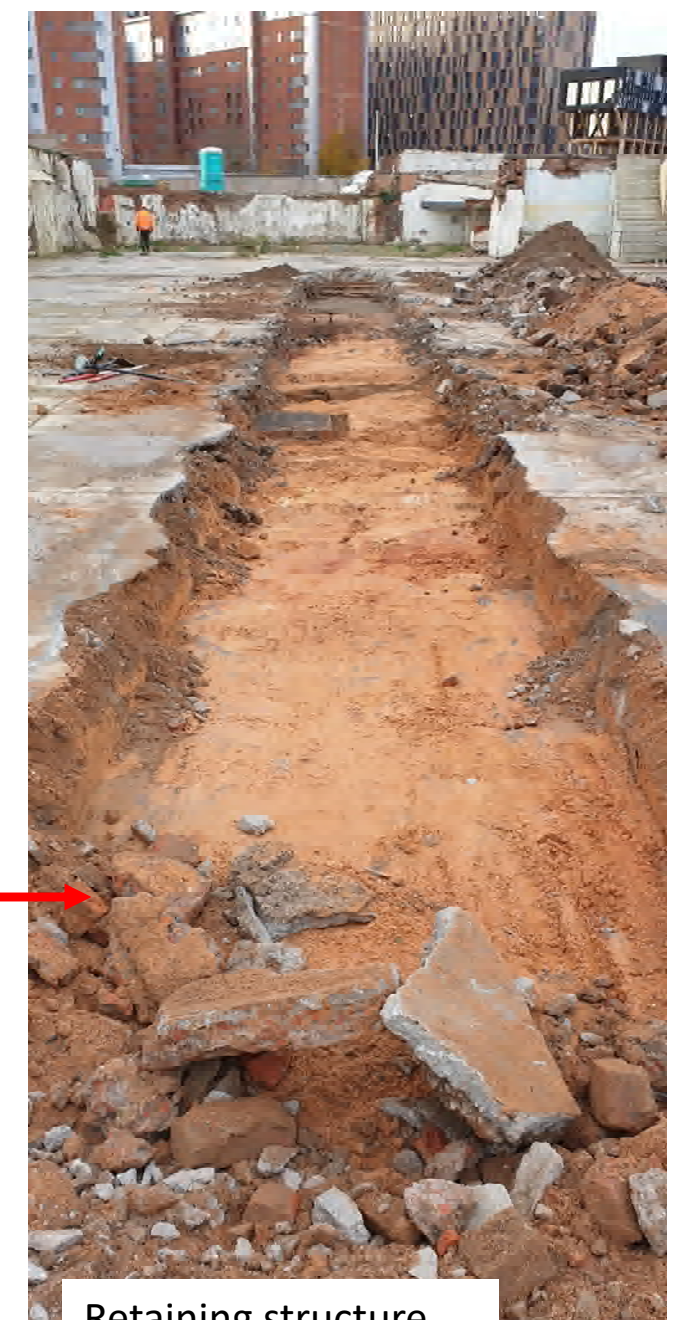
Retaining structure  
Slit trench formed through lower  
level showing sandstone beneath  
existing floor slab

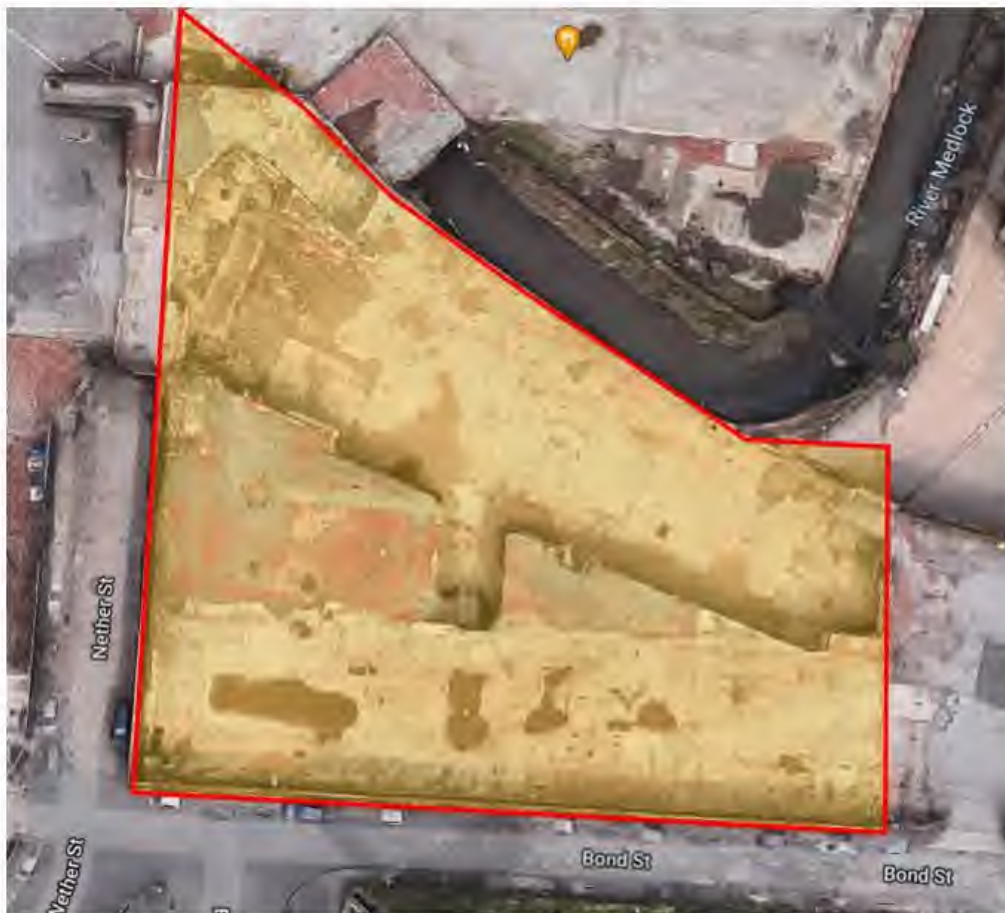
The following note has been prepared for all contractors to review and adhere with when completing any excavations or works that may break ground in the area of the former Ardwick Tannery (see Fig 1.0 below for location).

**Fig 1.0 : Portion of site containing former Tannery operation.**
