# Television Post-Construction Survey Report

Mulbury New Cross (Bendix Street)

Mulbury Homes Limited

July 2023

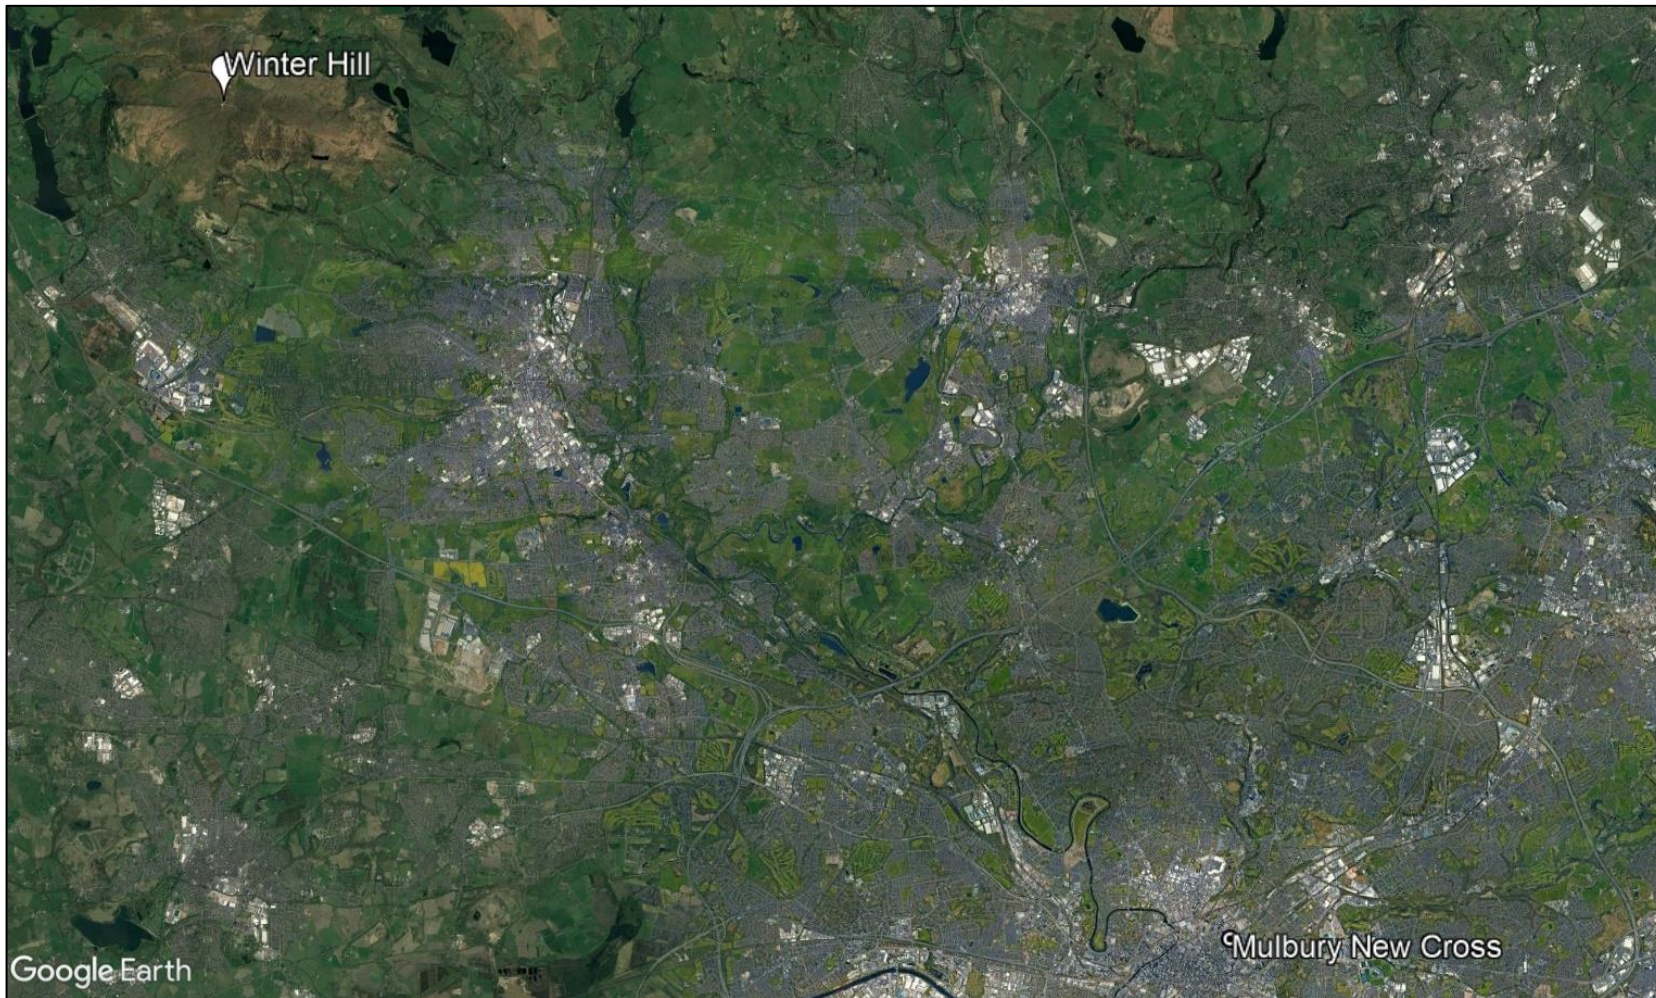
Figure 2 Winter Hill transmitter relative to Mulbury New Cross

Winter Hill is one of the UK's main television transmitters located approximately 24.4km northwest of the Proposed Development (published coordinates SD66051446).

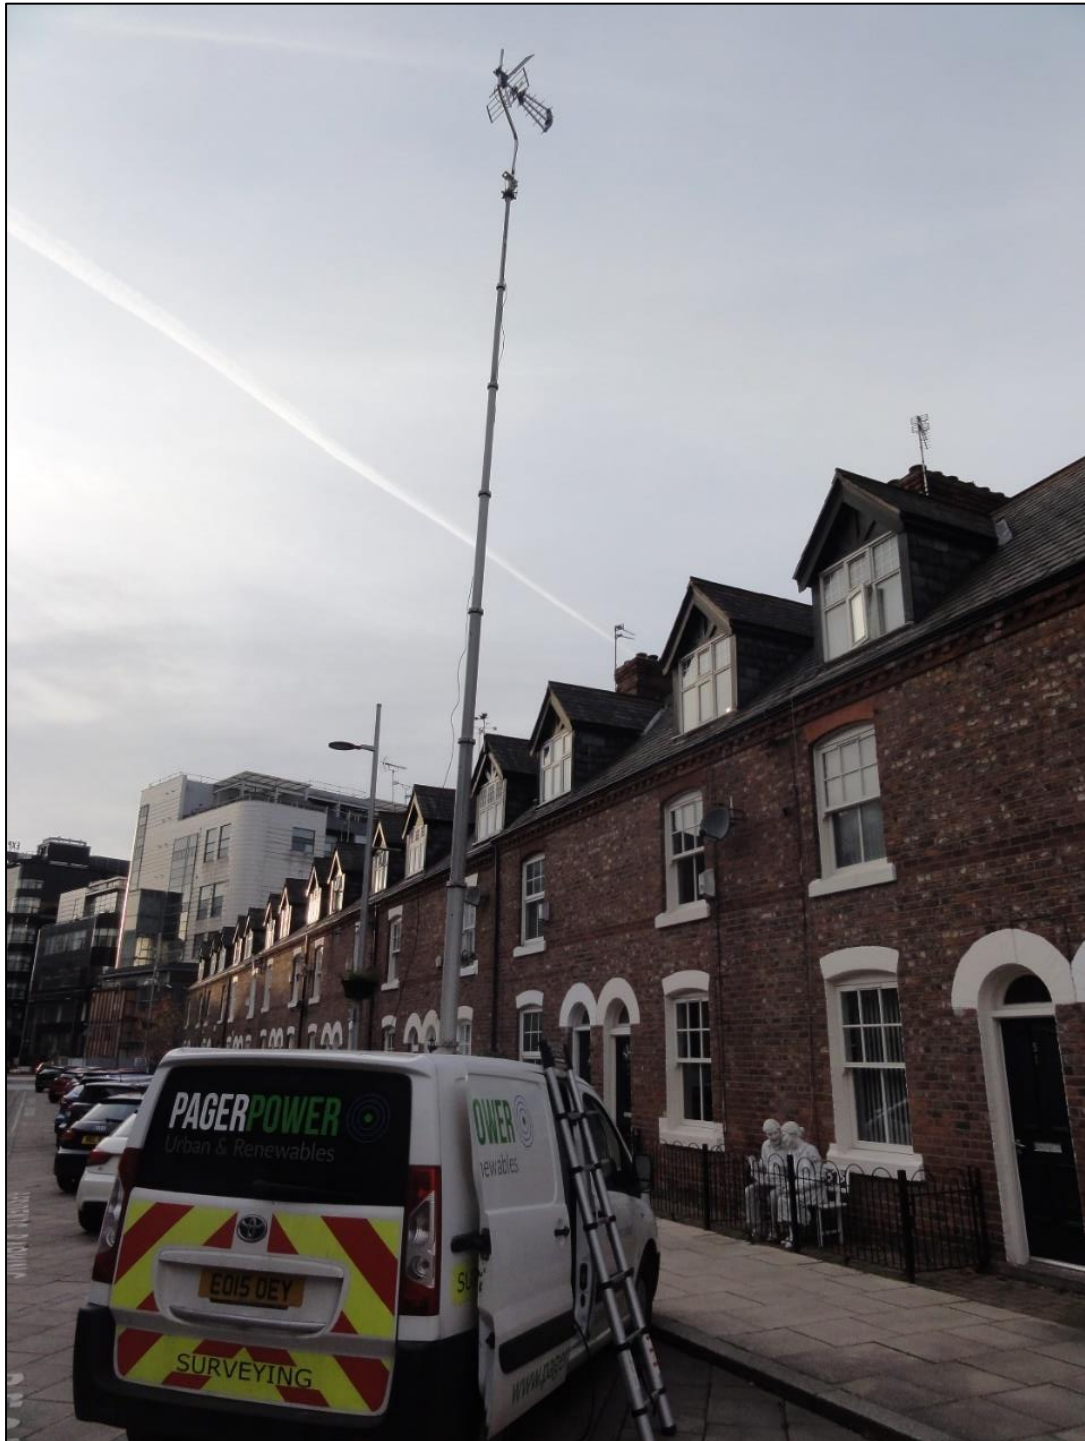
Location 1 (baseline survey)

| Location | Average Measured Signal Strength (dB) | Remarks | Conclusions |
|---|---|---|---|
| 1 | <u>Baseline</u><br>Main TV MUX: 41<br>Local TV MUX: 37 | <p>Horizontally polarised aerials directed towards the Winter Hill transmitter and satellite dishes were observed.</p> <p><u>Baseline:</u> All main multiplexes displayed fine picture and audio quality</p> <p>Two out of four local multiplexes were not decoded at this location</p> | <p>The survey location is within 200m of the closest of the Mulbury New Cross development and within its shadow zone</p> <p><u>The reduction in TV signal strength at this location could be attributed to the Mulbury New Cross development. However, there is no change in picture or audio quality to channels that did decode. Results are also consistent to channels that did/did not decode</u></p> |

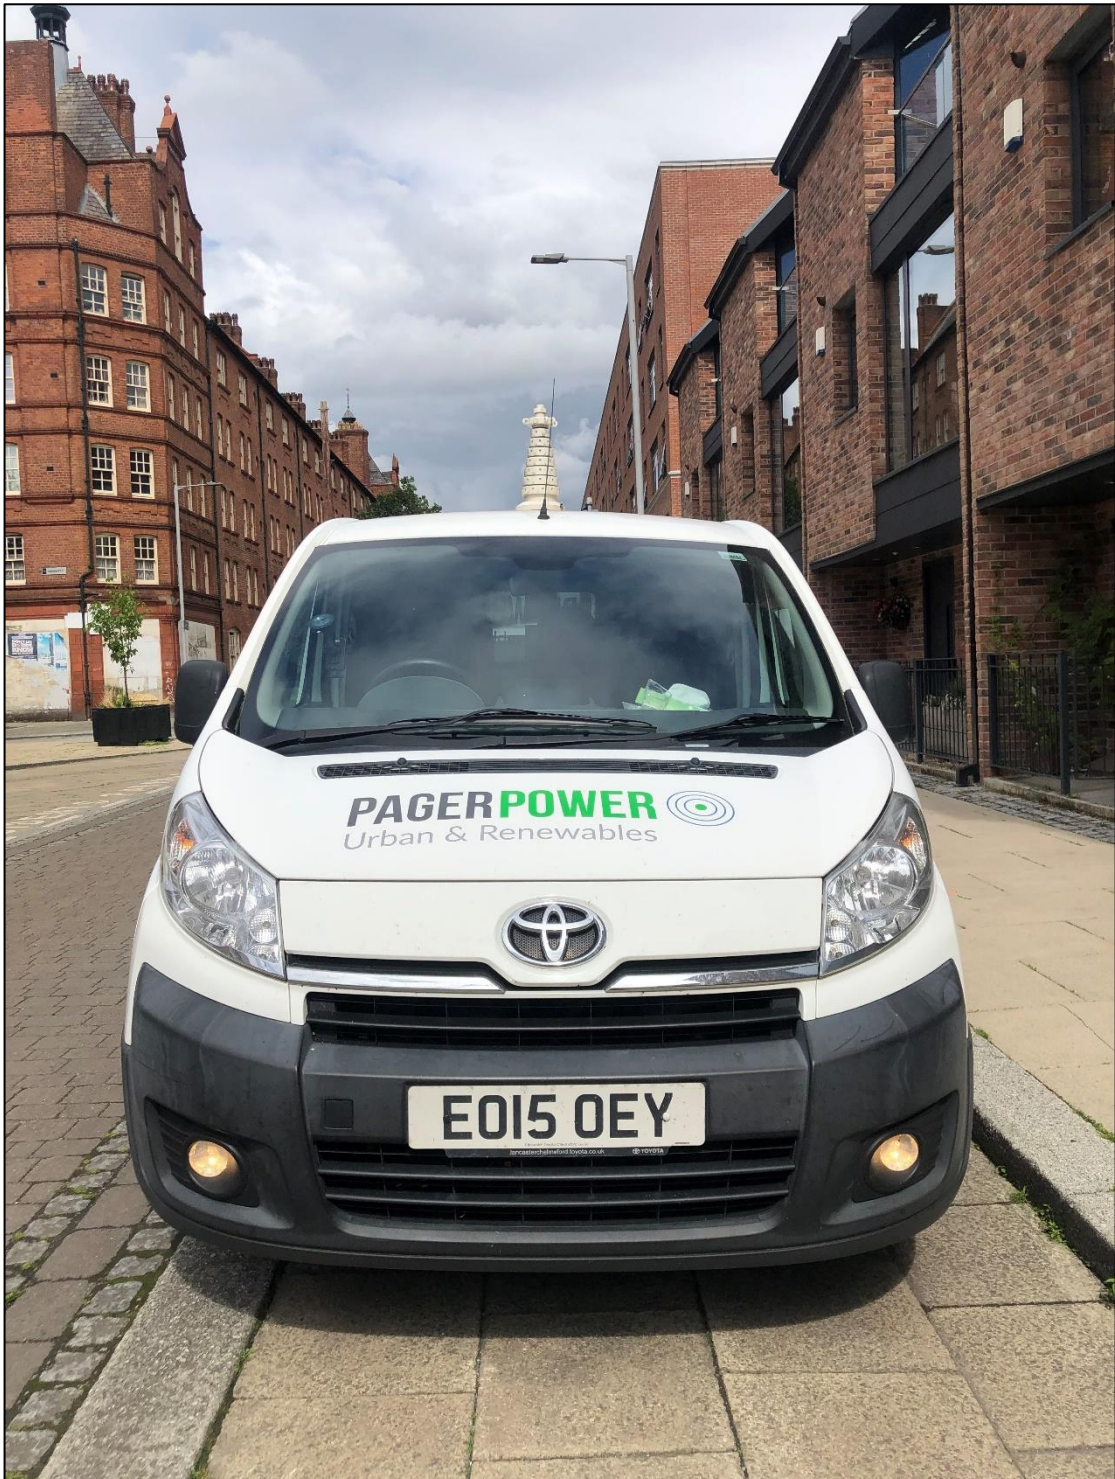
Location 1 (post-construction survey)

| Location | Average Measured Signal Strength (dB) | Remarks | Conclusions |
|---|---|---|---|
| | <u>Post-Construction</u><br>Main TV MUX: 32<br>Local TV MUX: 34 | <p><u>Post-Construction:</u> All main multiplexes displayed fine picture and audio</p> <p>Two out of four local multiplexes were not decoded at this location</p> | |

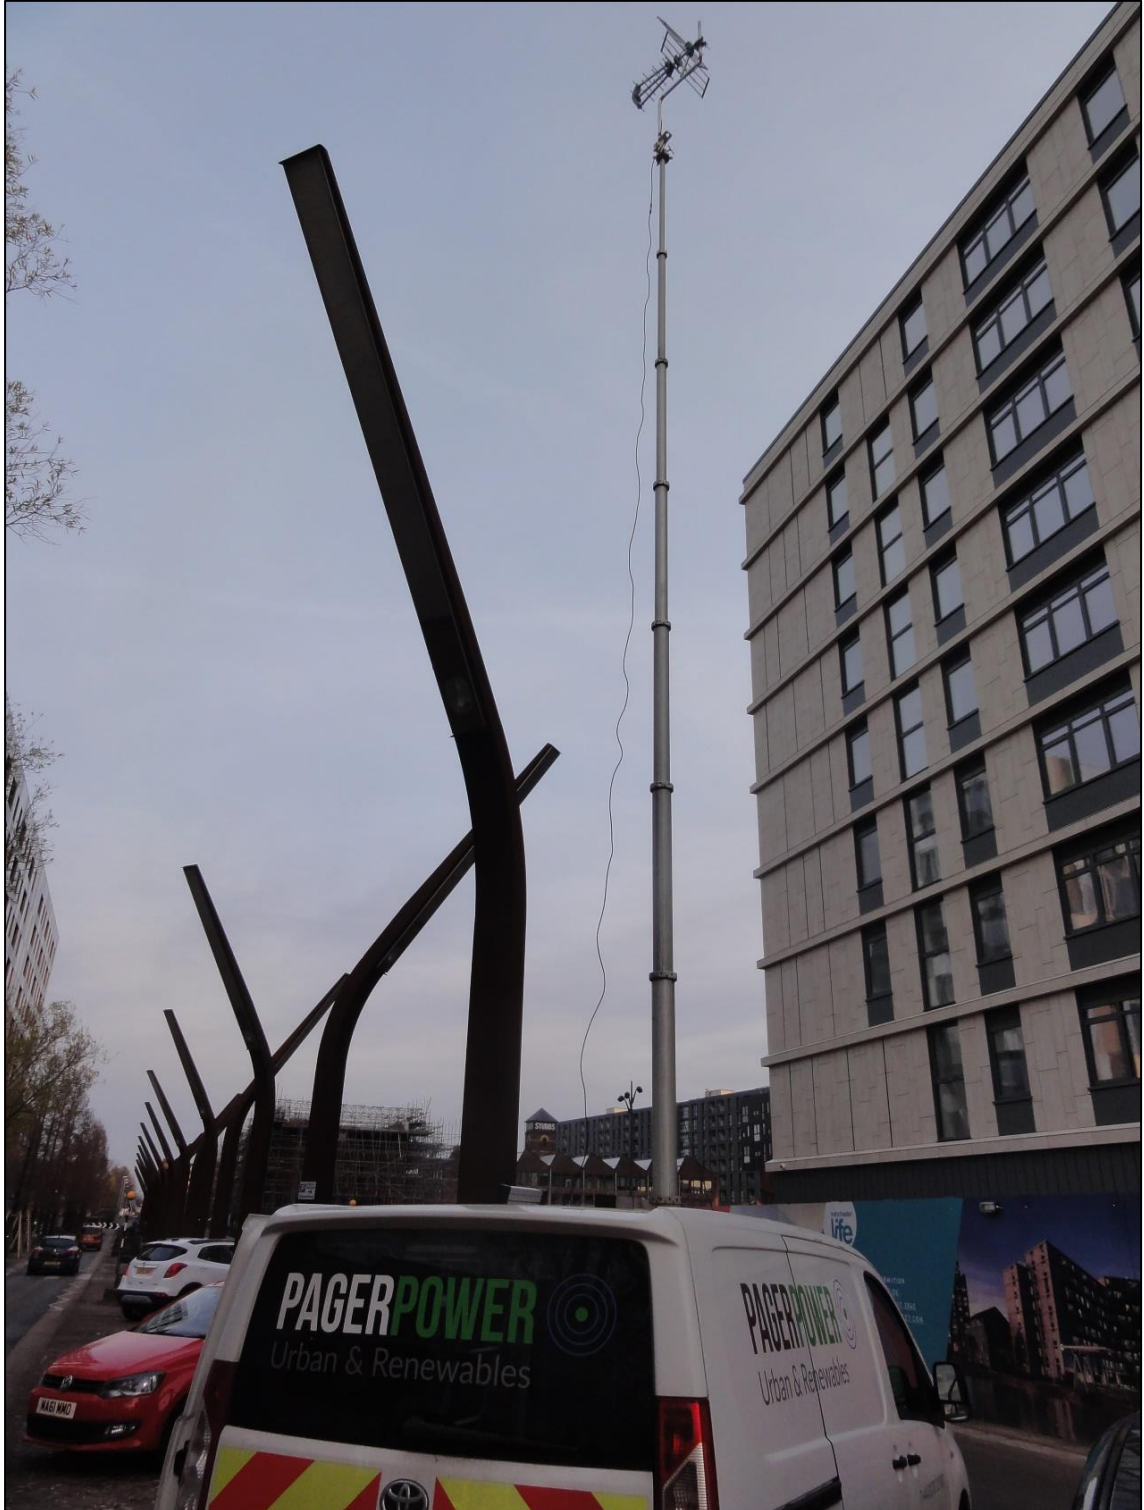
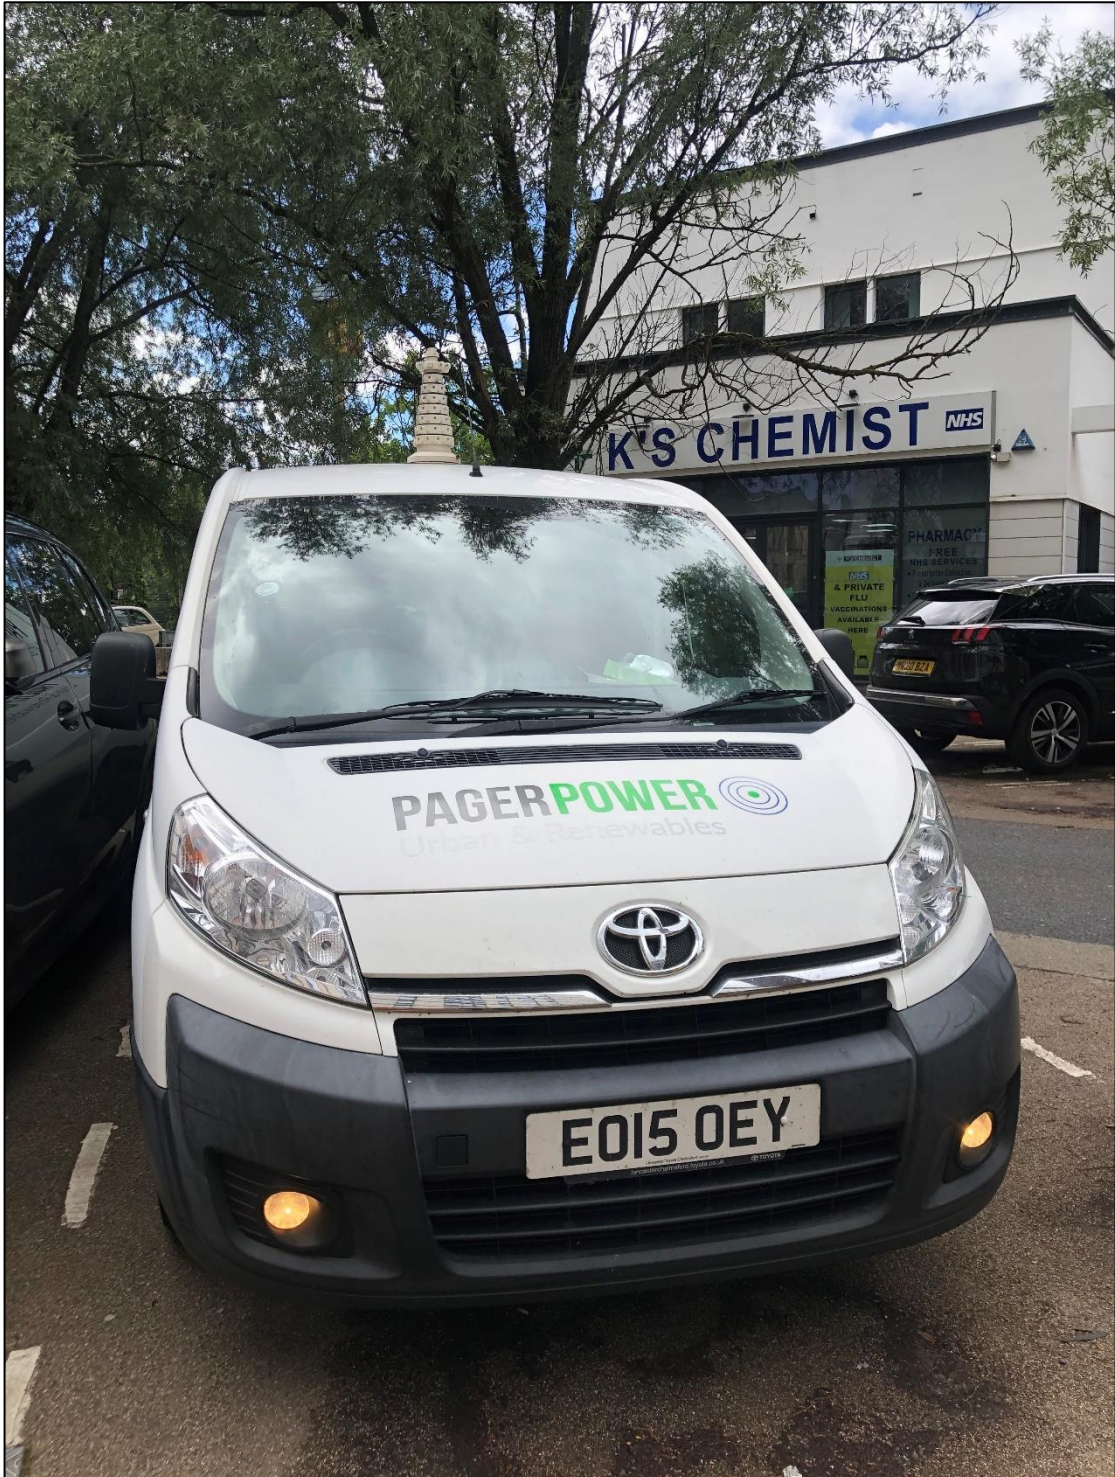
| Location | Average Measured Signal Strength (dB) | Remarks | Conclusions |
|---|---|---|---|
| 2 | <u>Baseline</u><br>Main TV MUX: 49<br>Local TV MUX: 39 | <p>External aerials were not visible at this location.</p> <p><u>Baseline:</u> All main multiplexes displayed fine picture and audio quality</p> <p>Two out of four local multiplexes were not decoded at this location</p> | <p>The survey location is within 700m of the Mulbury New Cross development site and within its shadow zone</p> <p><u>The reduction in TV signal strength at this location could be attributed to the Mulbury New Cross development. However, there is no change in picture or audio quality to channels that did decode. Results are also consistent to channels that did/did not decode</u></p> |

Location 2 (baseline survey)

Location 2 (post-construction survey)

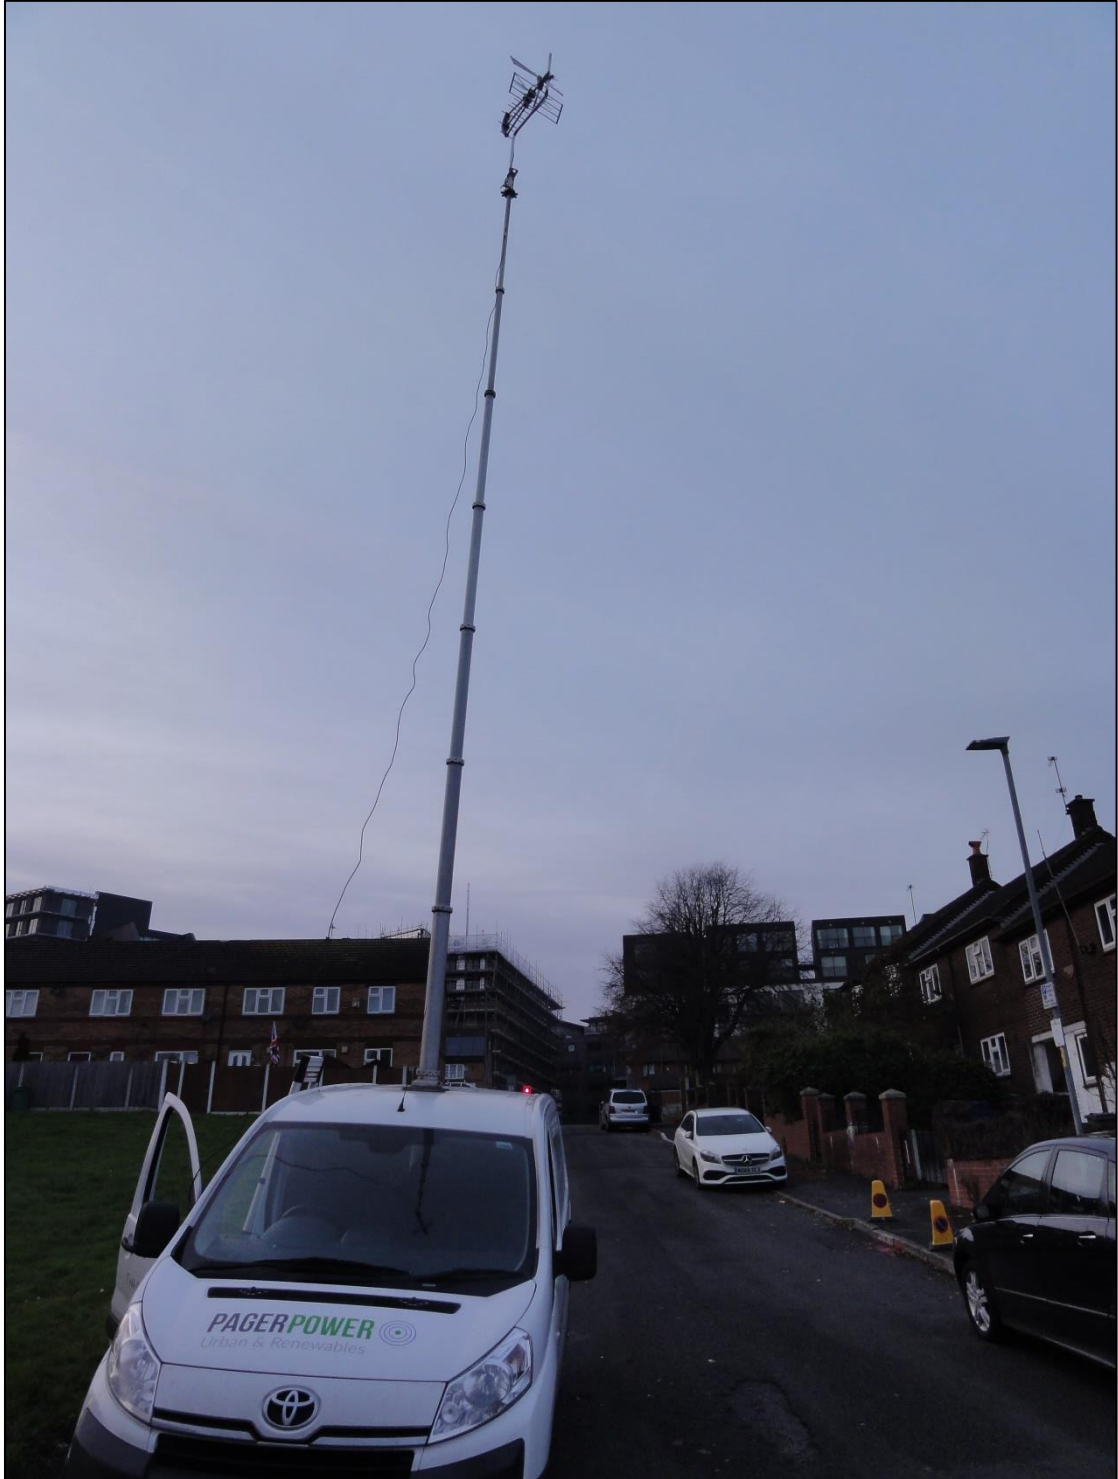
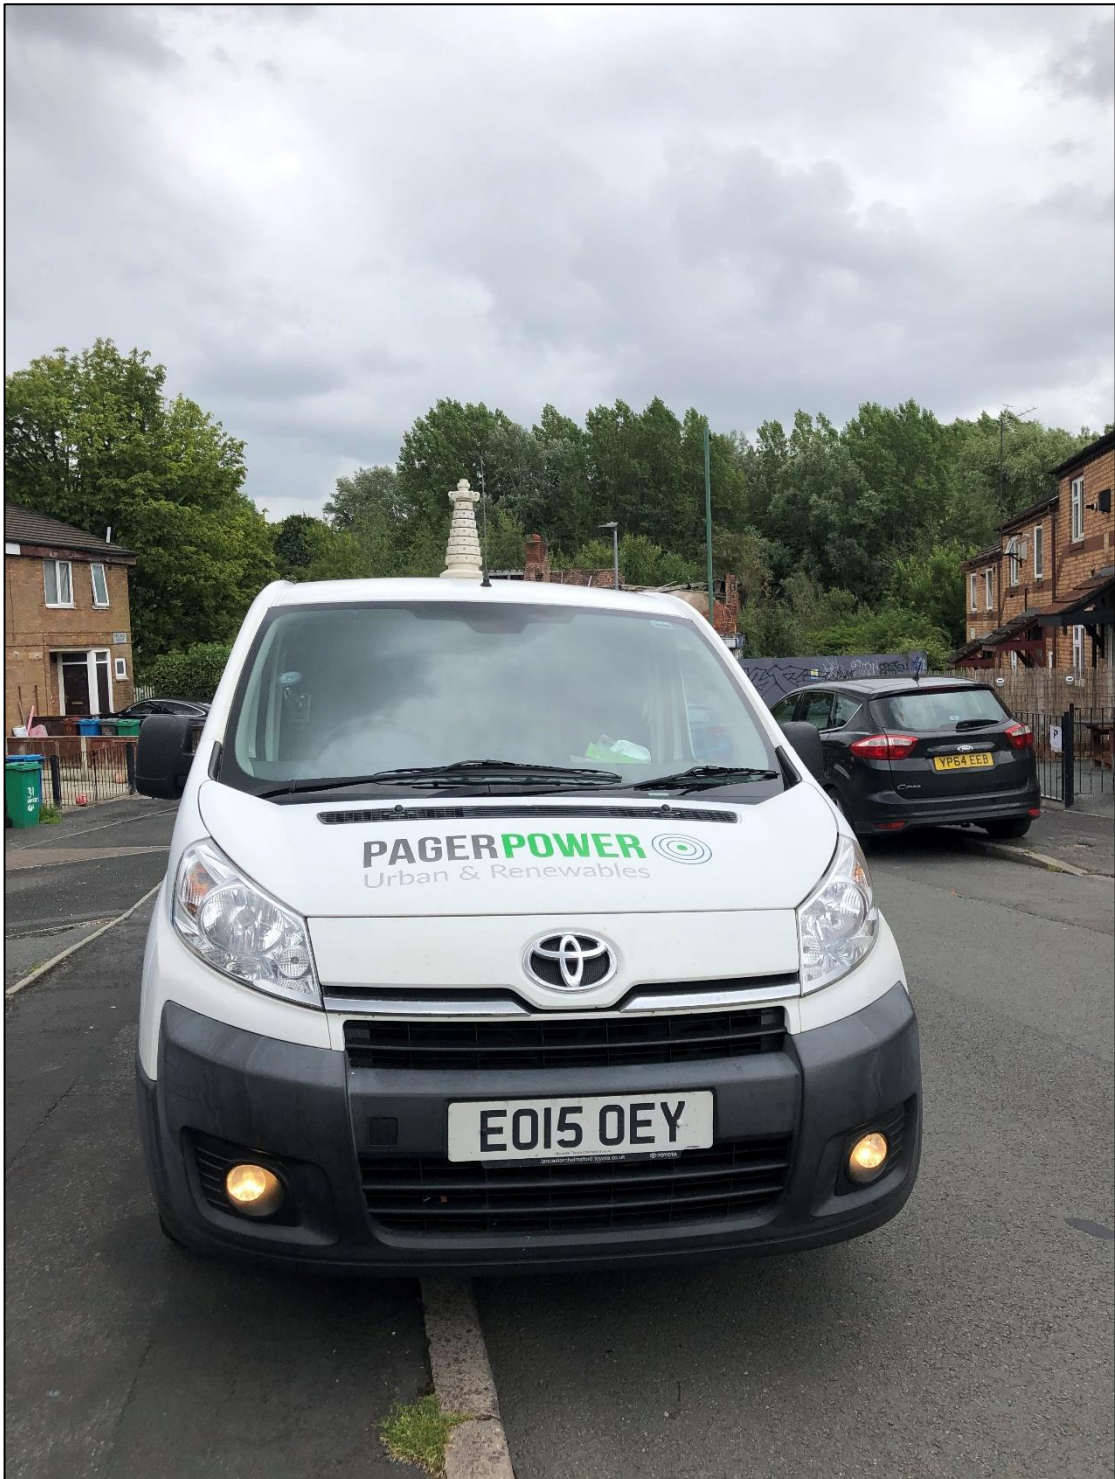
| Location | Average Measured Signal Strength (dB) | Remarks | Conclusions |
|---|---|---|---|
| 3 | <u><b>Baseline</b></u><br>Main TV MUX: 42<br>Local TV MUX: 36 | <p>Horizontally polarised aerials directed towards the Winter Hill transmitter and satellite dishes were observed.</p> <p><u><b>Baseline:</b></u> All main multiplexes displayed fine picture and audio quality</p> <p>Two out of four local multiplexes were not decoded at this location</p> | <p>The survey location was within 1.3km of the Mulbury New Cross development site and within its shadow zone</p> <p><u><b>The reduction in TV signal strength at this location is not likely to be attributed to the Mulbury New Cross development. However, there is no change in picture or audio quality to channels that did decode. Results are also consistent to channels that did/did not decode</b></u></p> |

Location 3 (baseline survey)

Location 3 (post-construction survey)

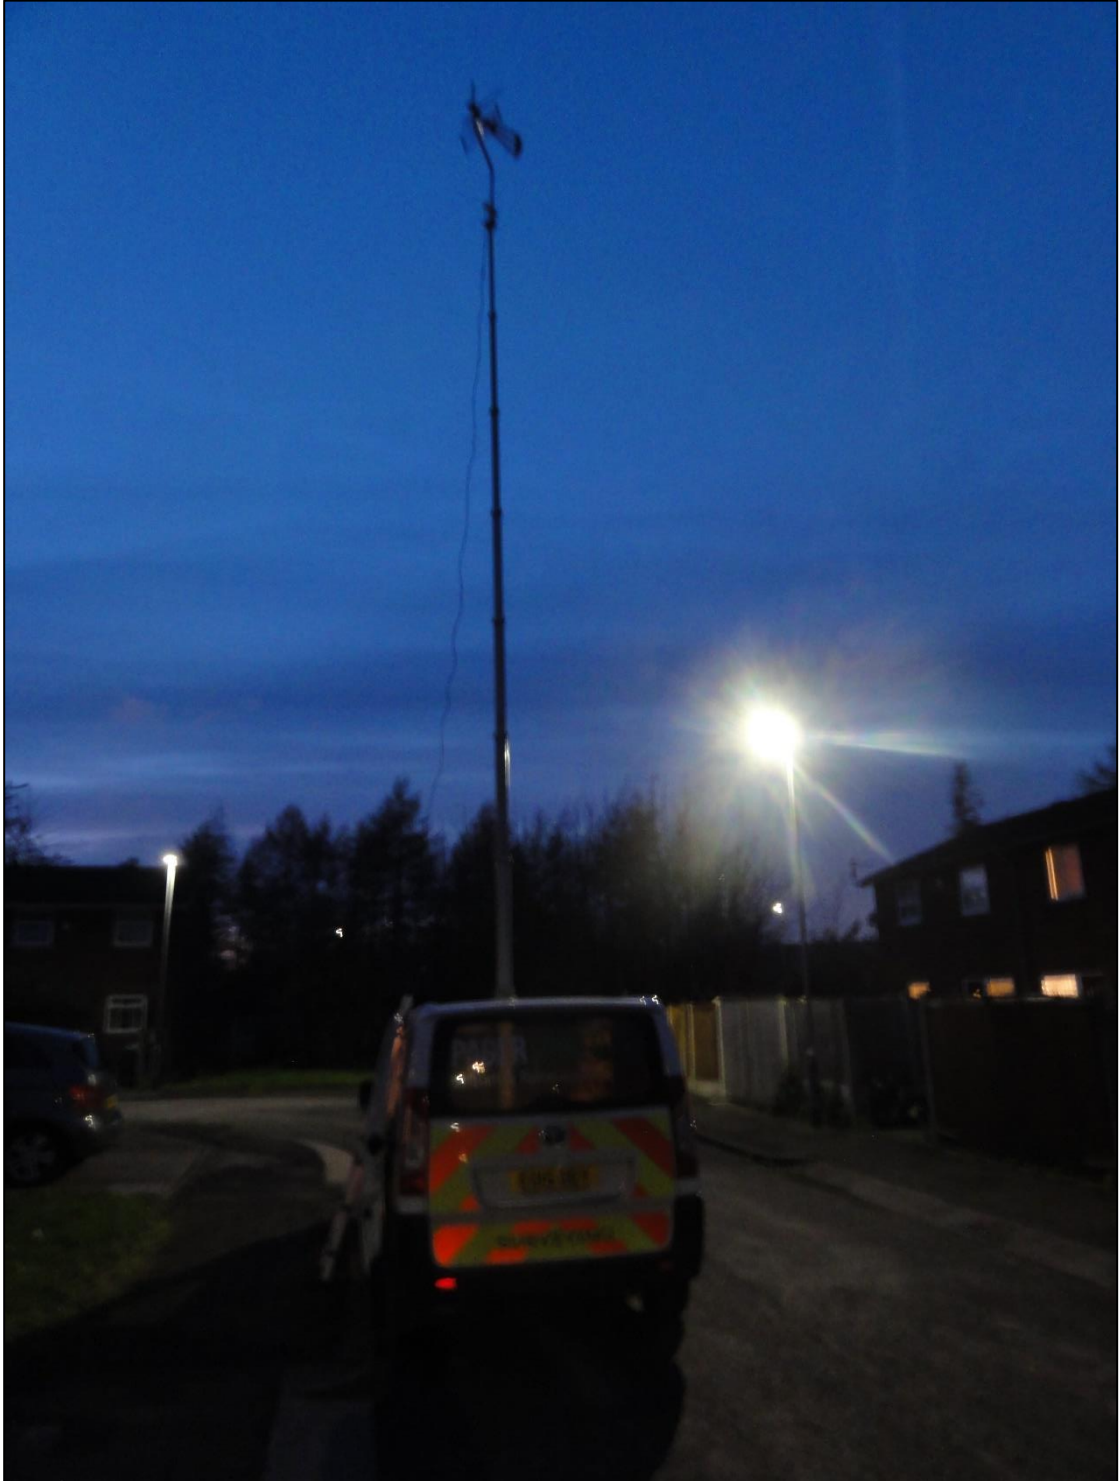
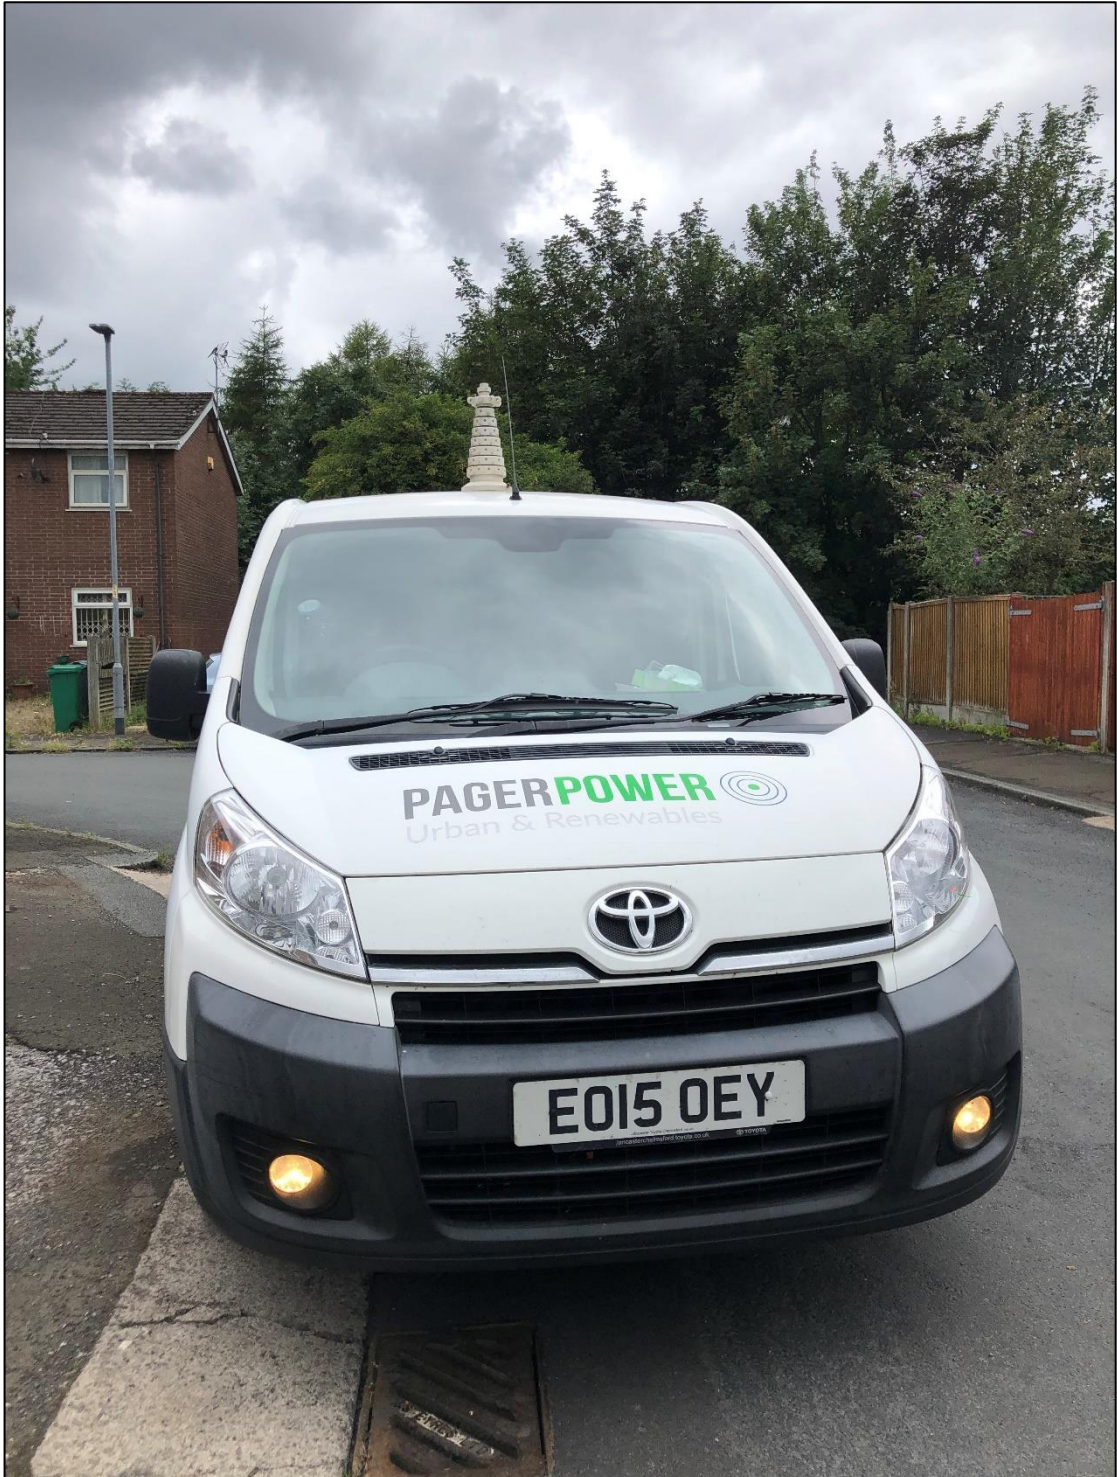
| Location | Average Measured Signal Strength (dB) | Remarks | Conclusions |
|---|---|---|---|
| 5 | <u>Baseline</u><br>Main TV MUX: 70<br>Local TV MUX: 51 | <p>Horizontally polarised aerials directed towards the Winter Hill transmitter and satellite dishes were observed</p> <p><u>Baseline:</u> All main multiplexes displayed fine picture and audio quality</p> <p>One out of four local multiplexes were not decoded at this location</p> | <p>The survey location was within 3.2km of the Mulbury New Cross development site and within its shadow zone.</p> <p><u>The reduction in TV signal strength at this location is not likely to be attributed to the Mulbury New Cross development. However, there is no change in picture or audio quality to channels that did decode. The reduction in local multiplexes is likely due to signal strength from weaker transmissions</u></p> |

Location 5 (baseline survey)

Location 5 (post-construction survey)

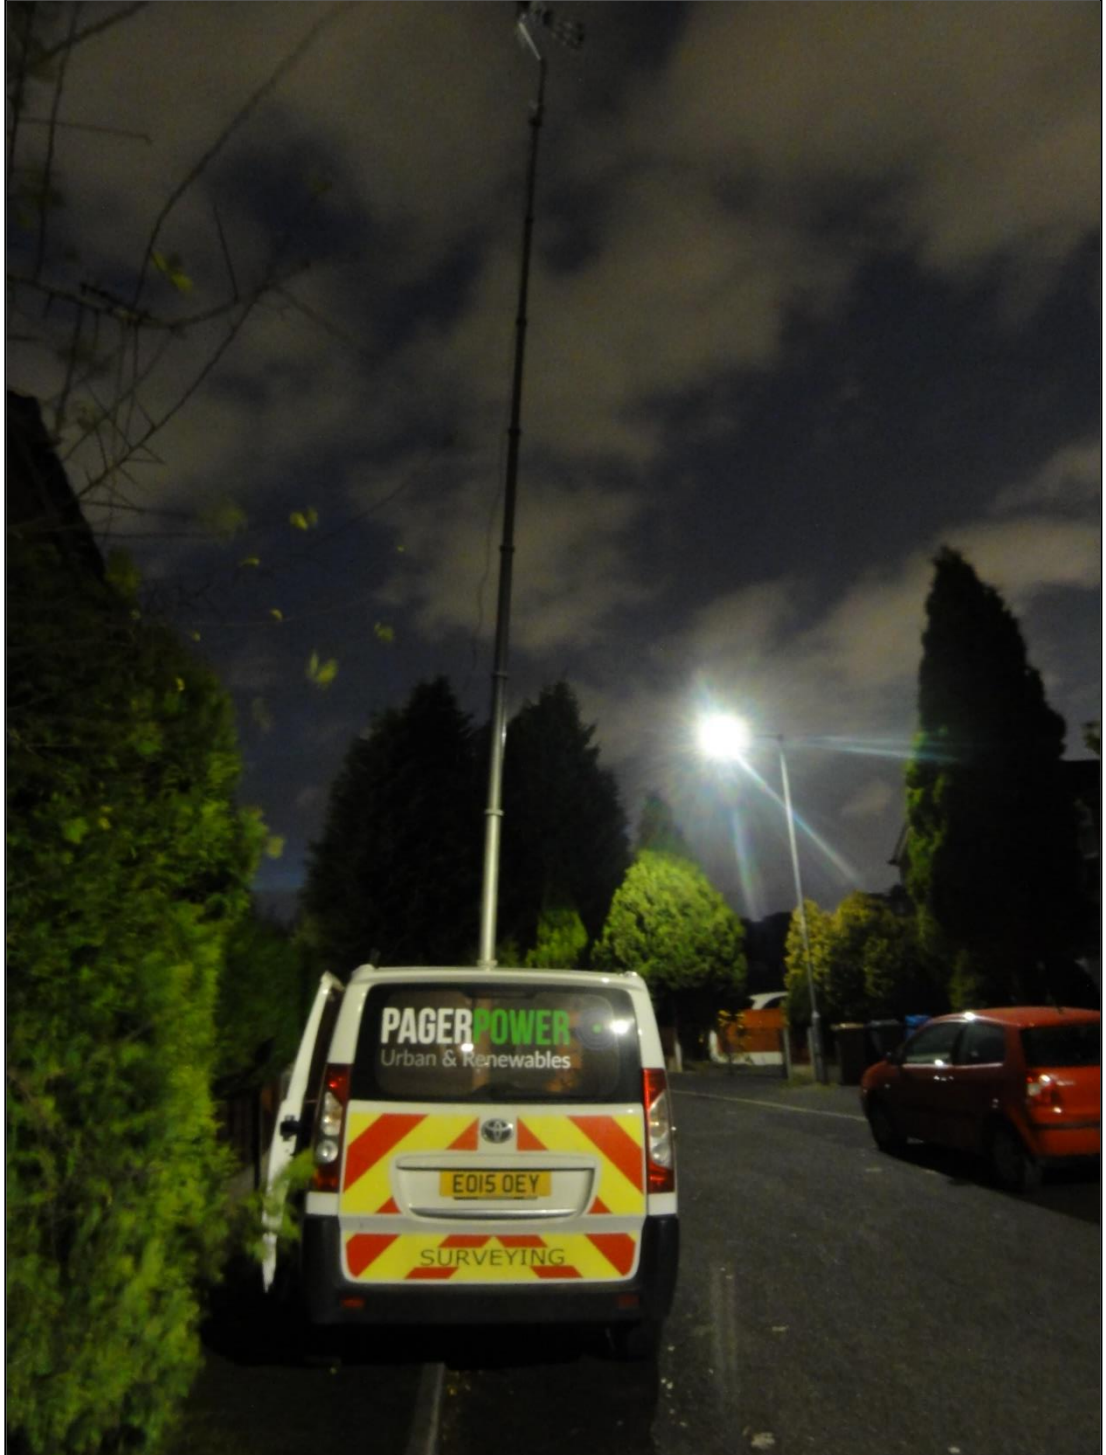
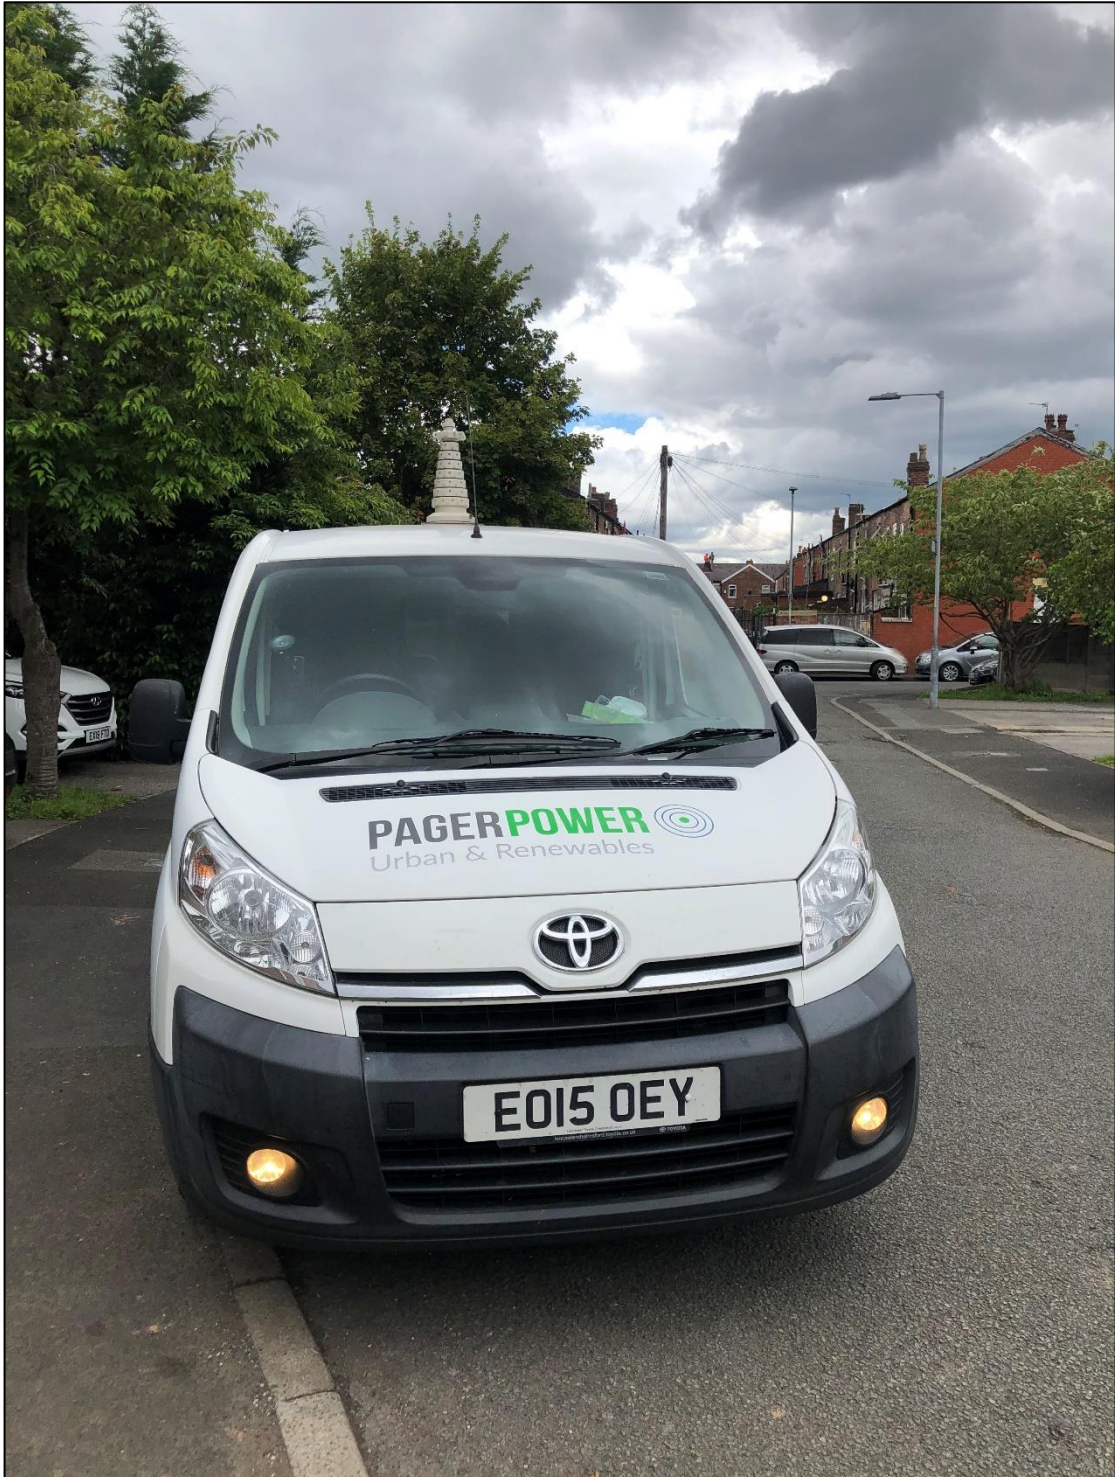
| Location | Average Measured Signal Strength (dB) | Remarks | Conclusions |
|---|---|---|---|
| 6 | <u>Baseline</u><br>Main TV MUX: 64<br>Local TV MUX: 48 | <p>Horizontally polarised aerials directed towards the Winter Hill transmitter and satellite dishes were observed.</p> <p><u>Baseline:</u> All main multiplexes displayed fine picture and audio quality, with signal fluctuations of less than 1dB and no signs of interference</p> | <p>The survey location was within 4.5km of the proposed development and within its shadow zone</p> <p><u>The reduction in TV signal strength at this location is not likely to be attributed to the Mulbury New Cross development. However, there is no change in picture or audio quality to channels that did decode. The reduction in local multiplexes is likely due to signal strength from weaker transmissions</u></p> |

Location 6 (baseline survey)

Location 6 (post-construction survey)
