## BS5837:2012 TREE SURVEY / Arboricultural Impact Assessment

Customer No: MBHDE05  
Document No: 800886  
24/03/2023

Site Address:  
FS963 - Fallowfield Service Station,  
Wilmslow Road, Manchester. M14 6AH

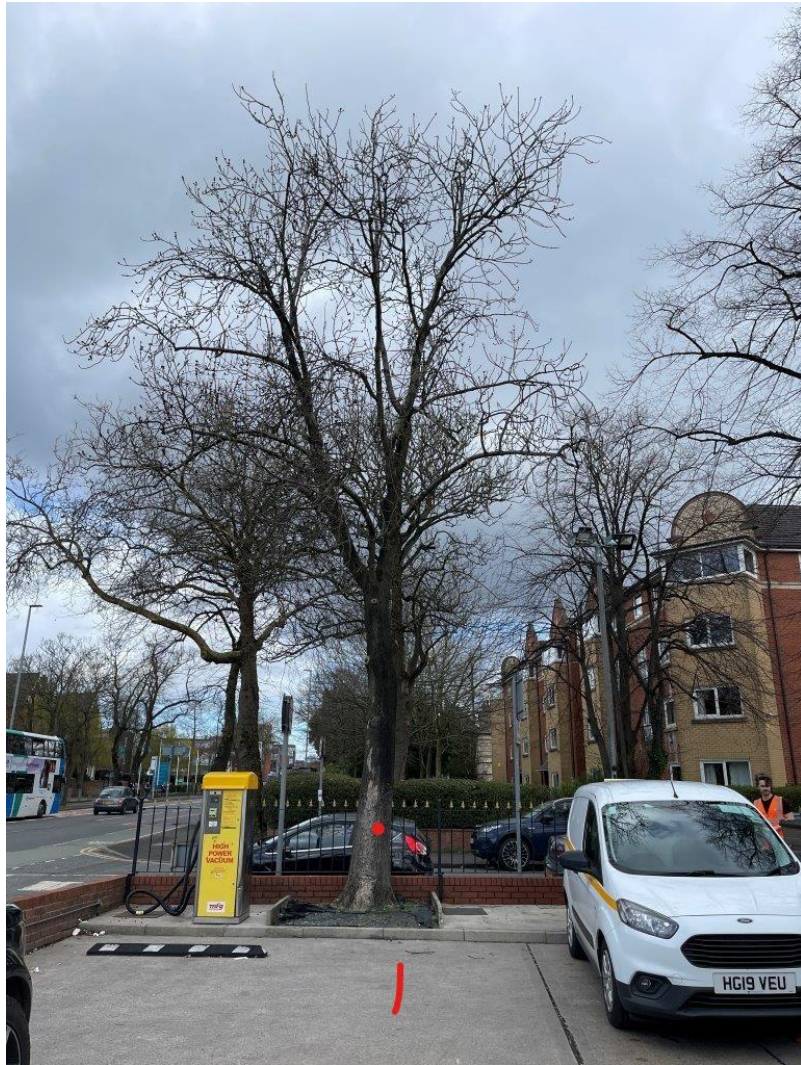
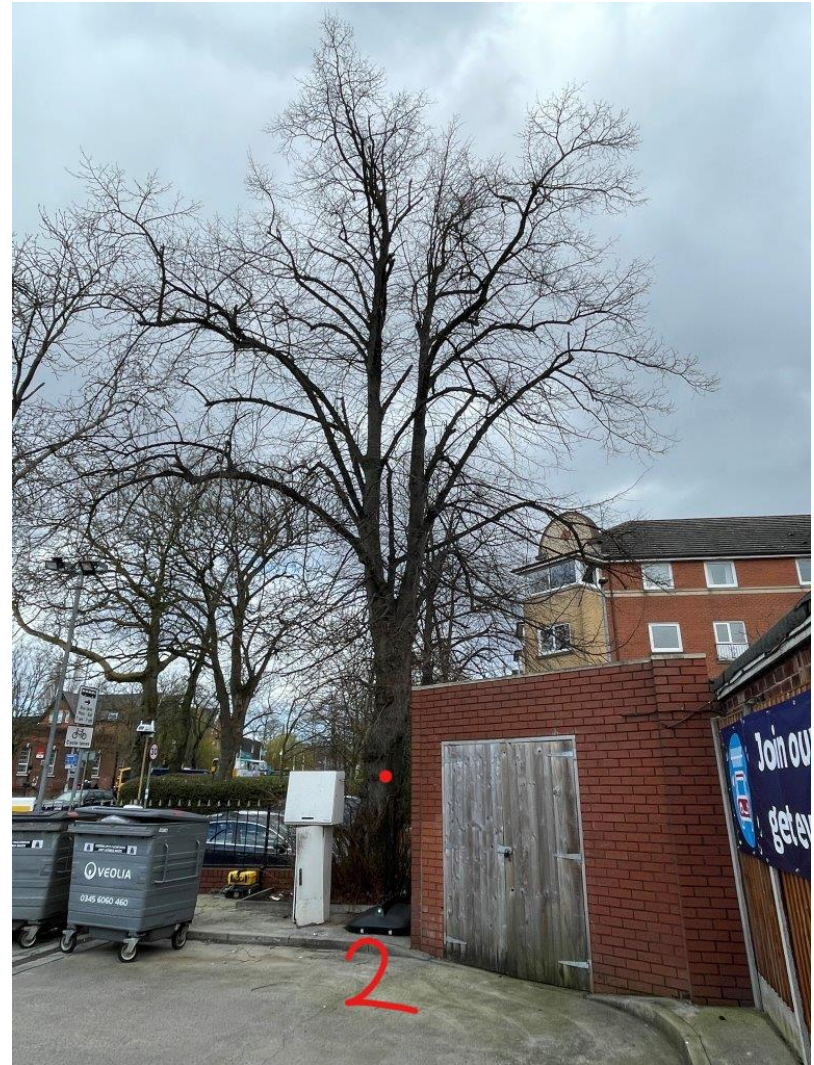
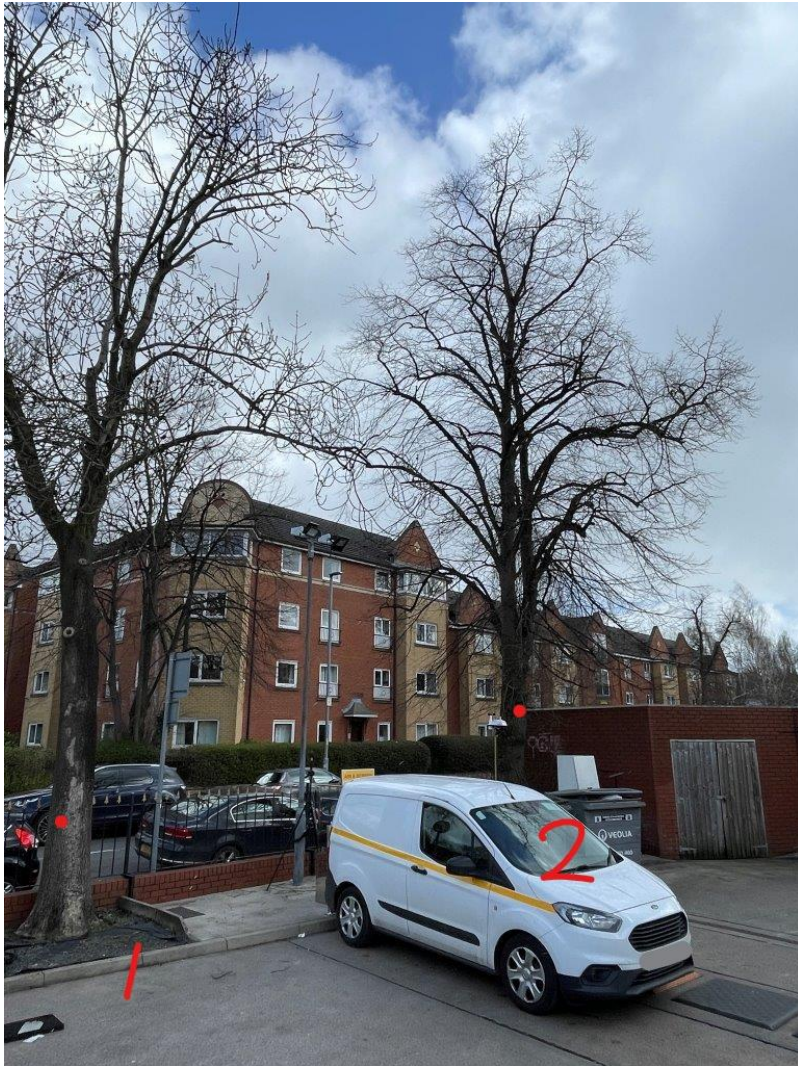
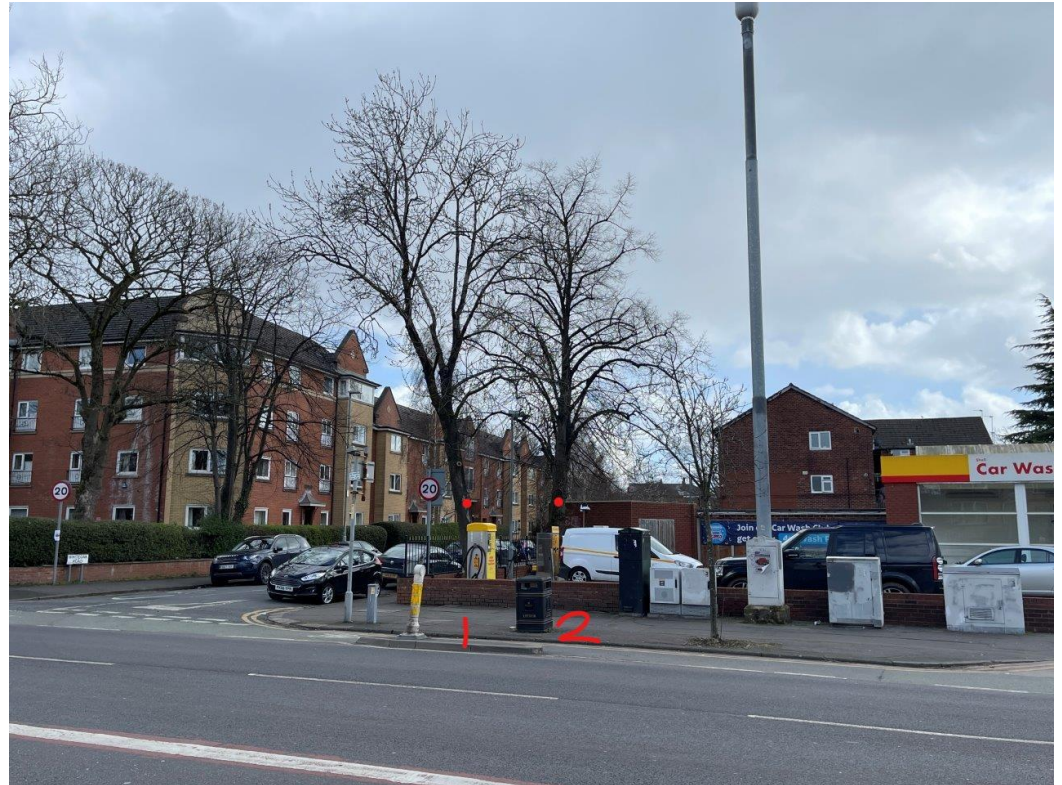
## Photos

T1 Ash tree displays evidence of past surgery to reduce the crown and remove lower branches. The tree appears healthy as observed from the ground, with, in particular, no current indication of Ash Dieback that is currently spreading through the Ash tree population in the UK.

T2 Lime is likewise a mature tree, several years ago, crown reduced. The typical epicormic growth (small branches at the base and on the trunk) is present. A scattering of deadwood is present, typical of the tree.

| Tree ID | Tree Type | Common Name | Maturity | Height (m) | Number of Stems | Stem (mm) | Spread N E S W (m) | Crown Height (m) | Crown | Stem | Basal Area | Category | Life Expectancy | Phys Condition | Comment |
|---|---|---|---|---|---|---|---|---|---|---|---|---|---|---|---|
| 1 | Ash | Common Ash | Mature | 13.5 | 1 | 445 | 5.4<br>3.2<br>2.9<br>4.7 | 3 | Good | Good | Good | B1 | 20 to 40 yrs | Good | Previously crown reduced, and crown lifted.<br>Small amounts of significant deadwood present. The trunk has a slight lean to the north, straightening out at approx 4.<br>A mature tree, with no signs as yet of the wave of Ash Dieback spreading across the country. |
| 2 | Lime | Common Lime | Mature | 16.5 | 1 | 650 | 5.8<br>5.8<br>5.8<br>5.8 | 3 | Good | Good | Good | B1 | 20 to 40 yrs | Good | Previously crown reduced and crown lifted. Now with significant epicormic growth at the base and to crown break. Typical amounts of significant deadwood within the crown. |

| Tree | Arboricultural Impact |
|---|---|
| T1 Ash and T2 Lime | <p>Remove both trees to enable the installation of the EV Charging Facility.</p> <p>Nearby mature trees will lessen the visual impact of the loss of the 2 trees.</p> |
