Preliminary Roost Assessment and Ecological Walkover

261 Wilmslow Road, Rusholme

Reference: 80-902-R1-1

Date: July 2023

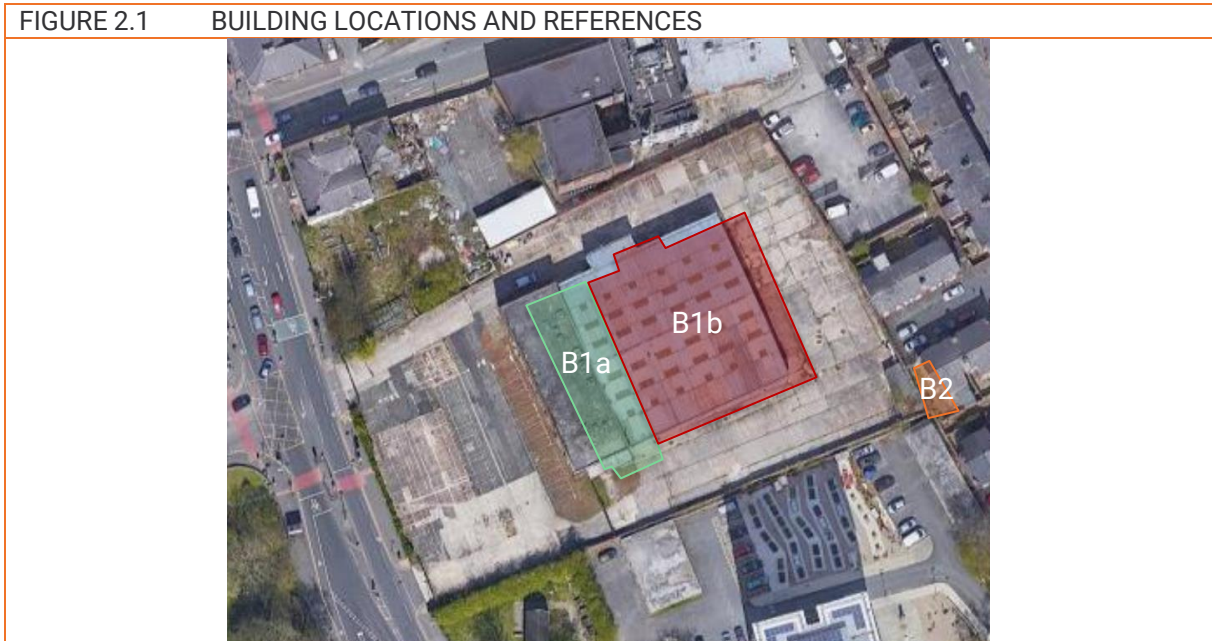
FIGURE 2.1 BUILDING LOCATIONS AND REFERENCES

A PRA was undertaken on the on-site buildings. No other structures or trees were present within the site boundary. Building 1 (B1) was a disused commercial building located in the centre of the site. The building was split into two sections; a brickwork section (B1a) and a corrugated metal section (B1b), both with flat roofs. An internal inspection of the building was completed during the survey. No loft void was present. Building 2 (B2) was a disused outhouse in the north-east corner of the site. The building was constructed from brick and had a flat roof.

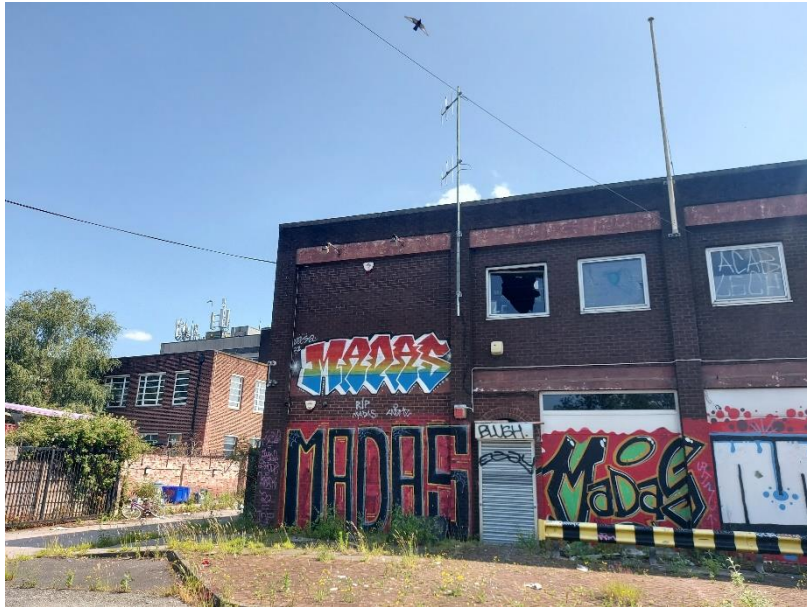
PLATE 1      SHOWING SOUTH WEST FACING ASPECT OF B1a

The brickwork was in good condition externally with no cracks or gaps that could support crevice dwelling bat species. The majority of the windows have been damaged/destroyed.

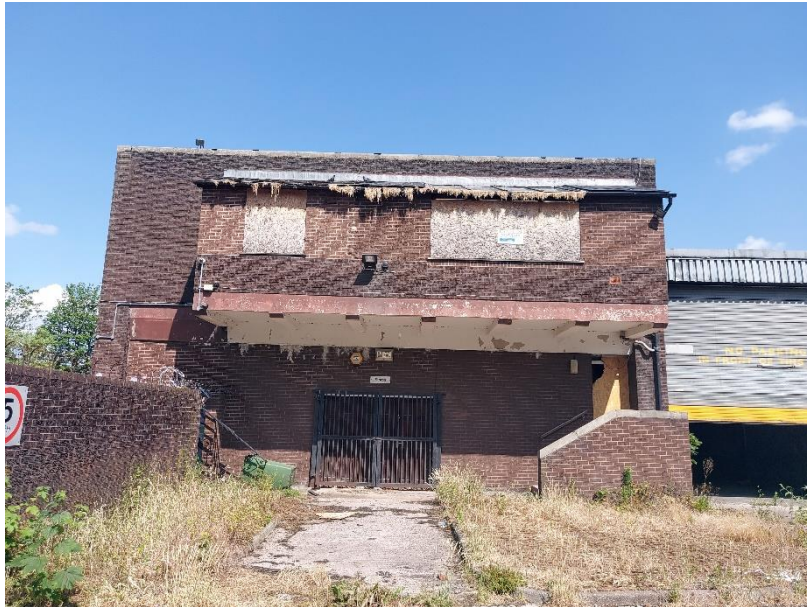
PLATE 3      SHOWING OUTCROP

An outcrop on the first floor was present on the southern side of B1a. The windows of the outcrop were boarded up, and there was an unidentifiable plant species growing out of the guttering. There was lifted lead flashing on the roof, and gaps on either side of the outcrop just below the roof and several lifted/damaged roof tiles were also present. These features may be used on an occasional basis by crevice-dwelling bats such as common and soprano pipistrelle.

Overall, B1a was assessed as having **Low** bat roosting potential due to the lifted lead flashing on the outcrop of the southern side of the building. B1a also has the potential to support nesting birds due to the flat roof.

B1 was assessed as having **Low** bat roosting potential. As such, one Nocturnal Bat Survey is required on the building between May and August (inclusive). If bats are identified roosting within the building, two more surveys would be required to characterise the roost, a European Protected Species Licence would also be required and would require up to date surveys from the survey season prior to the application submission.

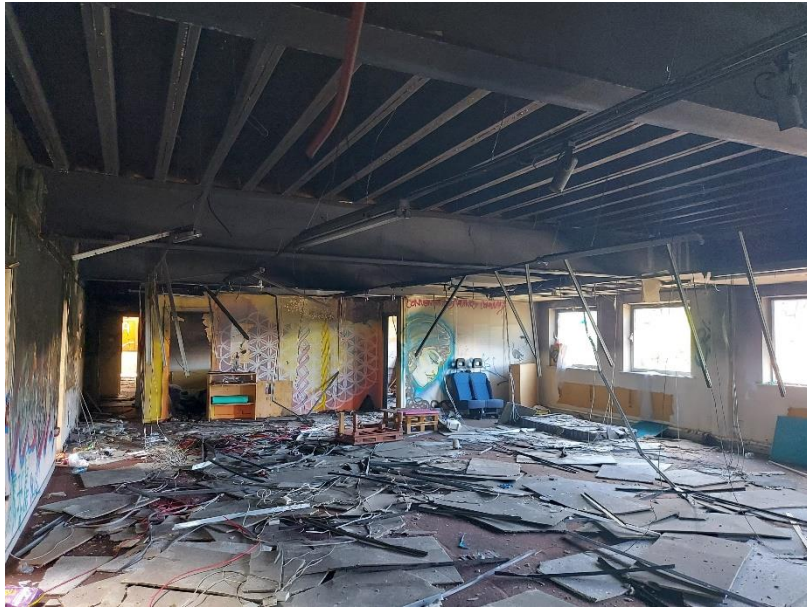
PLATE 5      SHOWING THE INTERNAL OF BUILDING B1A

An internal inspection of B1a was completed, and it was determined that there was no suitability for bats. There was access via the broken windows at the front of the building, however, this would cause a fluctuation in temperature. The ceiling was also made of concrete, and there were no potential roost features within the building that could be utilised by bats.

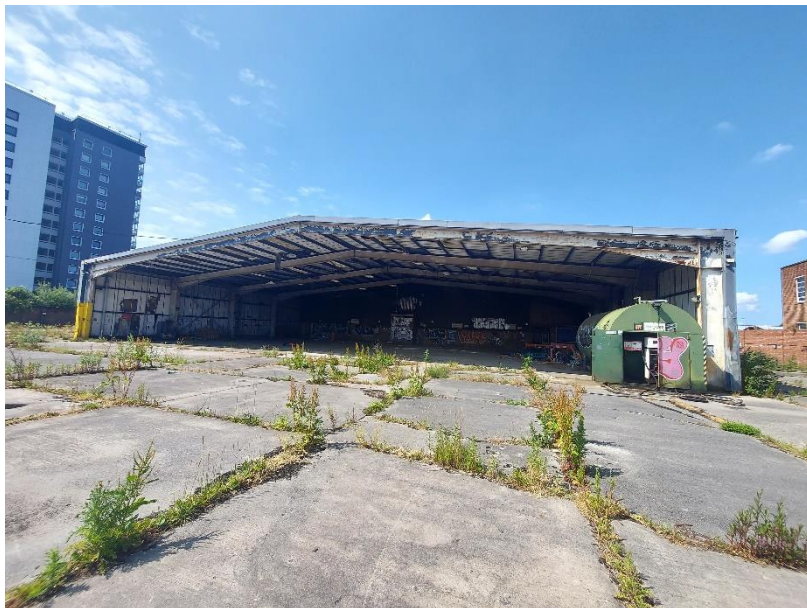
PLATE 6      SHOWING NORTH-EAST FACING ASPECT

The north-east facing aspect of the building was completely open and therefore would not be able to support bats due to a lack of suitable roost features, as well as fluctuations in temperature.

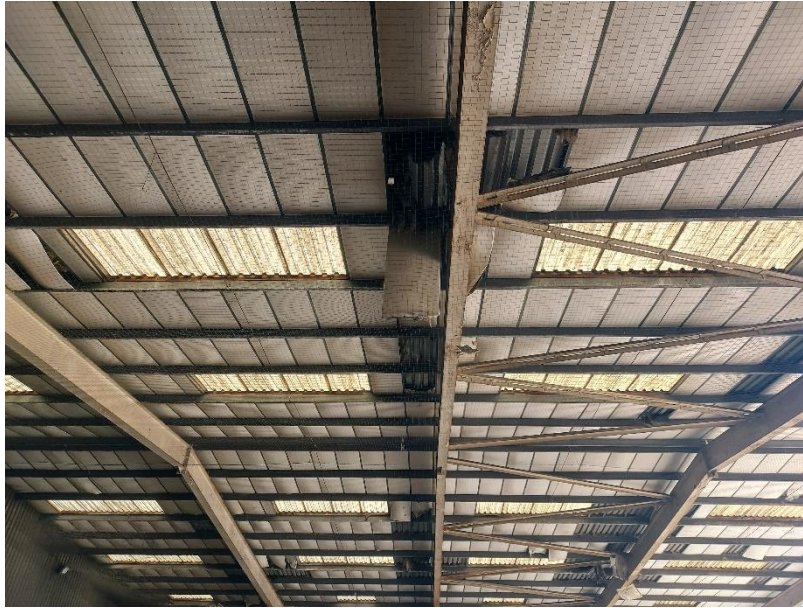
PLATE 7      SHOWING INTERNAL BIRD NETTING

There was bird netting on the internal ceiling, which would prevent any birds from nesting on the ceiling joints.

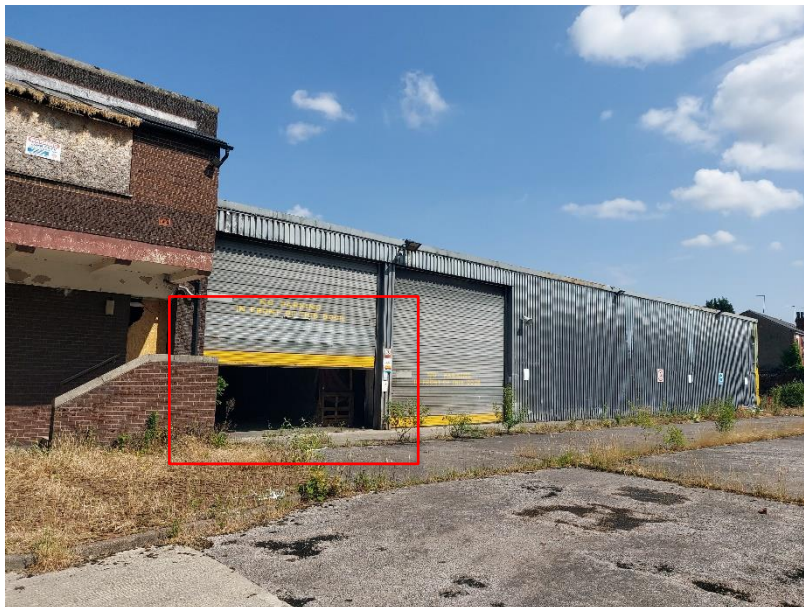
PLATE 8      SHOWING OPEN SHUTTER DOOR

One of the shutter doors on the south-east facing aspect of the building was open, which allowed access internally.

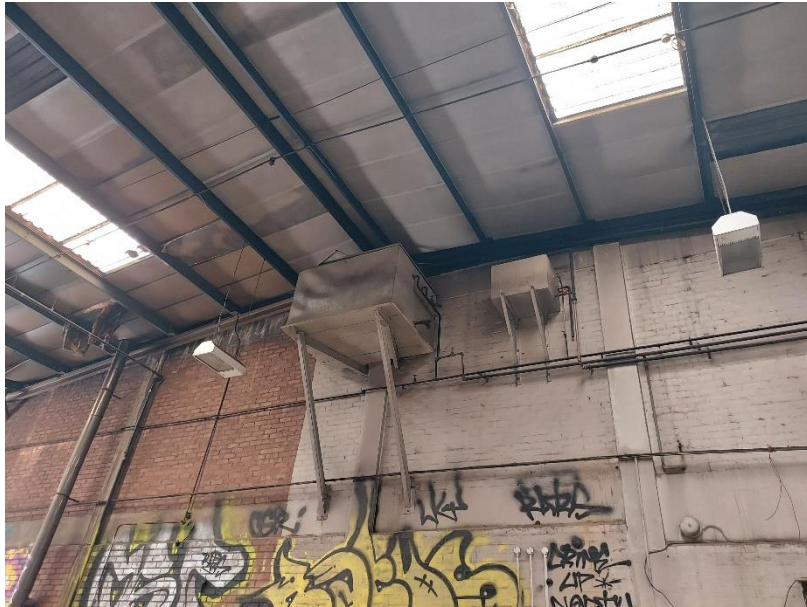
PLATE 9      SHOWING UNITS

There were several units attached to the internal wall which could be utilised by birds for nesting.

It is recommended that any demolition works or vegetation removal take place outside of the breeding bird season (March–September inclusive). However, if this is not possible, then a suitably qualified ecologist should inspect the area no more than 24 hours for nesting birds prior to works or vegetation removal. Should any nests, or nests in construction be located, a suitable stand-off distance should be maintained until the young have fledged. The ecologist will advise on suitable stand off and provide a toolbox talk to all site contractors regarding their working limits and legal implications.

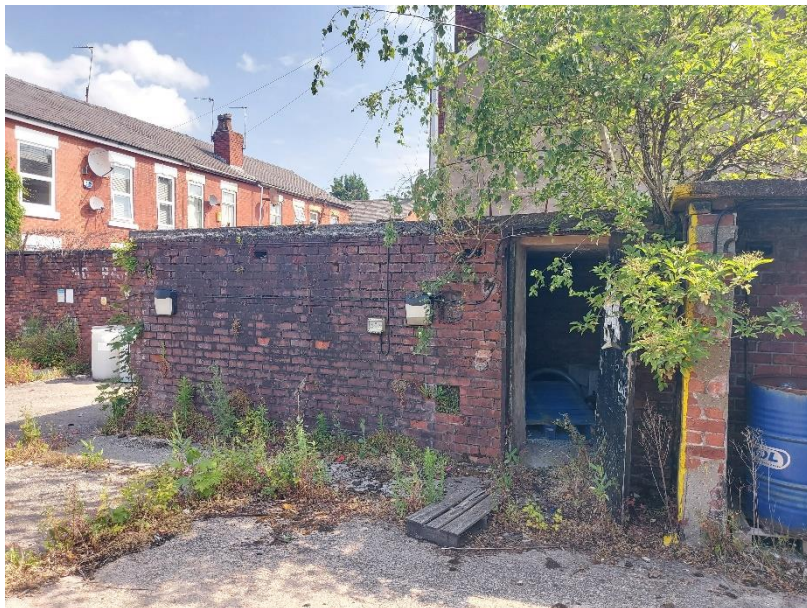
PLATE 10      SHOWING SOUTH-WEST FACING ASPECT

The brickwork was in good condition with no cracks or gaps that could support crevice dwelling bat species. There were no windows present, and the only door into the building was ajar.

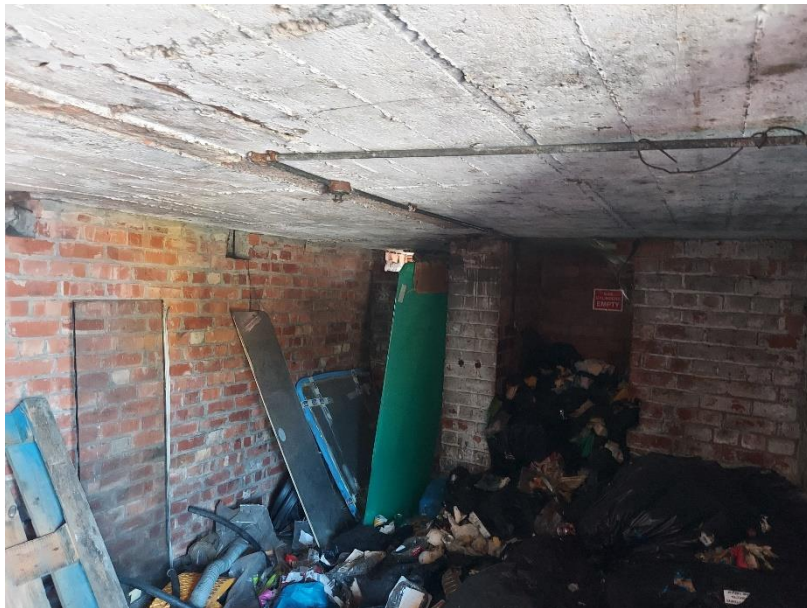
PLATE 11      SHOWING BUILDING INTERNALS

There was no evidence of roosting bats within the building. There were also several access points on the north-west and south-east facing walls.

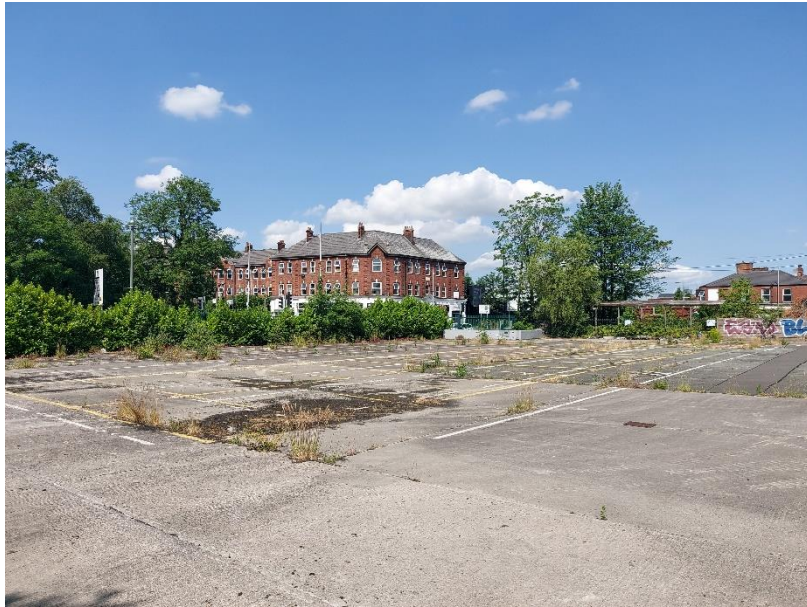
PLATE 12      SHOWING HARDSTANDING

A large portion of the site was comprised of hardstanding. The hardstanding had been left unmanaged and colonised in large areas by flora comprising broad-leaved dock (*Rumex obtusifolius*), common ragwort (*Jacobaea vulgaris*), sycamore saplings (*Acer pseudoplatanus*), creeping thistle (*Cirsium arvense*), butterfly-bush (*Buddleja davidii*), and wood avens (*Geum urbanum*).

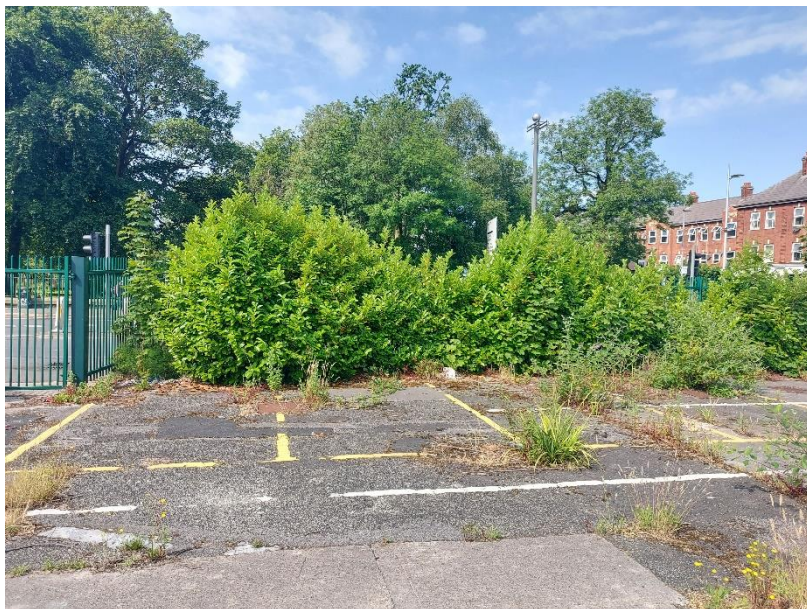
PLATE 13      SHOWING HEDGEROW

A hedgerow was present on the western border of the site boundary. Species comprised cherry laurel (*Prunus laurocerasus*), sycamore, and butterfly-bush. Cherry laurel is an invasive non-native species.

Cherry laurel was identified during the site walkover. As such, it is recommended that prior to development this species is eradicated following the most current guidance set out by the Environment Agency, to be carried out by a qualified contractor.
