# VARLEY STREET MANCHESTER

## FINAL ADDITIONAL SITE INVESTIGATION AND UPDATED REMEDIATION STRATEGY

**Job Number:** LKC 22 1670  
**Date:** September 2023  
**Client:** ISG Ltd

| <b>LK Consult</b> | | | |
|---|---|---|---|
| <b>Report Title</b> | Final Additional Site Investigation and Updated Remediation Strategy | | |

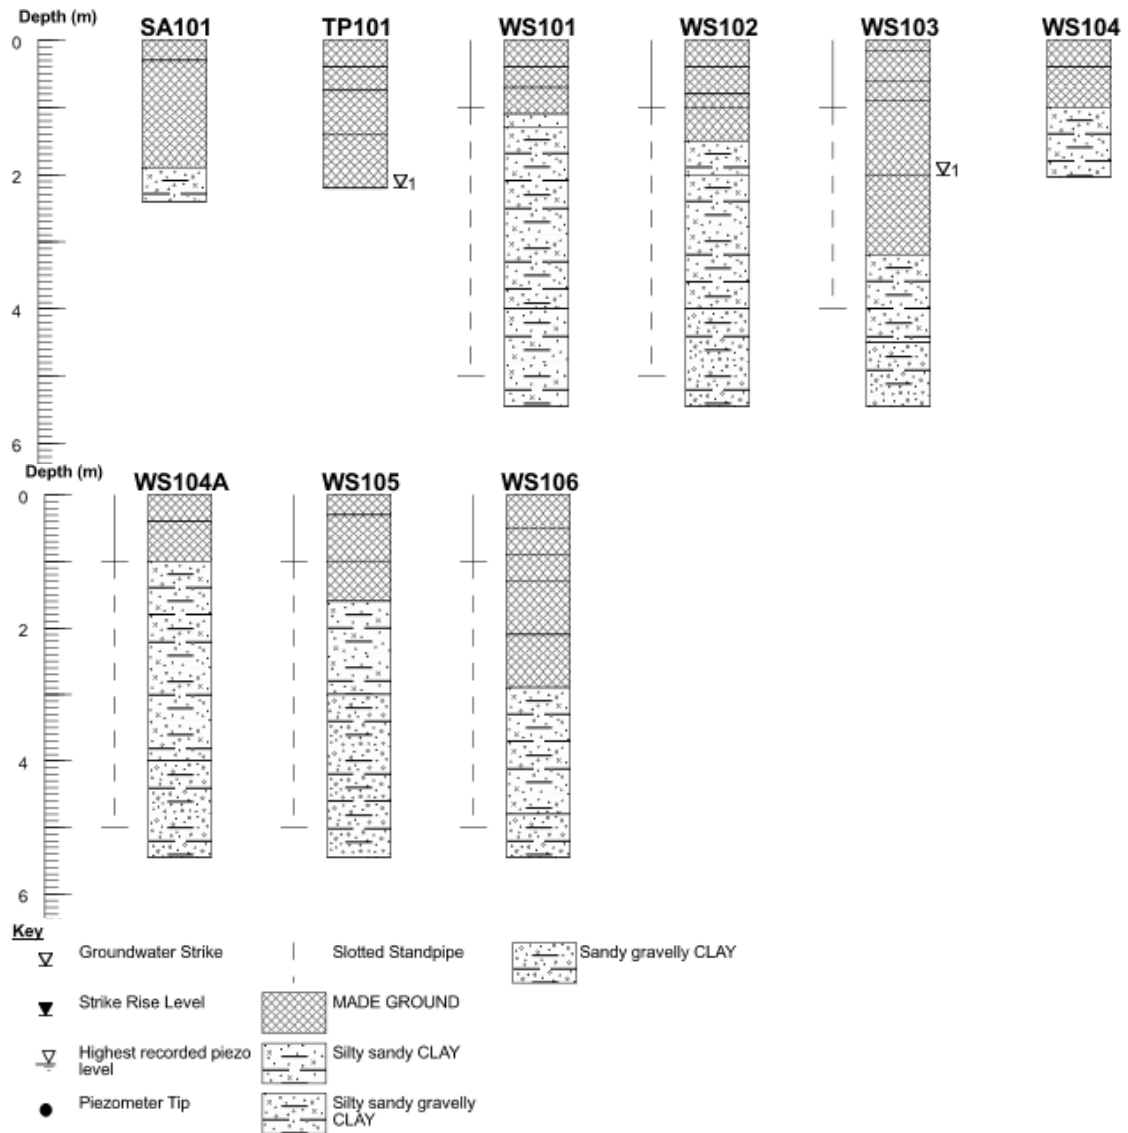
Plate 4-1: Summary of ground conditions.

The ground conditions beneath the site comprised made ground underlain by variably gravelly sandy clay. A summary section of the logs is provided in Plate 4-1, with additional comments below.

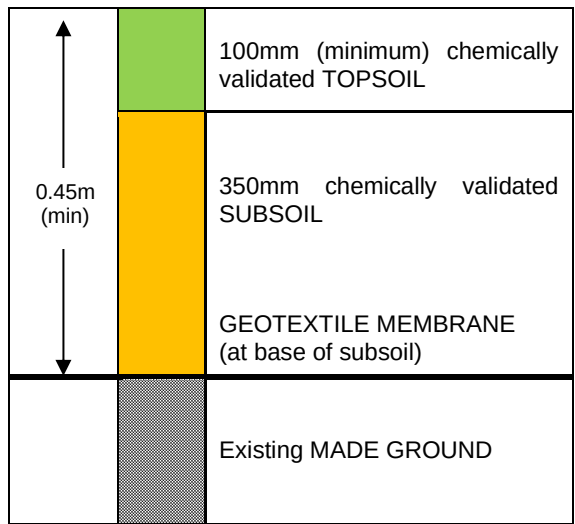
Plate 6-1: Typical Environmental Cover System Construction.

- **450mm thick environmental cover system comprising:** geotextile membrane and at least 450mm comprising clean inert fill and sufficient topsoil for a growing medium.

A diagram of a typical environmental cover system is shown in Plate 6-1 below.

**Notes:** Subsoil can be replaced with additional topsoil.  
Hardstood areas– No Remediation Required.

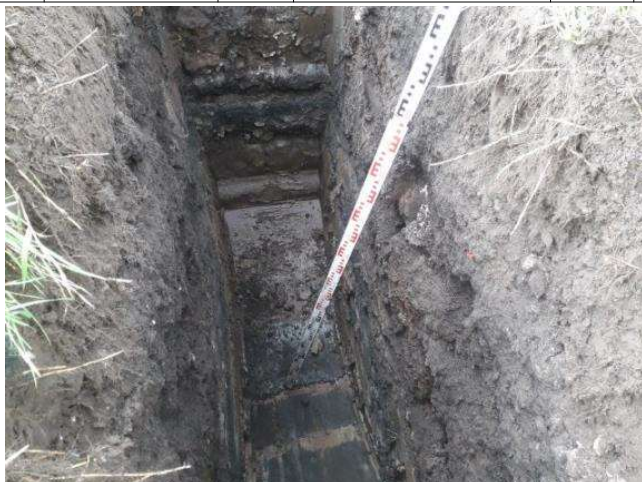
Pit dry and stable.  
Soakaway test undertaken in pit, refer to separate output sheet (ref. SA101).

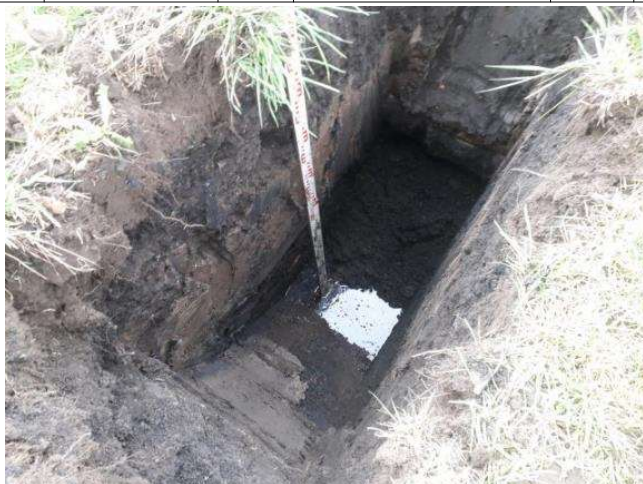
Soakaway pit not undertaken due to depth of made ground encountered, and due to refusal on dense made ground at 2.20mbgl. Pit relocated (ref. SA101). Perched water slowly seeping into base of pit at 2.20mbgl. Strata between 1.40-2.20mbgl is damp.
