## Archaeological Evaluation Report

Daisy Bank Mill,  
Terence Street,  
Newton Heath,  
Manchester

**Project:** Terence Street Archaeological Evaluation

**Document Type:** Evaluation Report

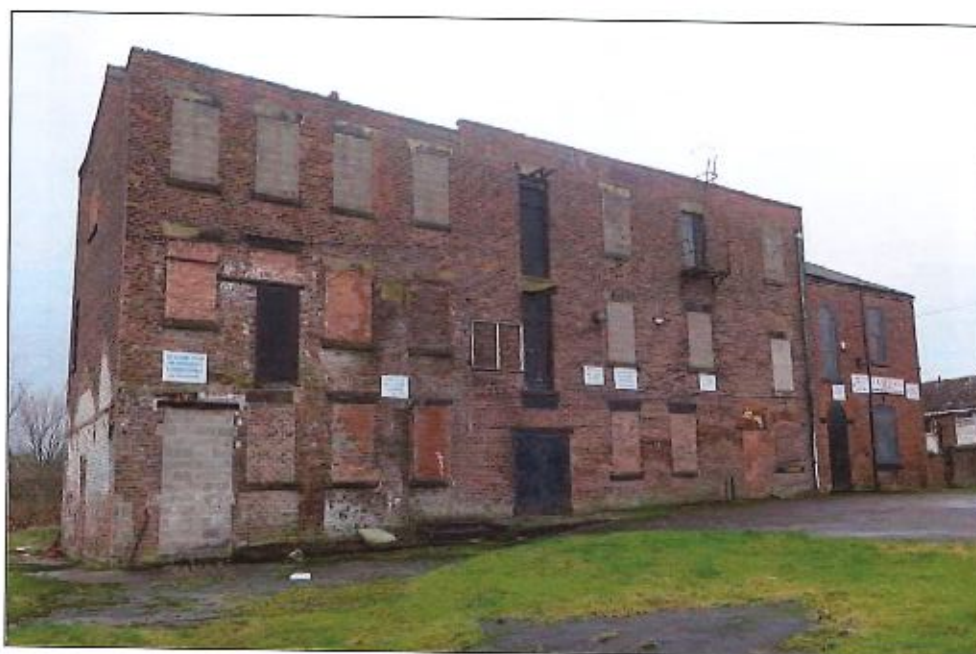
*Figure 4. Central warehouse block demolished in 2019 as seen in 2017.*

In 2017, a rapid survey was undertaken of Daisy Bank Mill for the Greater Manchester's Historical Textile Mills Survey (Miller & Reader 2017). The photograph below were taken during this survey and show the condition of the last upstanding remains of the mill prior to demolition in 2019.

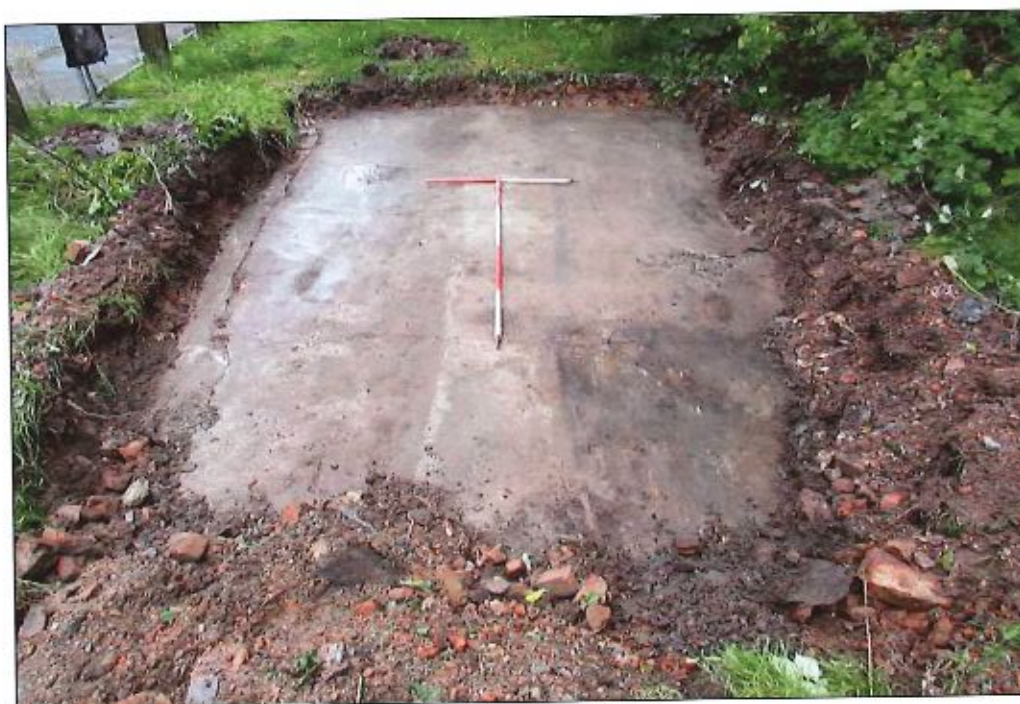
Following the removal of the overburden and subsoil a well preserved concrete floor 059 was revealed to lie at a depth of c.0.30m (Fig. 5). No features or distinguishing marks could be seen on this surface and it was thought to be related to the later 20<sup>th</sup> century occupation of the mill. As a result, it was decided to remove the concrete to assess the possibility of earlier features below.

*Figure 5. Concrete surface 059, prior to removal. Looking east.*

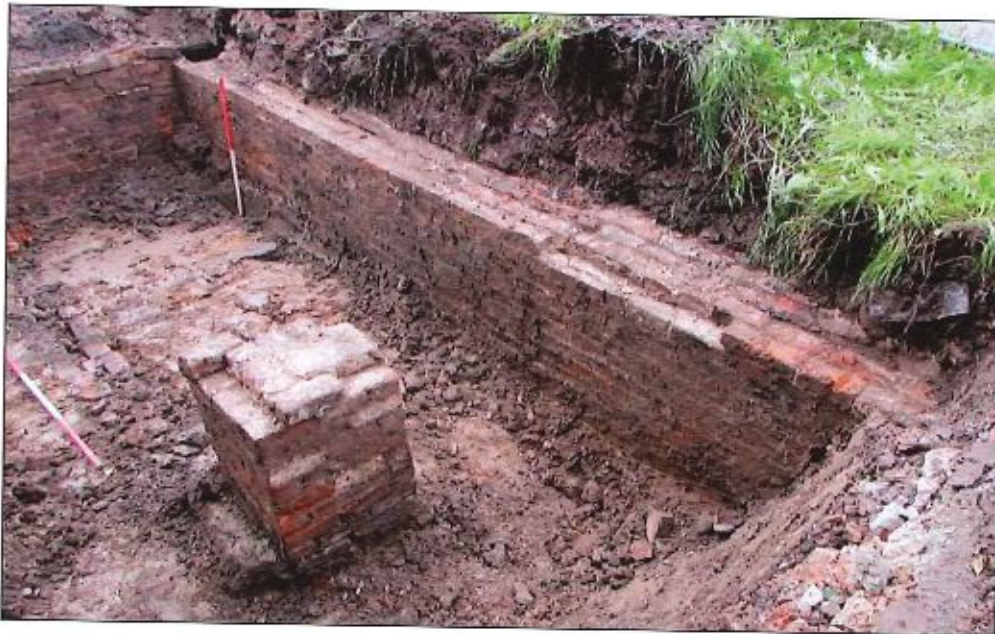
A handmade brick wall was identified running along the northern edge of the trench 021, which measured 5.80m in length with 0.30m projecting from the trench edge. The wall was found to have a stepped top which formed the roof of a vaulted channel within, which could be seen through a hole in the brickwork at the western end of the feature (Fig. 7). Externally, the wall stood to a height of 0.93m (11 courses) and was bonded in English Garden Wall bond with a white lime mortar (Fig. 6). Internally, the channel appeared to have been constructed from firebrick, again with a white lime mortar.

*Figure 6. Trench 1 showing wall 021 running along the northern edge. Looking north.*

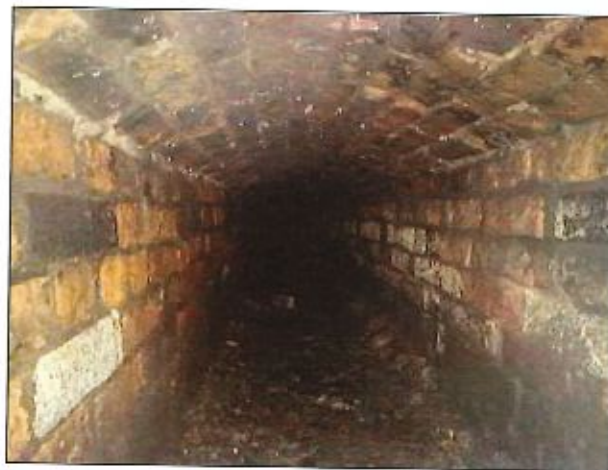
*Figure 7. View inside the vaulted channel to the north of wall 021. Looking west.*

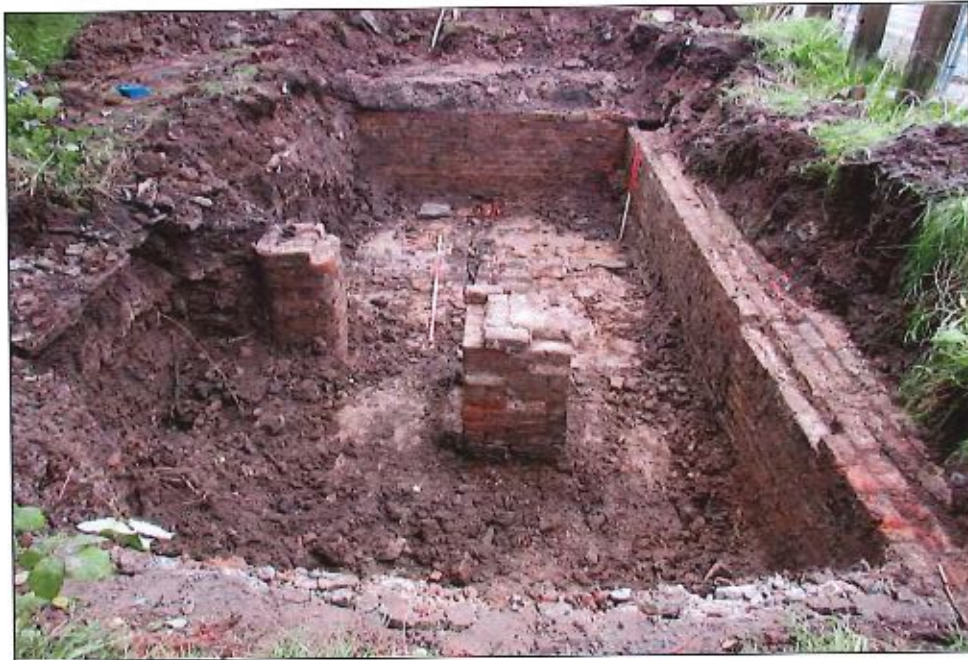
Wall 021 was abutted to the south by a second handmade brick wall 024, which continued southwards beyond the edge of the trench. The wall measured 4.60m x 0.24m and stood to a height of 1.02m (12 courses), constructed with white lime mortar in English Garden Wall bond (Fig. 8). lying between these walls in the centre of the trench

**Figure 8.** Trench 1 showing 022 and 023 in the centre of the trench and 024 in the background. Looking west.

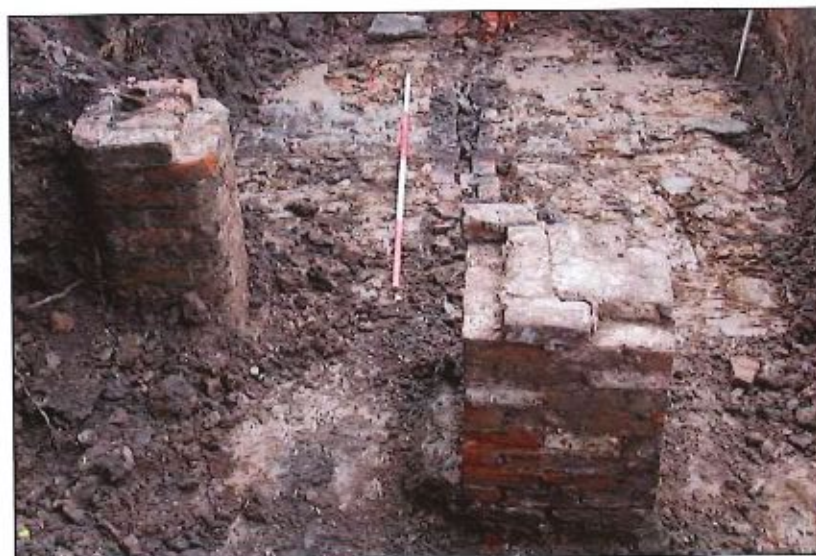
were two handmade brick columns, 022 to the north and 023 to the south (Fig. 9). Column 022 lay 0.90m south of 021 and was constructed from 9 courses of handmade brick bonded with white lime mortar. The column measured 0.60m x 0.60m and stood to a height of 0.74m with the lowest course of brick lying on a stone plinth c.0.09m thick. The second column 023 lay 0.90m to the southwest of 022 and was of a different construction, using bull-nose bricks in the upper 9 courses to create rounded corners (Fig. 9). The column measured 0.49m x 0.49m and was excavated to a height of 0.90m, although the lowest course was not revealed at this depth. Unlike 022, 023 had square

**Figure 9.** Detailed view of 022 and 023, with 025 in the background. Looking west.

brick foundations with no visible evidence of a plinth although, this may have been present at a lower level. The only other feature identified within Trench 1 was a small handmade brick culvert 025, running between the south-western corner of 022 and 024 (Fig. 9). This comprised 2 courses of bricks, laid on edge with a line of stone flag capping, although much of this was missing or badly damaged.

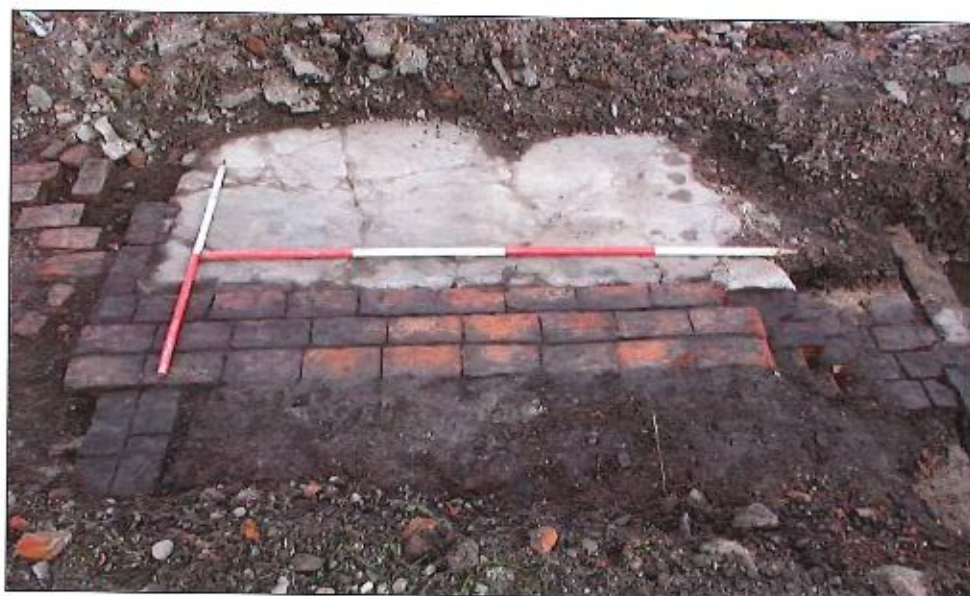
At the eastern end of the trench lay a 3 course wide brick wall running east-west 027 (Fig. 10). The wall was constructed from machine made bricks bonded with black mortar and measured 2.95m x 0.40m, exposed to a height of 0.30m (3 courses) and had a single course return of 2 bricks running northwards from its east end. To the west, the upper courses of 027 had been truncated and a lead pipe could be seen extending from the lowest course. The wall enclosed a concrete surface 026, which had been truncated to the east. At its western end 027 was abutted by 052, a 2 course machine made brick wall also bonded with black mortar, which measured 0.23m x 0.40m and continued beyond the trench edge to the south. Walls 027 and 052 were abutted by a compacted black surface 028, which comprised a high concentration of black mortar with occasional fragments of brick and clinker.

**Figure 10.** Western end of Trench 2 showing walls 027 and 052 and surfaces 026 and 028. Looking north.

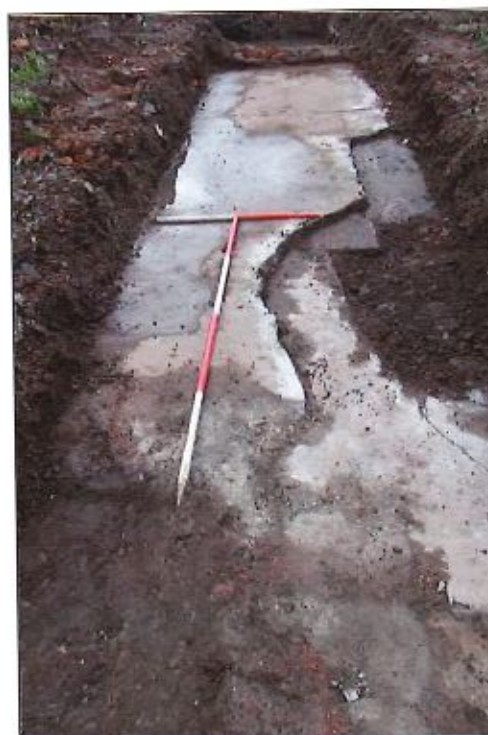
To the east of these features lay a large concrete surface 060 (Fig. 11). On excavation it was found to comprise three distinct layers of concrete that overlay a mixed demolition deposit 063 directly below. This deposit was found to cover several earlier handmade brick features in varying states of preservation (Fig. 12).

**Figure 11.** Concrete surface 060 in Trench 2. Looking west.

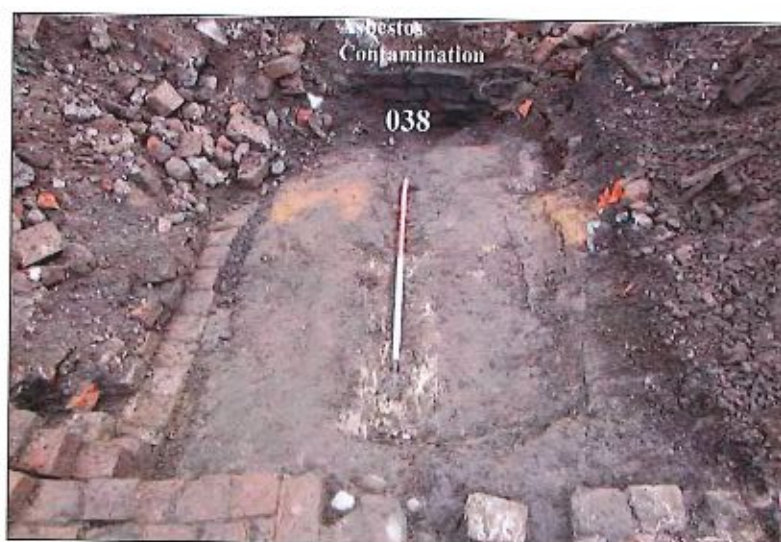
**Figure 13.** Walls 035, 037 and 038 showing the location of the inserted pipe to the south. Looking east.

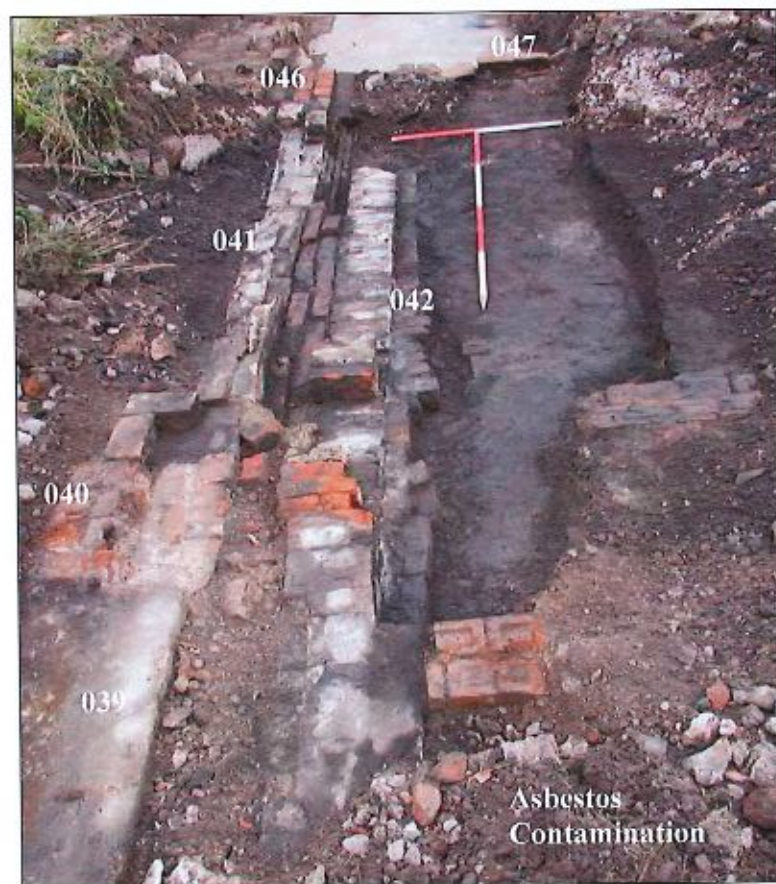
Excavation continued to the east where a number of linear features were uncovered which utilised significant quantities of firebrick (Fig. 14). On the northern edge of the trench, a small section of concrete floor 039 was revealed which was likely to have been associated with 063. This was abutted by a handmade brick feature 040 measuring 0.50m x 0.40m with bull-nose bricks forming the south-western corner and bonded with white lime mortar. The eastern side of this feature was abutted by the northern end of 041. This linear feature was constructed from firebrick and ran for 3.35m east-west along the northern side of the trench. The feature was 0.23m (2 courses) wide and was bonded using a hard dark grey mortar. At the point of its abutment with 040 it appeared to widen to 0.34m. A single larger firebrick block measuring 0.70m x 0.10m was uncovered at the western end of 041 which stood 0.15m taller than the upper course of the wall and revealed areas of black staining on its southern face (Fig.15).

**Figure 14.** Firebrick features at the eastern end of Trench 2, showing contexts 040-046. Looking east.

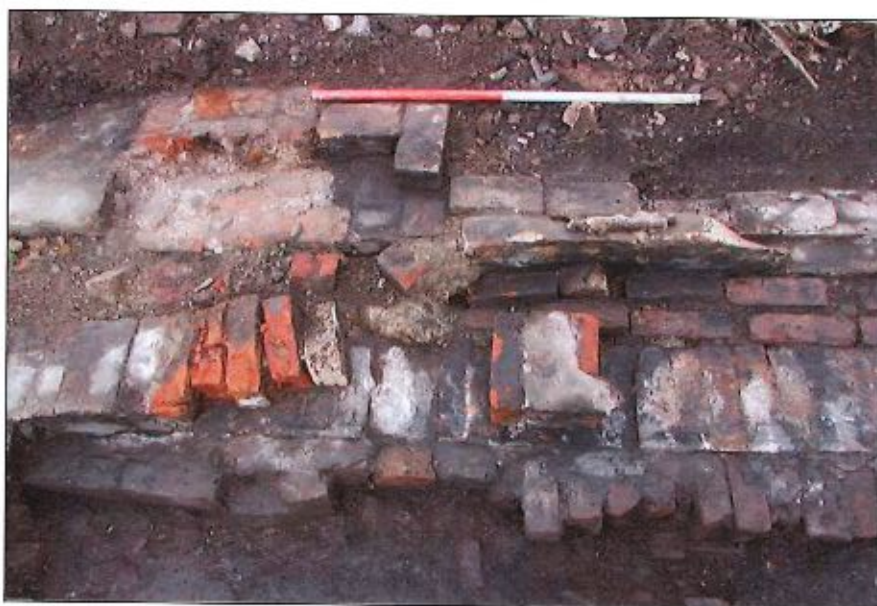
A second wall 042, running parallel to 041 was revealed 0.20m to the south of it. This wall was constructed of a row of randomly mixed fire and handmade brick. Wall 042 was 4.10m x 0.23m and was bonded using the same dark grey mortar as 041. In the west, it emerged from the area of asbestos contamination and ran to a point 1.50m west of 047. It appeared that the section which would have joined the two walls has been removed and asbestos cement pipes inserted to the east. Between the western ends of 041 and 042, two roughly laid courses of handmaid brick, laid on edge 043, were revealed, measuring 1.50m x 0.20m. The bricks had evidence of black staining on their surface and were set within a friable yellow mortar with occasional fragments of narrow (0.02m dia.) iron pipe. These bricks were found to cover 2 cast iron channels 053, lying side by side in the space between 041 and 042 (Fig.16). The channels appeared to continue eastwards below 046, however a further deposit of asbestos cement made this difficult to confirm.

**Figure 15.** Detailed view of contexts 040-043 and 054, showing larger firebrick in the centre. Looking north.

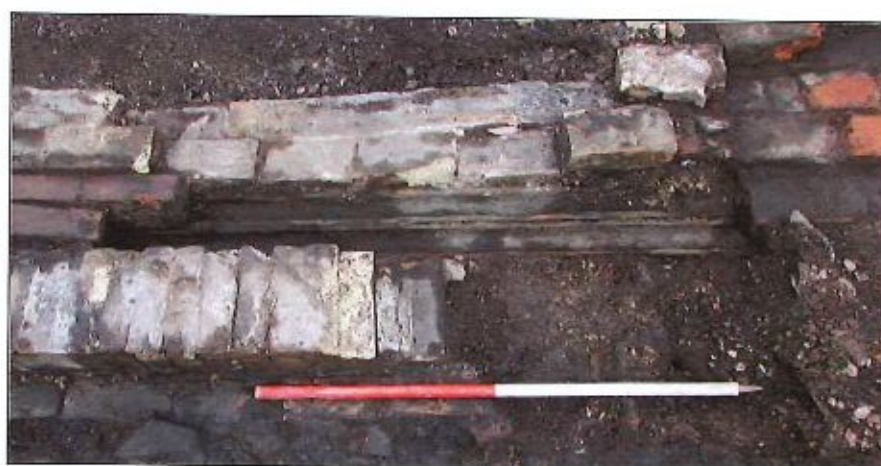
**Figure 16.** Detailed view of walls 041 and 042 showing channels 053 between. Looking north.

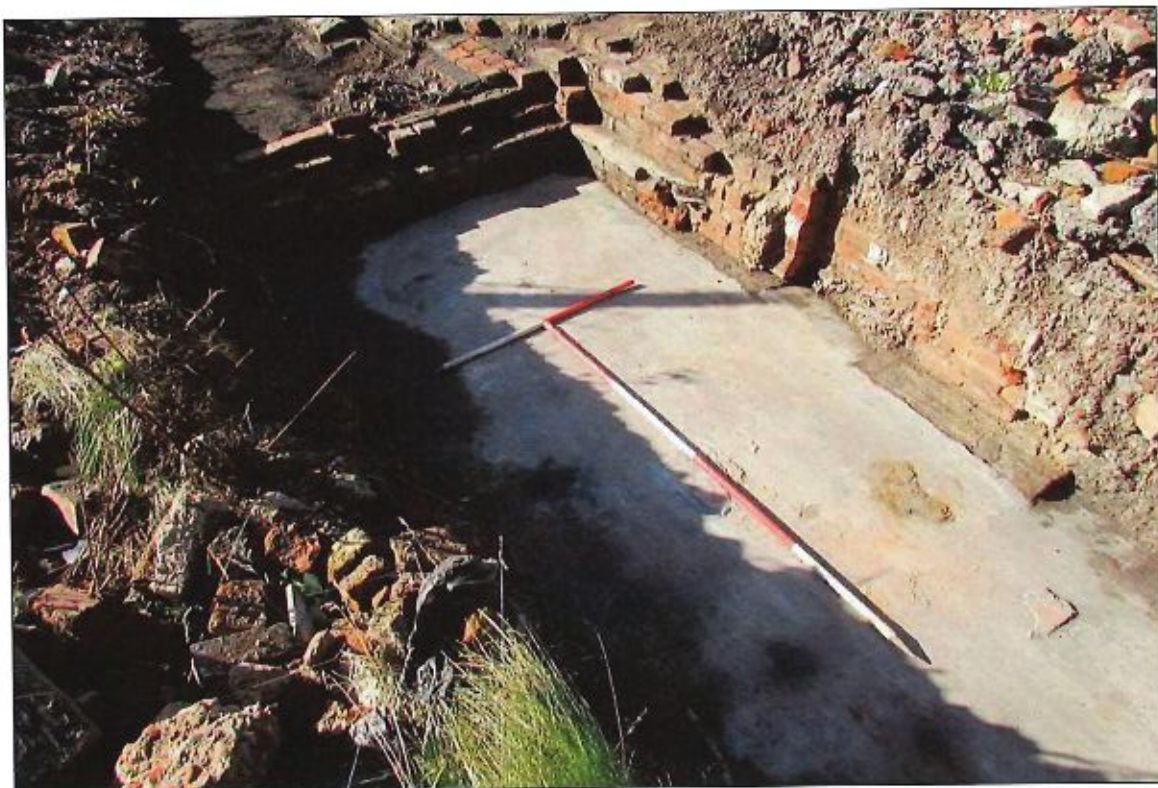
A handmade brick wall 046 was revealed abutting the eastern end of 041, which ran east-west for 0.75m and lay 3 courses wide. The similarity of the mortar on this wall and 041 suggests that they were both part of the same structure. This wall was abutted to the east by a north-south orientated handmade brick wall 047, which continued beyond the trench edge in both directions. Wall 047 was excavated on its east side to a height of 0.50m where, at the base, it was abutted by a lower concrete floor surface 051 (Fig. 17). To the north, this surface was also abutted by another handmade brick wall 048, which stood to a height of c.0.55m (6 courses) with a stone ledge inserted between the second and third courses. The ledge projected 0.12m from the southern face of the wall and measured 1.00m in length and 0.05m thick. No evidence of additional ledges further up the wall indicated that this was unlikely to be part of a set of steps. Wall 048 was truncated to the east by a 0.15m thick layer of concrete which adhered to a single course machine made brick wall bonded with a hard, bright white mortar 064. This wall appeared to cut wall 049, a possible continuation of 048, comprised of handmade brick laid 5 courses high (0.40m) with white lime mortar. The main part of the wall was set back from the line of 048 by 0.20m to the north with a return to the east to form a shallow niche abutted by 051. Two courses of handmade bricks running east-west, 050, were revealed abutting the return of 049 and were also abutted by 051, suggesting this was a standing wall that had been removed to floor level.

**Figure 17.** Eastern end of Trench 2, showing floor 051 and walls 048-050 and 064. Looking west.

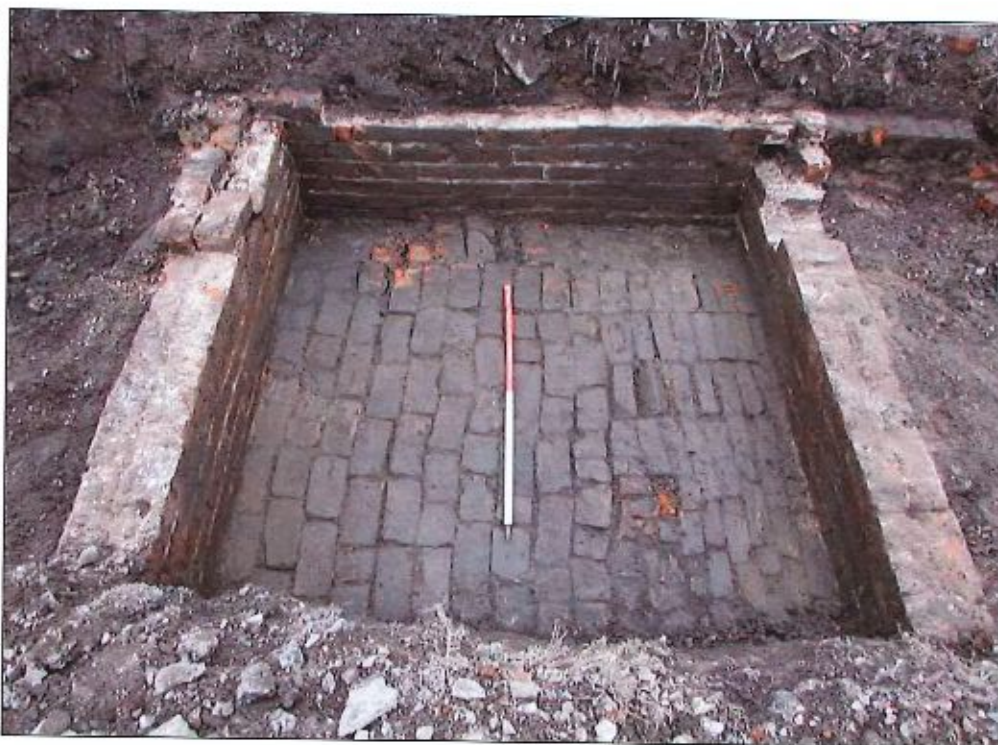
Following the removal of the overburden and concrete debris found in this area, several handmade brick features were revealed (Figs. 18-20) which lay below a demolition deposit 008, containing fragments of brick, stone mortar and concrete. The first of these was an east-west orientated wall, 009, running along the north facing section of the trench. The wall measured 5.50m long and stood to a height of c.0.45m high (5 courses), bonded with a pinkish-white lime mortar. Wall 009 was abutted 3.00m from its west end by another handmade brick wall, 010, which ran north-south and continued beyond the northern trench edge. The wall measured 2.00m x 0.24m x 0.54m (6 courses) high and was laid in stretcher bond with white lime mortar. A second, almost identical wall, 012, was identified 2.05m east of 010 which also ran north-south and had the same dimensions and construction. These walls enclosed a 2.00m x 2.00m handmade brick floor 011, comprising bricks laid north-south in rows. It was from the lowest level of the demolition deposit over this floor that the only find from the evaluation was made, a 19<sup>th</sup> century Hartley's creamware jam pot (Fig.19).

**Figure 18.** Brick floor 011 surrounded by walls 012, 009 and 010 to the left, centre and right, respectively. Looking south.

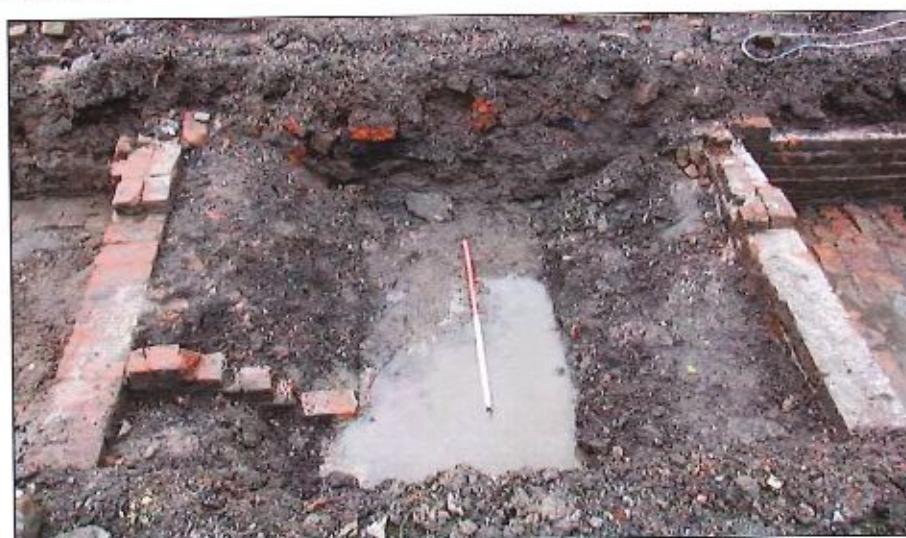
An extensive deposit of clinker, 013, was revealed against the eastern face of 012, which following the excavation of a sondage through it, was found to form a 0.40m deep deposit above the natural clay (Fig. 20). This deposit also lay against a third, 2 course

**Figure 20.** Clinker deposit 013 between walls 014 and 012 with 015 in the centre. Looking south.

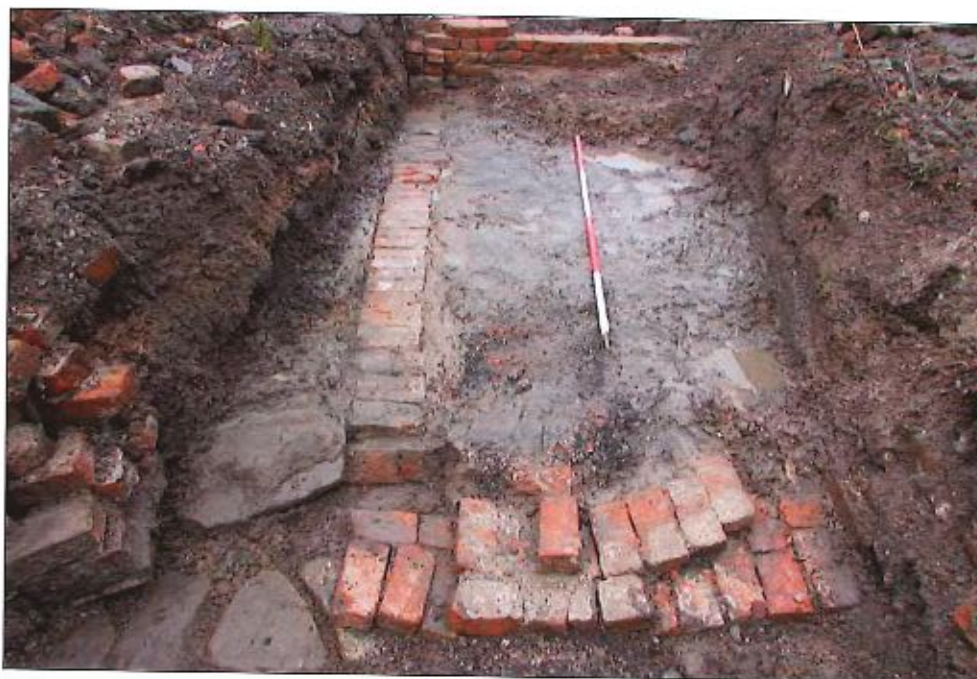
To the east, the southern end of wall 014 was abutted by a 2 course handmade brick wall 016, which measured 3.50m x 0.24m and ran slightly northeast-southwest. The upper 5 courses of the wall had been truncated, although a course of headers was still visible with evidence of white lime mortar. At its eastern end, wall 016 abutted wall 017 which was constructed from handmade bricks with evidence of stone foundations at its junction with 016. Wall 017 ran 2.00m north-south (Fig. 21). The wall measured 0.36m wide and continued to the north and could be seen in the southern section, bonded with a white lime mortar.

**Figure 21.** Walls 016 and 017. Looking west.

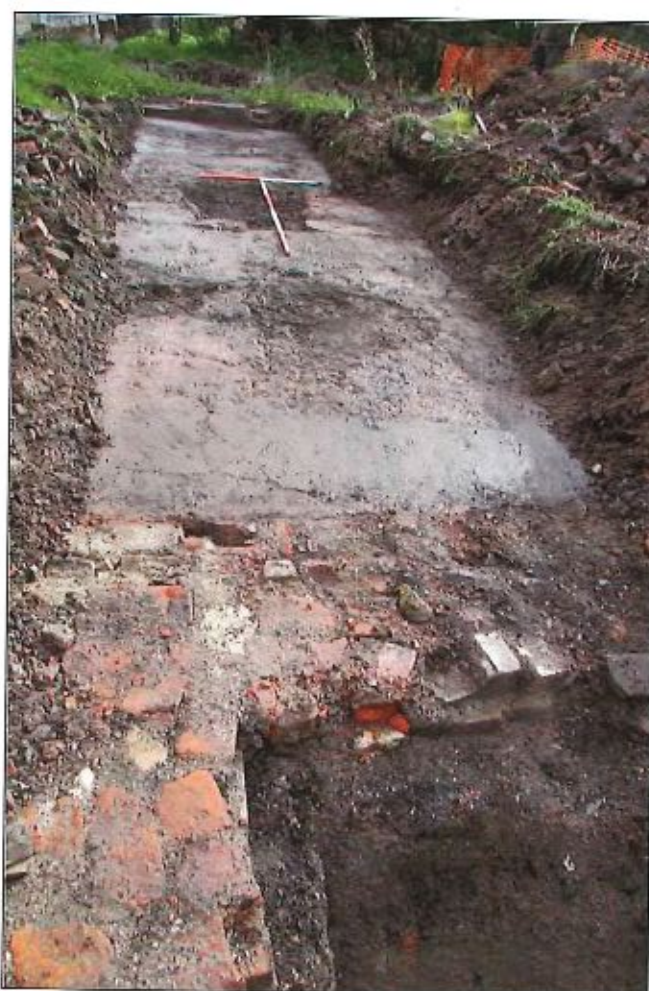
**Figure 22.** Concrete surface 019 with 018 in the foreground. Looking east.

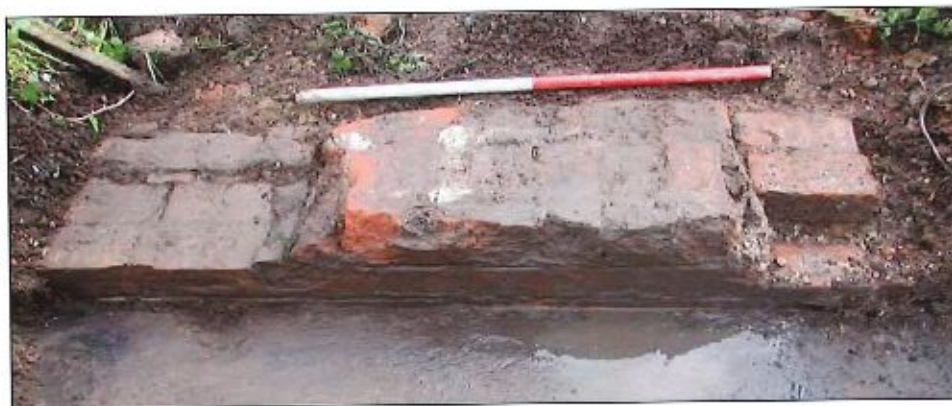
The final feature identified in Trench 3 was a machine made brick wall, 020, running north-south and measuring 0.36m wide. The wall was 3 courses wide, constructed from a row of stretchers to the west and headers to the east and bonded with a hard white mortar (Fig. 23). This wall was also identified in Trench 1/3 Extension where it stood to a height of 0.80m (9 courses).

**Figure 23.**  
Wall 020  
as seen in  
Trench 3.  
Looking  
east.

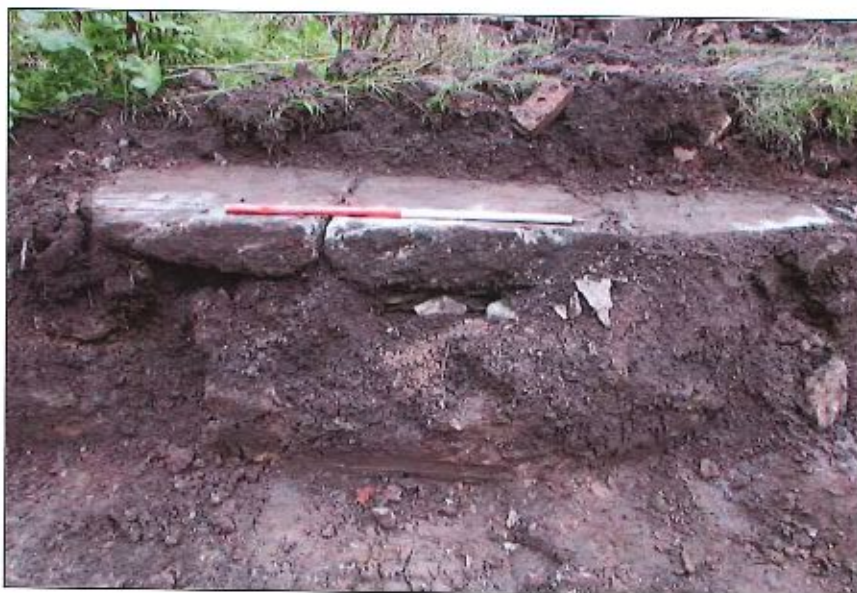
**Figure 24.** Concrete blocks with evidence of flag stones below. Looking south.

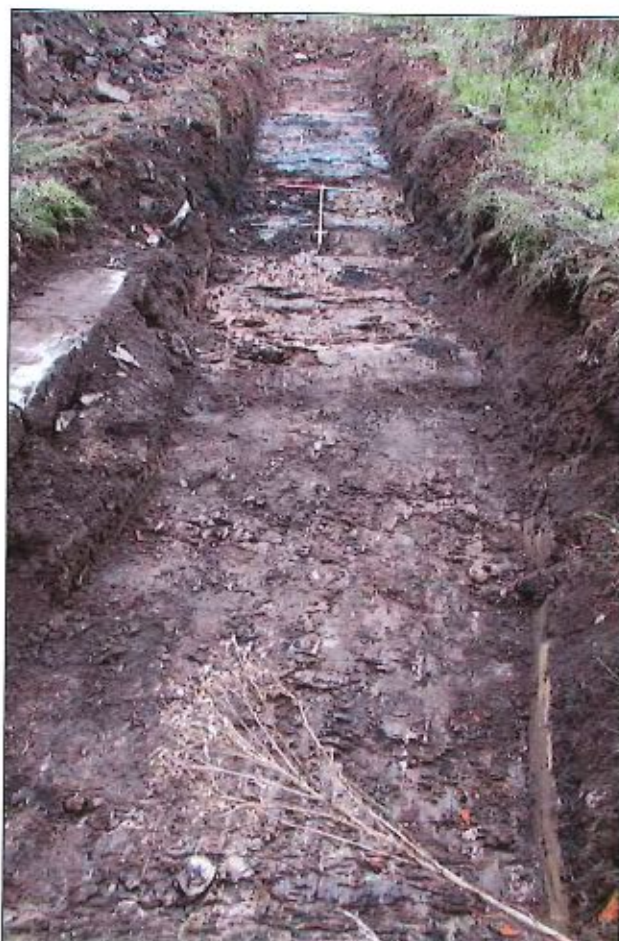
**Figure 25.** General view of Trench 4 showing concrete blocks to the south and the natural clay in the centre. Looking west.

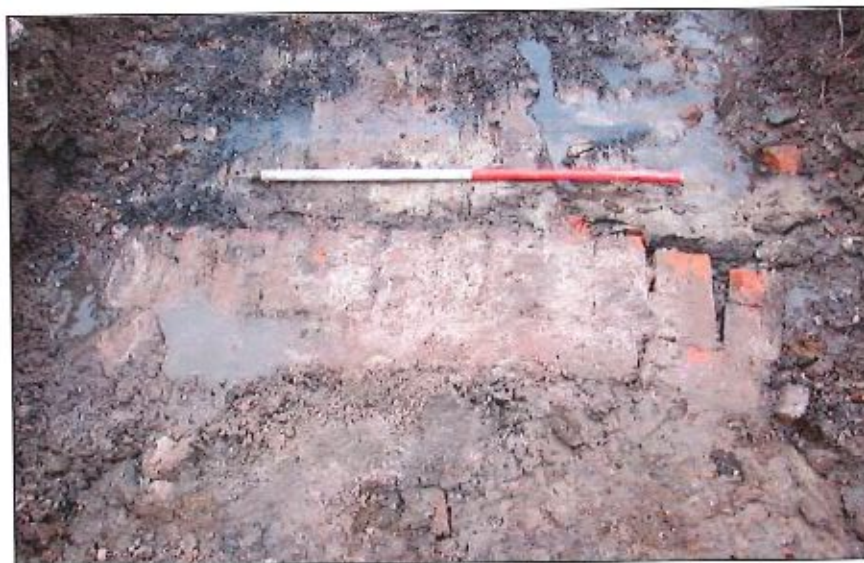
To the west of 066 lay a handmade brick feature 004, set within the natural clay running northeast-southwest across and measuring 0.35m wide (Fig. 26). There was no evidence of any upper courses of 004 in the either side of the trench and along with this, the ingress of water surrounding it led to its interpretation as a drainage feature.

**Figure 26.** Drainage feature 004. Looking west.

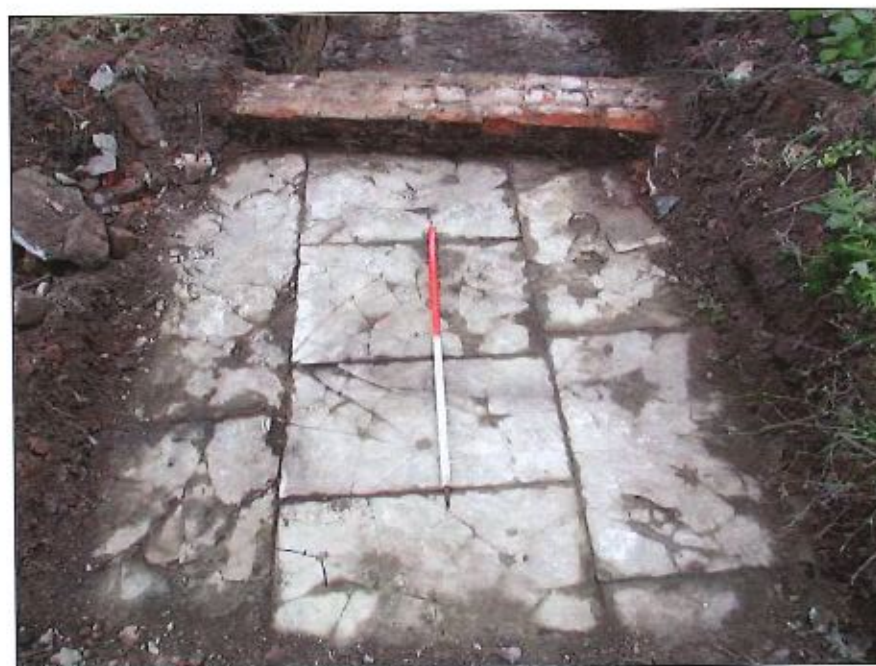
Approximately 3.80m west of 004 the trench was stepped to the north by 2.00m to avoid standing trees in the south of the site. Again, the demolition deposit 001 was revealed which lay to a depth of 0.45m where it covered a concrete surface. Following the removal of this surface, a flagged floor 005, was uncovered at a depth of 0.50m containing flag stones measuring c.0.70m-0.80m x 0.50m (Fig. 27). This floor abutted a handmade brick wall 006, running north-south and bonded with a pinkish-white lime mortar. The wall measured 0.35m wide and, following the excavation of a sondage on its western face, was found to stand to a height of 0.71m (7 courses), with an additional projecting foundation course (Fig. 28).

**Figure 27.** Flagged floor 005 abutting wall 006. Looking west.

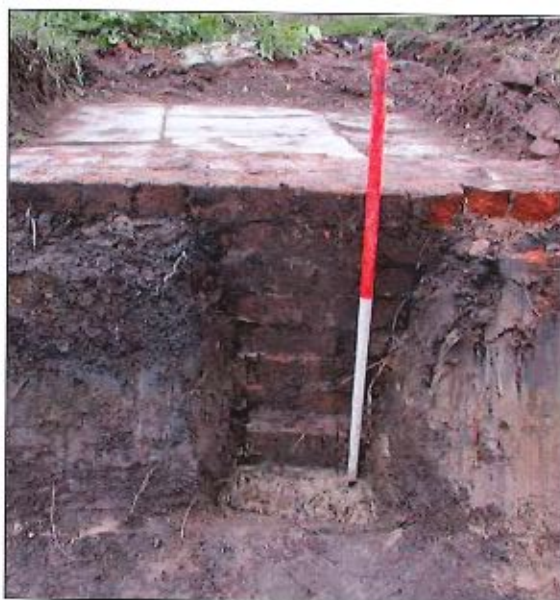
**Figure 28.** Sondage cut against western face of wall 006 showing foundation course and depth of natural clay. Looking east.

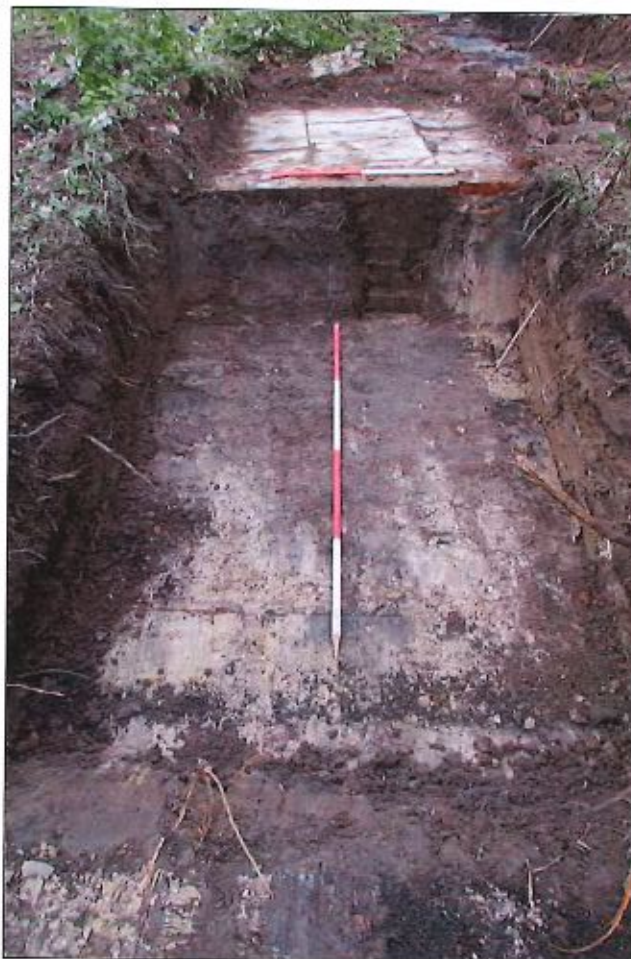
**Figure 29.** General view of the western end of Trench 4, showing wall 006 with the flagger floor 005 behind and the natural clay in the foreground. Looking east.

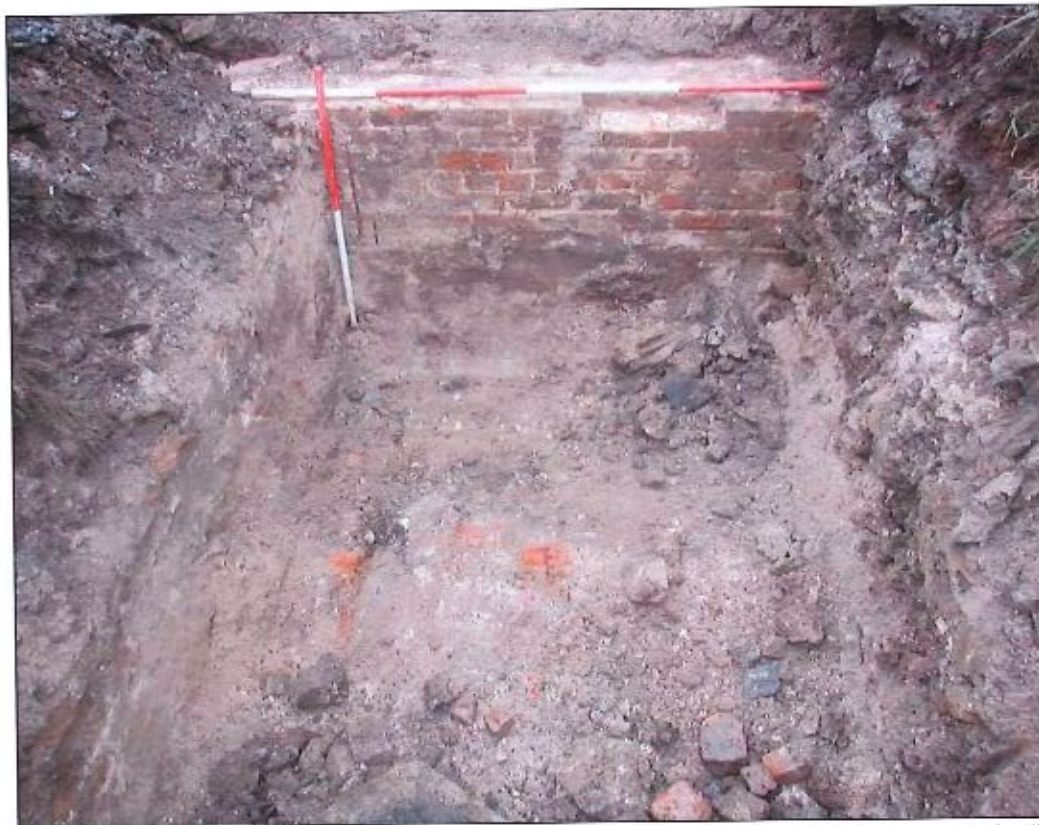
Following the re-exposure of walls 021 and 024, a sondage was excavated to assess the depth of these features and the nature of their foundations. Again, the demolition deposit 008 was encountered which, in this trench, contained considerable amounts of concrete, suggesting that a surface had been broken out during demolition. At a depth of 1.60m a truncated handmade brick surface, 055, was uncovered which lay 1.00m from wall 024 and abutted 021. The surface could not be fully exposed due to its depth, however, evidence of a yellowish-white mortar could be seen lying over some of the bricks within the surface (Fig. 30). To the west of 055, at a depth of 1.00m lay a stone flagged surface, 056, some of which appeared to have been adhered to the concrete which was removed as part of the

**Figure 30.** Walls 021 and 024 to the north and east respectively with surface 055 in the foreground. Looking east.

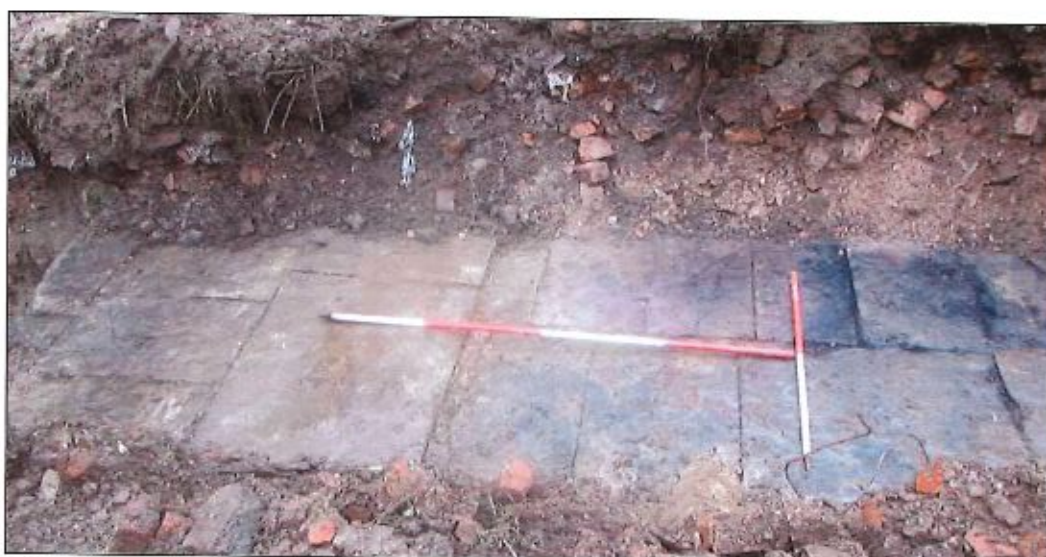
**Figure 31.** Flagged surfaces 056 (left) and 058 (right) with the former location of 057 indicated. Looking south.

excavation of 008, leaving the surface truncated to the east. The surface measured 2.25m x 2.00m with the flag stones varying in size between 0.40m-0.90m x 0.90m-1.00m. One of the stones on the southern side of the surface had two small (0.03m dia.) holes cut into it, lying 0.33m apart (Fig.31). the west end of 056 was marked by a north-south row of handmade bricks, 057, set at the same level as the flags. The bricks were bonded with a white mortar. To the west of 057 there was a second flagstone surface. Surface 058 measured 4.15m x 2.00m and was almost identical to 056, but with slightly

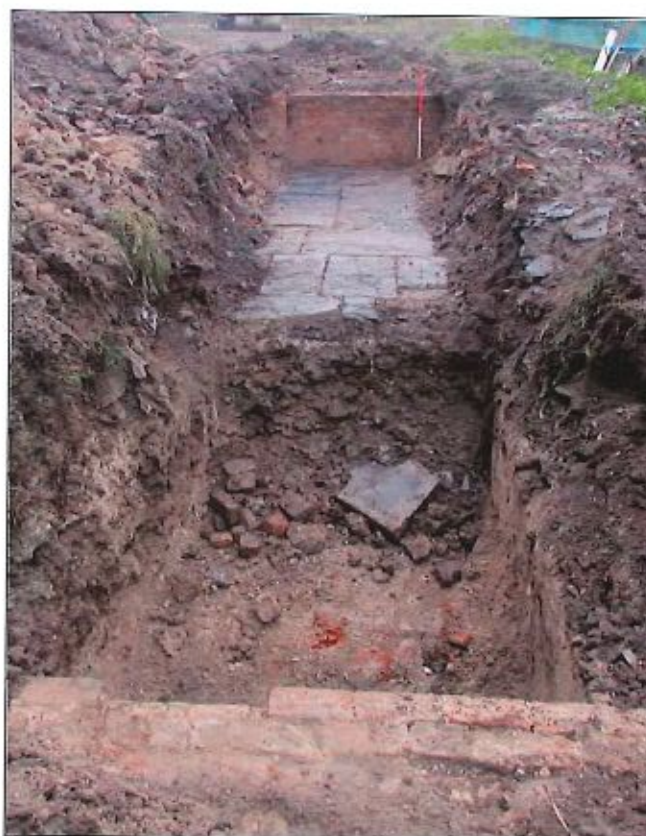
**Figure 32.** General view of Trench 1/3 Extension, showing wall 024 in the foreground with surfaces 055, 056 and 058, leading to wall 021 in the background. Looking west.

smaller, more uniformly sized flags which measured 0.40m-0.70m x 0.70m-0.90m. As a result of material within the overlying deposit 008, surface 058 had a considerable area of dark blue staining in the south-western corner (Fig. 32). This surface abutted the eastern face of wall 021 which stood to a height of c.0.88m (9 courses), bonded with a hard, white mortar and with a possible buttress visible extending from the southern trench edge.
