# Ground Investigation Report

Former Happy Man Public House, Portway

Report Status

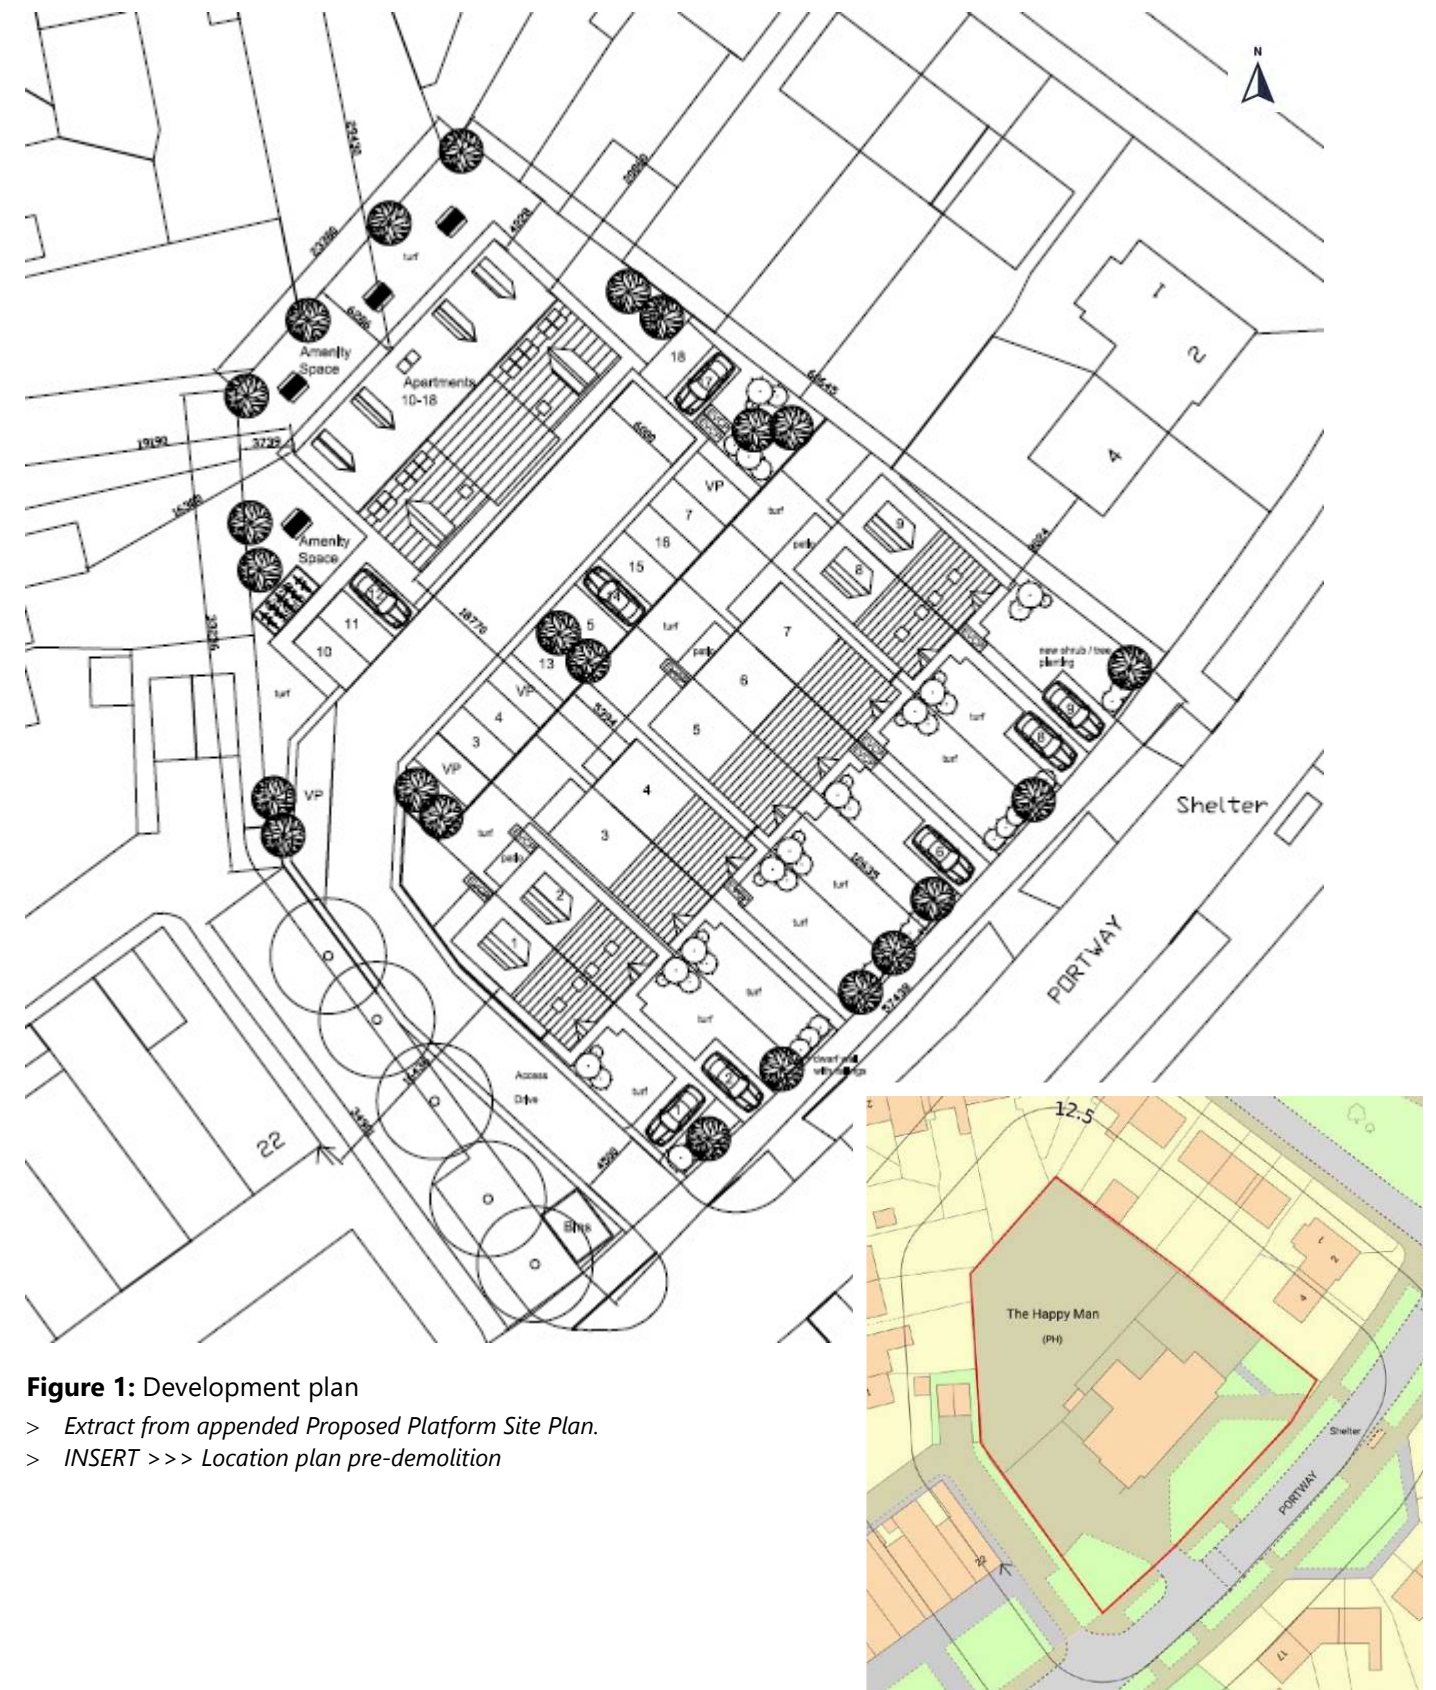
**Figure 1:** Development plan

**Development proposals:** Development proposals include for construction of nine semi-detached three storey town houses and a block of eight apartments with associated hard-standing and soft landscaping areas (Figure 1).

- > Extract from appended Proposed Platform Site Plan.
- > INSERT >>> Location plan pre-demolition

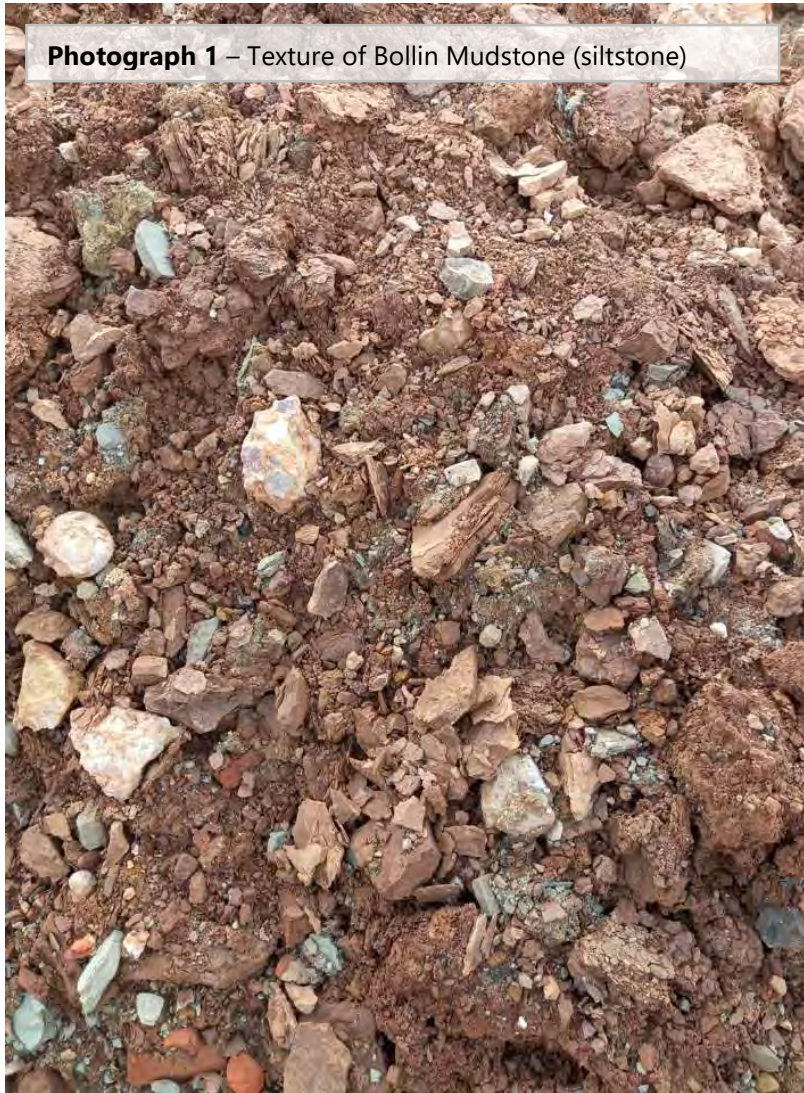
**Photograph 1** – Texture of Bollin Mudstone (siltstone)

- > Observation 1: Weathered mudstone and siltstone was encountered within 2.0 m of the Site surface;
- > Observation 2: Alluvium was confirmed within the former pond alignment to depths of 1.8 m below ground level (where investigated);
- > Observation 3: The Till and weathered bedrock were found to be ‘practically impermeable’ (very low permeability) holding surface water at varied depths. and,
- > Observation 4: The weathered bedrock (Bollin Mudstone Member) is prone to rapid loss of strength when exposed to water.

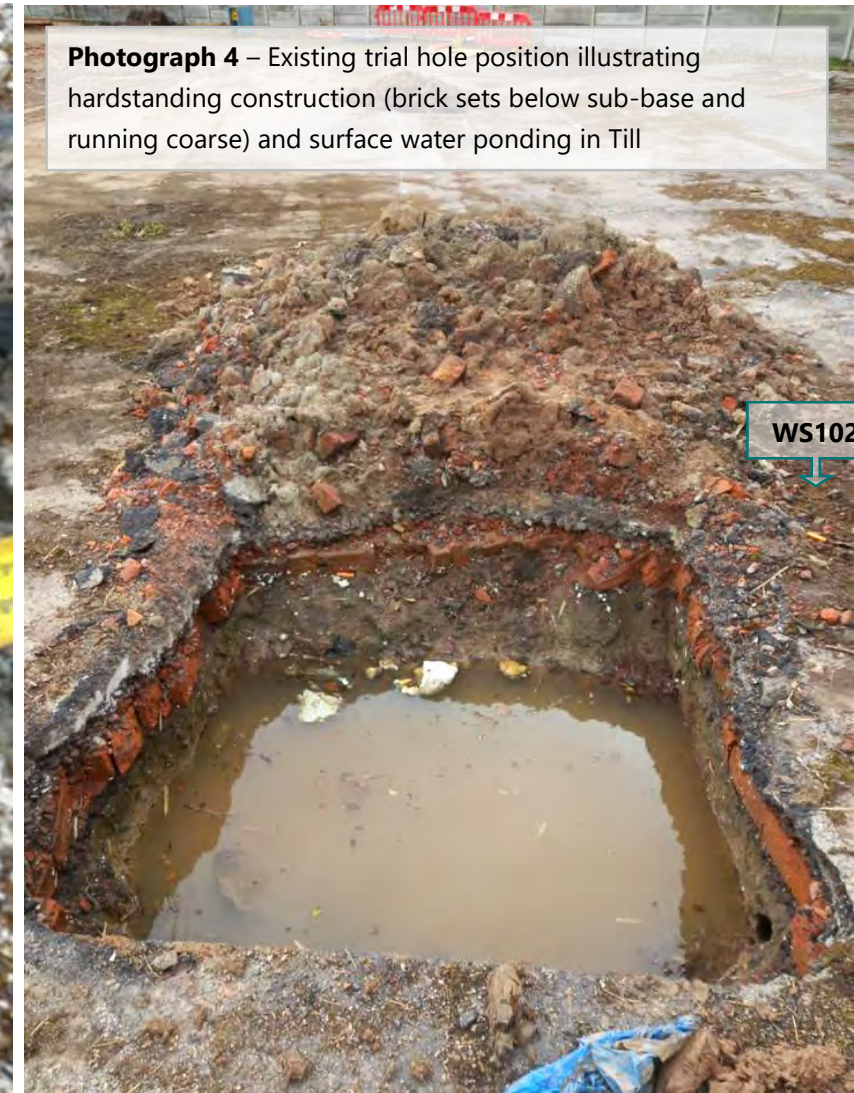
**Photograph 4** – Existing trial hole position illustrating hardstanding construction (brick sets below sub-base and running coarse) and surface water ponding in Till

> **Groundwater** was not encountered in any of the exploratory holes however standing water was noted within open excavations.

Attention should be given to not keeping the Till sub-grade exposed to inclement weather given this material is expected to rapidly soften and loose strength under these conditions.

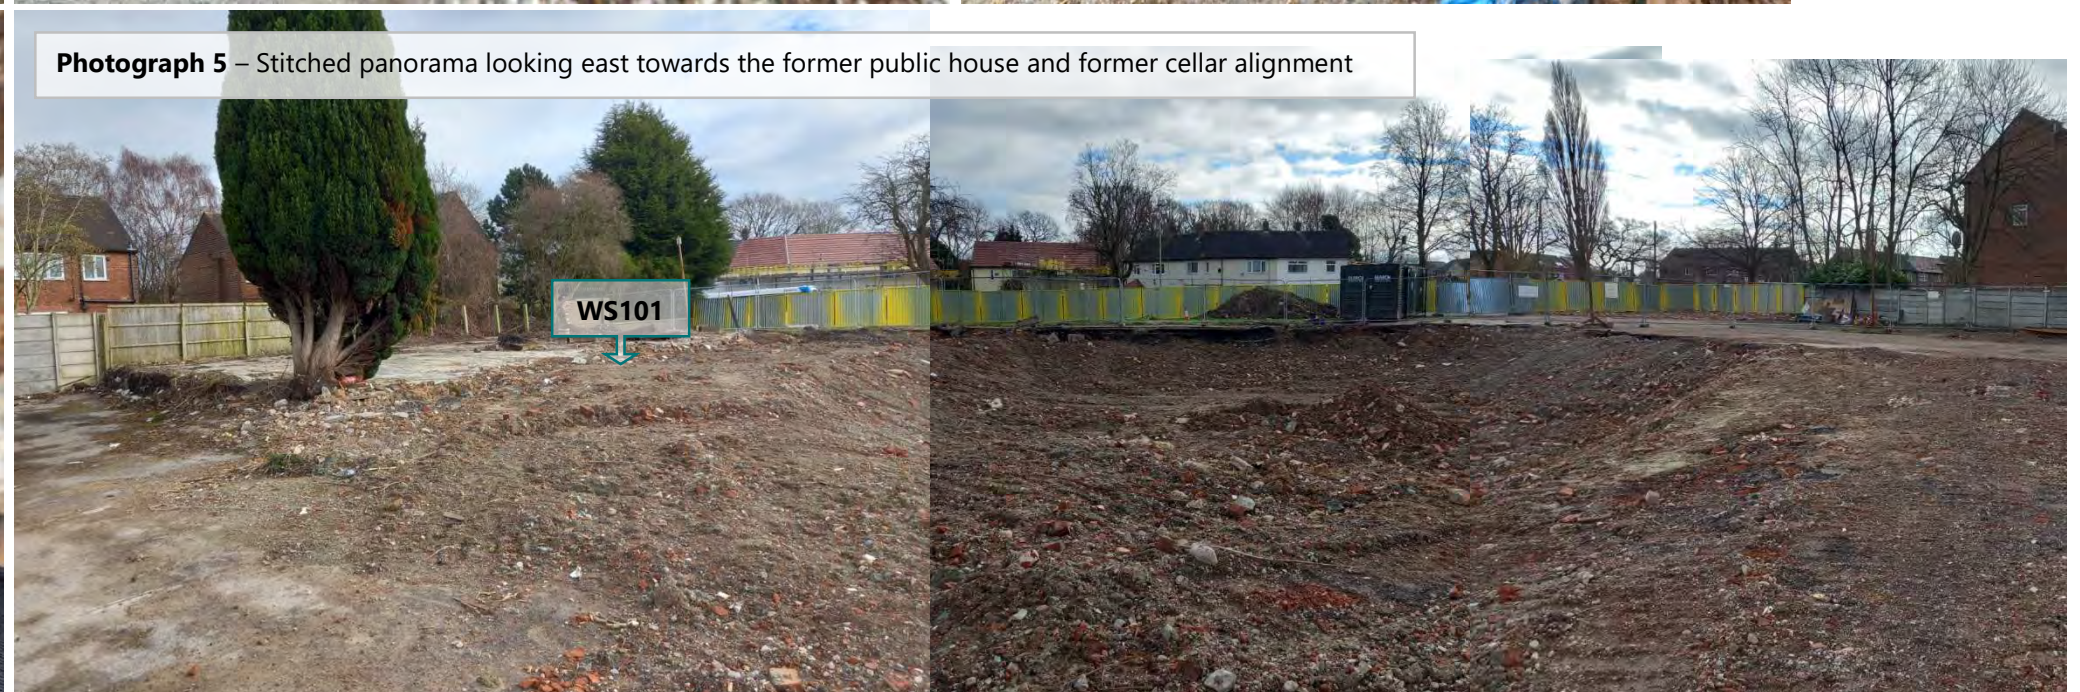
**Photograph 5** – Stitched panorama looking east towards the former public house and former cellar alignment

**Existing structures:** At the point of the ground investigation fieldworks, the former Happy Man public house had been completely demolished with the former cellar removed with the resultant excavation left open and unfilled.

- > Ensuring filling operations across the excavation for the former cellar are completed in such a manner as to ensure that re-excavation through the fill can be completed safely and practically (minimising the potential for collapse). Partial filling of the excavation to limit the depth of excavations for proposed foundations could be considered with blockwork making up the residual depth of the footing; and,
