**Victoria Baths**  
Proposed Fire Alarm Installation  
Design and Access Statement  
April 2023

## DESIGN AND ACCESS STATEMENT

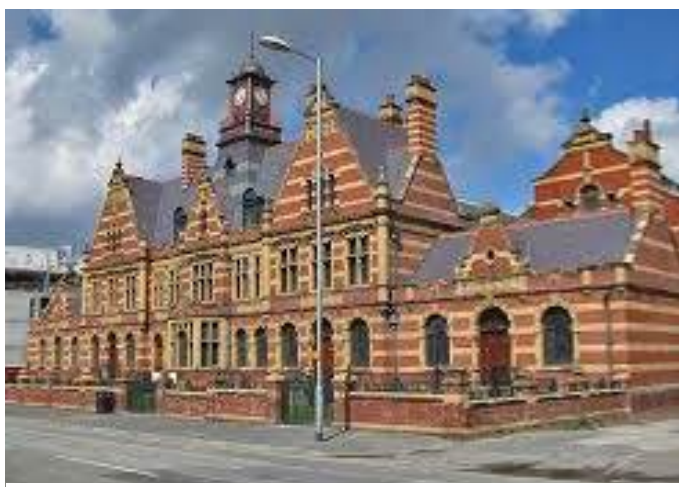
*The front (Hathersage Road) block from the south-east.*

The principal elevations of the building are constructed of smooth red 'Ruabon' facing brickwork with contrasting buff terracotta features. A less expensive common brick was used for the rear elevations, ancillary buildings, and those areas of the facades visually shaded from public view, although even in these locations smooth red engineering brickwork, masonry, and terracotta was used for contrasting features.

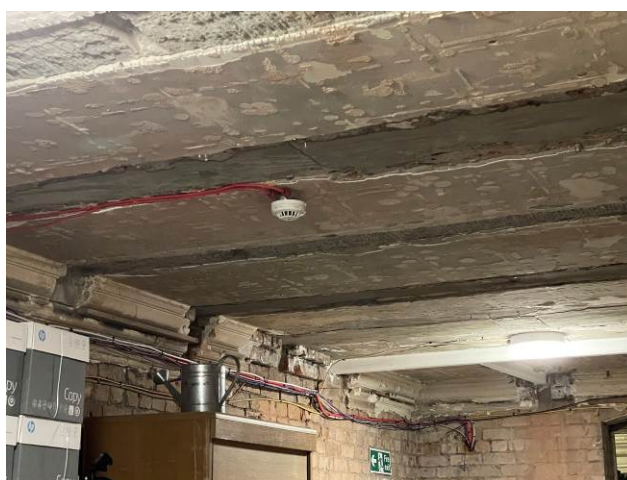
*Plastic clips to poorly fixed cabling in the basement*

- The current system is only part working
- The main panel shows faults to the system
- Coverage does not extend to all areas
- Wiring has not been installed to recommended standards, nor is it particularly well hidden from view, and some runs are fixed with standard plastic cable clips

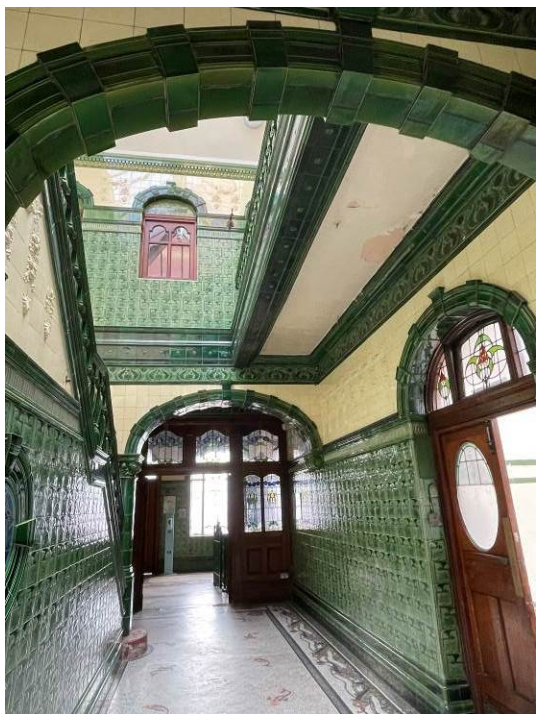
*A wireless solution is proposed for historically sensitive areas with surviving finishes.*

2. Areas where wiring is difficult or in historically sensitive areas such as the Turkish baths which are fully tiled (walls, floor and ceiling) or rooms with no void access, a wireless system will be installed. This will consist of wireless fire devices connected on a local ring.

3. The wireless devices are battery and radio operated and are intended to be installed by fixing into the grout runs to avoid damage to tiles and ceilings

3. It was noted that some of the grout runs are tightly spaced between tiles, so difficult provide fixings for fittings without damaging tile edges. In such instances fittings are either to be fixed to timber screens / door surrounds, or to utilise redundant fixing holes, damaged tiles, or fixed to conceal redundant openings previously formed through the walls for service runs.

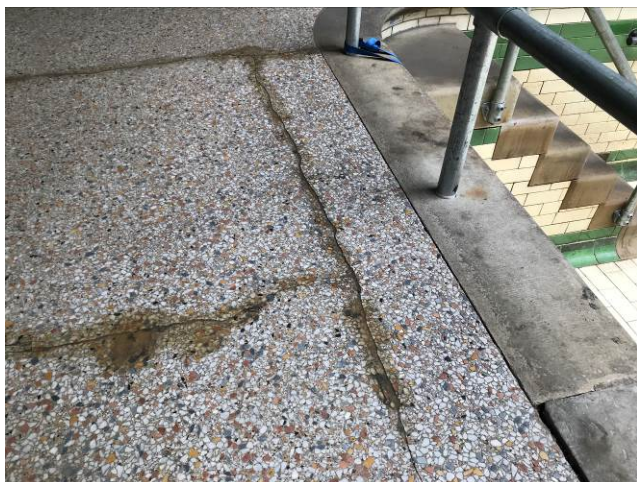
*Cracks in terrazzo finished filler joist floors around the edge of the Females Pool*

Oxidisation and subsequent corrosion expansion of the steelwork manifests in cracking noted through the wall finishes and spalling of concrete from the underside of floors, exposing the corroded steelwork behind. Hairline cracks in the terrazzo finished walkways around the pool edges can also be attributable to corrosion of the steelwork embedded deep in the floor construction beneath.

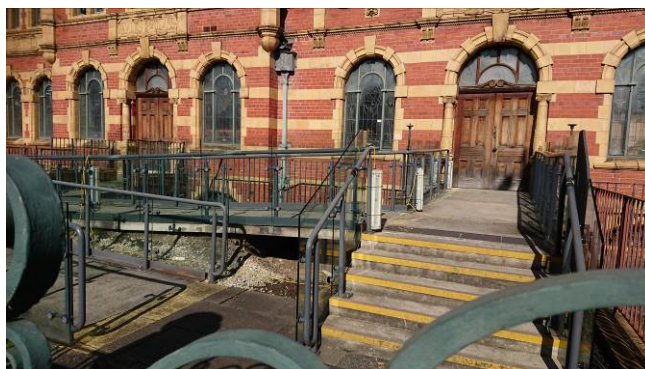
There is no dedicated, wheelchair compliant, ramp to any of the main doors except that to the lesser used Females Pool entrance, from where all ground floor areas are accessible to wheelchair users (except the Gala and Females pool basins), and a temporary ramp to the rear of the Females Pool also affords access and egress from the service yard. There is no provision within the building for wheelchair transfer between floors, although this is currently being explored as part of a design study.

*The ramp to the Females Pool entrance*
