123 & 125  
Liverpool  
Road  
Manchester

## Addendum Heritage Statement

7<sup>th</sup> June  
2023

**123 & 125 Liverpool Road, Manchester – Addendum Heritage Statement**

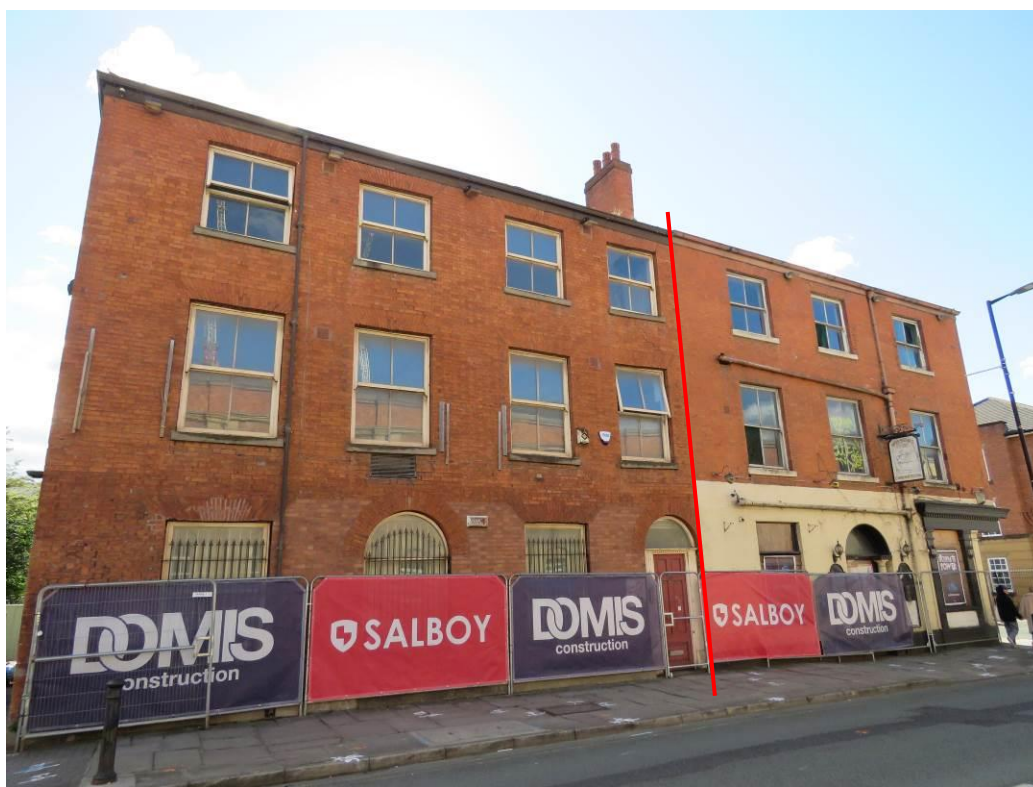
**Figure 1** – No. 123 to the left (east) of the red line and No. 125 (the Commercial Hotel) to the right (west). (Source: SLHA Sept 2022)

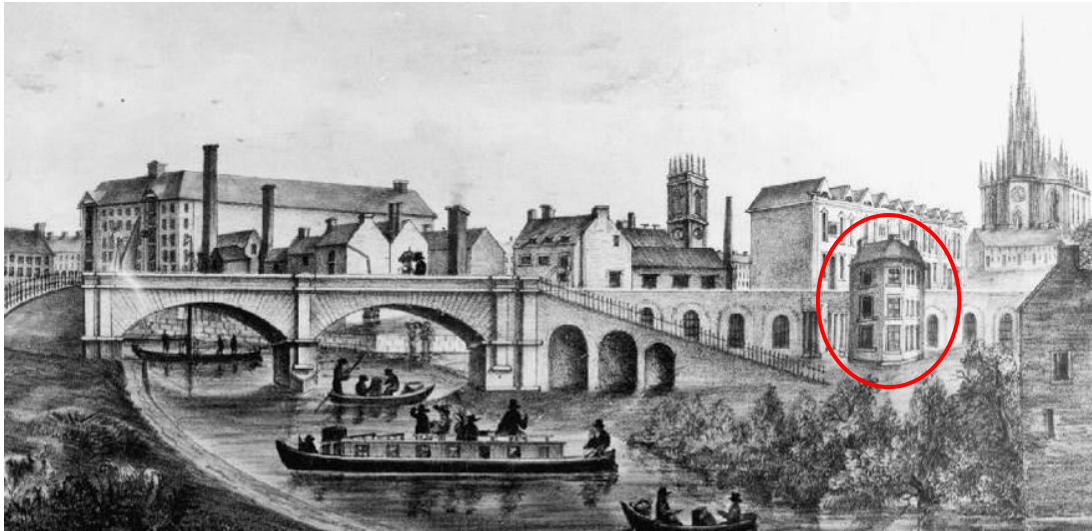
**Figure 4** – An etching looking north across the River Irwell towards the newly completed bridge across Water Street in c1829. The former residential townhouse (circled red) marks the corner of Water Street and Liverpool Road. (Source Manchester Local Imaged Archive).

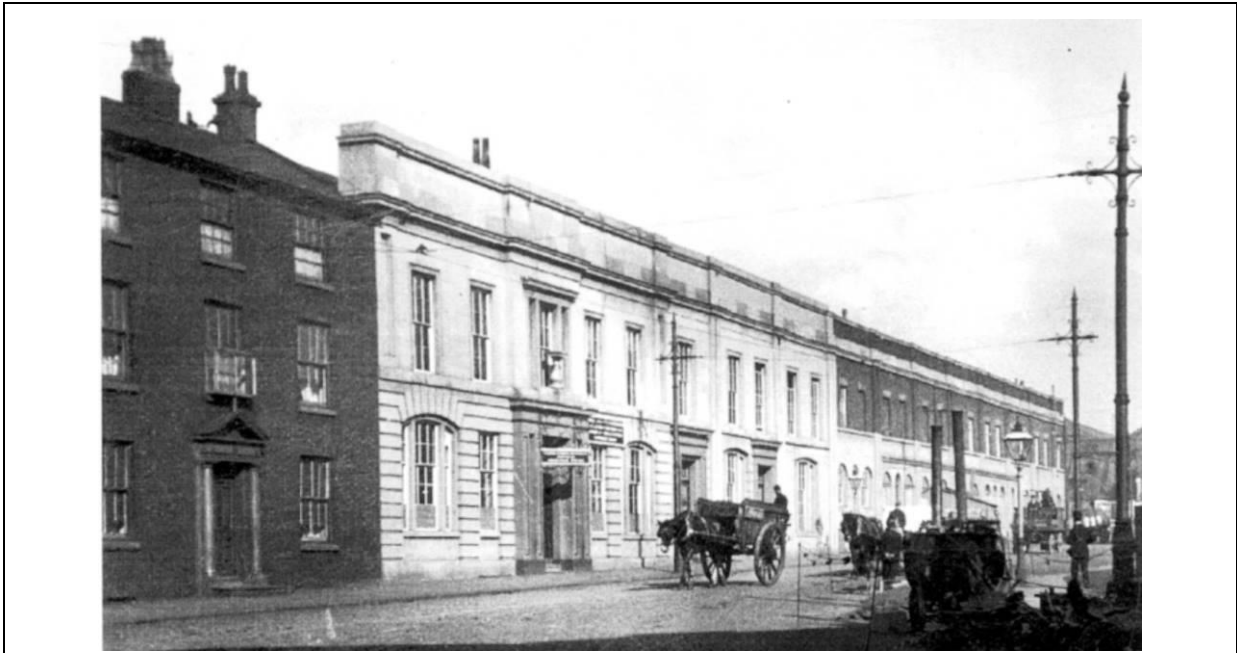
**Figure 6:** The station buildings as they appeared in 1902 when used as a goods station. The Site is located just off the image to the right. (Source Manchester Local Imaged Archive).

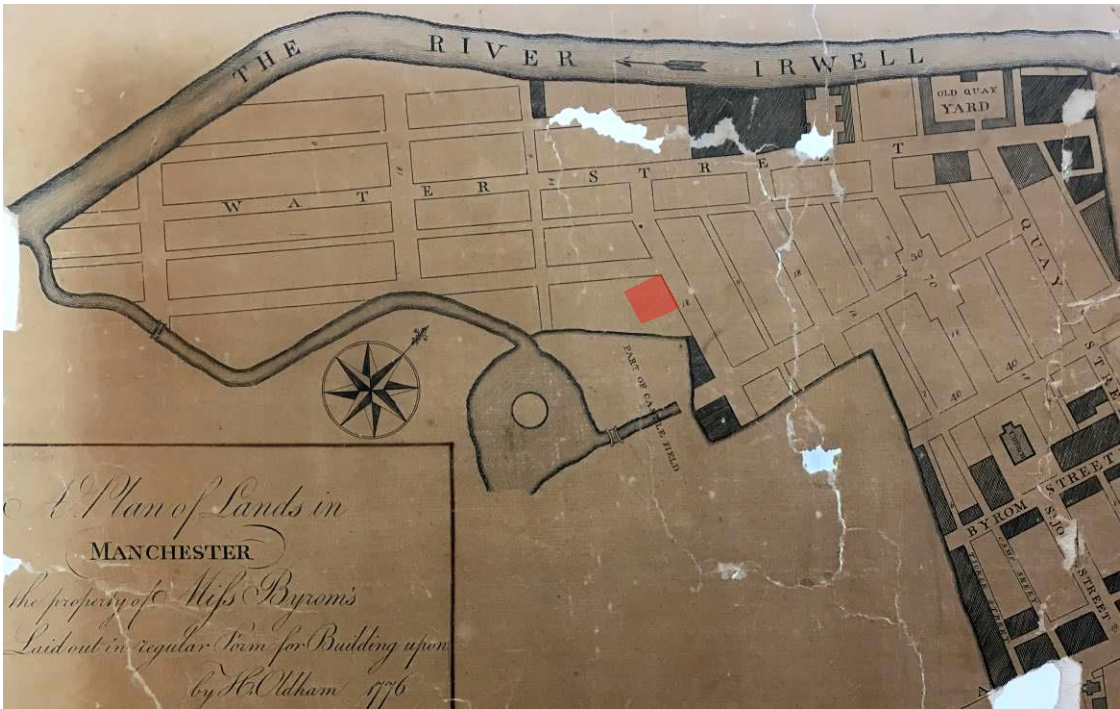
**1776 – A plan of lands in manchester, the proprty of Henry Atherton Esq and Miss Byrom** – This early map of the western end of Liverpool Road was drawn up by H. Oldham to show the areas of open grass land which was to be divided into residential plots and new streets by Miss Byrom. This map shows the Site is undeveloped at this time, and forms part of the extention of Liverpool Road to meet with Water Street.

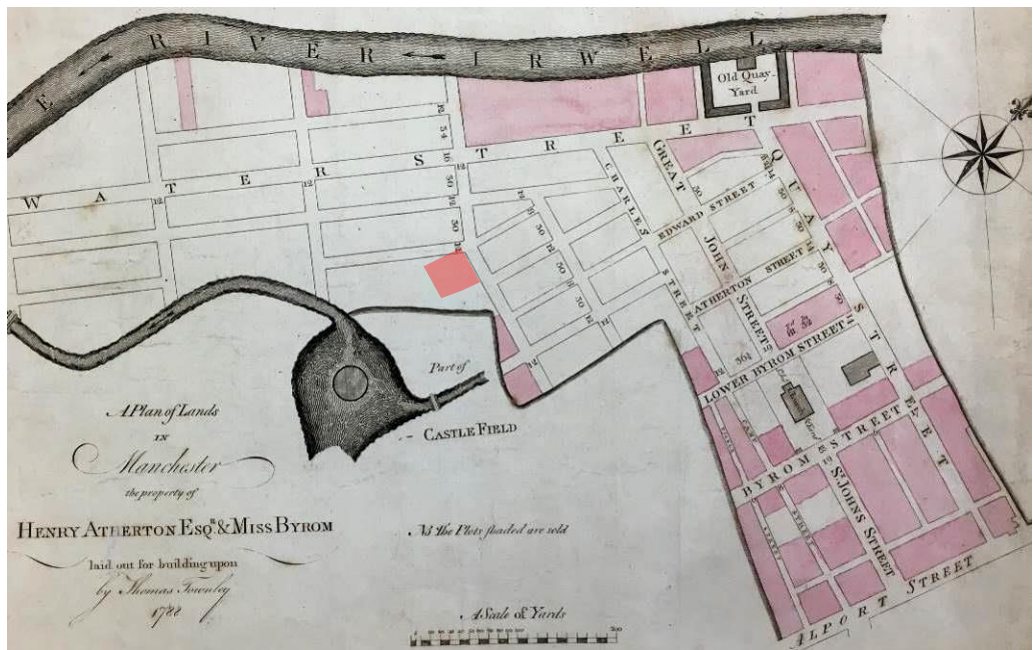
**1788 - A plan of lands in manchester, the property of Henry Atherton Esq and Miss Byrom** – This plan, drawn by Thomas Townsley in 1788, shows the lands belonging to Henry Atherton and Miss Byrom, indicating new numbered building plots and streets around the Site still undeveloped. Pink areas are areas of exisisting buildings.

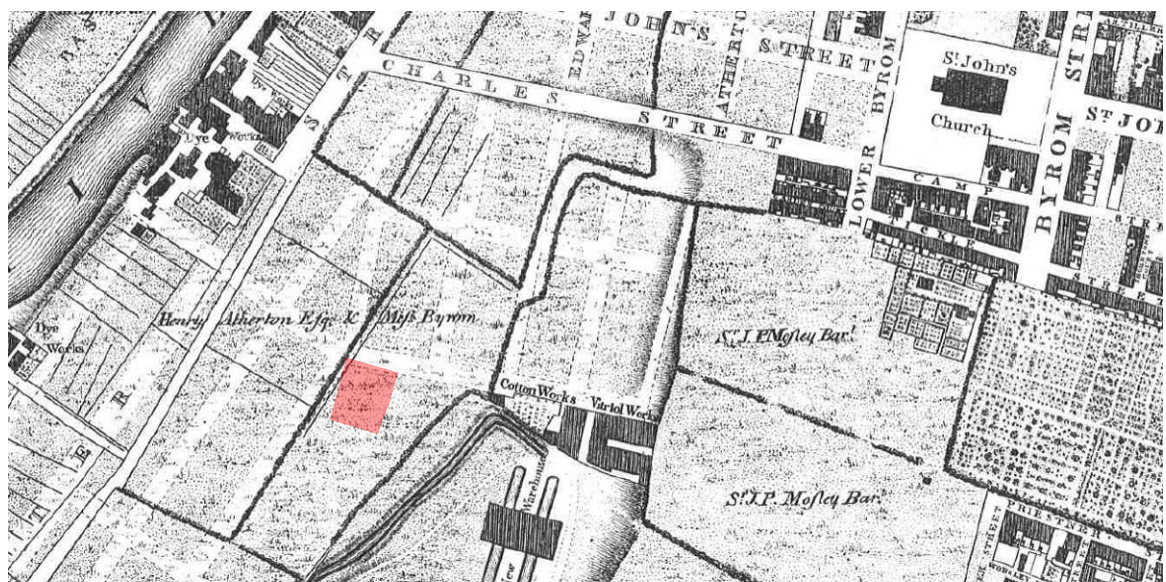
**William Green 1794** – By 1794 the immediate environs still largely consist of open fields and hedgerows, with a group of quayside warehousing between Water Street and the River Irwell to the left of the map. The eastern end of Liverpool Road can be seen to be called Priestner Street during this period, and stops one quarter of the way from Aldport Street (now Deansgate).

This map shows the names of land owners around the Site at this time. This map shows that the Site is still undeveloped, and Liverpool Road has not been extended from the existing Priestner Street.

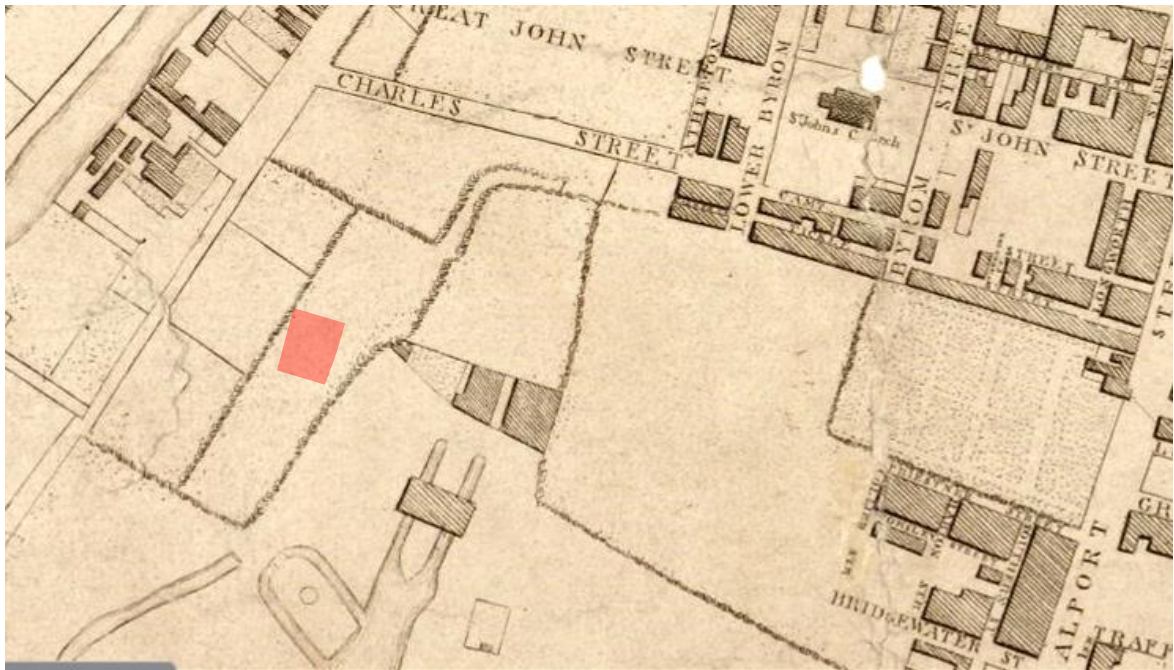
**1800 Pocket Plan of Manchester and Salford** - By 1800 there appears to be no changes to the immediate area, and the Site, along with the surrounding empty plots remain undeveloped.

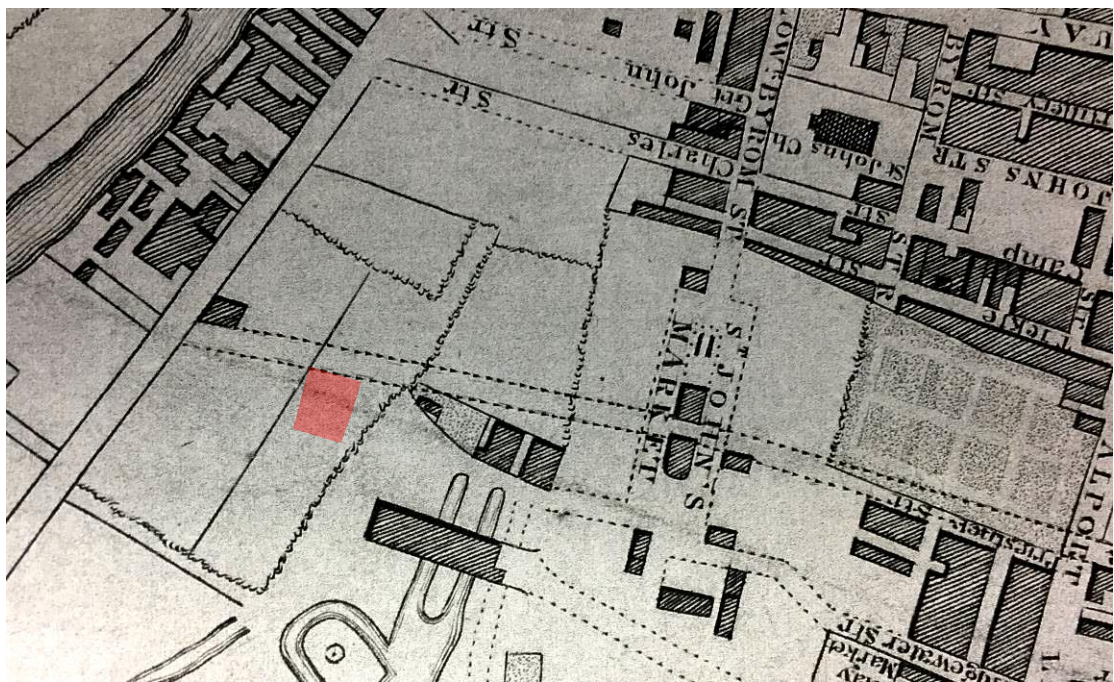
**1808 A Plan of Manchester and Salford** – By 1808 the continuation of Liverpool Road can be seen to have been planned. The map shows that Liverpool Road has been initially planned by this date, however it has yet to be paved and completed. The first house on the western end of Liverpool Road can be seen to be constructed on the corner of Water Street.

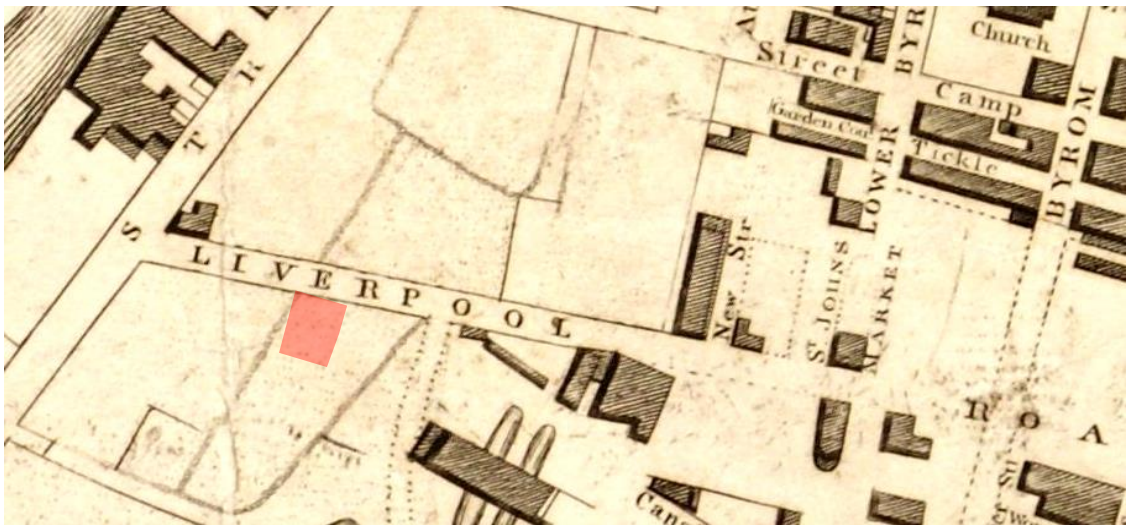
**1819 Pigot's Plan of Manchester and Salford** – By 1819 Priestner Street has been renamed Liverpool Road, and is now laid out with a few new buildings to its eastern end. The Site remains undeveloped.

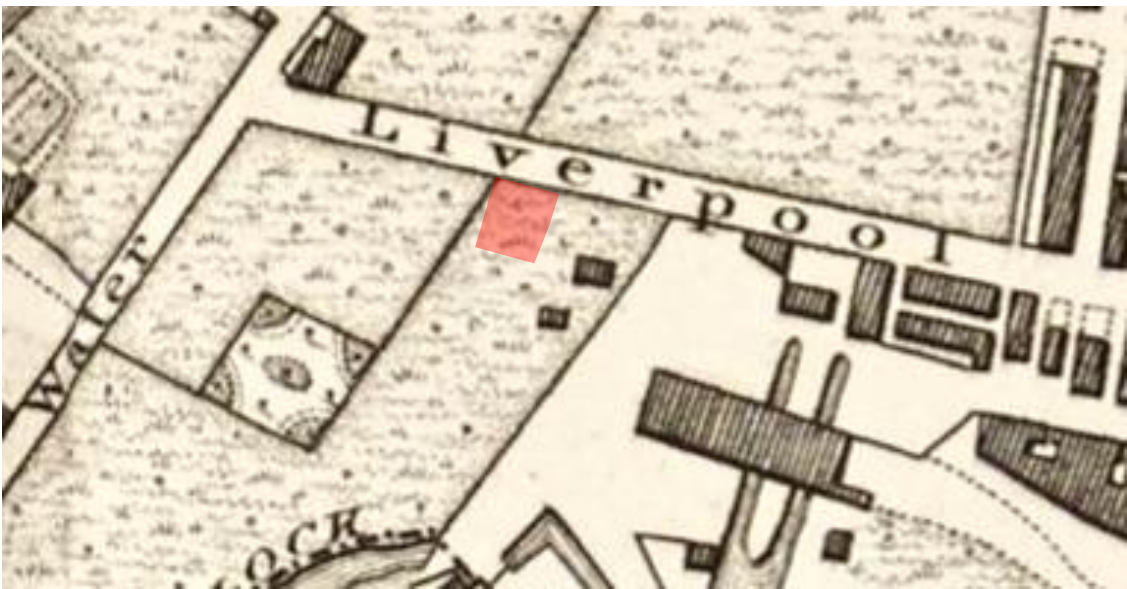
**1824 Swire's Manchester and its Environs** – By 1824 the immediate area has not greatly altered. The Site can be seen to be still undeveloped.

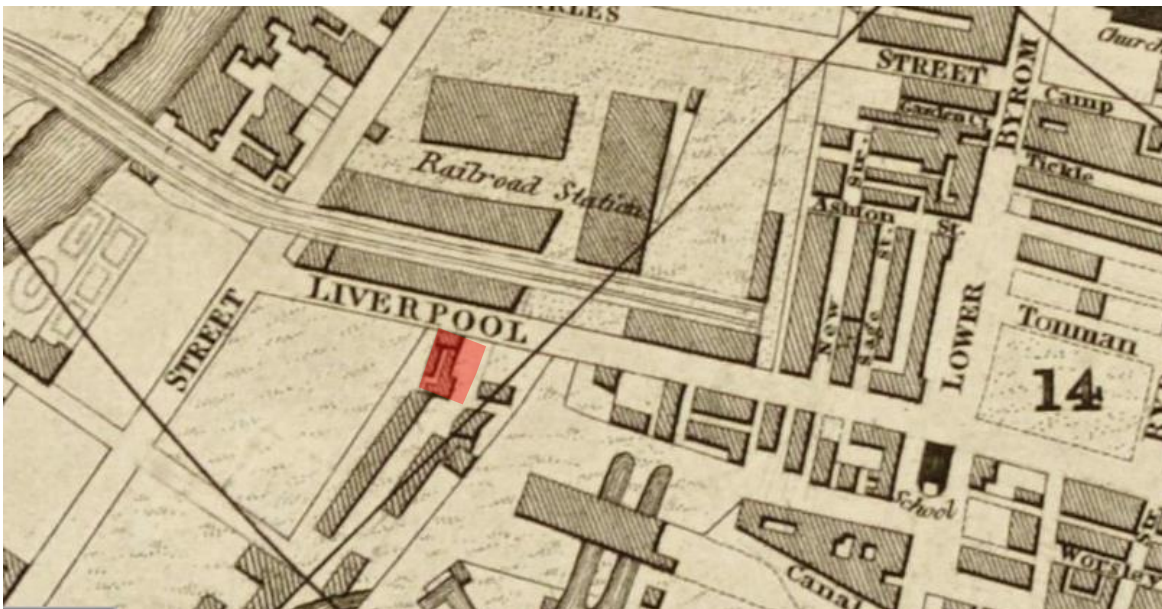
**Pigot 1836** – By the date of this map Woollam Place can be seen to have been laid out, and a long row of terraced houses have been constructed along its eastern side. The Site still only contains the Commercial Inn, and its associated rear outbuildings and stables.

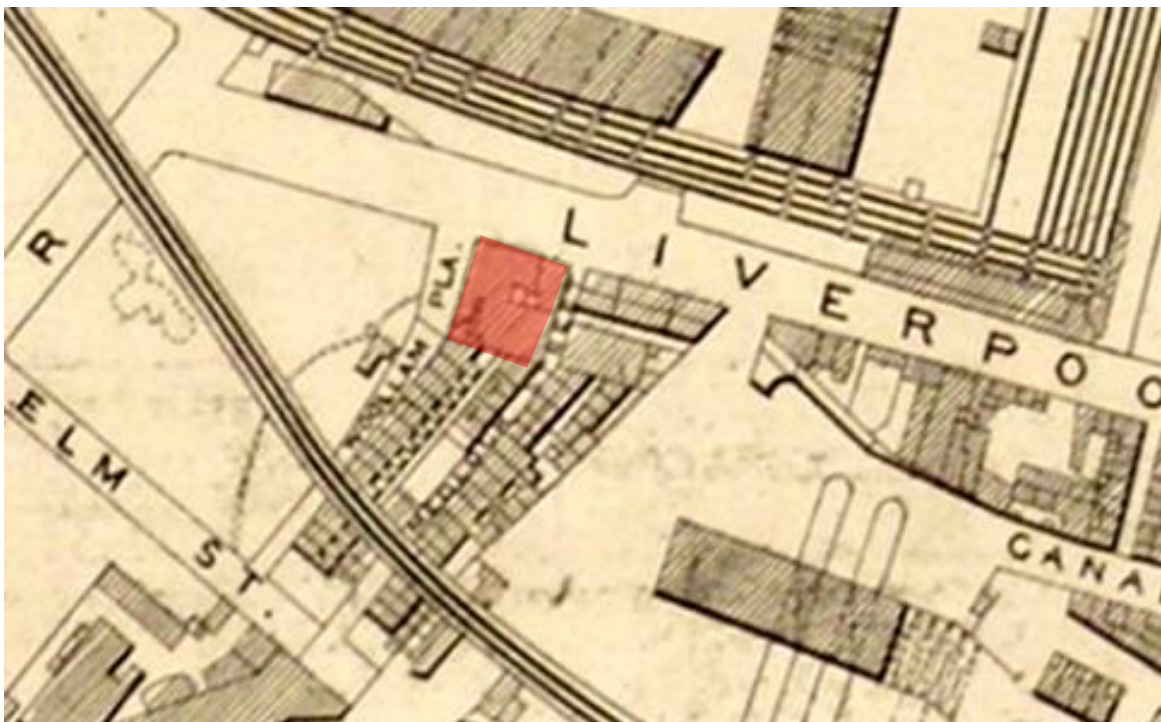
**Simms 1858 - City of Manchester and its Neighbourhood** – By 1858 the hotel is still in residential use, and not marked as an 'Inn'. It is likely that the hotel is being used as a school by teachers John and Eliza Powell, who taught from there in 1861-3.

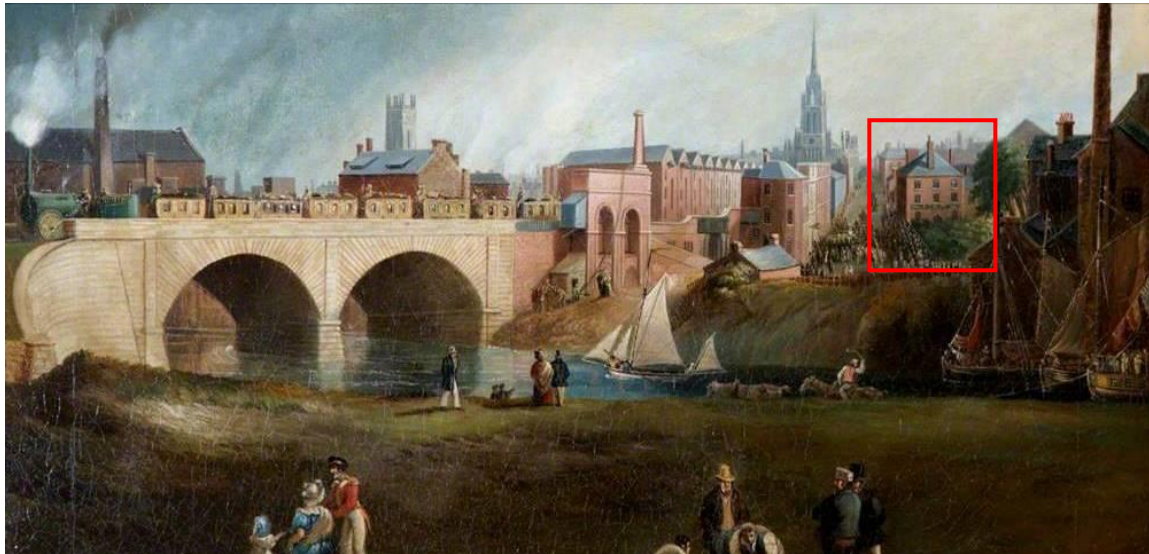
**Figure 8:** An oil painting of the Rocket at Liverpool and Manchester Railway Station, crossing the bridge over the River Irwell, by an unknown artist c1830. This view, looking east across the Irwell from Salford, shows the start of Liverpool Road from Water Street, and illustrates the partly complete station buildings.

The west elevation of the Railway & Commercial Hotel (the Site) can be seen clearly looking over the mature trees and grassland to the western side of what would become Woollam Place. This painting shows that from its early beginnings, the hotel appears to have used both its Liverpool Road and Woollam Place frontages as main entrances into the building, with a large painted hotel sign extending across the Woollam Place façade and doorway. (Source: Images courtesy of Elaine Ward, National Trust Collection, Greenway, Devon)

It appears that William Westall purchased the business and had spent a considerable amount of money in substantially improving and enlarging the hotel, including the constructing the three-storey rear extension along Woollam Place, which had replaced an original brick garden wall structure (see Figures 8 & 9, which show the c1830 view of the hotel).

The hotel's side return extends along Woollam Place to the west of the building. When the hotel was originally constructed, this aspect of the building would have looked out over open fields, trees and the River Irwell, and was advertised at the time as having the "advantage of country air" (see Figures 8 & 9, which show the c1830 view of the hotel).

This elevation originally matched that of the Liverpool Road elevation and contained a central doorway within a brick arch and flanked by two sash windows. The first and second floor levels contained three window openings, the middle window to the first and second floors were bricked-up when the c1836 extension was erected to the south to allow for circulation into the new extension from the existing hotel (see Figures 8 & 9, which show the c1830 view of the hotel).

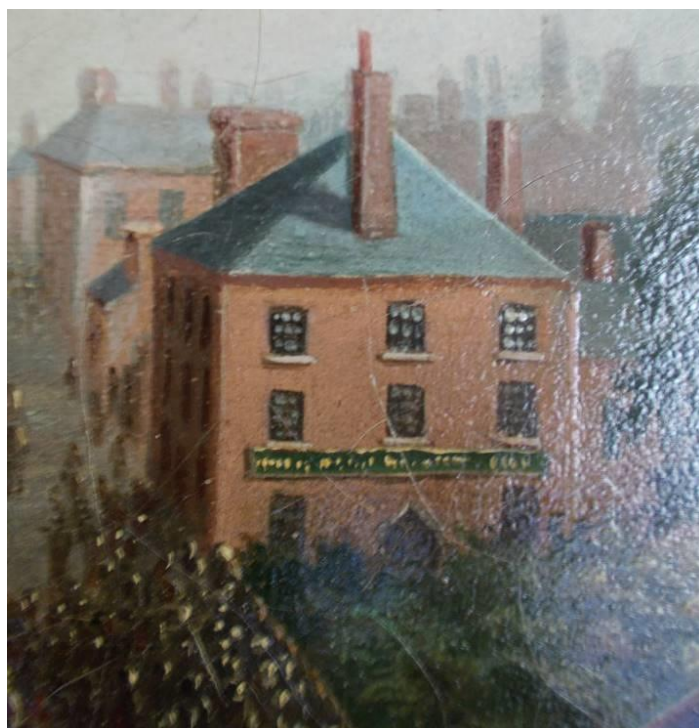
**Figure 9:** Detail of the oil painting of the Rocket at Liverpool and Manchester Railway Station, crossing the bridge over the River Irwell, by an unknown artist c1830. This closer view shows the west elevation before the c1836 extension was constructed.

The painting indicatively shows the original ground and first floor windows were six-over-six sashes, whilst the slightly shorter second floor windows were three-over-six sashes, however, the last surviving original sash window to the No. 123 confirms the lower levels of the building used eight-over-eight sashes, and that this would have meant four-over-eight sashes would have been used on the second floor level.

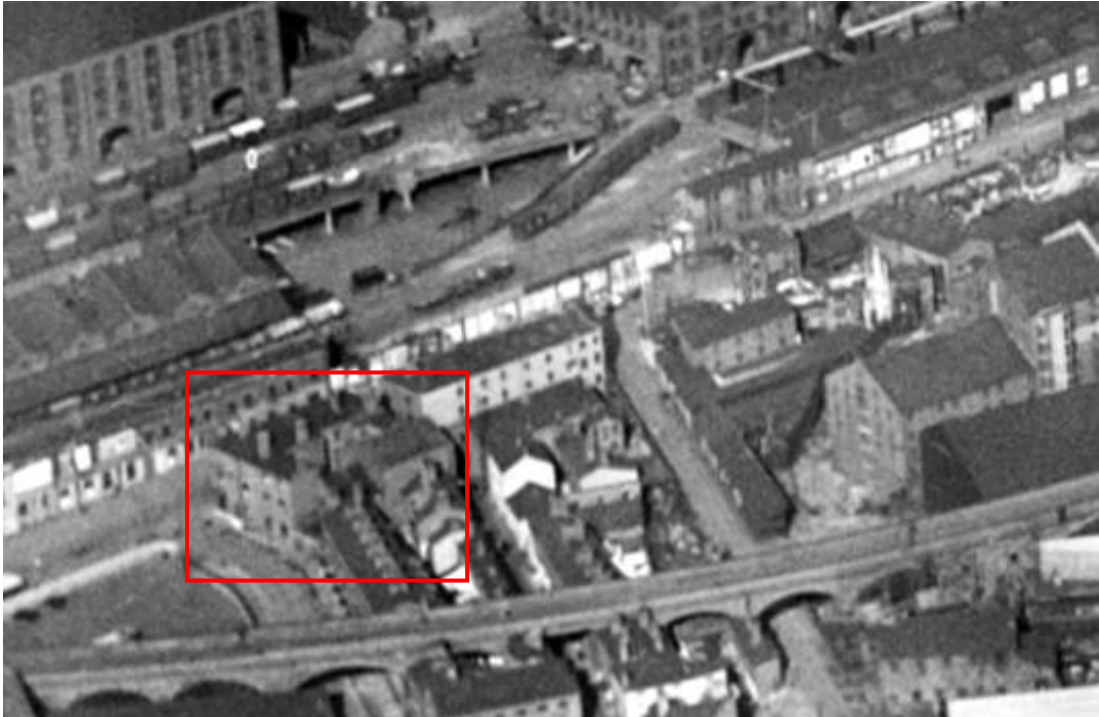
| <p><b>Figure 15</b> – Aerial view looking north-east over the site in 1934, showing the former single-storey outhouse to Woollam Place, and the rear of the two-storey original stables/coach house, which was demolished at some point between 1946 and 1953, , likely to have originally provided extra accommodation for the hotel via a now demolished link corridor at ground and first floors. (Source Manchester Local Imaged Archive).</p> | | |

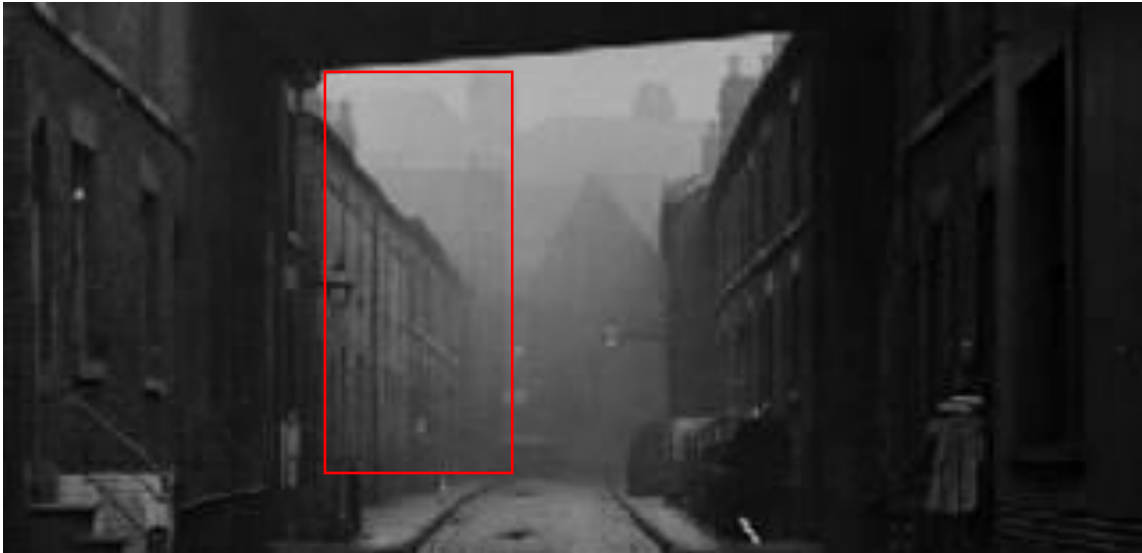
| <p><b>Figure 16:</b> Looking north along Medlock Street towards its junction with Liverpool Road in 1907. The south-east corner of the original stables/coach house is marked by the red box. (Source Manchester Local Imaged Archive).</p> | | |

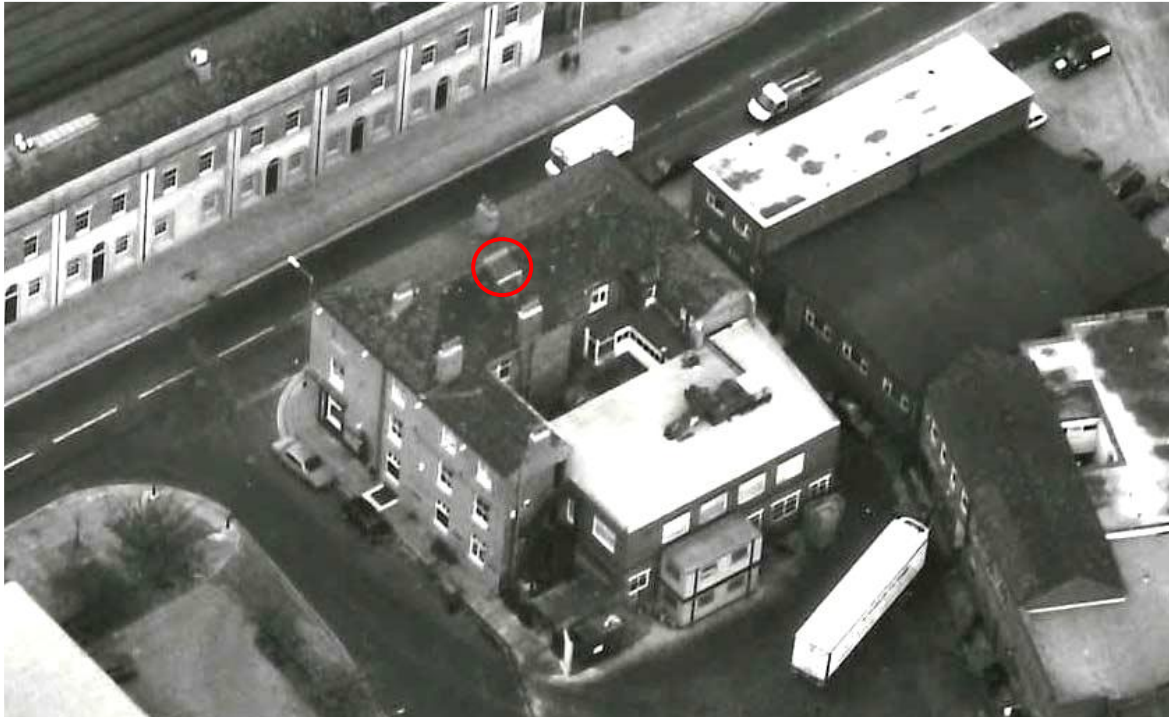
**Figure 17** – Aerial view looking north over the Site in the early 1980s, showing the large c1950s/60s block on the site of the original stables/coach house. Note the skylight over the main staircase of the Commercial Inn (circled). (Source Manchester Local Image Archive).

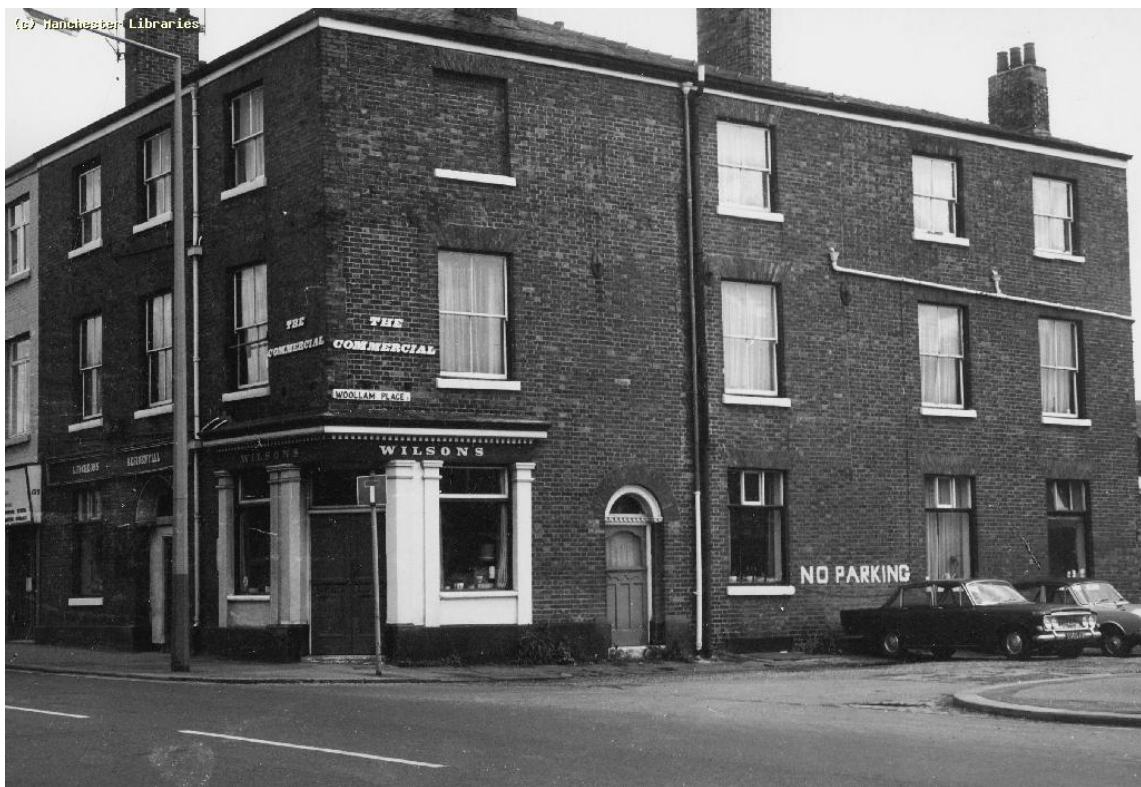
**Figure 18** - The west elevation on Woollam Place in 1972. (Source Manchester Local Image Archive).

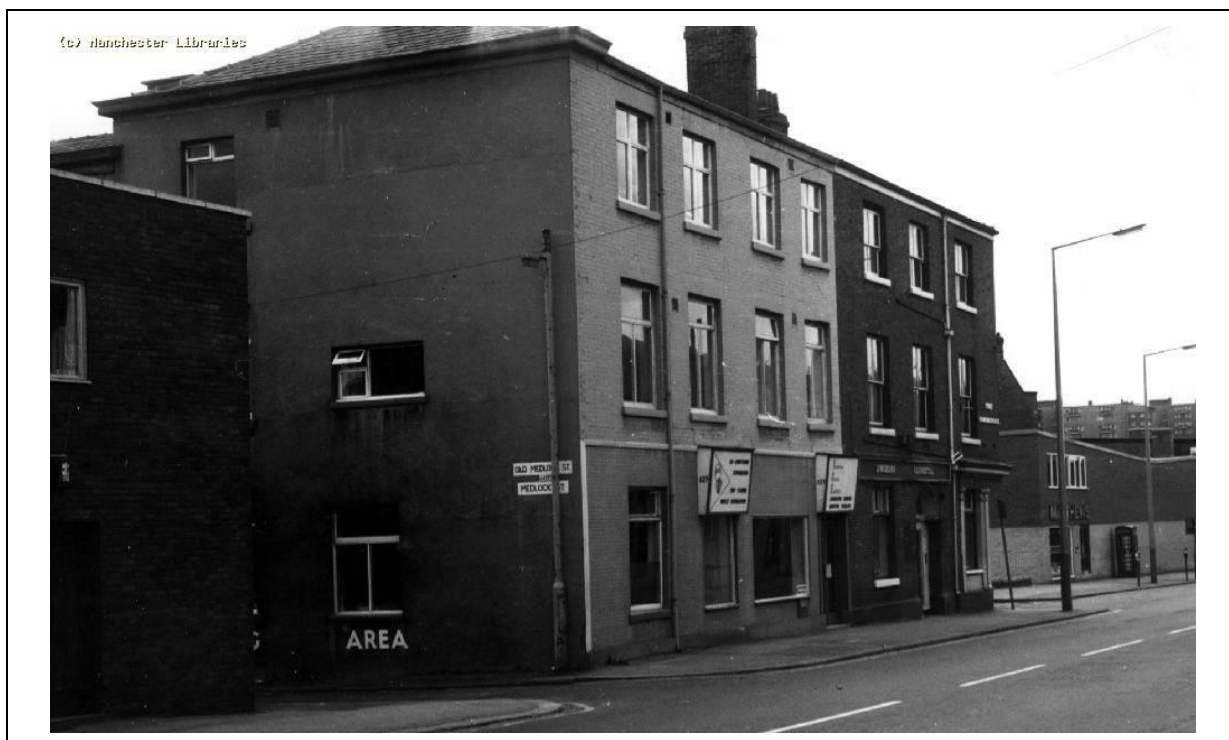
**Figure 19** – Looking westerly along Liverpool Road at its junction with Medlock Street (then renamed Old Medlock Street) in 1972. This image shows the modern render coating applied over the front and side elevations of No. 123, along with the insertion of a new window openings on the east and north elevations, and all windows being replaced with casements. (Source Manchester Local Imaged Archive).

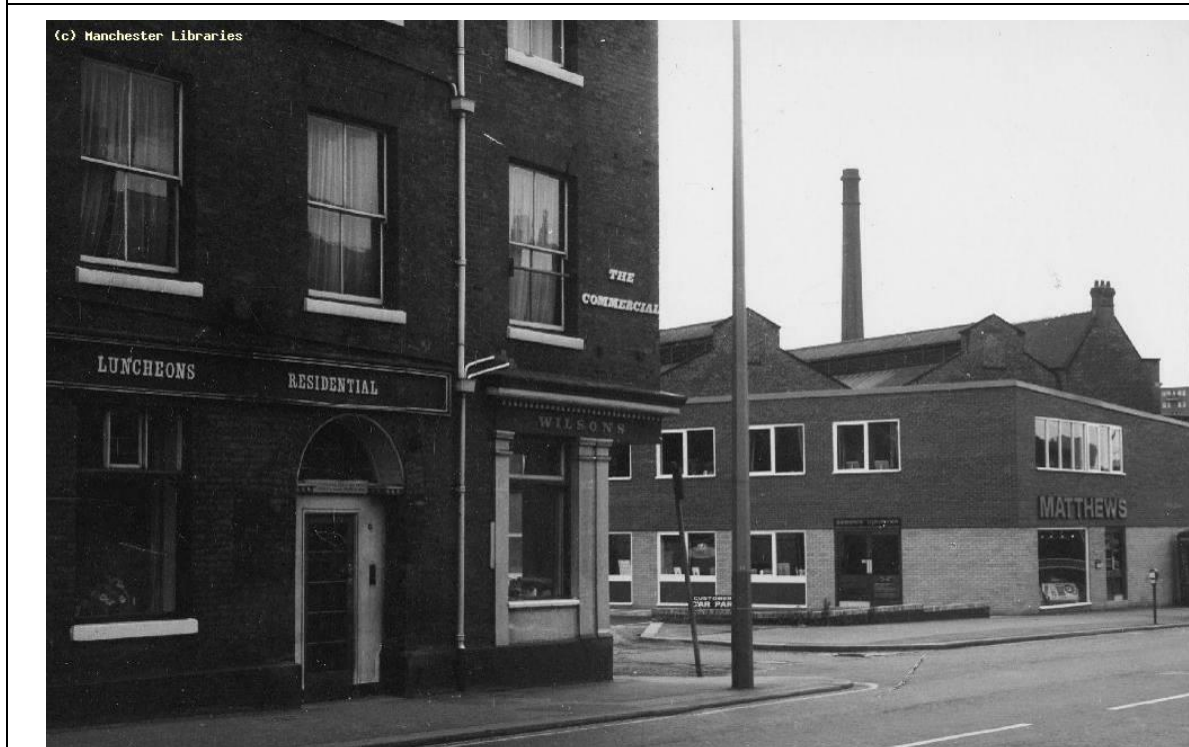
**Figure 20**– The corner of the Commercial Hotel in 1972, showing the insertion of a new glazed door and the removal of the original timber columns either side. (Source Manchester Local Imaged Archive).

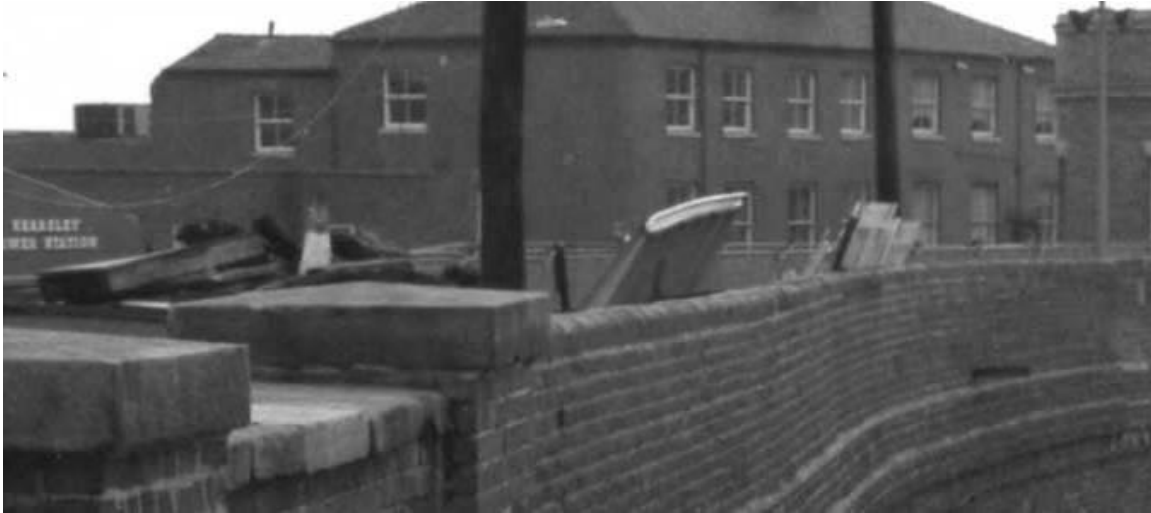
**Figure 21** – A view looking in a southerly direction towards the front (north) elevation of the Site from the Liverpool Road Station site in 1992. This image shows that by 1992 No. 123 has had its render removed and brickwork restored, including replacement casements in the style of sash windows. (Source Manchester Local Imaged Archive).

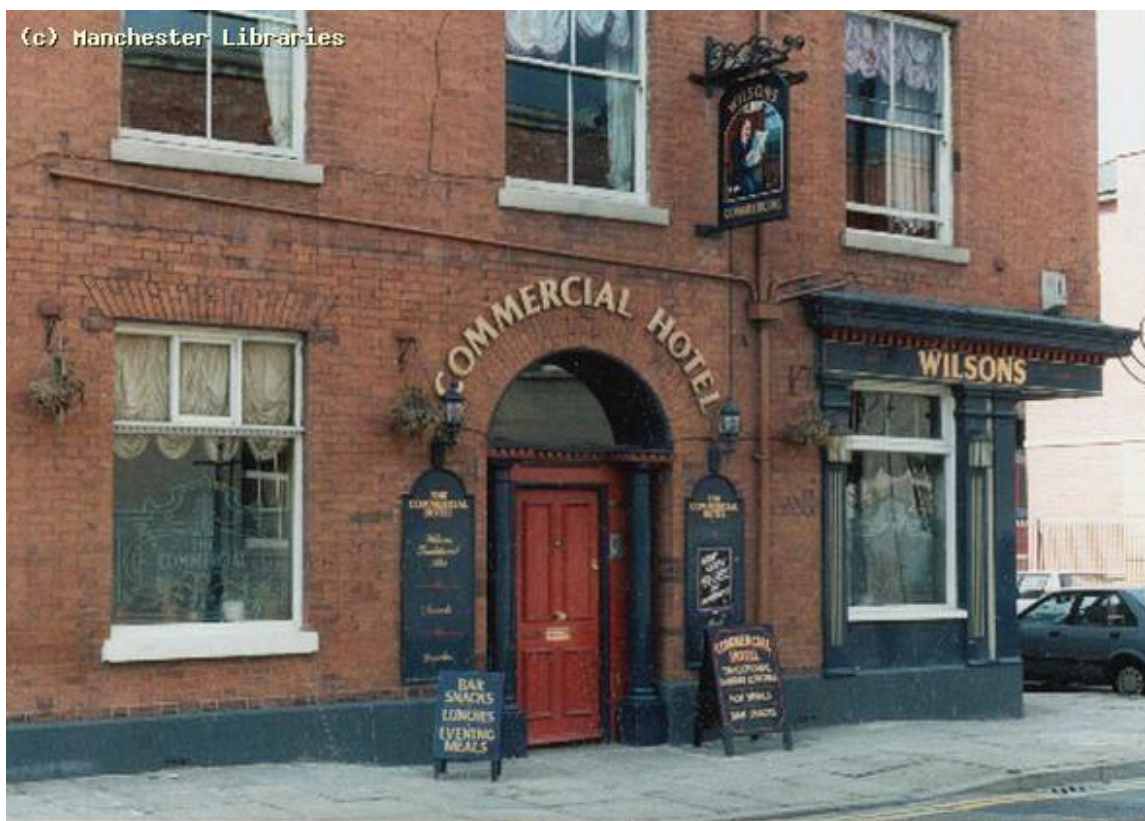
**Figure 22** – The same view as seen in 1994, showing the reintroduction of two new timber columns and a more appropriately designed timber panelled door.

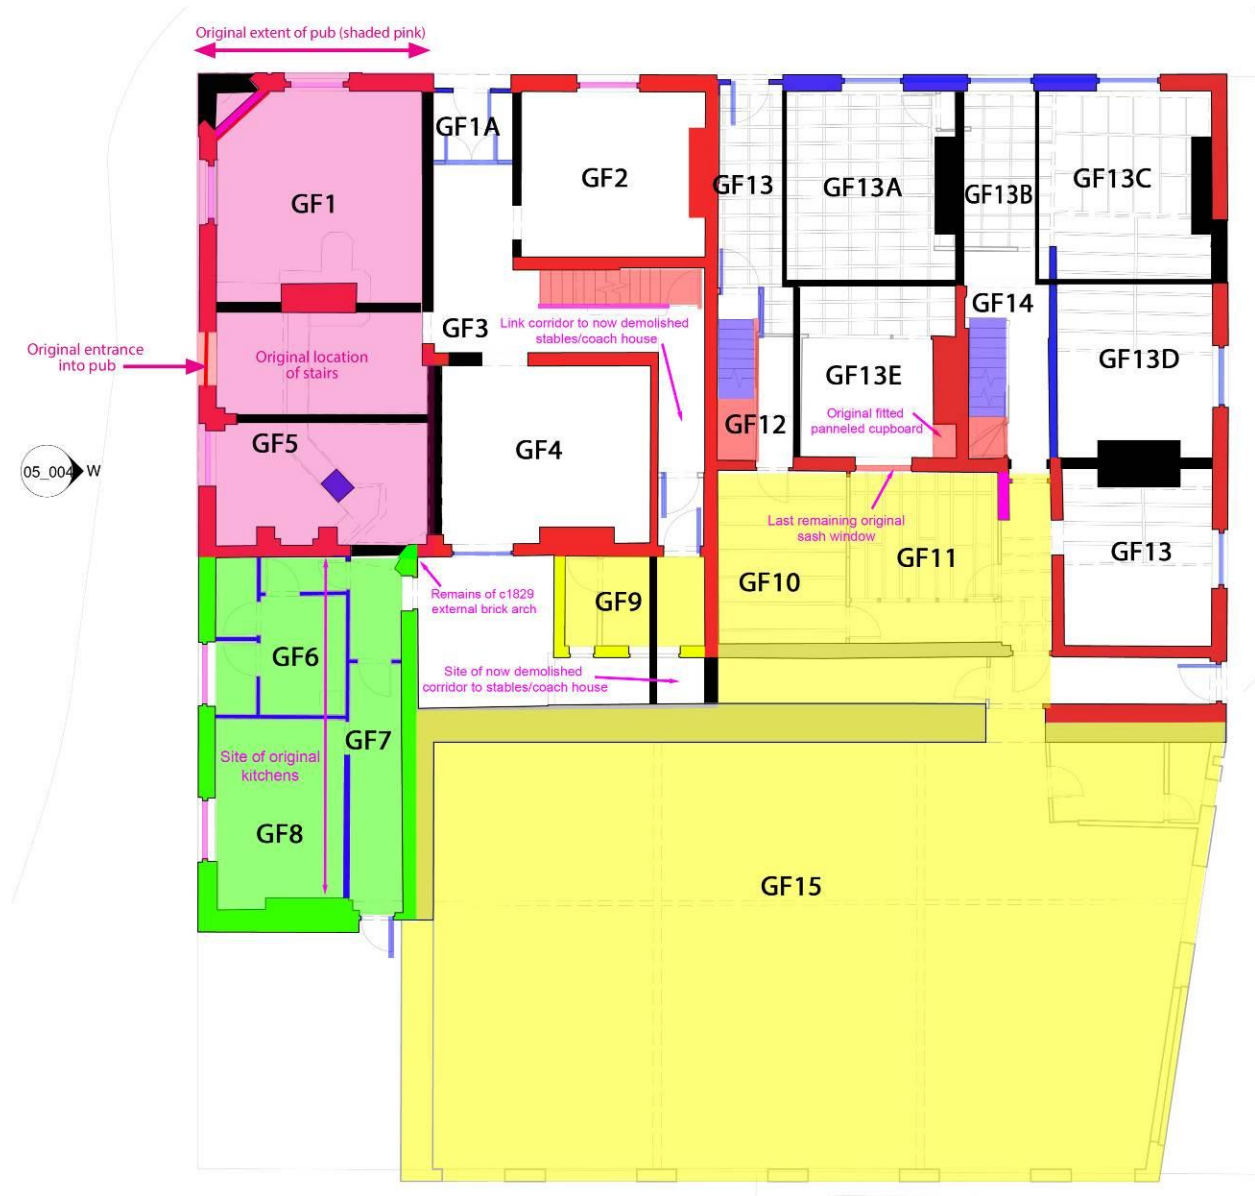
**Figure 22a – Ground Floor Morphological Plan**

**Black = Location of original wall, now removed**

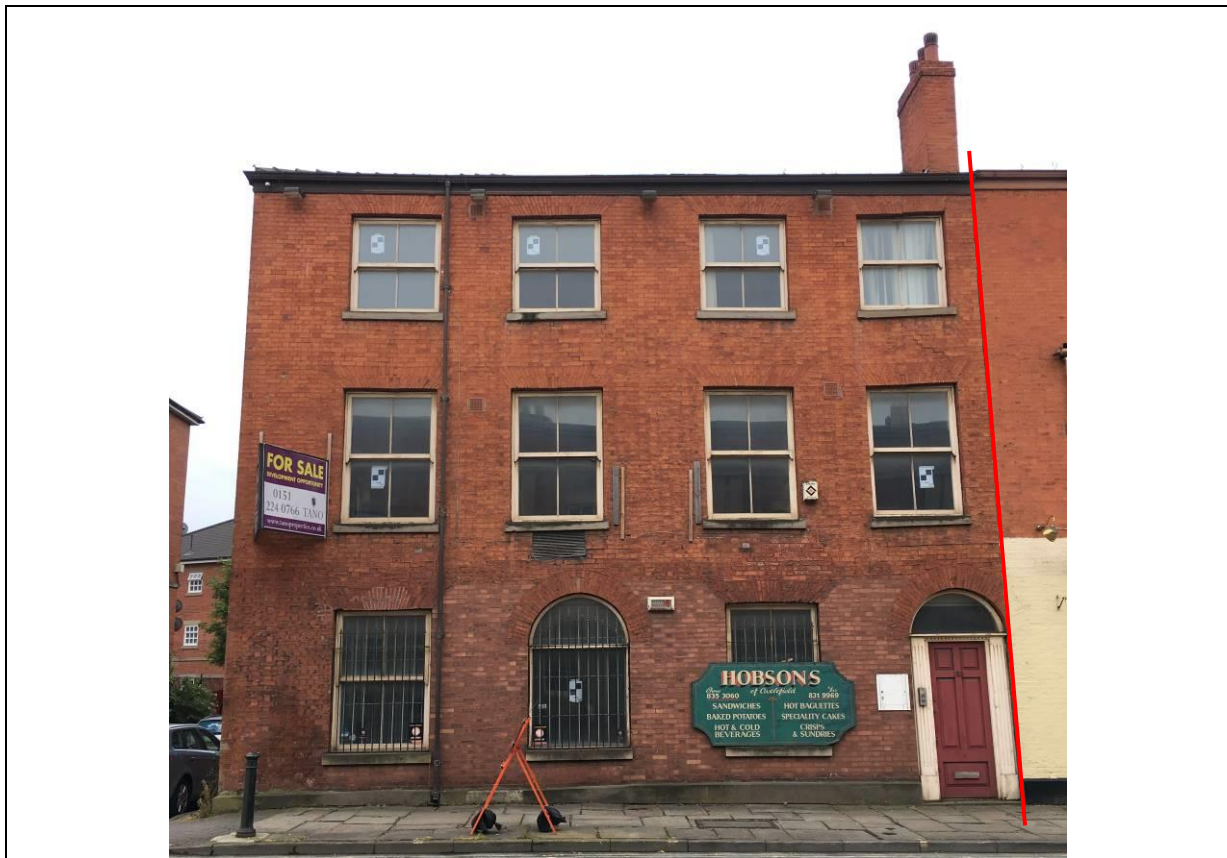
**Figure 23** – The north (front) elevation of No. 123 Liverpool Road. Note the original entrance to No. 121 now forming a window to the left, and entrance to No. 123 to the right.

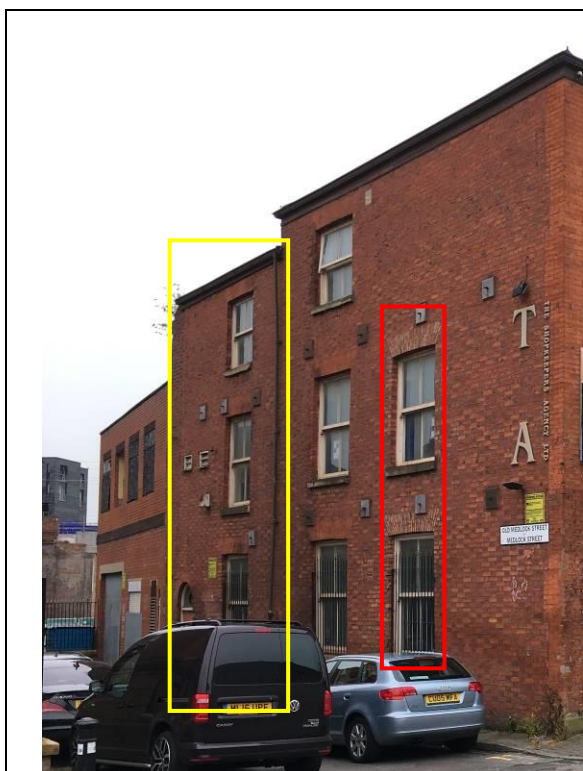
**Figure 24** – The east elevation on Old Medlock Street, showing the side aspect of No. 121 to the right with inserted windows outlined in red, and the

The east return of the building extends along Old Medlock Street (originally called Medlock Street). This elevation extends southwards and includes three separate parts. The return includes the side elevation of No. 123 (originally No. 121) and includes three flat-headed window openings to each floor, which originally would have allowed daylight into the three rear rooms on the ground, first and second floors.

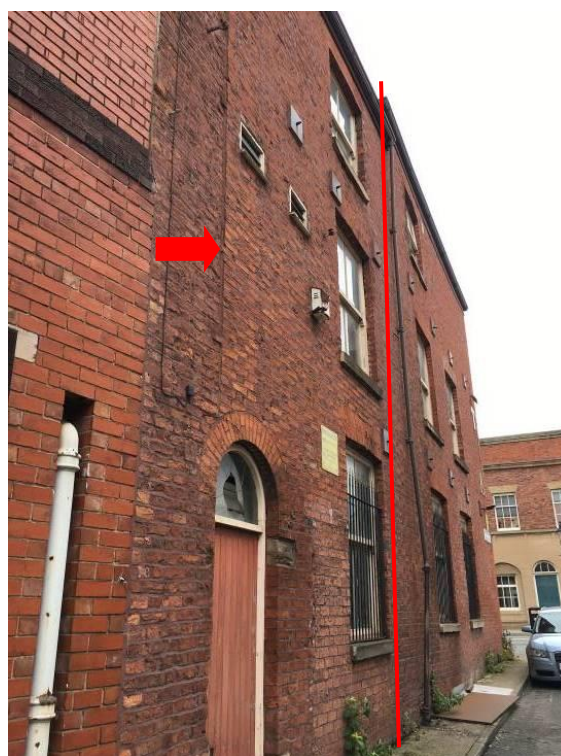
**Figure 25** – Looking north along Old Medlock Street showing the neighbouring former dwelling to the left, with original entrance into side alley.
