123 & 125  
Liverpool  
Road  
Manchester

## Addendum Heritage Statement

7<sup>th</sup> June  
2023

**123 & 125 Liverpool Road, Manchester – Addendum Heritage Statement**

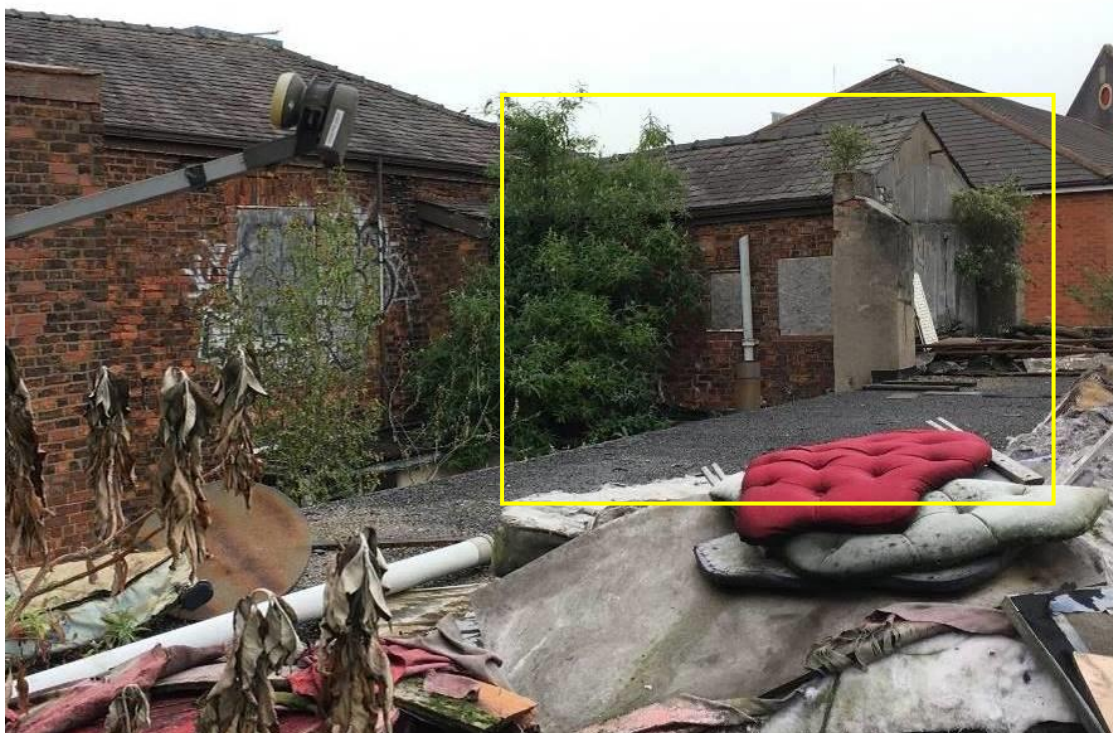
**Figure 26** – The rear (south) elevation of the building, showing the rear of the east return along Old Medlock Street to the right (outlined yellow). The areas of grey render mark the remains of the original c1829 coach house and stables.

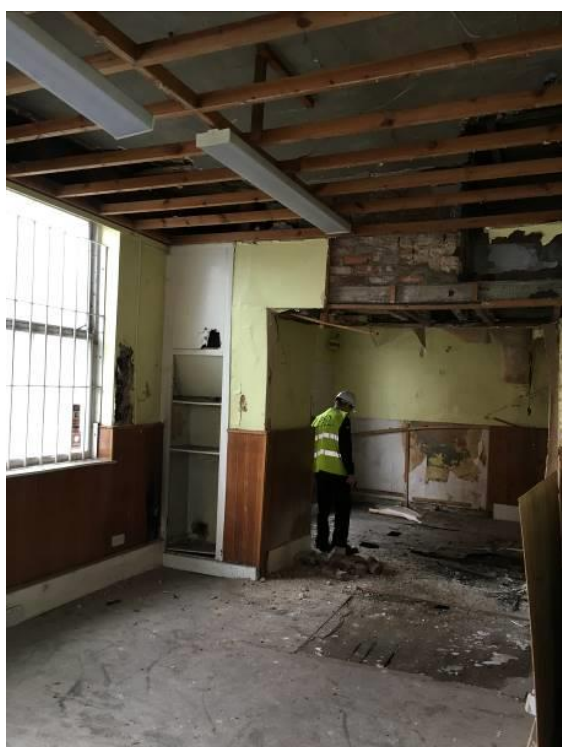
**Figure 27** – Looking east across the now combined front rooms of the buildings (GF13).

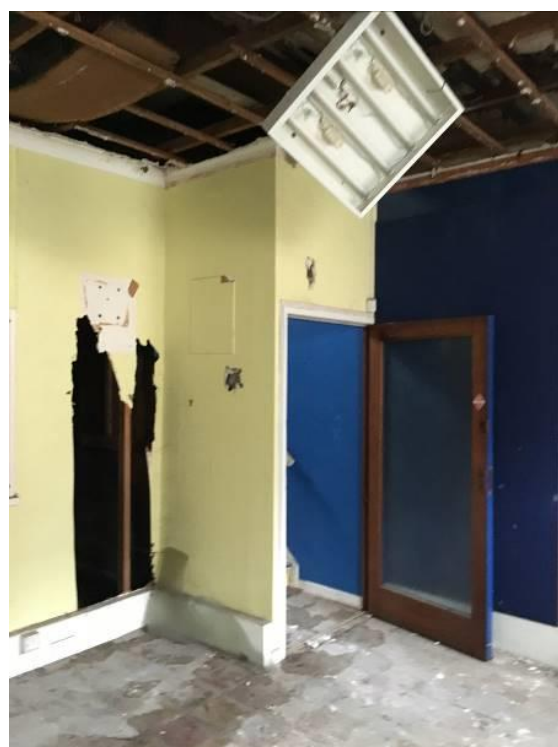
**Figure 28** – The location of the original staircase to No. 123 (GF12).

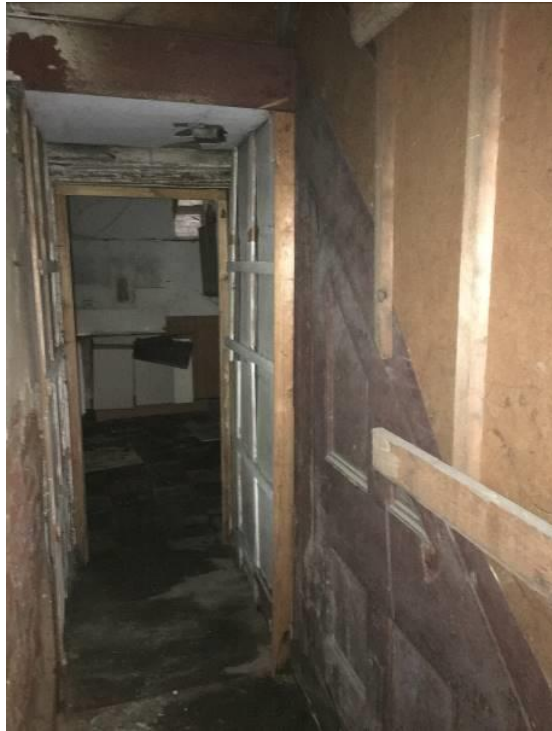
**Figure 29** – The surviving original timber panelling to the side of the staircase in No. 123 (GF12). Note the original access to the basement beside the panelling is blocked.

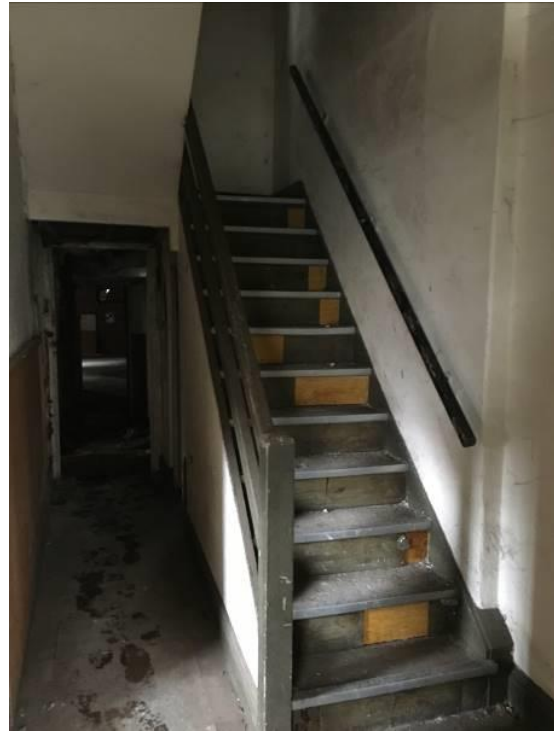
**Figure 30** – The modern staircase inserted in the location of the original example at what was No. 121 (GF14).

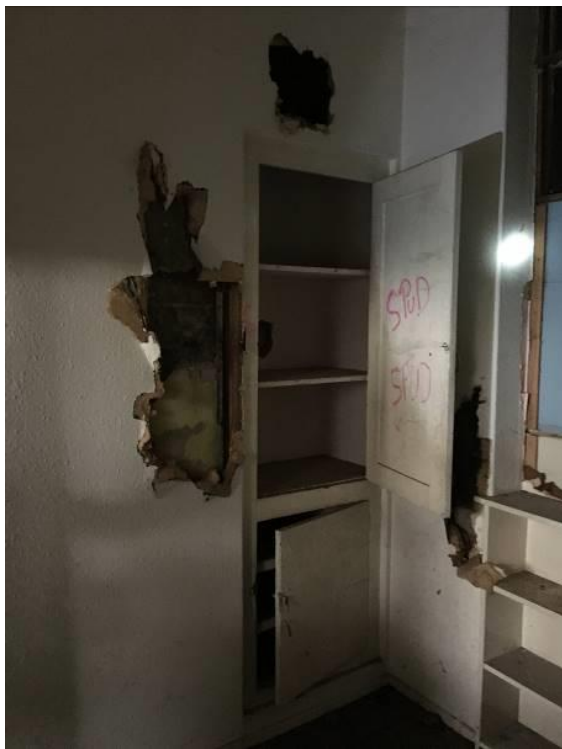
**Figure 31** – The surviving original, hand made,

panelled alcove cupboard to the rear room of No. 123 (GF13).

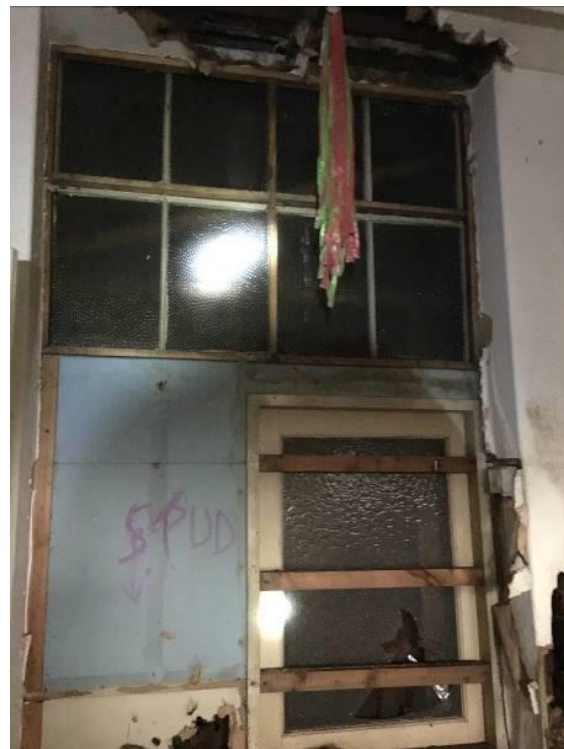
**Figure 32** – The last surviving original eight-over-eight

sash window within the building located in the rear room of No. 123 (GF13).

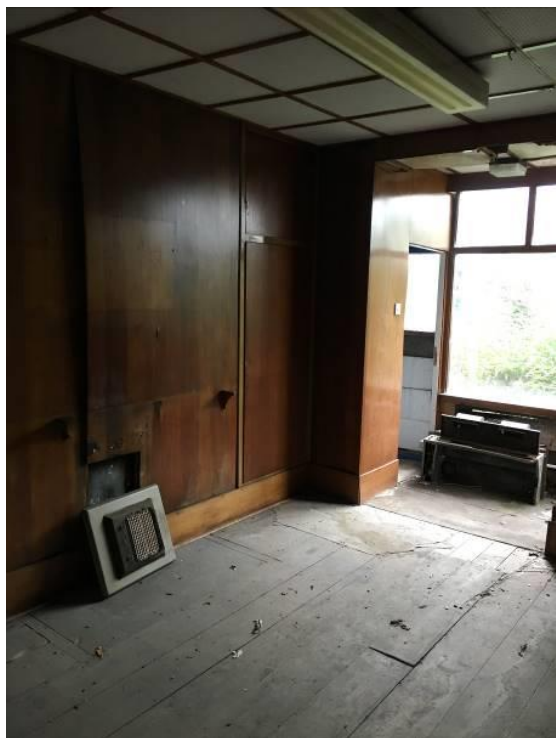
**Figure 33** – The rear room on the first floor, showing the 1950s panelled interior and glazed extension (1F17).

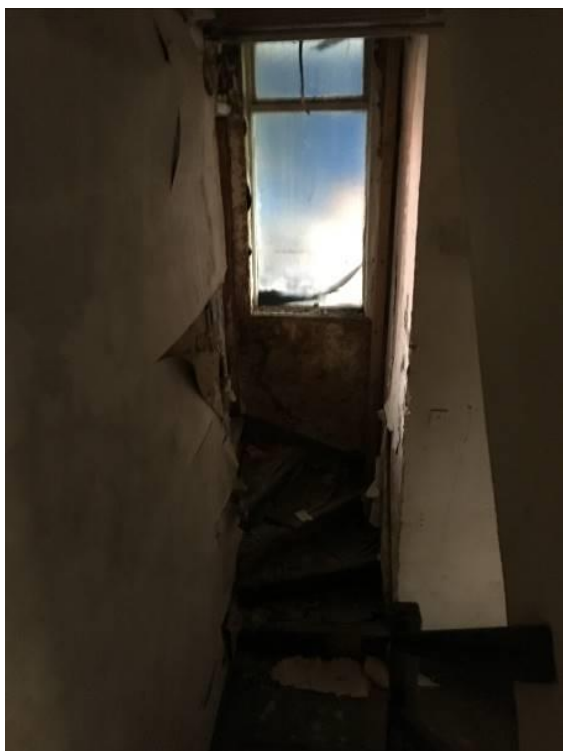
**Figure 35** – The first floor landing of No. 123, showing the later inserted steps into the first floor level of the building.

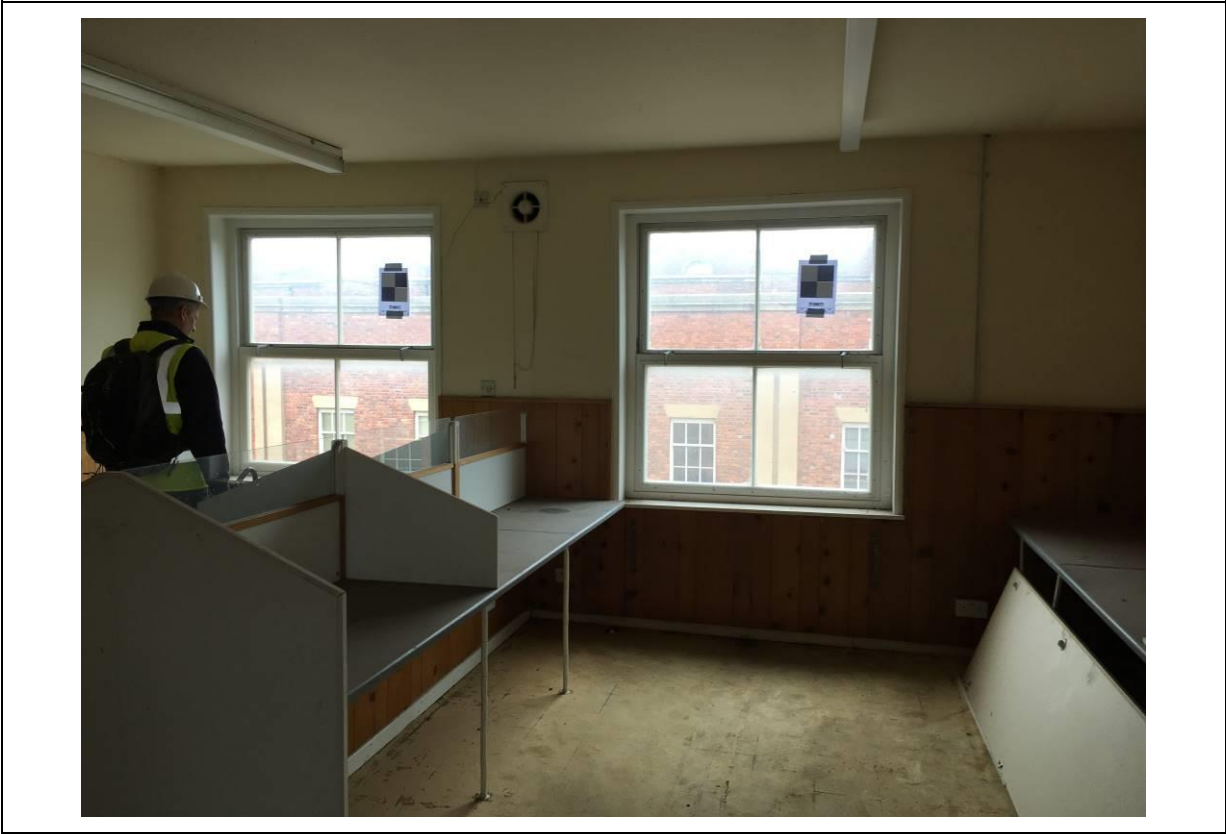
**Figure 38** – Second floor looking towards the front of what was No. 121. (2F14)

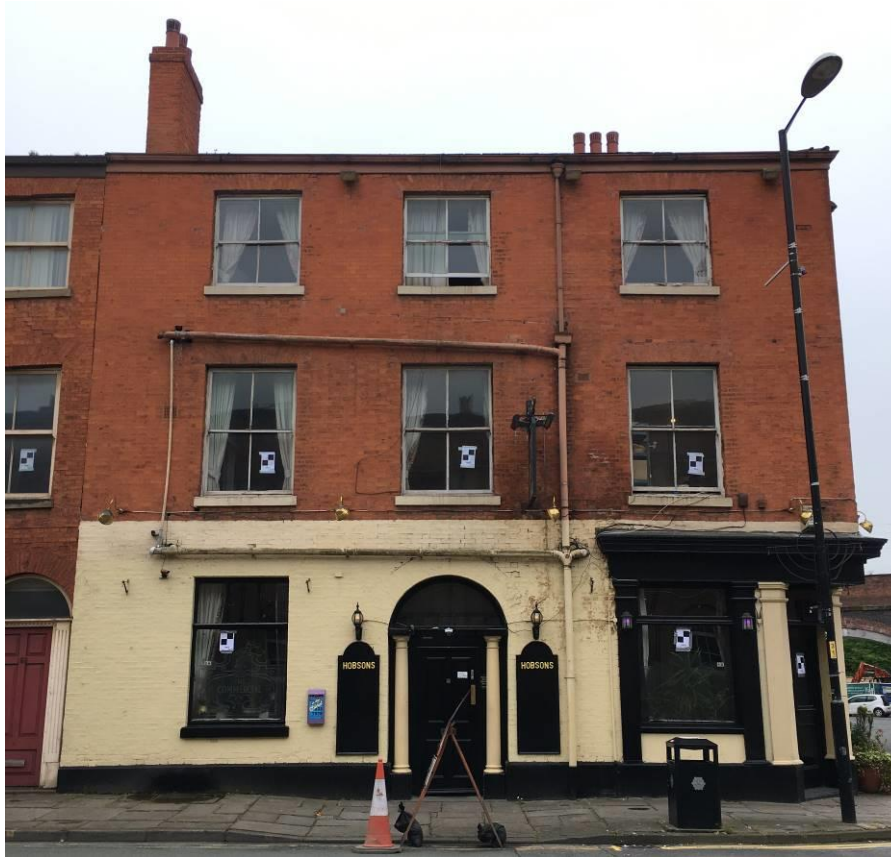
**Figure 39** – The front (north) elevation of the Commercial Hotel (No. 125 Liverpool Road).

The principal elevation of the Commercial Hotel fronts onto Liverpool Road. The building is double-fronted, with a central entrance door contained within a wide, brick-voussoir arch. The original panelled door and side columns have since been replaced. Flanking the entrance are two flat-arched window openings, also using rubbed-brick voussoirs.

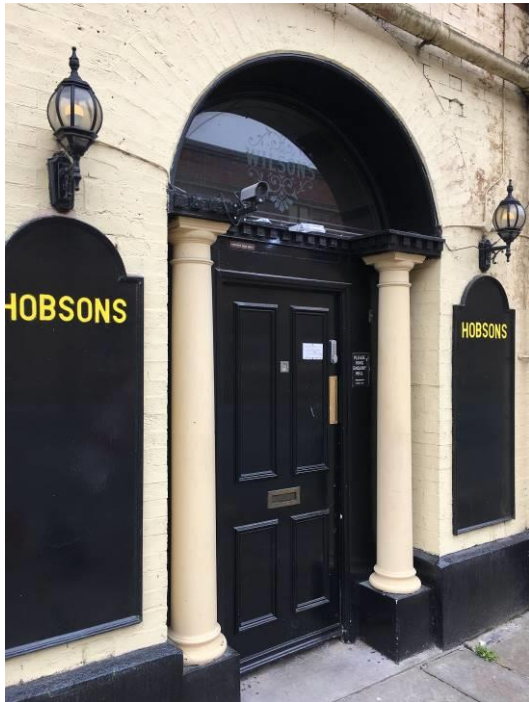
**Figure 40** – The original entrance into the hotel, showing the partial survival of classical door case.

| <b>Principal entrance to No. 125</b> | Replace door | No change | (A - 2018)<br><br>Existing door is not original.<br><br>Negligible beneficial |

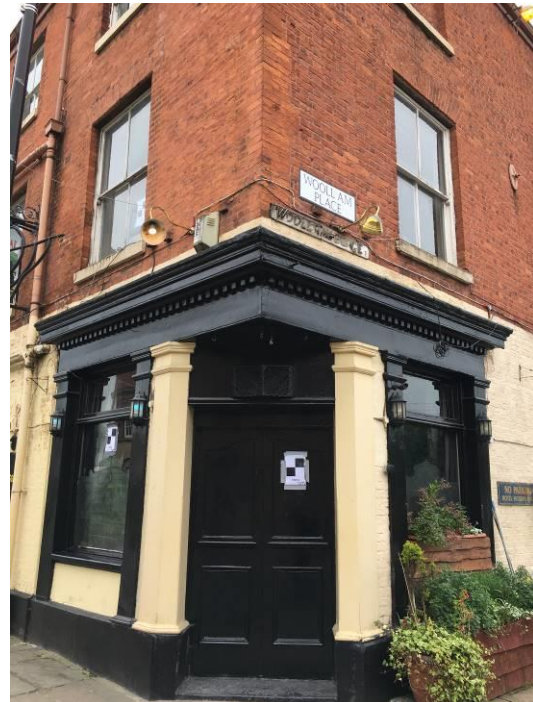
As part of this refurbishment, the distinctive corner entrance was inserted in order to provide a direct entrance into the bar area. This alteration included the removal of the original matching ground floor windows to Liverpool Road and Woollam Place, and their replacement with large plate glass windows which form a 'shop front'.

**Figure 41** – The c1890s inserted corner entrance and bar shop fronts on the corner of Woollam Place.

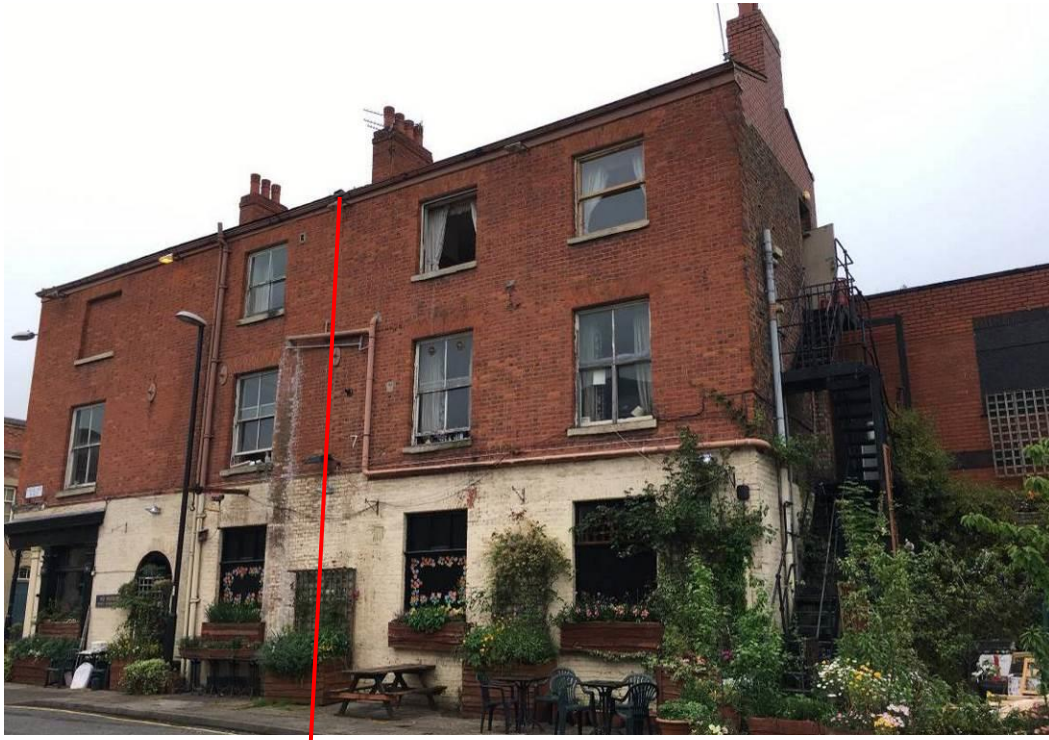
This elevation originally matched that of the Liverpool Road elevation and contained a central doorway within a brick arch and flanked by two sash windows. The first and second floor levels contained three window openings, the middle window to the first and second floors were bricked-up when the c1836 extension was erected to the south to allow for circulation into the new extension from the existing hotel (see Figures 8 & 9, which show the c1830 view of the hotel).

**Figure 42** – The west return elevation along Woollam Place, showing the c1836 extension undertaken by William Westall to the right of the red line. (see Figures 8 & 9, which show the c1830 view of the hotel).

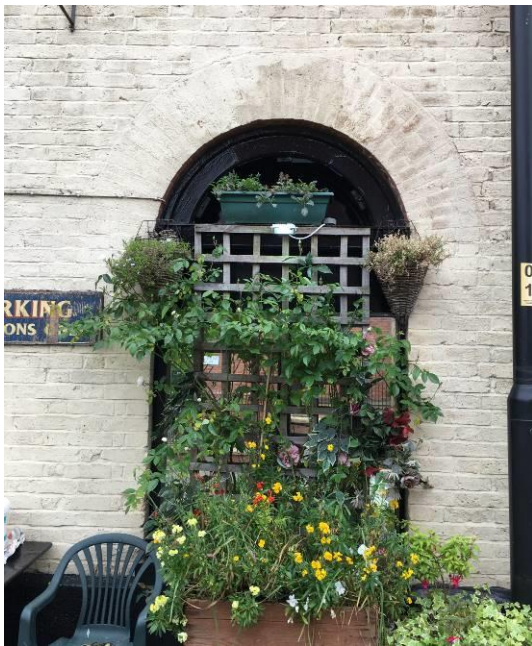
**Figure 43** – The now blocked central entrance on Woollam Street (see Figures 8 & 9, which show the c1830 view of the hotel).

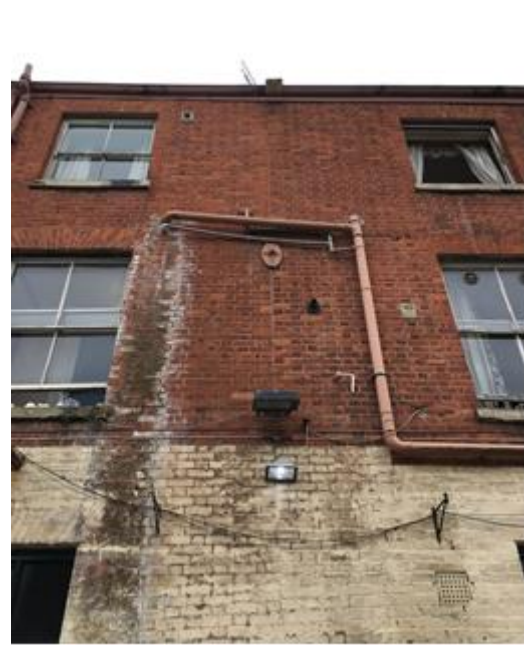
**Figure 44** – The vertical joint between the c1829 hotel to the left, and the c1836 extension to the right. (see Figures 8 & 9, which show the c1830 view of the hotel).

Between the rear of the original hotel and the extension is a clear vertical joint, which extends from part way up the ground floor level to the eaves, indicating the location of both building periods.

At ground floor level, a vertical joint is partly not present, indicating that originally a single-storey outhouse or garden wall was attached to the rear of the hotel, and that parts of that wall on Woollam Place was retained and built upon to create the extension.

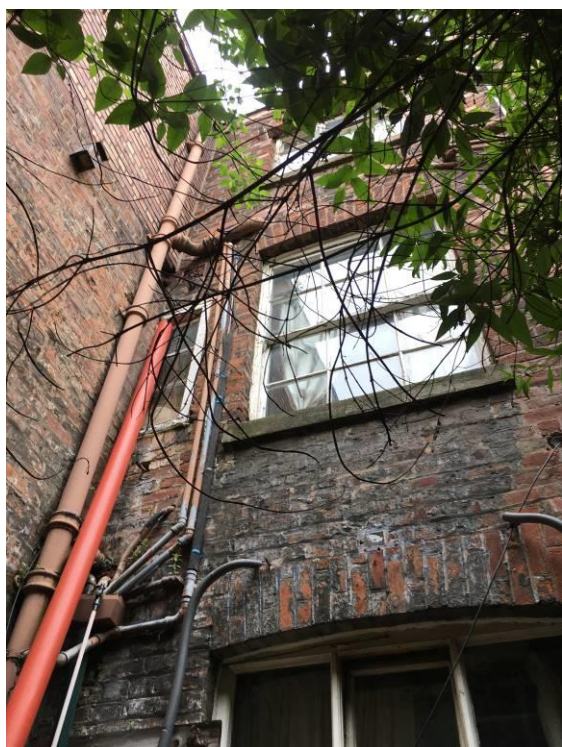
**Figure 45** – The rear (south) elevation as seen from the central courtyard space. The structure to the left forms the rear of the 1836 extension.

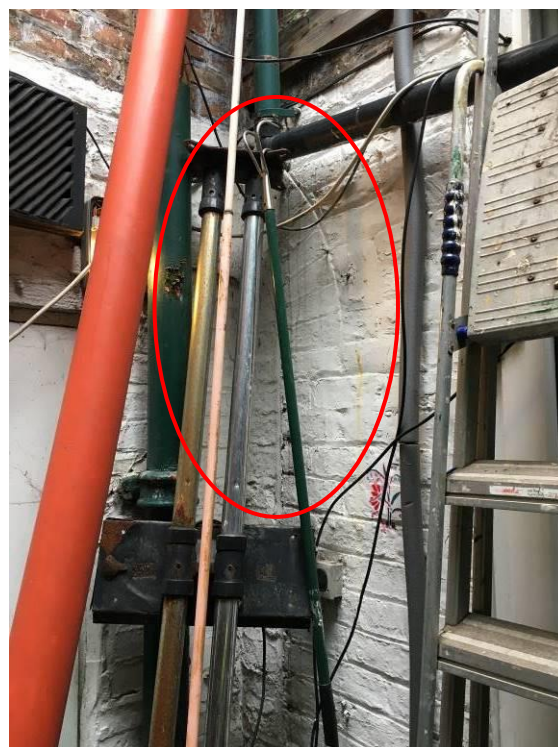
**Figure 46** – A detail of the junction between the original c1829 hotel to the right, and the c1836 extension to the left, showing an original round-headed arched door opening (circled red) from the hotel into the rear yard, which was blocked when the extension was built.

To the centre of the site is an external courtyard, which is enclosed to the west by the c1836 extension, and to the south by the c1950s/60s factory. This external space provides further evidence of the c1836 extension and retains the remains of a now bricked-up original door opening from the ground floor of the original hotel out into the yard. This doorway was blocked when the c1836 extension was constructed.

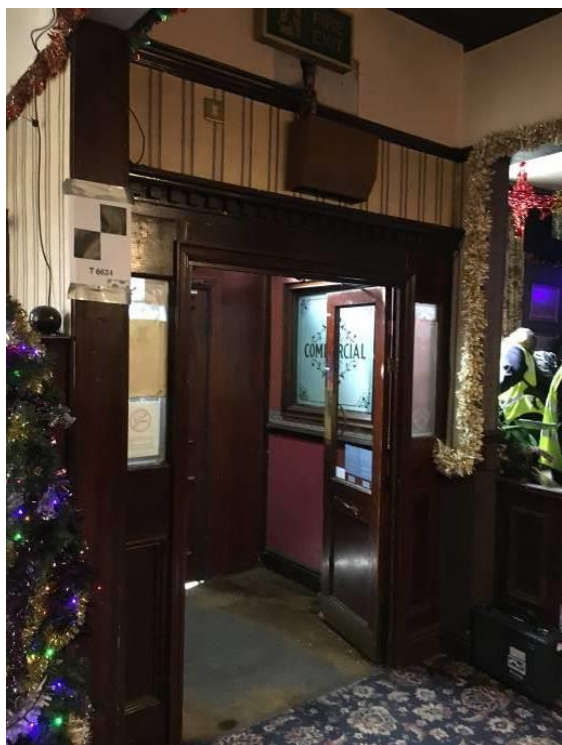
**Figure 49** – The altered entrance vestibule. (GF1A)

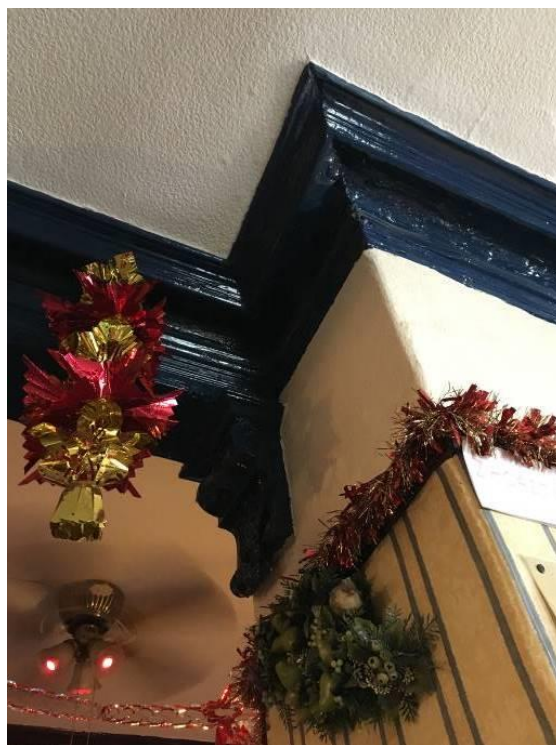
**Figure 50** – The former chimney alcove to the corner bar to the west, showing the later removal of a wall and insertion of decorative corbel.(GF1)

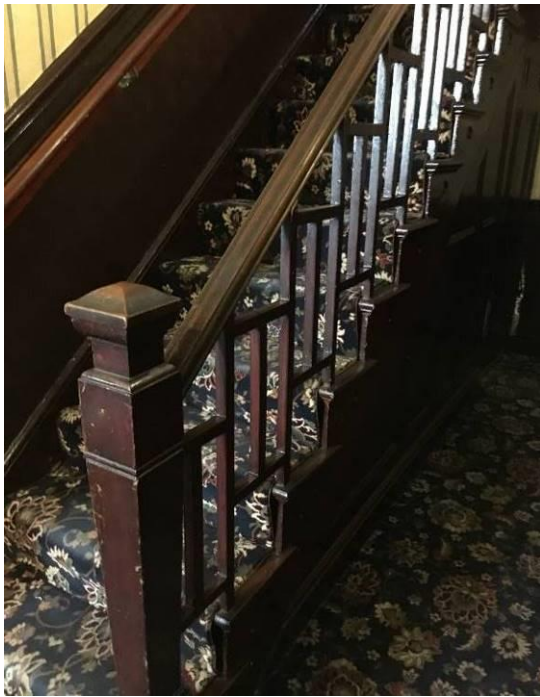
The main staircase dates to the original construction of the building, however the section between ground and first floors was altered in the late-19<sup>th</sup>/early-20<sup>th</sup> century when the hotel was modernised.

**Figure 52** – The altered c1890s-1900s staircase (GF3).

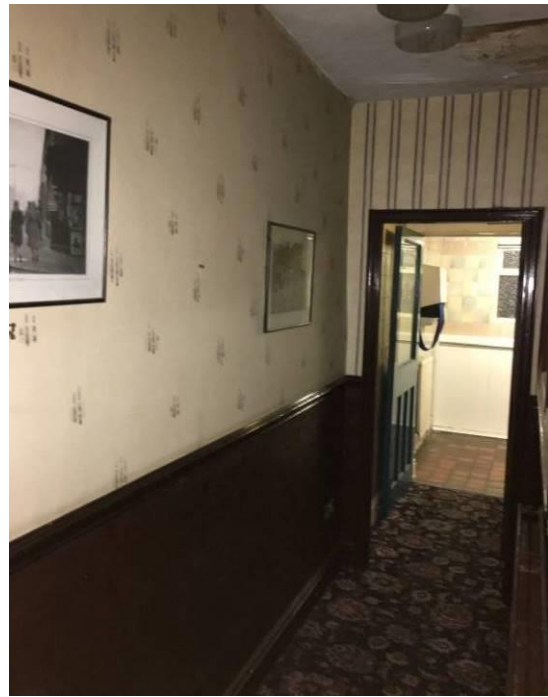
**Figure 53** – The rear corridor (GF3) which would originally have linked the hotel to the original rear buildings in the yard. This corridor was removed when the stables were demolished and now lead into a modern toilet (GF9).

This corridor arrangement can also still be seen directly below on the ground floor, where the corridor remains but now terminates at a modern toilet block (see Figure 53).

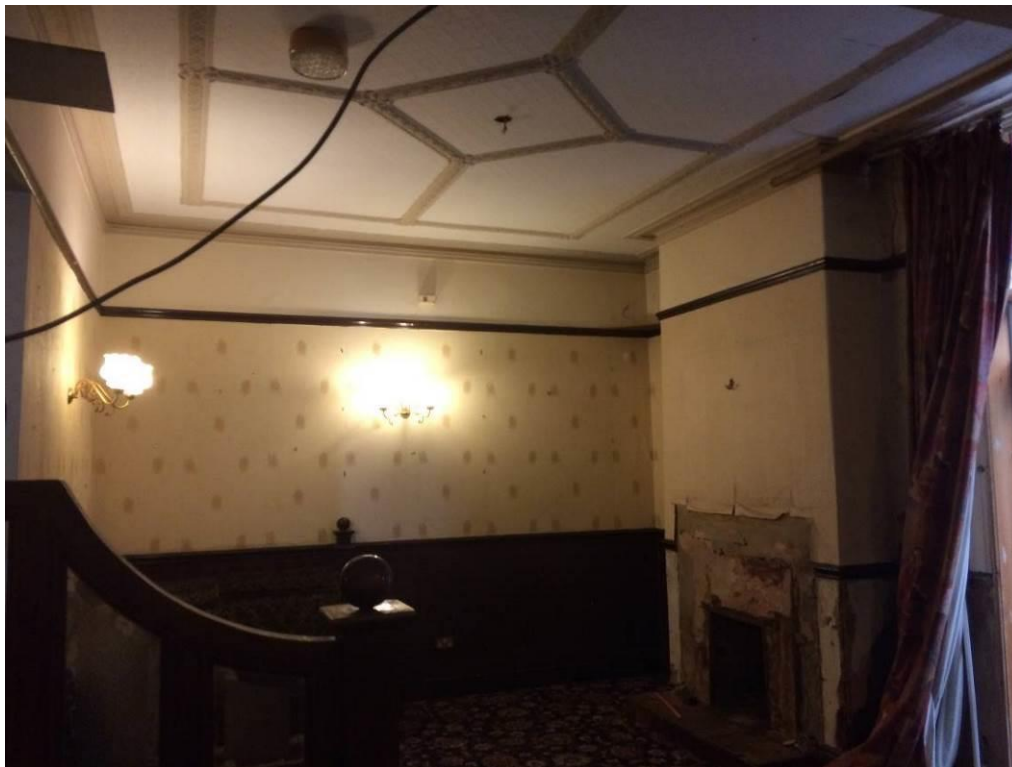
**Figure 54** – The rear (south) reception room (GF4), showing the original plaster cornice and 19<sup>th</sup> century

plaster ceiling border decoration. The door to the right leads into the small courtyard and was formally a window.

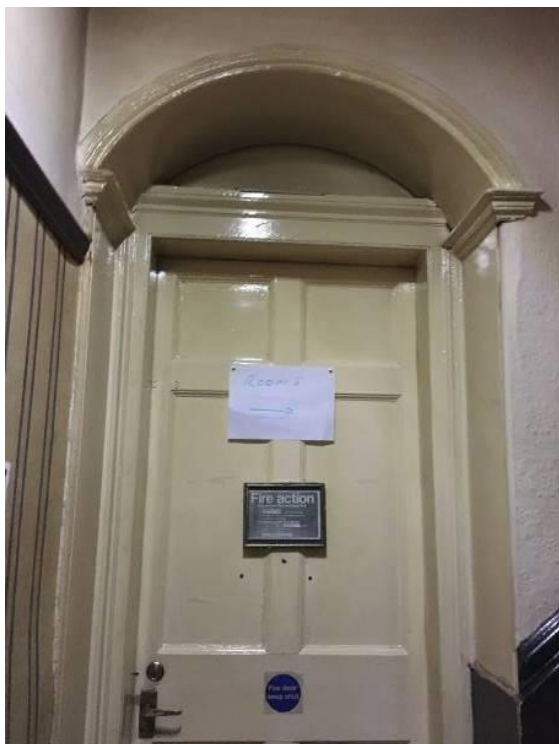
**Figure 55** – The mid-landing doorway which originally led up into a link corridor connected to the first floor level of the now demolished rear stables/coach house building. Now a foreshortened cupboard (1F05).

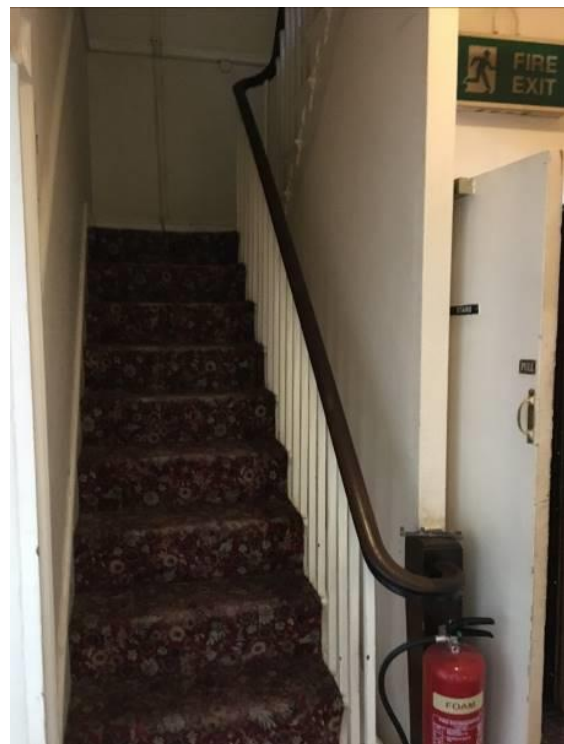
**Figure 56** – The original c1829 staircase at first floor level. (1F04)

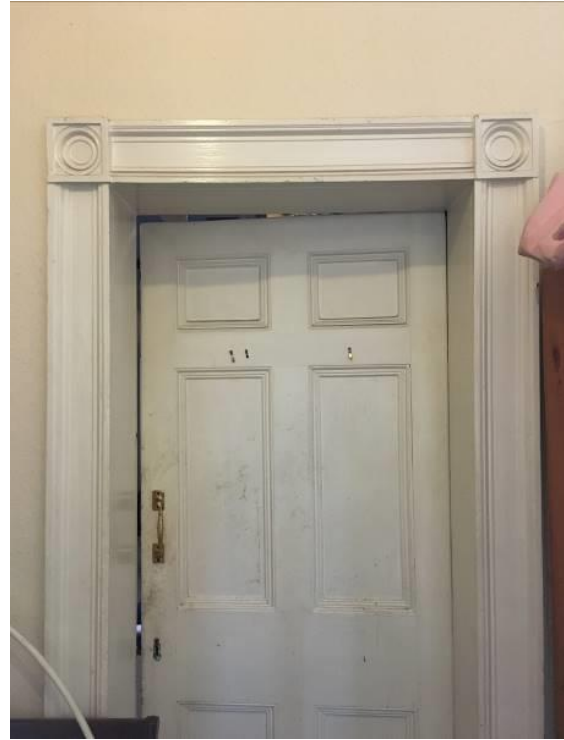
**Figure 58** – An original six-panelled door and distinctive architrave with circular corner blocks on the first floor corridor (1F07) leading into 1F08.

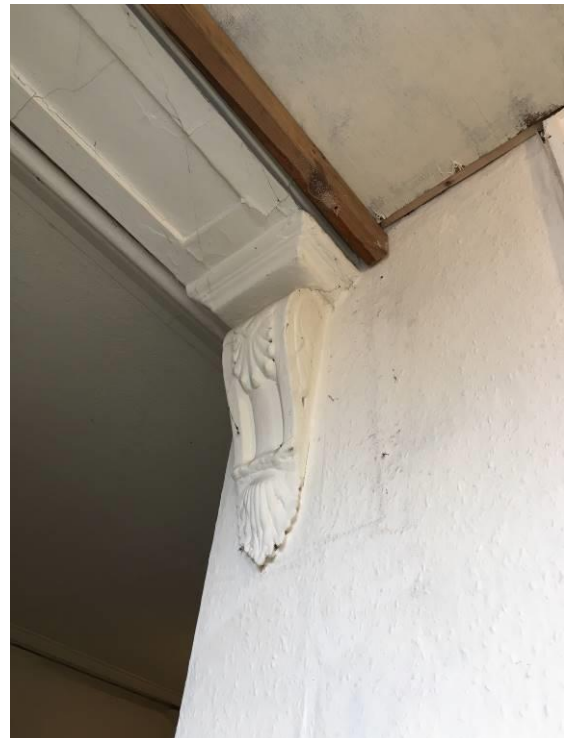
**Figure 60** – The c1836 plaster corbel inserted into the new link corridor to the rear extension 1F07.

The start of the corridor was marked by two decorative scrolled plaster corbels, featuring acanthus leaves (one corbel now missing) and flat arch, both contemporary with the c1836 alterations. The plaster cornice to this corridor is also contemporary to this date.

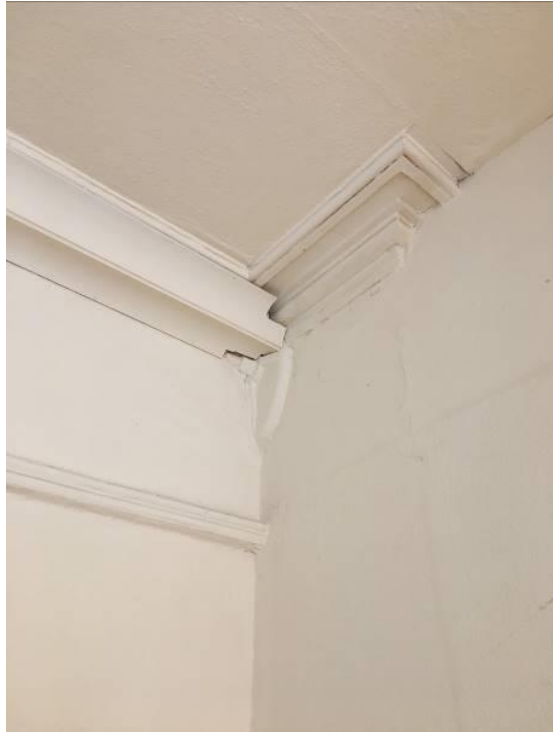
**Figure 61** – A section of original plaster cornice around the chimney breast of the former commercial room, which is now largely concealed by a modern partition dividing the room into two, as viewed from the eastern side of the partition (1F02).

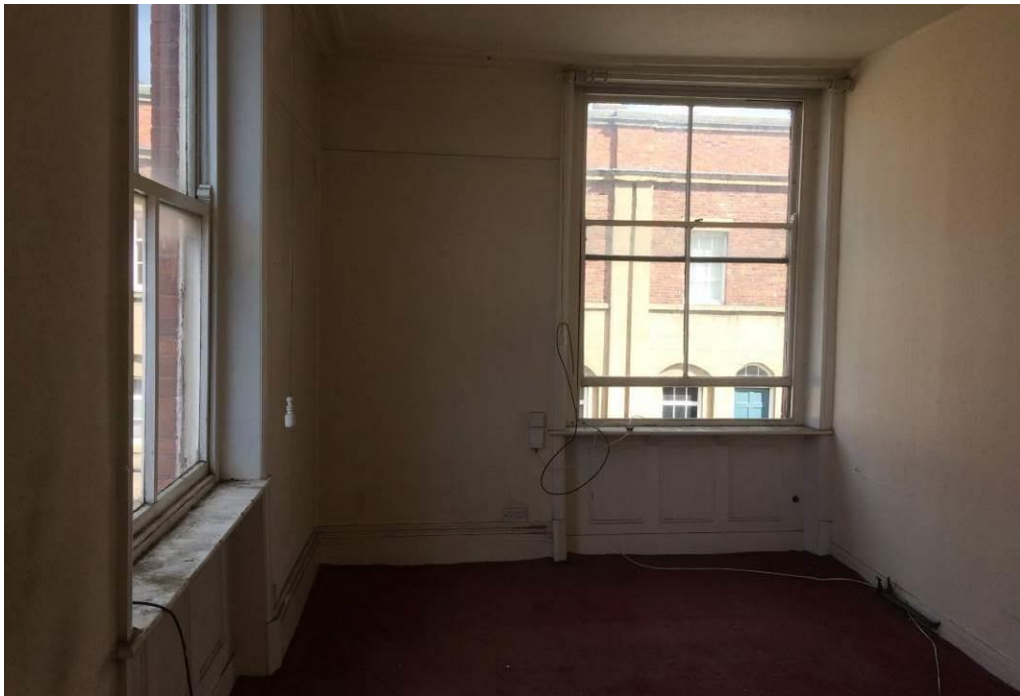
**Figure 63** – Looking north into the former commercial room (1F01), showing the original timber panelling beneath the window. The wall on the right is a modern partition which divides the original room into two halves with the adjacent 1F02.

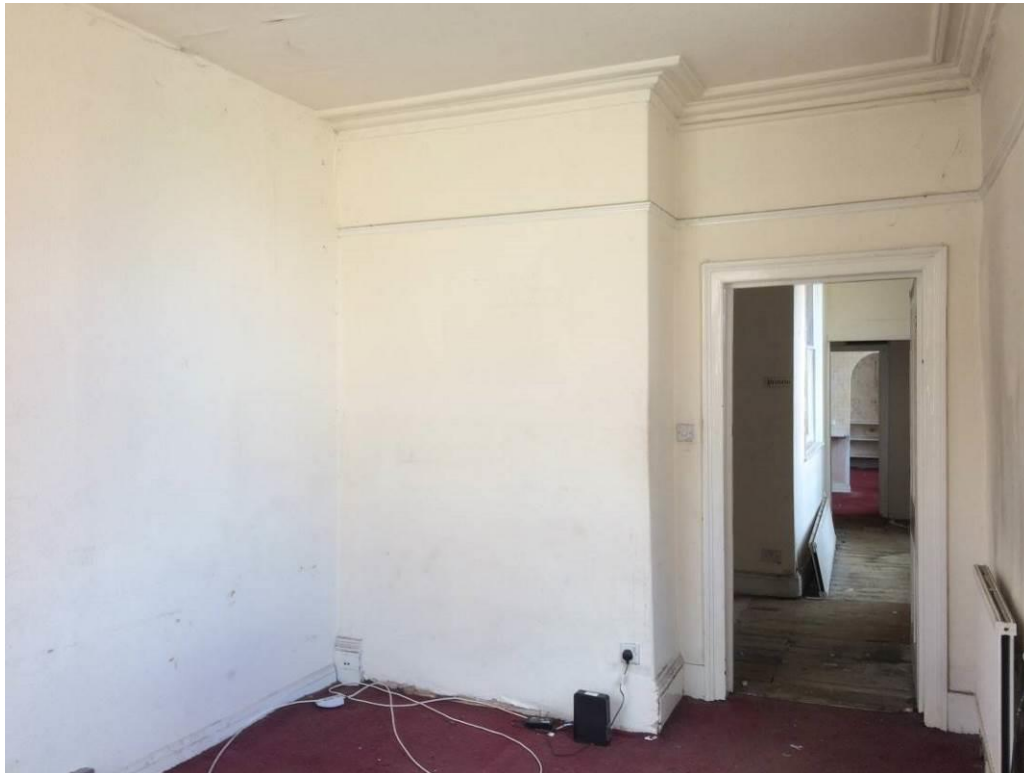
**Figure 64** – Looking south across the former commercial room (1F01), showing the original chimney breast and doorway. The wall on the left is a modern partition which divides the original room into two halves with 1F02.

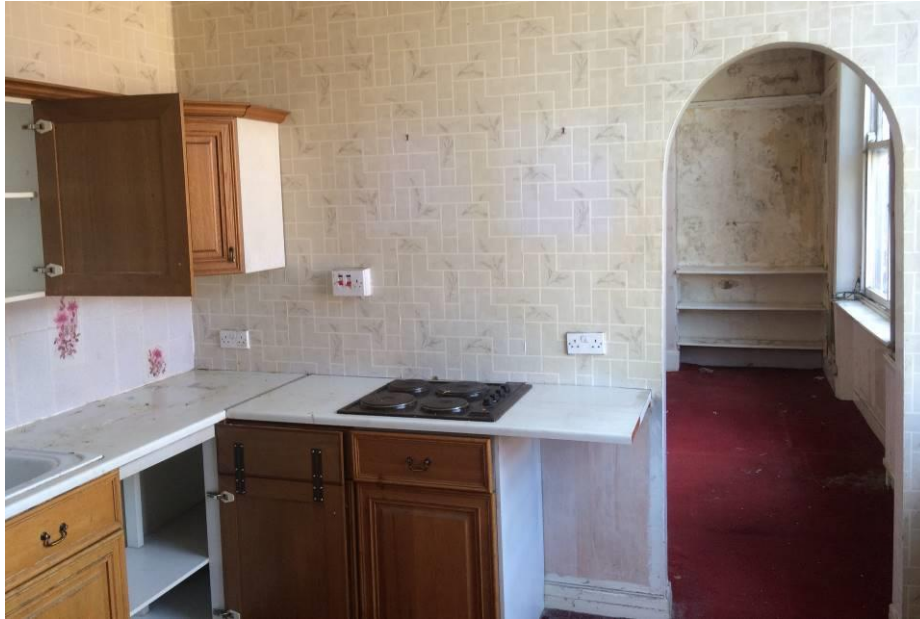
**Figure 64a** – Looking south from 1F10 into 1F11 which was originally one large room probably used as a commercial room or sitting room for guests. Beneath the two sash windows to the right is similar timber panelling as found in the neighbouring rooms 1F01 and 1F02.

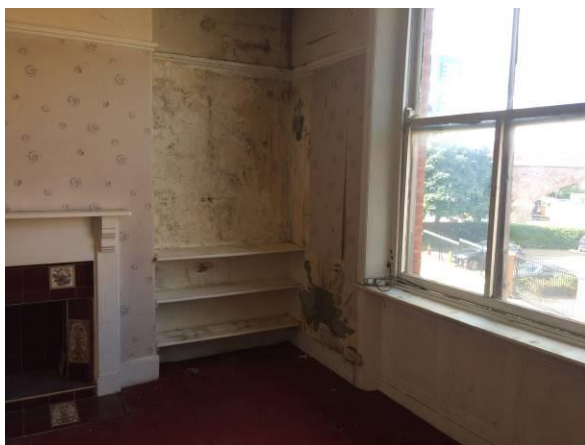
**Figure 64b** – The corner of the room (1F11), showing the Victorian fire surround and panelling.

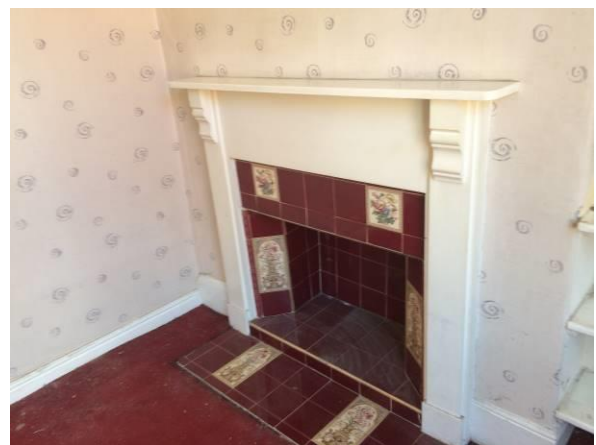
**Figure 64c** – The Victorian fire surround, showing the inserted modern partition wall to the left (1F11).

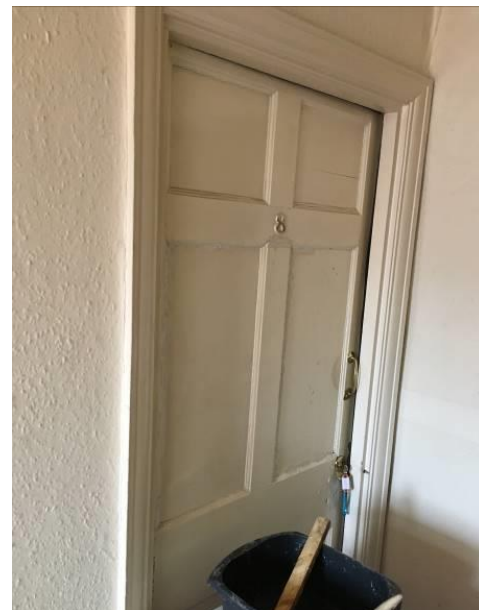
**Figure 68** – An early six-panelled door located in the c1836 extension (2F10), which has been relocated

[leading into 2F12.](#)

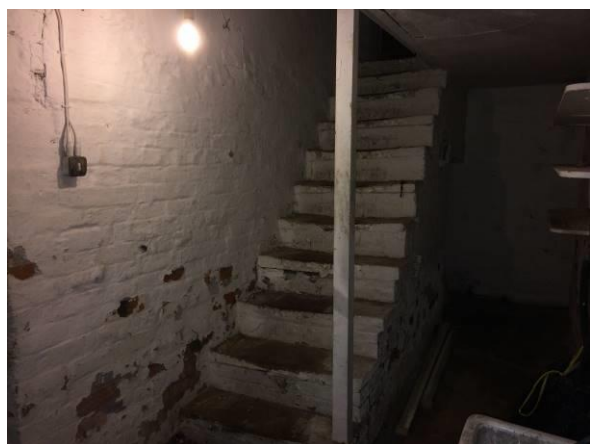
**Figure 69** – The original stone and brick basement steps.

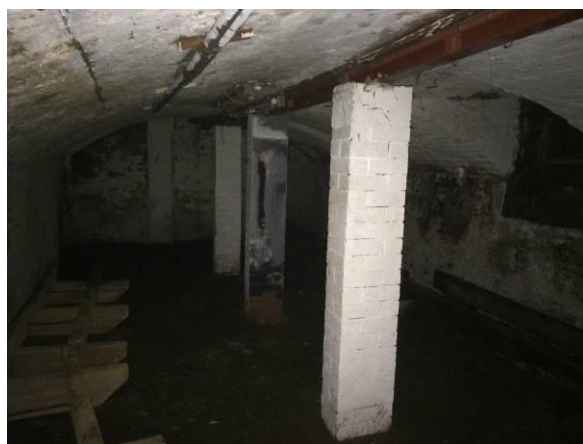
**Figure 70** – Looking south into the barrel-vaulted basement room.

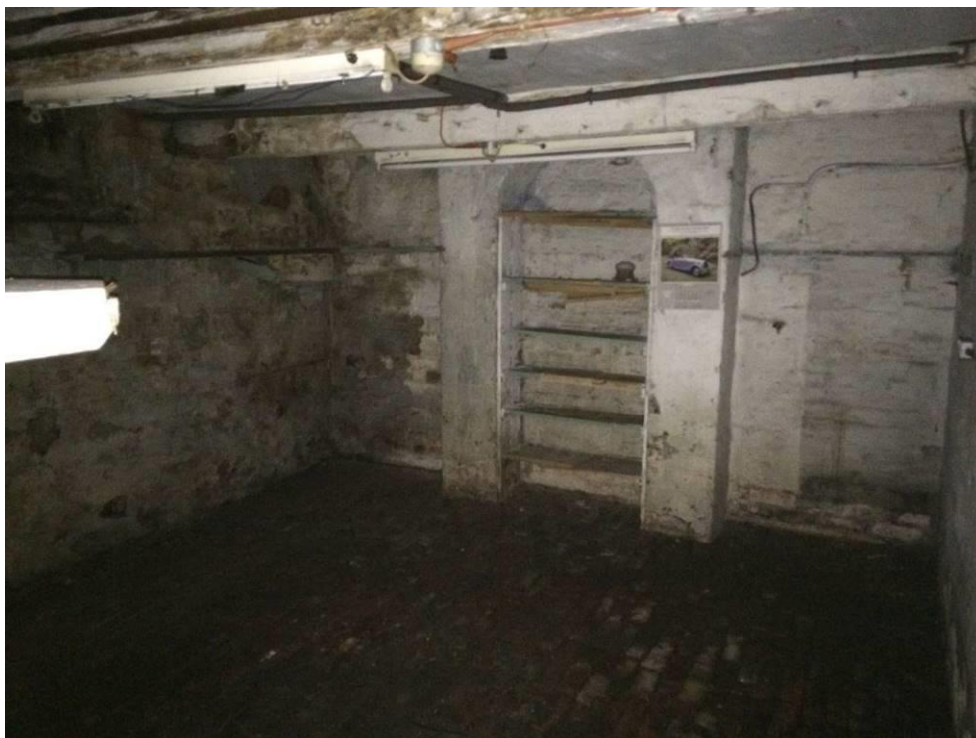
**Figure 71** – The cellar room below the eastern bar room (GF2).

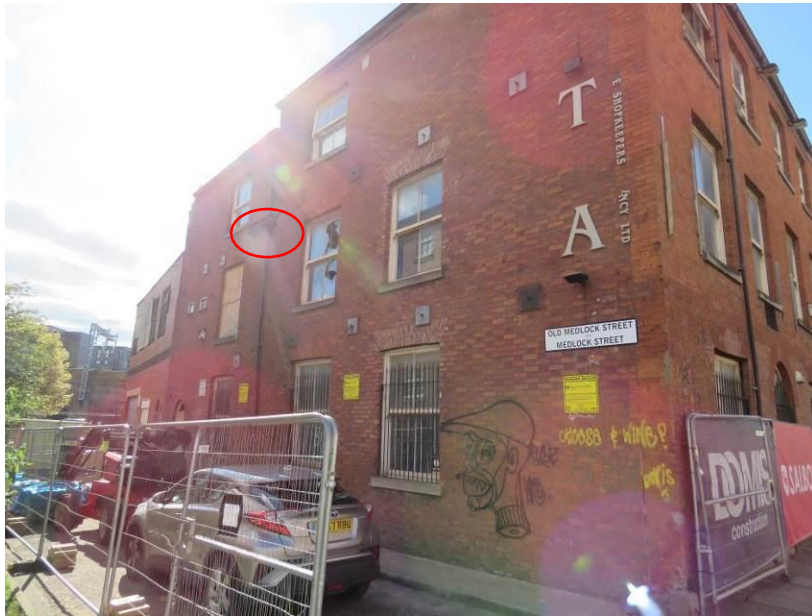
Since consent for the current scheme was granted in 2018 there has been no alterations to the external elevation of No. 125 apart from the emergency works to the east elevation (See Figure 73).

**Figure 73** – Looking south along the east elevation, showing the recently completed emergency stabilisation works (circled).

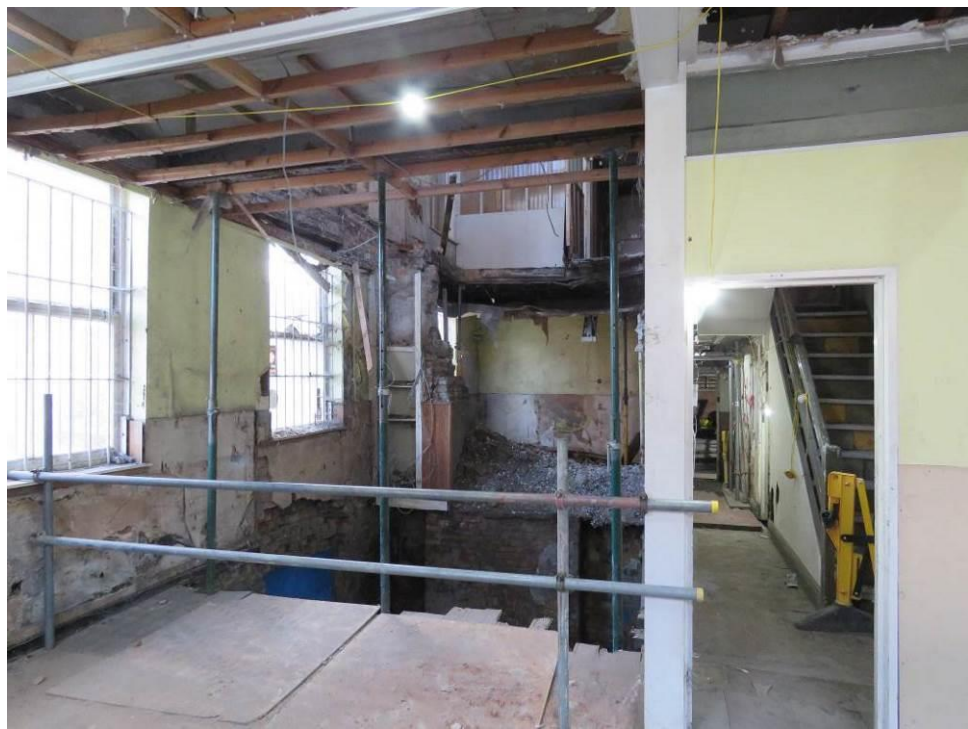
Figure 76 – Looking south through the eastern part of GF13 showing the large area of collapse from second to basement floor levels.

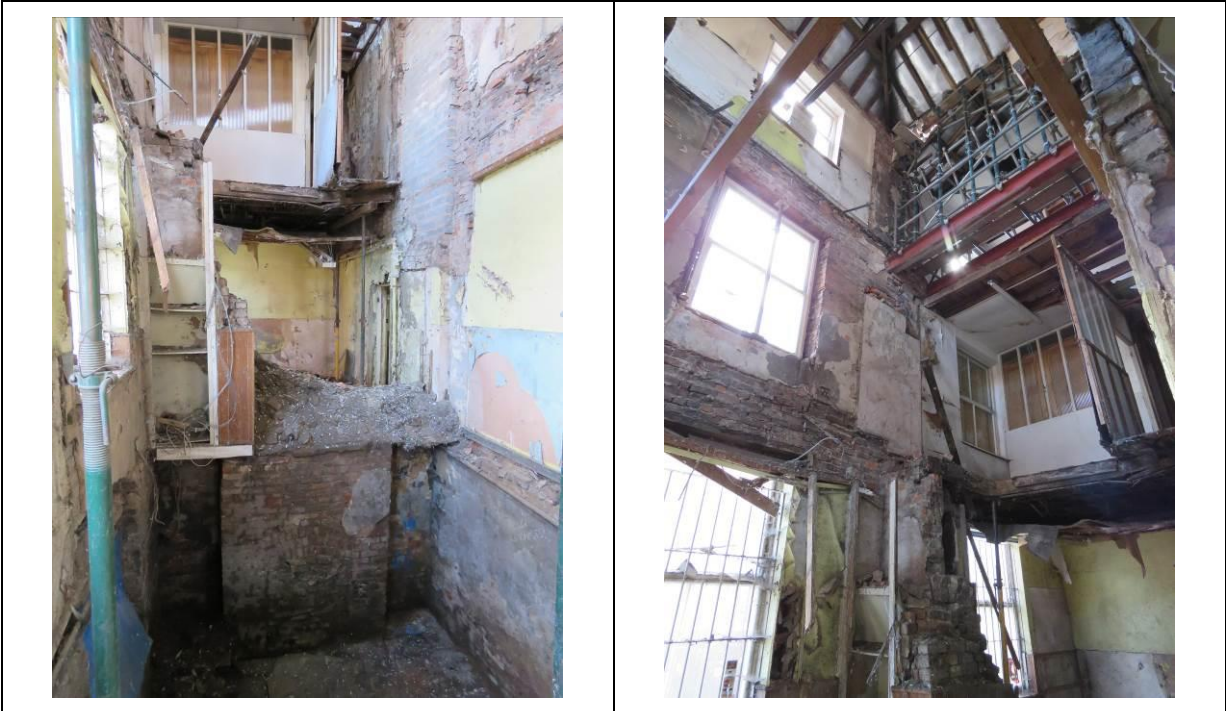
Figure 78 – Looking towards the southern end of the area of collapse (GF13).

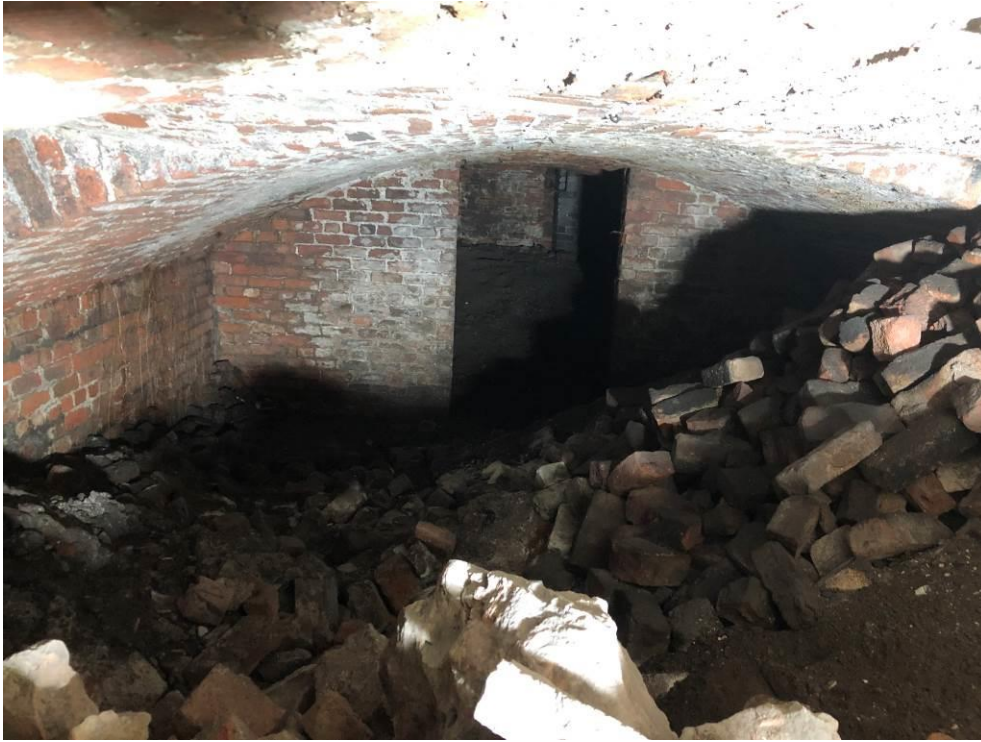
**Figure 83** – A view looking east into one of the newly discovered subterranean chambers beneath the 1950s/60s building, which originally formed part of the basement of the original coach house and stables.
