123 & 125  
Liverpool  
Road  
Manchester

## Addendum Heritage Statement

7<sup>th</sup> June  
2023

**123 & 125 Liverpool Road, Manchester – Addendum Heritage Statement**

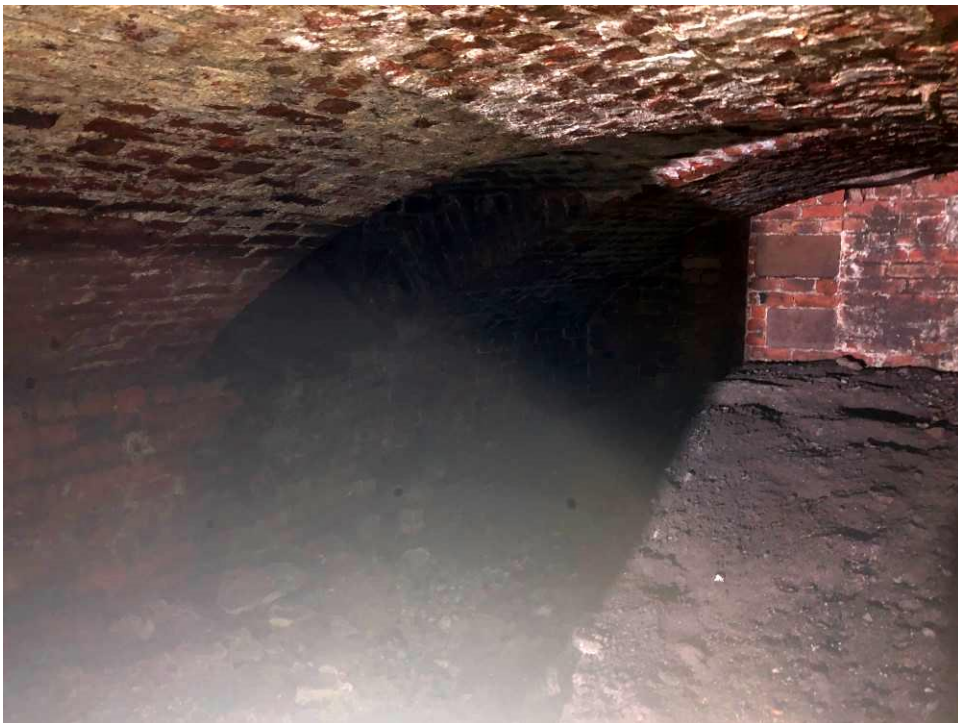
**Figure 84** – A view further east into one of the newly discovered subterranean chambers beneath the 1950s/60s building.

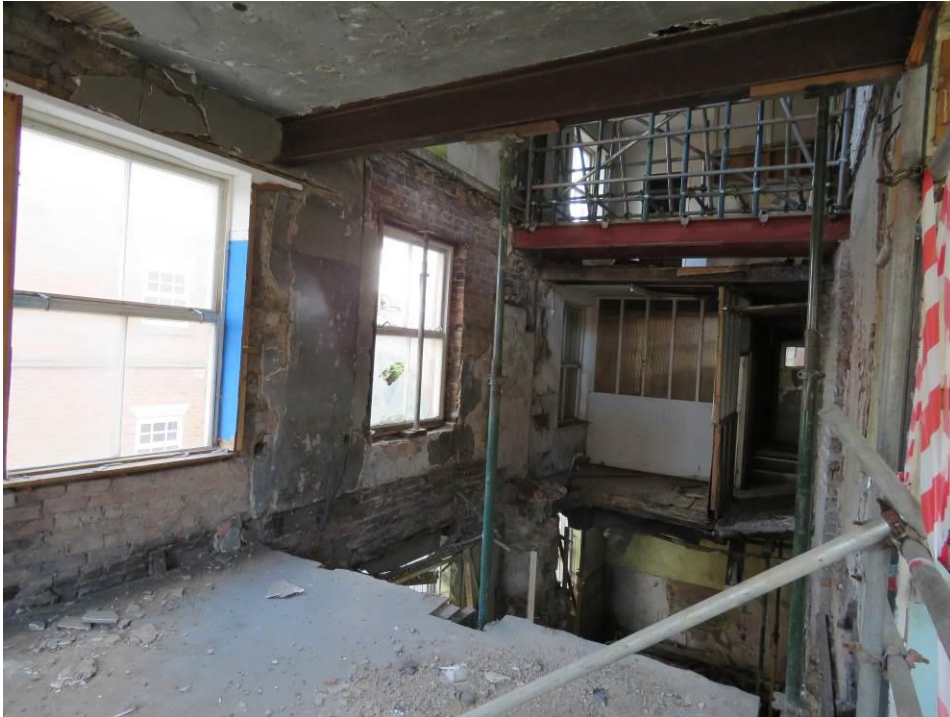
**Figure 88** – The collapsed area of the first floor level (1F14) looking into 1F16.

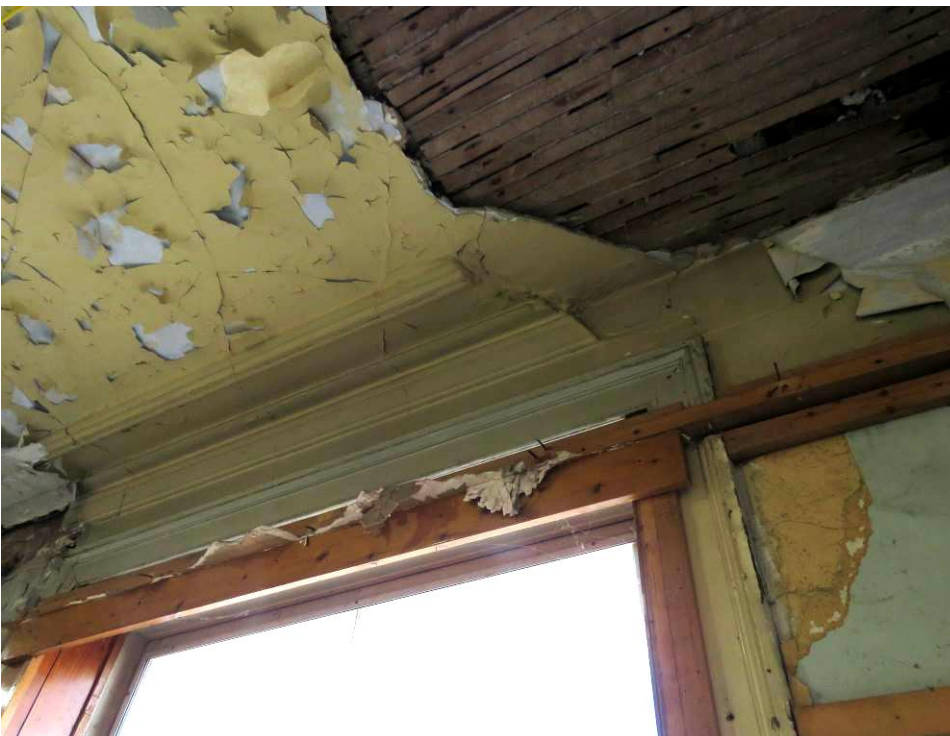
**Figure 89** – An area of newly uncovered original moulded timber window surround and plaster cornice above one of the windows in 1F13.

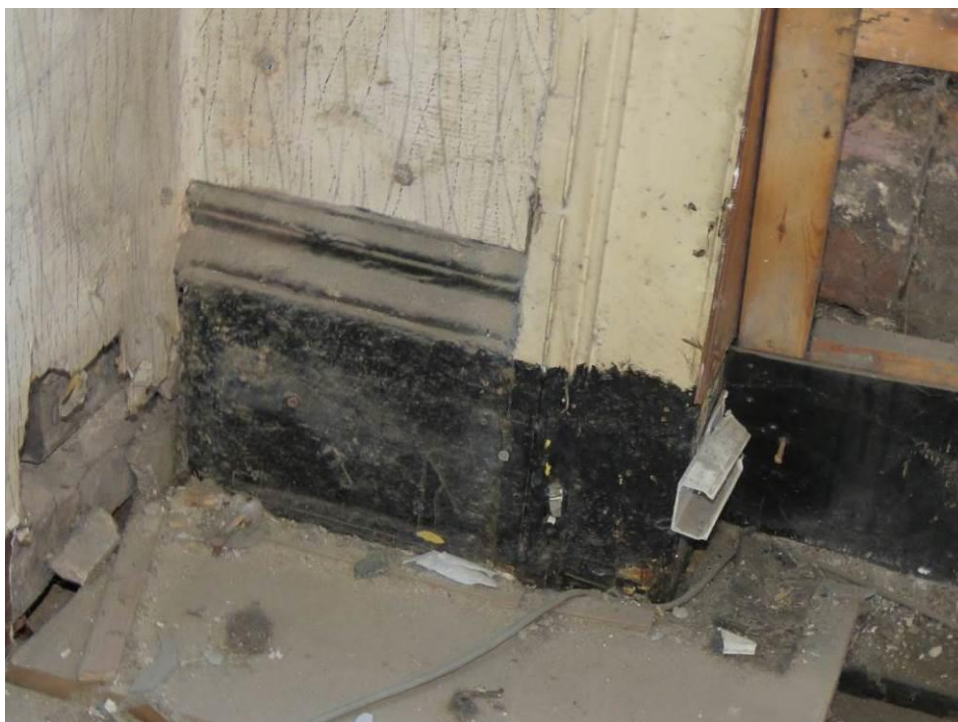
**Figure 90** – A small example of surviving original timber skirting discovered adjacent to a window in 1F13.

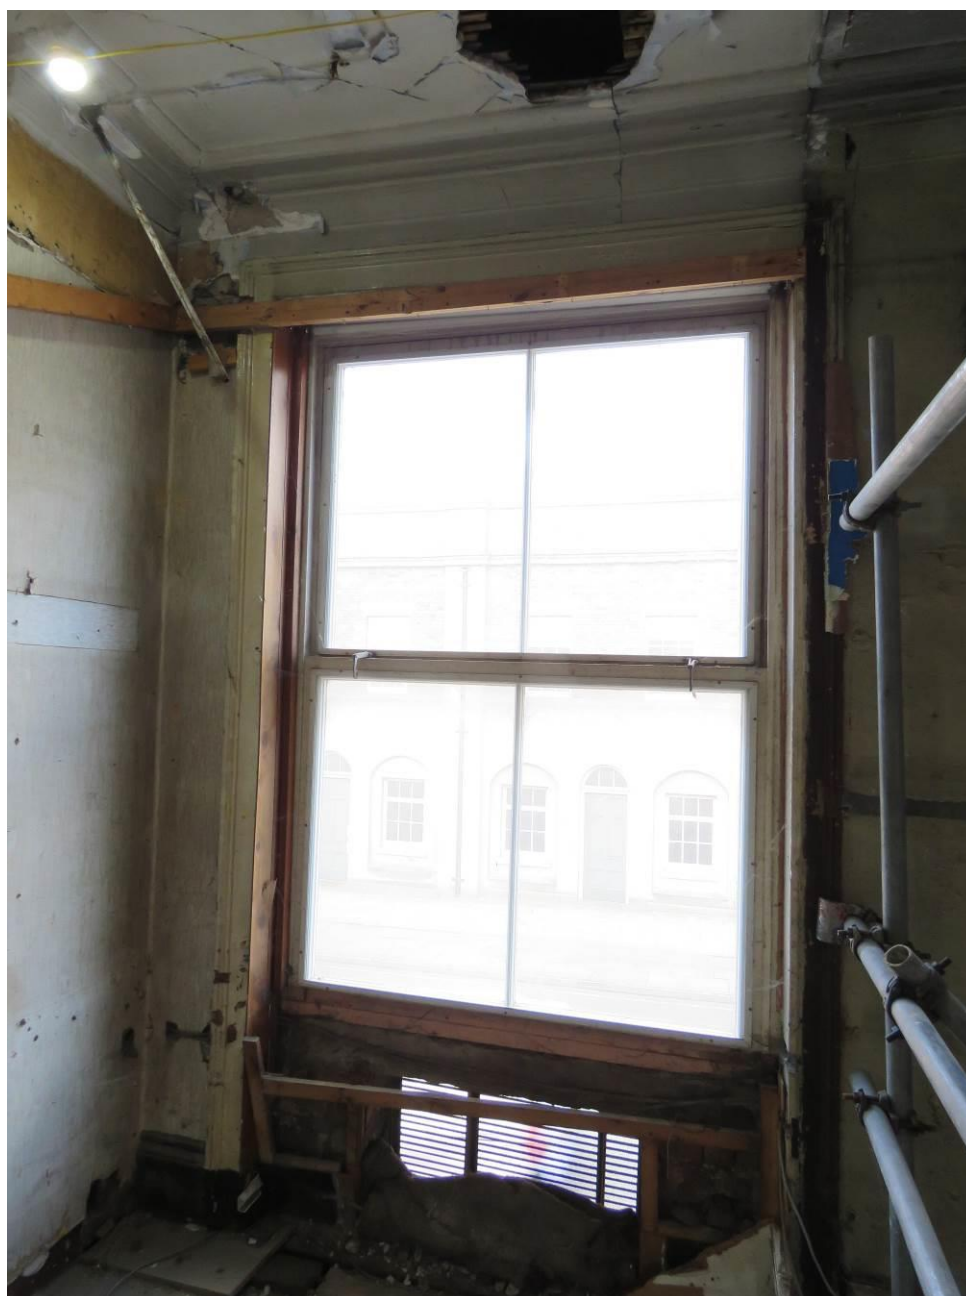
**Figure 90a** – A length of newly uncovered original moulded timber window surround and plaster cornice above one of the windows in 1F13.

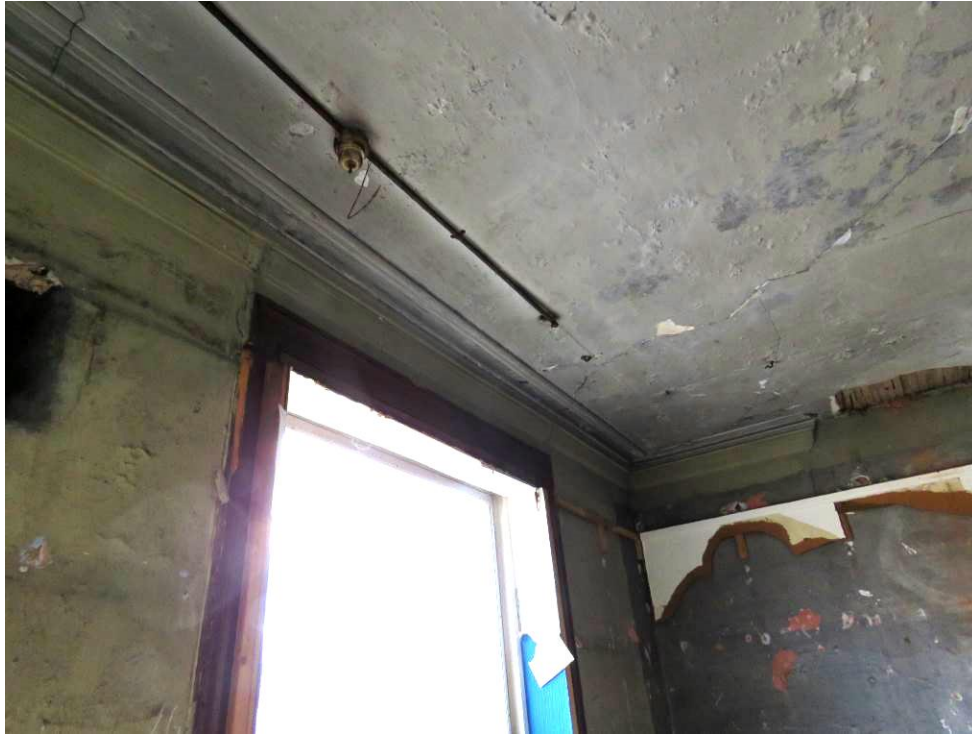
**Figure 90b** – A length of newly uncovered original moulded timber window surround and plaster cornice above one of the windows in 1F14

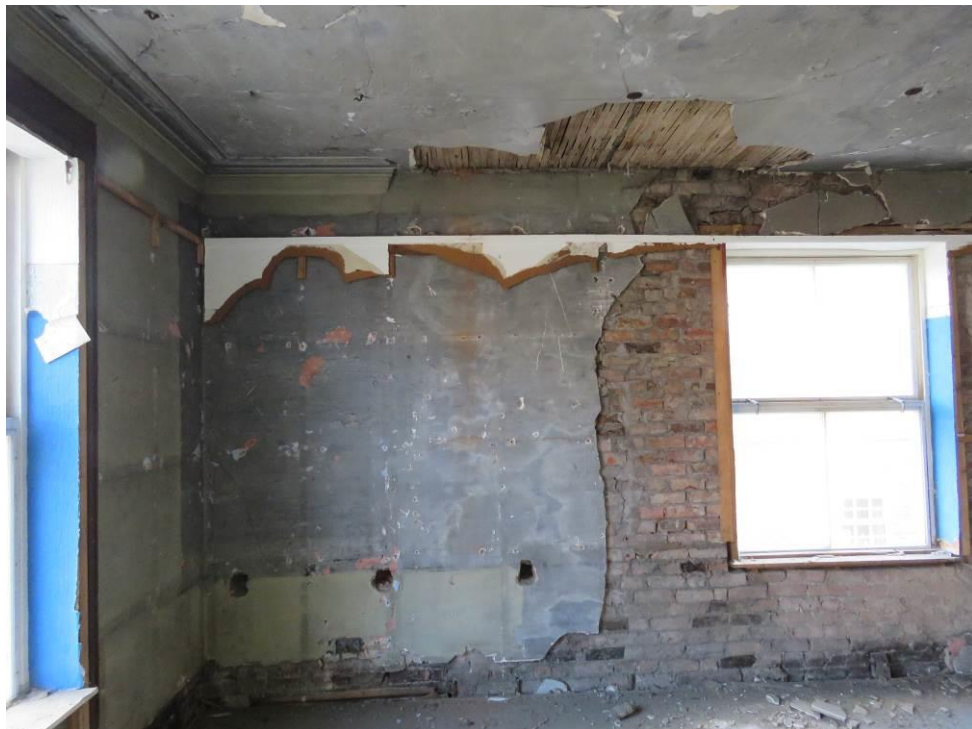
**Figure 91** – Looking along the east elevation of 1F14, showing the area of cornice.

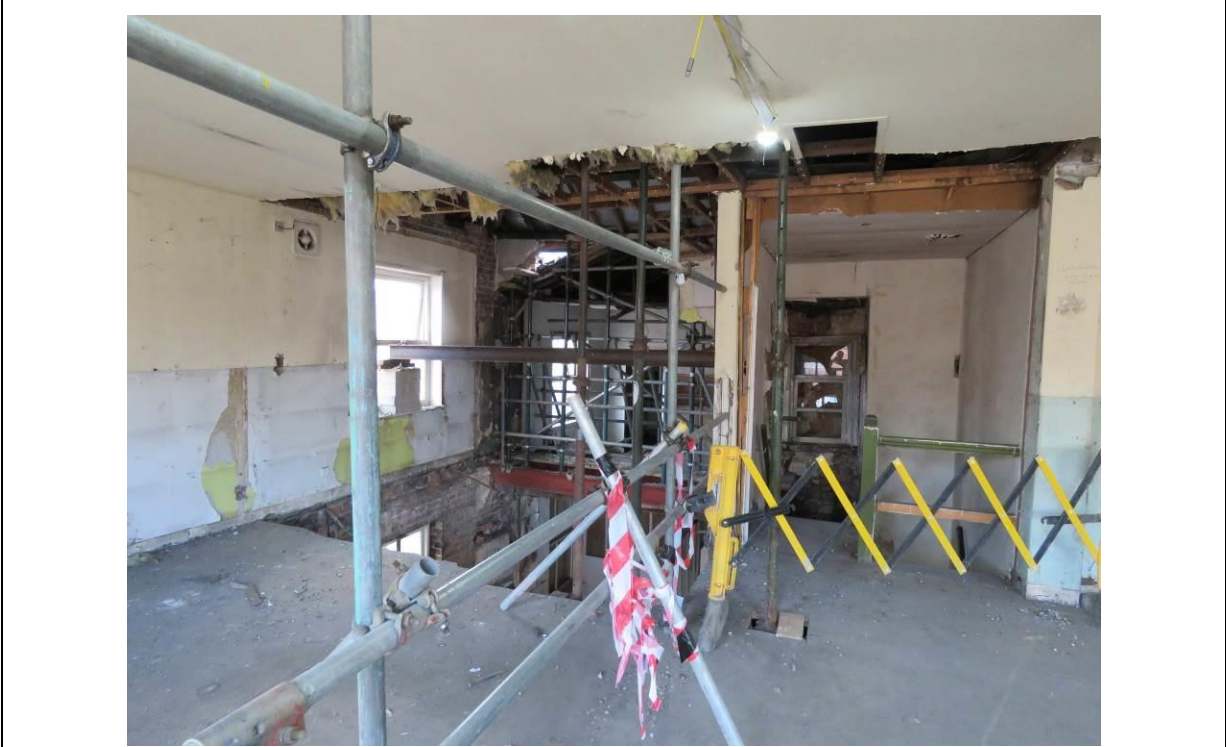
Figure 93 – Looking south from 2F14 into the collapsed area of the building (2F17). The stairs (2F16) can be seen to the right.

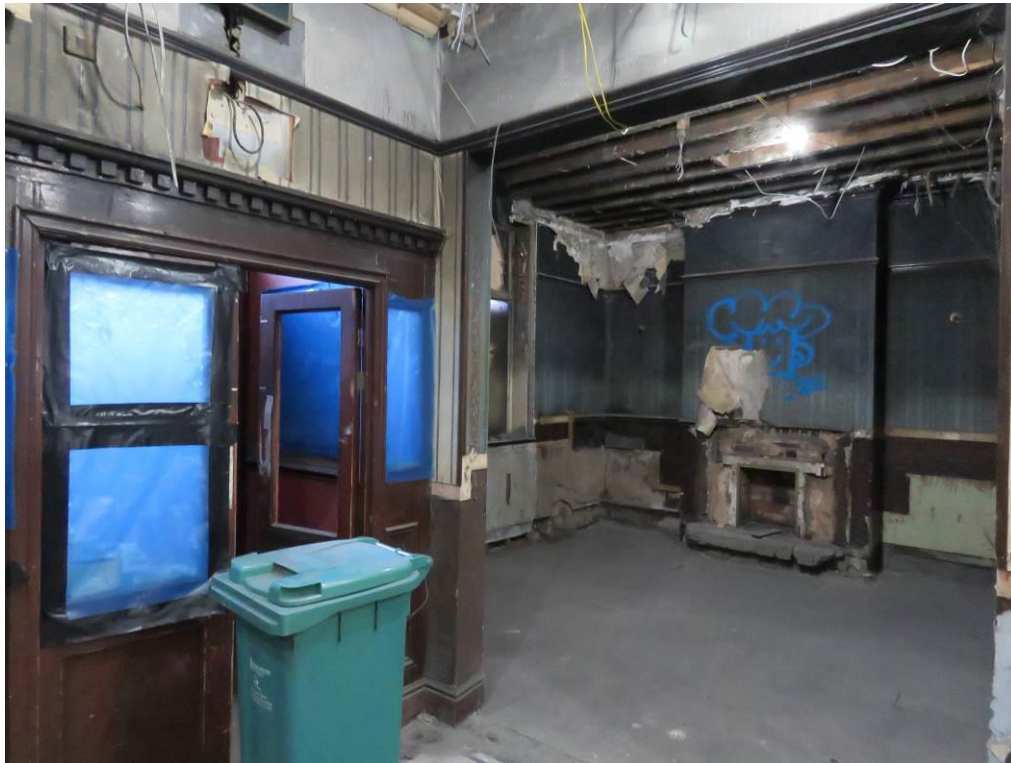
**Figure 101** – Looking east from the original entrance hall (GF3) into the adjacent bar room (GF2) which can be seen to have had its original lath and plaster ceiling and cornice removed. The modern doors to the left lead into the entrance vestibule (GF1A).

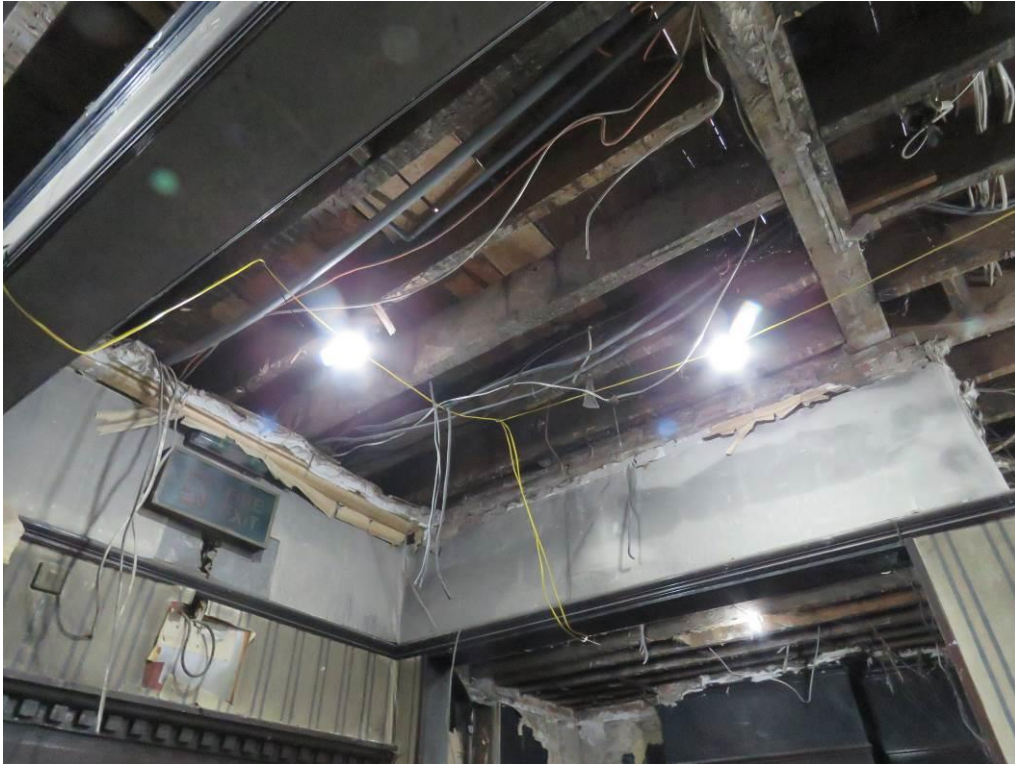
**Figure 102** – Looking up at the removed lath and plaster ceiling and cornice to the entrance hall ceiling (GF3)

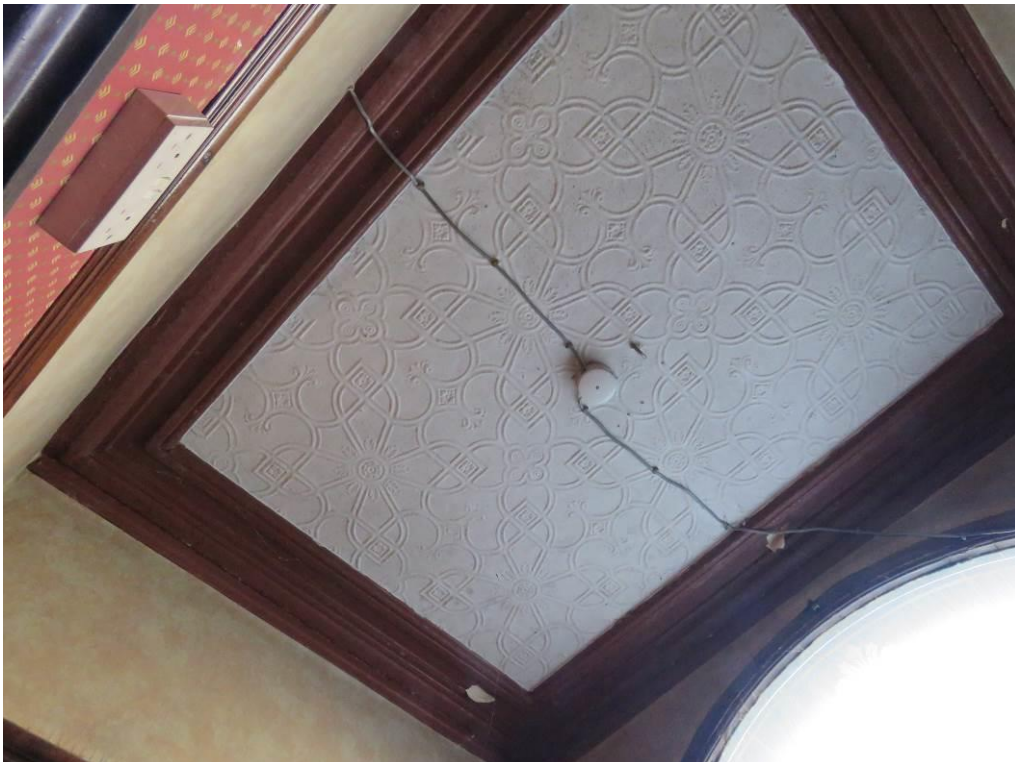
**Figure 103** – The surviving original plaster cornice, lath and plaster ceiling and decorative ceiling paper found complete in the entrance vestibule (GF1A).

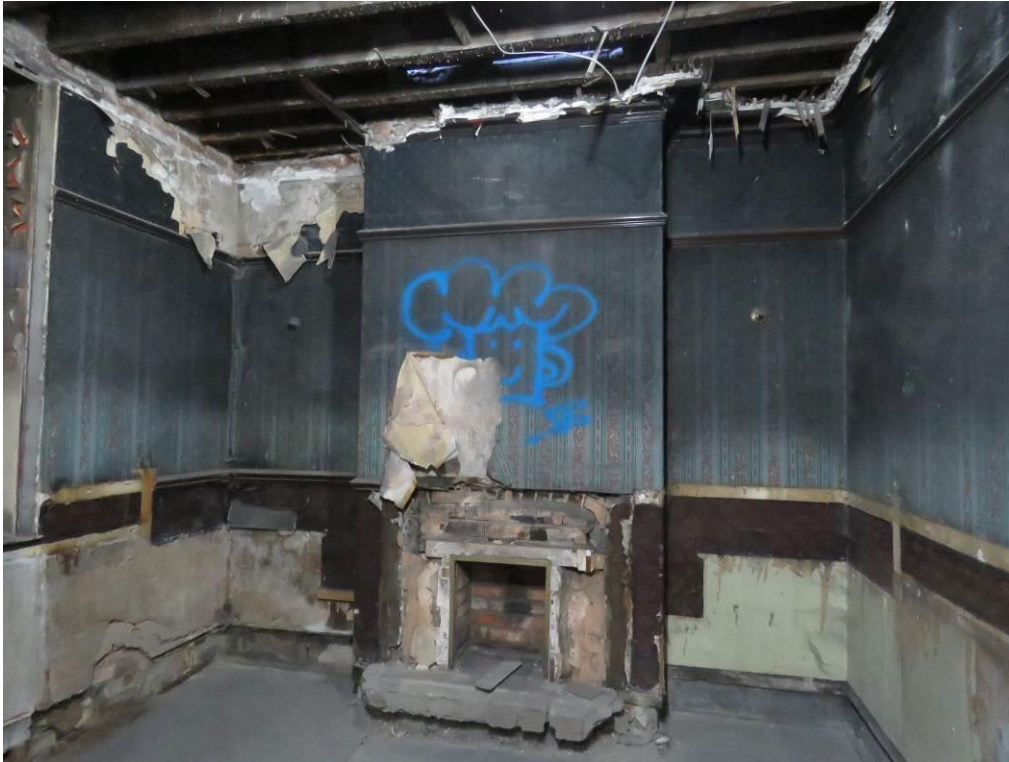
**Figure 104** – Looking into the front bar room showing removed ceiling, cornice and timber fire surround (GF2).

| Skirtings and cornices/ceilings | Retain | Due to almost all examples of cornice and skirting having been removed without consent throughout No. 125, it is proposed to recreate the missing elements using moulds taken from fragmentary remains of cornice and skirting and to reproduce these elements using traditional techniques. | (A - 2018)<br><br>Down stand beams will allow existing cornices and skirtings to be retained allowing for understand and appreciation of original plan form.<br><br>Minor Beneficial |

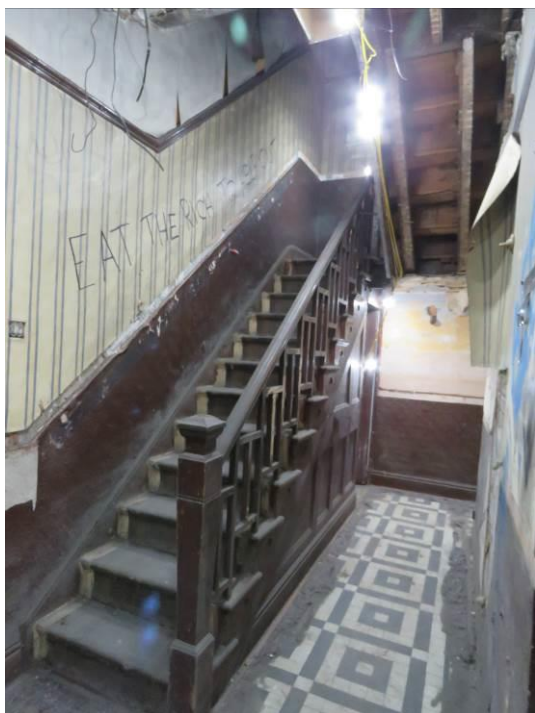
**Figure 106** – Looking east towards the main staircase and hall corridor of GF3, showing the uncovered black and white tiled floor/ Note the removal of original ceiling/cornice.

| <b>Tiled walls to entrance hall/stairs of No. 125 (Commercial Hotel)</b> | n/a | Uncover/repair areas of tiled walls, restoring where necessary to form part of the internal decorative scheme. | (P – 2023)<br><br>Moderate beneficial |

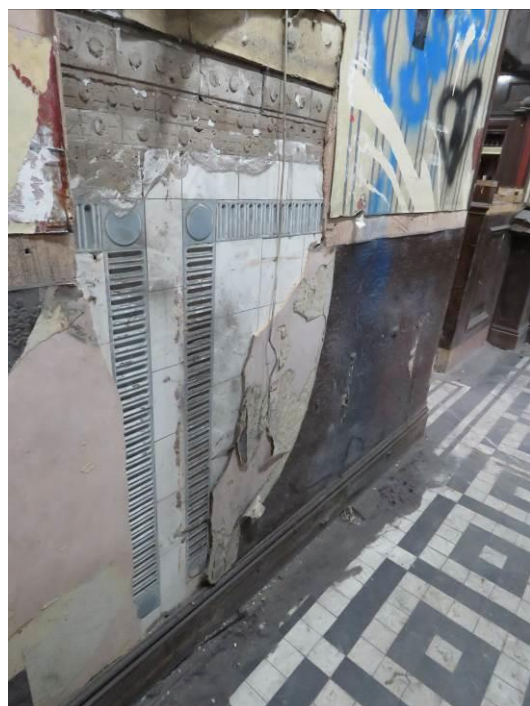
**Figure 108** – An area of newly discovered c1920s/30s decorative tiled wall tiles to the hall corridor to GF3.

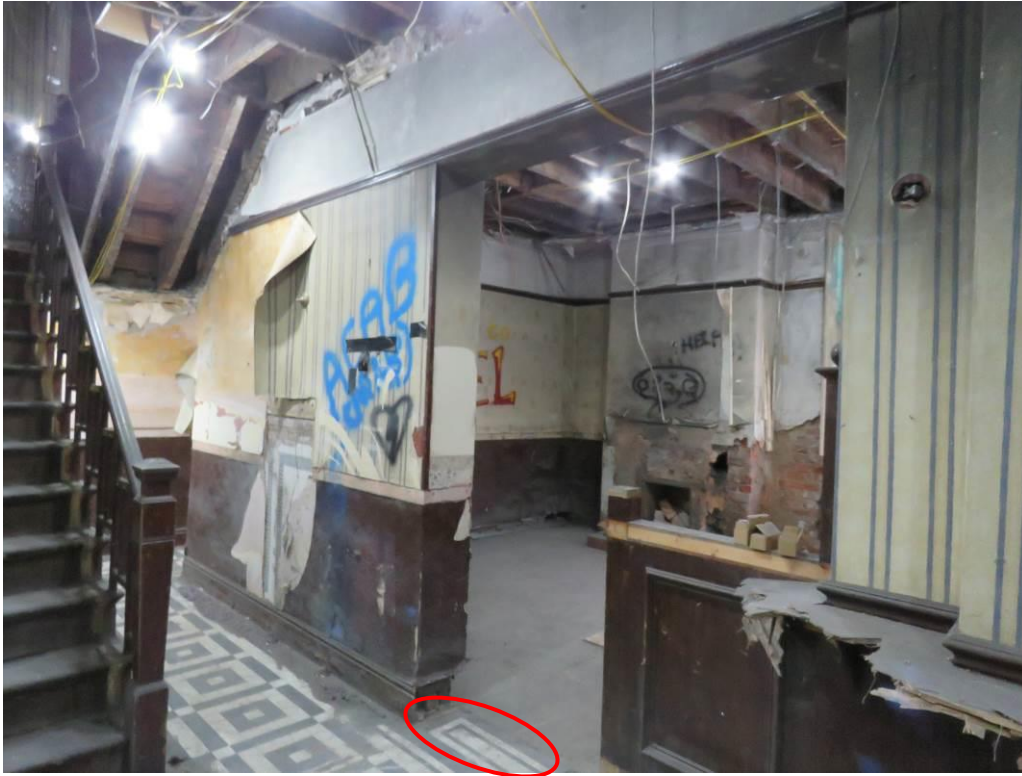
**Figure 110** – The entrance hall and stairs (GF3) looking into GF4 (right). The original location of the door into GF4 can be seen in the uncovered floor tiles (circled).

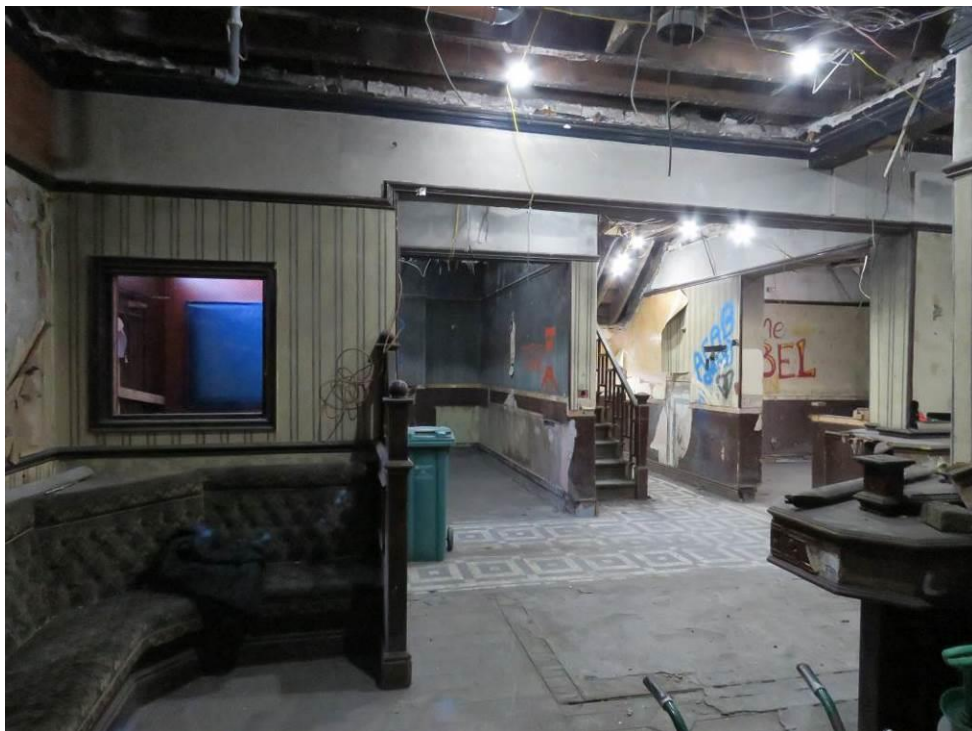
**Figure 111** – Looking east from GF1 through the original hallway of GF3 into GF2 (left) and GF4 (right) note the demarcation of the original extent of the entrance hall marked by the newly discovered black and white tiled floor.

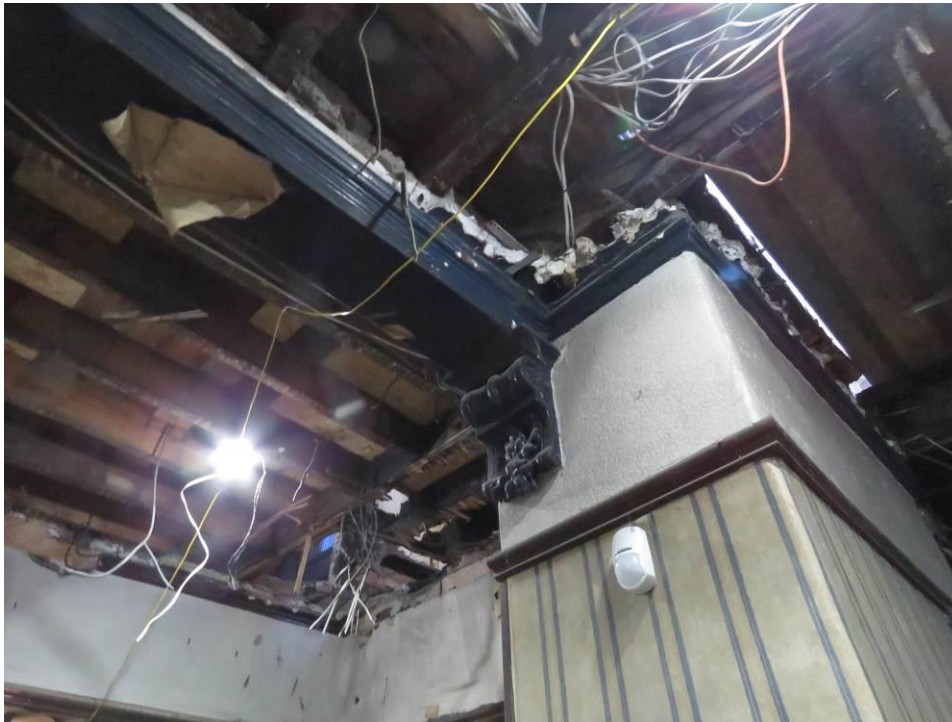
**Figure 113** – The surviving decorative plaster corbel between GF1 (right) and GF5 (left).

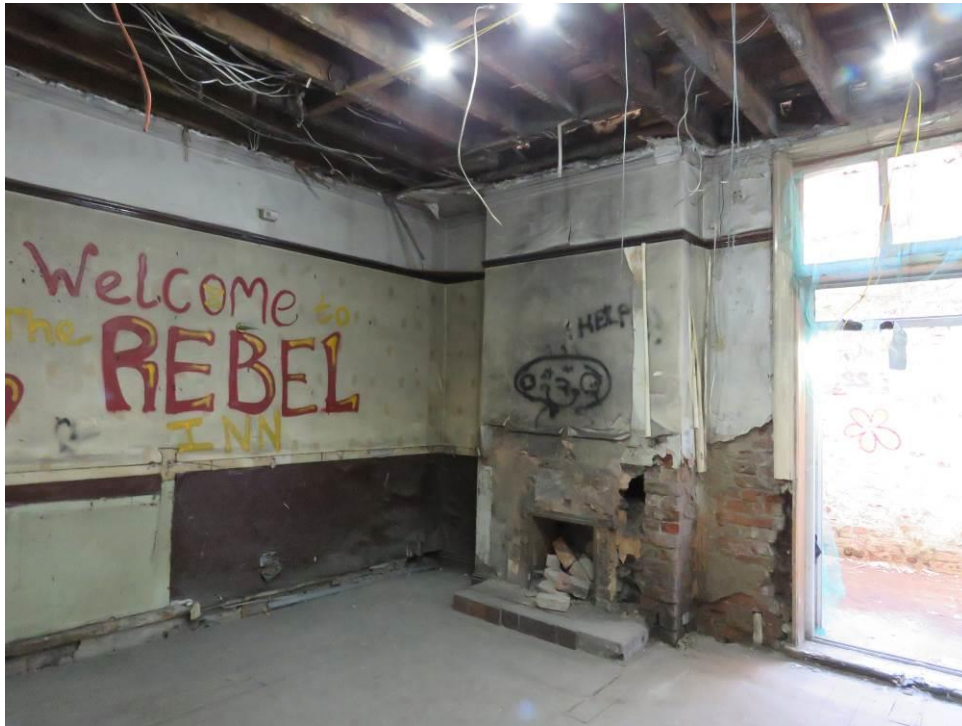
**Figure 114** – Looking into the rear bar room (GF4), showing the removal of lath and plaster ceiling, cornice, and decorative plaster ceiling decoration.

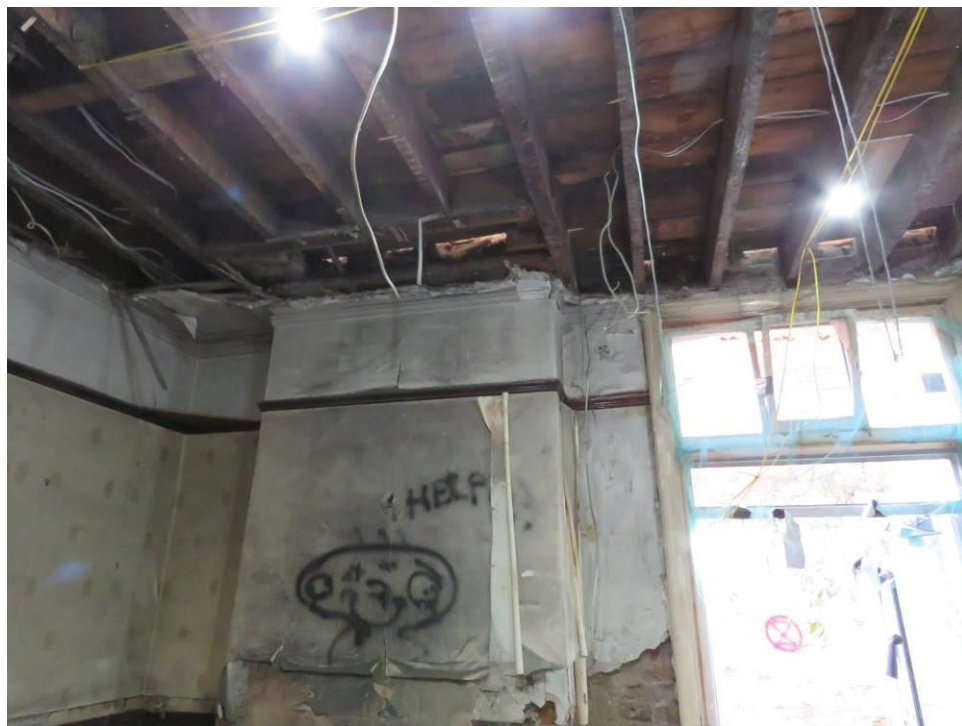
**Figure 115** – The rear bar room (GF4) showing the removal of lath and plaster ceiling, cornice, and decorative plaster ceiling decoration.

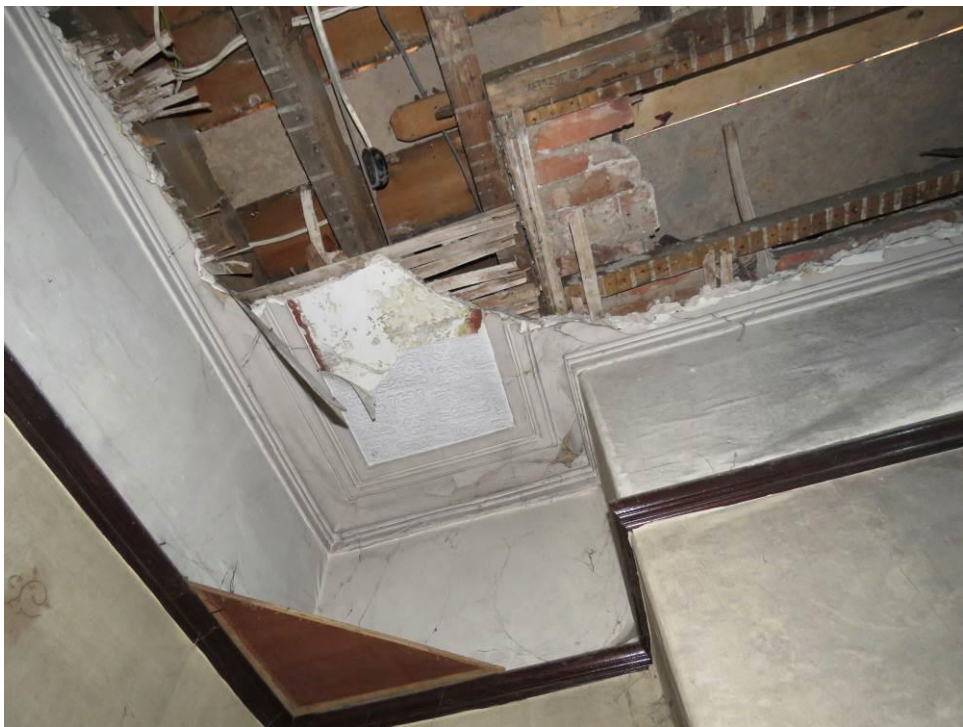
Figure 116 – A detailed view of a small area of surviving plaster cornice to the alcove of GF4.

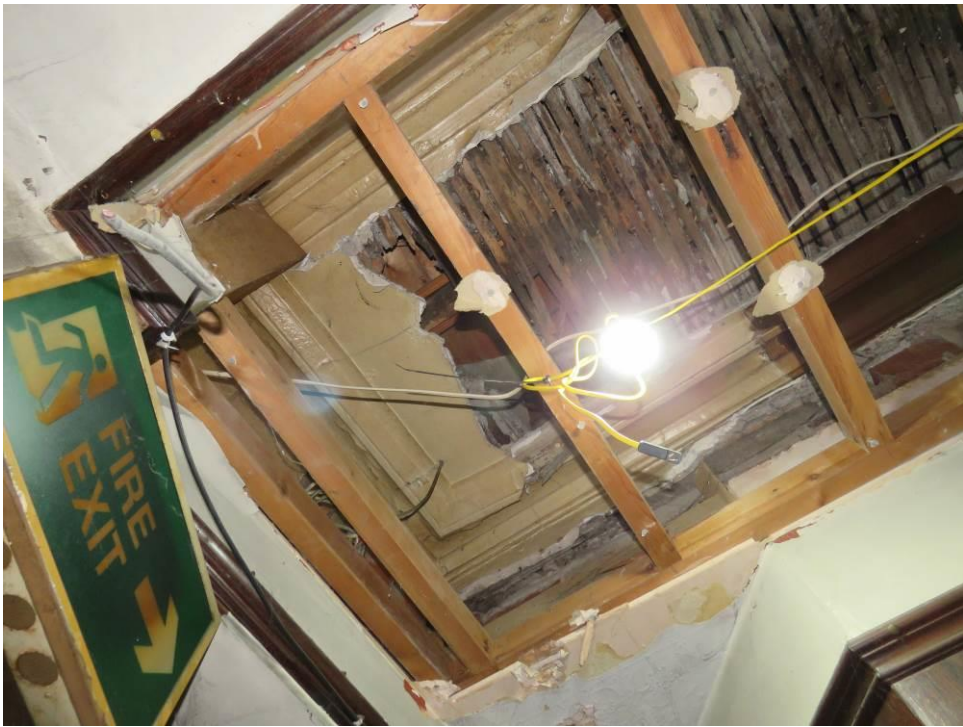
Figure 117 – Looking up at the ceiling of GF5, showing an area of surviving laths, lath and plaster and cornice,

which remains partly concealed beneath the modern dropped ceiling.

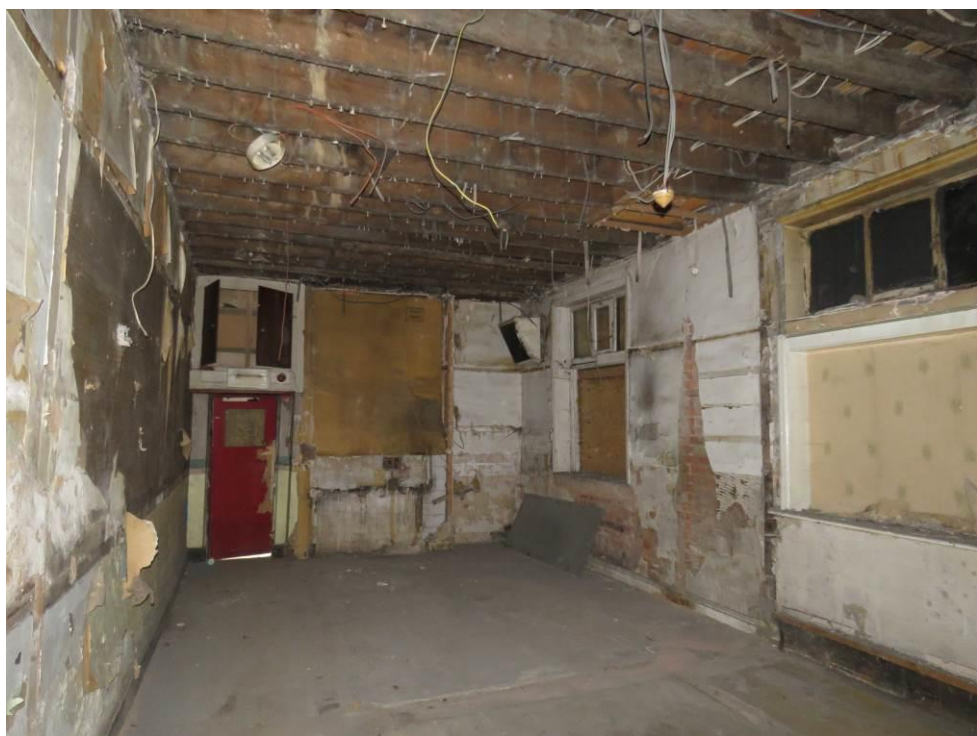
**Figure 118** – Looking south through GF6/7 and 8, showing the removal of all modern partitions.

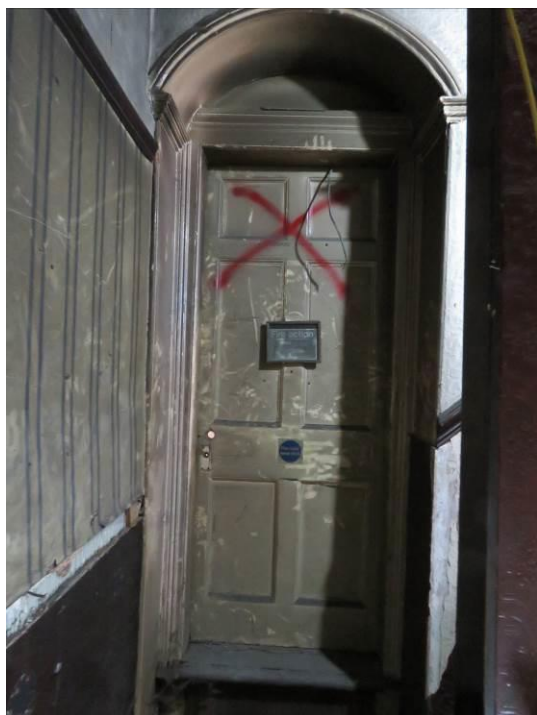
**Figure 119** – The mid-landing (1F04) looking towards an original surviving panelled door to 1F05, which formed the original link corridor to the coach house/stables.

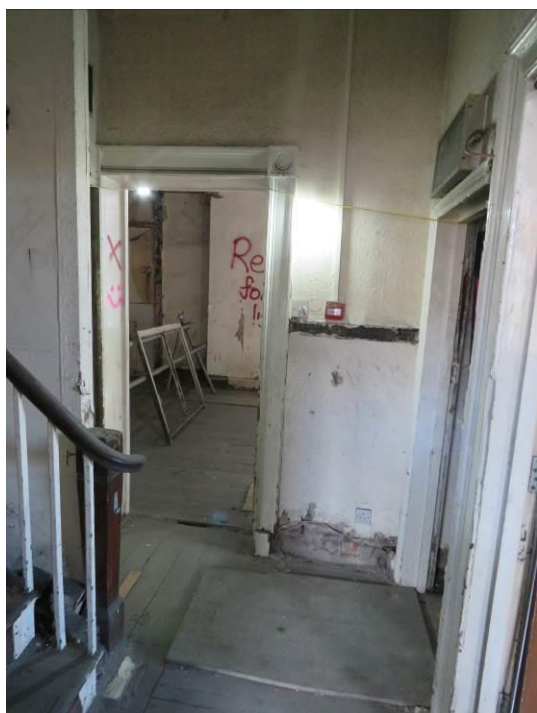
**Figure 121** – Looking south across the landing, showing the removal of original skirting boards.

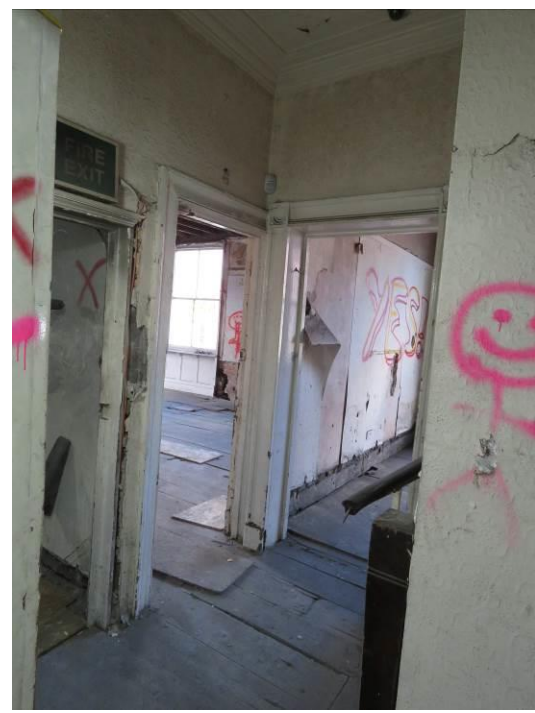
**Figure 122** – Looking north across the landing.

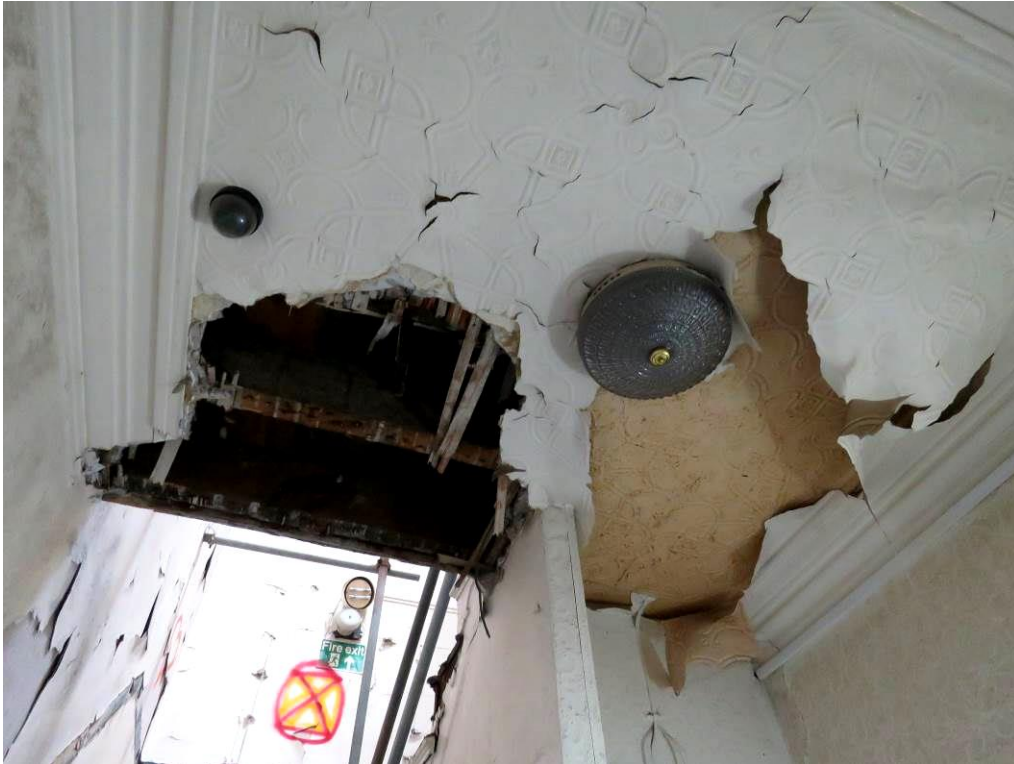
**Figure 123** – The original lath and plaster ceiling, cornice and decorative ceiling paper that can be seen to largely survive to the landing ceiling.

| | | <p>plaster. No cornice historically existed at this floor level so none will be recreated.</p> <p>Retain and repair original surviving lath and plaster ceiling and 19th century Anaglypta paper to staircase soffits (No. 125)</p> | <p>(P – 2023)</p> <p>Moderate adverse</p> |

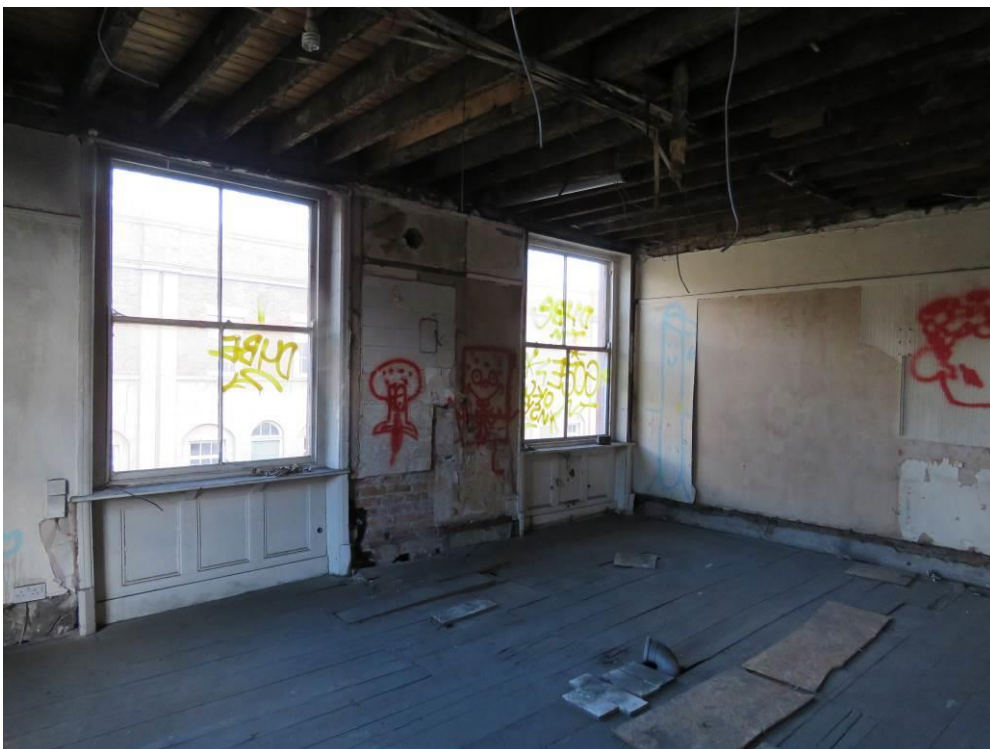
**Figure 124** – Looking north-east across the two former rooms of 1F01 (left) and 1F02 (right) which can now be seen in its original proportions, showing the consented removal of modern partitions and bathrooms. Note the removal of original skirting boards.

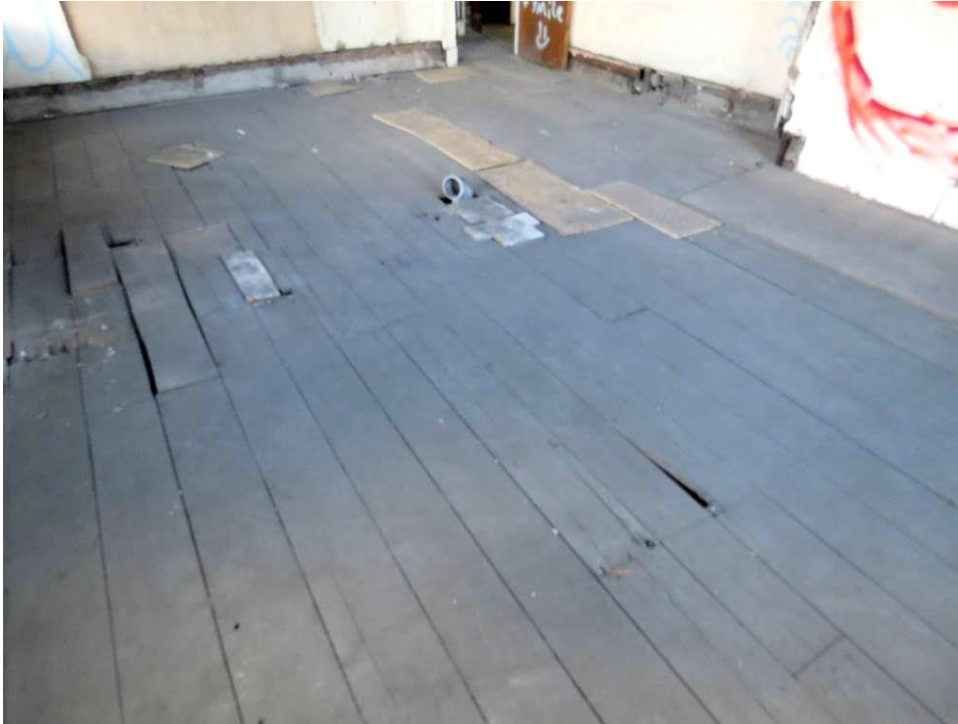
**Figure 125** – Original, wide floorboard uncovered in 1F01 and 1F02. Note the removed skirting boards throughout.

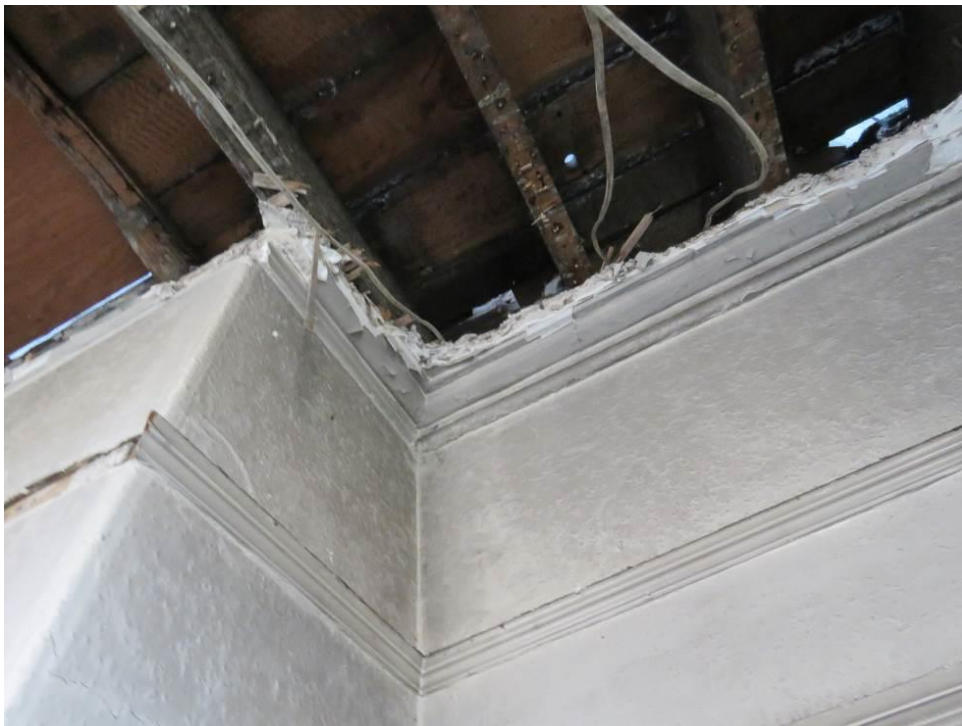
**Figure 126** – An area of partially surviving cornice to the alcove of 1F01, and small area of removed picture rail.

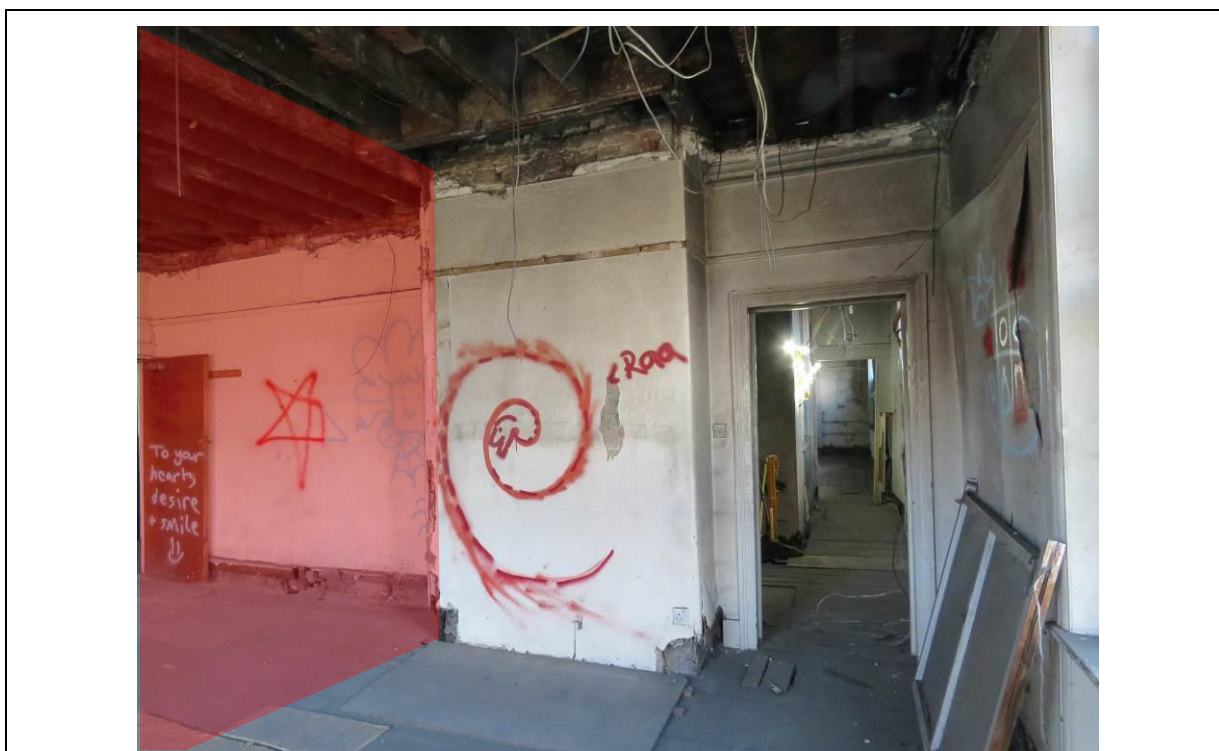
**Figure 127** – Looking south through 1F01, showing the now removed modern partition (shaded red) that divided this room from 1F02. Note the removed original lath and plaster ceiling, cornice, original panelled door to the opening (right) and skirtings.

| <b>Internal doors</b> | Retain and reuse | <p>All, bar two, original panelled doors were removed from the first floor level of the Commercial Hotel (No. 125) without consent.</p> <p>It is proposed to replace all lost original doors using surviving doors where available as a template, and /or historic site photos. The surviving original door at mid-landing level will be retained/redecorated and used as entrance to proposed luggage store room.</p> <p>A number of new openings will be created to access guestrooms, using historic door designs for new timber panelled doors.</p> <p>Historic door openings that are not to be used will be fitted with new panelled doors using historic templates and sealed shut from the guestroom side.</p> | <p>(A - 2018)</p> <p>Minor Beneficial</p> <p>(P – 2023)</p> <p>Moderate adverse</p> |
