123 & 125  
Liverpool  
Road  
Manchester

## Addendum Heritage Statement

7<sup>th</sup> June  
2023

**123 & 125 Liverpool Road, Manchester – Addendum Heritage Statement**

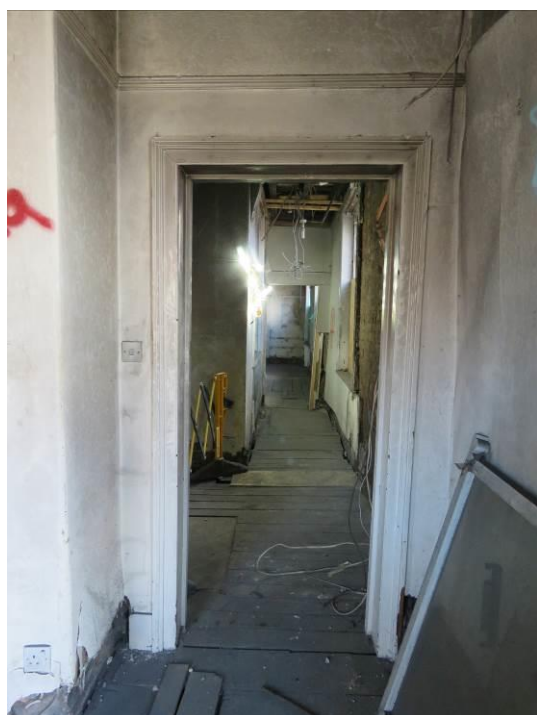
**Figure 128** – A closer view of the location of the missing original panelled door into 1F01.

| <b>Internal doors</b> | Retain and reuse | <p>All, bar two, original panelled doors were removed from the first floor level of the Commercial Hotel (No. 125) without consent.</p> <p>It is proposed to replace all lost original doors using surviving doors where available as a template, and /or historic site photos. The surviving original door at mid-landing level will be retained/redecorated and used as entrance to proposed luggage store room.</p> <p>A number of new openings will be created to access guestrooms, using historic door designs for new timber panelled doors.</p> <p>Historic door openings that are not to be used will be fitted with new panelled doors using historic templates and sealed shut from the guestroom side.</p> | <p>(A - 2018)</p> <p>Minor Beneficial</p> <p>(P – 2023)</p> <p>Moderate adverse</p> |

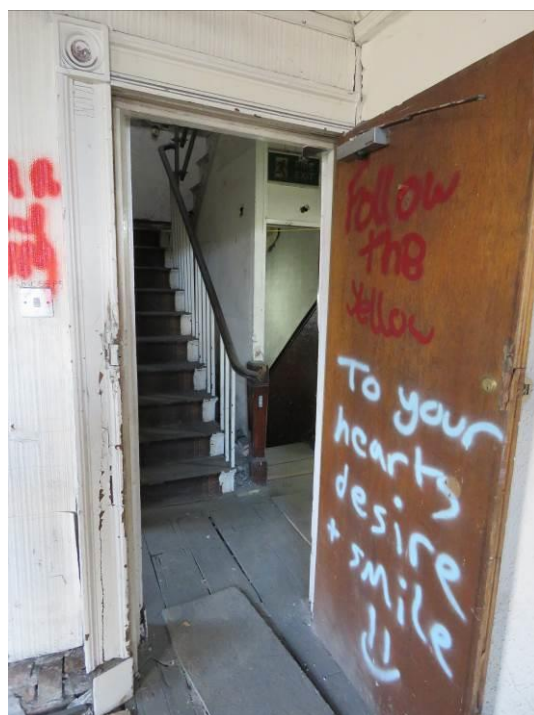
**Figure 129** – The original decorative architrave surrounding the door into 1F02 from the landing.

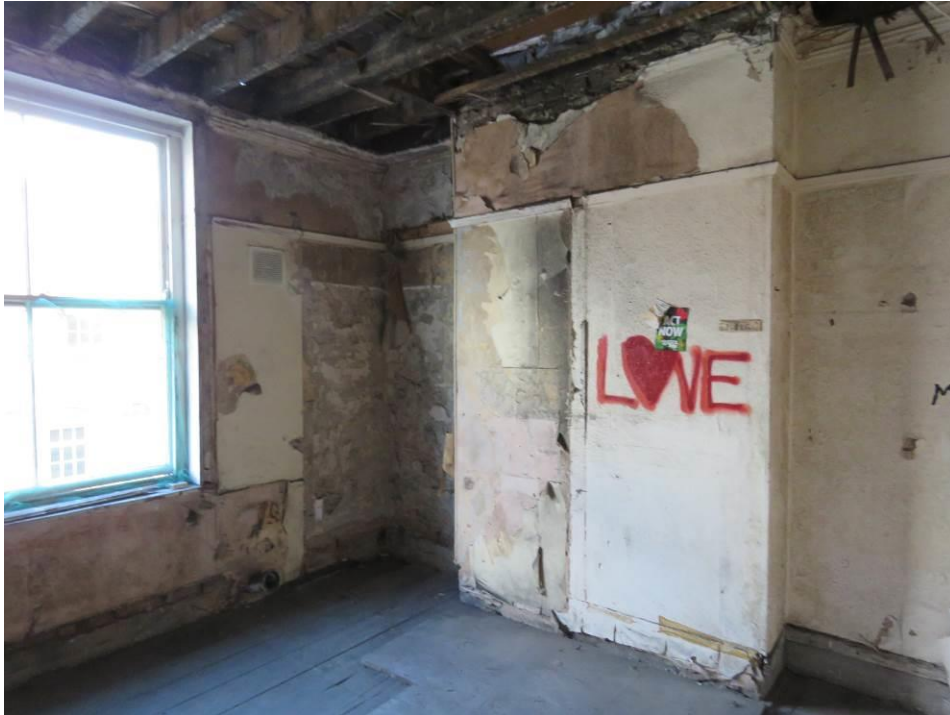
**Figure 130** – Looking into 1F03, showing the consented removal of modern bathroom en-suite to the corner alcove, and unauthorised removal of original lath and plaster ceiling, cornice and skirtings.

| Skirtings and cornices/ceilings | Retain | Due to almost all examples of cornice and skirting having been removed without consent throughout No. 125, it is proposed to recreate the missing elements using moulds taken from fragmentary remains of cornice and skirting and to reproduce these elements using traditional techniques. | (A - 2018)<br><br>Down stand beams will allow existing cornices and skirtings to be retained allowing for understand and appreciation of original plan form.<br><br>Minor Beneficial |

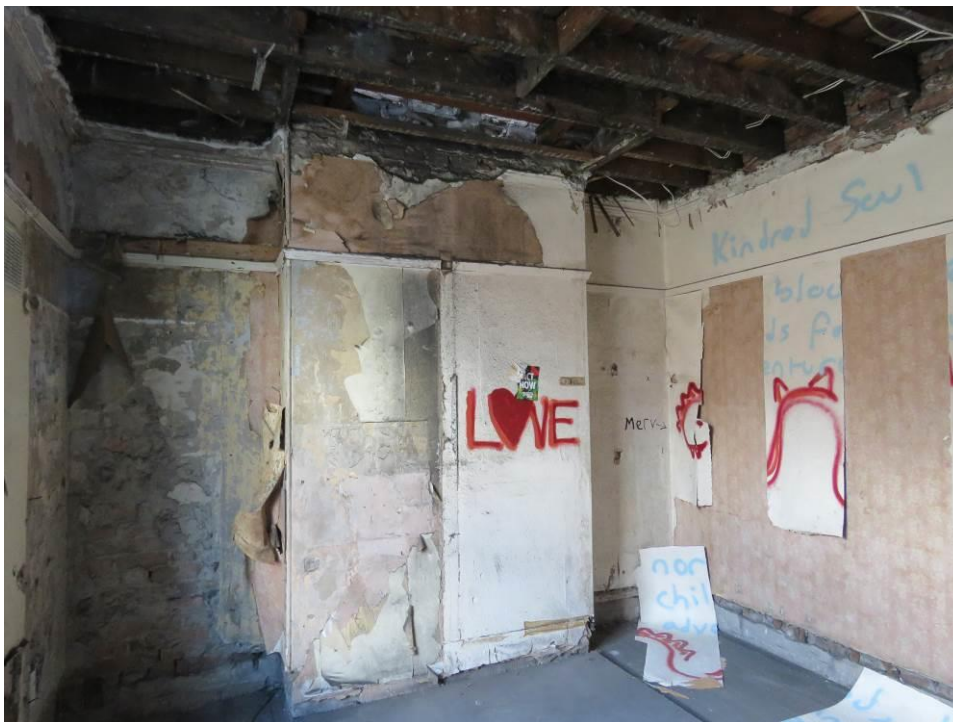
**Figure 131** – The east elevation of 1F03, showing the consented removal of modern bathroom en-suite to the corner alcove (left) and unauthorised removal of original lath and plaster ceiling, cornice and skirtings

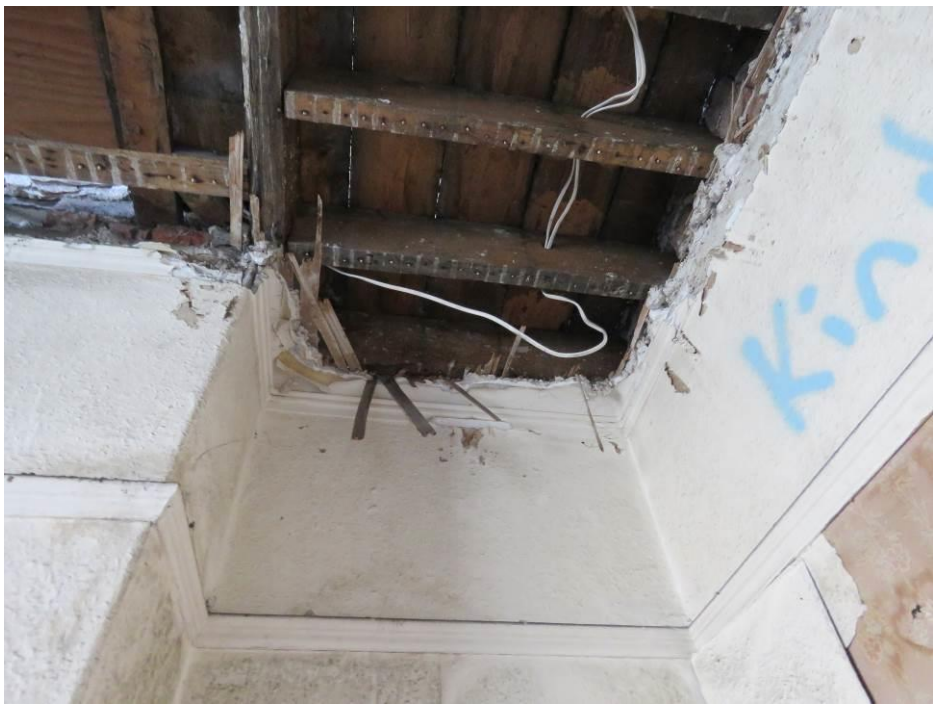
Figure 132 – A small surviving area of damaged cornice to the alcove of 1F03.

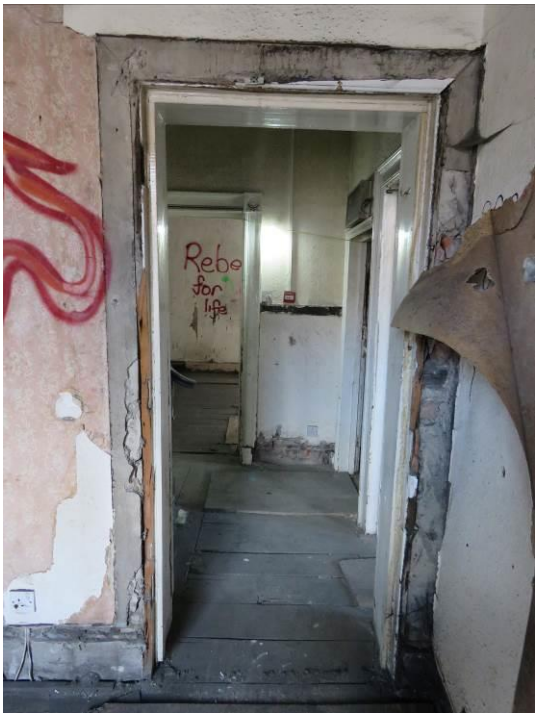
Figure 133 – Removed architraves to 1F03.

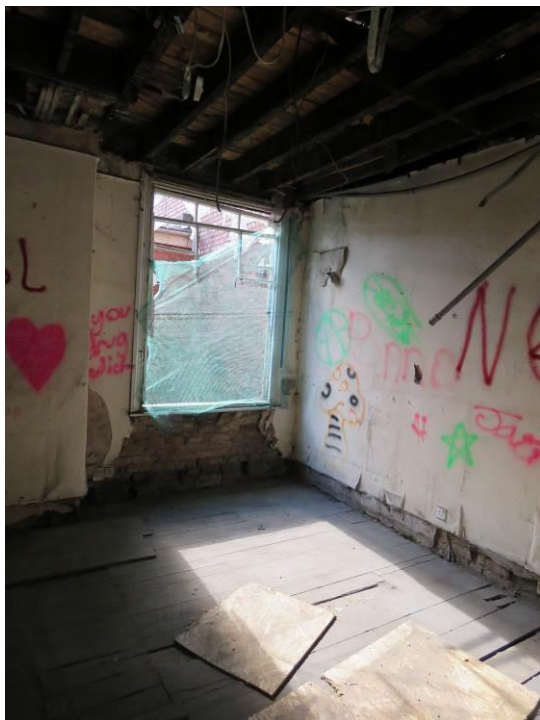
**Figure 134** – Looking into 1F06, showing removal of skirtings, a largely destroyed sash window, and consented removal of ceiling.

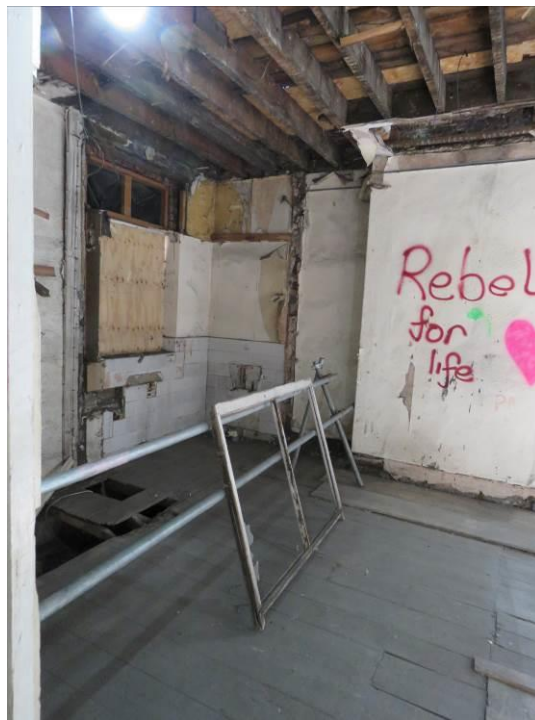
**Figure 135** – Looking into 1F06, showing the original location of the now removed partition (with consent) which enclosed the original link corridor (1F05) to the coach house/stables from the landing (1F04).

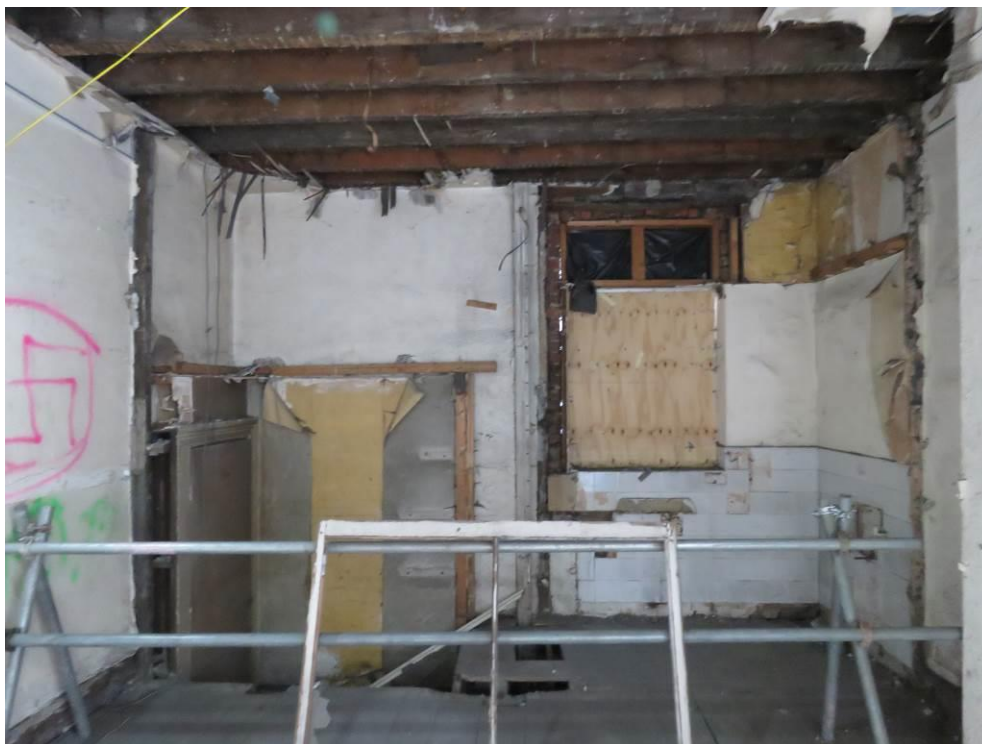
**Figure 136** – Looking east across 1F06 towards the now removed partition enclosing the original link corridor. The extent of the former walk-in cupboard of 1F05 can now be seen to the left.

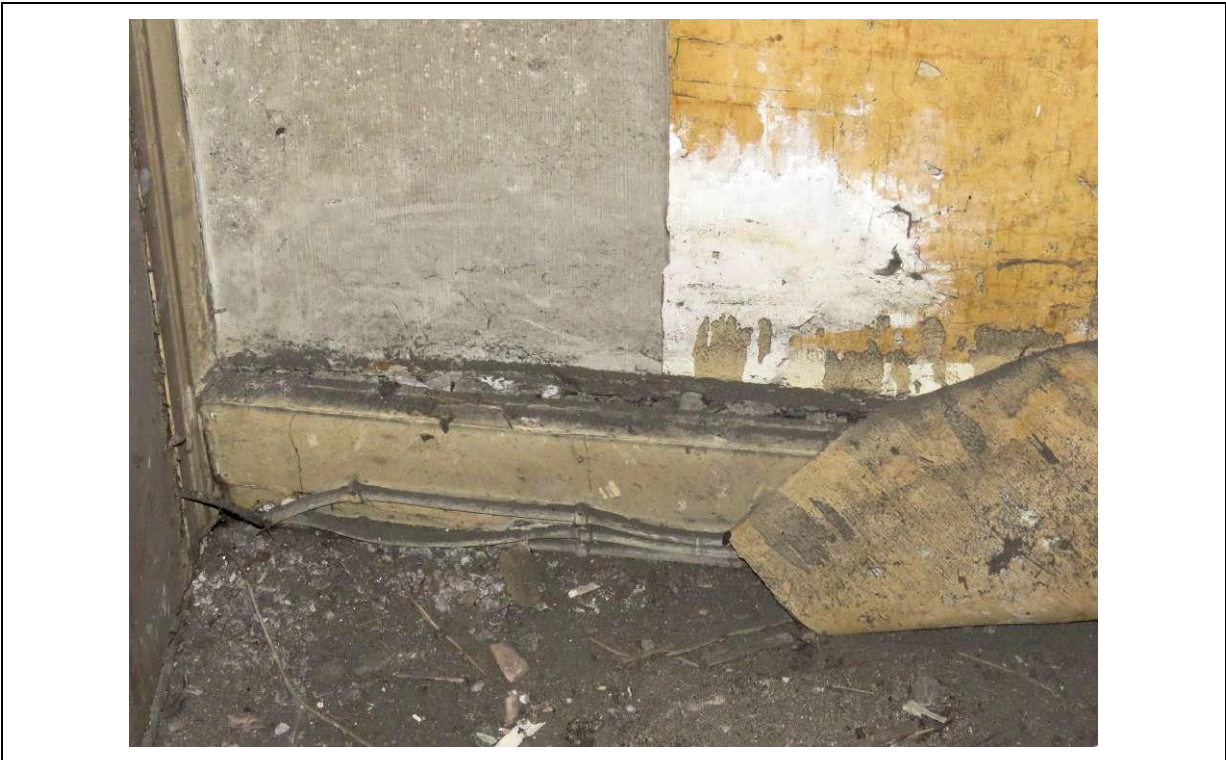
Figure 137 – A surviving area of original skirting to the former link corridor (1F05).

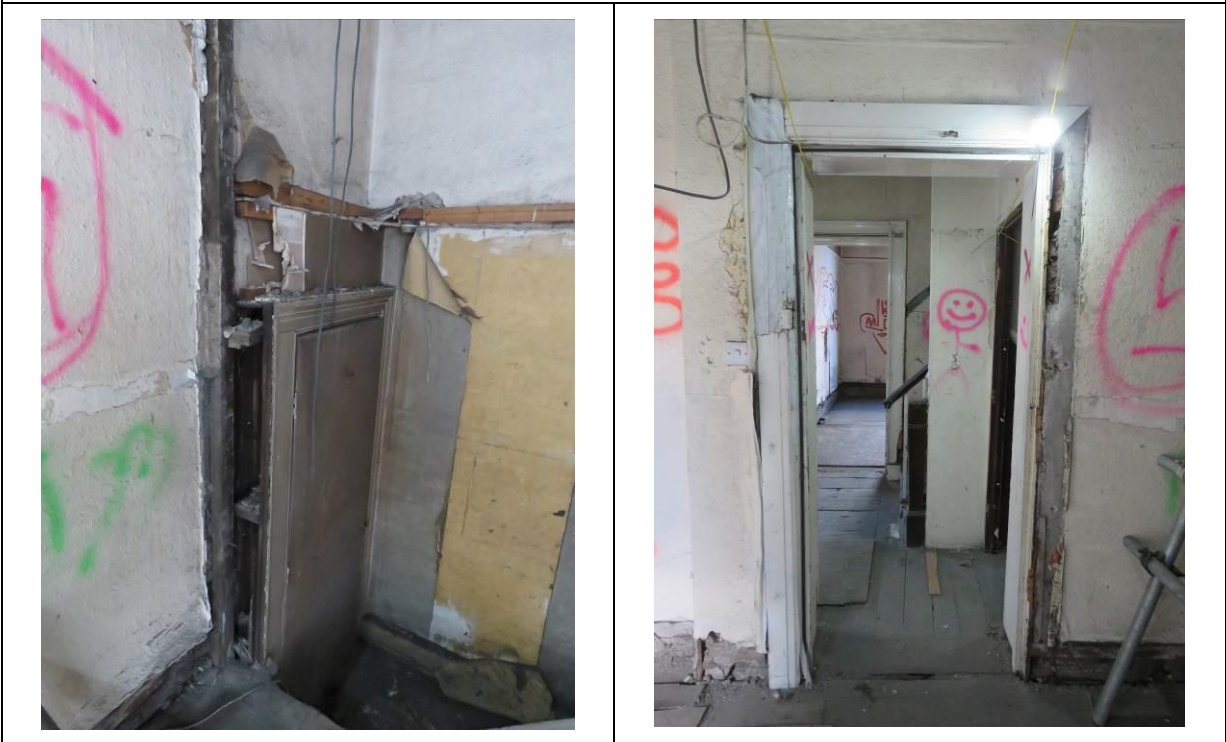
Figure 138 – Looking down into the lower level of the former link corridor (1F05).

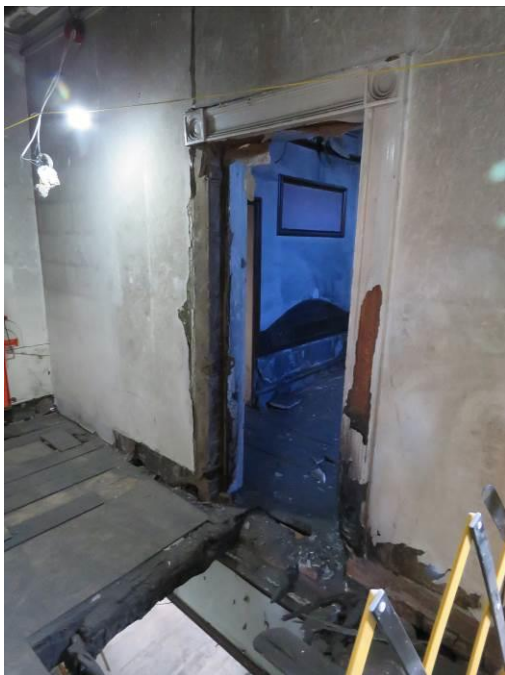
**Figure 140** – Looking across corridor 1F07 towards the door opening into 1F08, which is inaccessible due to fire damage to the floor in front. Note the original panelled door and the left architrave is now missing.

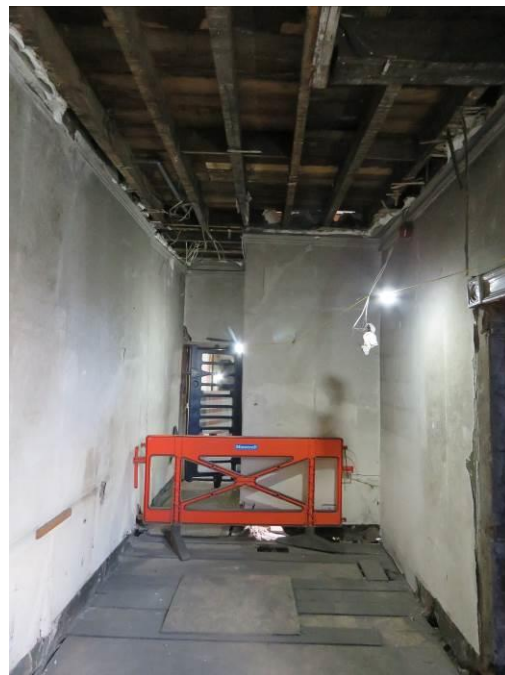
**Figure 141** – Looking east along corridor 1F08, showing the removal of original lath and plaster ceiling, cornice and skirtings.

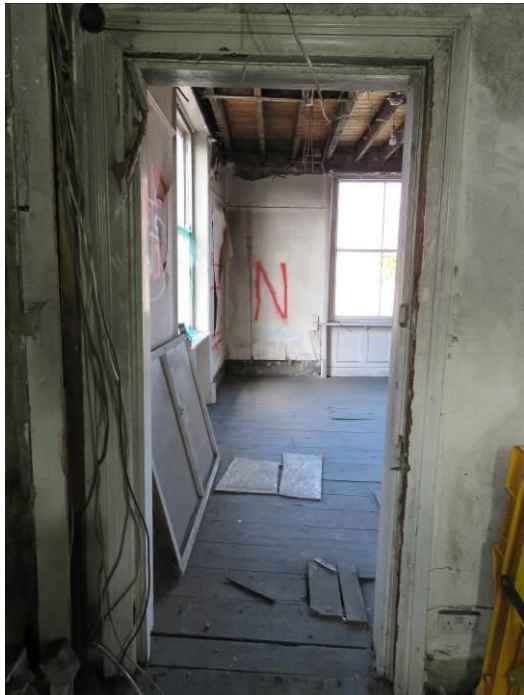
**Figure 145** – The corridor side of the entrance into 1F01, showing the missing panelled door.

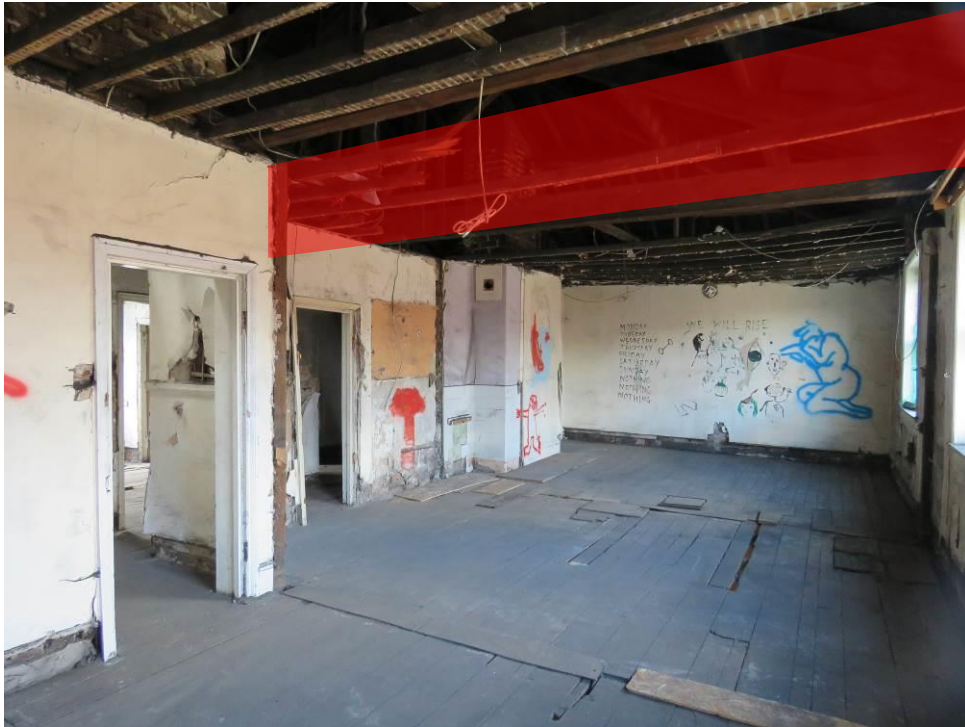
**Figure 146** – Looking west from 2F03, into 2F02 and 2F01, showing the consented removal of walls, but the unconsented removal of the downstand beam (shaded red), lath and plaster ceilings and skirtings.

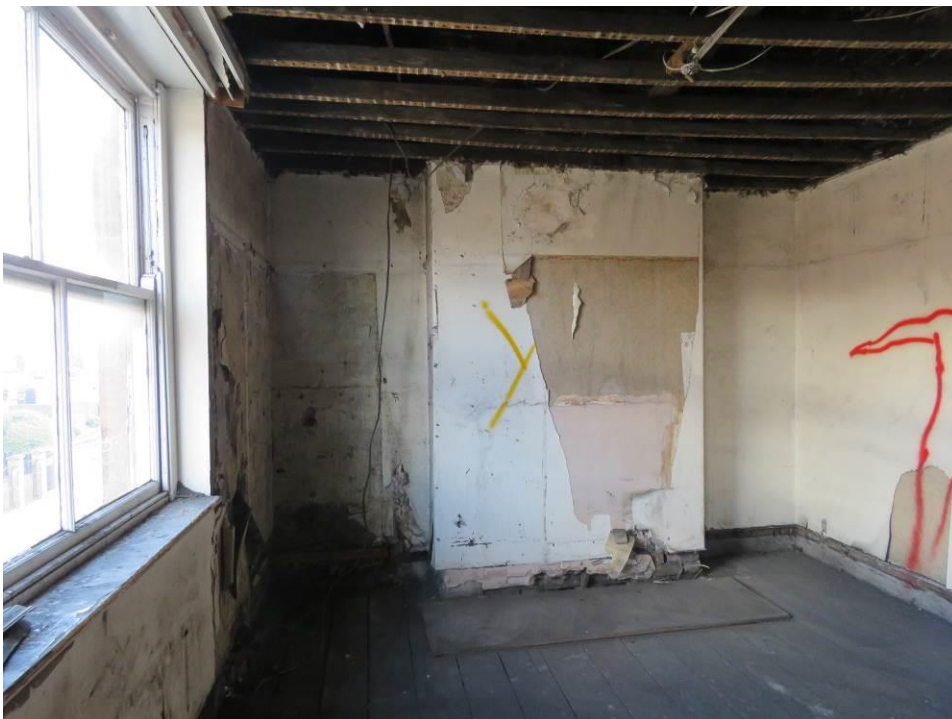
**Figure 147** – Looking east across 2F03 showing the removal of skirtings and lath and plaster ceiling.

| <b>Skirtings and cornices/ceilings.</b> | Retain | <p>Due to almost all examples of lath and plaster and skirting having been removed without consent, it is proposed to recreate the missing elements of skirting.</p> <p>Under draw joists with fire resistance board and</p> | <p>(A - 2018)</p> <p>Down stand beams will allow existing cornices and skirtings to be retained allowing for understand and appreciation of original plan form.</p> <p>Minor Beneficial</p> |

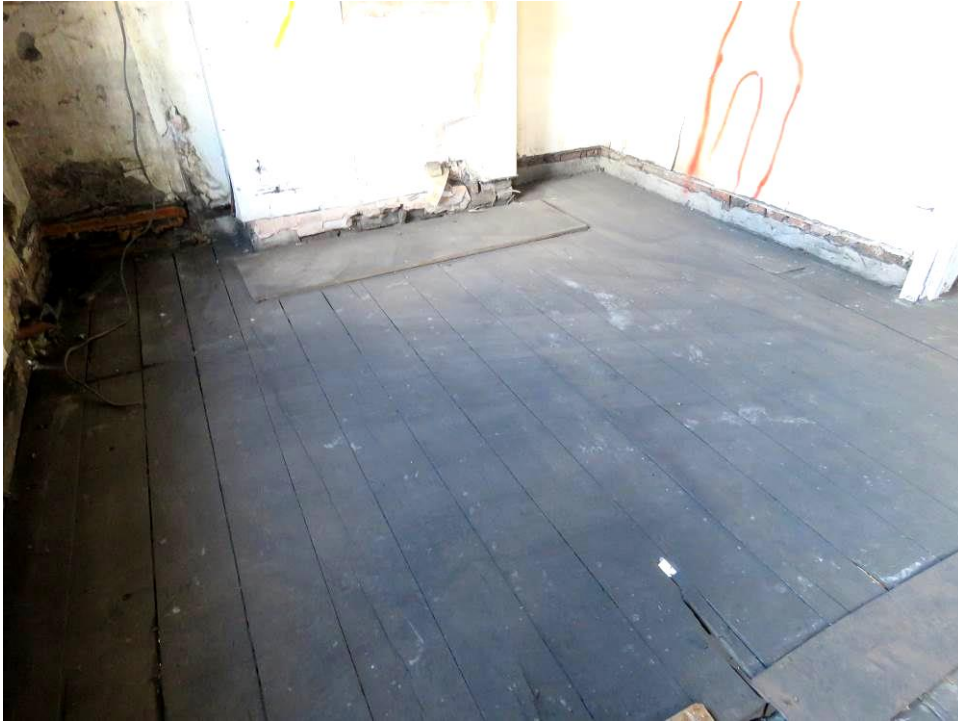
**Figure 148** – The now exposed original wide floorboards in 2F03.

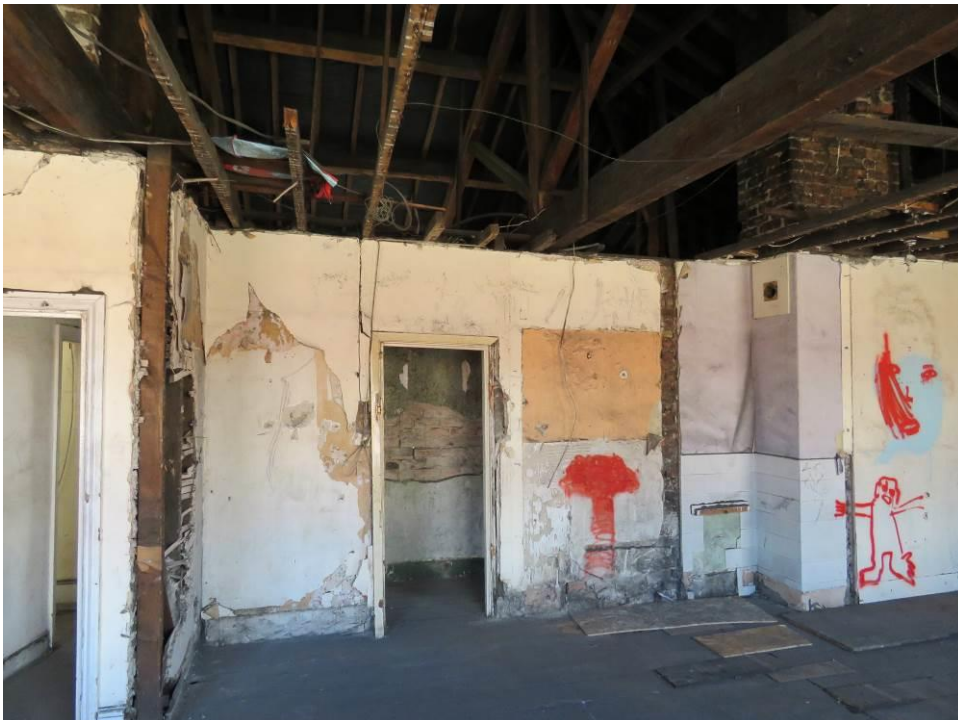
**Figure 149** – Looking south through 2F02 showing the removal of lath and plaster ceilings and area of ceiling structure.

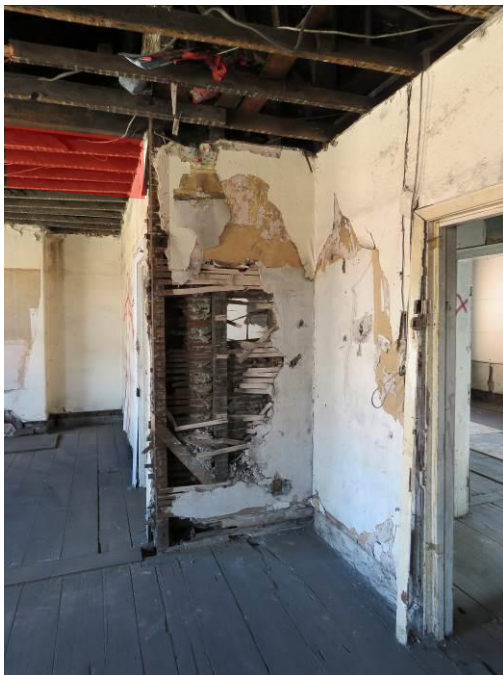
**Figure 152** – Looking east towards 2F03 from 2F02, showing the consented removal of dividing wall, and unconsented removal of downstand (shaded red) and lath and plaster ceiling.

| | | allow for the change in height. | |
|---|---|---|---|
| Downstand to second floor | n/a | The unauthorised removal of the entire wall between 2F02 and 2F03 to the second floor level<br><br>Reconstruct missing downstand. | (P – 2023)<br>Negligible adverse |

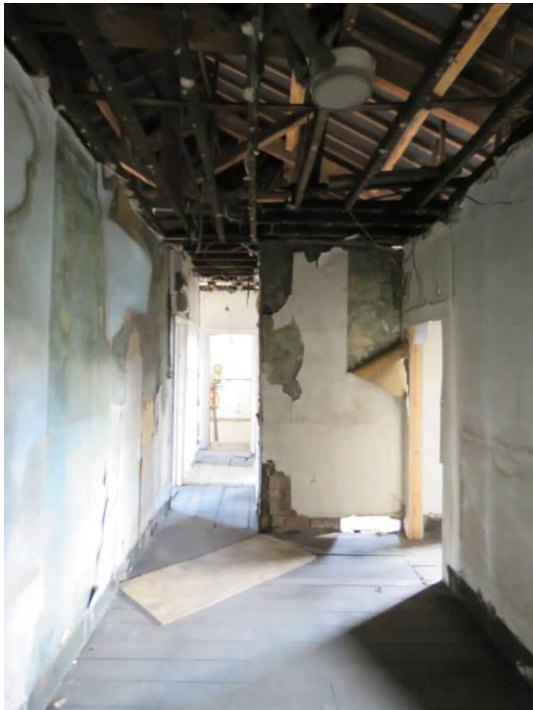
**Figure 159** – 2F05 looking east, showing removal of skirtings and ceiling.

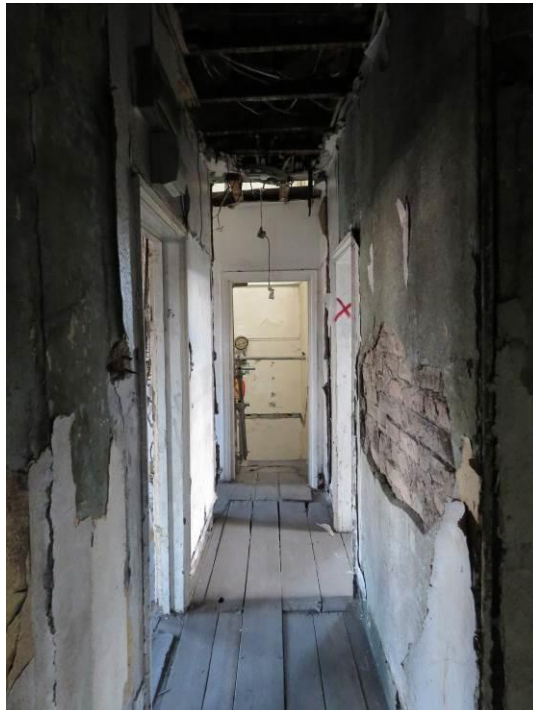
**Figure 160** – 2F05 looking east, showing removal of skirtings and ceiling.

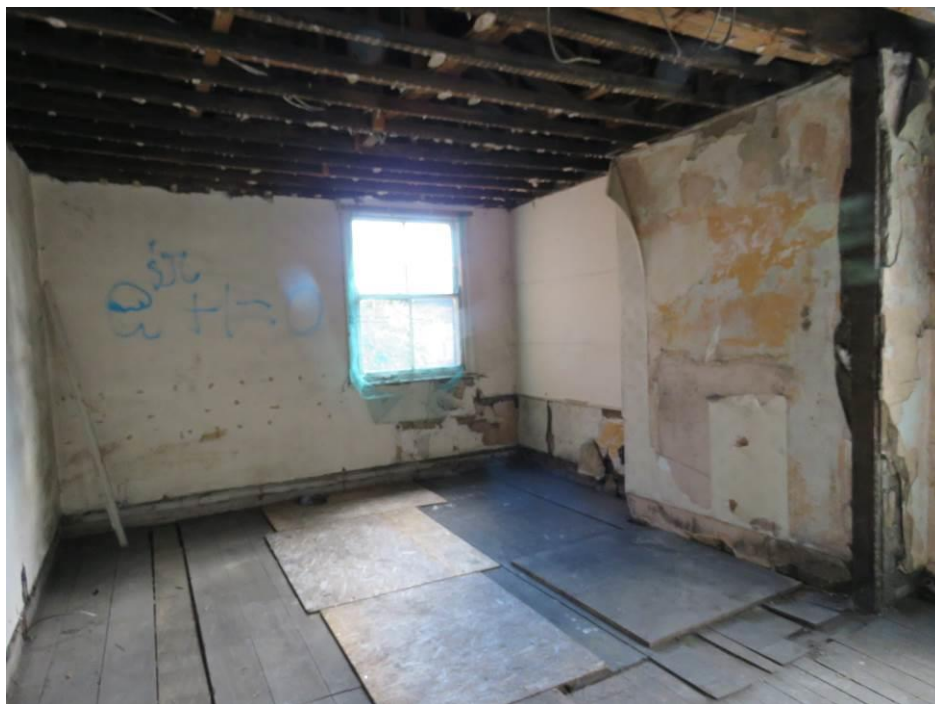
**Figure 161** – 2F06, showing removal of lath and plaster ceiling and skirtings.

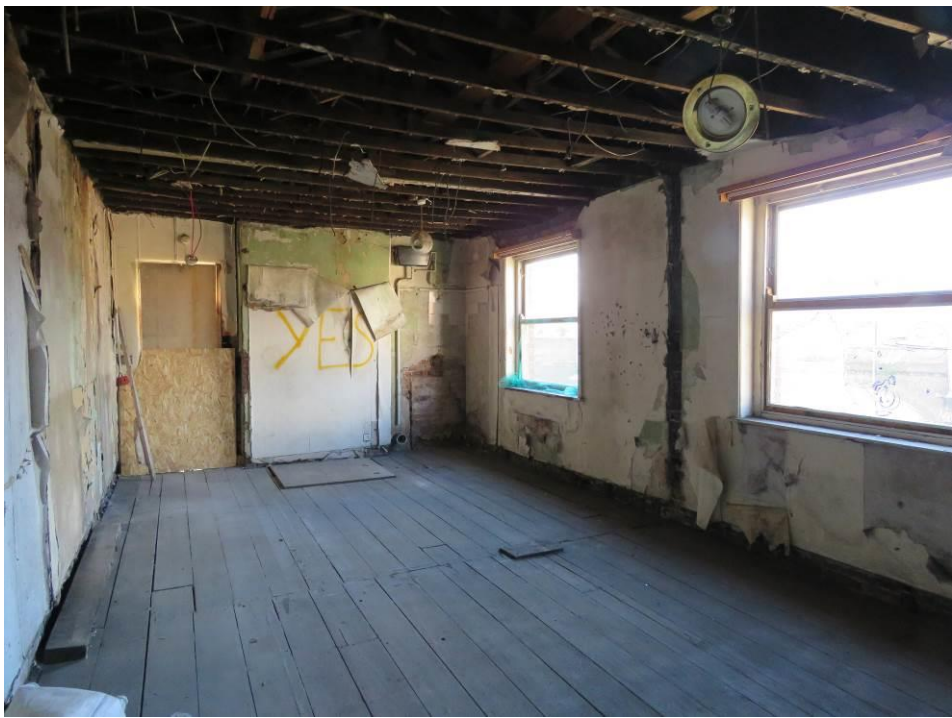
**Figure 162** – Looking south through 2F010/11/12, showing removal of skirtings and lath and plaster ceiling.

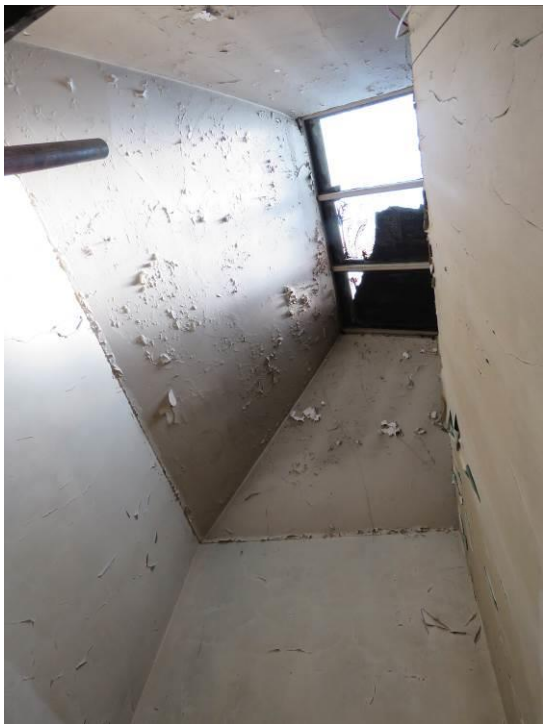
**Figure 163** – The original rooflight to the head of the staircase (2F04).

| | | allow for the change in height. | |
|---|---|---|---|
| Skylight to stairs in No. 125 | n/a | Replace current timber and glass skylight to second floor level of No. 125's staircase and install an AOV (automatic opening vent) in | (P – 2023)<br>Negligible adverse |

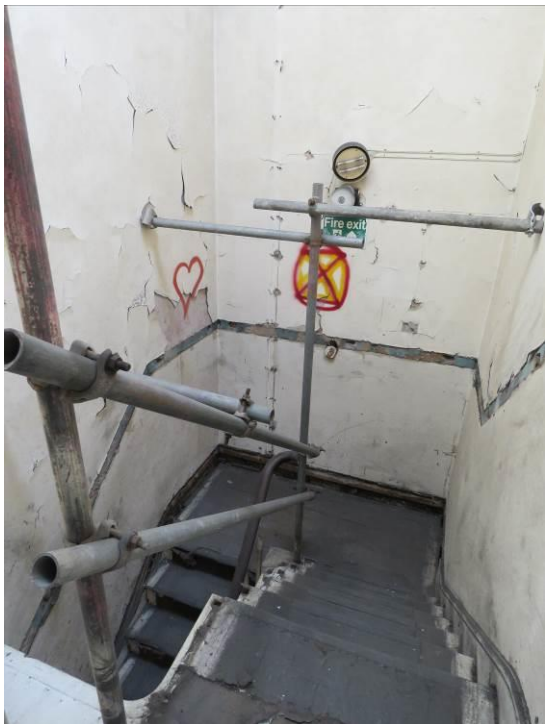
**Figure 164** – Looking down the original staircase (2F04), showing the removed original balustrading/handrails and dado rail.

| <b>Staircase</b> | Retain (No.125) and Express location of historic location (No.123) | <p>Unauthorized removal of original spindles and handrails to staircase at second floor level.</p> <p>Replacement of removed spindles and handrails to the upper parts of the staircase at second floor level like-for-like, using remaining elements of the staircase as templates.</p> | <p>(A - 2018)</p> <p>The original staircase to No.125 will be retained. The proposal to mark the location of the original stairs in No.123 will enhance the ability to understand and appreciate the historic plan form of No.123 and the fact it used to be two separate dwellings.</p> <p>Minor Beneficial</p> |

| Dado rails to staircase | n/a | Replace dado rail to staircase and landing removed without consent | <p>(P – 2023)</p> <p>Negligible Adverse</p> |

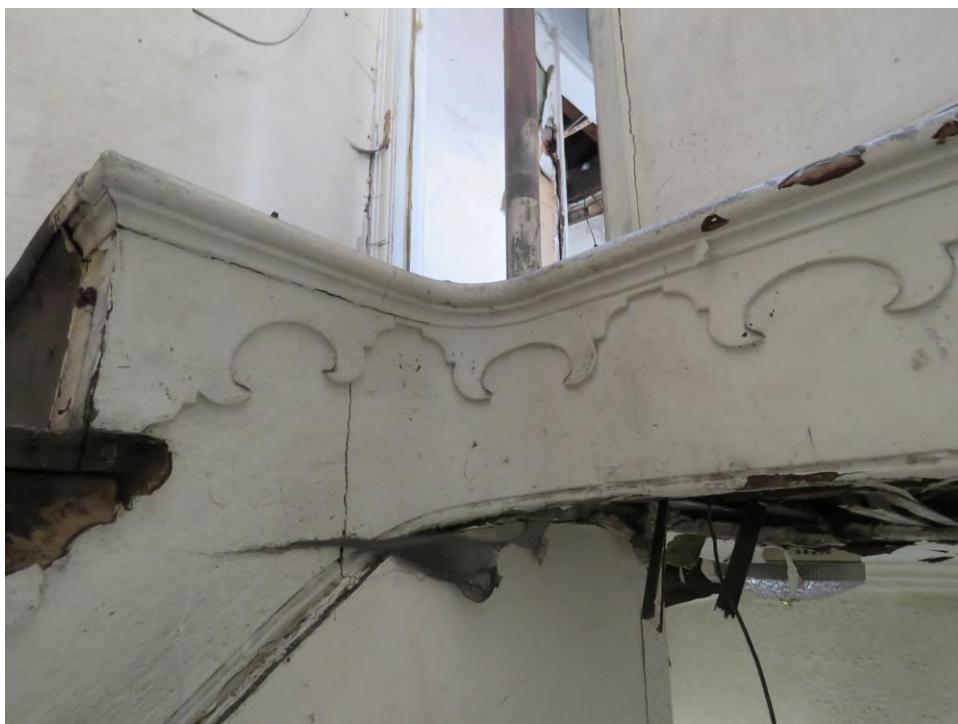
**Figure 165** – Detail of the original cut string carved decoration to 2F04.

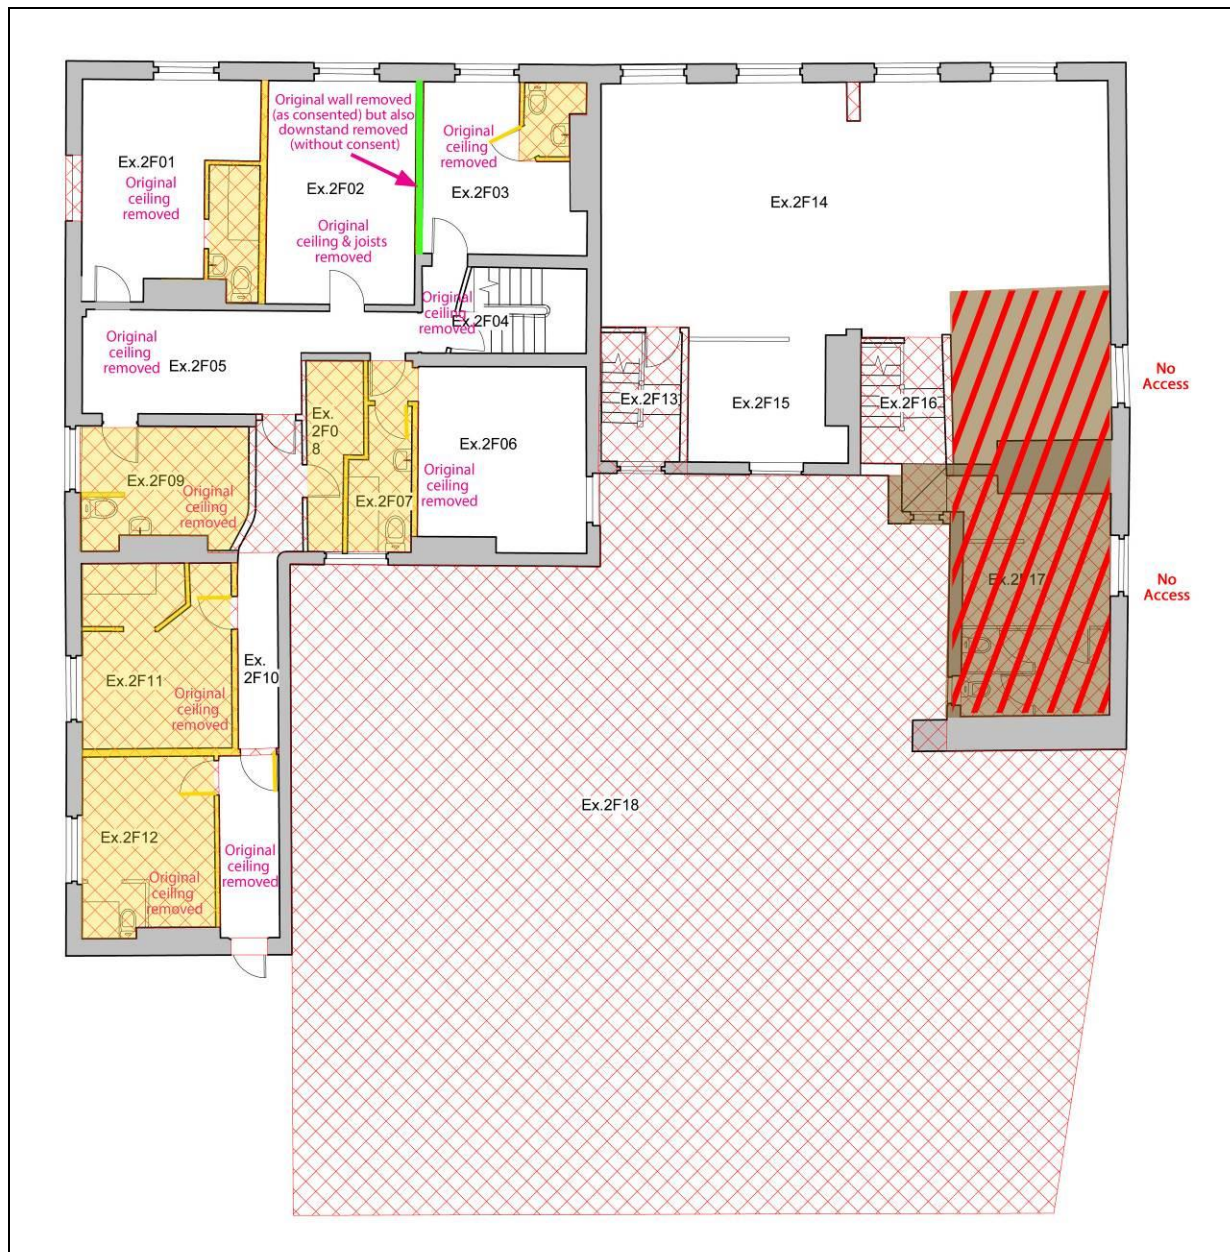
Figure 171 – Existing second floor plan. Although not shown, all skirtings have also been removed.
