# GEOSHIELD Verification Report

## VERIFICATION ITEM ONE

LOCATION/GRID LINE: Upper Raft Slab

NOTES: Taped Lap Joints

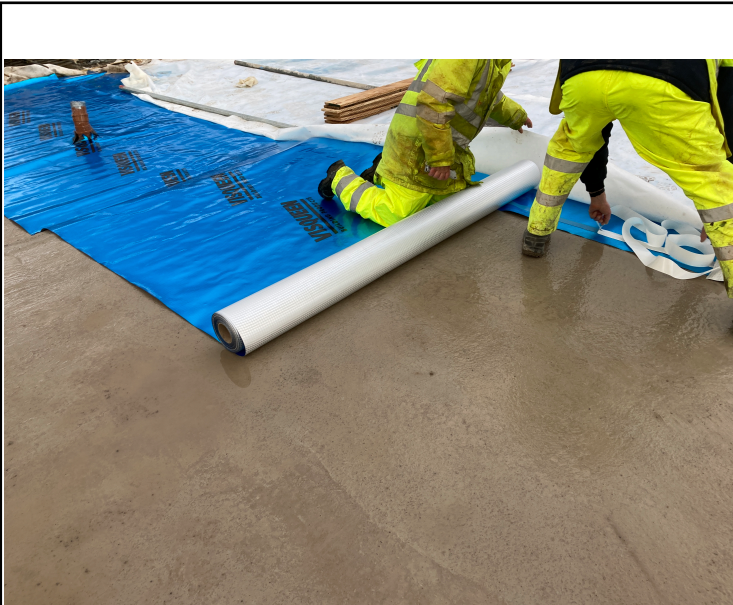
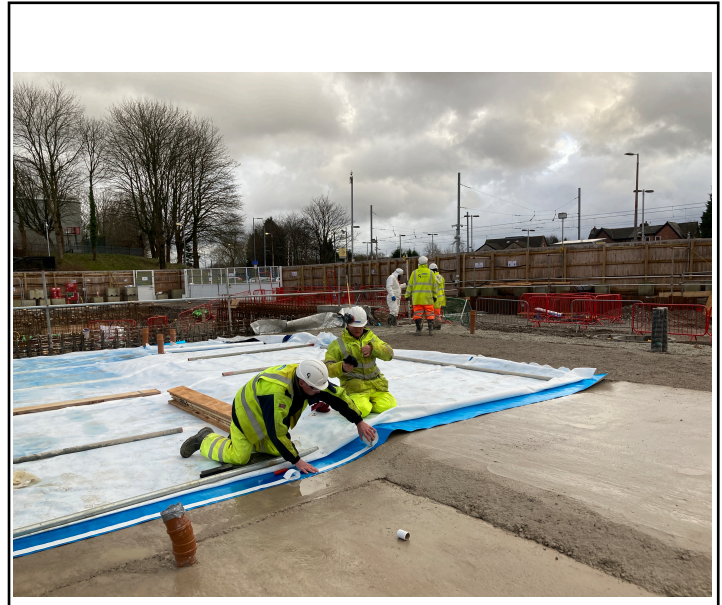
Visqueen Standard Gas Barrier has been installed across the verified area and overlaps of 100mm have been created, they have then been sealed using 40mm double sided butyl tape forming a continuous barrier. The photos below show the installation of

membrane and the double sided butyl tape.

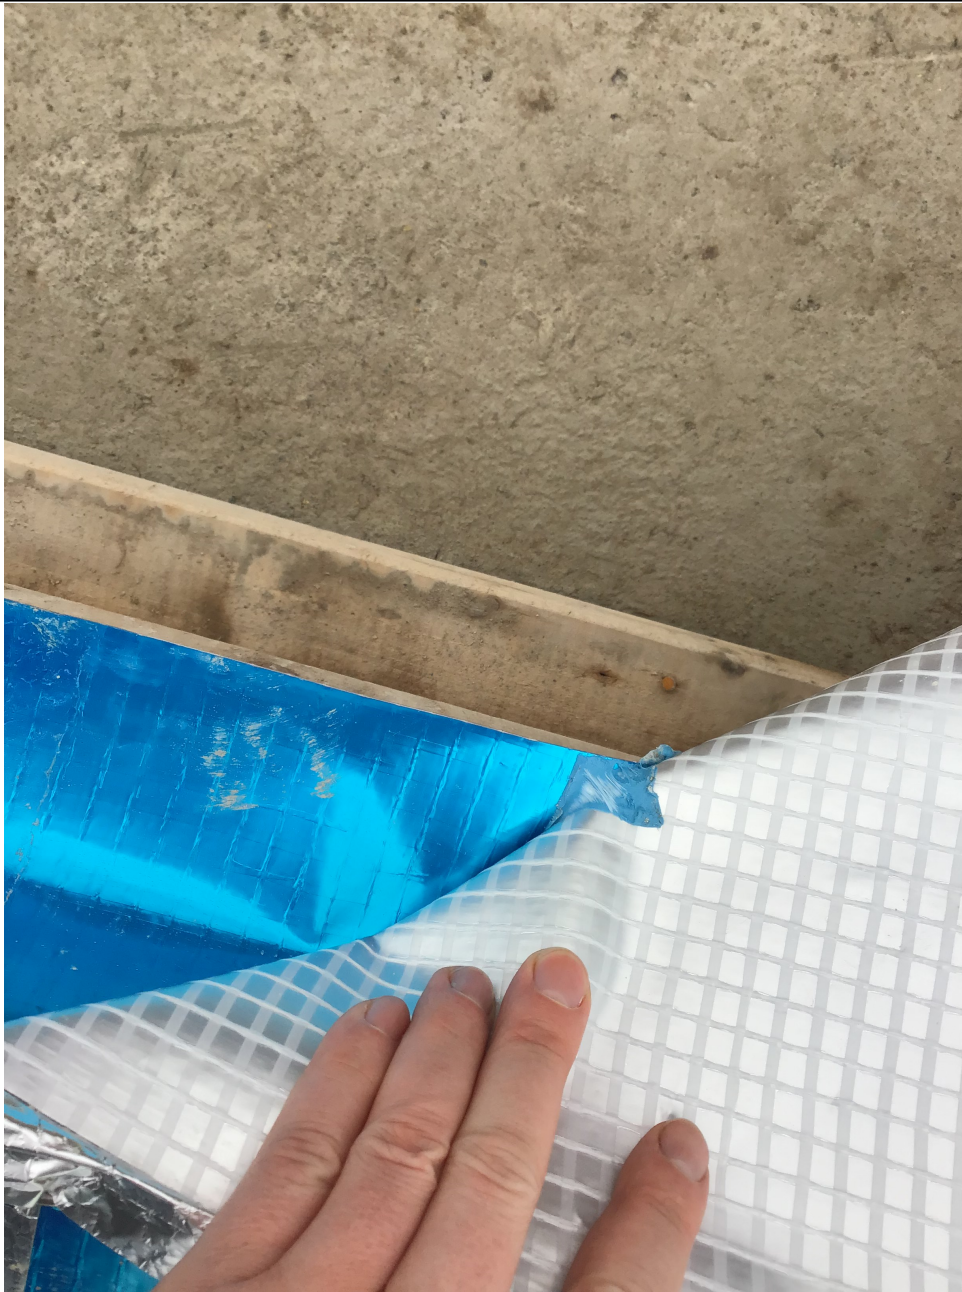
This shows a close up of the double sided butyl tape. The joints were complete with silver foil tape and no defects found during the verification process.
