# PRELIMINARY RISK ASSESSMENT

Application 5: Plots NT02-04 (Full Application)

**PROJECT NO. 70079268**

**DATE: APRIL 2023**

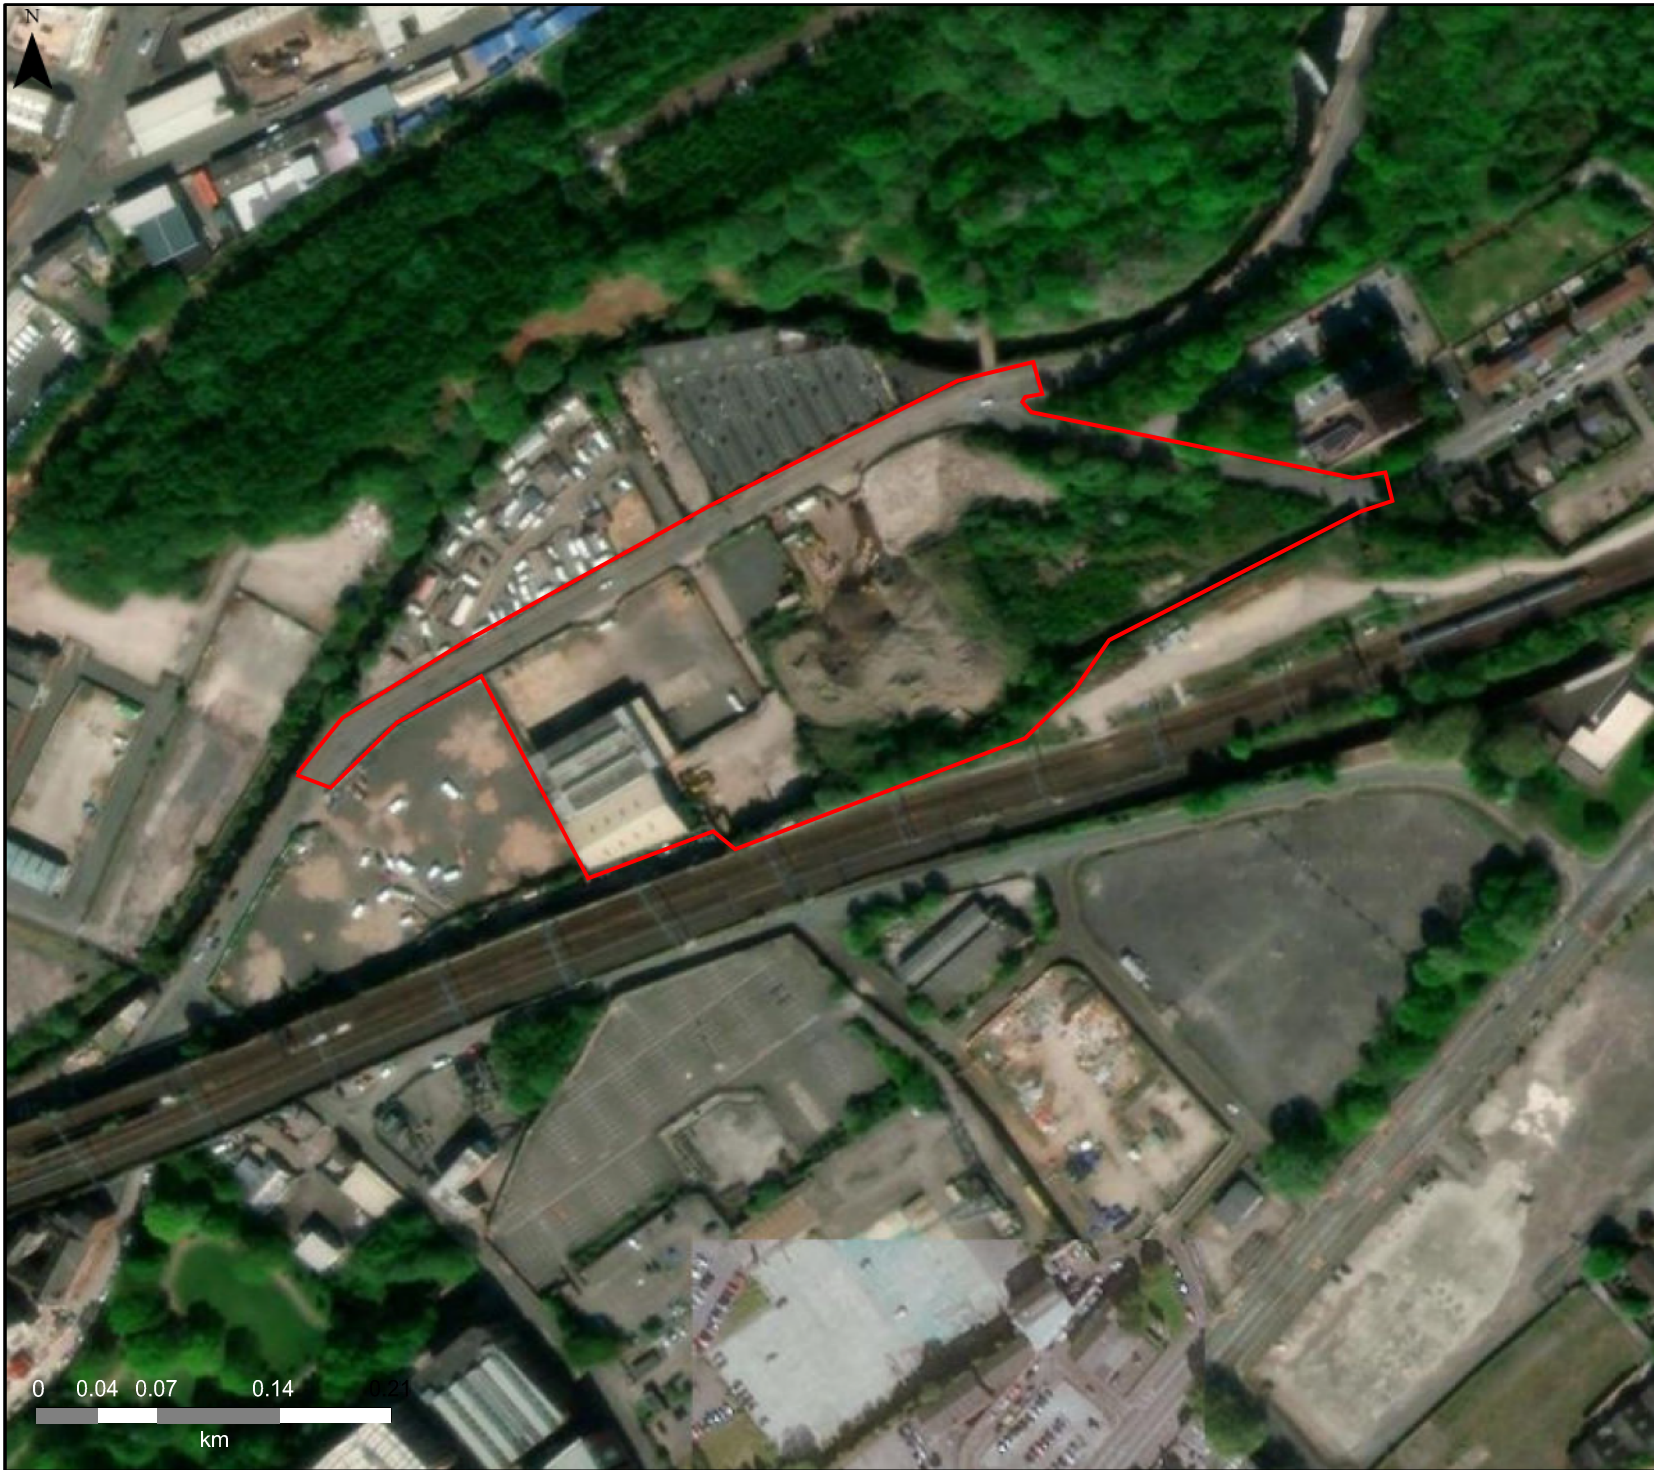
Title : Figure 2 - Site Boundary Plan  
Author : EL  
Scale : 1:4,514  
Layout : WSP A4 Landscape  
Current Time : 23/03/2023 11:20

Site Boundary
