| <b>Project:</b> Fraser House | <b>Eng:</b> MWS |
| <b>Title:</b> Third floor structure | <b>Date:</b> May'23 |
| <b>No:</b> LM21346-DYSE-XX-ZZ-SK-S-0025 | <b>Rev:</b> P03 |

## Third Floor Structure Indicating Fourth Floor Structure Over

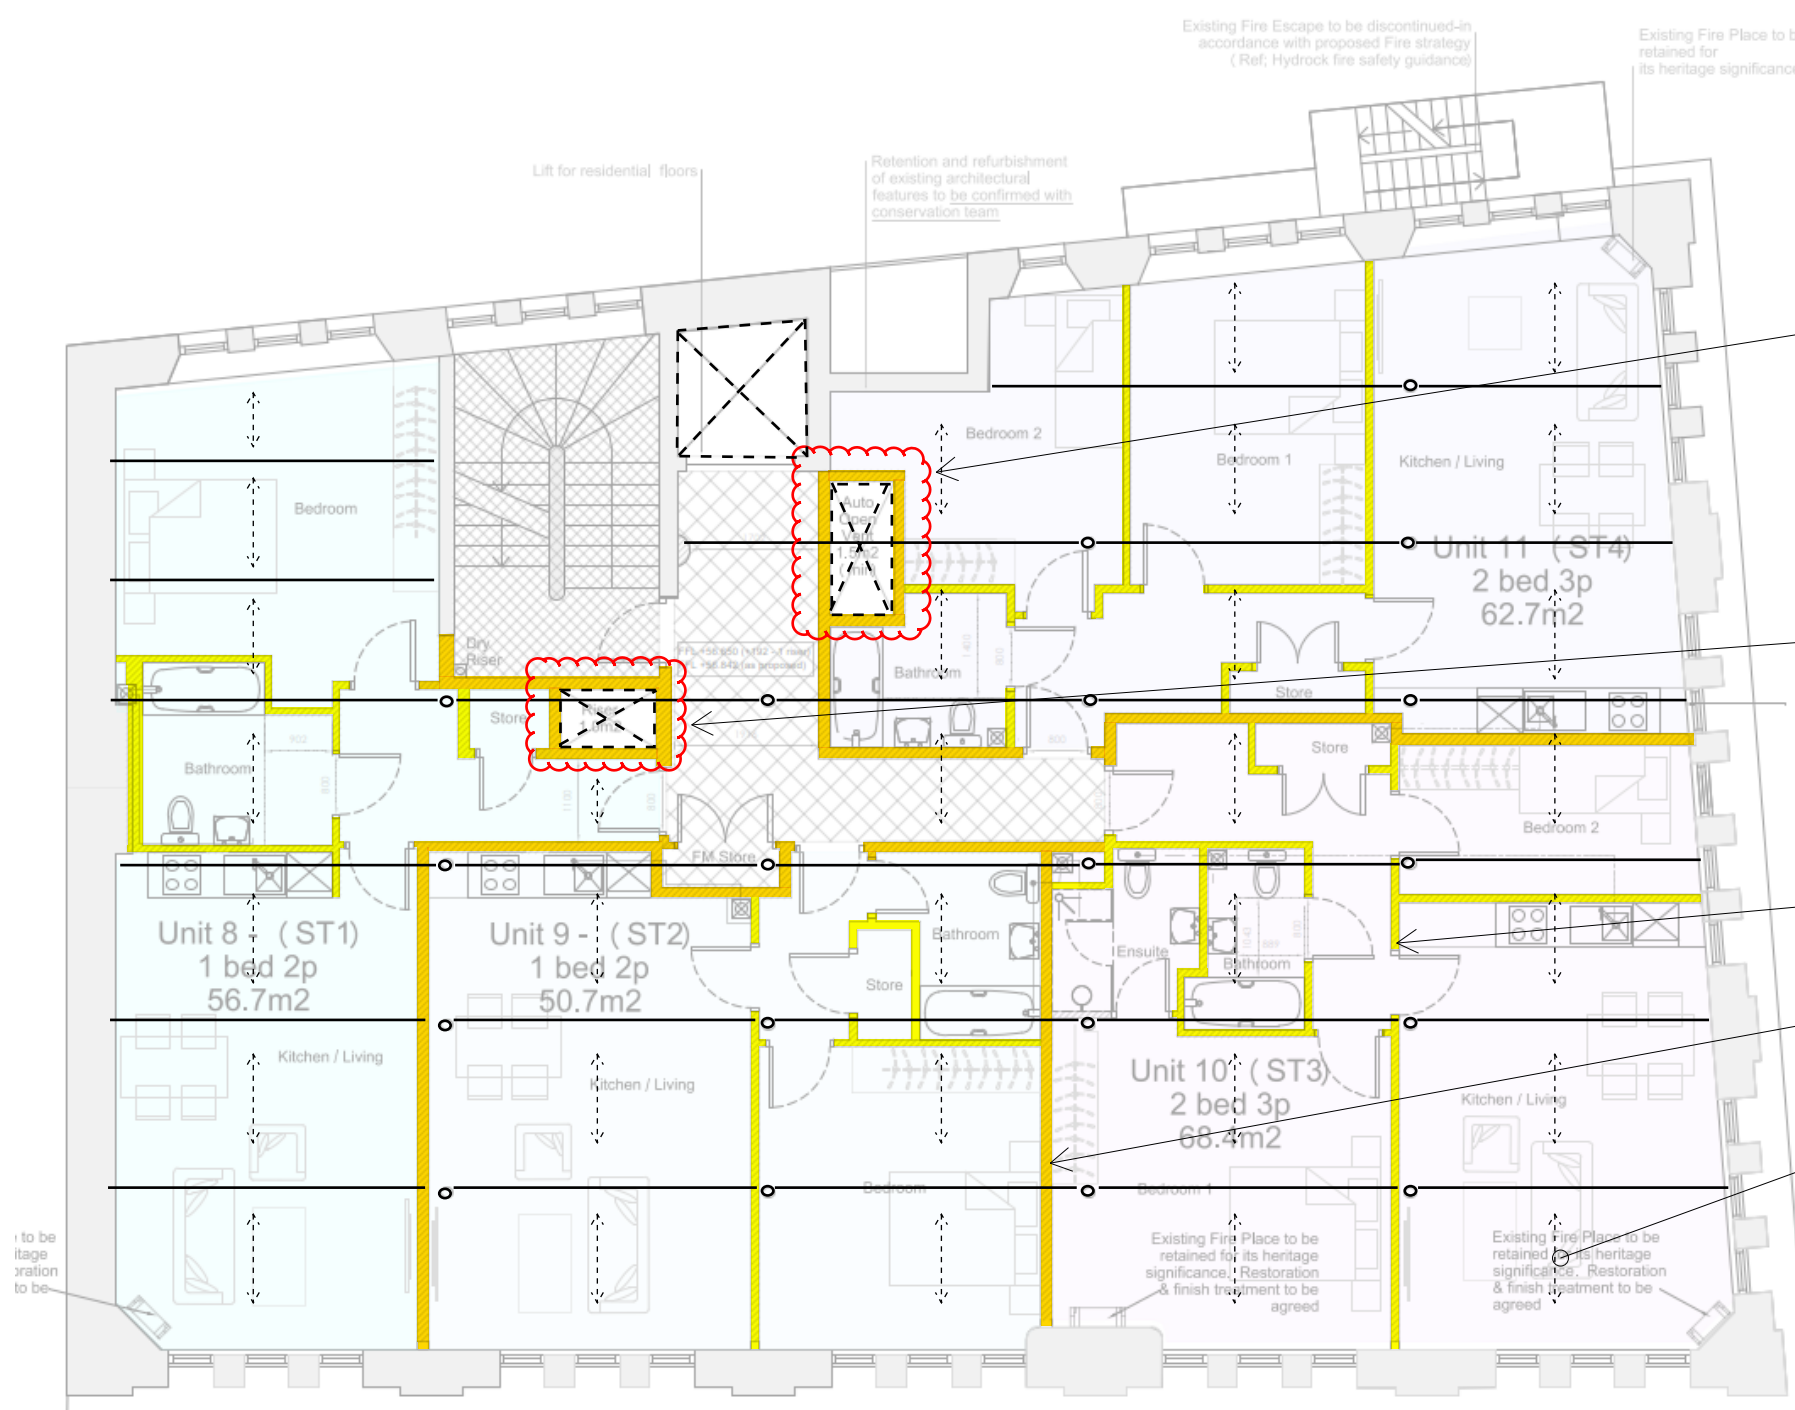
Location of smoke vent cuts through existing primary timber floor beam. Can smoke vent be moved to avoid additional significant structural framing to trim out void for smoke vent. Architects to confirm acceptance.

Location of service riser cuts through existing primary timber floor beam. Can beam continue to pass through service riser to avoid additional significant structural framing to trim out void for smoke vent. Architects & M&E consultants to confirm acceptance.

Non-structural studwork partitions to be built up off the existing timber floor structure.

Structural studwork walls to be built up off the existing timber floor structure.

New raised floor build up to architects design and details.
