# Design and Access Statement

Science and Industry Museum  
1830s Warehouse

Client: The Board of Trustees of the Science Museum  
Date: April 2023  
Revision: B

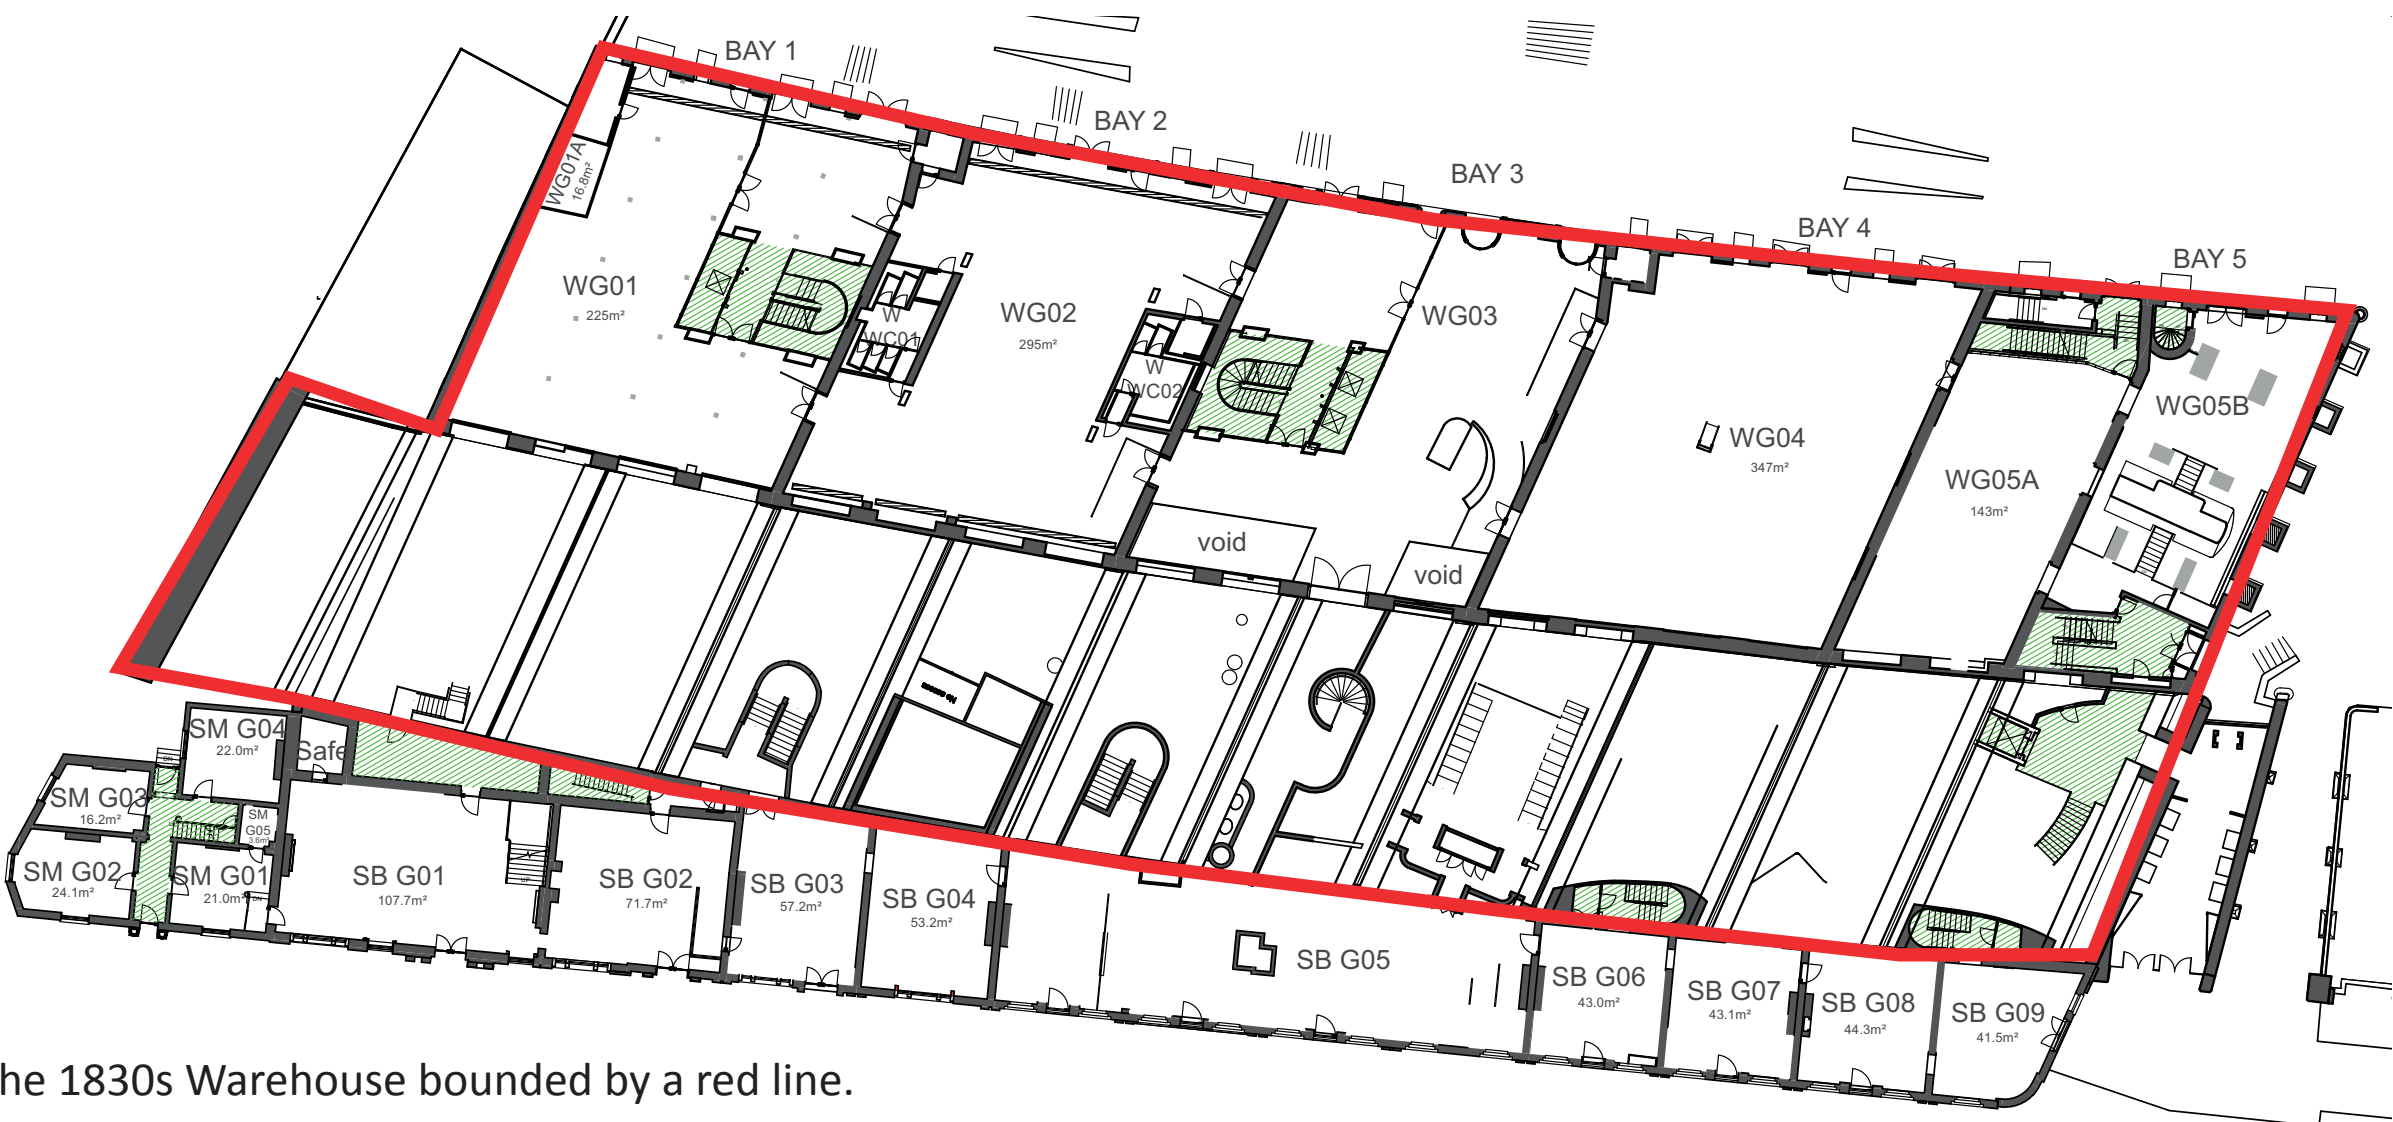
Plan showing the 1830s Warehouse bounded by a red line.  
The rest of the building is the Station Building

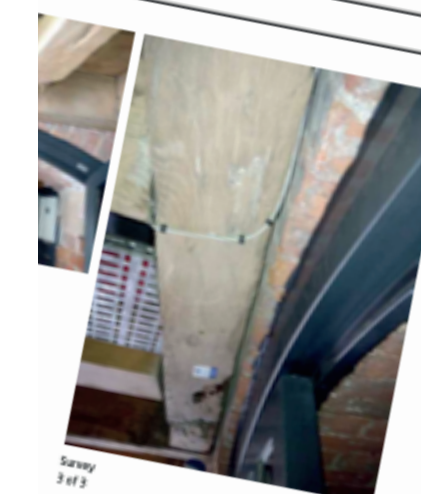
ap where the metal conduit penetrates the blockwork. Use RWA-45 to pack out the gap and mastic.

istic seal is needed to close the gap. Push up rwa45 as high as can so mastic seal is not on show as much.

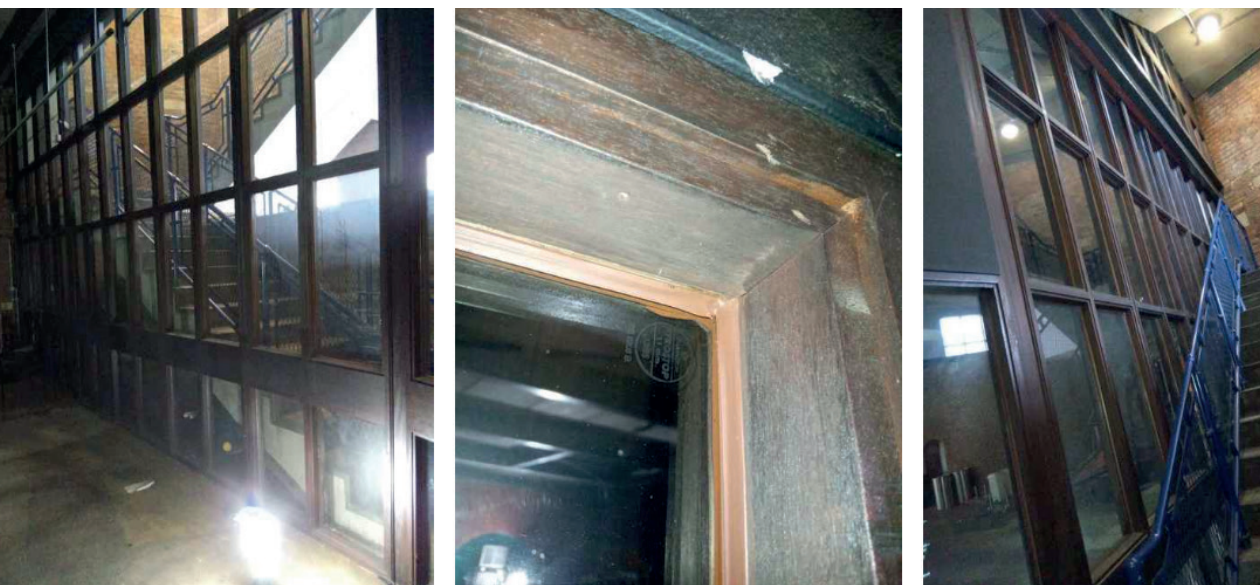
Example photo of non fire rated glazing within non historic partition

Replacement of non fire rated glazing within existing non historic partitions with fire rated glazing. Visually the detail will match the existing.

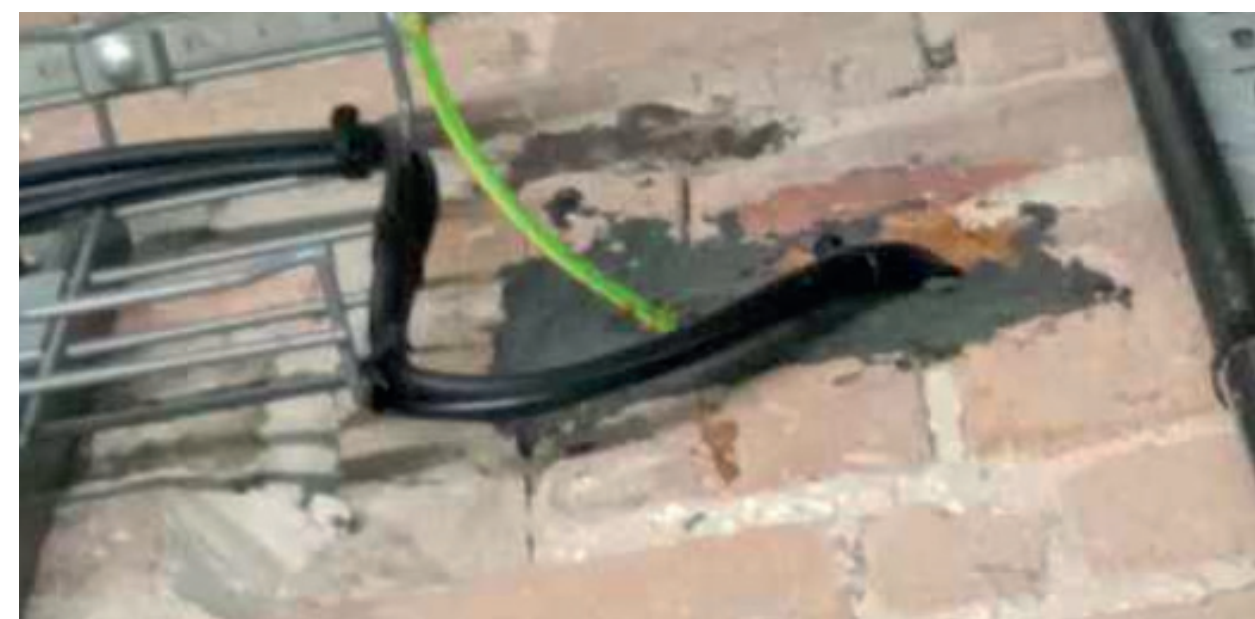
Example photo of localised cleaning of brickwork to remove mastic

Localised cleaning of brickwork to remove either mastic sealant and/or cement based mortar. This is to be done by hand tools or where applicable poultices only, and if this is unsuccessful then the CA will review on site and consider leaving the deposits rather than risk damaging the underlying brickwork.

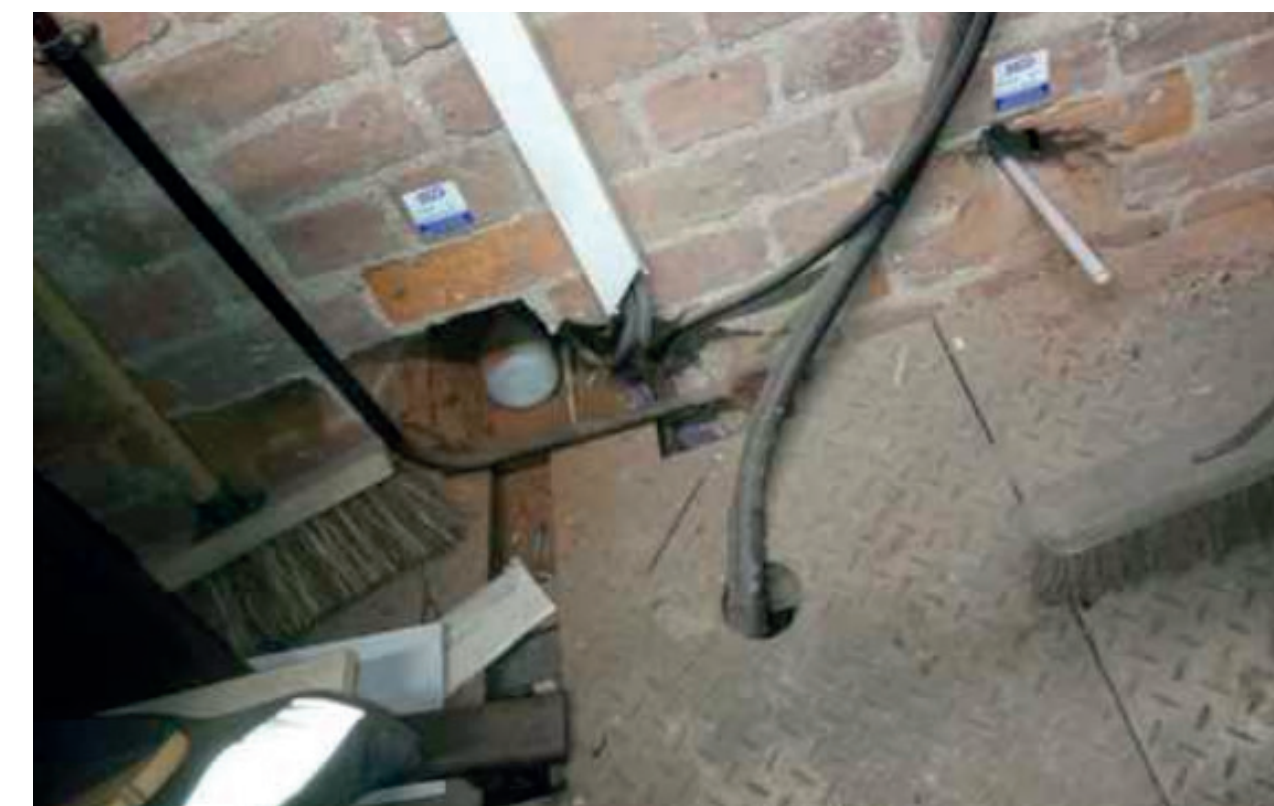
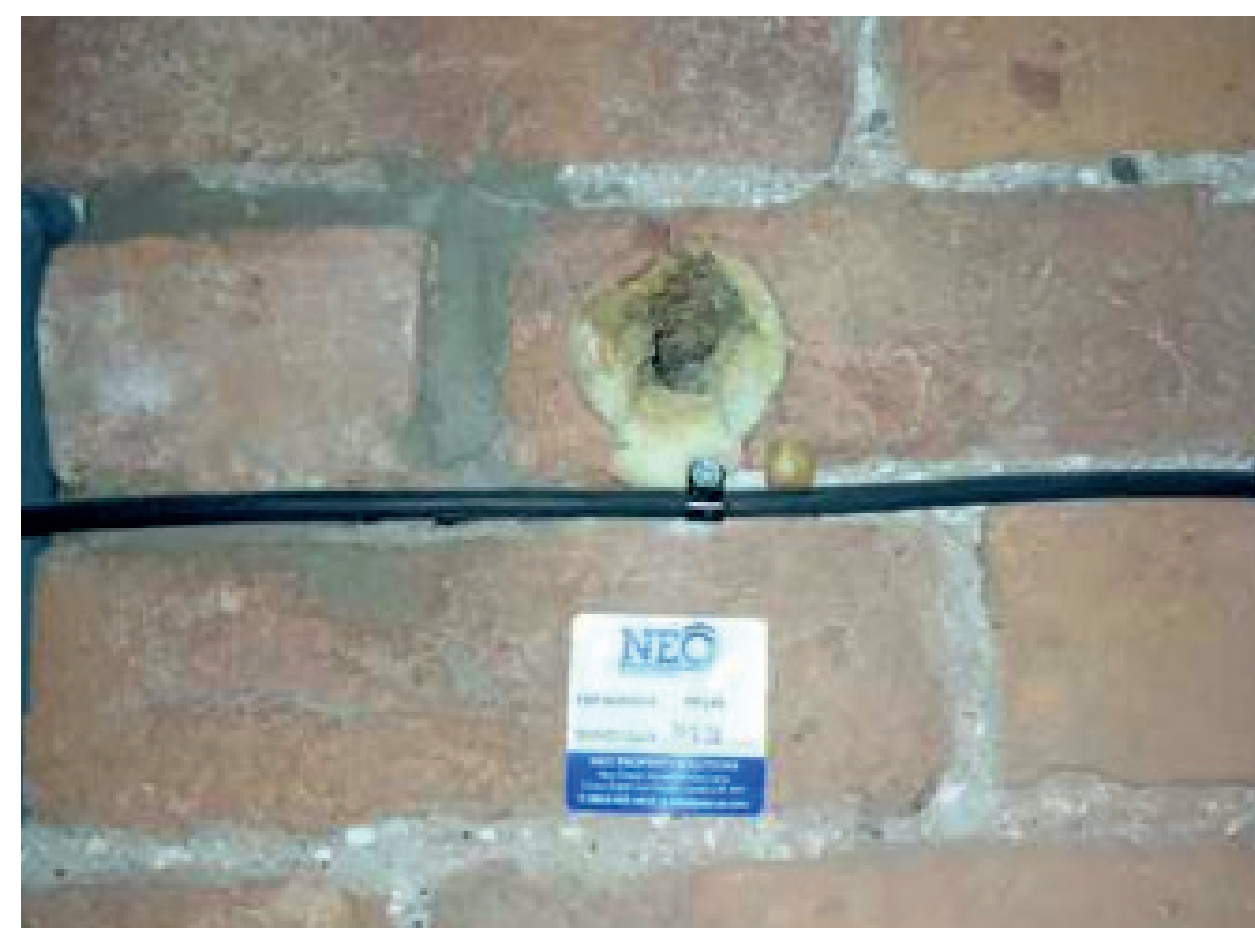
Example of isolated brick requiring a mortar repair

Localised brickwork repair or replacement where damaged bricks surrounding the cable/duct/pipe need to be repaired to prevent further deterioration and to ensure the fire separation of the masonry wall is not compromised.

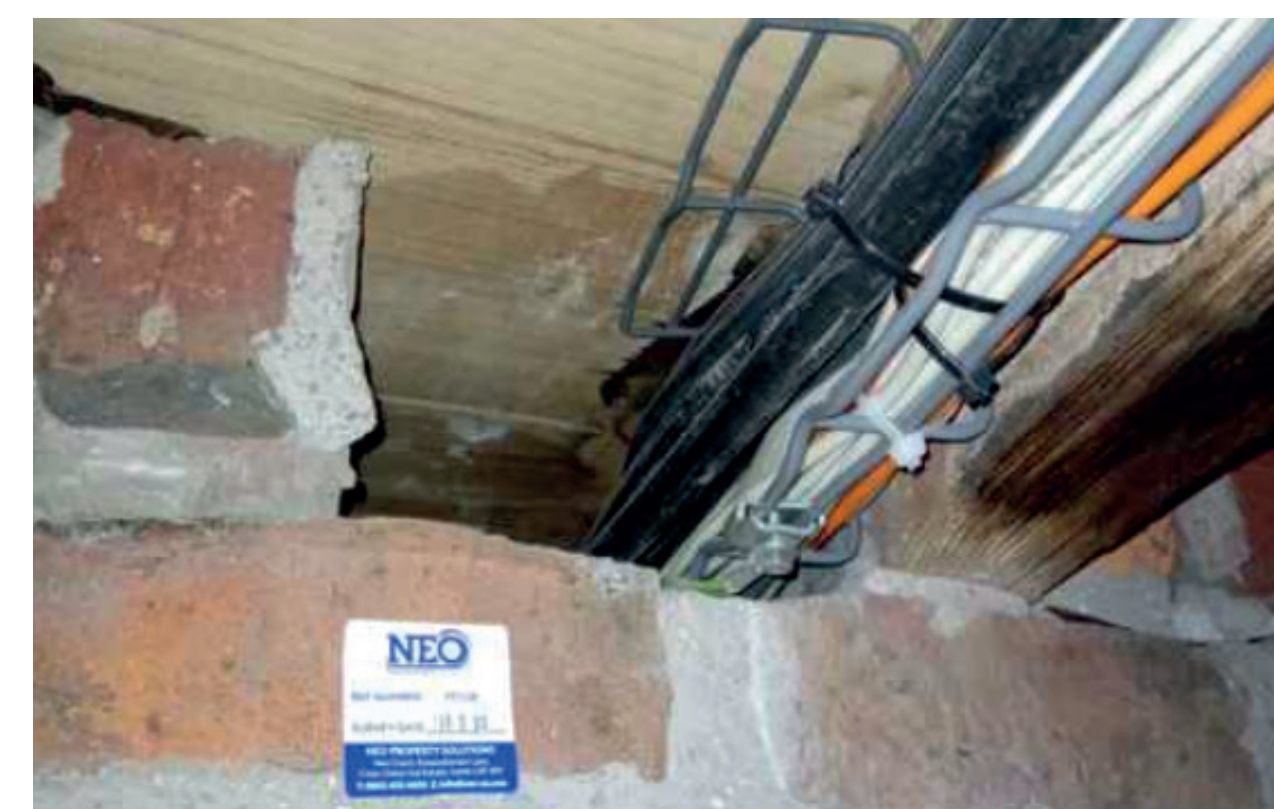
Example photos of localised areas of missing or damaged brickwork to be repaired prior to standard fire stopping details being carried out.

Localised brickwork reinstatement where openings exist at the location of pipes/ducts/cables which are larger than they need to be and can therefore be filled with matching brickwork to an extent.

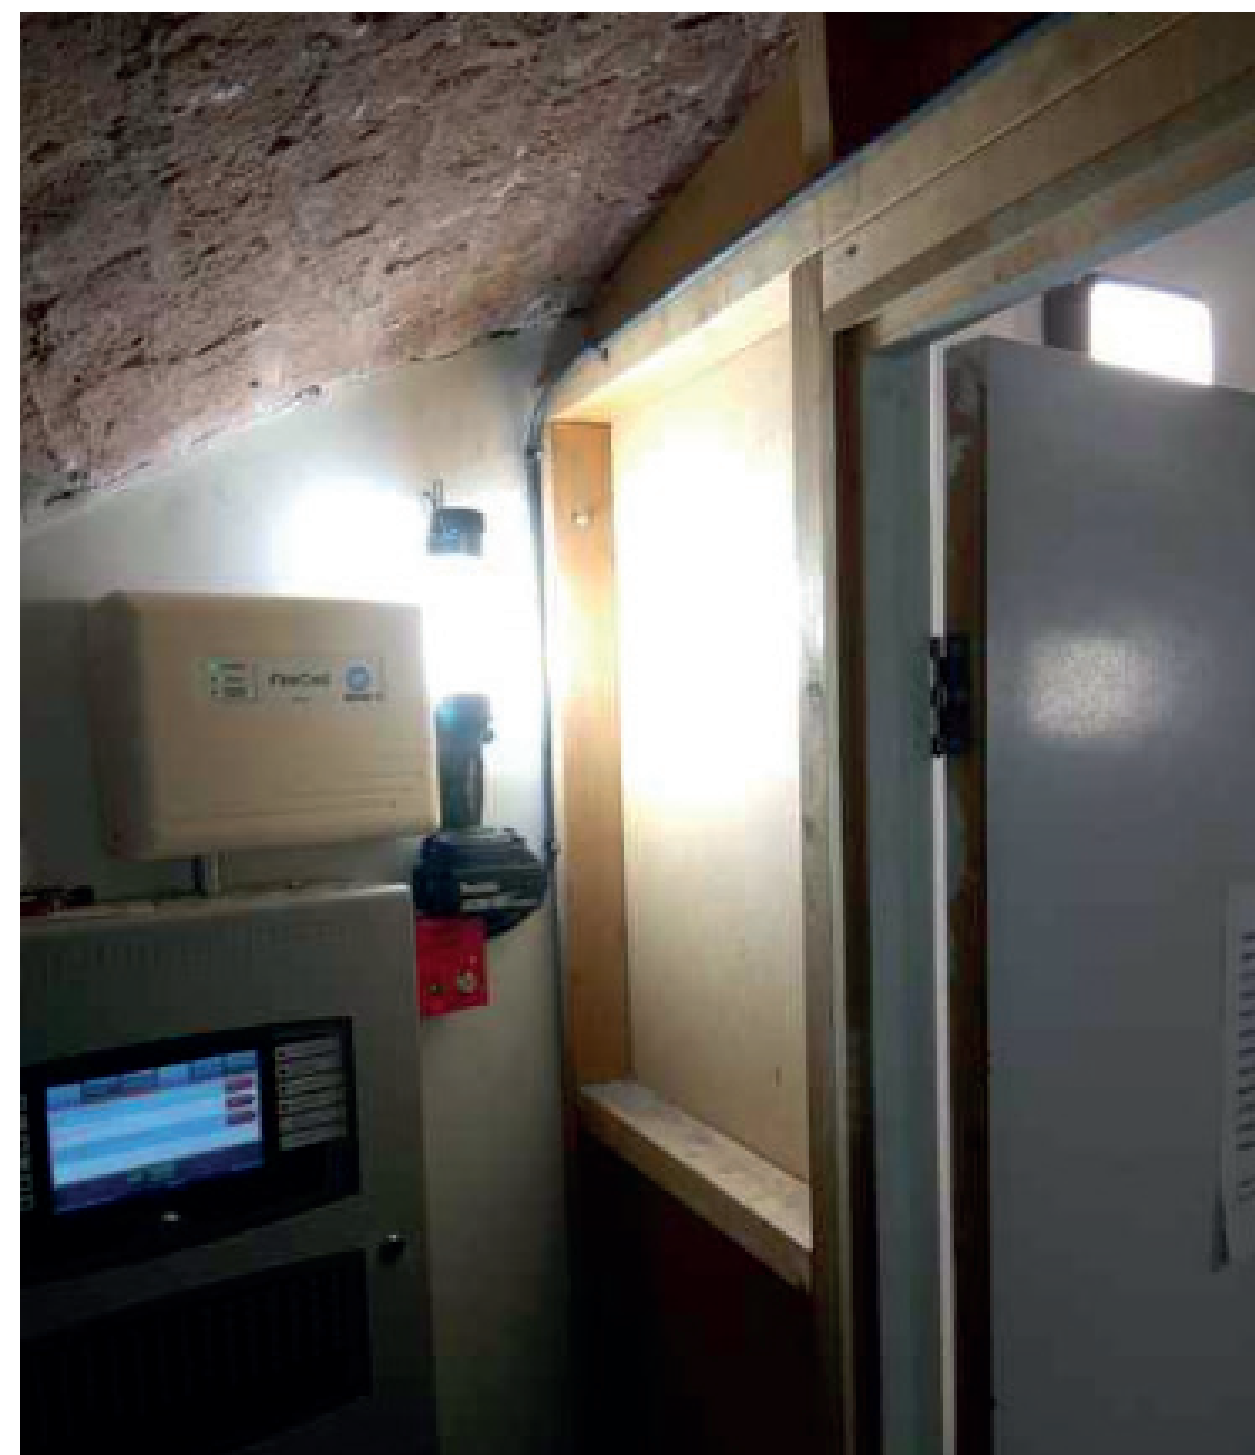
Example of a partition and door which are not fire rated. These will be carefully taken down and a fire rated equivalent reinstated. All fixings will be into the mortar joints of the surrounding brickwork only.

In isolated locations, existing stud walls have been found that are not fire rated to the correct standards. In these situations, the walls will be carefully removed and reinstated using an appropriate fire rated build-up.

These proposals will have minimal impact on the historic fabric, as the fixings will be made into the existing mortar. This is as per our methodology documentation. The use of modern materials will also ensure that these reversible changes are legible.

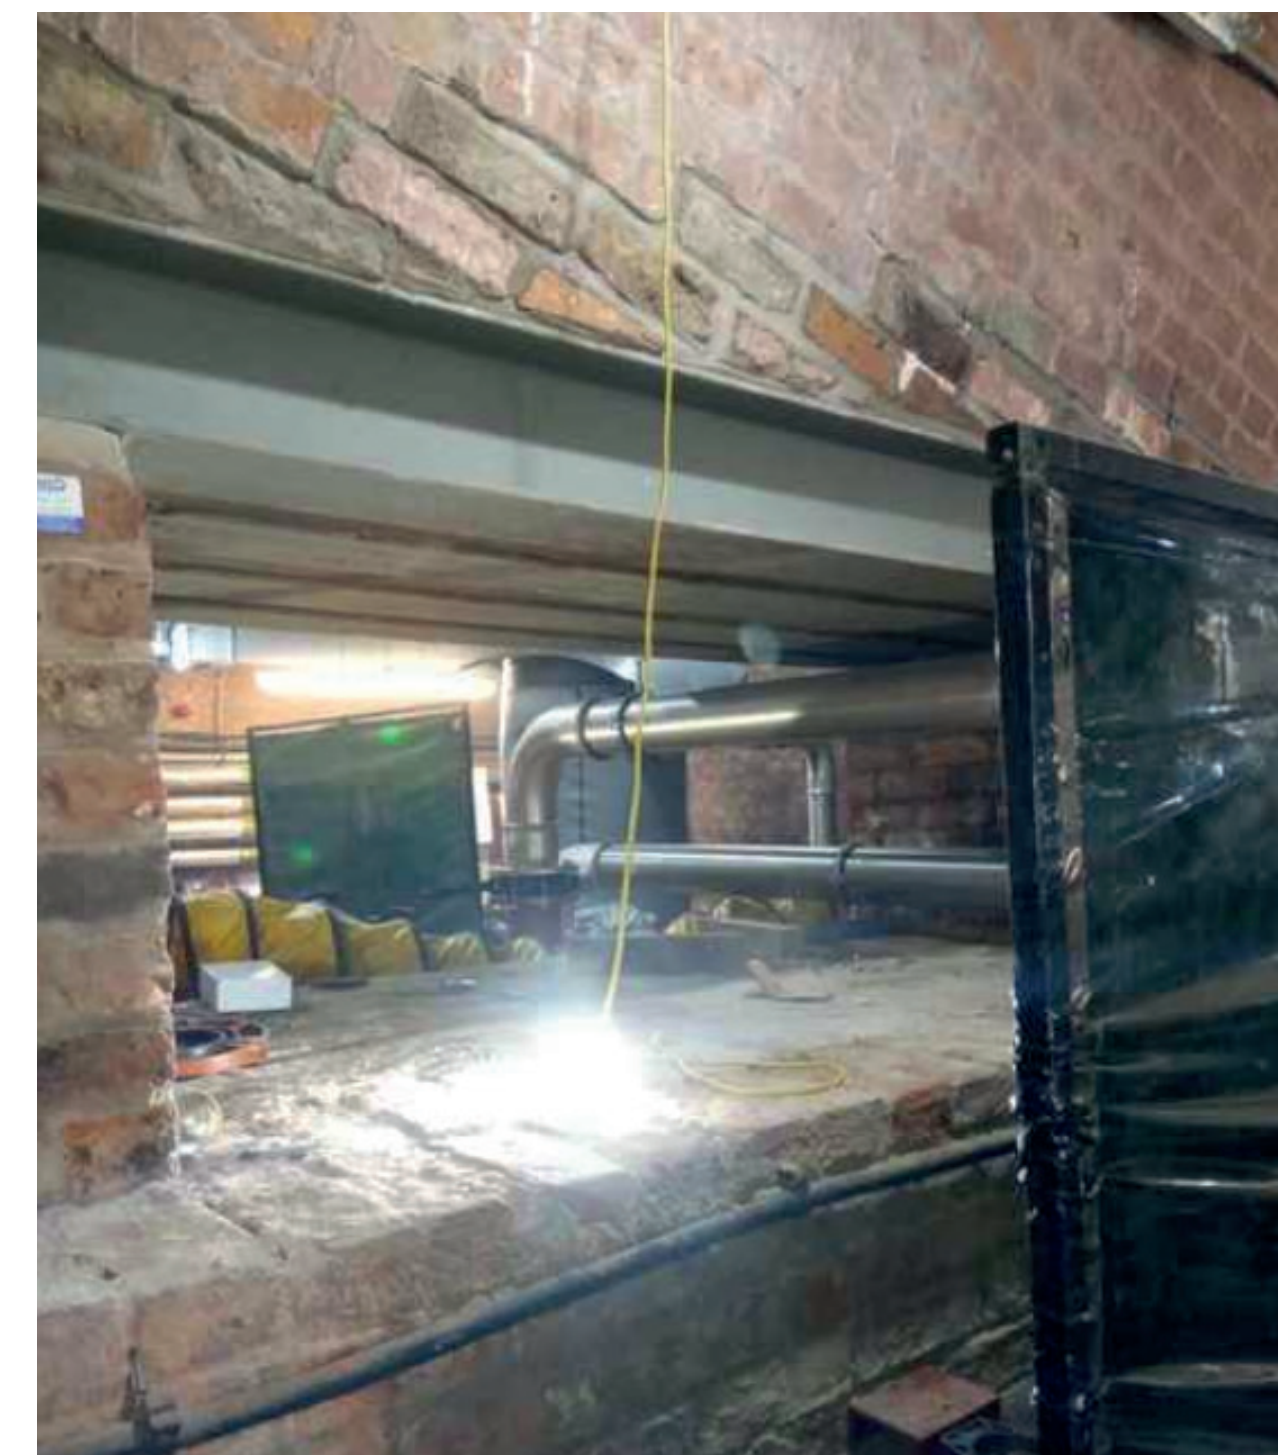
Opening between two spaces to be filled with fire rated partition

In one location, an existing opening between two areas in the basement needs to be fire rated due to the nature of the plant equipment on each side of the wall. Therefore we will install a fire rated metal stud partition with the necessary fire stopped penetrations to suit the existing pipework which transverses the wall. (See drawing P(120))

Similarly to above, in one location a new fire rated partition is required between two areas of plant. This is to complete the 60minute fire wall which is proposed in the Fire Strategy for the building. (See drawing P(121))

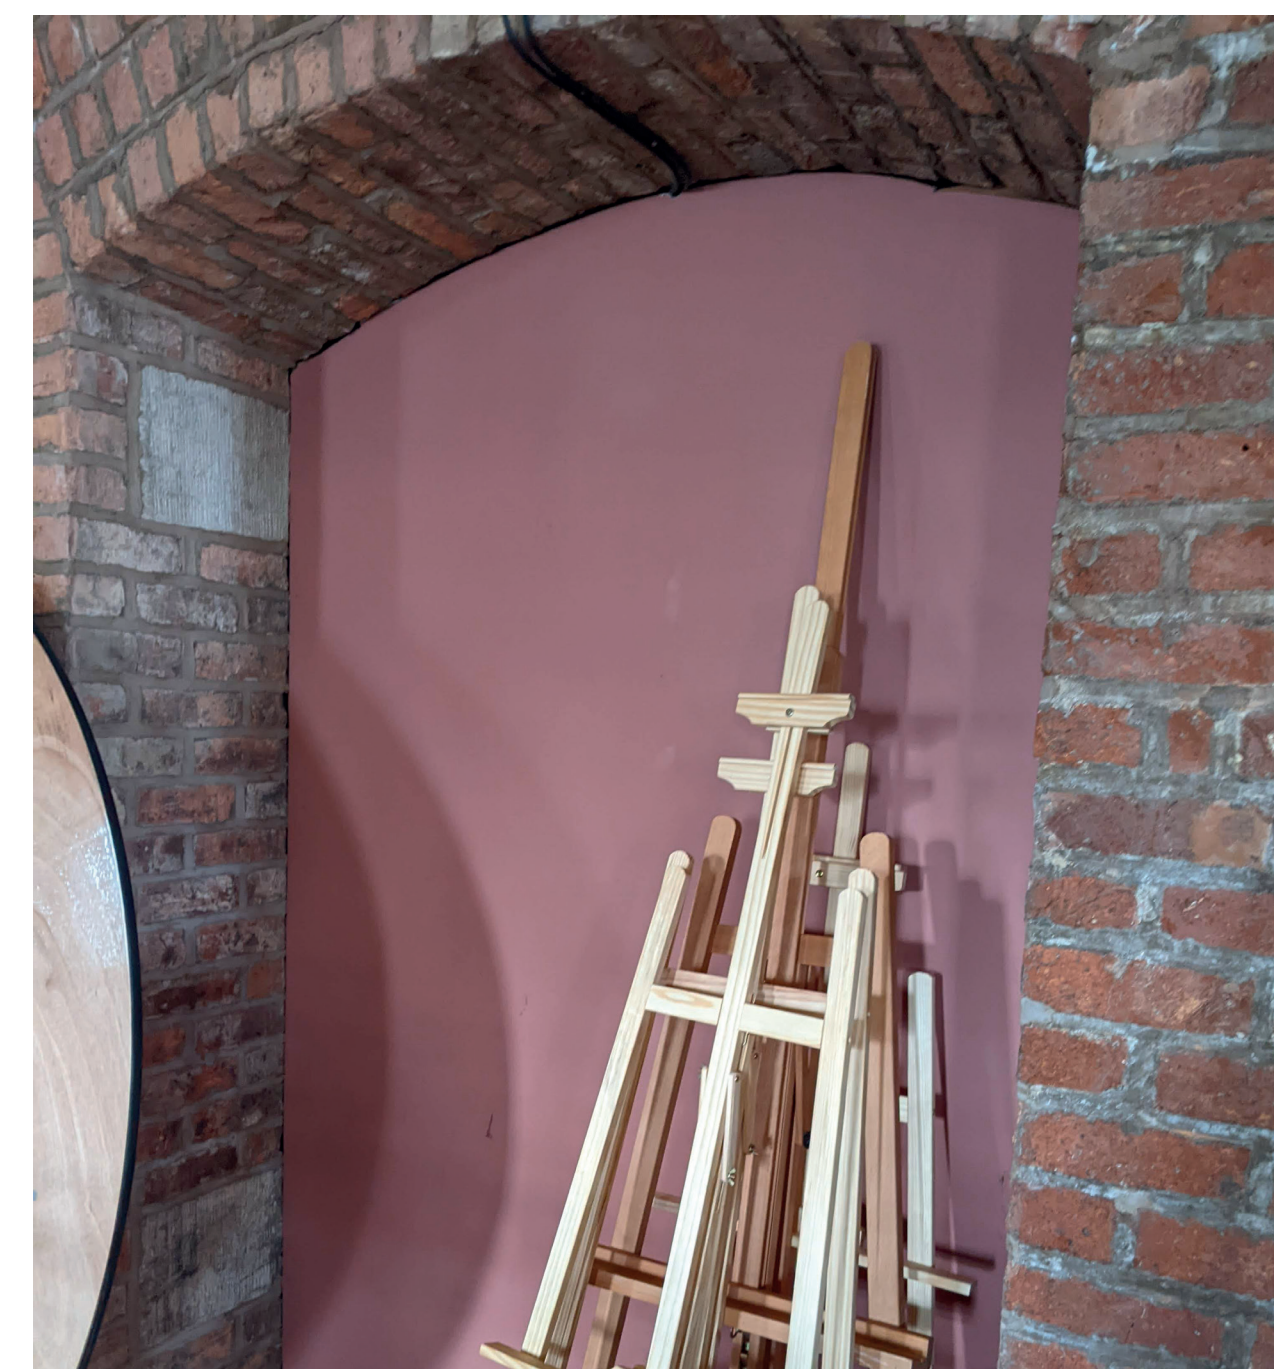
Example of an existing opening within masonry wall. This partition is not sufficiently fire rated and therefore we will upgrade this. Refer to drawings P(110), P(122) and P(123) for locations.

In 5 no. locations there are existing arched openings within brick walls which have been infilled with non fire rated boarding.

For example, where LG07 in the Station Building meets the 1830s building, a former opening has been infilled with a metal stud partition. However, this has not been completed and is therefore not fire rated. In this location, we propose to complete the fire rating of the partition. This will not cause any further intervention to the historic fabric as the partition is already in place.
