## Tree Survey Report

### Manchester Science Park

March 2014

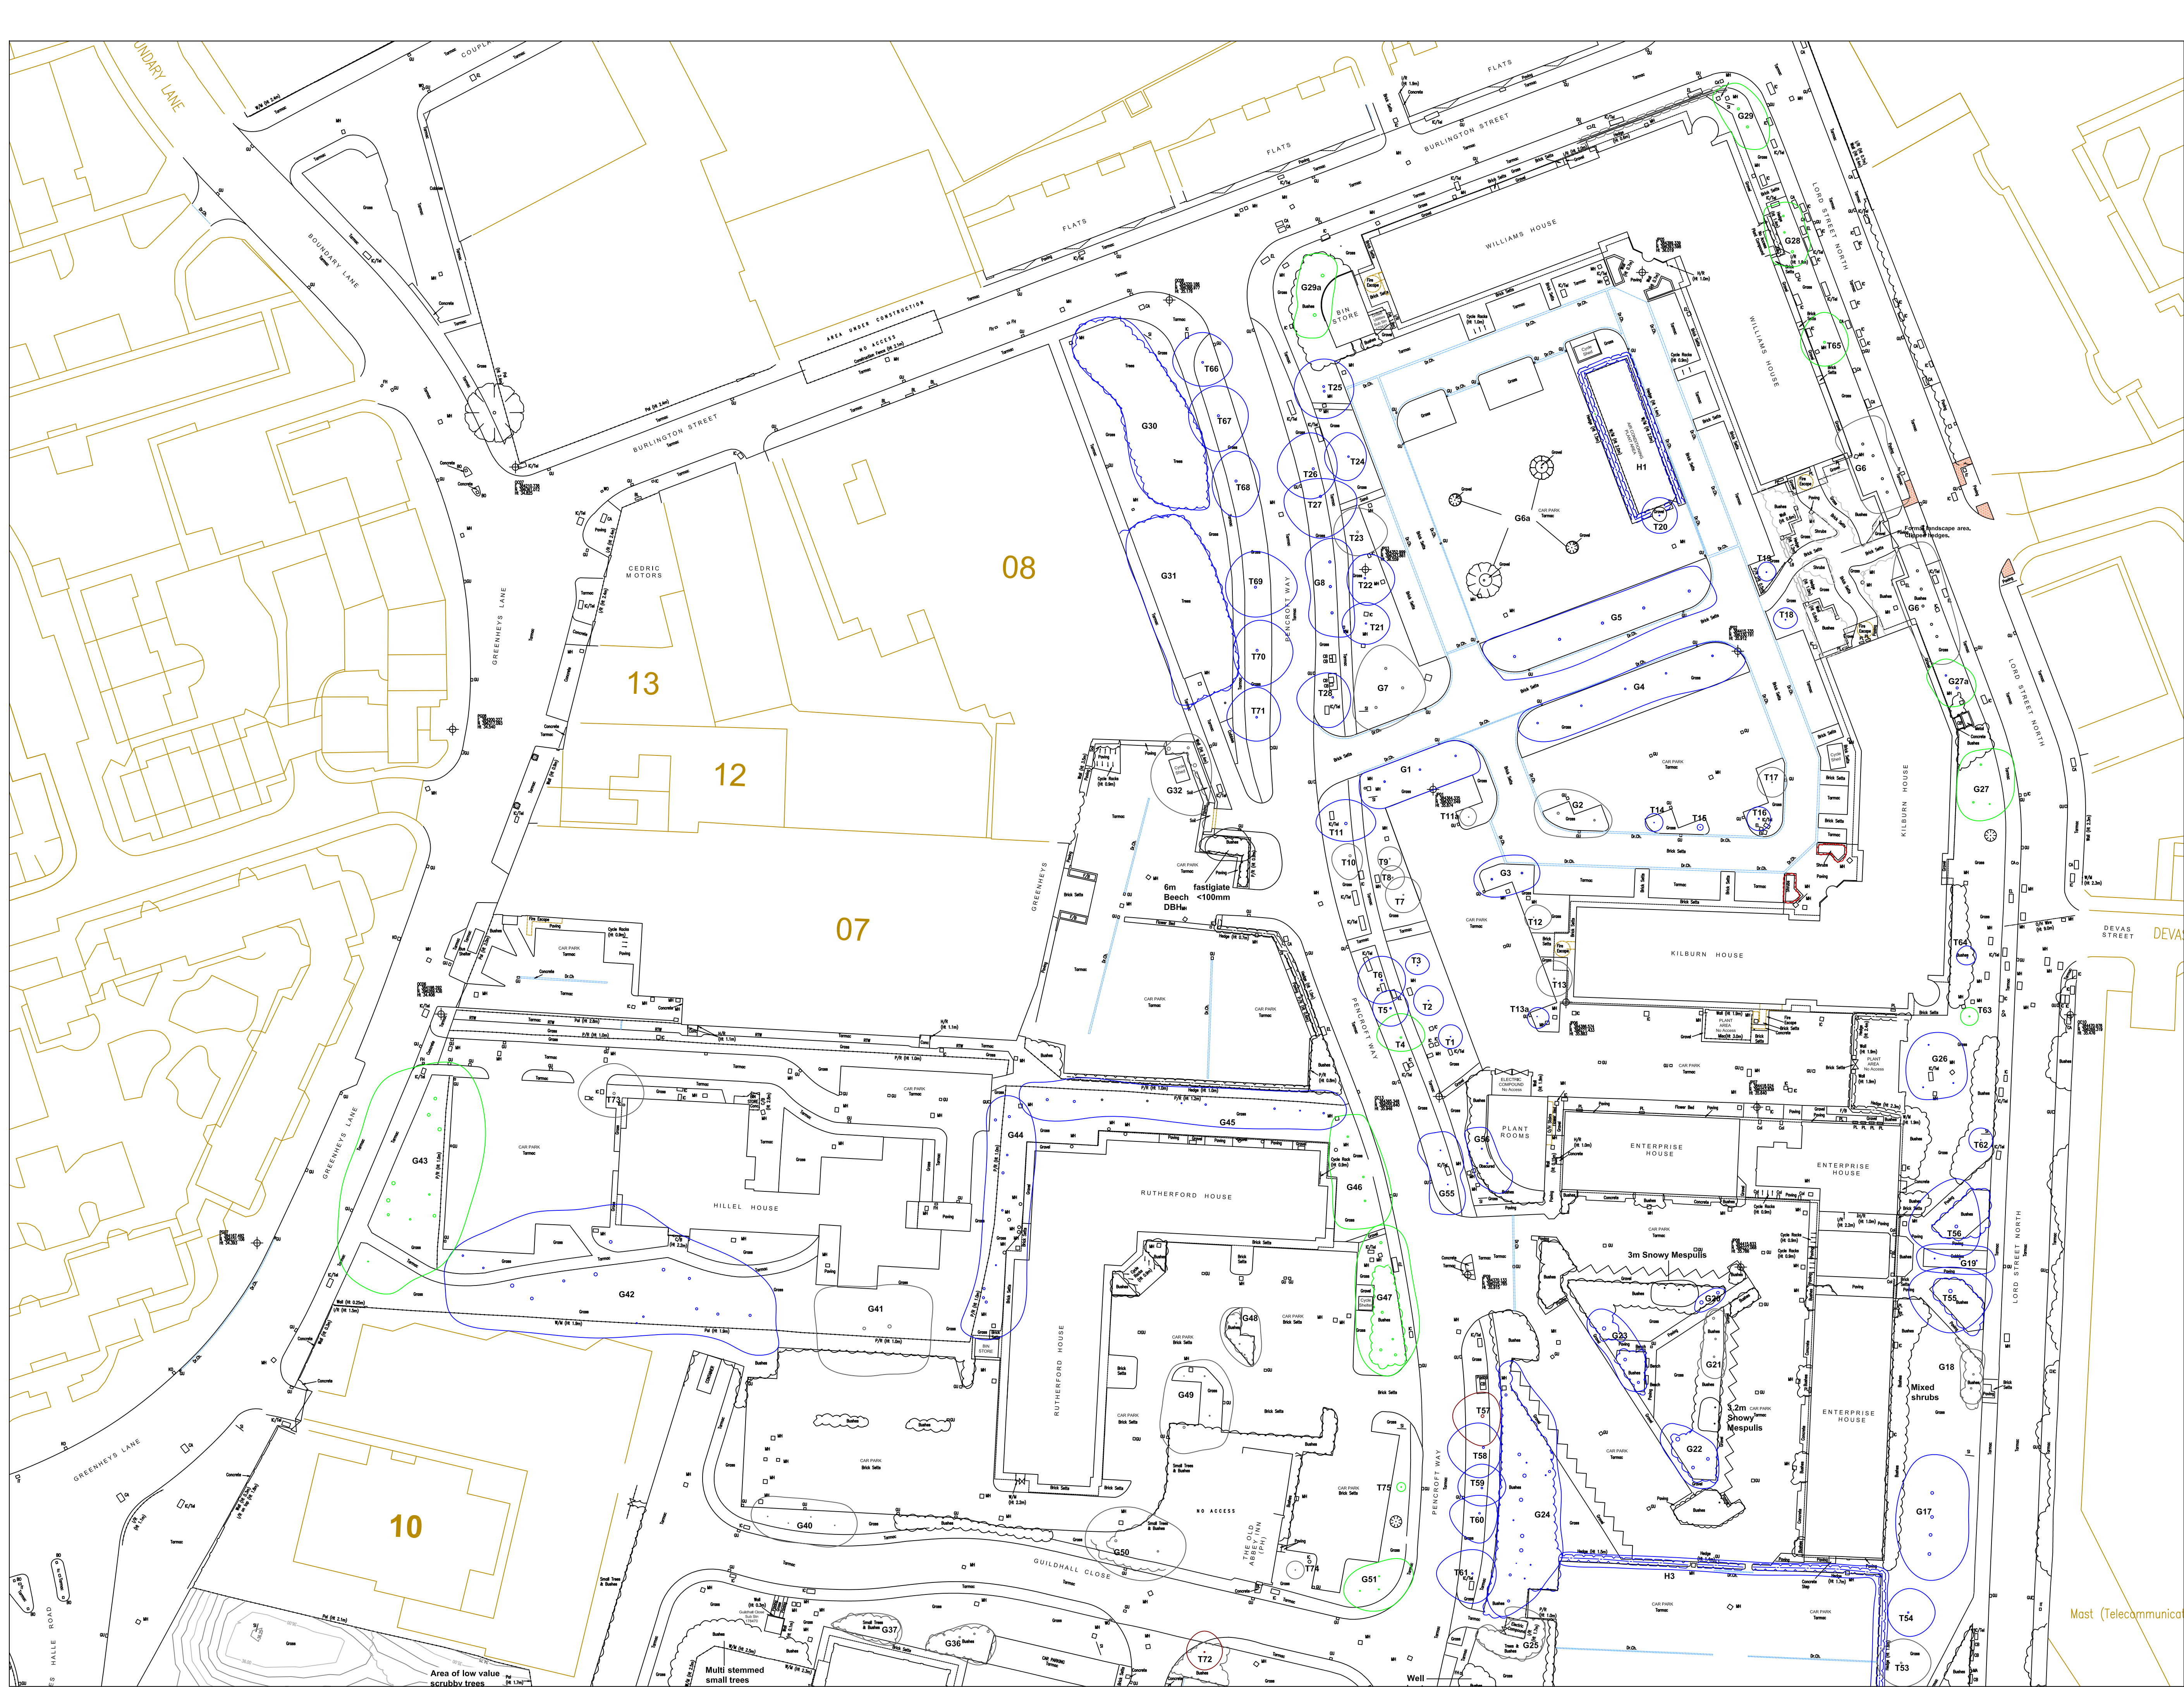
| DATE:<br>14/03/2014 | CHKD BY:<br>AM | P.390.14.01 | B |

Trees surveyed in accordance with BS5837:2012 Trees in relation to design, demolition and construction - Recommendations. Shrubs and trees below 100mm stem diameter not included in survey.

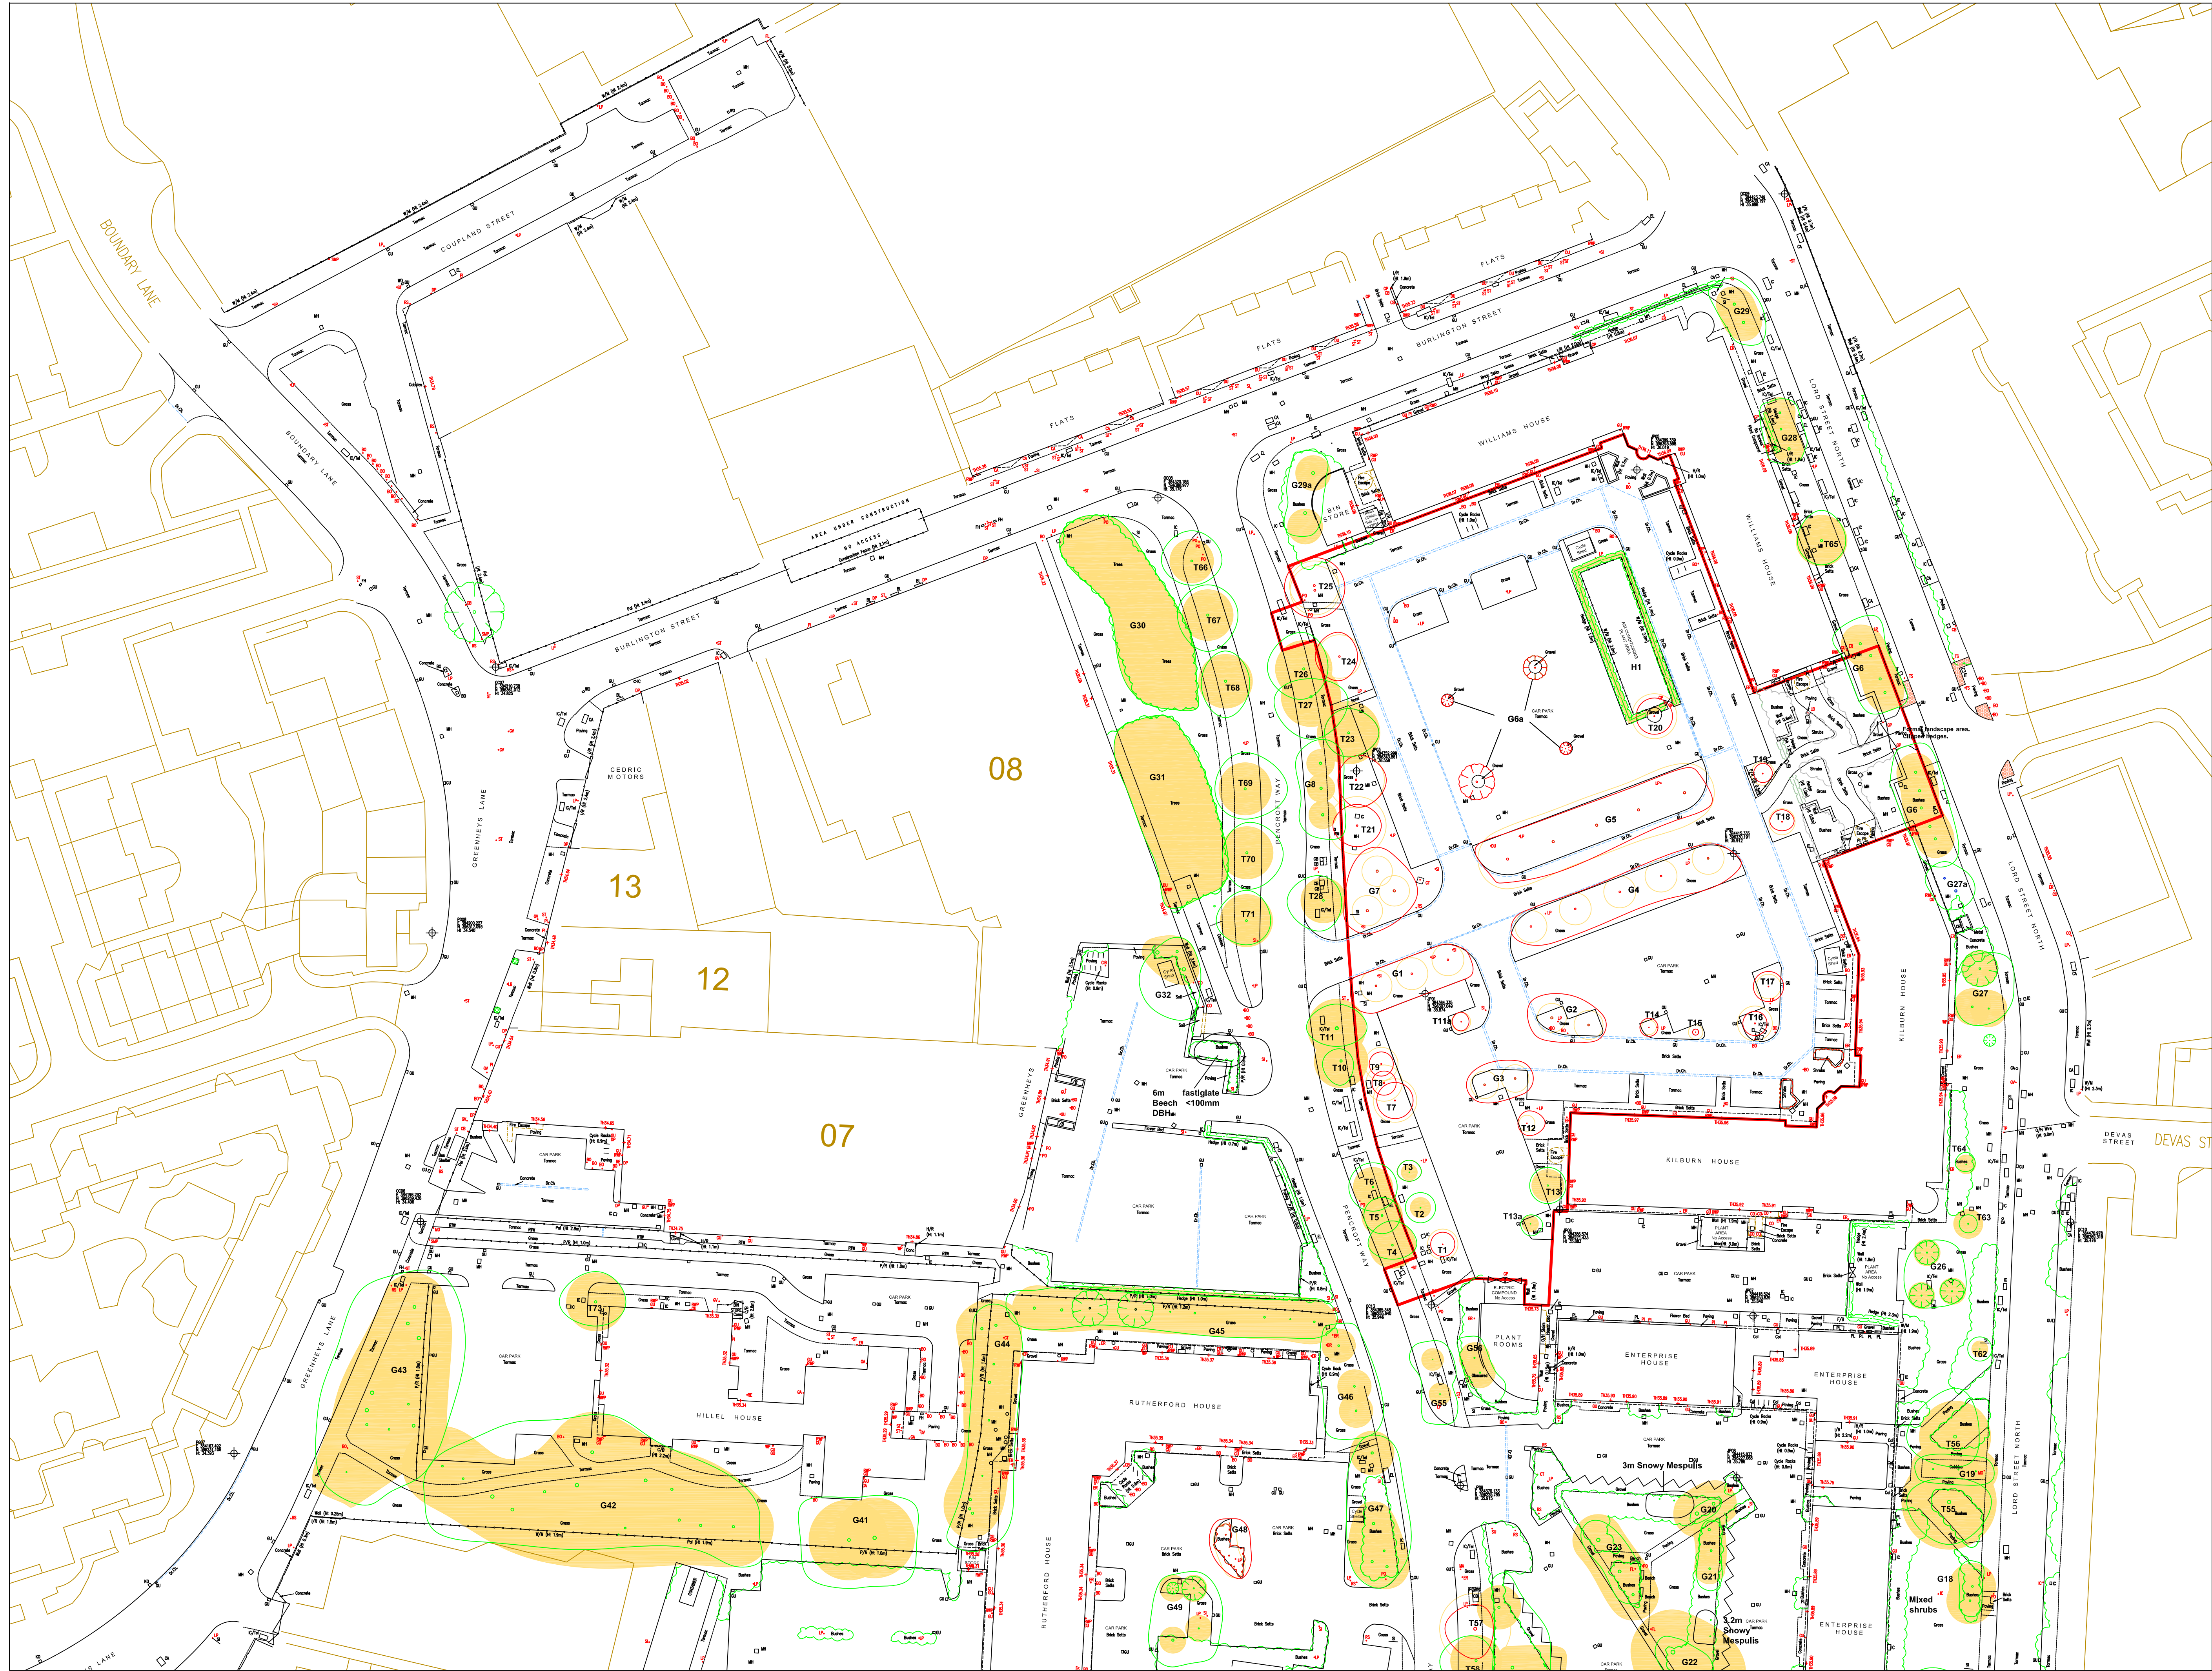
| DATE: | 12/03/2014 | CHKD BY: | AM | P.390.14.02 | | | C |

Extent of Root Protection Area for trees in accordance with BS5837:2012 Trees in relation to design, demolition and construction - Recommendations

Extent of Root Protection Area for category U trees in accordance with BS5837:2012 Trees in relation to design, demolition and construction - Recommendations

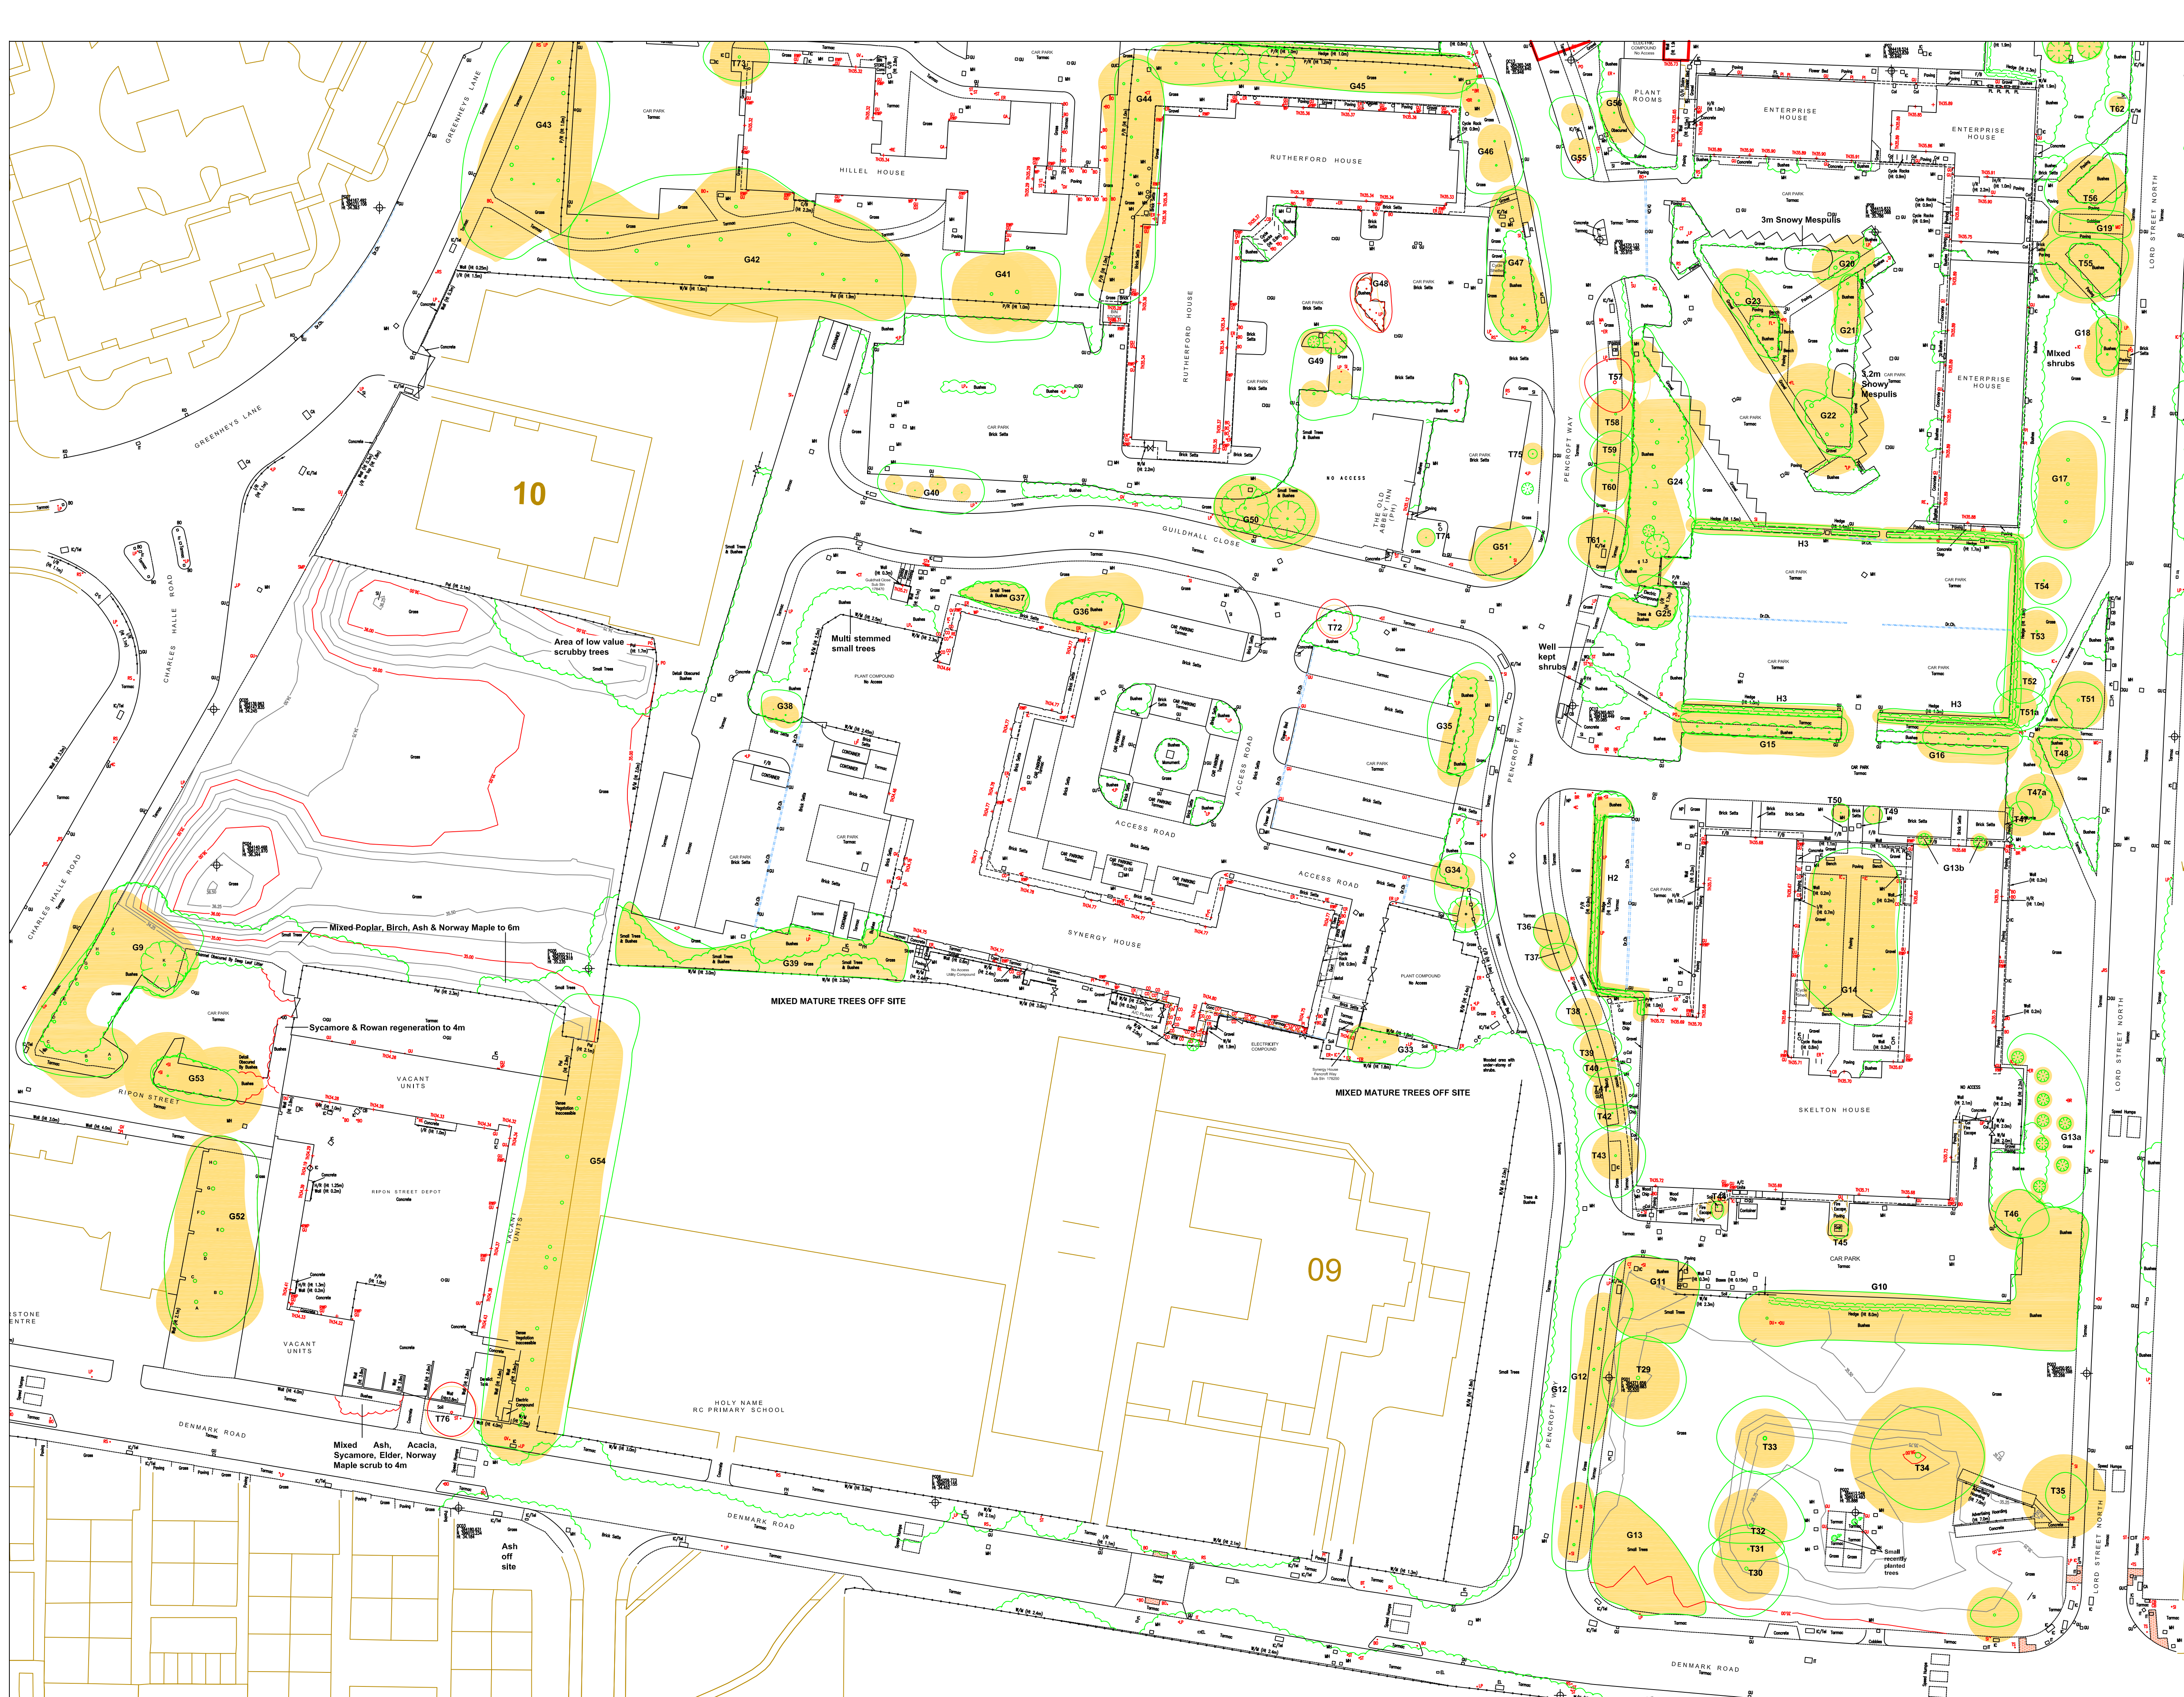
Extent of Root Protection Area for trees in accordance with BS5837: 2012 Trees in relation to design, demolition and construction - Recommendations

Extent of Root Protection Area for category U trees in accordance with BS5837: 2012 Trees in relation to design, demolition and construction - Recommendations
