**Re: Proposed development at Arch 13, Sheffield Street, Manchester M1 2ND  
(Grid Reference SJ 85026 97839)**

We understand that the proposal is for a conversion of the existing arch into a bar business.

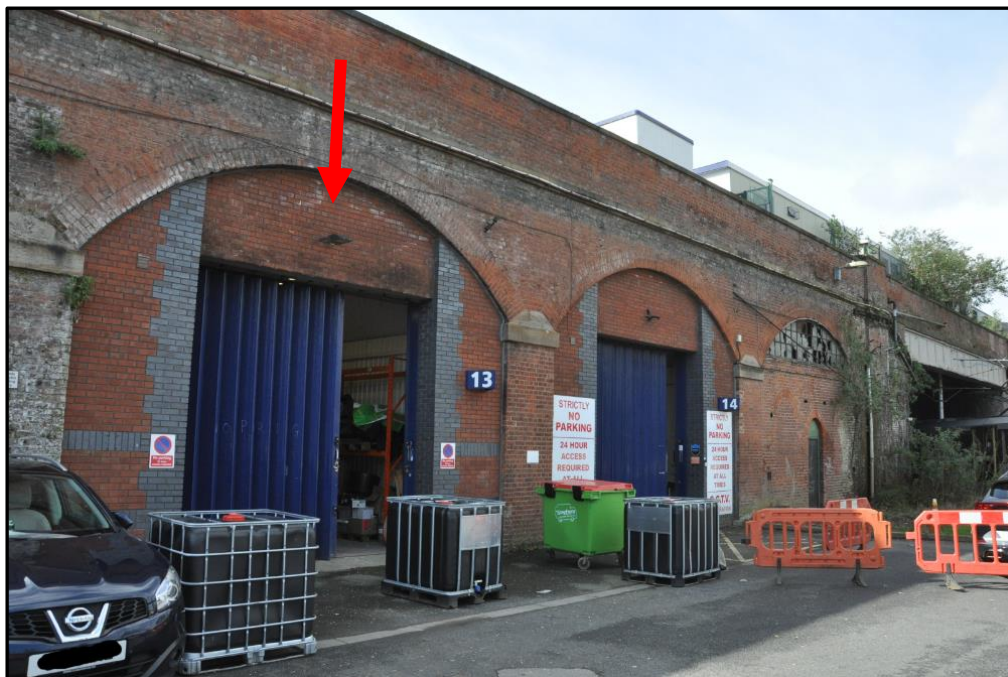
Arch 13 Sheffield Street is a renovated railway arch that is currently used for storage and workshop. The exterior comprises brick walls and a secure metal entrance door. The external walls are in good condition with no gaps or cavities. The interior is a single room with walls and ceiling arch clad with painted metal sheeting. There is a concrete floor and timber partition walls have been part constructed. There are no windows and no roof voids. There is a single fire door to the rear (south west) which leads into a covered shared fire exit area.

There are no potential access points for use by bats and birds and no suitable roost features for bats and nesting sites for birds associated with Arch 13.

*Close up image showing external view of Arch 13 (red arrow)*

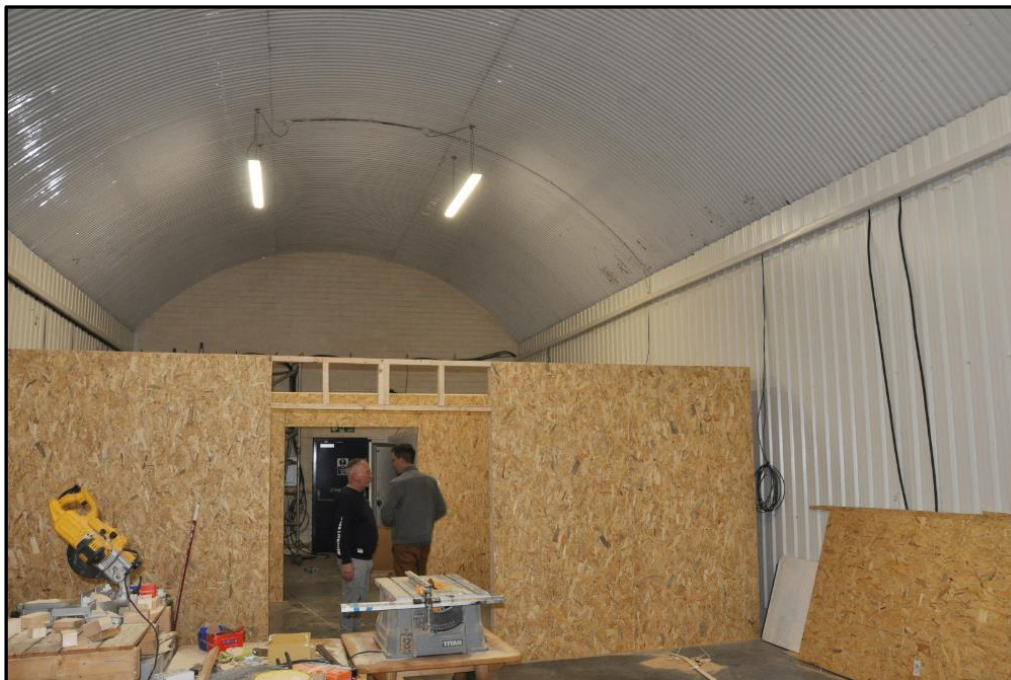
*Internal view of Arch 13 looking south west*

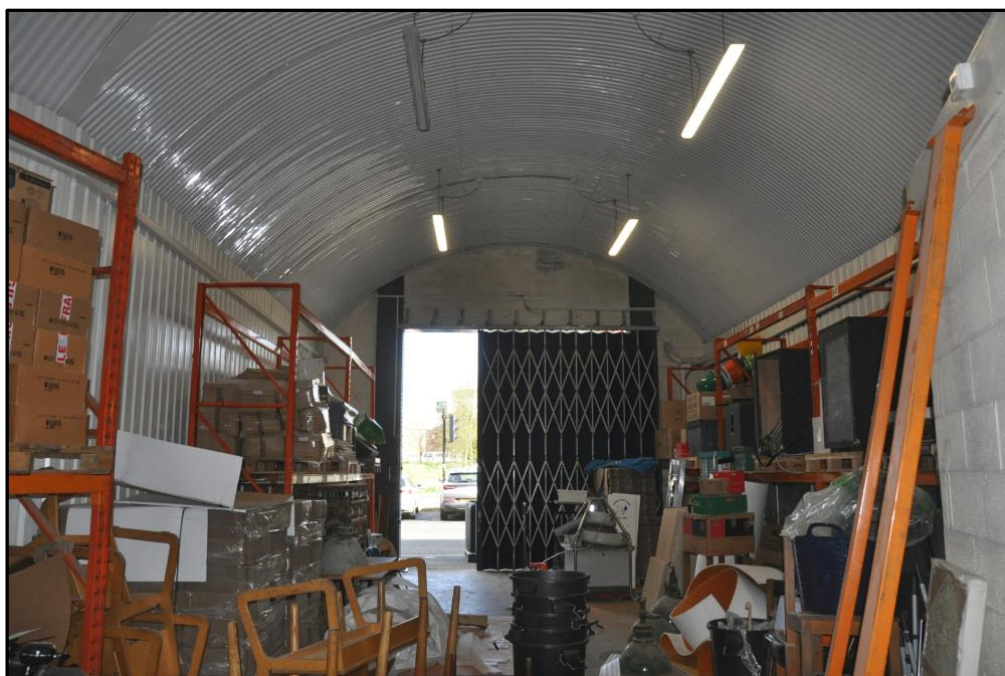
*Internal view of Arch 13 looking north east*
