Phase I Geoenvironmental Site Assessment  
Renaissance, Manchester

Reference: 14-261-R1-1  
Date: September 2020

Renaissance,  
Deansgate  
Manchester  
M3 2FE

Prepared for:  
**Property Alliance Group Ltd**

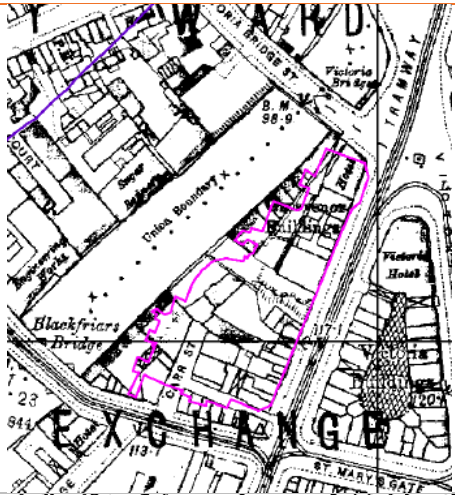
| MAP EDITION | HISTORICAL LAND USE | HISTORICAL MAP EXCERPT |
|---|---|---|
| <b>1892</b><br><br><b>1:2,500</b> | <p>The site has been developed since Pre 1892. A hotel is recorded in the north of the site, with numerous other buildings present across the site.</p> <p>A section of Carr Street is present in the south western corner of the site.</p> | |

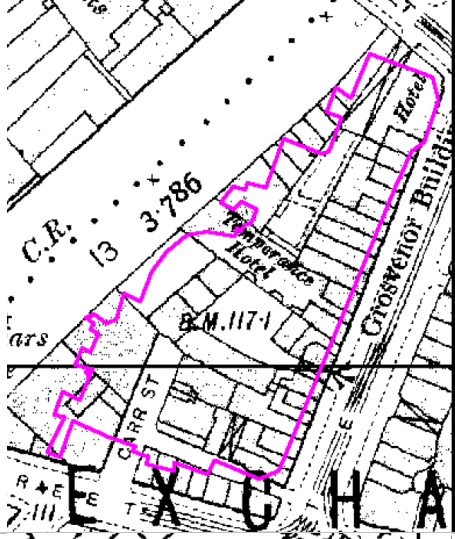
| MAP EDITION | HISTORICAL LAND USE | HISTORICAL MAP EXCERPT |
|---|---|---|
| <b>1908</b><br><br><b>1:2,500</b> | <p>A building in the centre of the site is named as the Temperance Hotel.</p> <p>The rest of the site remains relatively unchanged.</p> | |

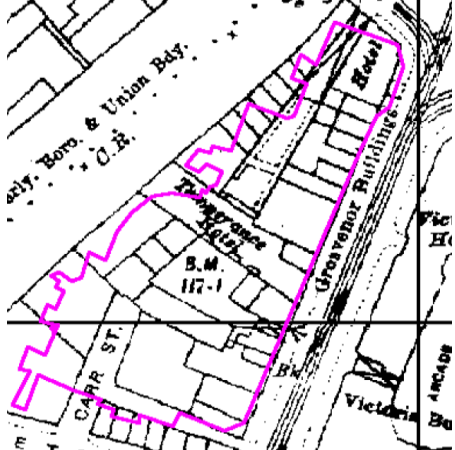
| MAP EDITION | HISTORICAL LAND USE | HISTORICAL MAP EXCERPT |
|---|---|---|
| <b>1932-1933</b><br><br><b>1:2,500</b> | <p>The site remains relatively unchanged.</p> | |

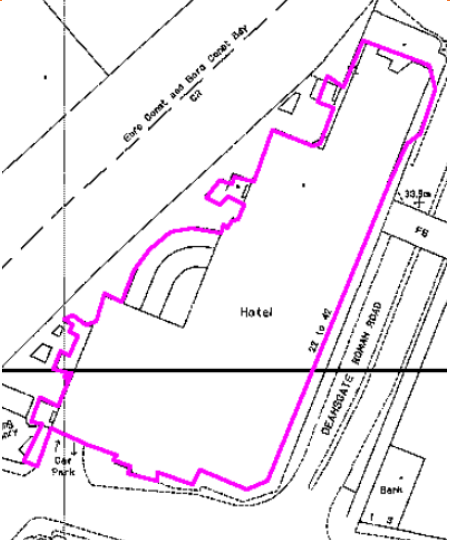
| MAP EDITION | HISTORICAL LAND USE | HISTORICAL MAP EXCERPT |
|---|---|---|
| <p><b>1992</b><br/><b>1:1,250</b></p> | <p>There are no significant changes recorded at the subject site.</p> | |

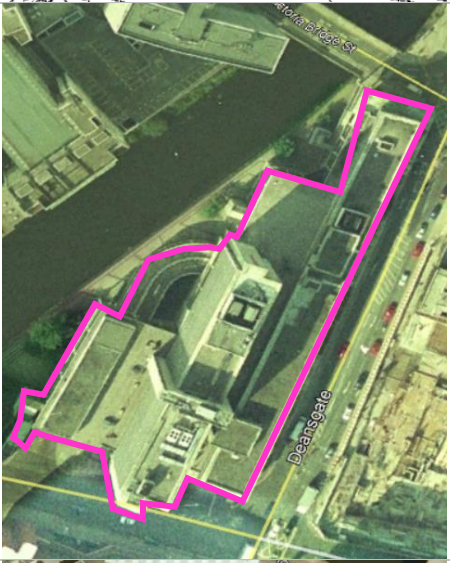
| MAP EDITION | HISTORICAL LAND USE | HISTORICAL MAP EXCERPT |
|---|---|---|
| <p><b>Google Earth</b><br/><b>2000</b></p> | <p>There are no significant changes recorded at the subject site.</p> | |

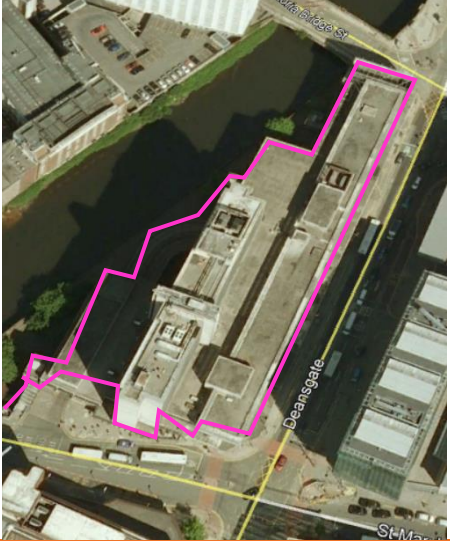
| MAP EDITION | HISTORICAL LAND USE | HISTORICAL MAP EXCERPT |
|---|---|---|
| <p><b>Google Earth</b><br/><b>2009</b></p> | <p>There are no significant changes recorded at the subject site.</p> | |

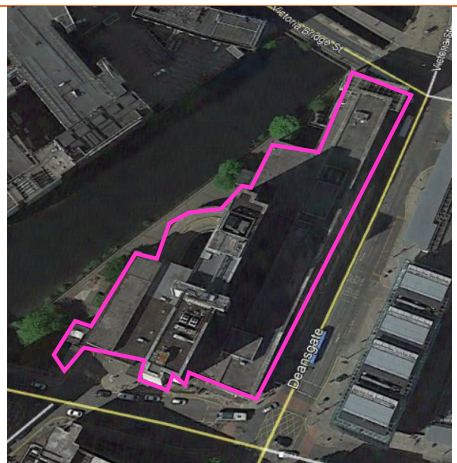
| MAP EDITION | HISTORICAL LAND USE | HISTORICAL MAP EXCERPT |
|---|---|---|
| Google Earth<br>2019 | There are no significant changes recorded at the subject site. | |
