# Television Post-Construction Survey Report

Mulbury New Cross (Goulden Street, Oldham Road and  
Bendix Street)

Mulbury Homes Limited

March 2023

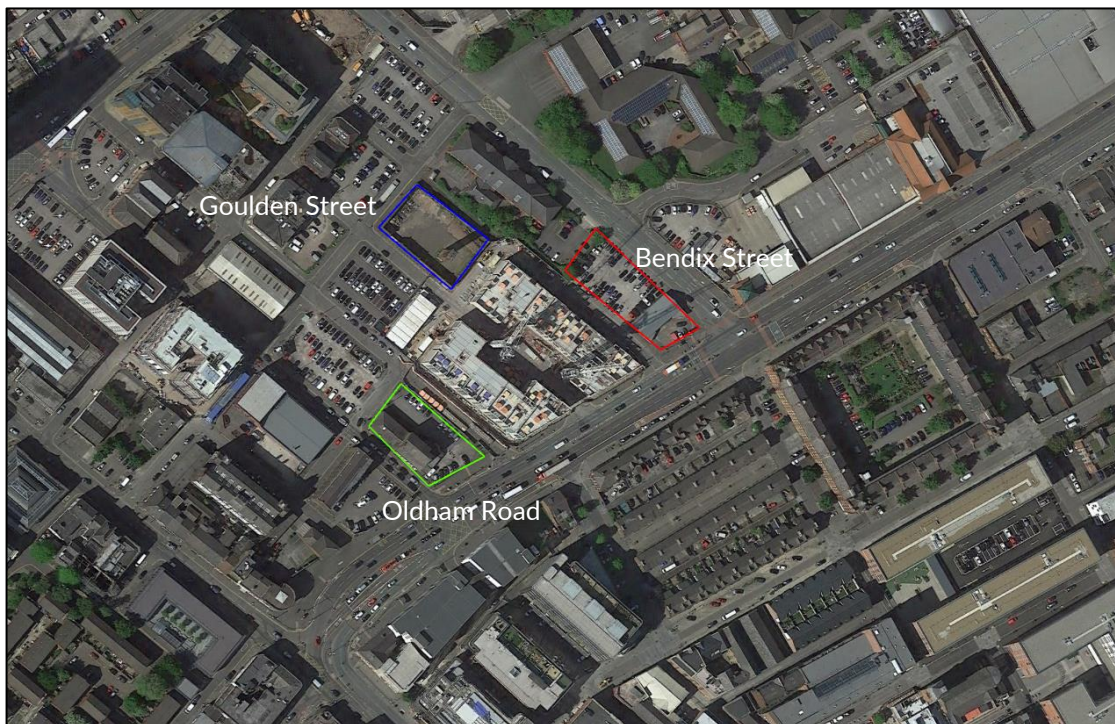
Figure 1 Building boundaries

The development consists of three separate buildings built at Goulden Street (8 storeys), Oldham Road (11 storeys) and Bendix Street (9 storeys). The development boundaries overlaid on an aerial image from November 2019 are shown in Figure 1 below.

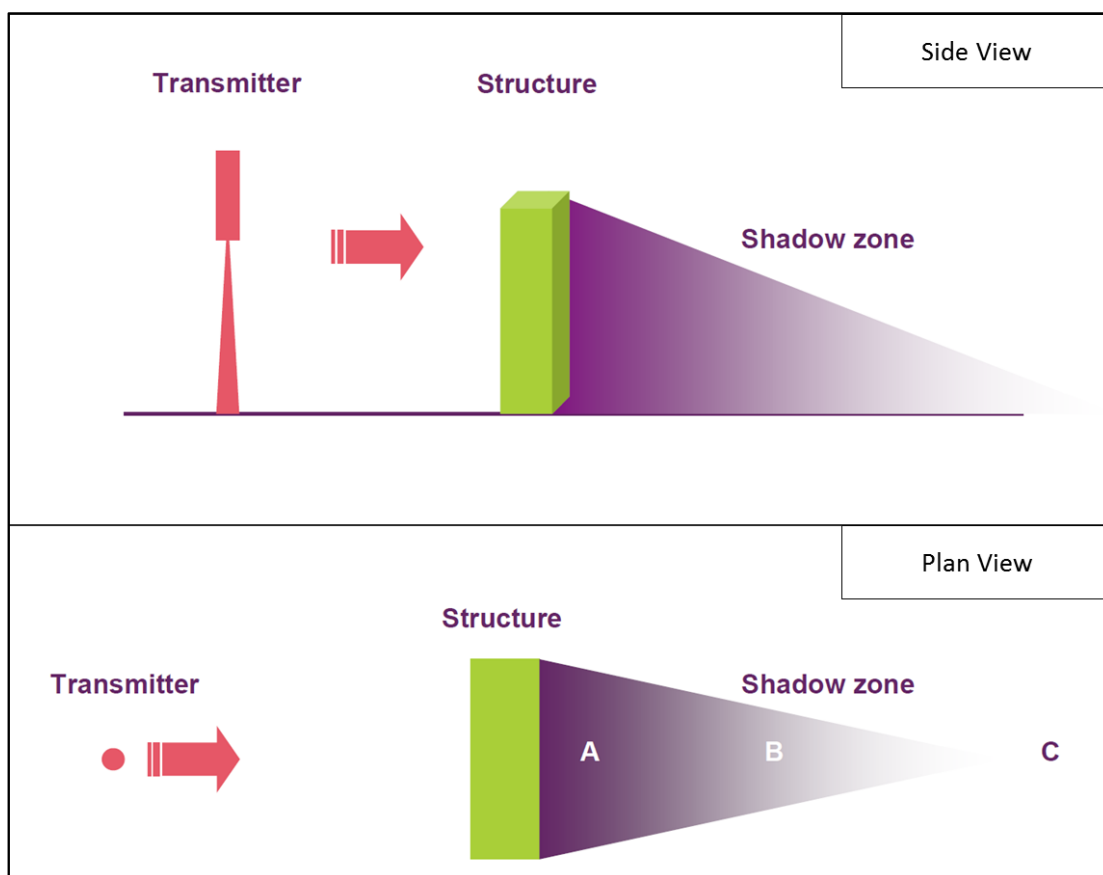
Figure 3 Diffraction Loss Zones

*"In general, there will be three 'zones' behind the structure:*

*Zone A - close behind the structure (typically a few tens of metres) there may be a large reduction in signal level with a possible complete loss of reception*

*Zone B - further away (typically a few hundred metres) the signal reduction is less severe and the shadow will be smaller as diffraction effects partially fill in the shadow. Depending on the size of the structure, some locations could still lose reception completely*

*Zone C - some distance away (1-5km) the shadow will effectively have disappeared."*

The zones mentioned are illustrated in Figure 3<sup>3</sup> on the following page, taken from Section 3.2 of the OFCOM guidance regarding the impact of buildings on broadcast signals.

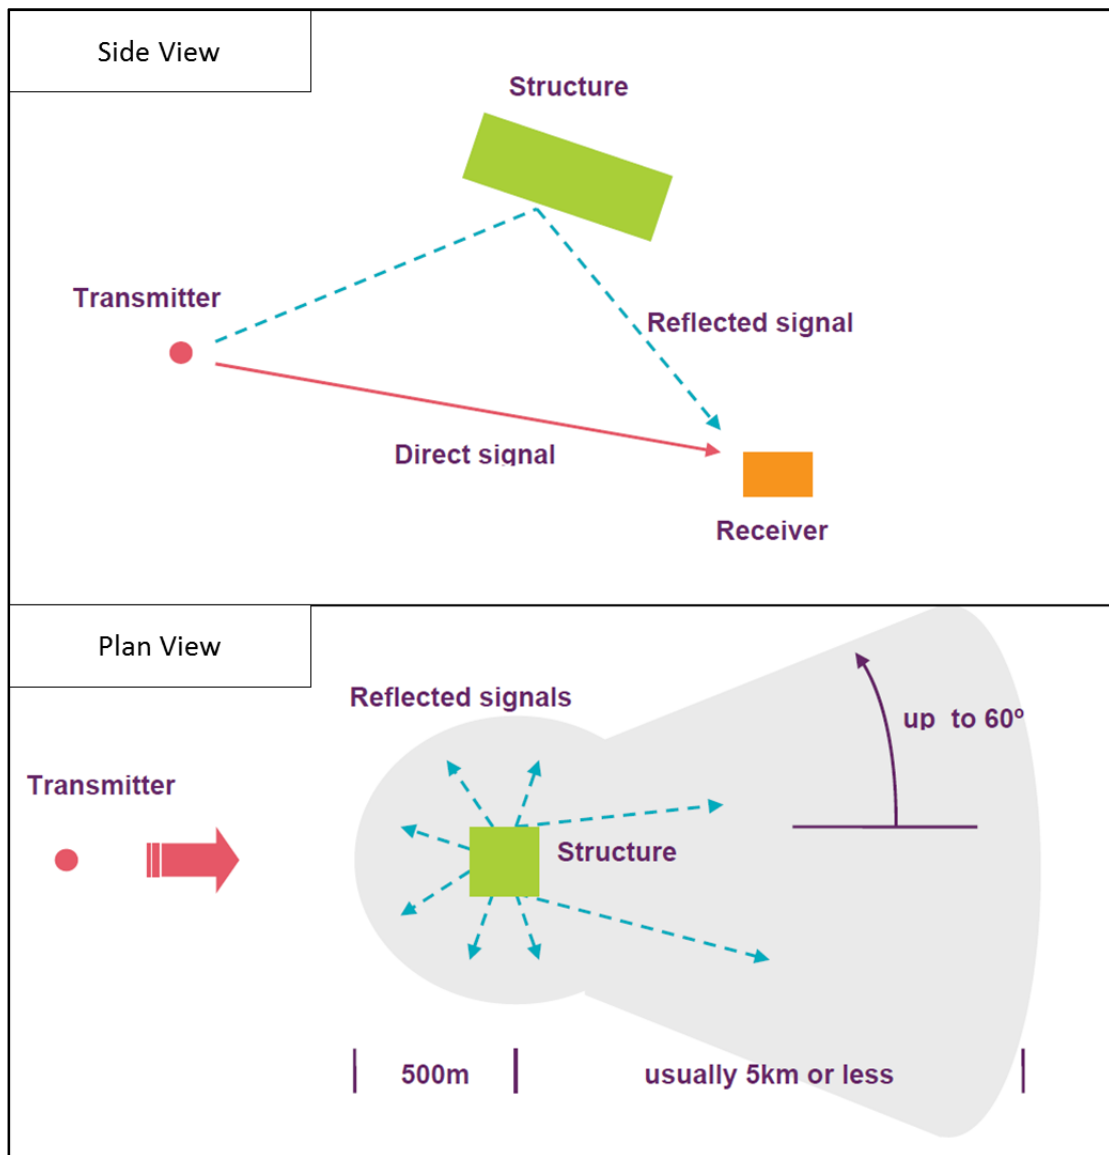
Figure 4 Reflection Zones

For large developments with straight edges, the transmitted signal can be reflected by the building itself. This causes an effect known as ‘multipath interference’ whereby the signal is received twice by an aerial at different times. The direct signal arrives first because it has a shorter distance to travel.

Figure 4<sup>4</sup> on the following page (taken from Section 3.3 of the OFCOM guidance referenced previously) illustrates this effect.

In practice, it is considered highly unlikely that reflections will have an effect for receivers in front of the building or on either side when viewed from the location of the transmitter. For digital transmissions in particular, it is unlikely that issues will occur if the angle between the direct signal and the reflected signal is more than 30 degrees<sup>5</sup>.

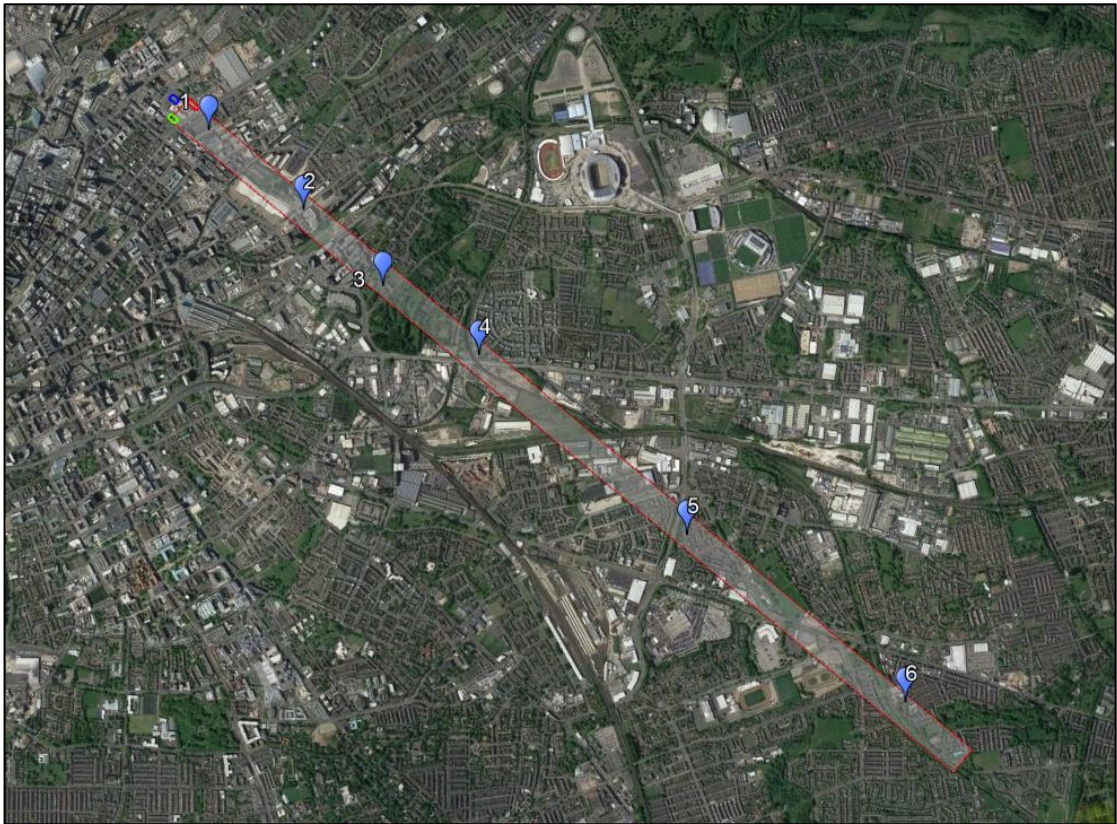
Figure 7 Survey locations

Figure 7 on the following page shows the survey locations overlaid onto aerial photography with the icons showing where television reception measurements were taken. The shadow and reflection zones (grey area highlighted red) is also shown. Survey locations were chosen pre-survey (within the shadow zone) however safe and available access influenced the specific position on the day. The locations on the following page show the actual survey locations. The coordinates of these points can be found in Appendix A and B.

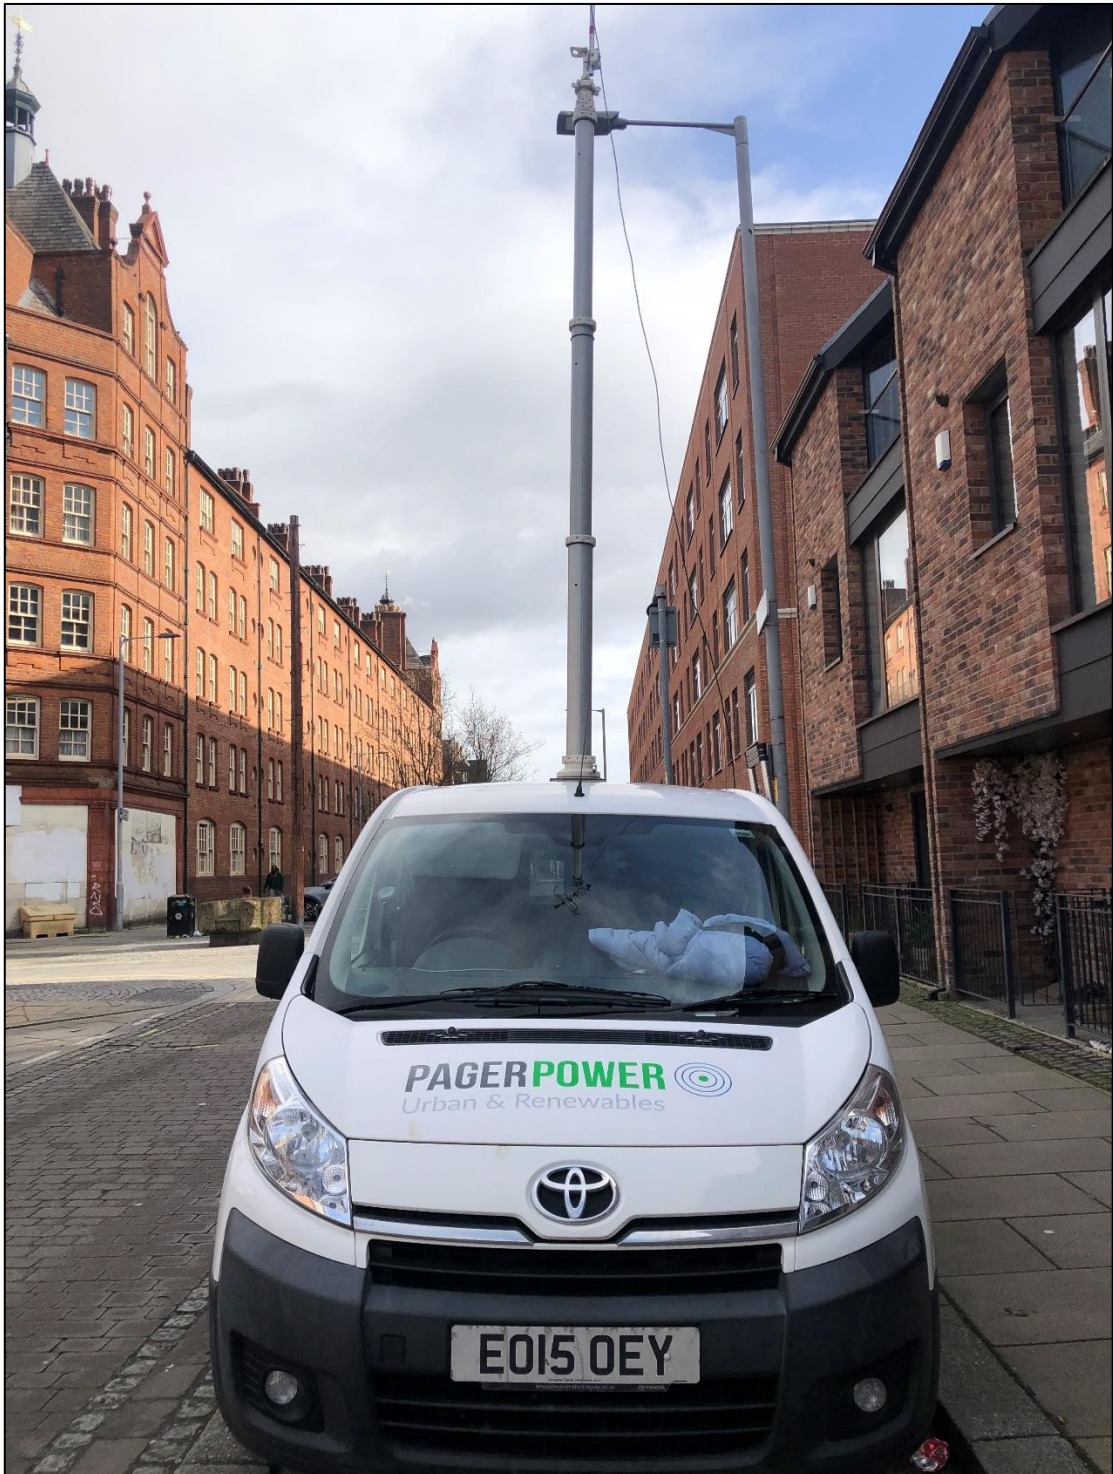
Location 1 (baseline survey)

| Location | Average Measured Signal Strength (dB) | Remarks | Conclusions |
|---|---|---|---|
| 1 | <u>Baseline</u><br>Main TV MUX: 41<br>Local TV MUX: 37 | <p>Horizontally polarised aerials directed towards the Winter Hill transmitter and satellite dishes were observed.</p> <p><u>Baseline:</u> All main multiplexes displayed fine picture and audio quality</p> <p>Two out of four local multiplexes were not decoded at this location</p> | <p>The survey location is within 200m of the closest of the Mulbury New Cross development and within its shadow zone</p> <p><u>The reduction in TV signal strength at this location could be attributable to the Mulbury New Cross development. However, there is no change in picture or audio quality to channels that did decode. Results are also consistent to channels that did/did not decode</u></p> |
| | <u>Post-Construction</u><br>Main TV MUX: 30<br>Local TV MUX: 31 | <p><u>Post-Construction:</u> All main multiplexes displayed fine picture and audio</p> <p>Two out of four local multiplexes were not decoded at this location</p> | |

The current picture and audio quality of main multiplexes in the immediate shadow has not changed, therefore mitigation is not recommended. However, any reported television interference within the immediate shadow zone (within 1km of the development) should be investigated by means of a reception measurement.

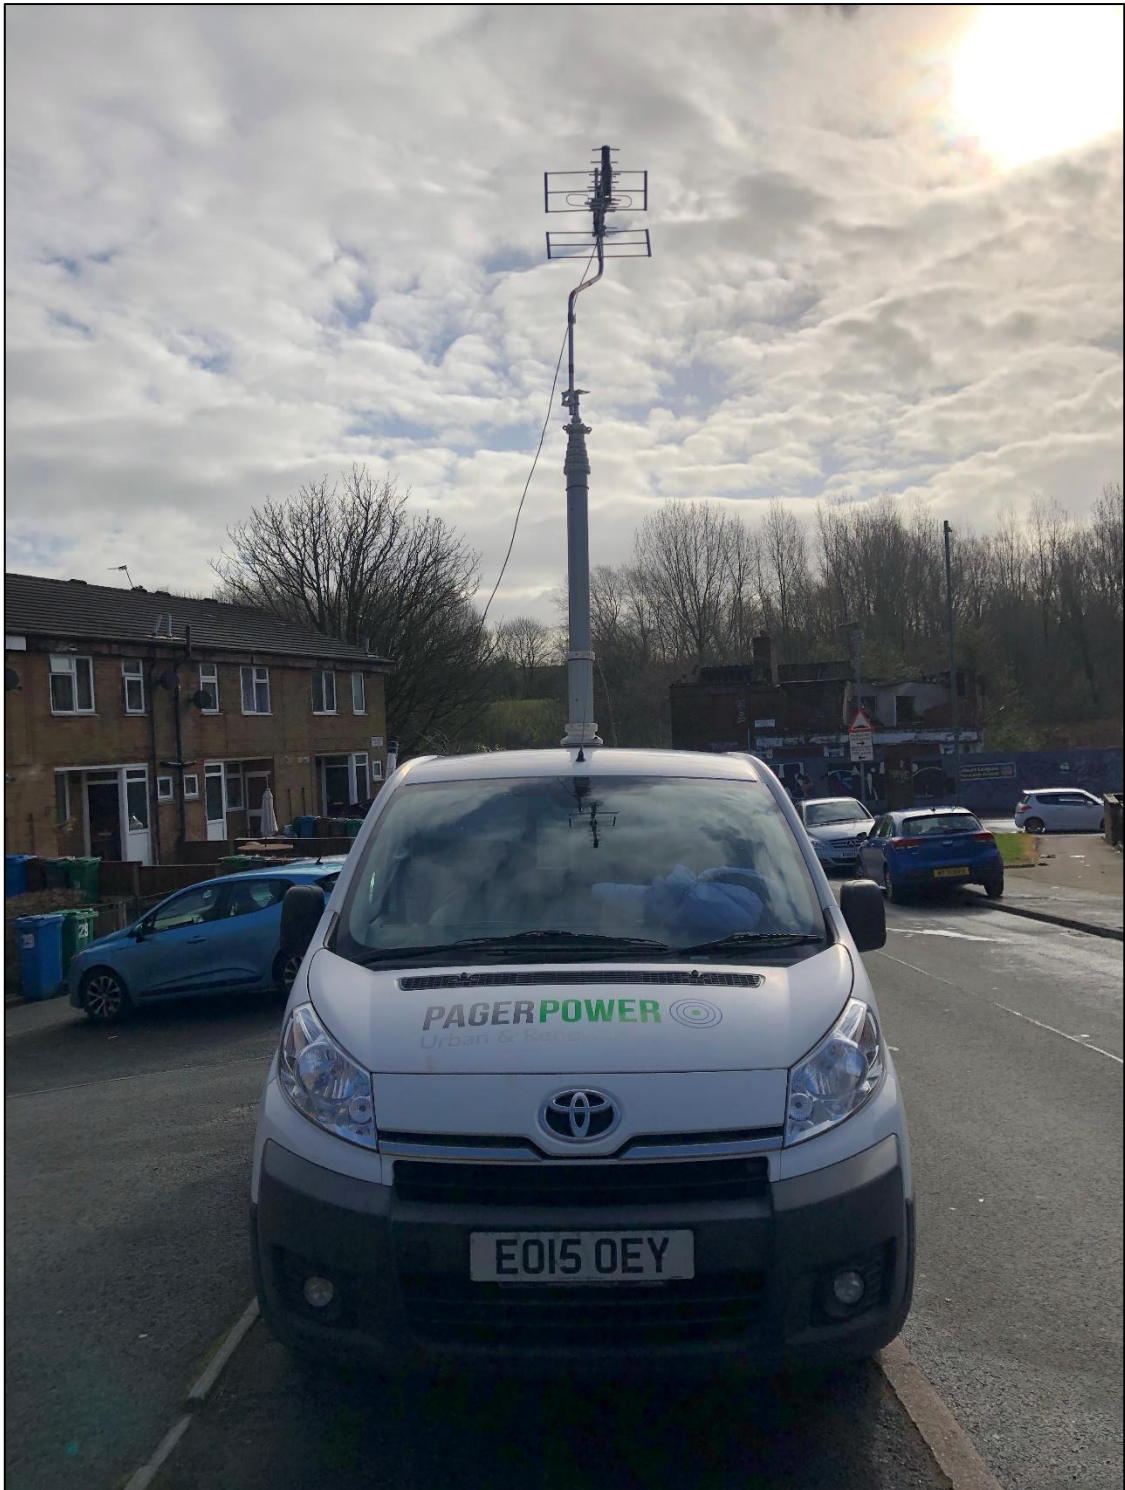
Location 3 (baseline survey)

| Location | Average Measured Signal Strength (dB) | Remarks | Conclusions |
|---|---|---|---|
| 3 | <u><b>Baseline</b></u><br>Main TV MUX: 42<br>Local TV MUX: 36 | <p>Horizontally polarised aerials directed towards the Winter Hill transmitter and satellite dishes were observed.</p> <p><u><b>Baseline:</b></u> All main multiplexes displayed fine picture and audio quality</p> <p>Two out of four local multiplexes were not decoded at this location</p> | <p>The survey location was within 1.3km of the Mulbury New Cross development site and within its shadow zone</p> <p><u><b>The reduction in TV signal strength at this location is not likely to be attributable to the Mulbury New Cross development. However, there is no change in picture or audio quality to channels that did decode. Results are also consistent to channels that did/did not decode</b></u></p> |
| | <u><b>Post-Construction</b></u><br>Main TV MUX: 32<br>Local TV MUX: 32 | <p><u><b>Post-Construction:</b></u> All main multiplexes displayed fine picture and audio</p> <p>Two out of four local multiplexes were not decoded at this location</p> | |

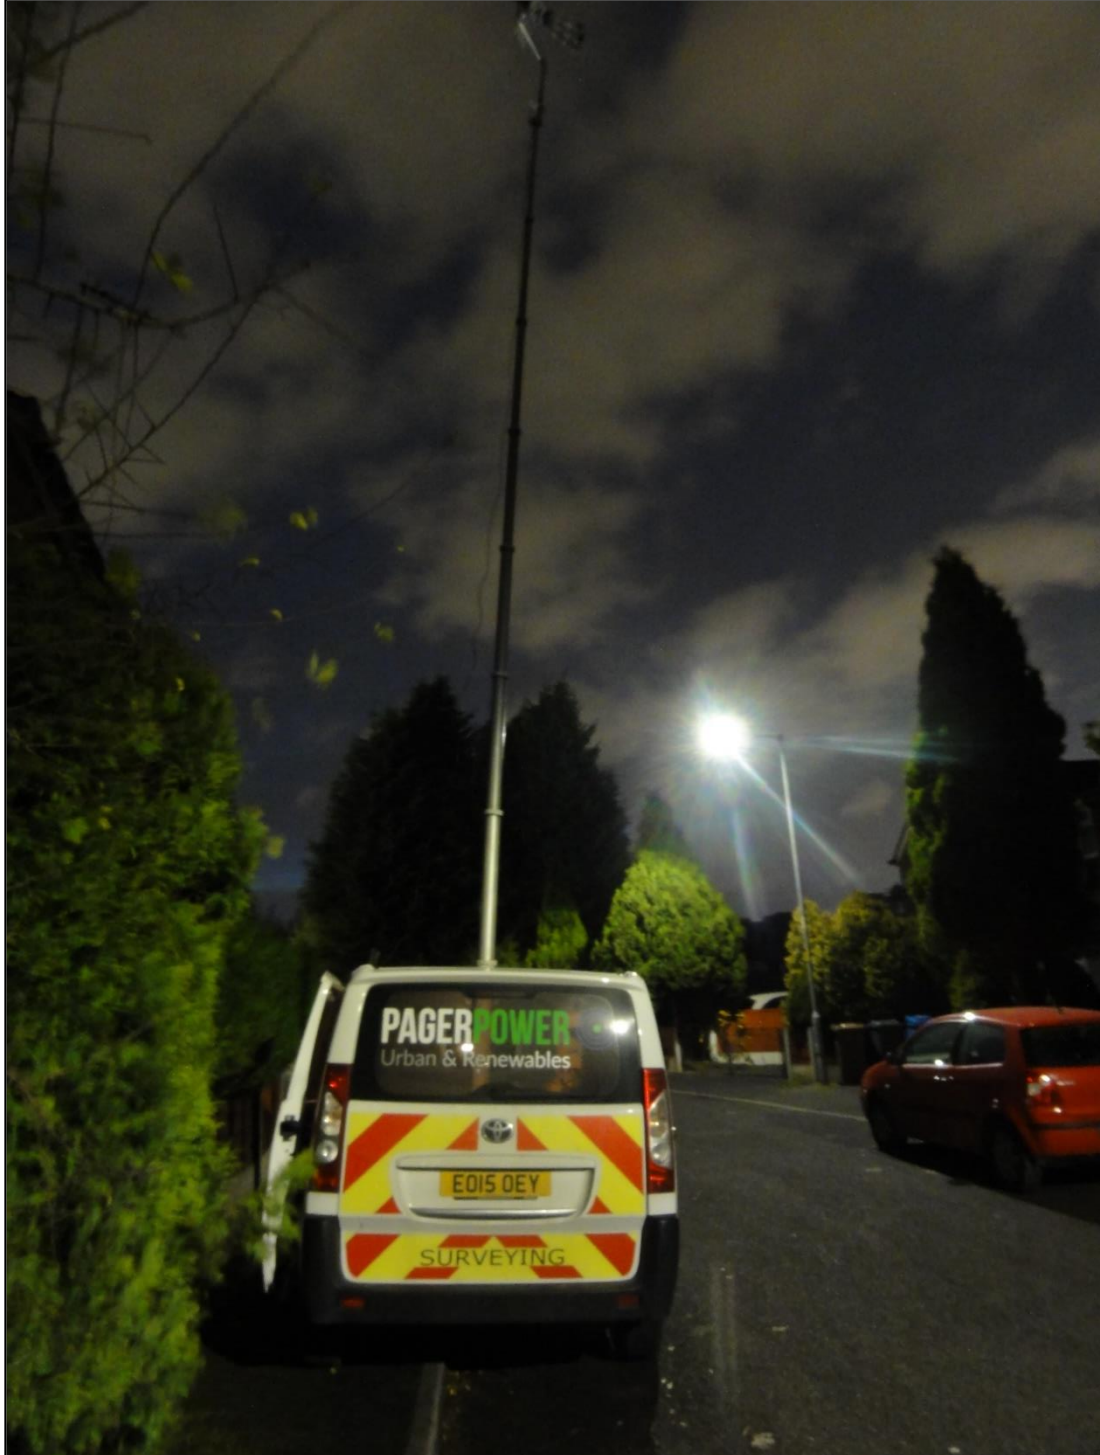
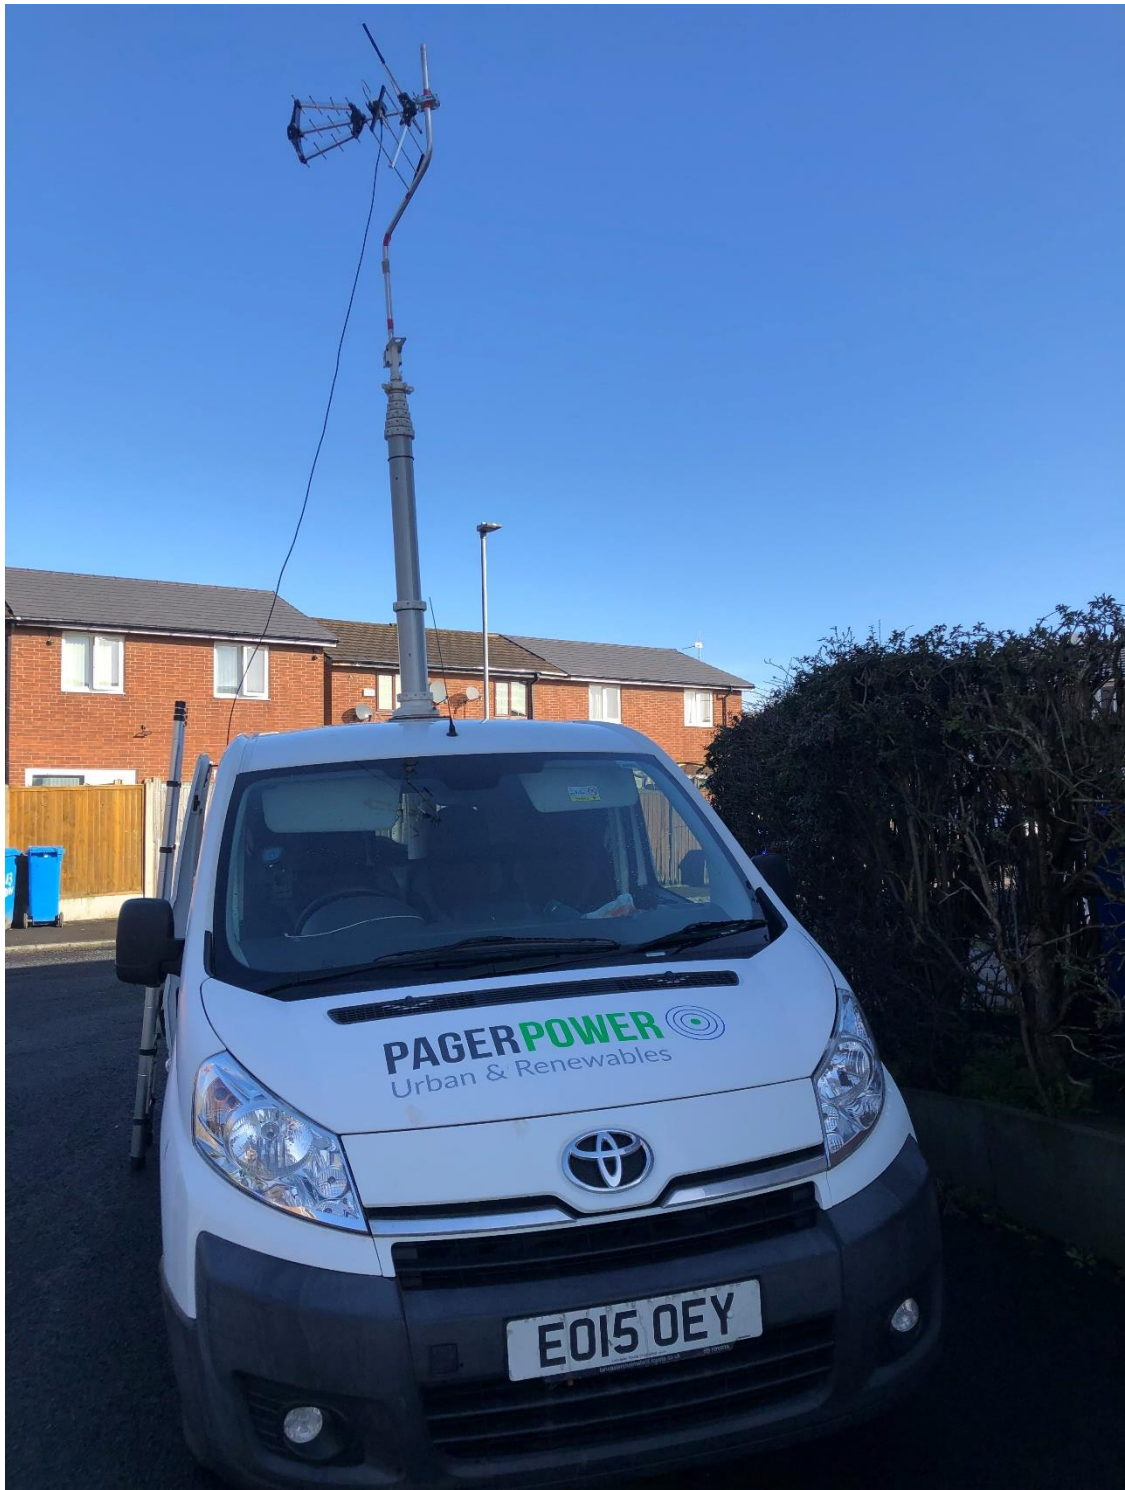
Location 6 (baseline survey)

| Location | Average Measured Signal Strength (dB) | Remarks | Conclusions |
|---|---|---|---|
| 6 | <u>Baseline</u><br>Main TV MUX: 64<br>Local TV MUX: 48 | <p>Horizontally polarised aerials directed towards the Winter Hill transmitter and satellite dishes were observed.</p> <p><u>Baseline:</u> All main multiplexes displayed fine picture and audio quality, with signal fluctuations of less than 1dB and no signs of interference</p> | <p>The survey location was within 4.5km of the proposed development and within its shadow zone</p> <p><u>The reduction in TV signal strength at this location is not likely to be attributable to the Mulbury New Cross development. However, there is no change in picture or audio quality to channels that did decode. The reduction in local multiplexes is likely due to signal strength from weaker transmissions</u></p> |
